# A487 PROPOSED PENYGROES TO LLANLLYFNI BYPASS (G1271)

# ARCHAEOLOGICAL EVALUATION

**REPORT NO.159**

April 1995

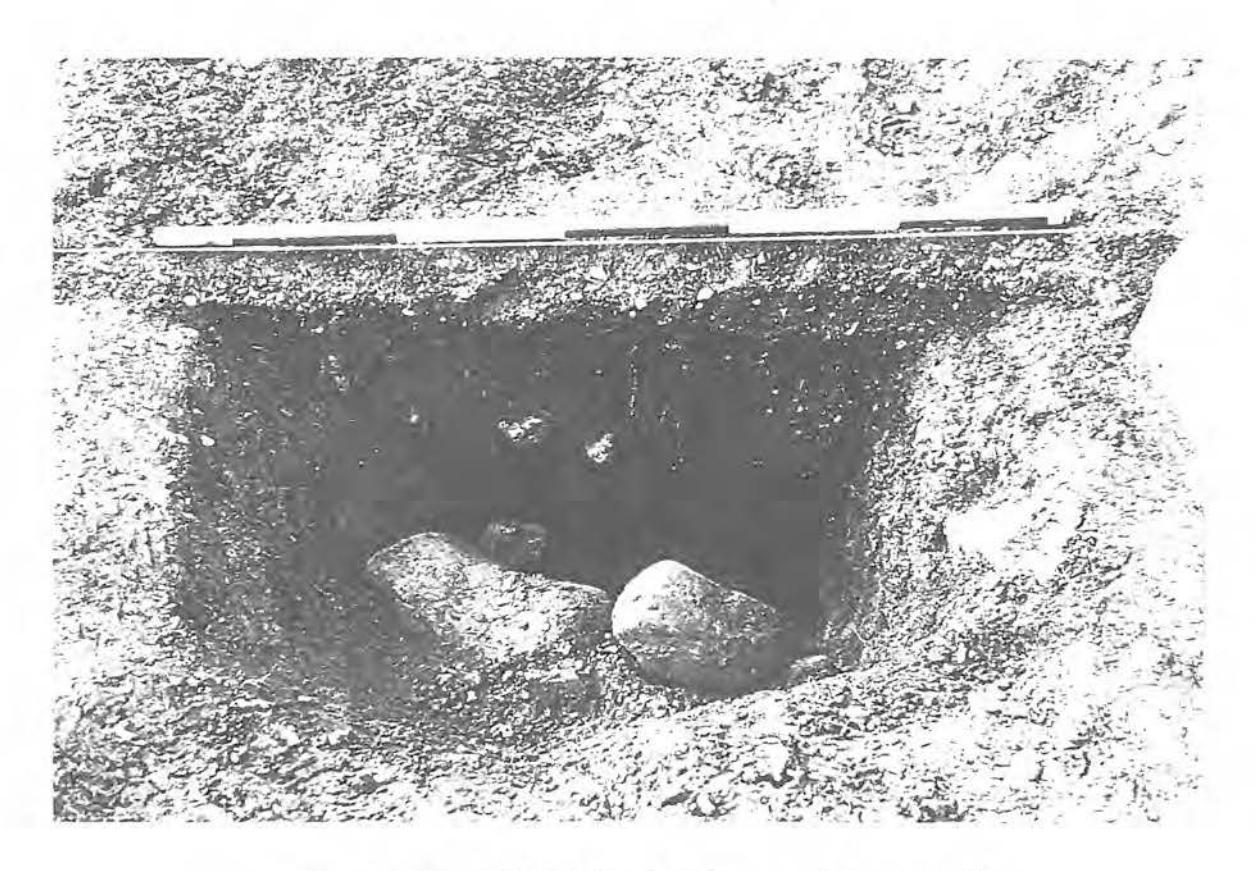
Plate 1 Area 1 - Trench B - Post hole partly excavated

**Trench B** Trench B measured 5 x 2 m and was located on the brow of a slight platform which offered commanding views of the area west of Bodychain Uchaf farm. A fairly substantial post hole with packing stones was located and excavated. The post hole measured  $1.7m \times 1.2m$  and was 0.50m deep. There is no context or date to which the post hole can be ascribed.

No significant archaeological remains were located in this area. There may be extant features relating to the posthole found in Trench B, although none were found in the adjoining trenches. However in view of the small sample excavated, it is recommended that a watching brief is maintained during the early stages of construction to watch for surviving archaeology which may occur outside those areas sampled.

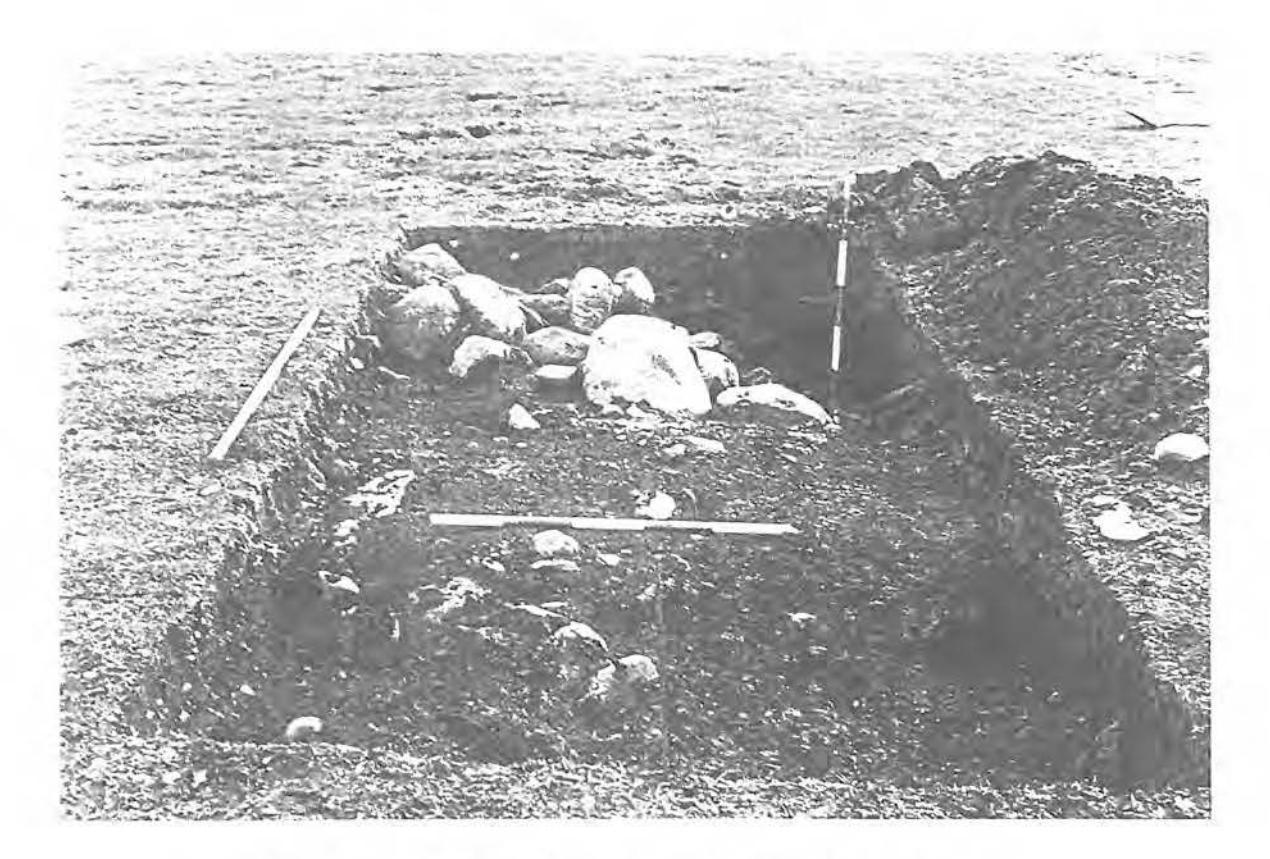
Plate 2 Area 1 - Trench G - "sump" feature in SW corner

**Trench** G Trench G measured  $6 \times 2$  m and was located across the faint geophysical anomaly detected in the main geophysical grid. The field drain already encountered in trench A crossed the trench at its northern end, this also contained modern pot sherds in its lower silt. In the southern end of the trench there was another spread of boulders. Immediately west of and

abutting the stone spread was a large cut feature. The feature measured 0.50m at its deepest point the accumulation of deposits within the feature and the sloping nature of the ground meant that the profile of the trench section at this point was 0.90m deep from the bottom of the cut to the turfline. The fill of the feature contained a large amount of boulders, there were traces of burning on the south and north edges of the cut. While it is not possible to be certain as to the function of this feature it may have acted as a sump for the slighter field drains already recorded, the backfilling of the feature with boulders might support this contention.

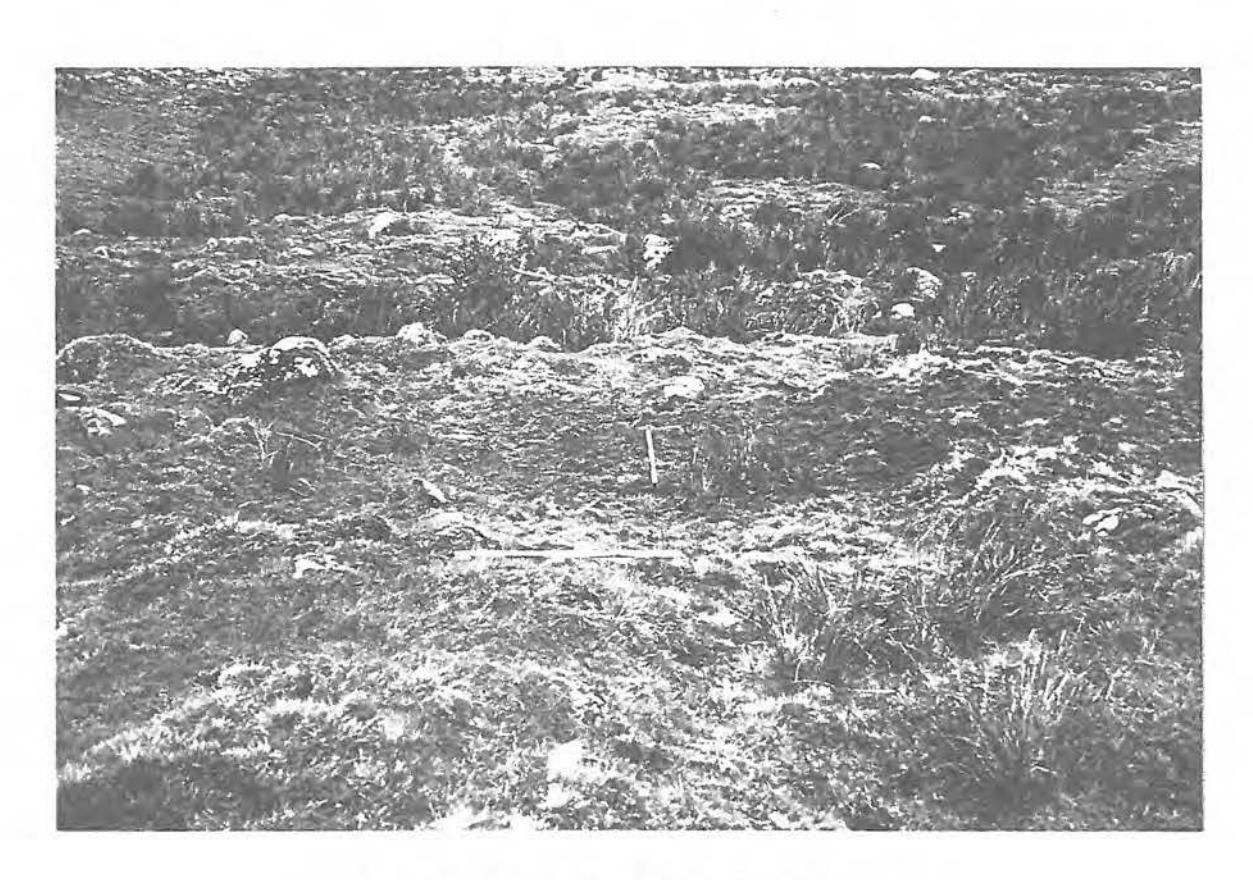
Plate 3 Site 46 - Trench C before excavation

Trench C Trench C measured 3.00 x 1.20 m. The trench was opened across the northern end of a quite well defined platform cut into and across the slope. The south edge of this feature may have been created by upcast from periodic machining of the stream which curves around the south and west sides of the platform. The northern edge was defined by outcropping rock which proved to be natural in origin. A compacted surface aligned on the corner of the platform may have been a trackway; it is possible that this may have contributed to erosion of and the subsequent creation of this hollow in the slope of the hill.

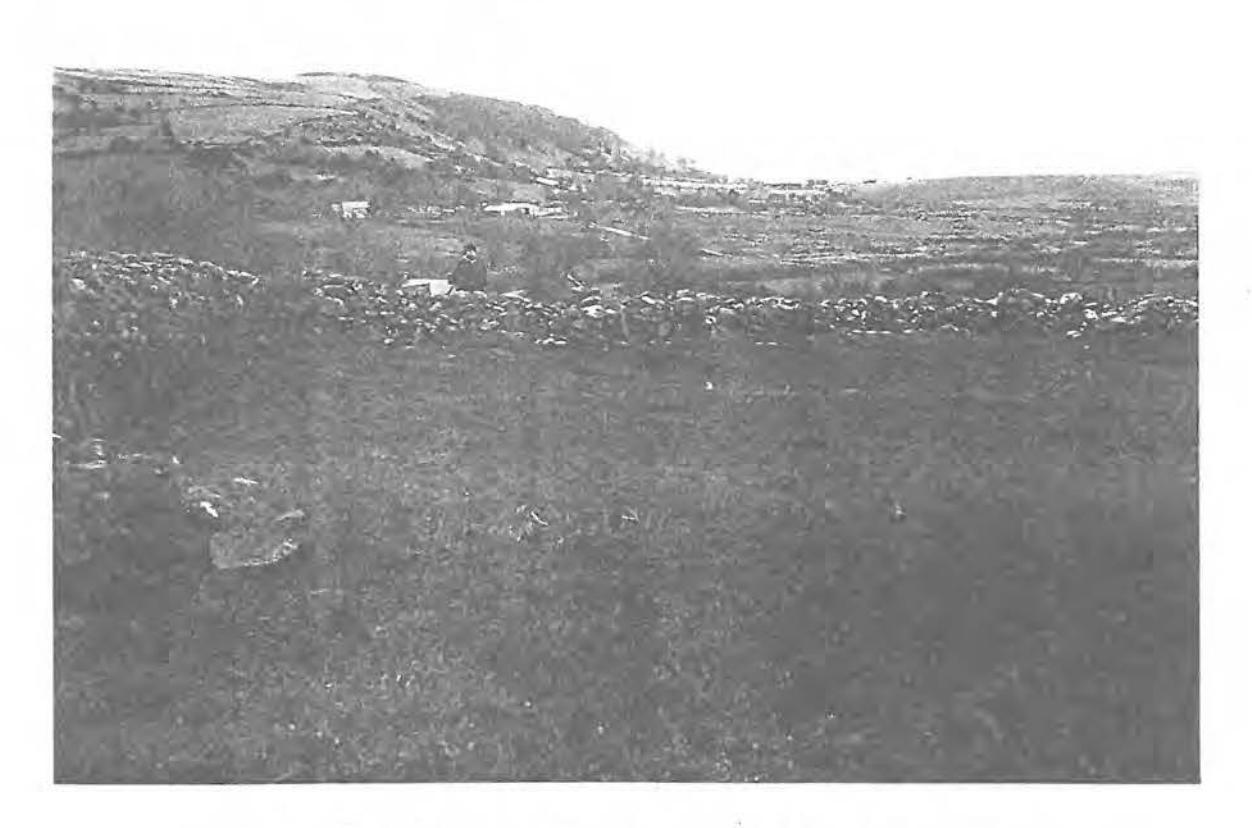
Plate 4 Site 46 - Field wall and possible enclosure in field 5250

The old field system The existing field walls appear to have been built following the construction of the railway (c. 1866), but remains of the earlier field system are still visible as occasional lengths of field wall (see fig. 1b). The principal one of these emerges from under the railway in the north-east corner of field no. 4859, and then runs south through that field and the next field, where it forms the dividing wall between fields 4852 and 5250. The wall is of dry stone construction, c. 0.5 m high on the east side, and, because of the difference in ground level between the two fields, c. 1 m high on the west side. This wall is clearly marked on the 1840 tithe map where it is shown forming part of a field system which became unusable when the railway was built. However at the southern end of field 5250 the field wall kinks round to the west, and at the same time changes slightly in appearance, with the inclusion of a large number of small stones. These latter may be the result of field clearance, but may also indicate the former presence of a structure, an indication which is strengthened by the break in slope which is visible east of the kink, and which appears to form part of an earlier enclosure. It is therefore possible that these features indicate the former presence of structures, most probably of the Late Prehistoric period.

(iii) The measured survey plotted the remains of an earlier field system which was superseded following the construction of the railway. At the southern end of this survey area, a possible Late Prehistoric settlement was noted.
