CONSTRUCTION OF A NEW SEA WALL AT ST. HYWYN'S CHURCH, ABERDARON

ARCHAEOLOGICAL RECORDING AND WATCHING BRIEF

Report No. 221

prepared for Posford Duvivier

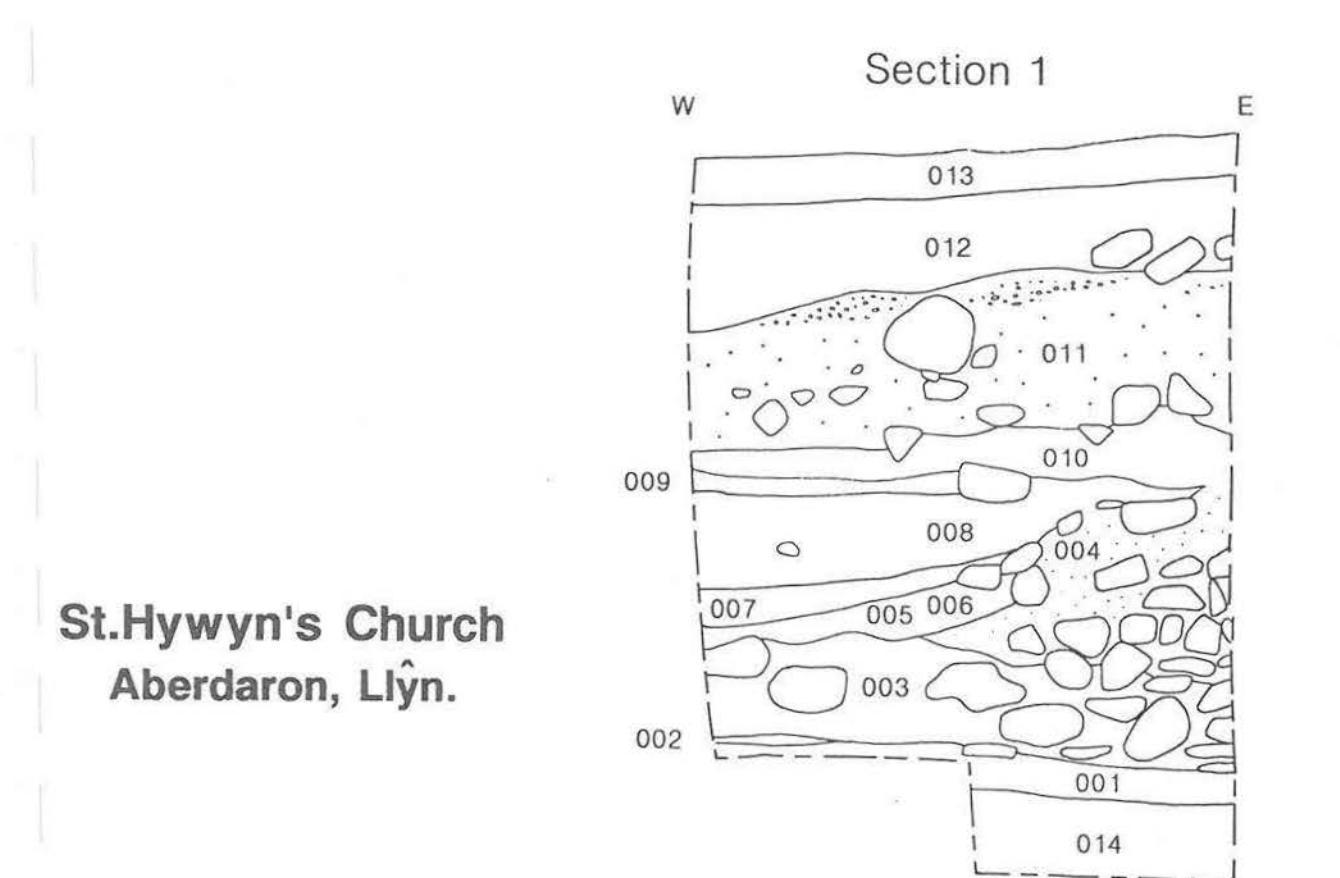
Section 01.

The first section was cut to a depth of 2m revealing 15 contexts, the lowest of which was of clean sand (014) extending below the level of the section. Above this was a firm sandy clay containing organic matter degraded to carbon and occasional flecks of charcoal (001). This layer was visible as a level surface which extended for

approximately 1m in front of the section. The presence of organic material would suggest a former ground surface.

Above this, a linear drystone wall or revetment (015) was visible for 0.6m before running into the centre of the section. It was constructed of rounded stone from the sea shore and lay at an angle of c.20 degrees to the line of the section. A mid to dark brown slightly humic clayey sand (003, 004) was visible in between the stones which was in marked contrast to the sand found in front of the section. A few stones were removed from the wall at the edge of the excavation revealing a continuation of fairly uniform brown clayey sand and further rounded stones suggesting an established soil horizon. To the west of the exposed stones, the brown clayey sand continued at the same level, perhaps indicating that the revetment had collapsed. This was also reflected in a fall in height of the stones at this point in the section.

Overlying this was 0.3m of windblown sand (007, 008), below four dumped contexts overlain by 0.1m of gritty topsoil. These consisted of 009 - a 0.05m context of hard reddish brown clay; 010 - up to 0.2m of brown clayey sand; 011 - 0.4m of mixed and beach stones plus occasional pieces of roofing slate and broken human bone and 012 - up to 0.3m of sand, mortar, broken roofing slate, angular stone, brick and concentrations of broken human bone. It is known that during the refurbishment in 1900 the church floor was replaced and that a new sea wall was built, involving the removal of large amounts of soil which, according to the Rector, were mainly dumped to the north of the church. Context 012, the main dump horizon, is presumably associated with these events and could be traced along almost all of the exposed section

The west facing section at 90 degrees to this showed successive deposits of sand coloured by a range of humic contexts ranging from almost white sand to very dark brown sand with a somewhat greasy, high humic content possibly from seaweed. These were sloping down from the revetment and were probably windblown deposits. One fragment of bone, probably human, (part of a scapula) was recovered from the sand below the level of the base of the wall. Two human teeth, pre-molars worn down close to gum level, were recovered from in between the stones.

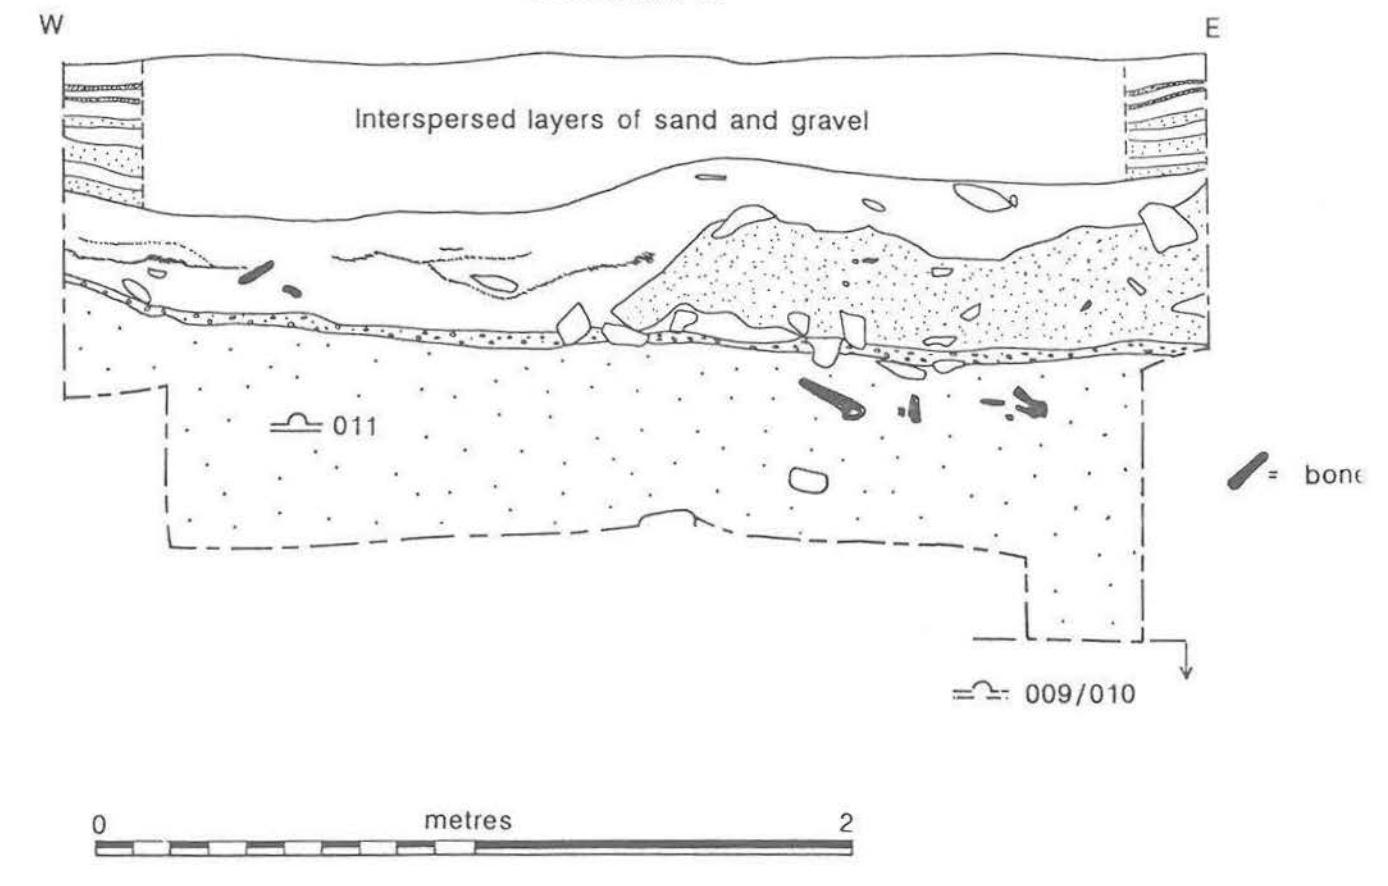
Section 2

A second section, 3m wide and located to the east of the first was cut to a depth of 1.5m corresponding with the top of a context of hard reddish brown clay. Above this was 0.7m of fairly clean sand containing a small concentration of disarticulated human bone towards the west of the section. No cut was visible, suggesting that the bone was deposited as part of the context and was not an inhumation. Above this was a thin gritty context which could be traced for the whole length of the originally exposed section sealing all contexts below it and which appears in section 01 in a slightly more diffuse form at the top of context 011.

Above this was a continuation of 012, the dump horizon containing human bone, slate, mortar etc. associated with the 1900 works to the church. The west facing section cut at 90 degrees to this showed a cut into the clay at the base of the north facing section, presumably the cut for the building of the earlier sea wall, now collapsed.
