LLYN DULYN HYDRO ELECTRIC SCHEME

ARCHAEOLOGICAL RECORDING & WATCHING BRIEF

REPORT NO. 274 G1476

NATIONAL POWER

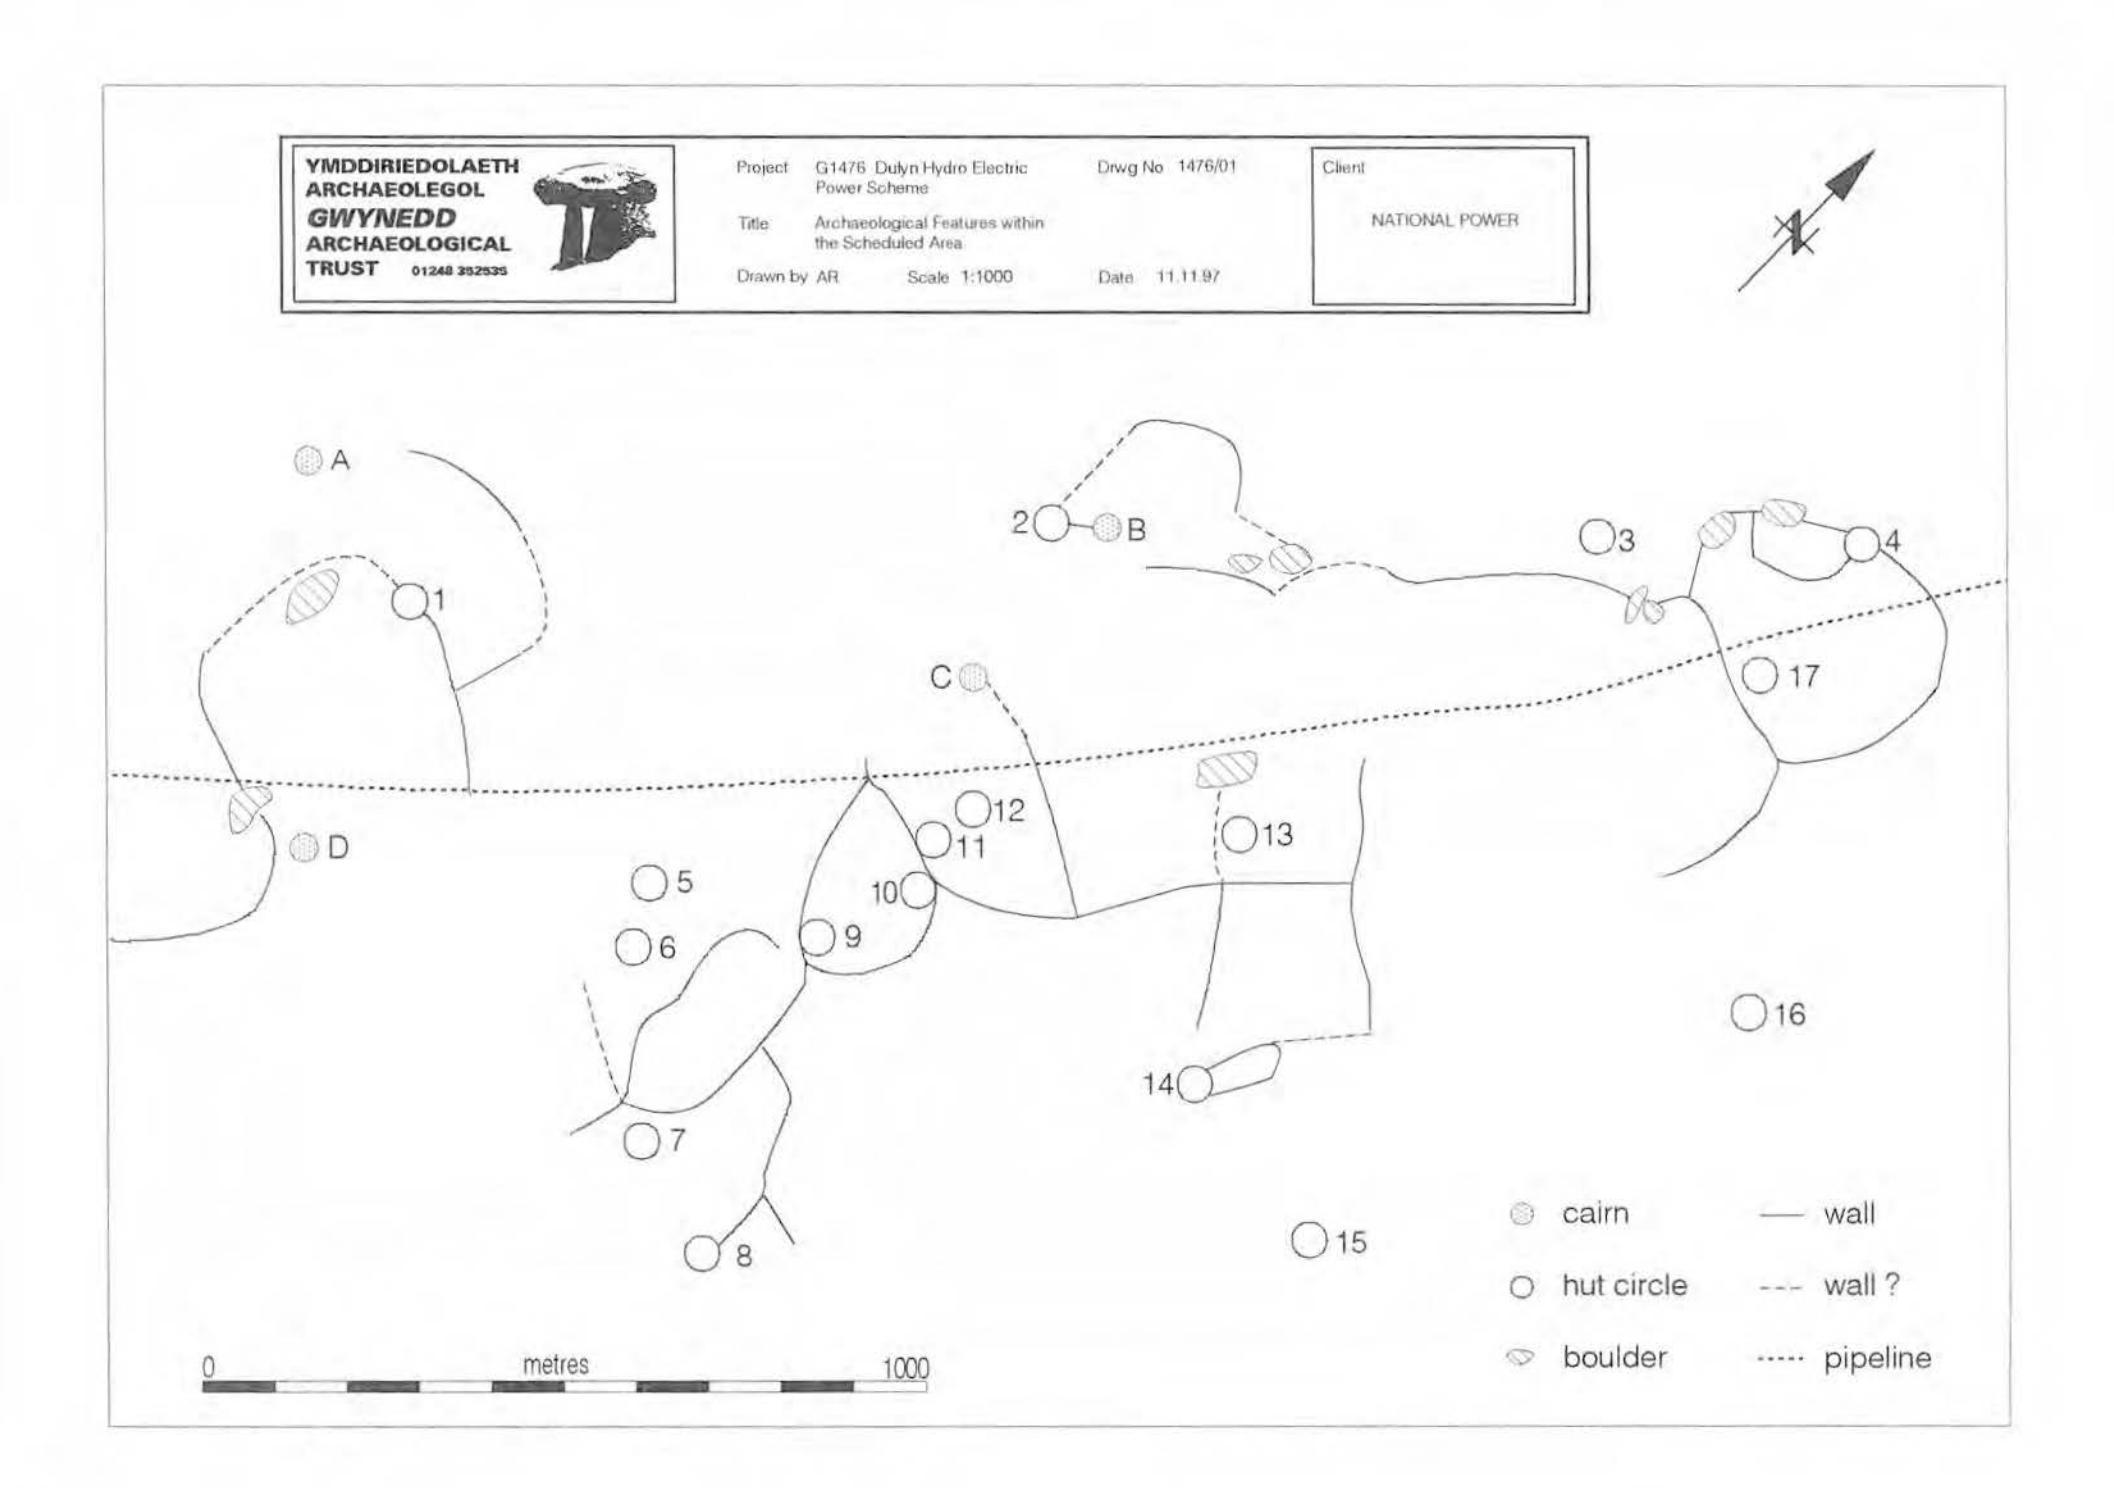
A plan of the archaeological features within the working area for the pipeline is shown in Drawing No 1476/01. It shows 17 huts and 4 cairns none of which are on the line of the pipe and only a few are close to the easement. Definite walls are shown and the line of possible walls are noted. In referring to specific huts or cairns in this document the numbers or letters used in this plan have been used.

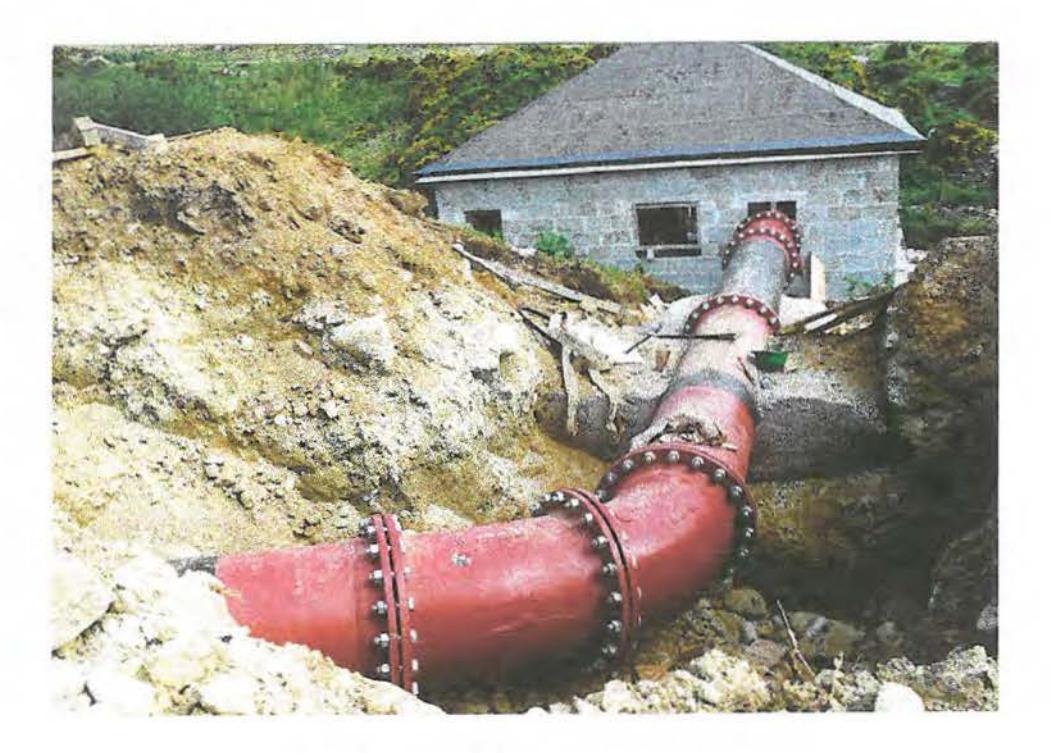
Plate 1 - Water pipe entering turbine house

A building to house the turbine was constructed of stone-clad breeze blocks under a slate roof at SH72386753. A trench was dug to west side of the building to carry the water pipe, as shown in Plate 1, and another to the north side to carry the electric cables. These trenches were monitored on the 8th and 11th August.

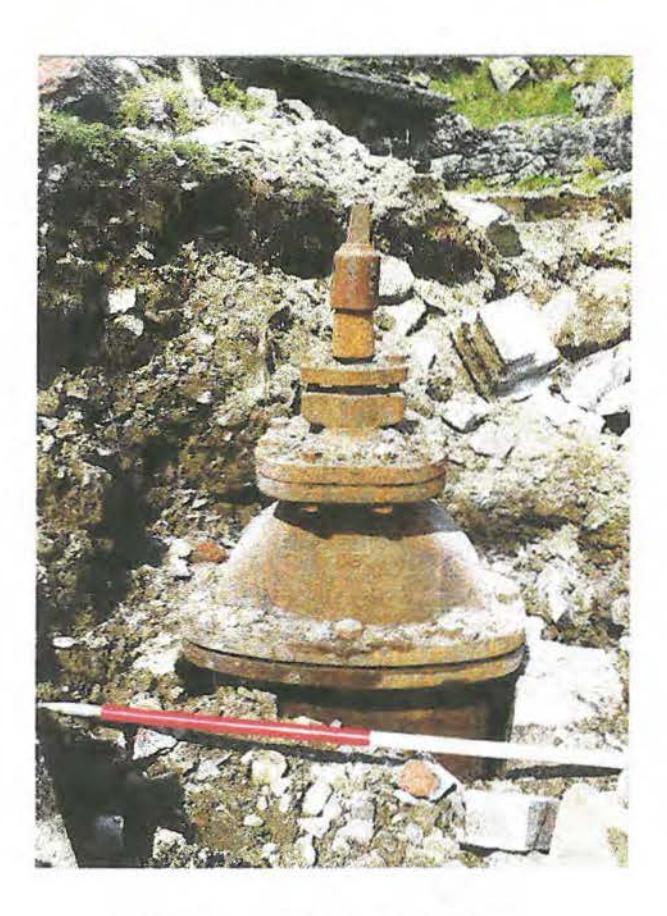
Plate 2 - Valve below Llyn Dulyn

Work on the western end of the pipeline, from the scheduled area to Llyn Dulyn, was monitored from 23rd July until 15th August. The excavators involved in this work had to be taken over the hill to the north of the scheduled area to avoid the sensitive area between the settlement and Afon Dulyn. The new pipe was joined to the existing valves below Llyn Dulyn. One of these valves is illustrated in Plate 2.

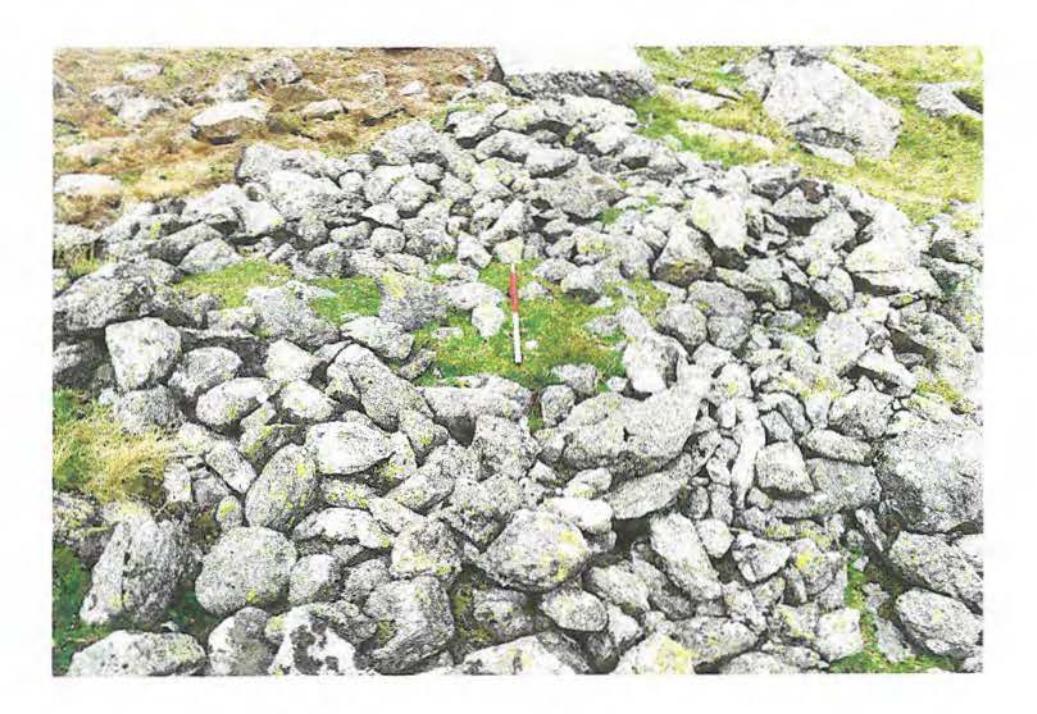
Plate 3 - Hut 17 to south of pipeline

The pipeline did not pass through any of the huts or cairns within the scheduled area although it was very close to Huts 8, 11, 12 and 17 (Plate 3) and two cairns, B and C. It crossed six of the enclosure boundaries and the northern tip of the smaller circular 'pound'. The boundaries were marked on the north and south sides of the working corridor with coloured ribbon to identify them as requiring special care by the contractors.

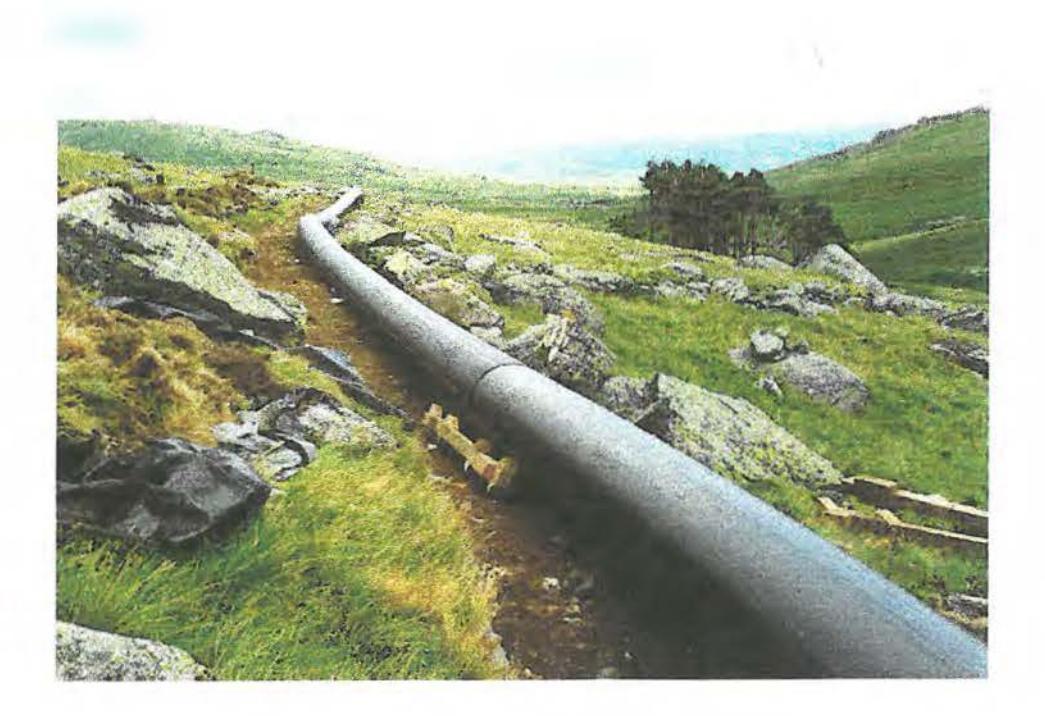
Plate 4 - Welded pipe within easement

The welded pipe, shown in Plate 4, then had to be moved out of the easement to enable the 4.5 ton excavator to dig the trench. It was decided to move the pipe to the south side of the easement as the spoil had to be stored on the north side. The excavator could not lift the welded pipe so it had to be moved using a turfer, crow bars and wedges of timber. This operation, which was monitored between 18th and 23rd July, was also potentially damaging to the archaeology and although some stones were slightly dislodged and others were loosened, great care was taken to minimise the damage.

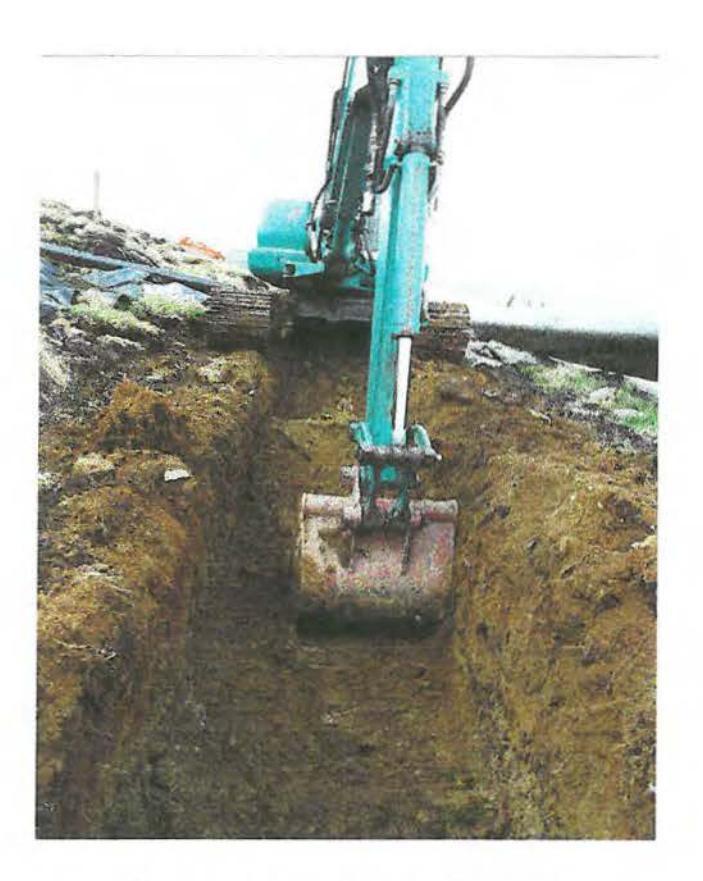
Plate 5 - Trench within scheduled area

work from the east end of the settlement, digging the trench by machine, as shown in Plate 5, and inserting the pipe simultaneously by hand using the turfer, block and tackle, crow bars and timber wedges. It proved impossible to lift the pipe over a particularly pointed rock near the middle of the settlement. The stone had a drill hole in it showing that it had been moved previously so, in order to avoid damage elsewhere, it was decided to knock the point off with a sledge hammer. The spoil from the trench was stored on terram sheets to the north of the easement. Some of it had to be stored on top of the enclosure boundaries as the top soil had been stored in the most suitable places. Inevitably some spoil went over the sides of the terram and proved very difficult to retrieve from between the rocks.

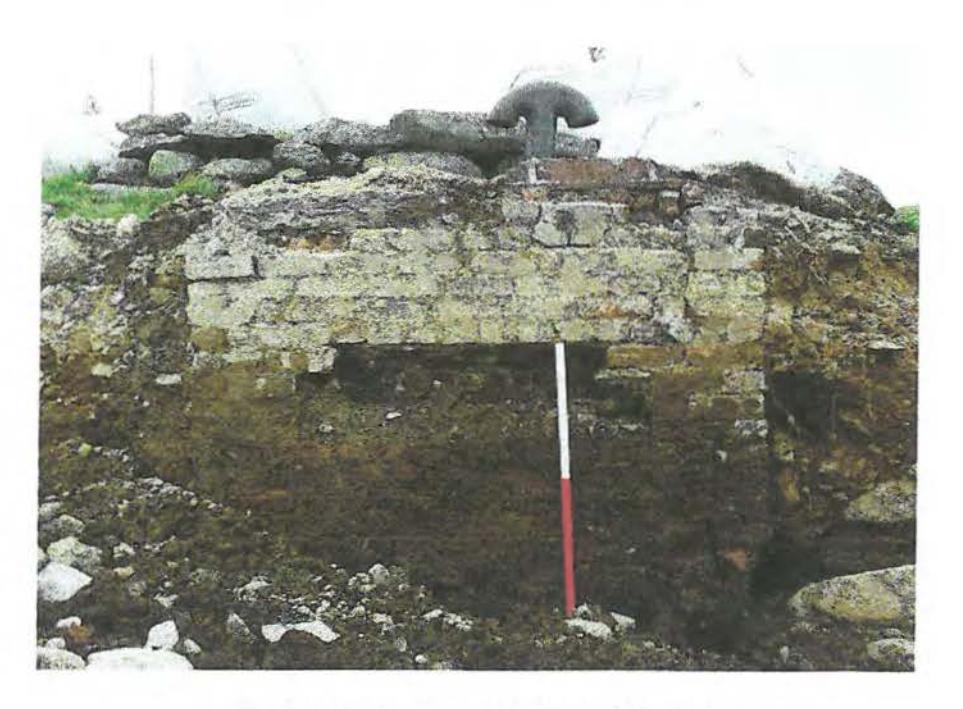
Plate 6 - Inspection chamber of old pipeline

The trench had an average width of 1.5m but varied in depth from 1.5m - 4m depending on the undulations of the terrain. The excavation of the pipe trench closely followed the line of the nineteenth century pipe. This was identified by the exposure of the 14 inch diameter salt-glazed ceramic pipe in 1.2m lengths, made by Doulton & Co. Concrete markers identified brick-lined inspection chambers with iron manhole covers and raised air vents, shown in Plate 6, which occurred at regular intervals along the course of the pipeline.
