CEMAES BAY WASTEWATER TREATMENT SCHEME, ANGLESEY

ARCHAEOLOGICAL RECORDING & WATCHING BRIEF

Report No. 317

Prepared for DWR CYMRU March 1999

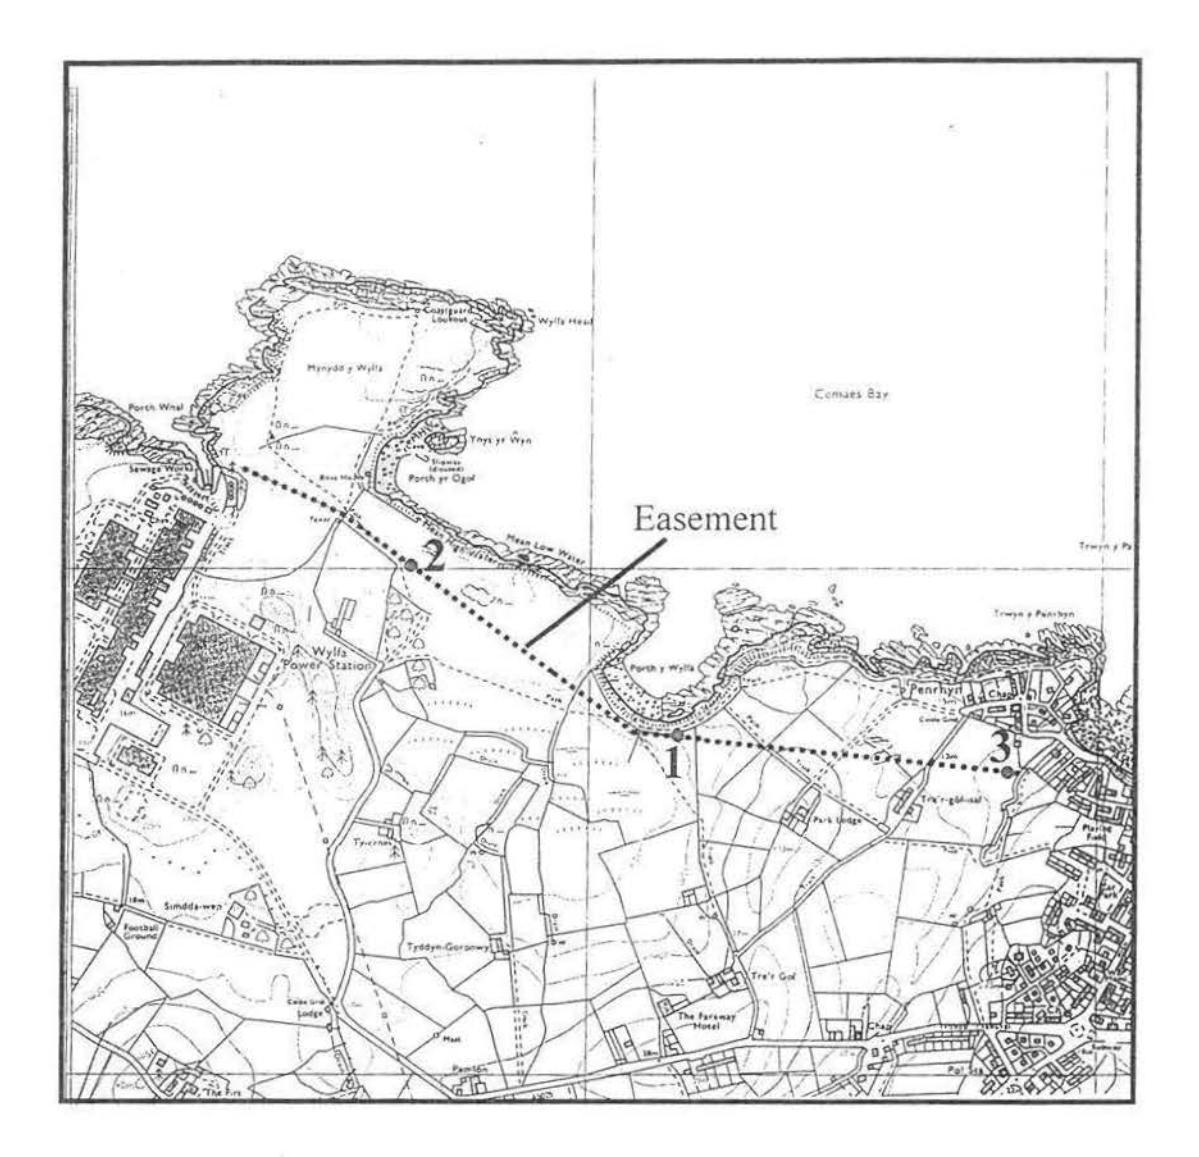
Fig.1 Location of easement route, descriptive zones and identified features.

The pipeline route crossed areas of light coloured glacial till and of bedrock and stripping of the generally thin topsoil produced quite good visibility in terms of recognition of possible archaeological features. The results should therefore be reliable. The area exposed was largely sterile in terms of archaeological remains although three features of interest were noted: an old cobbled road, an area of both worked and naturally occurring chert and an 18th century boundary or drainage ditch (Fig.1)

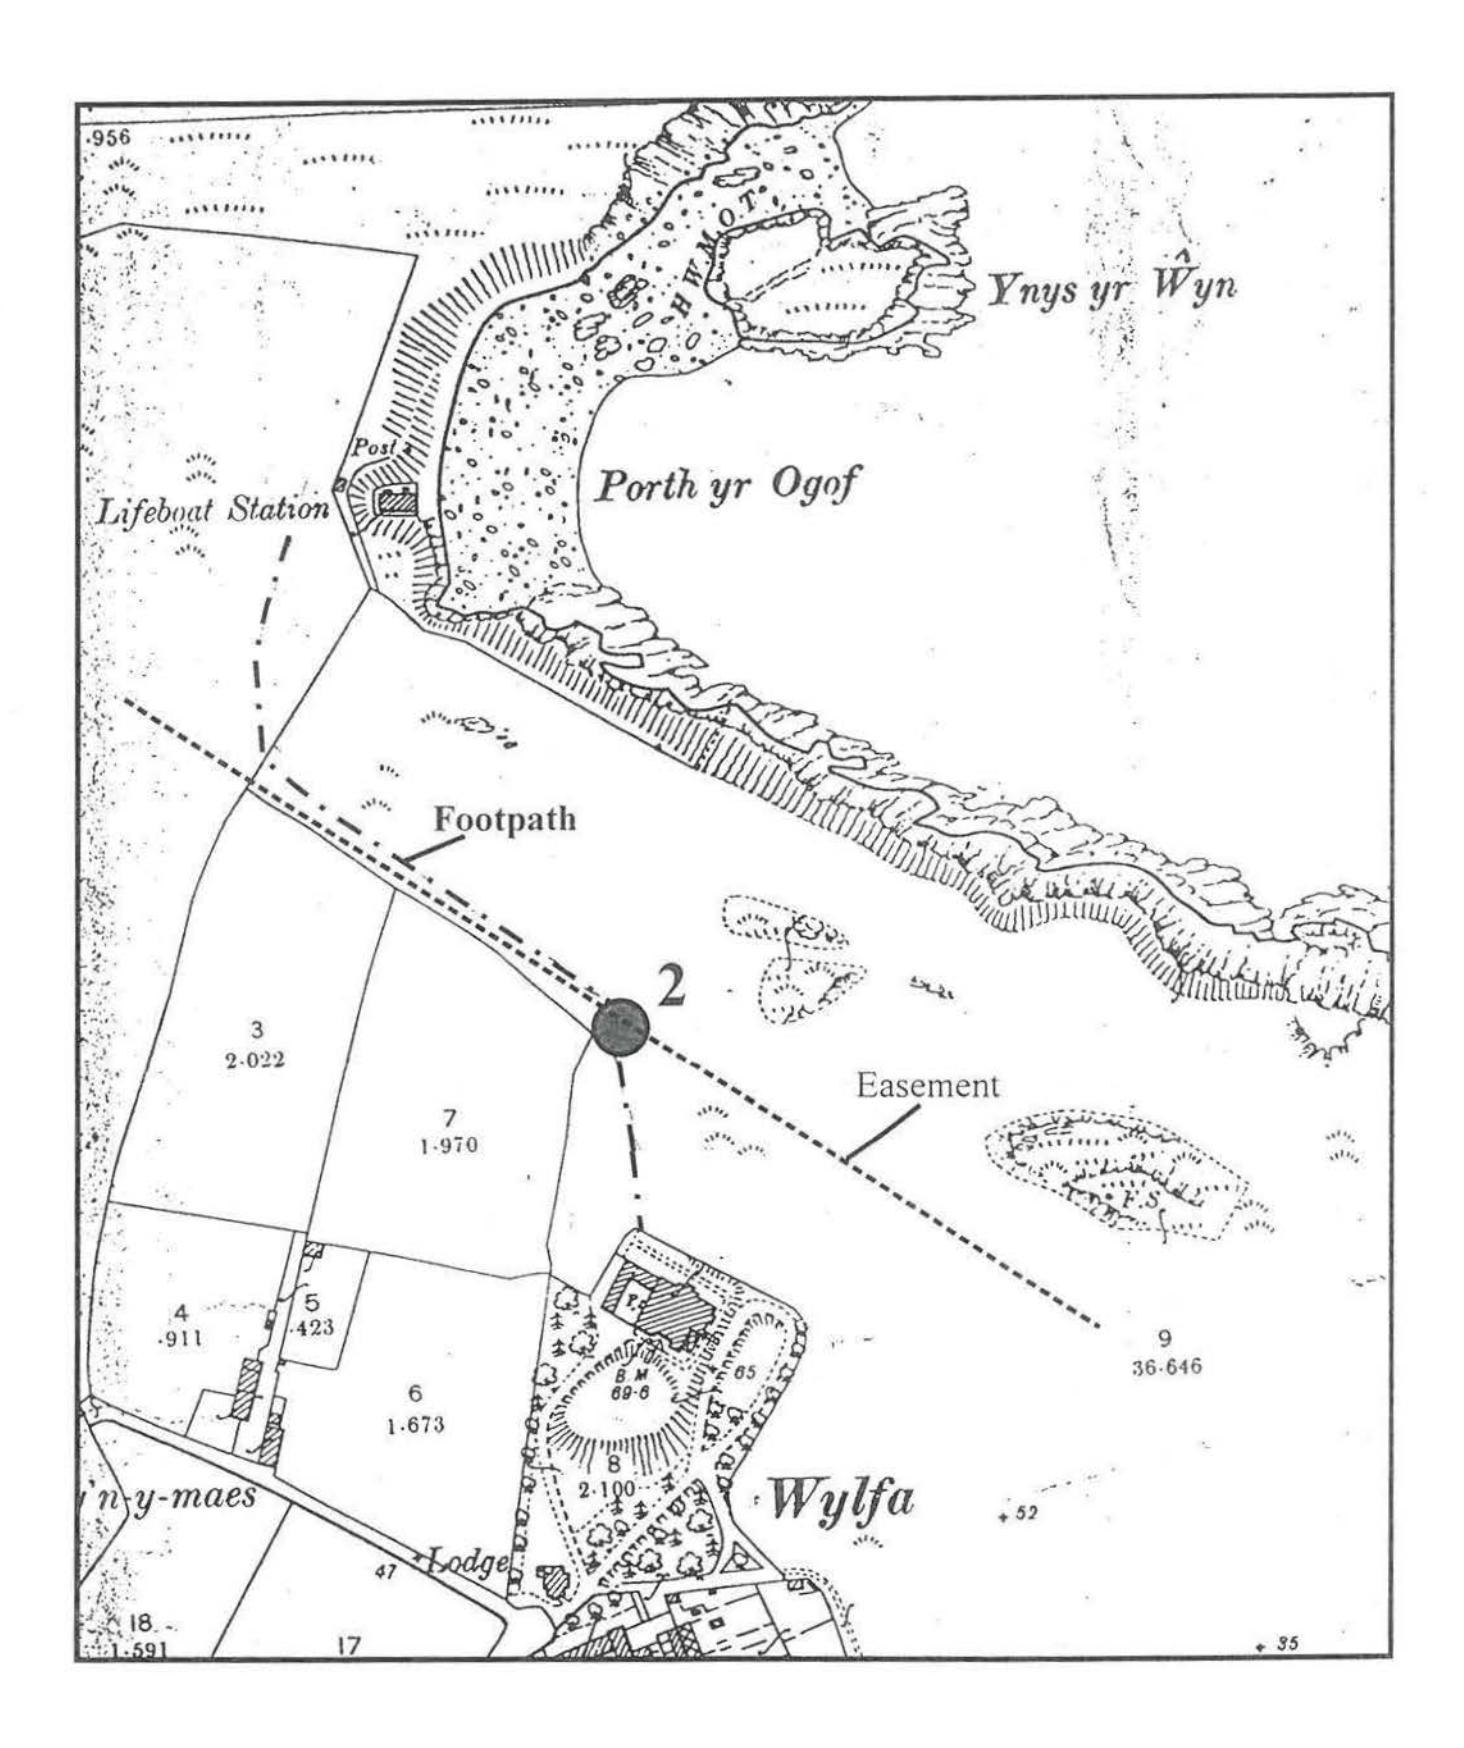
Fig. 2 Detail from OS 1st edition 25 inch map, 1900. Position of trackway, feature 2.

This stage of the topsoil stripping had also been carried out before GAT were notified and had already been badly obscured by the time of the first visit. One feature was noted, a road or track defined by heavy cobbling. This was not marked on the OS first edition, 2 inch map of or the first edition 25inch map of 1900. It lay on the line of an existing footpath and is almost certain to be a track providing access to the former lifeboat station in Porth yr Ogof. Subsequent cutting of the pipe trench involved much rock cutting and revealed some good geological sections showing the relationship between the rock surface and the glacial drift but did not reveal any archaeological features.

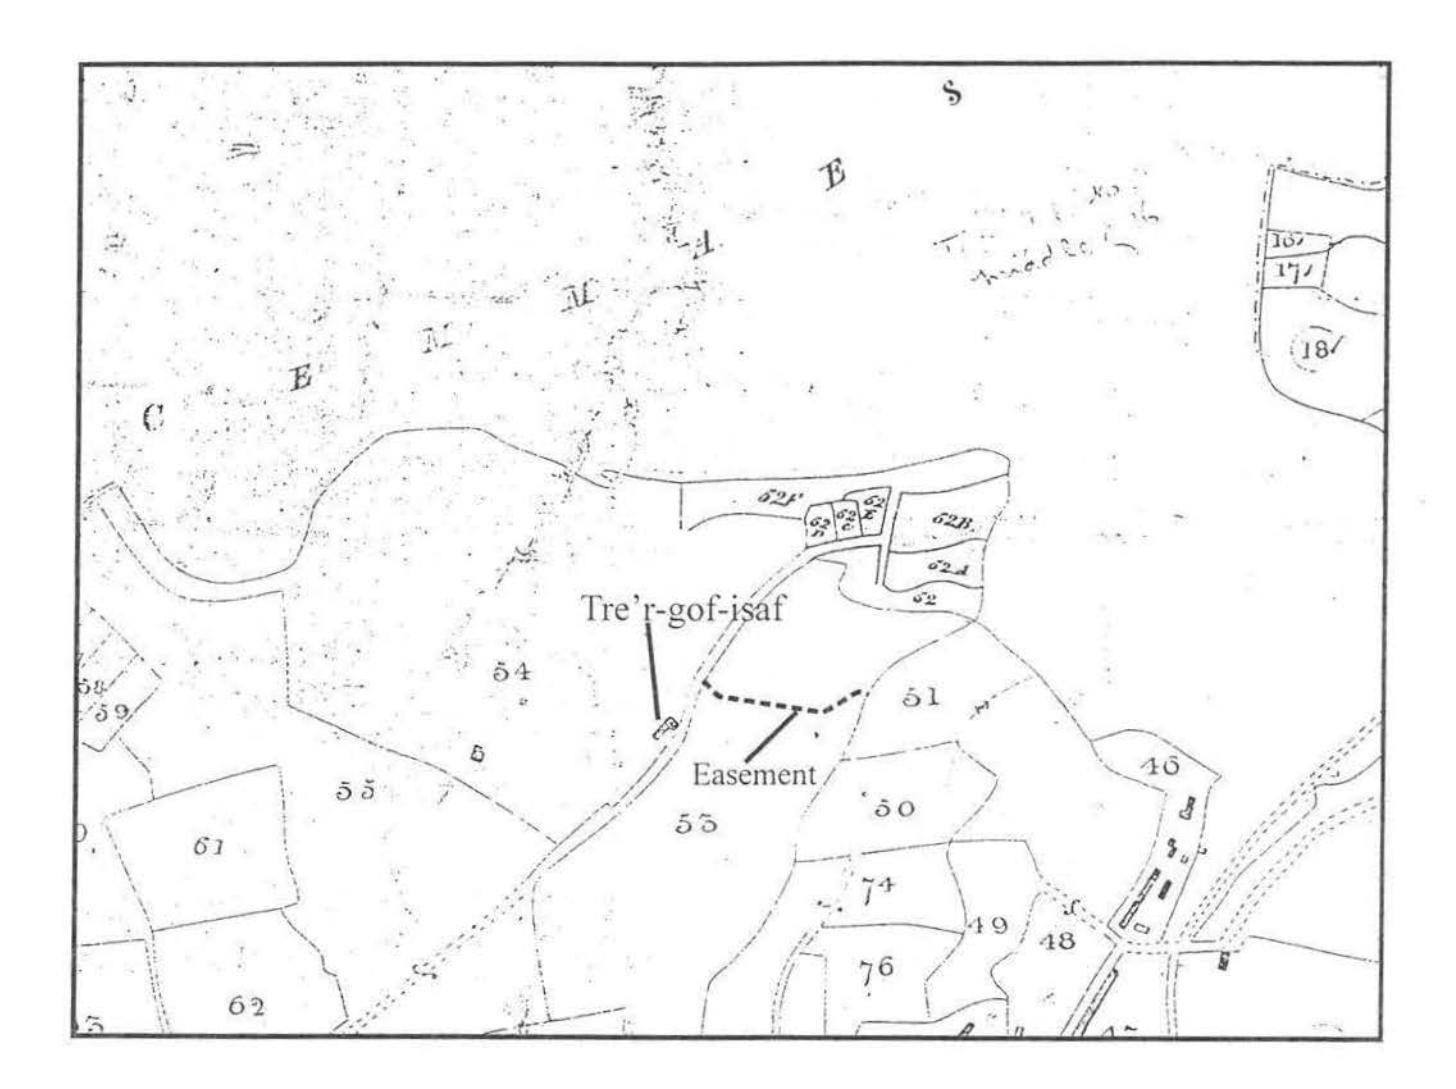
Fig. 3A Detail from 1845 Tithe map, Tre'r-gof-isaf.

This area cut only through glacial till and no features were located. There was a build up of soil uphill of a field boundary between two rock outcrops north of Tre'r-gof-isaf but this was all relatively recent as this boundary was part of a 19th century reorganisation of the field layout here. This can be said because the boundary was shown on the OS 1st edition 25 inch map of 1900 but did not exist at the time of the Tithe Apportionment map of 1845.

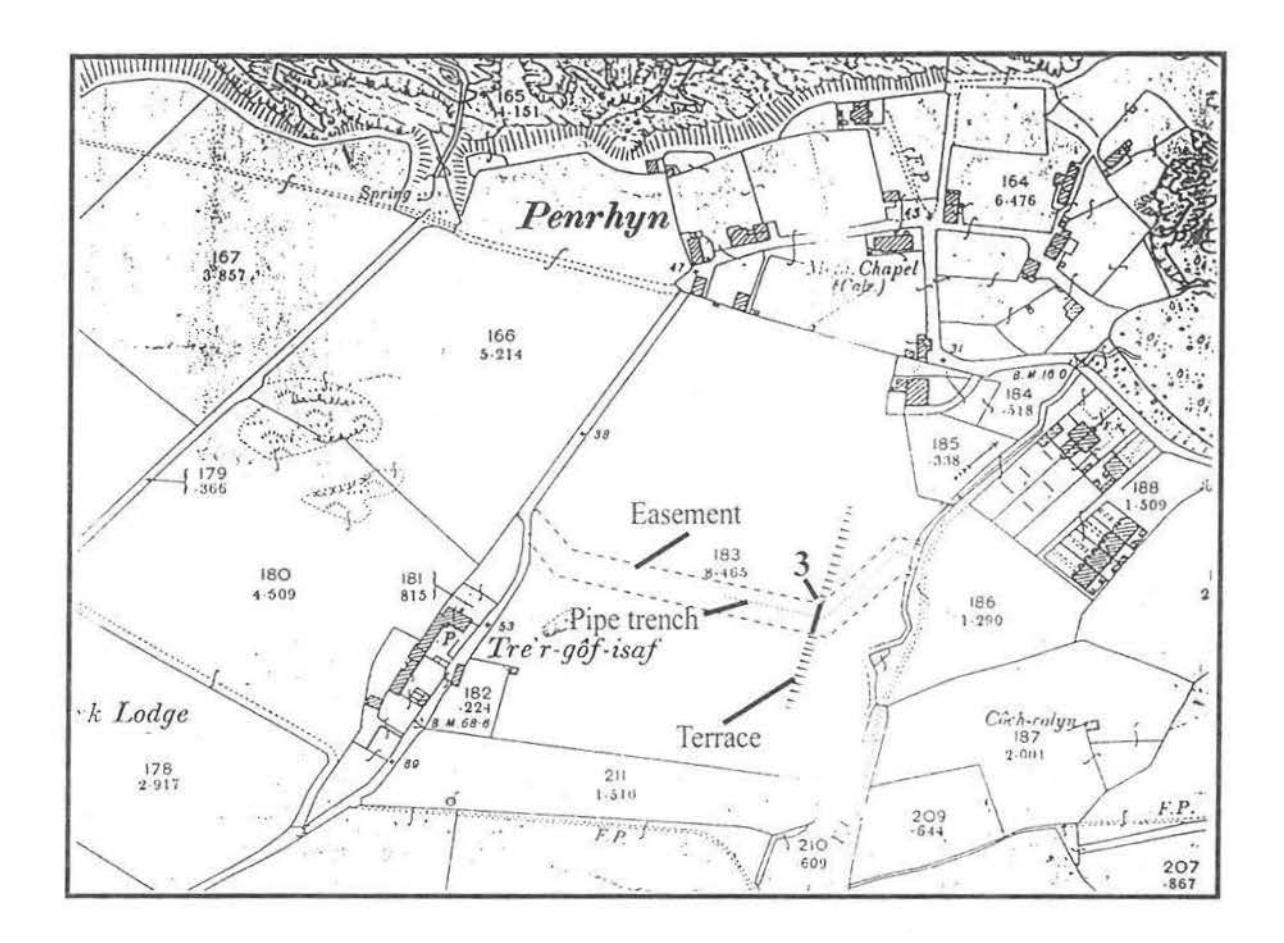
Fig. 3B Detail from OS ist Edition 25 inch map. Tre-r-gof-isaf and location of feature 3

The final field was relatively low lying but in the first part, surprisingly, the topsoil lay directly over bedrock. The subsoil of the lower part of the field, in the valley bottom, was of red-brown glacial till. One feature was identified here, a linear, ditch-like feature that was apparent because of its dark, humic fill. This was oriented approximately parallel to the nearby stream and 40m from it (Fig. 3b). This was exposed in the side of the pipe trench and the section cut back and recorded. It proved to be relatively broad and shallow scoop rather than a ditch, c. 1.5m wide and 0.30m deep with a shallow sloping side downhill grading out on the uphill side where its fill was cut buy a (later) narrow, stone-filled field drain ((Fig. 4). The fill was dark, humic soil, fairly clearly ploughsoil. The only find from its fill was a small fragment of post-medieval pottery but unfortunately so

small that it may not be in its correct context, that is, it could have moved down due to animal burrowing or cultivation disturbance etc. The feature is best interpreted as a field boundary ditch, that would have also acted as a drain and would have separated the sloping, better-drained part of the field, that may have been cultivated, from the more level valley bottom, that may have been hay meadow. A slight terrace is still visible on the present field surface on the line of the feature, following the contour, approximately parallel to the stream. However, no field boundary is shown in this position on the first edition OS 25 inch map of 1900 (Fig. 3b). Neither is any boundary shown on the Tithe Apportionment map of 1845 (Fig. 3a) and this shows the field pattern that existed prior to 19th century reorganisation. At that time the whole of this side of the stream, consisting of five fields at the present time was shown a s a single large field. However, the feature located is almost certainly agricultural and may have just been simply an open drain within a meadow and so would not have been recorded as a land boundary.
