FOUR MEDIEVAL OR SUB-MEDIEVAL RURAL SETTLEMENTS IN GWYNEDD Survey and excavations in 1997, 1998 and 1999 as part of the Deserted Rural Settlement Project (GAT Projects G1466 amd G1528)

Report No. 447

Prepared for Cadw: Welsh Historic Monuments

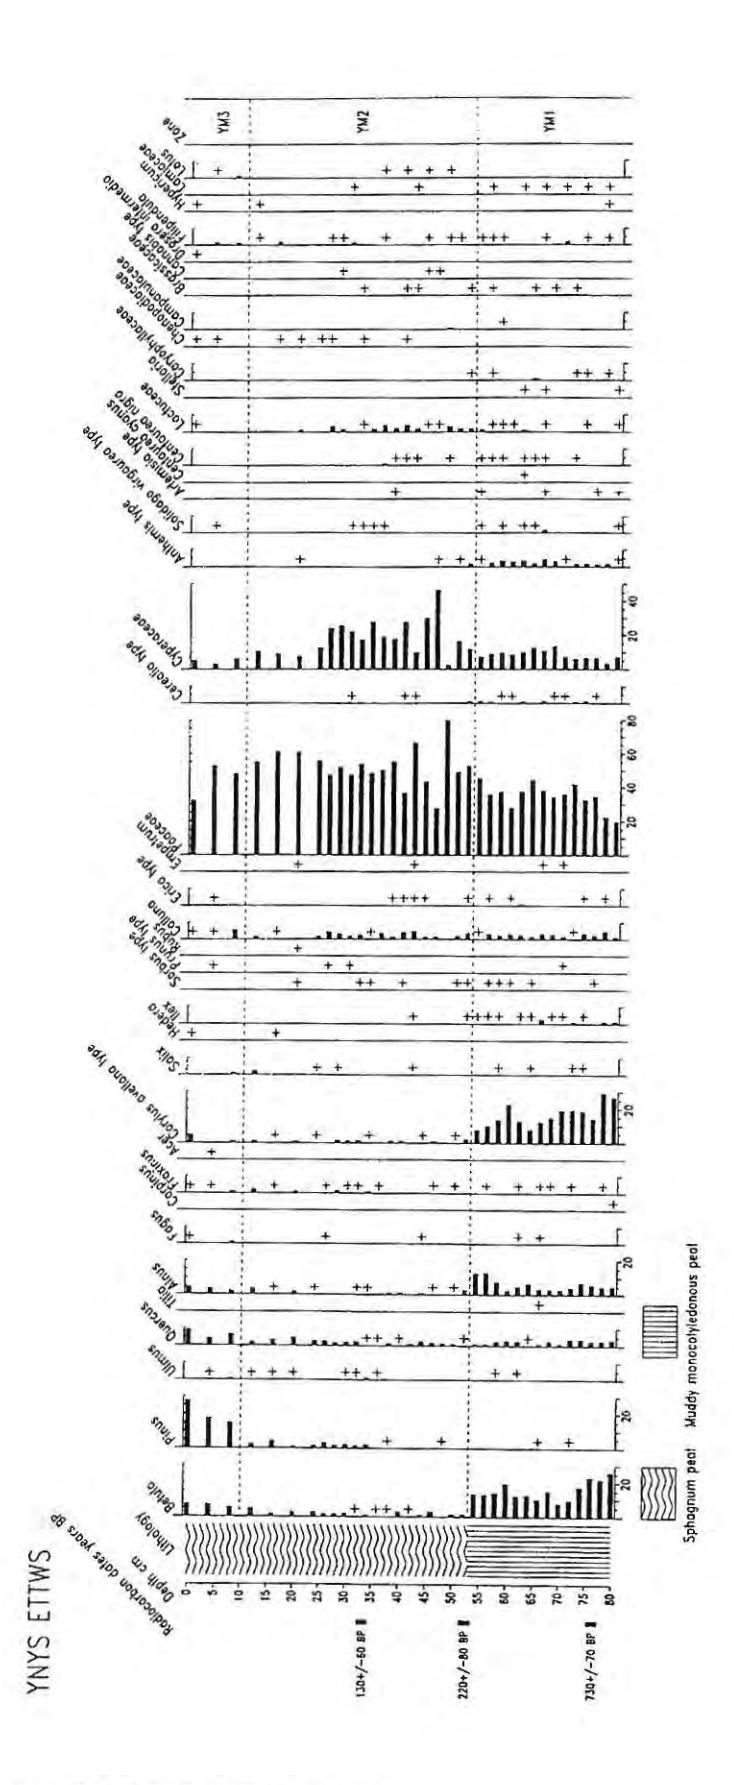
Fig 1a Percentage pollen diagram from Ynys Ettws.

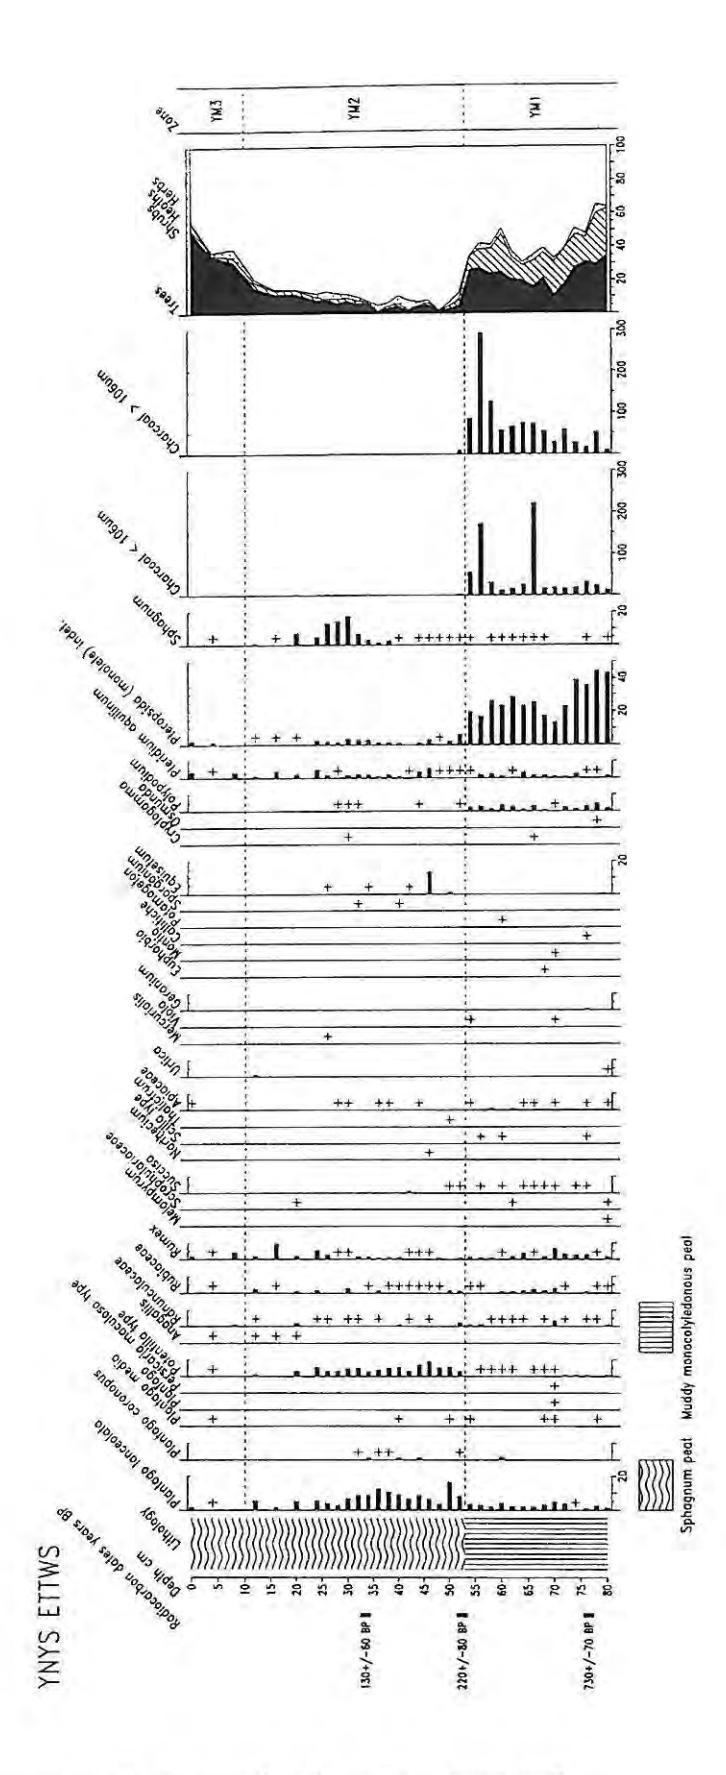
Fig 1b Percentage pollen diagram from Ynys Ettws (continued).

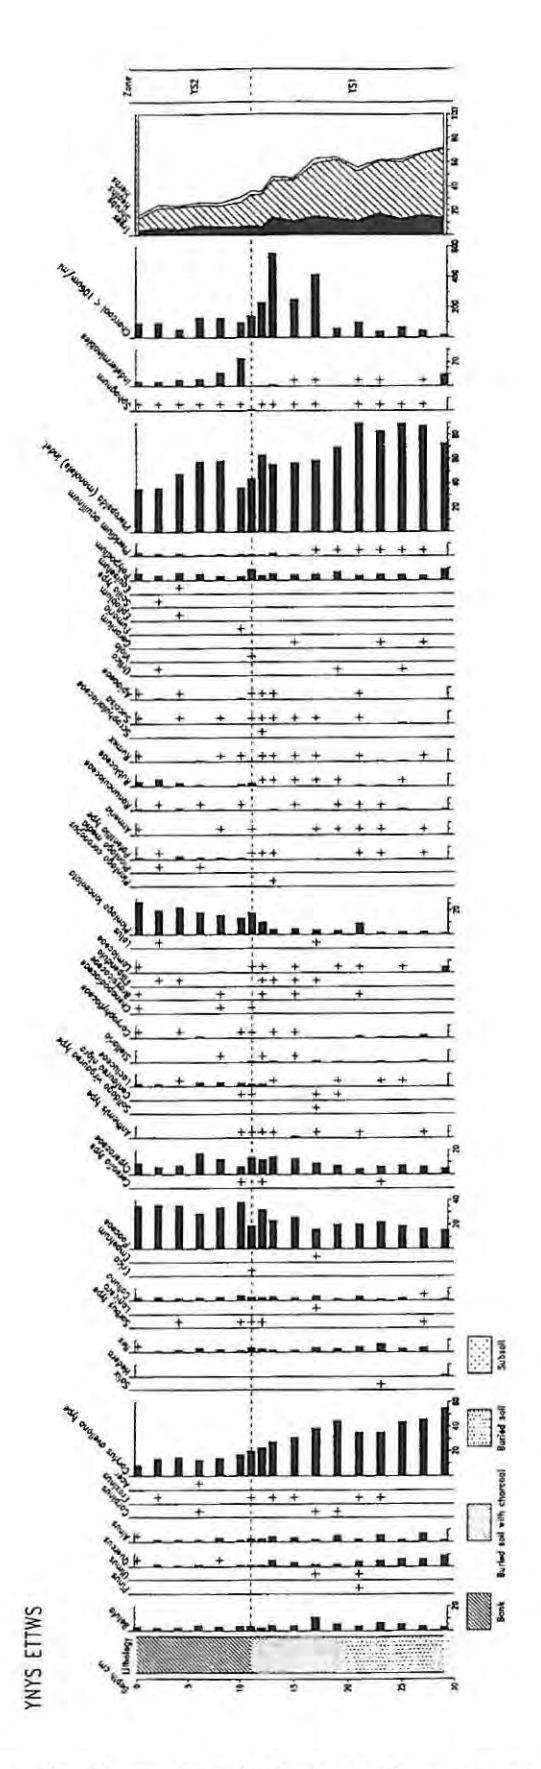
Fig 1 Percentage pollen diagram from the buried soil beneath the hood bank at Ynys Ettws.

Date years BP 220	Pollen zone	Vegetation	Land use
800	Poaceae- <i>Plantago</i> - <i>Corylus</i> YS2	Grassland dominates but some ?contemporary local birch and hazel woodland, with alder and oak in valley.	Pastoralism
800	Corylus-Poaceae YS1	Hazel woodland with grassland dominates locally but with some birch, oak and alder in the area.	Pastoralism and increasing clearance, particularly of hazel locally. ?Local cultivation at end of zone.

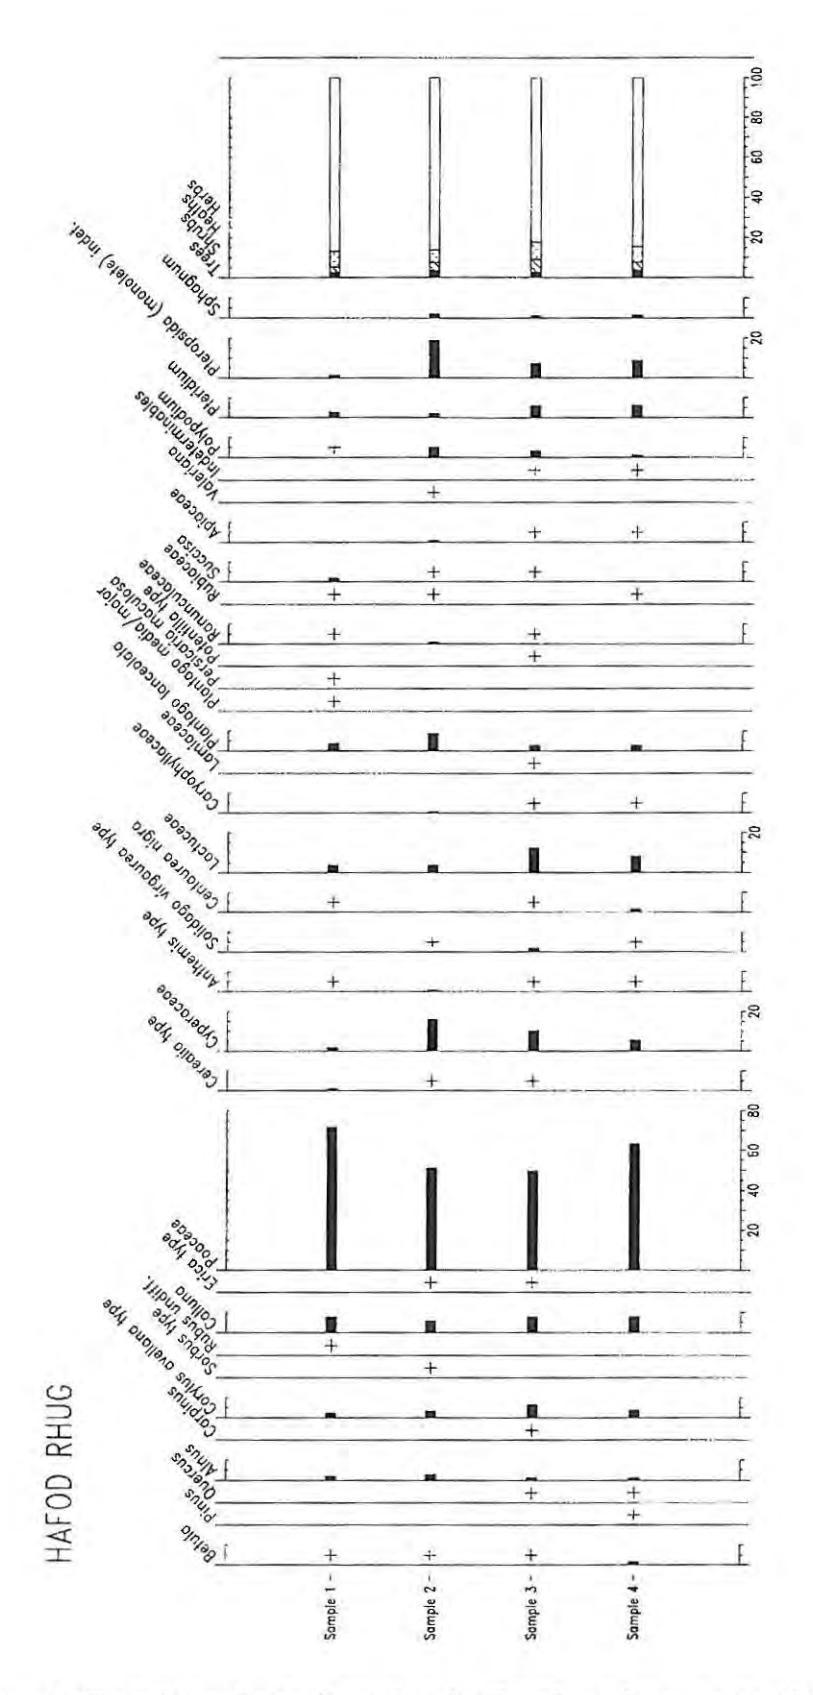
Fig. 1 Percentage pollen evidence from soil samples taken from beneath structures at Hafod Rhug.

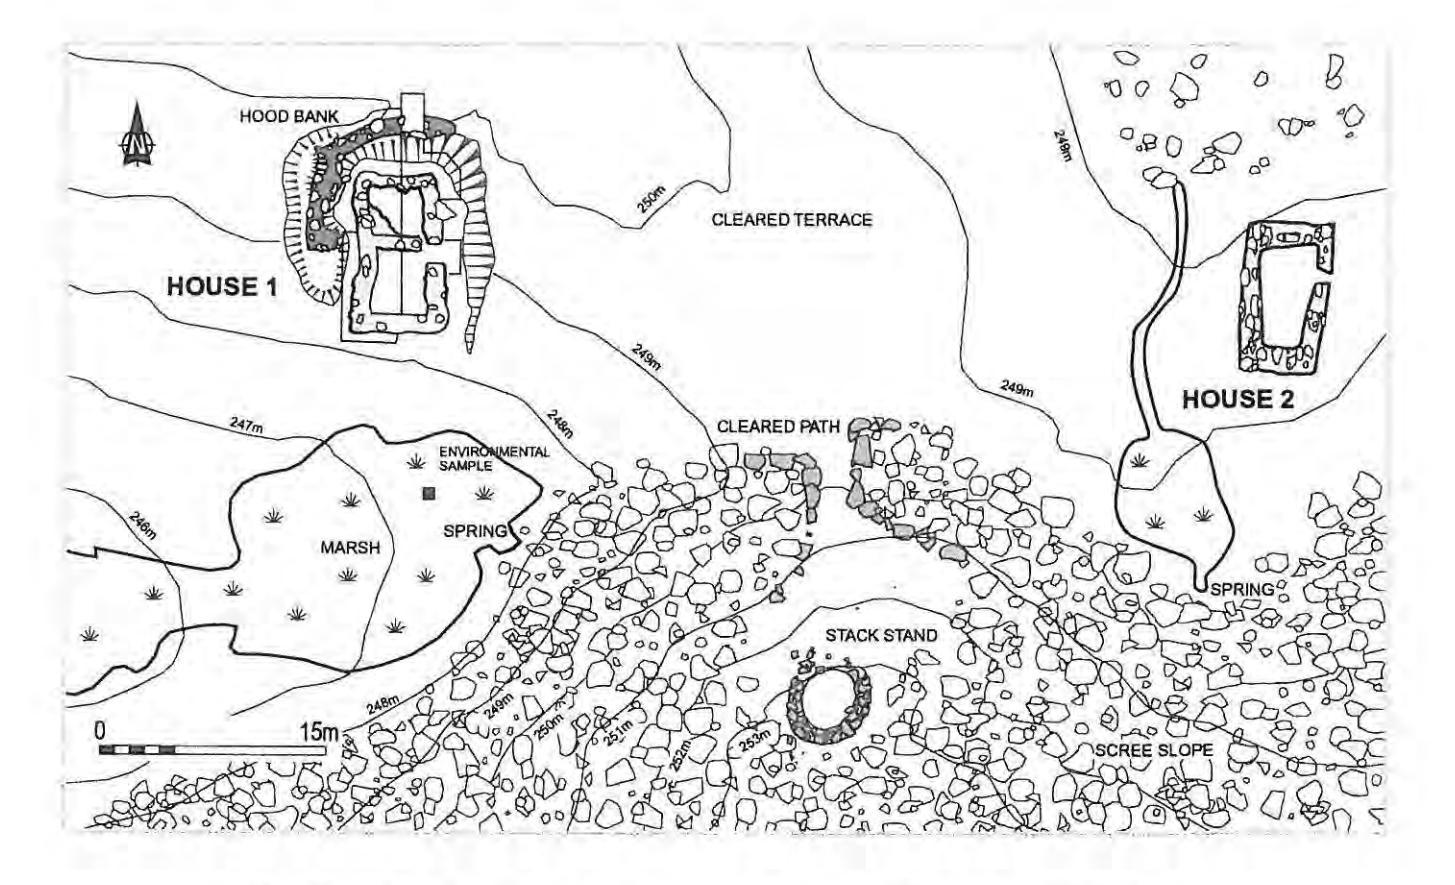
Lower: Fig. 3 Ynys Ettws. Area plan.

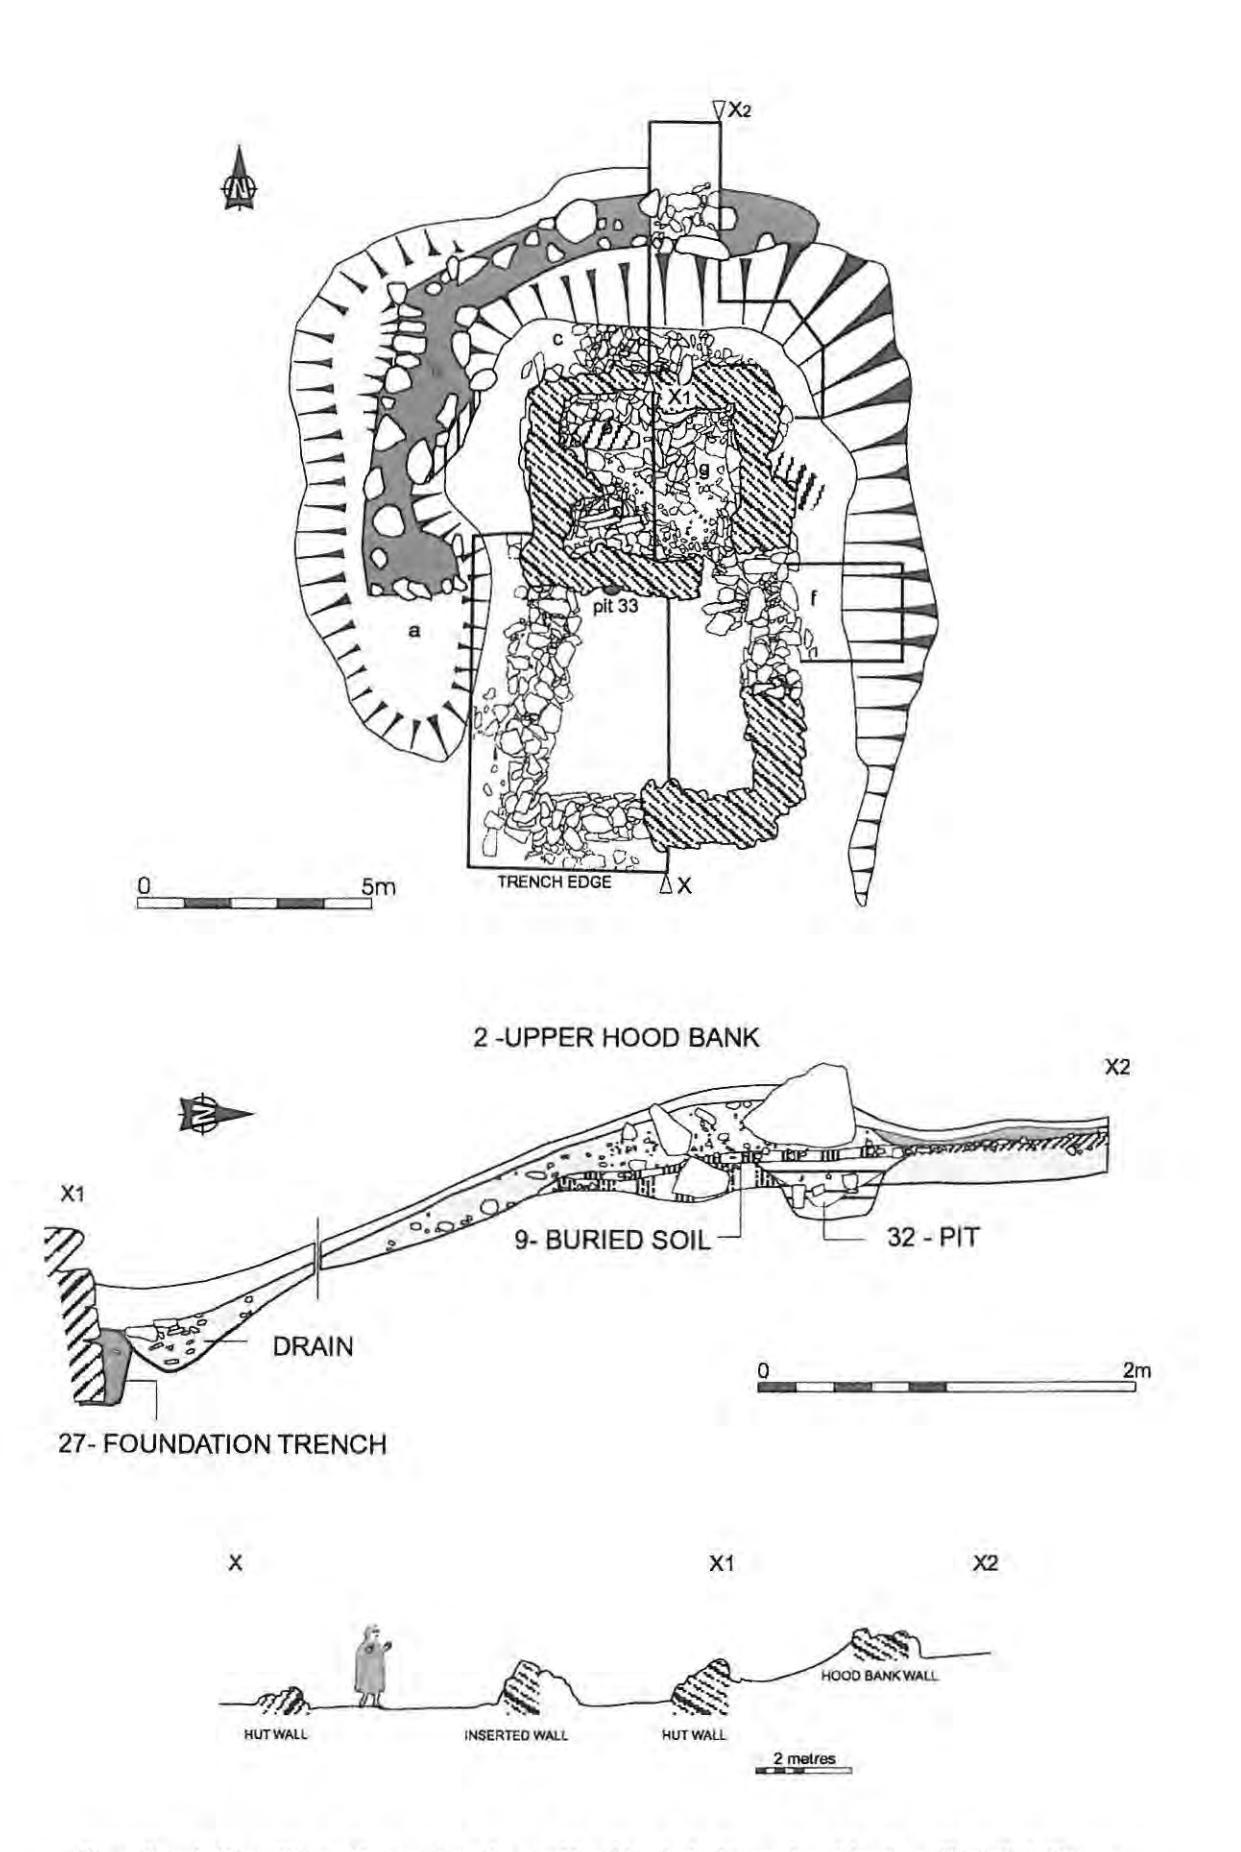
Lower: Fig. 5 Ynys Ettws. Hood bank section and overall house profile.

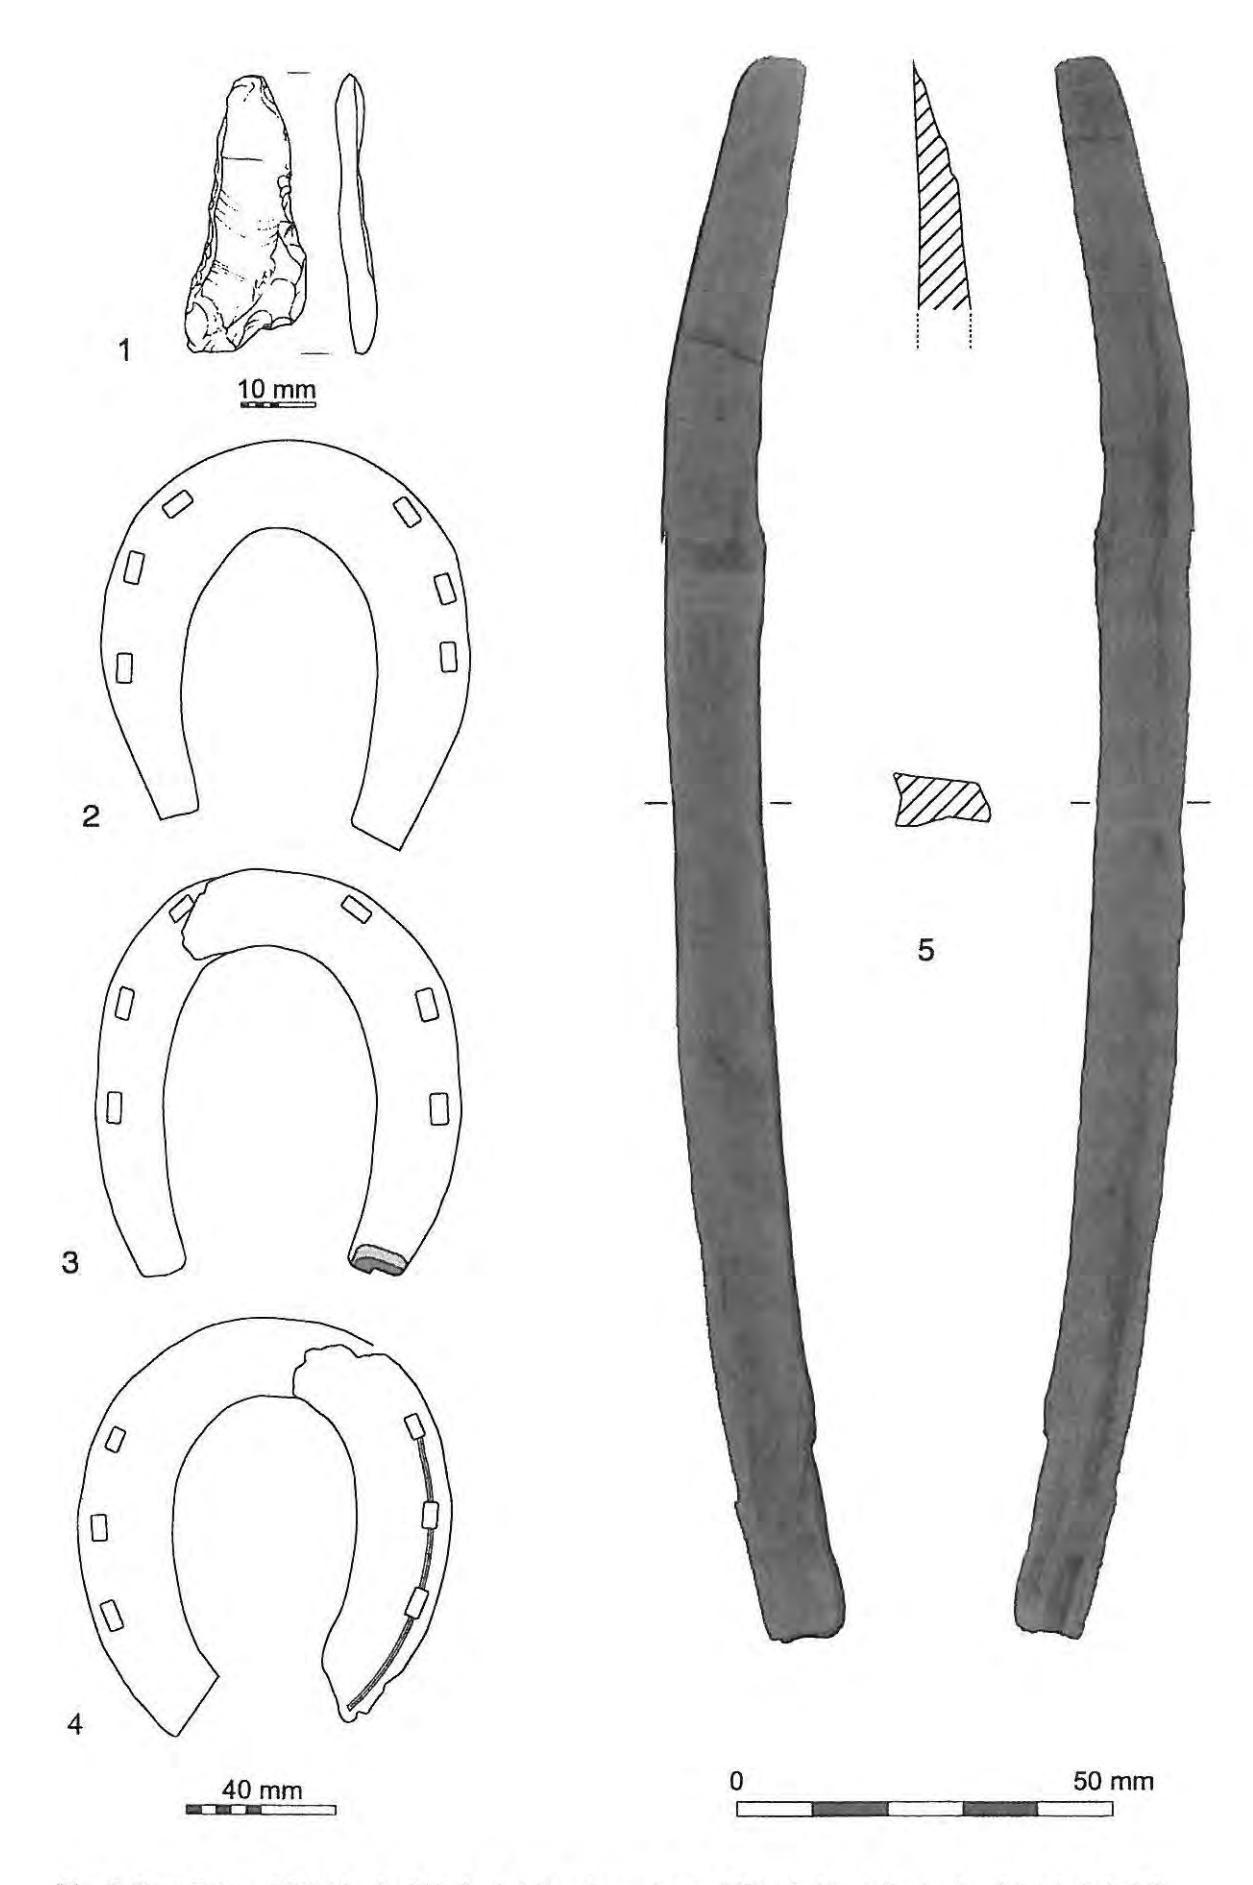
Fig. 6 Ynys Ettws. 1 Flint backed blade. 2-4 Iron horseshoes. 5 Wood object. Scale: 1and 5 1:1. 2-4, 1:2.

The flint backed-blade is not a closely datable diagnostic type but suggests Mesolithic or Neolithic activity here. This is not surprising because it is a favourable location for settlement and provides a sheltered and relatively level space next to a spring. The three pebbles found are likely to have been imported rather than come from the fluvio-glacial till. Elongated pebbles are frequently found as utilised tools on Mesolithic sites around the west coast of Britain and their presence here is probably connected with the flut blade.

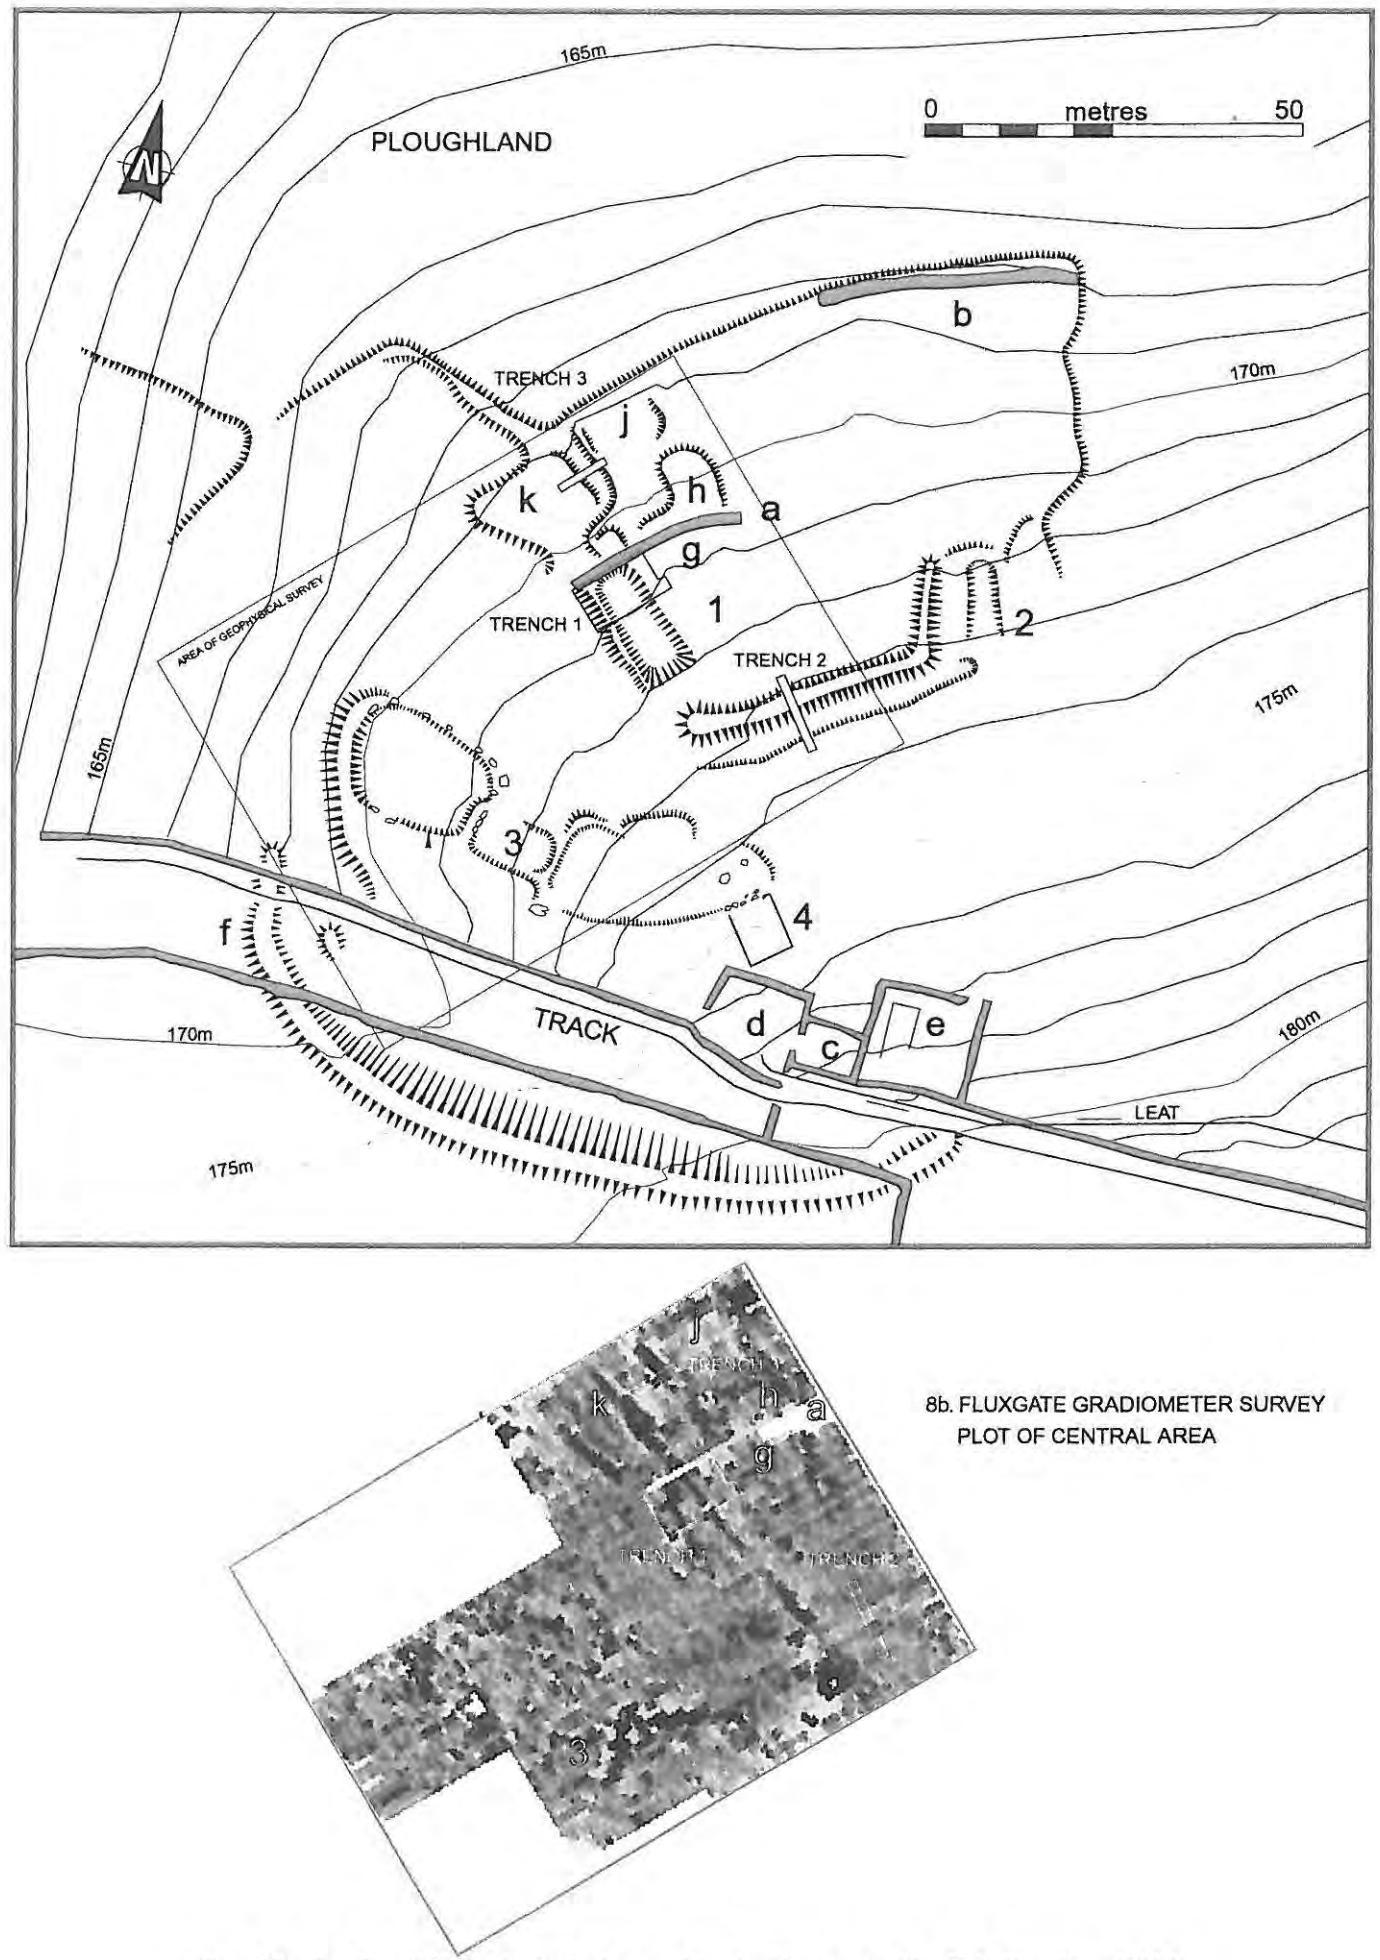
Top: Fig. 8a. Gesail Gyfarch. Area plan combined with survey of Dr C.A. Greasham (1954) Lower: Fig. 8b. Gesail Gyfarch. Fluxgate gradiometer plot.

Trench 1 (Fig. 9) investigated House 1 by excavation of c. 50% of the platform area which was about 16m by 6m internally, the largest within the settlement and therefore tentatively identified as the principal hall. The shelter wall incorporated the foundations and corner stones of the west gable of the house (Plate 6), thus showing that the wall was 1m (3ft 4in) wide and the house 6.2m (20ft 4in) wide, internally. The shelter wall also incorporated the foundations of the wall of an adjoining wing or other structure, further to the east, where the survey also recorded the tentative outlines of other platforms (h, j and k, Fig. 8).

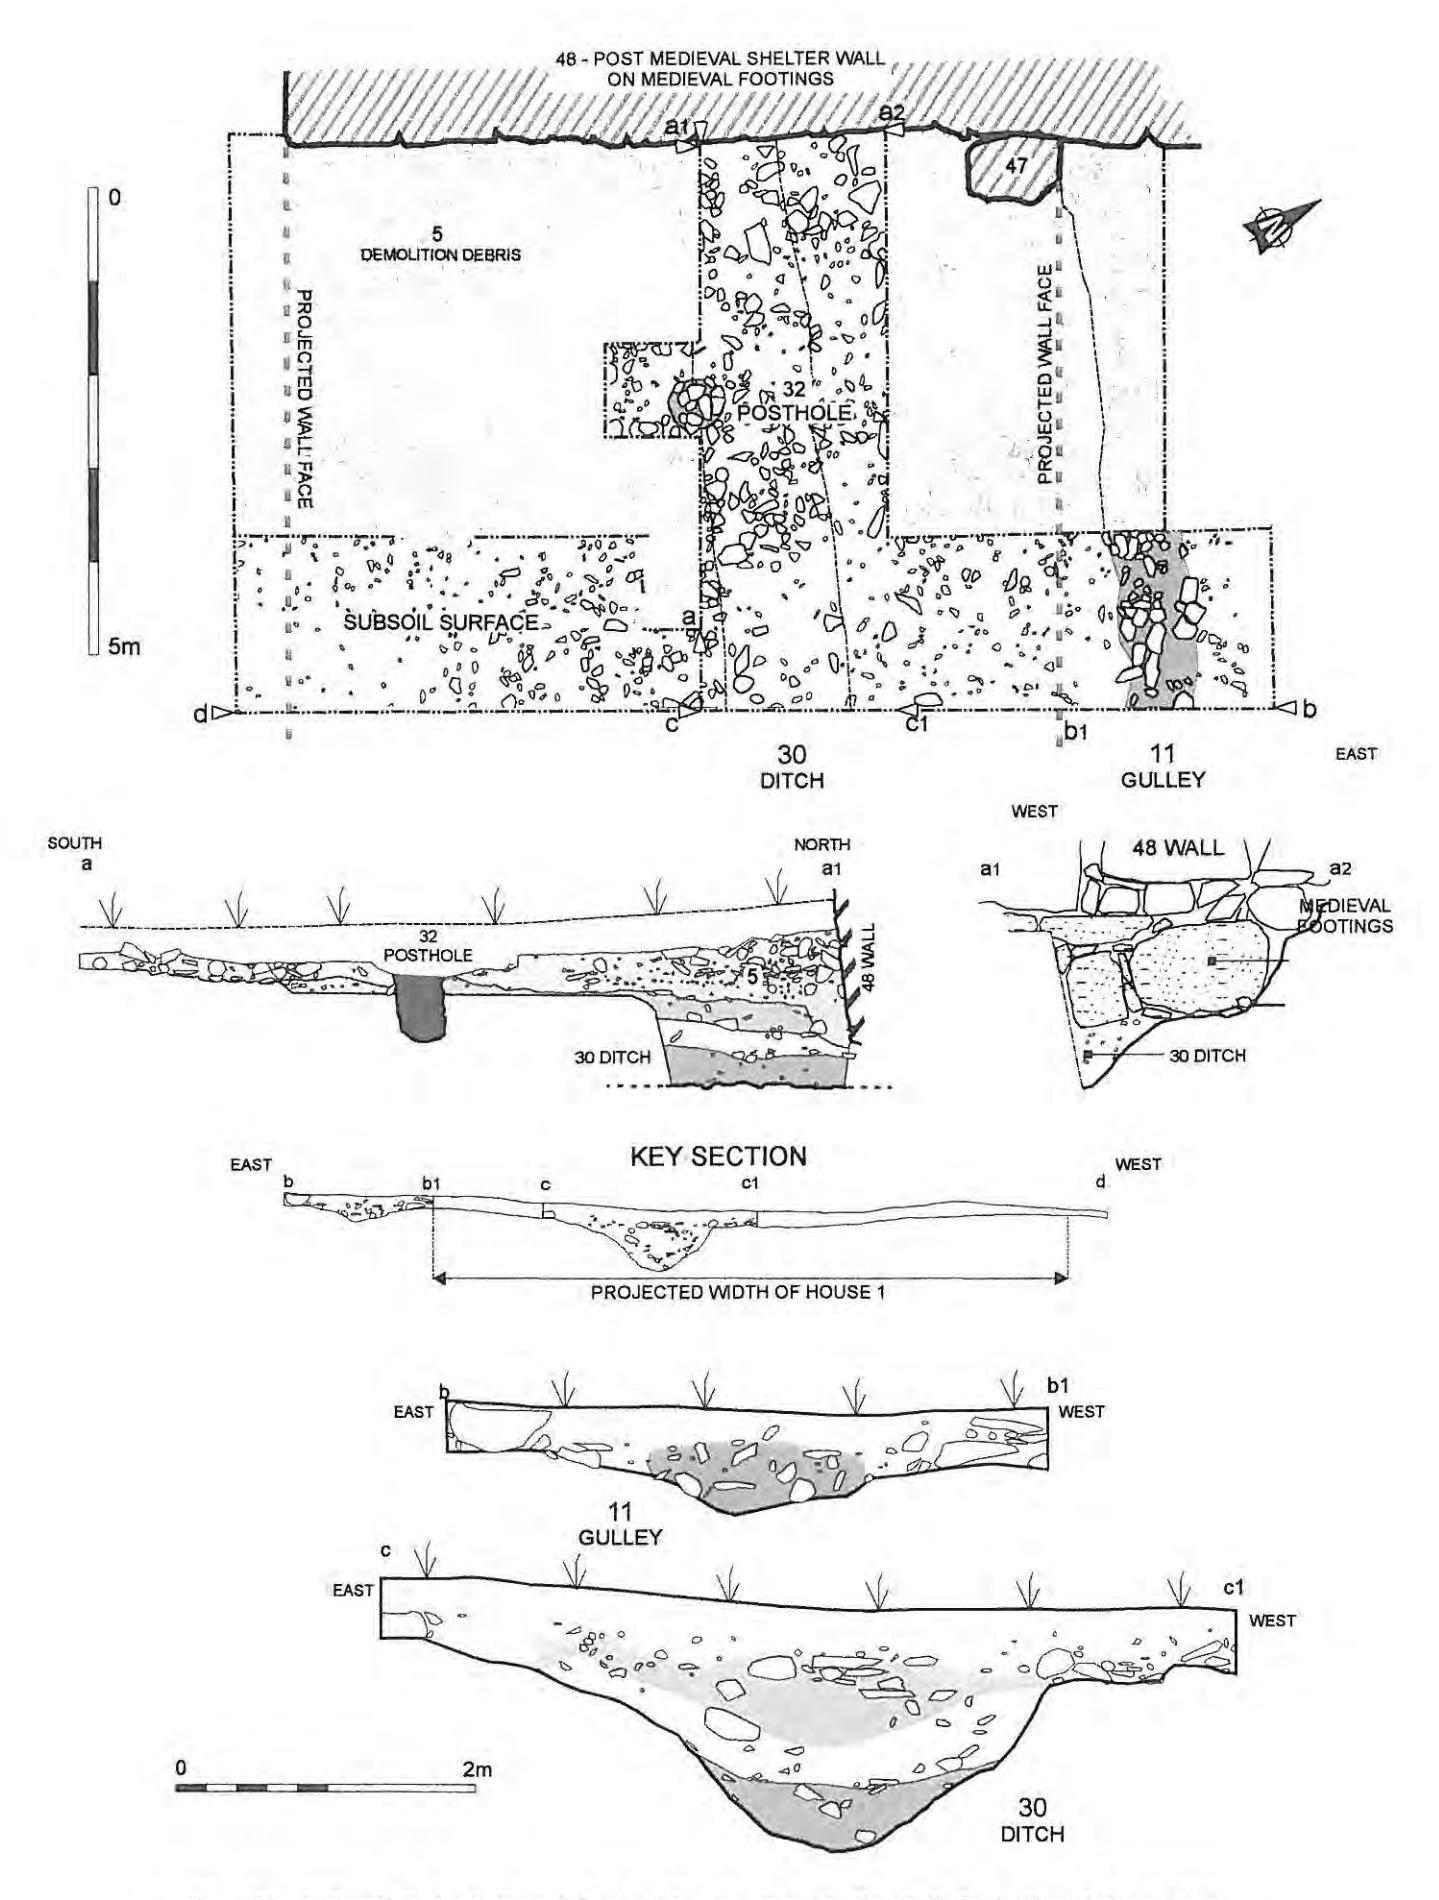
Top: Fig. 9 Gesail Gyfarch. Trench 1, plan. Lower: Fig. 10 Gesail Gyfarch. Trench 1, sections.

In the centre of the platform, removal of the rubble spread revealed a stone-packed post-hole (32), 0.32m diam. and 0.40m deep (Fig. 10). This lay approximately central to the width of the house and so seems likely to be part of its structure. On the basis that the house would have been built in regular bays another post-hole could have occurred within the excavated area but none was found. However, a linear feature, 30, was recorded, lying slightly east of the centre line of the house. This was a small ditch with sloping sides and rounded base, c. 1.75m wide and 0.6m deep (below the subsoil surface) filled with clayey silt (Fig. 10). It pre-dated the shelter wall and the wall of the platform house. No sign of the ditch could be seen on the surface of the field and the house platform had been built over the line of the ditch. However, the line of the ditch was recorded in the geophysical survey (Fig. 8b). The size of the ditch suggests that it had been a small field ditch that might be expected to belong to a phase of the settlement before the construction of House 1. A small amount of charcoal was recovered from the fill by hand picking and sieving. This was identified as *Quercus, Corylus* and *Fraxinus* (Caseldine, 1998) and was submitted for radiocarbon dating but proved to be too small for a conventional date and was rejected for AMS dating because it was an aggregate sample from a secondary context.

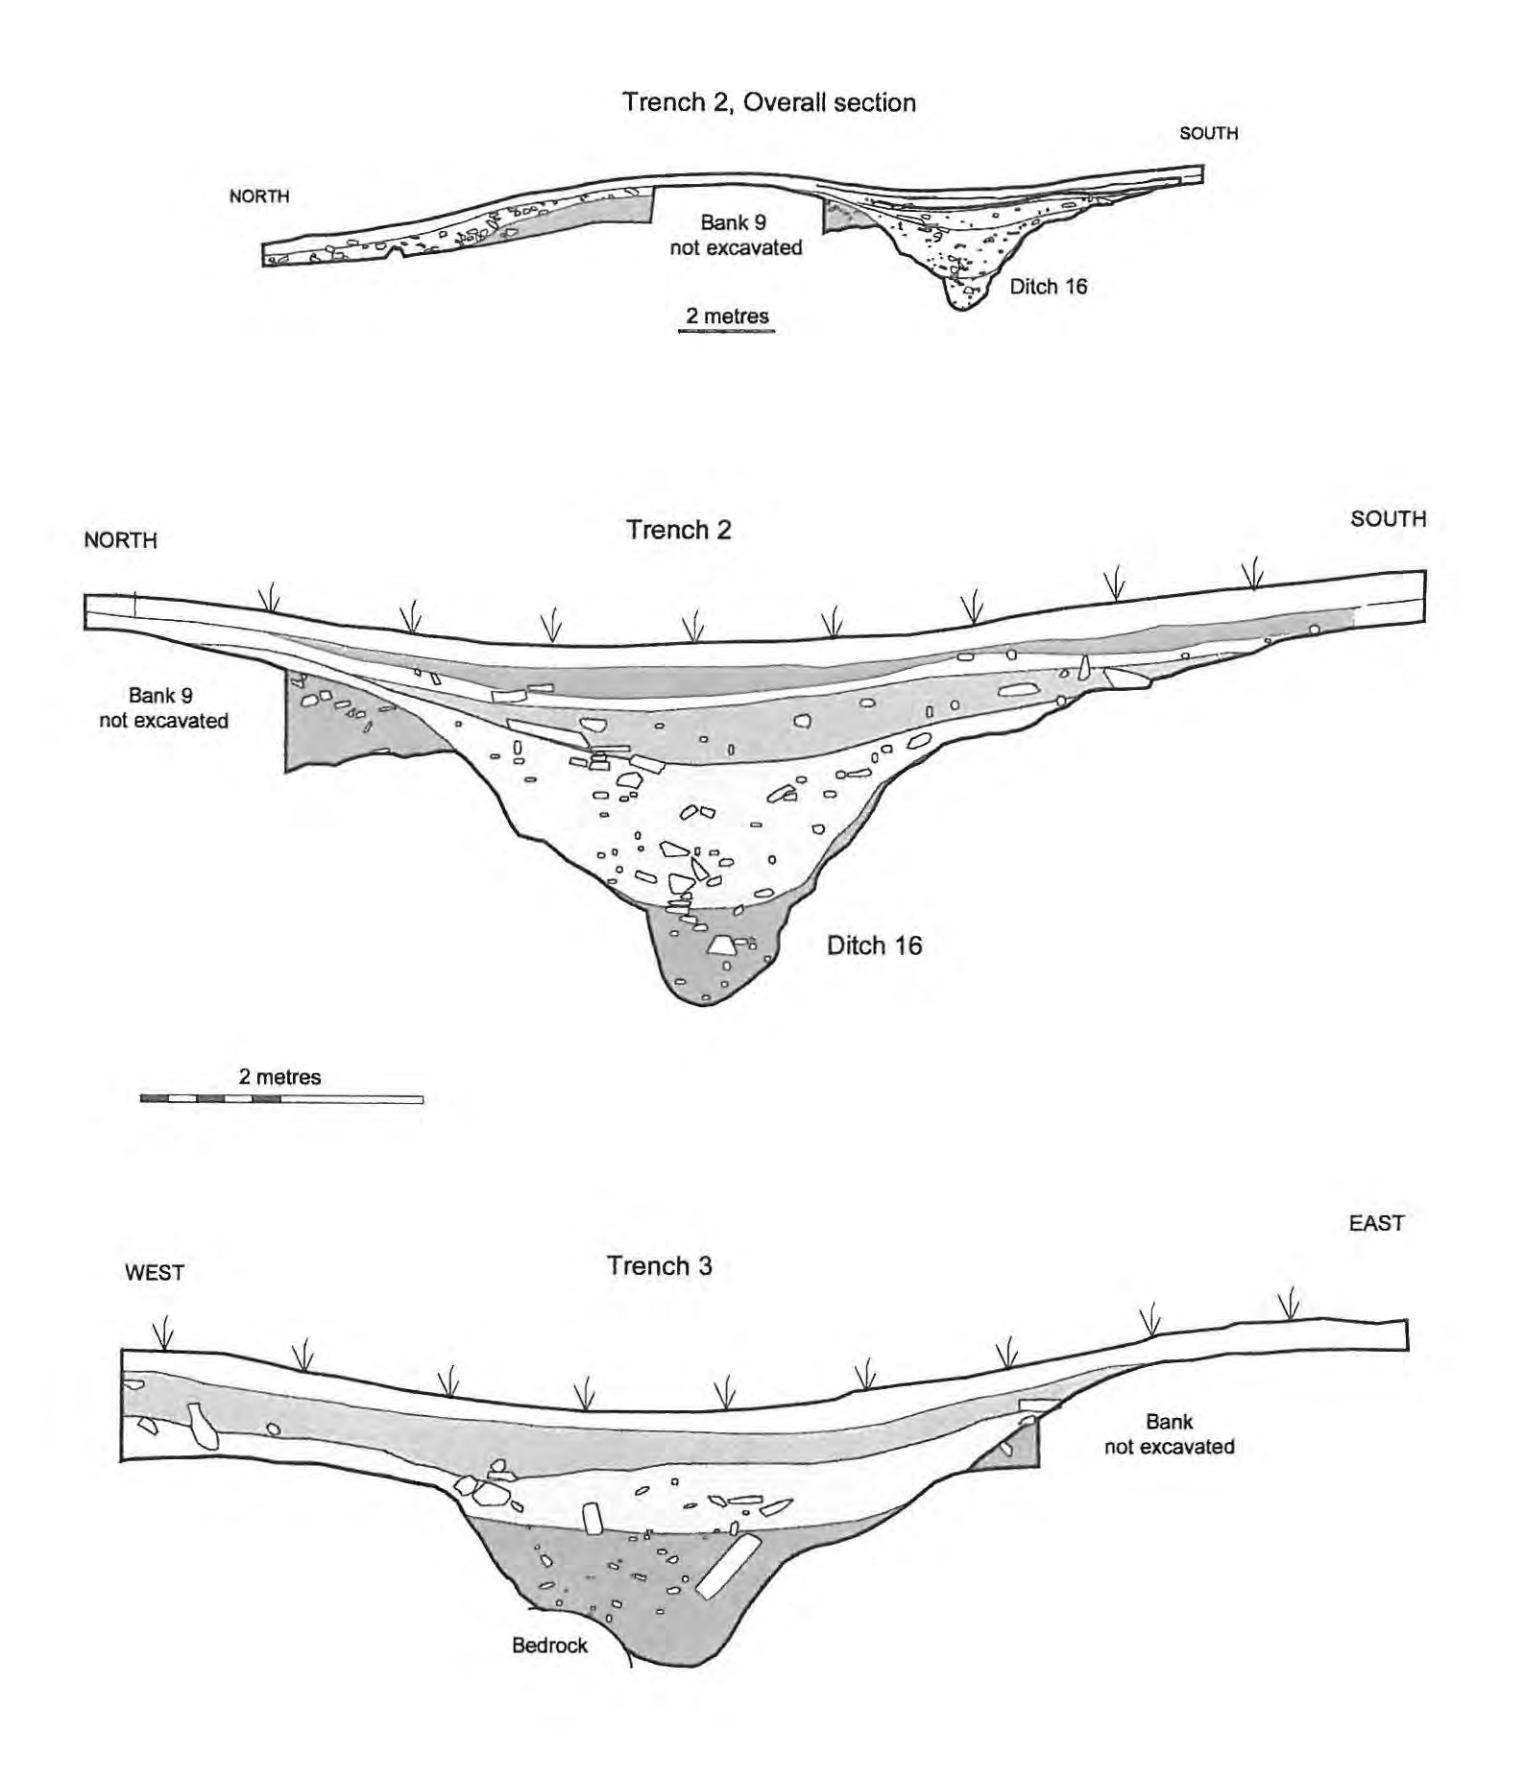
Fig. 11 Gesail Gyfarch. Trenches 2 and 3, sections.

(Plate 9, Fig. 11), was c. 1.9m wide and 1.10m deep with a simply-silted fill that was lacking in finds of any kind, despite the fact that it was only some 10m downhill from the probable site of another platform house (Fig. 8a). The ditch appeared to have initially silted in quite rapidly. The later episodes of silting were a result of ploughing evidenced by a number of plough marks found cut into the top of the bank and of the counterscarp surface. The bank, 9, was 3m wide and 0.5m high, well spread by erosion and ploughing. Its original downslope edge defined by a scatter of stones, probably eroded from the bank (Fig. 11) and this contained a fragment of pottery of 14th-15th century type (Edwards below). The buried soil beneath the bank was thin and indistinct (observations by Dr D. Jenkins). It was not a deep forest brown earth as might be expected if it was an undisturbed soil on a previously unsettled site and was more likely to represent a thin, well-grazed turf or even ploughsoil, more like the present day thin soil on the site. The soil was not sufficiently well sealed to warrant pollen analysis and similarly contained a little charcoal but insufficiently well stratified to justify radiocarbon dating.

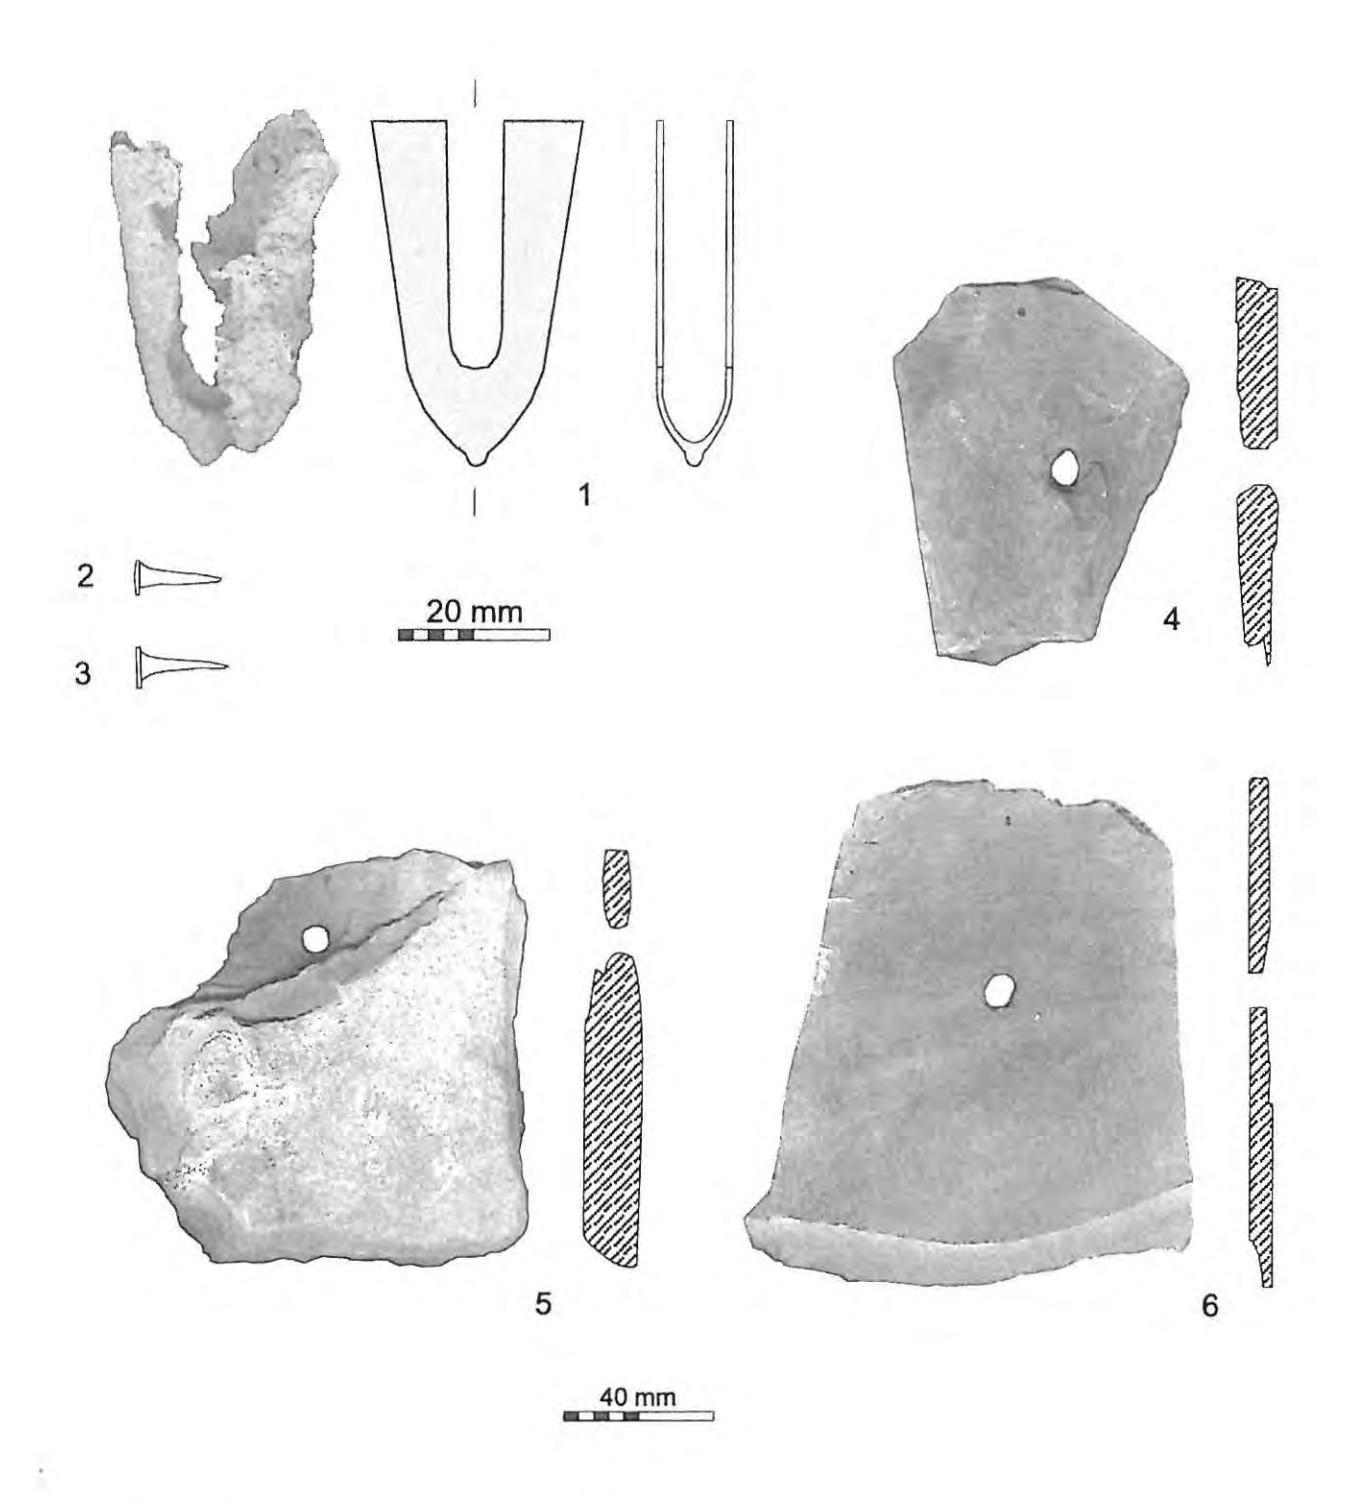
Fig. 12 Gesail Gyfarch. 1. Iron sword/dagger chape, left: as conserved, right: reconstructed view.
2-3. Iron horse-shoe nails. 4-6. Slate roof-tile frgaments. Scale 1-3, 1:1. 4-6, 1:2.
