FOUR MEDIEVAL OR SUB-MEDIEVAL RURAL SETTLEMENTS IN GWYNEDD Survey and excavations in 1997, 1998 and 1999 as part of the Deserted Rural Settlement Project (GAT Projects G1466 amd G1528)

Report No. 447

Prepared for Cadw: Welsh Historic Monuments

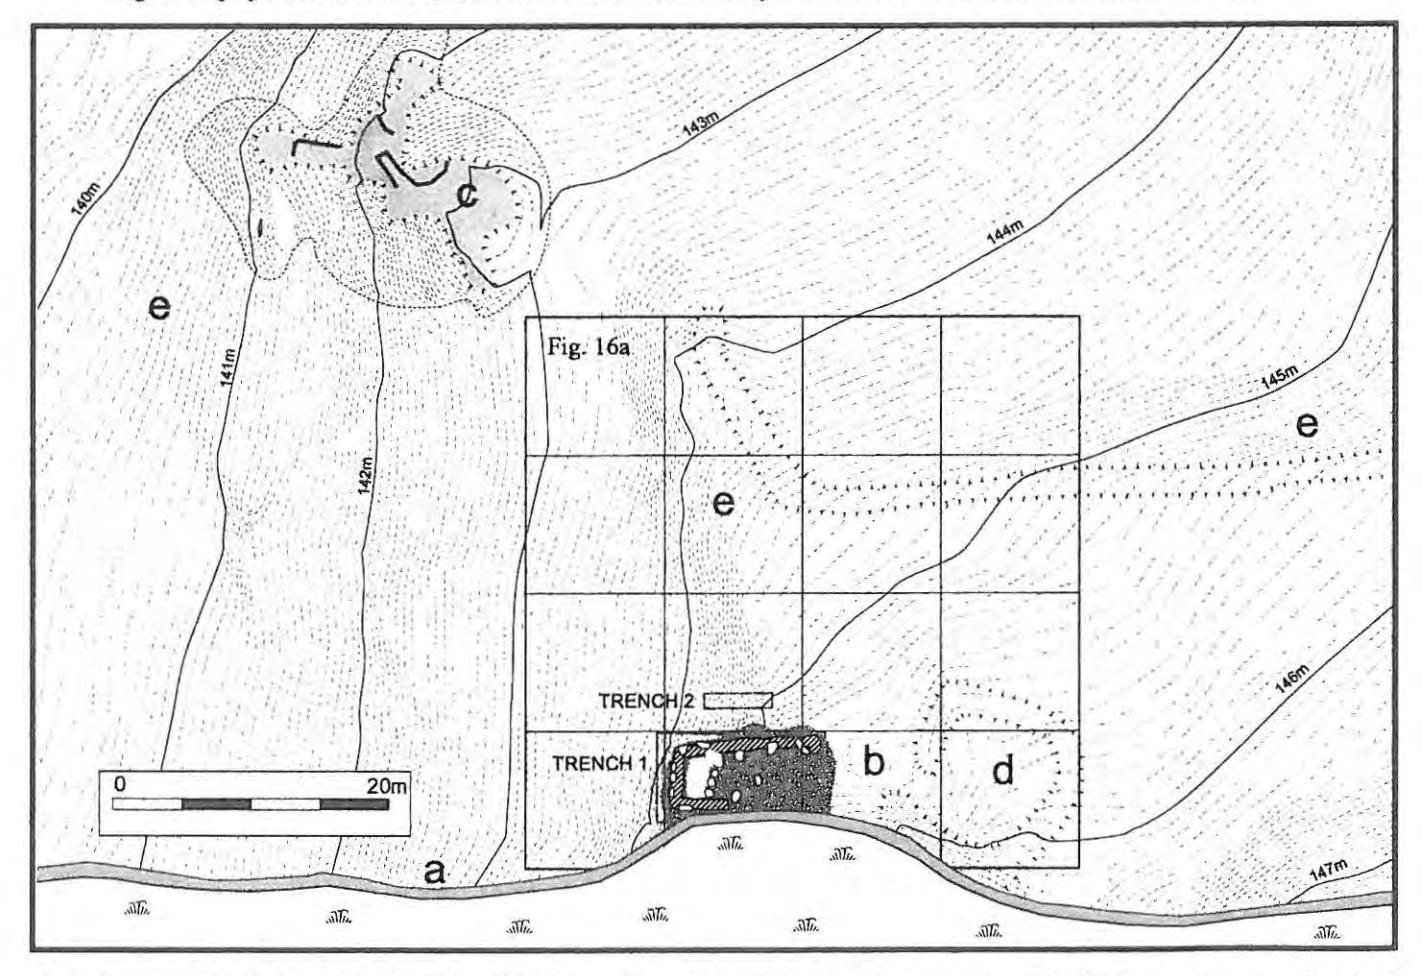
Fig. 14 Llystyn Ganol. Area plan. a. Field wall. b. House site. c. House? under modern stone dump. d. Platform/enclosure. e. Lynchets.

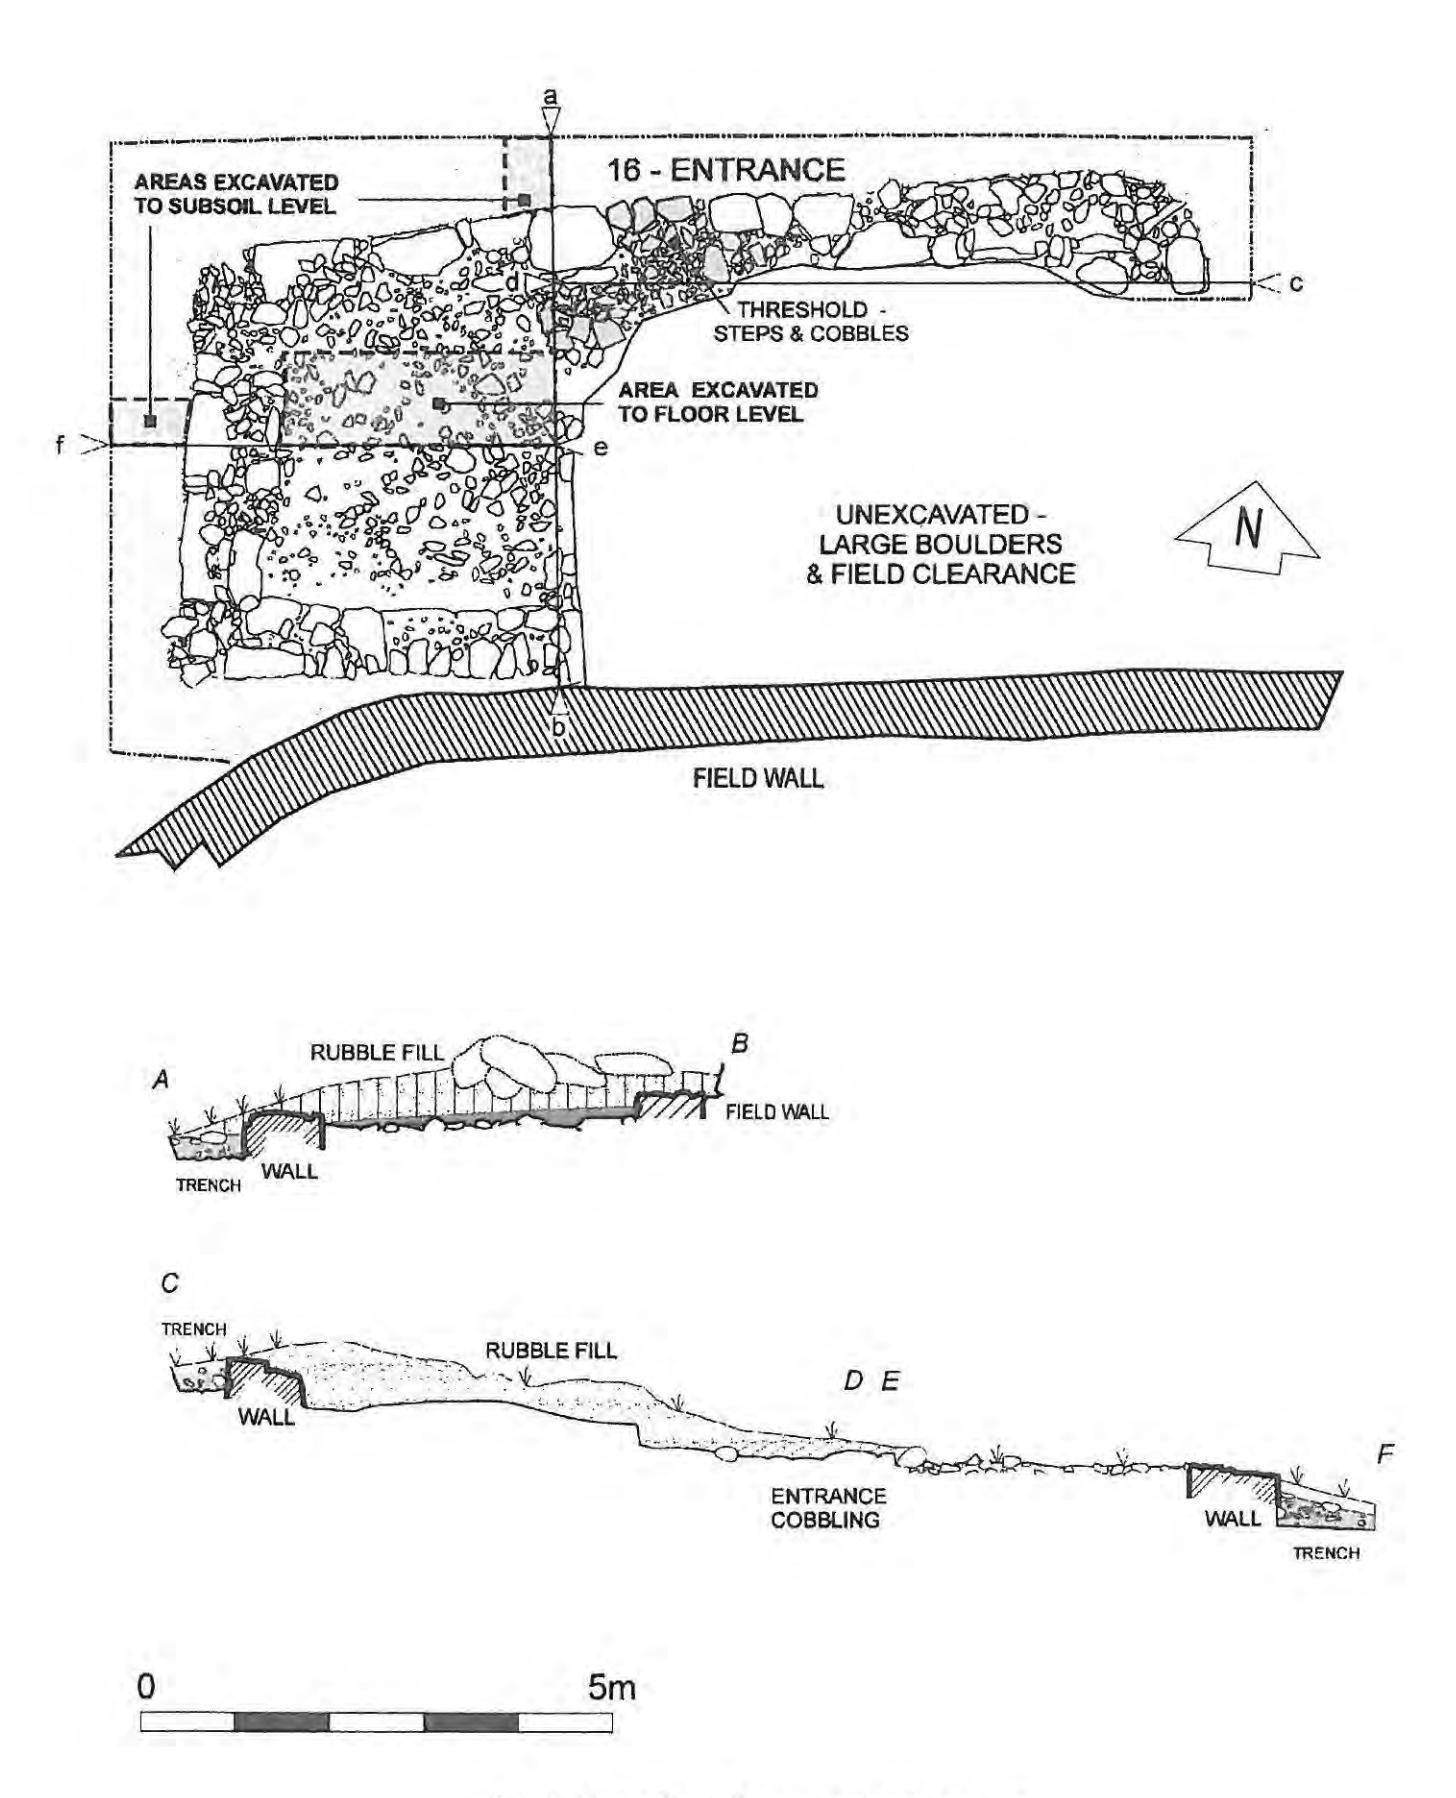
Fig. 15 Llystyn Ganol. Excavation plan and sections.

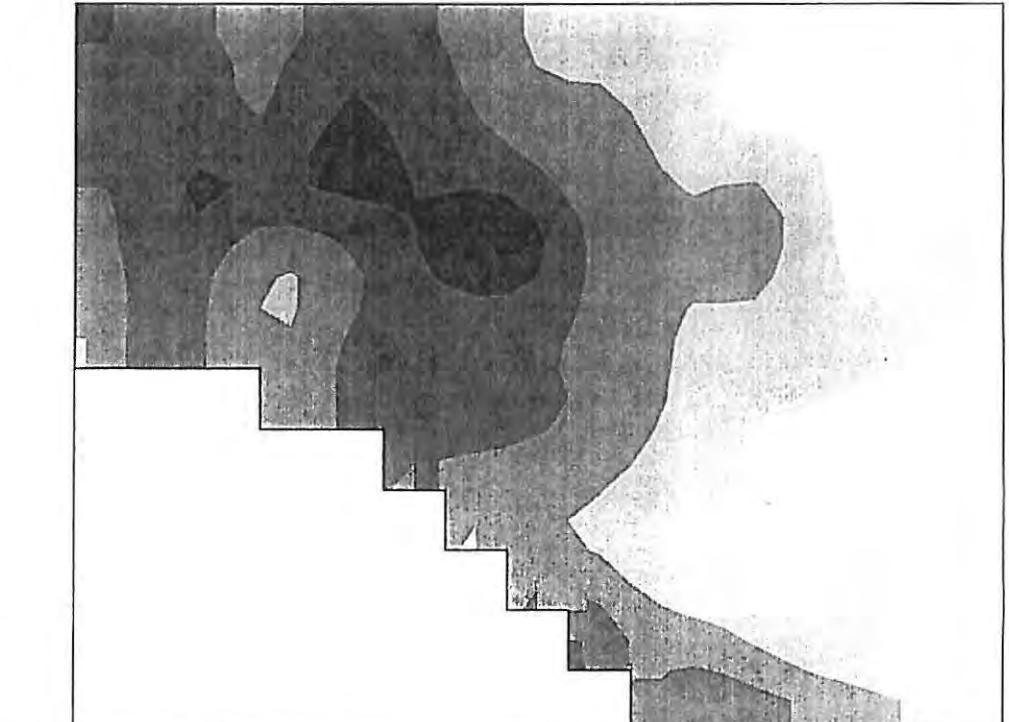
Fig. 16. Llystyn Ganol. Topsoil phosphate plots (for location of plot areas see fig. 14) a. field general, 10m sampling interval. b. platform east of the house, detail, 1m sampling interval.

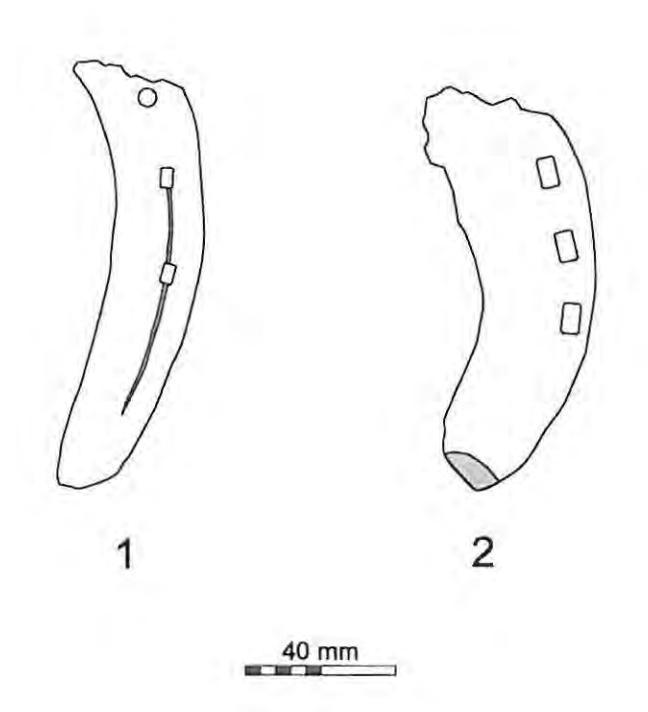
Fig. 17 Llystyn Ganol. Iron horse-shoes. Scale 1:2.

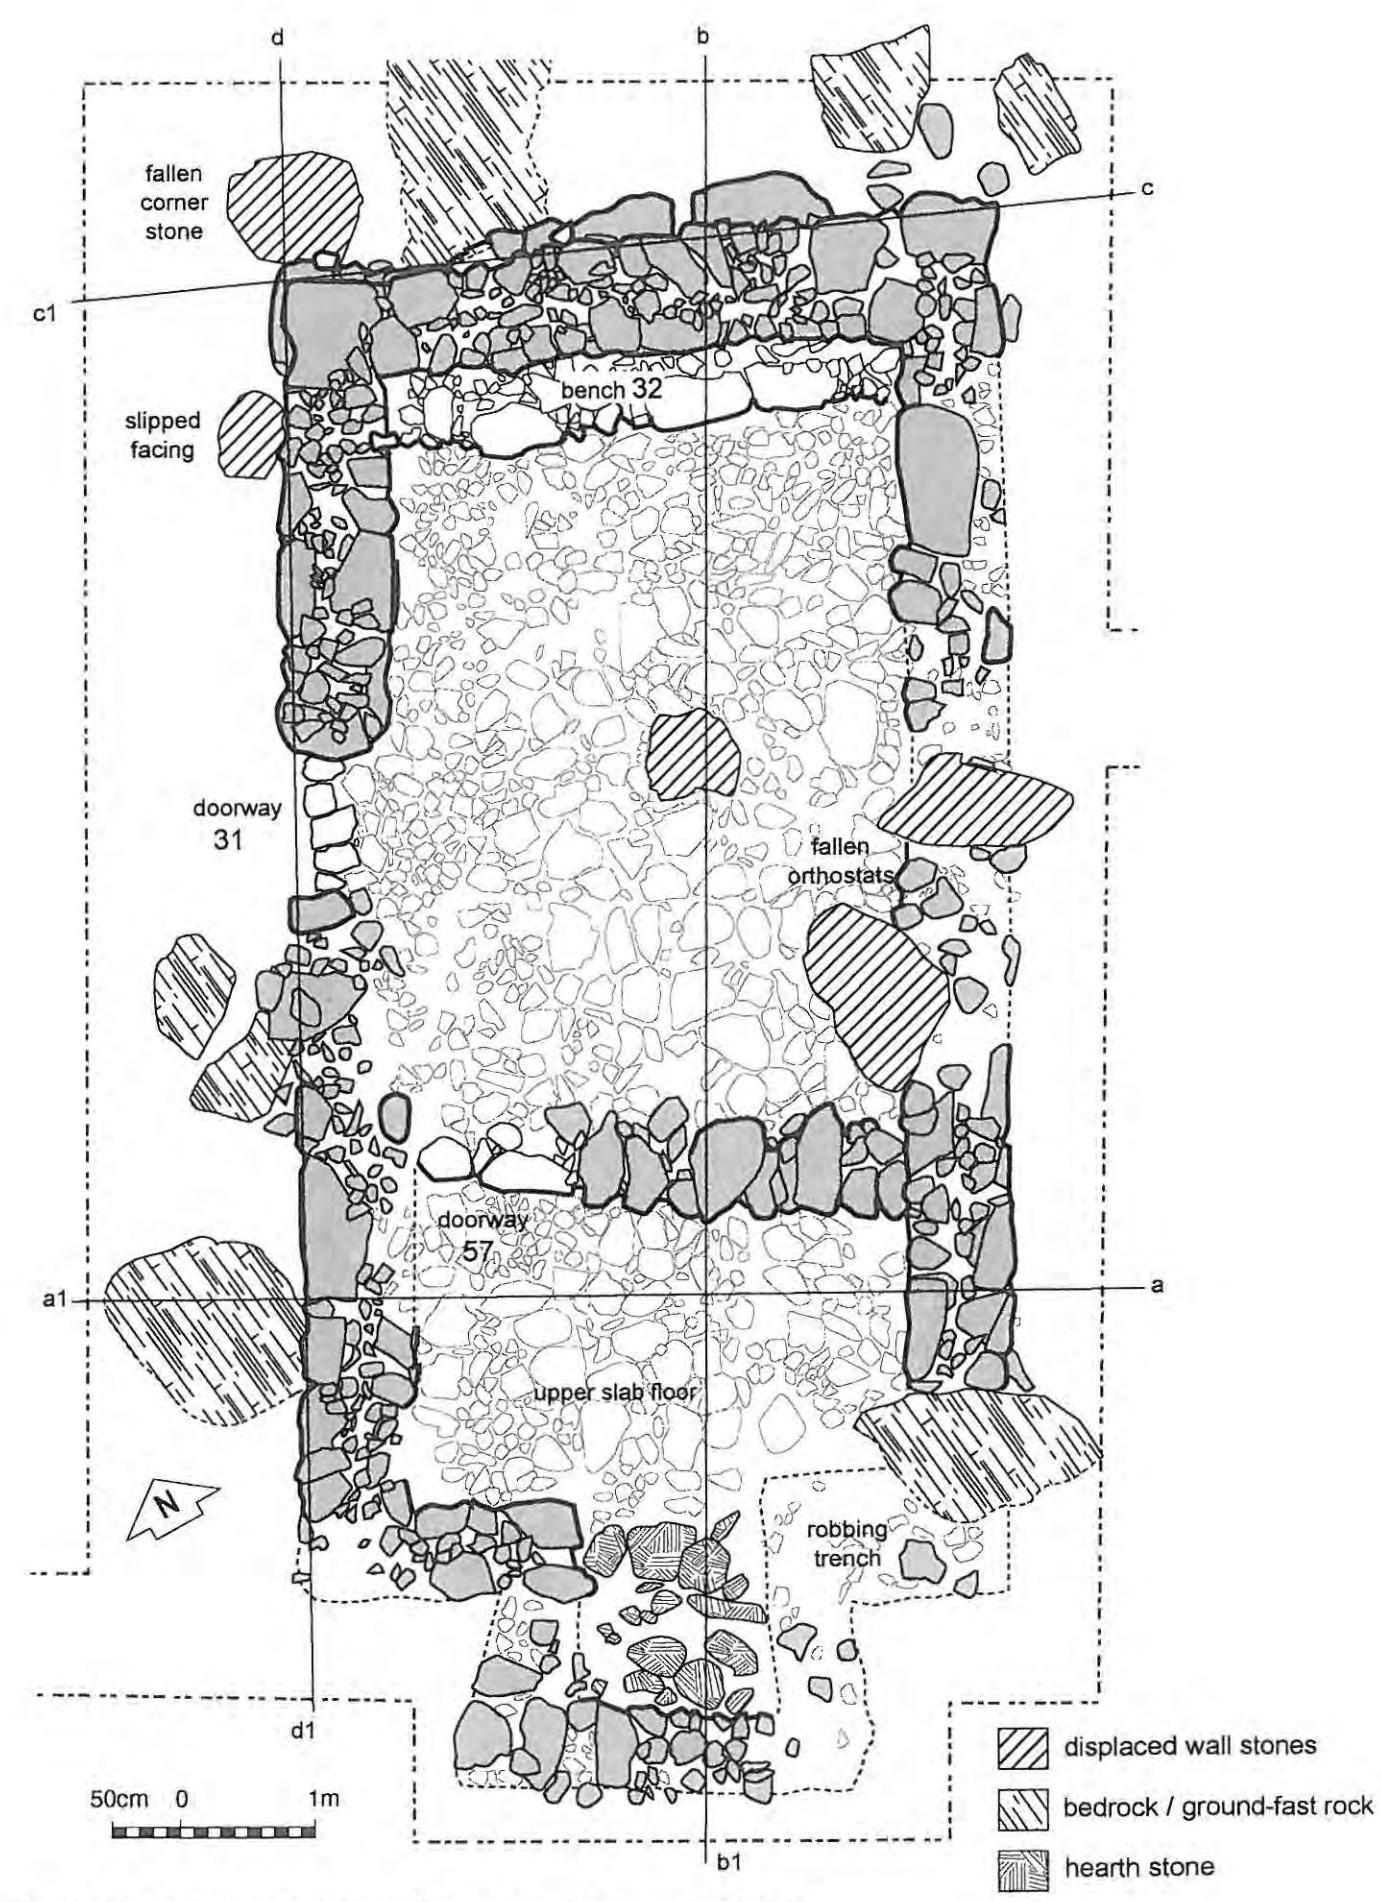
Fig.19 - Hafod Rhug Uchaf. Plan of house showing latest floor levels.

Lying on the floor of the northern room and approximately central to it was a single massive subrectangular stone block. It is possible that this could have been a deliberate feature, but had no signs of wear on its surface and seems most likely to have been a wall-stone abandoned during robbing of the eastern wall. At the northern end of the room a line of large boulders, with smaller material interspersed, lay against the end wall. These stones were loosely set in clayey soil, with no structural strength and so were probably a purely internal feature, a bench or low shelf support, c. 0.50m (1ft 8ins) wide and 0.25m (10ins) high (Figs 19, 20 and Plate 18).

The walls were all of dry stone construction and of a very consistent width of c. 0.83m (2ft 6ins) suggesting deliberate design. The side walls were laid out accurately parallel but the one surviving end wall was very much off square (Fig. 19) again suggesting a conscious design possibly because of the way the existing ground rocks were incorporated in the foundations. The walls were constructed of a base layer of massive boulders laid so as to give a fairly level foundation for the upper wall of smaller stones. This upper wall had been entirely robbed away apart from a small portion at the north end (Fig. 20). A cutting was made at the south-east (up hill) side to see if the wall had been laid on a cut platform or in a prepared trench but surprisingly, at this point it had been laid directly onto a buried soil so must have been utilising an existing natural terrace (Fig. 20, section 1). The buried soil, context 58, was sampled for environmental information (Appendix 3, Sample 2).

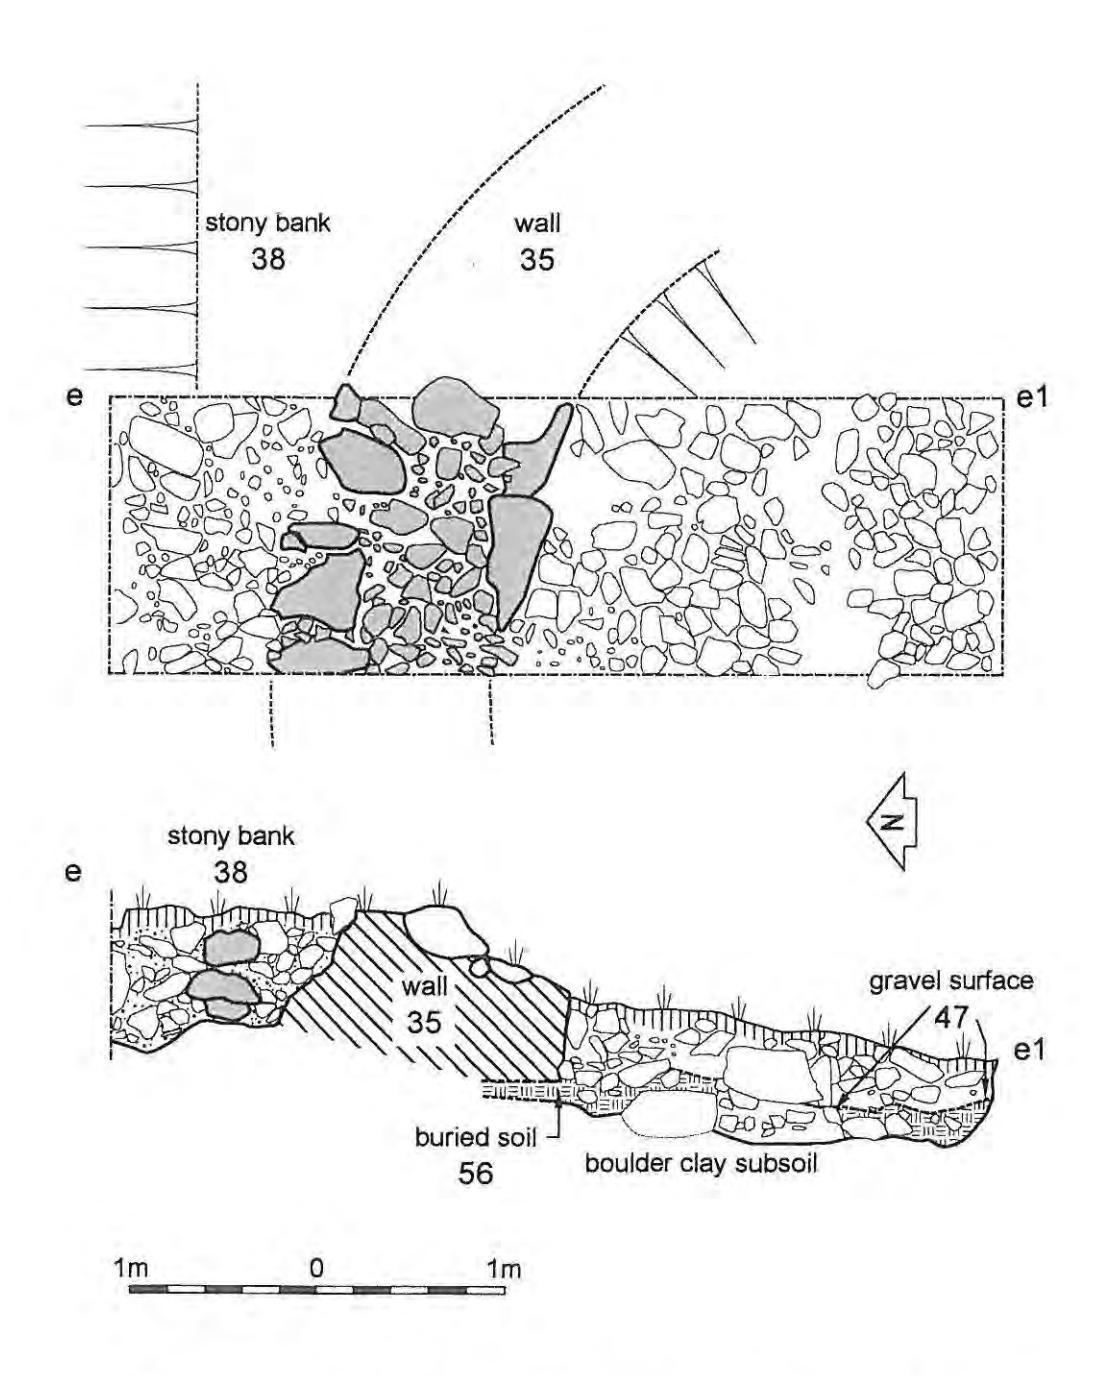
Fig. 21 - Hafod Rhug Uchaf. Trench 3, plan and section of curvilinear structure.

This trench was laid out to provide a diametric section across the circular earthwork feature and its enclosing bank recorded here (Fig. 21) which formed part of a longer irregular bank. The bank was shown to be 2.0m wide and deliberately faced on the inner side with selected slabs, one of which was set as an orthostat. The wall of the circular feature was separate from the longer bank that abutted it on the north side and was therefore later. Within the curve of the wall was a mass of rubble, presumed to be tumble from the collapsed wall, and this overlay a loose, gravely surface (47). The latter was the floor of the structure but was quite different from any of the surfaces or buried soils seen in trench 1, which were either slabs, small cobbles or stony loam. The gravely surface was c. 180mm deep and overlay a red-brown clay mixed with 50% stone which was a natural glacial till. The wall of the circular structure was founded on the rocky

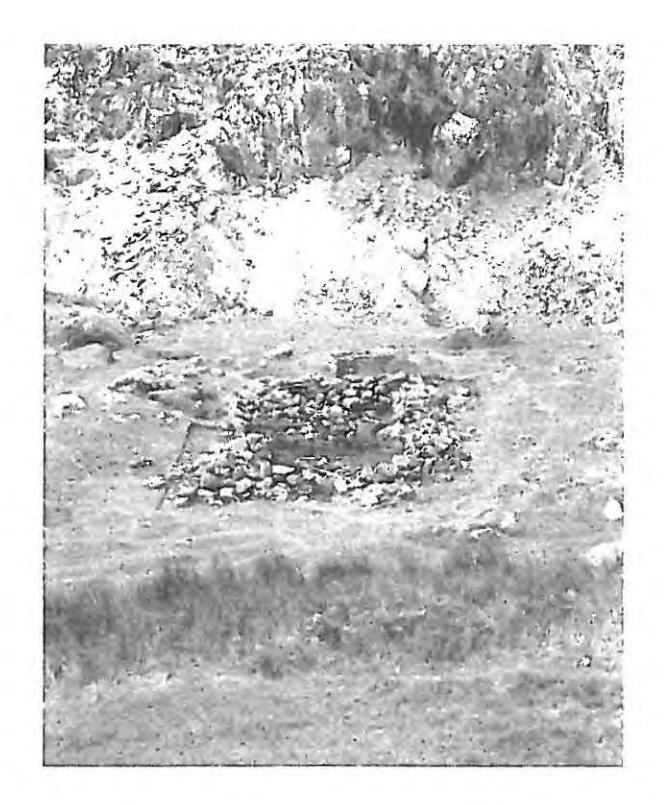
Plate 1 Ynys Ettws: General view of House 1, looking north. Peat-filled spring pool in foreground. Scale with 50cm divisions.

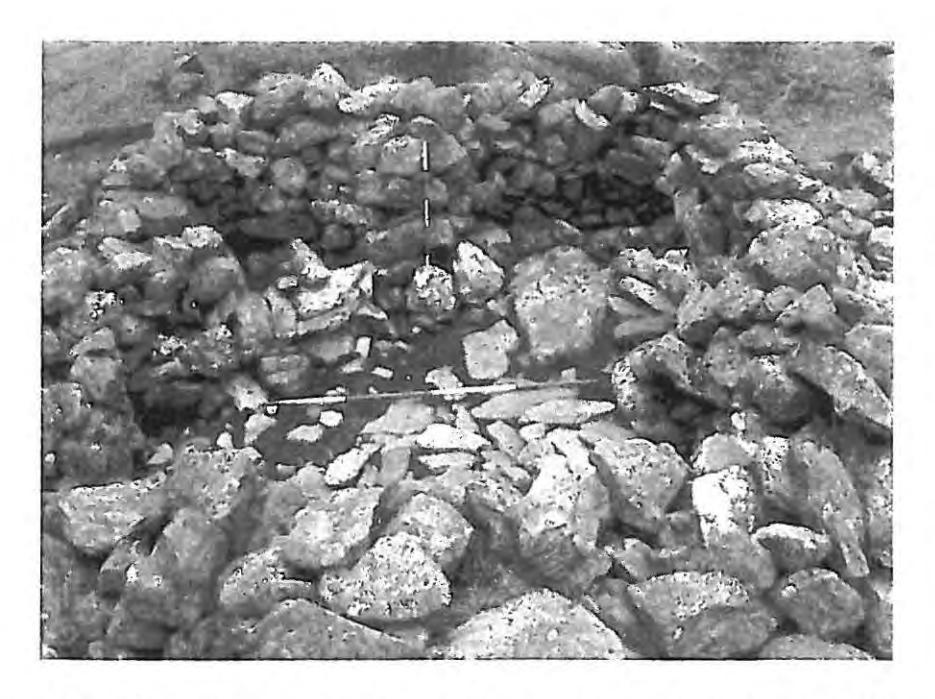
Plate 2 Ynys Ettws: Phase 2 north compartment, looking west. Corner fireplace on left, bed-recess on right. Horizontal scale 50cm divs, vertical scale 20cm divs.

Inside the hut the main feature (d) was a low wall of slabs that divided off the south-west corner. Resting from the back angle to the low wall was a long, thin bar-like stone slab and next to it were three other similar slabs that originally lay parallel to the first slab, but that had fallen into the wall angle. These slabs showed probable discolouration and cracking from heat and so were probably fire-bars for a raised corner fireplace (Plate 2).

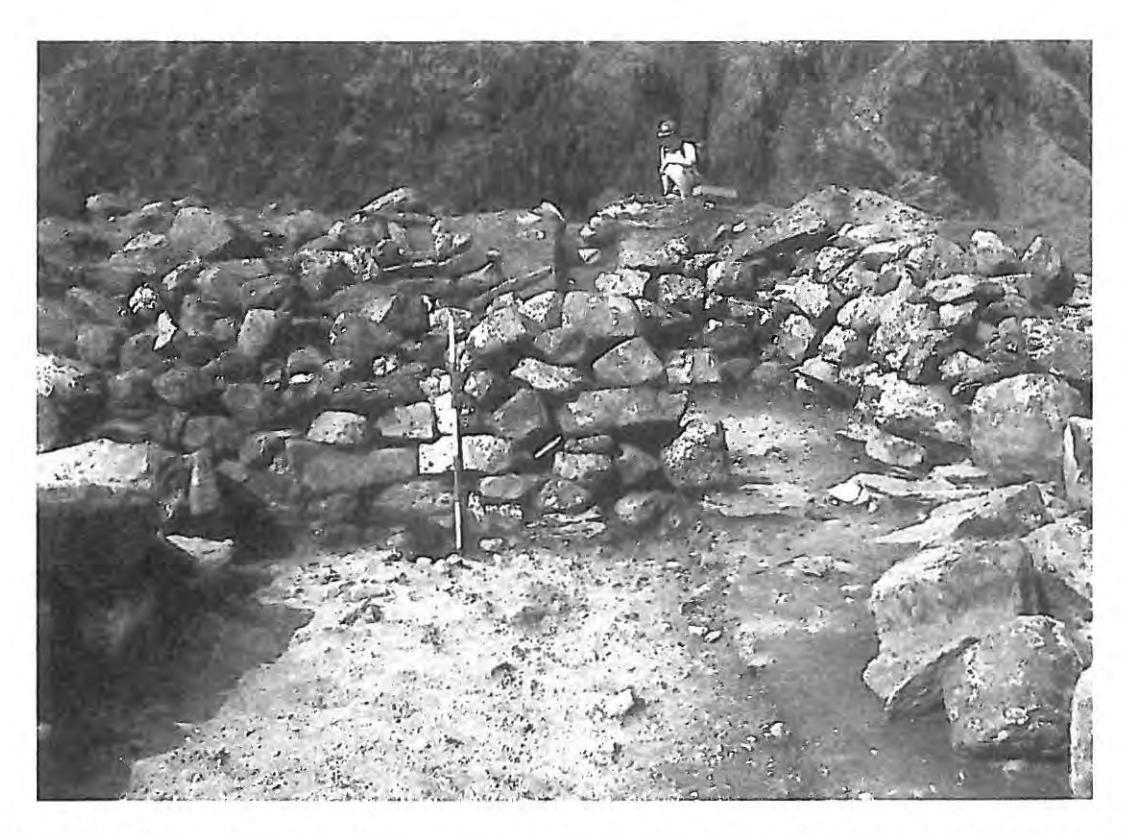
Plate 3 Ynys Ettws: Phase 2 south compartment, looking north, showing Phase 2 inserted partition wall, Phase 1 floor and Phase 1 pit below the partition wall (below tip of scale). Scale with 20cm divs.

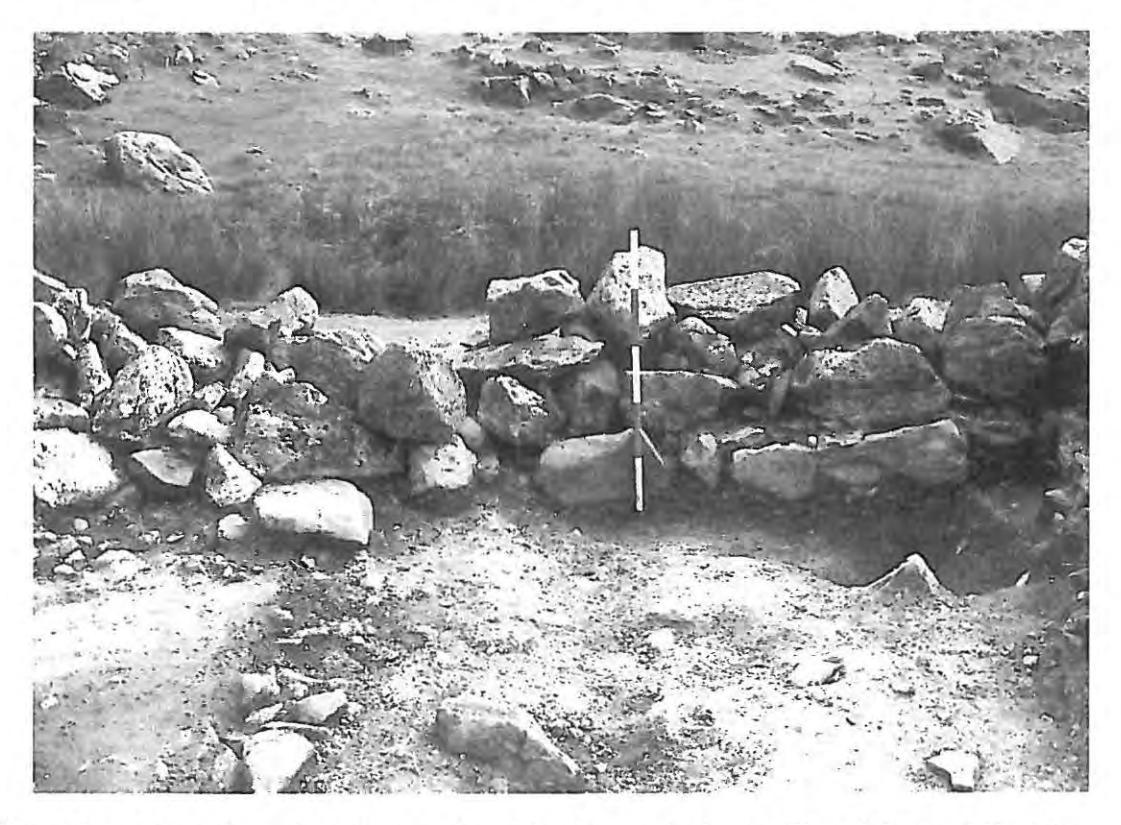
Plate 4 Ynys Ettws: Phase 2, south compartment, looking south, showing Phase 1 floor and Phase 2 roughly laid wall built over Phase 1 neatly laid wall. Scale with 20cm divs.

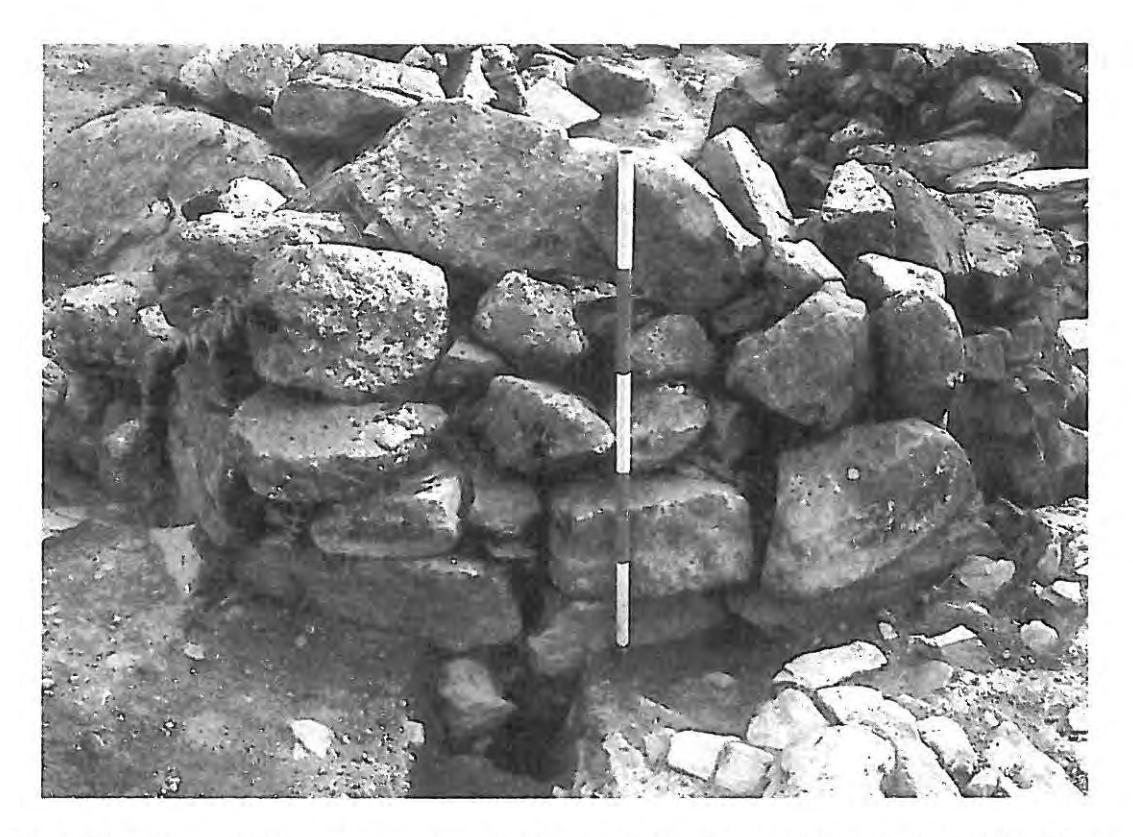
Plate 5 Ynys Ettws: North-east outer corner, looking south, showing rounded angle of neatly laid Phase 1 wall overlaid by roughly laid Phase 2 wall. Scale with 20cm divs.

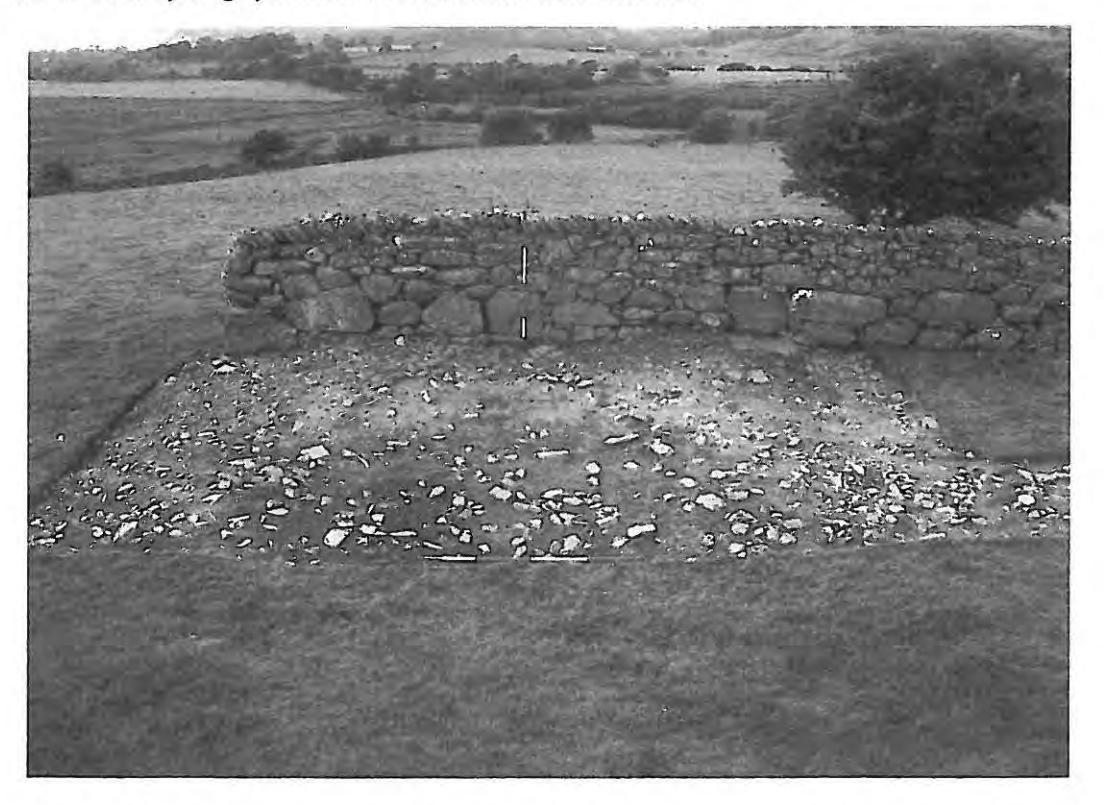
Plate 6 Gesail Gyfarch: General view of trench, looking north, after removal of turf, showing demolition stone scatter and post-medieval shelter wall built over the remains of the north gable wall of the house. Scale with 50cm divs.

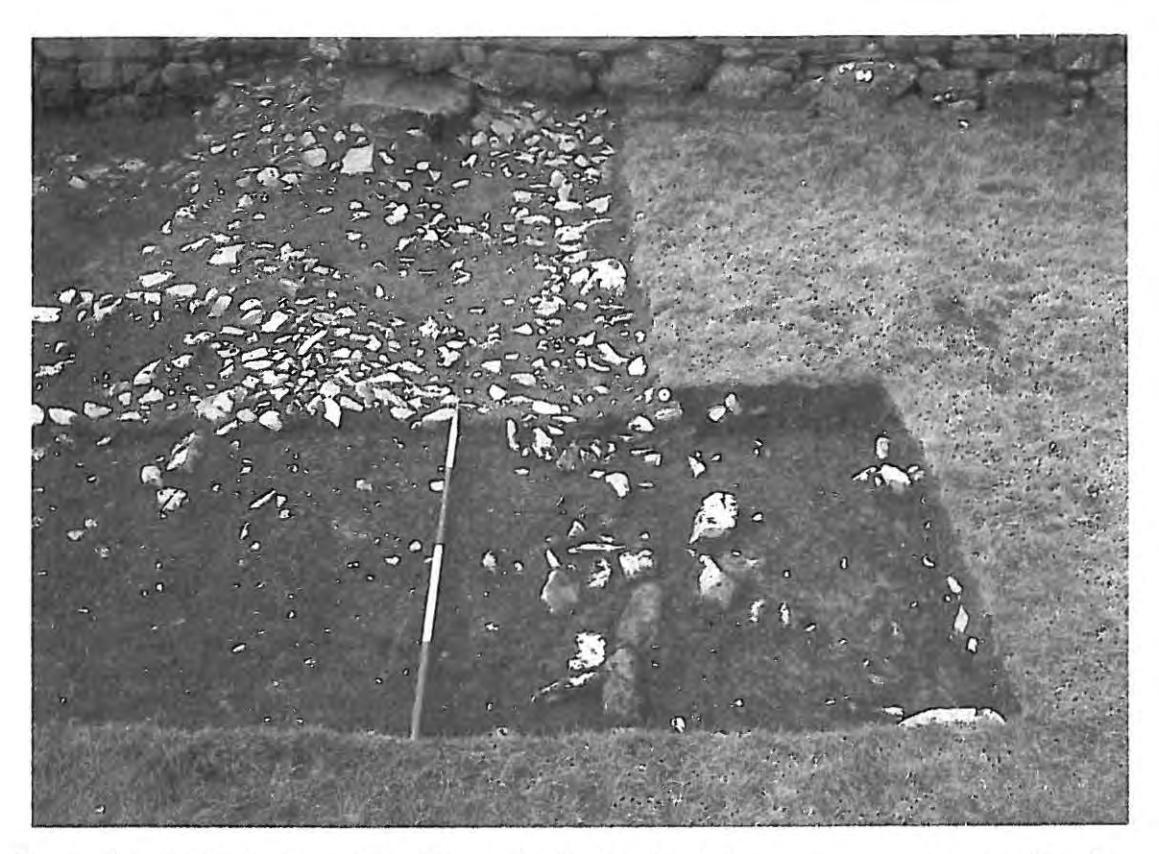
Plate 7 Gesail Gyfarch: Trench 1, looking north, showing demolition scatter removed to subsoil level across line of east wall of house and stone-lined water culvert before excavation. Foundation quoin of house in situ in background. Scale with 50 cm divs.

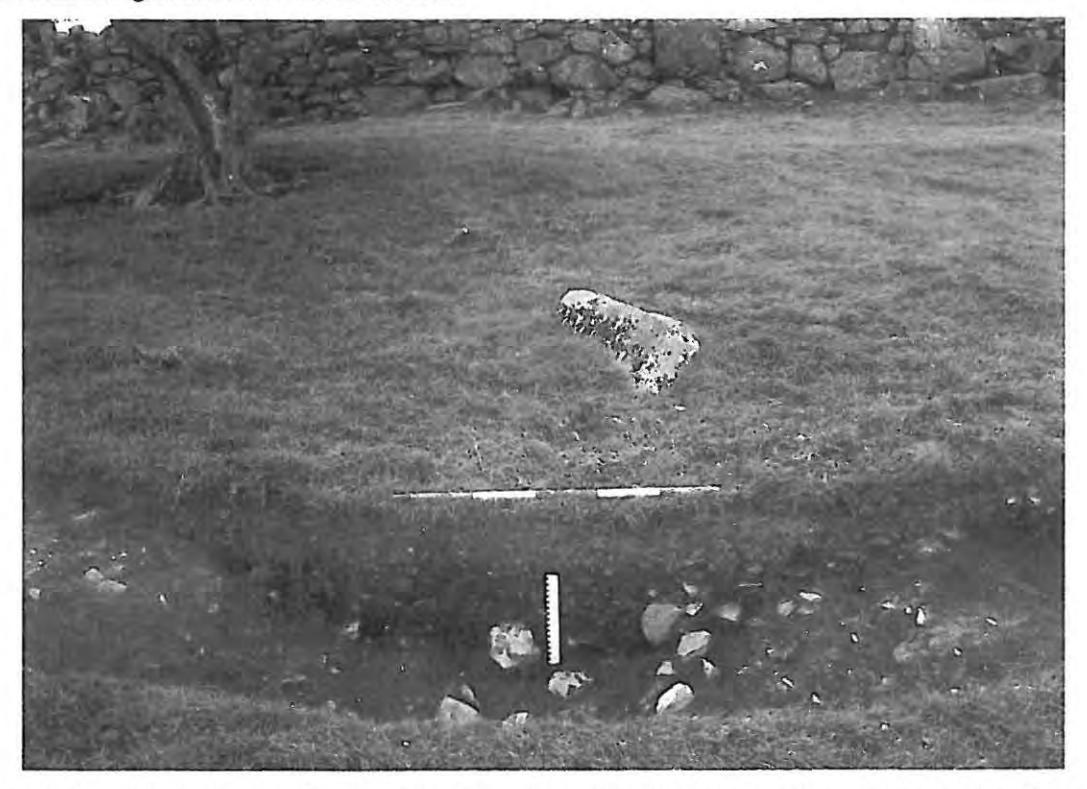
Plate 8 Gesail Gyfarch: Trench 3, looking south, ditch taking water from culvert, shown at later silting level. House corner within shelter wall in background right. Horiz. scale 20cm divs, vert. scale 1cm divs.

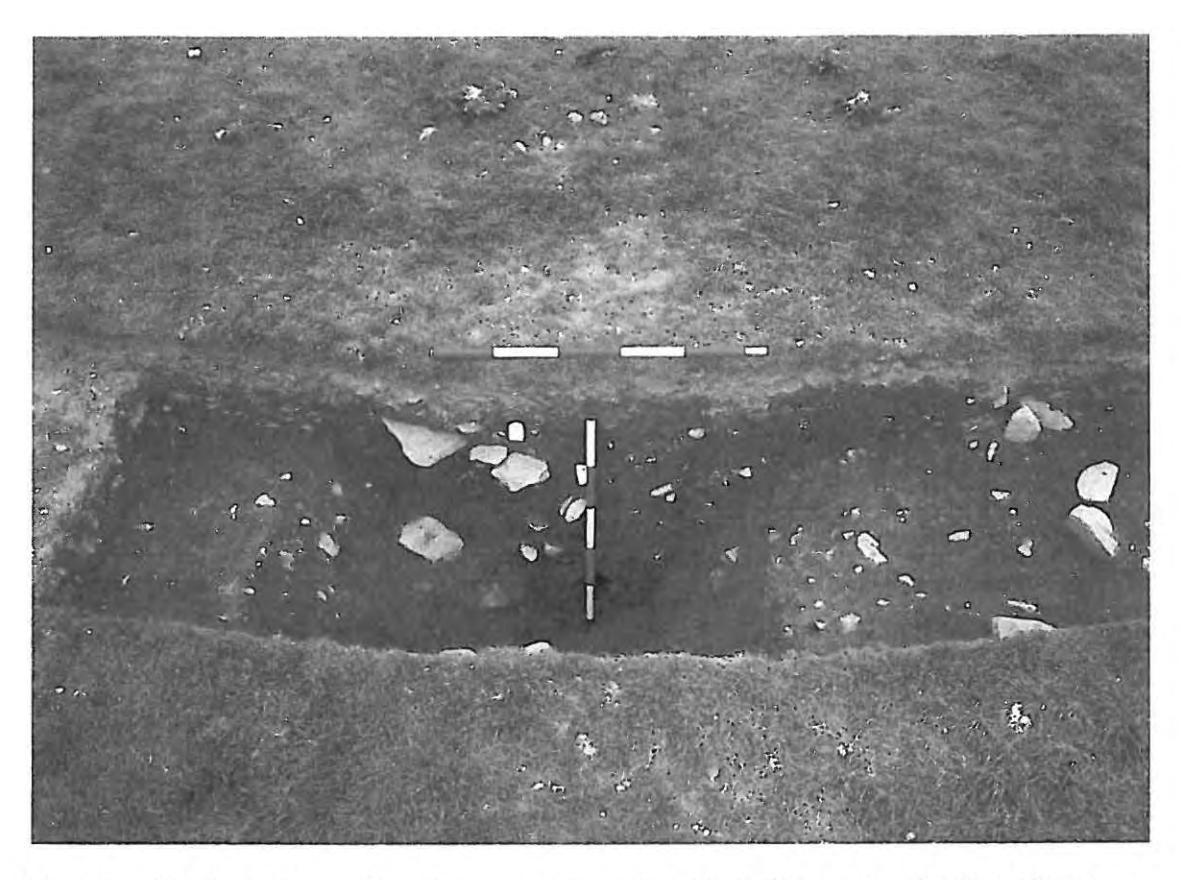
Plate 9 Gesail Gyfarch: Trench 2, looking east, enclosure hood-bank ditch excavated to base. Scales

(Plate 9, Fig. 11), was c. 1.9m wide and 1.10m deep with a simply-silted fill that was lacking in finds of any kind, despite the fact that it was only some 10m downhill from the probable site of another platform house (Fig. 8a). The ditch appeared to have initially silted in quite rapidly. The later episodes of silting were a result of ploughing evidenced by a number of plough marks found cut into the top of the bank and of the counterscarp surface. The bank, 9, was 3m wide and 0.5m high, well spread by erosion and ploughing. Its original downslope edge defined by a scatter of stones, probably eroded from the bank (Fig. 11) and this contained a fragment of pottery of 14th-15th century type (Edwards below). The buried soil beneath the bank was thin and indistinct (observations by Dr D. Jenkins). It was not a deep forest brown earth as might be expected if it was an undisturbed soil on a previously unsettled site and was more likely to represent a thin, well-grazed turf or even ploughsoil, more like the present day thin soil on the site. The soil was not sufficiently well sealed to warrant pollen analysis and similarly contained a little charcoal but insufficiently well stratified to justify radiocarbon dating.

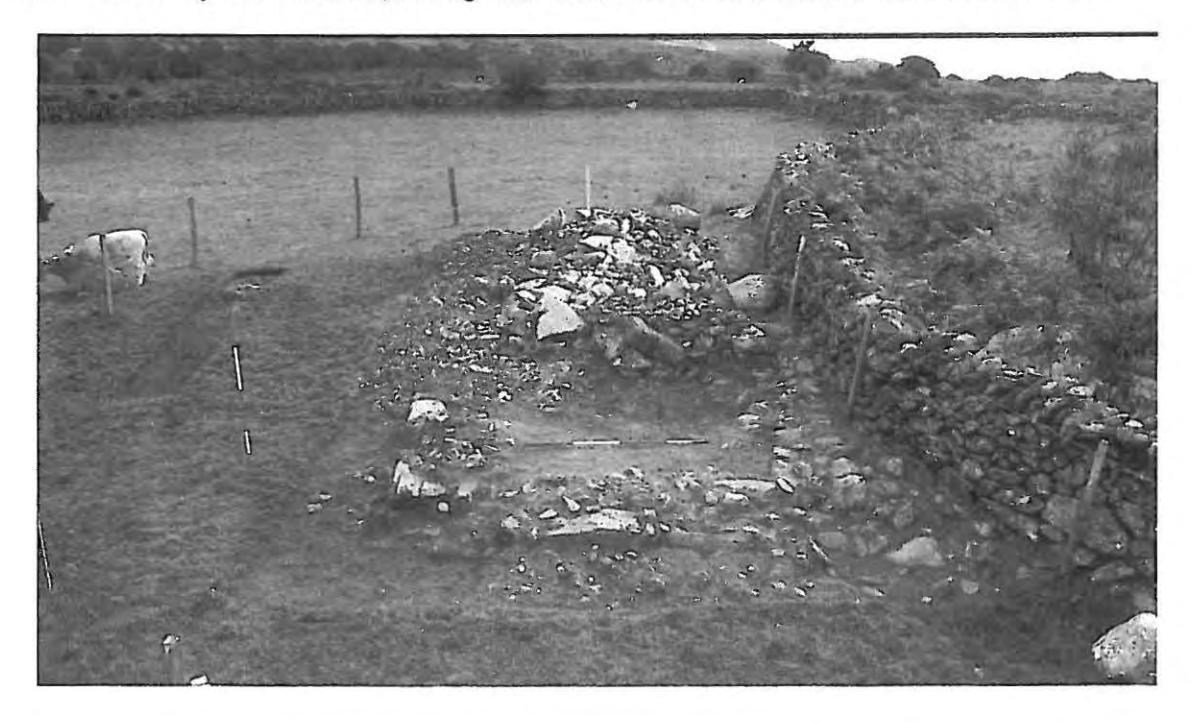
Plate 10 Llystyn Ganol: House with clearance cairn overlying, looking east, after removal of turf. Scale with 50cm divs.

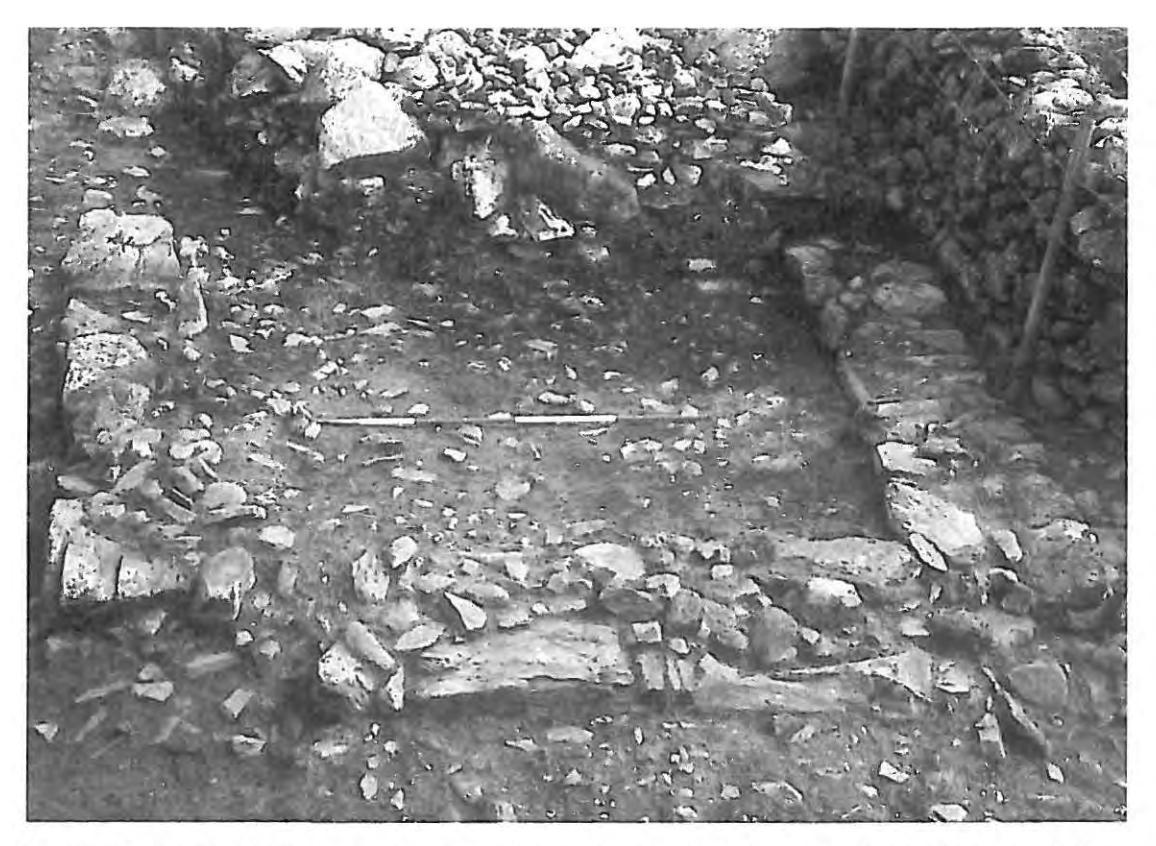
Plate 11 Llystyn Ganol: House west end excavated to floor level, looking east. House doorway at left background. Scale with 50cm divs.

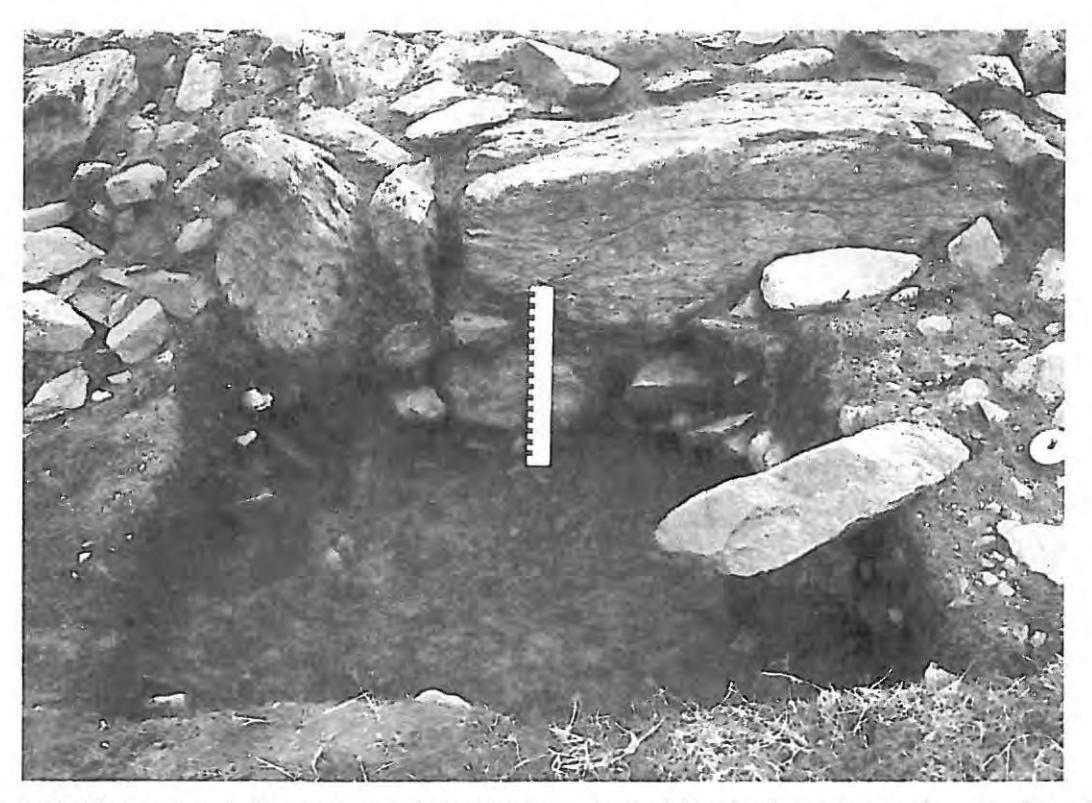
Plate 12 Llystyn Ganol: House west wall, looking east, external face footings excavated to subsoil level (loessic till) showing absence of foundation trench. Scale with 1cm divs.

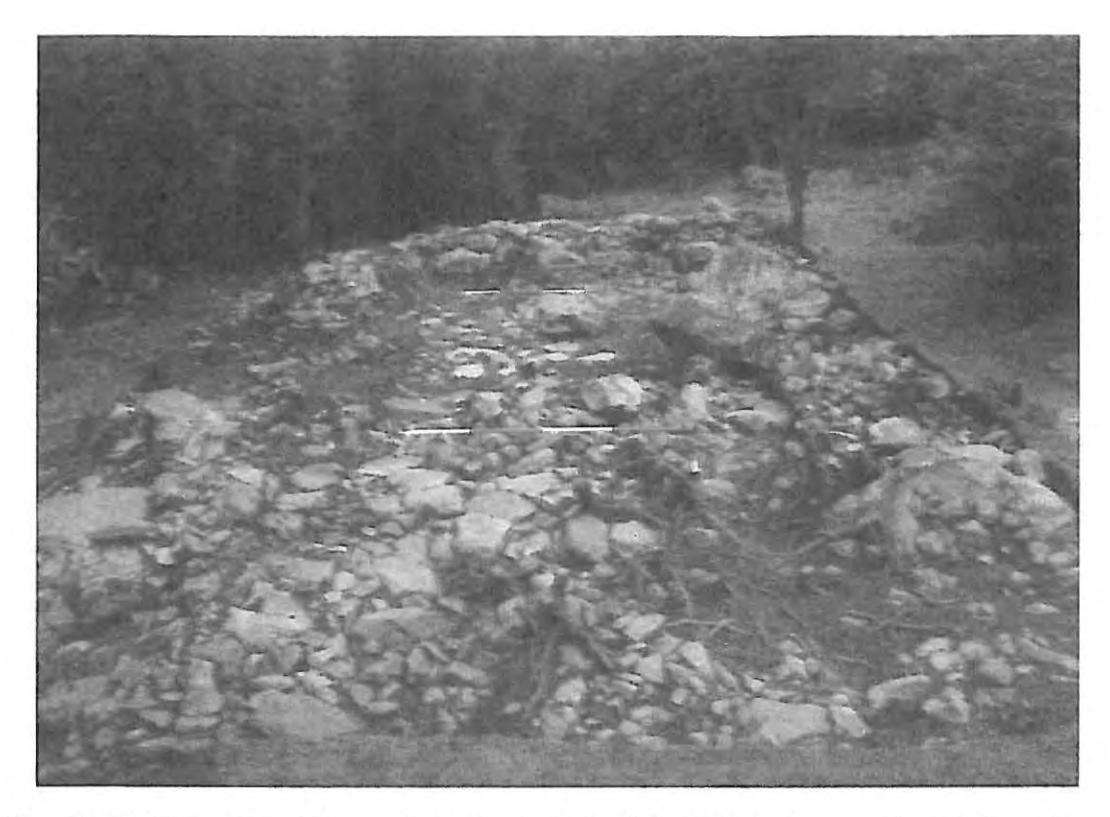
Plate 15 Hafod Rhug Uchaf. House after removal of topsoil, lookinig north-east, scale with 50cm divs.
