FOUR MEDIEVAL OR SUB-MEDIEVAL RURAL SETTLEMENTS IN GWYNEDD Survey and excavations in 1997, 1998 and 1999 as part of the Deserted Rural Settlement Project (GAT Projects G1466 amd G1528)

Report No. 447

Prepared for Cadw: Welsh Historic Monuments

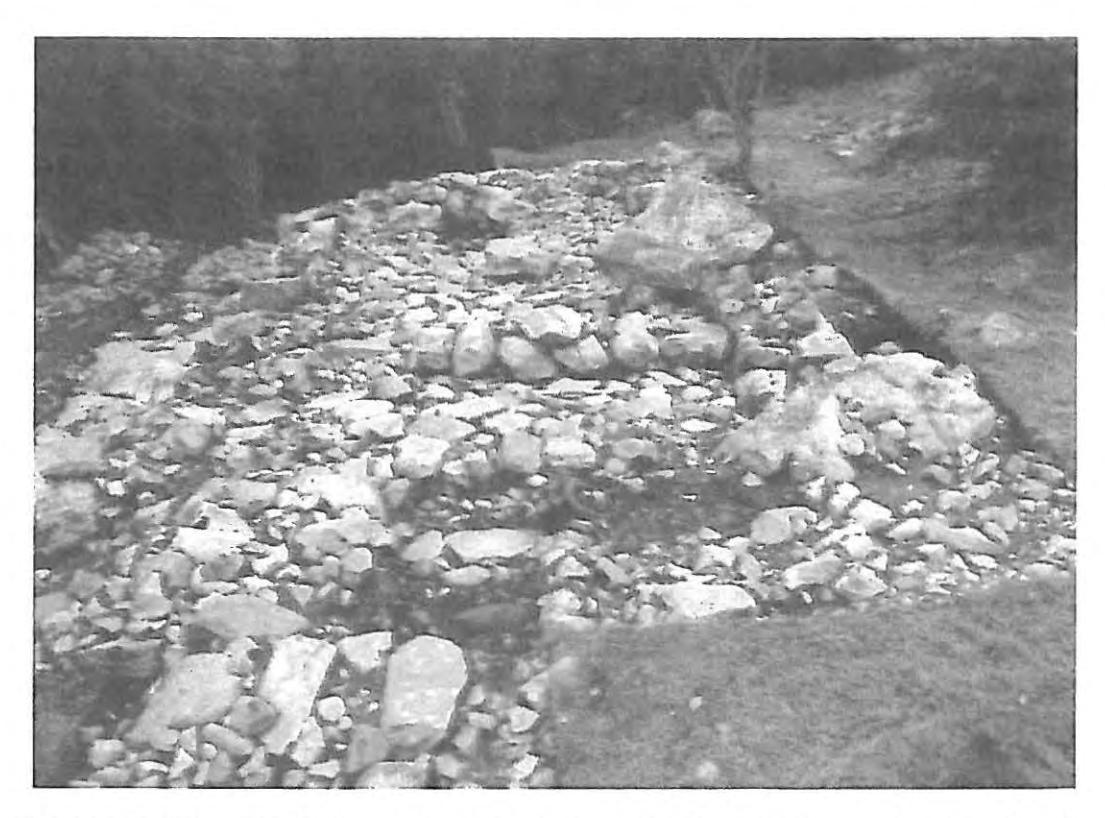
Plate 16 Hafod Rhug Uchaf. House excavated to the latest floor levels, looking north-east, scale with 20cm divs.

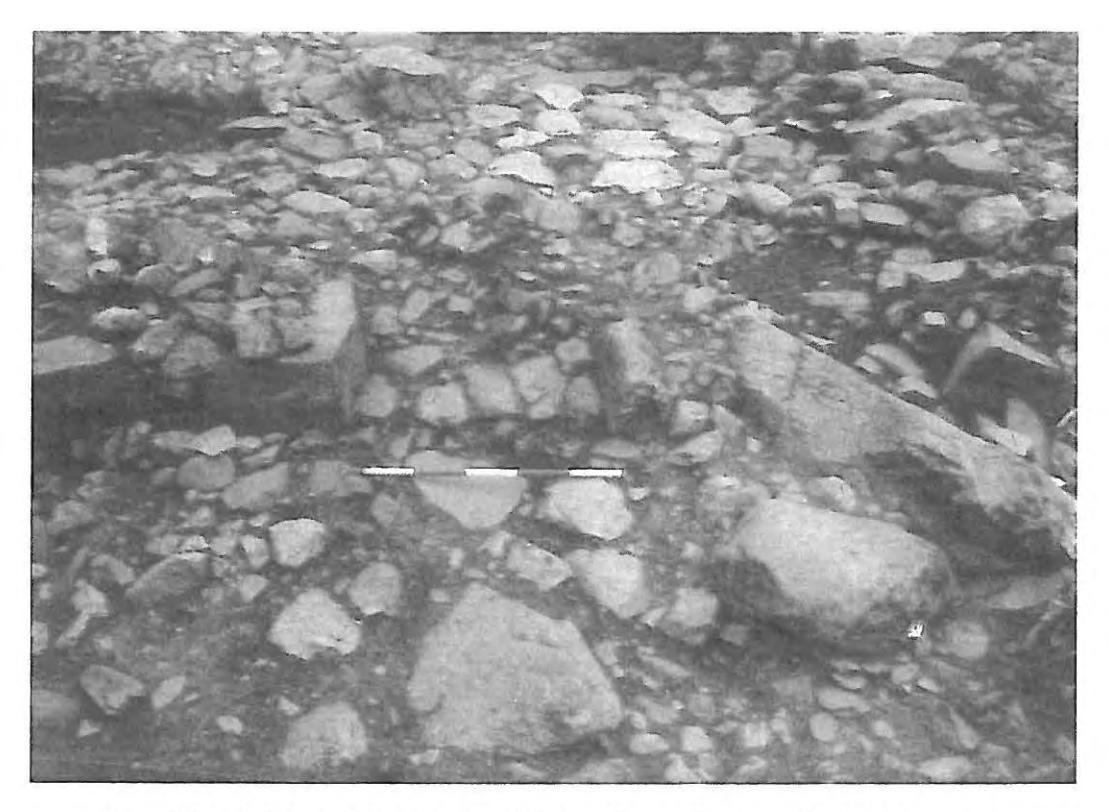
Plate 17 Hafod Rhug Uchaf. Doorway 31, looking south-east, scale with 20cm divs.

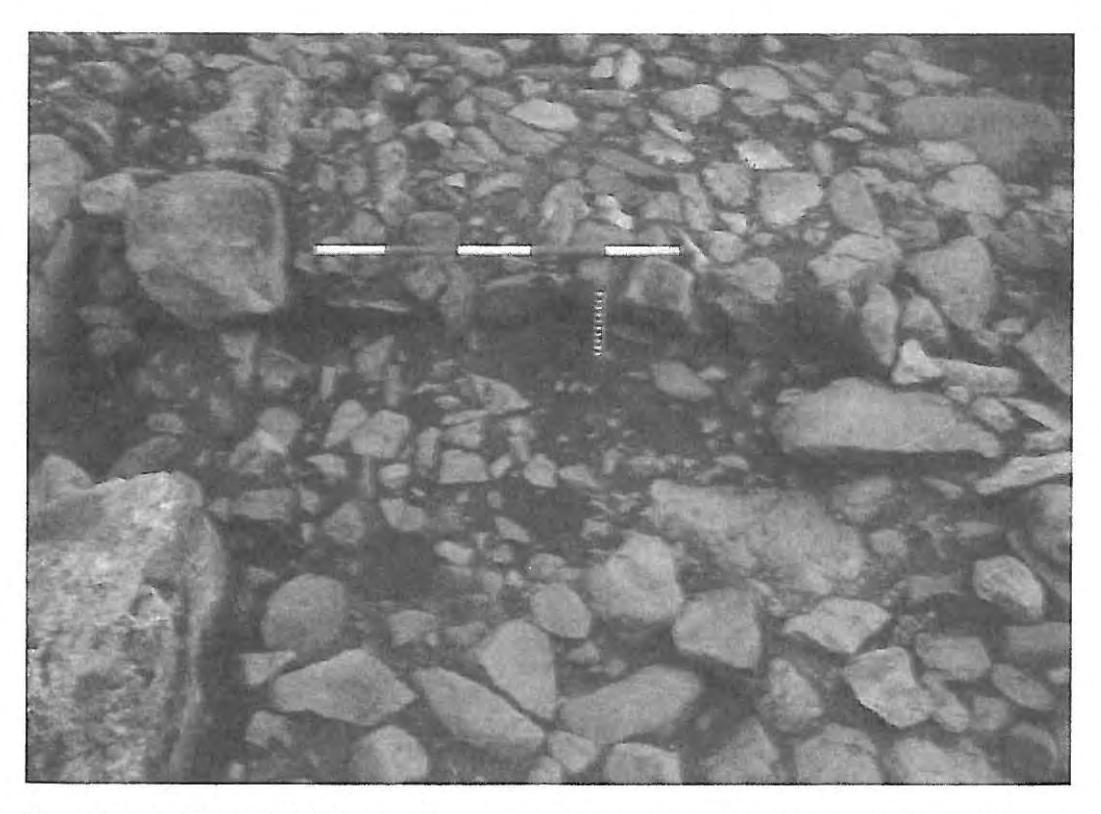
Plate 18 Hafod Rhug Uchaf. Cutting through bench 32 and floor of north room, looking south-east, horizontal scale with 20cm divs, vertical scale with 1cm divs.

Lying on the floor of the northern room and approximately central to it was a single massive subrectangular stone block. It is possible that this could have been a deliberate feature, but had no signs of wear on its surface and seems most likely to have been a wall-stone abandoned during robbing of the eastern wall. At the northern end of the room a line of large boulders, with smaller material interspersed, lay against the end wall. These stones were loosely set in clayey soil, with no structural strength and so were probably a purely internal feature, a bench or low shelf support, c. 0.50m (1ft 8ins) wide and 0.25m (10ins) high (Figs 19, 20 and Plate 18).

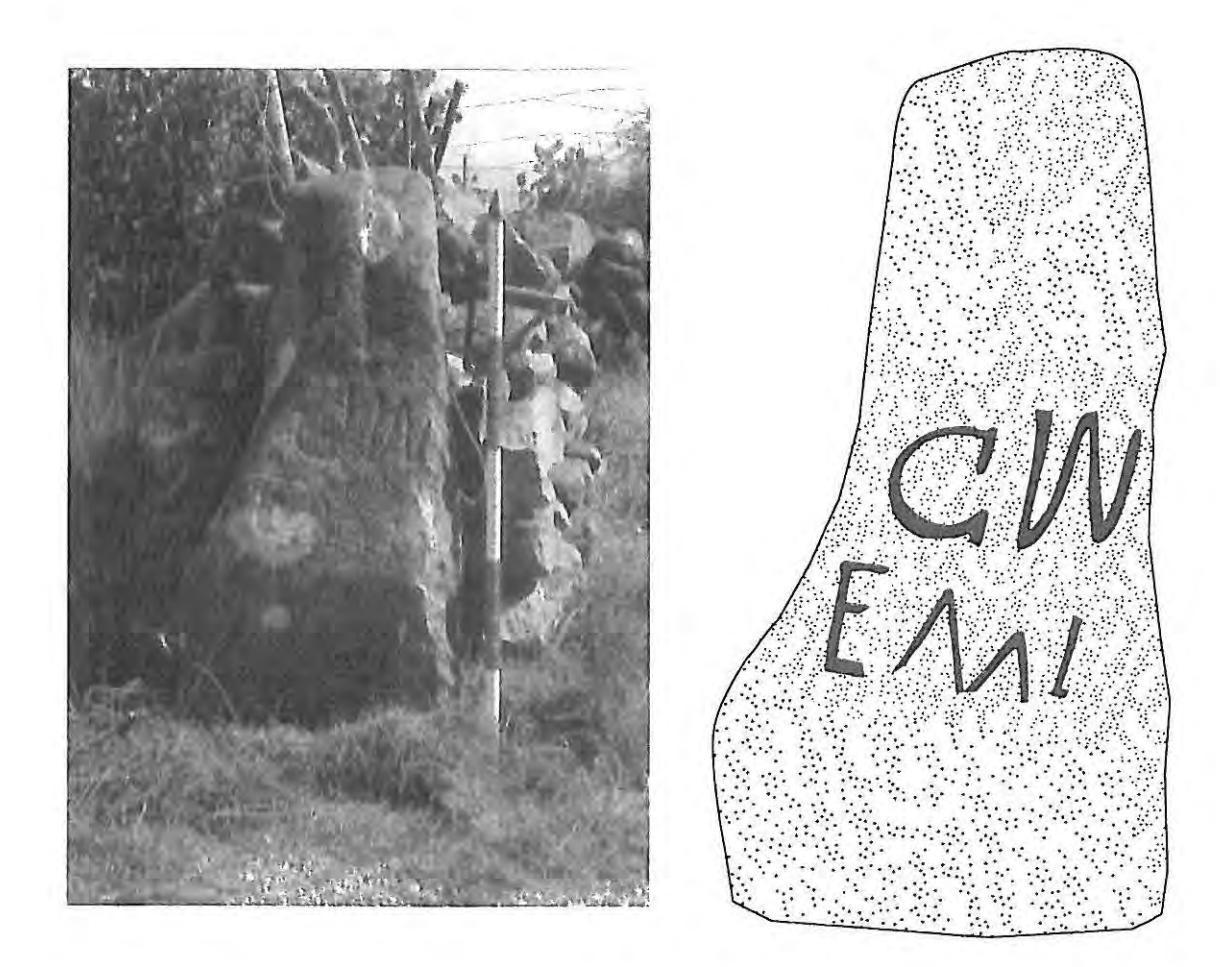
Plate 19 Hafod Rhug Uchaf. Inscribed stone, looking north-east, scale with 20cm divs.

During the excavations David Longley of GAT noticed some inscribed lettering on a stone post of the gate entering the farm track, up hill to the east (Fig. 22). The inscription consisted of large, crude Roman capitals that seem to make up initials rather than a word. The letters are very shallow, well weathered and partly erased at the right side because of wear to the stone post. They are only visible at extreme low light and the presence of the lettering was not known to the farmer despite passing the stone every day. The lettering is transcribed as a top line of 'CW' and a lower line of 'EM (D or L?)'. The inscription is not readily datable but the use of the 'W' at least means it could not be early Medieval Latin. The most likely explanation is that this is an early post-medieval boundary stone, the two lines representing the initials of adjoining owners. Neither line accords with the family name of the tenant of Hafod Rhug at the time of the 1841 Tithe Survey, who was Owen Jones nor of Hafod Rhug Isaf which was Jane Richards. Nor is it a Vaynol estate marker. The owner of the land to the south of Hafod Rhug Uchaf in 1777 was John Williams (Vaynol MS. VP 4055-6, p. 90) and possibly the 'CW' stands for one of his predecessors. The stone actually lies close to the meeting point of three parishes, Llanbeblig, Llanfairisgaer and Llanrug (Fig. 18), as they were in 1841, and so must have been an especially significant boundary point. Between all three parishes at this point was a triangle of waste land, not recorded by the Tithe Apportionment as being in any parish. The Vaynol Estate must have incorporated this because it later built a gamekeeper's cottage there (named Bryn Goleu in 1841, now Monte Verita).
