# WALLED GARDEN, HENLLYS, BEAUMARIS

# ARCHAEOLOGICAL RECORDING AND EVALUATION

Report number : 485

John Moore and Partners

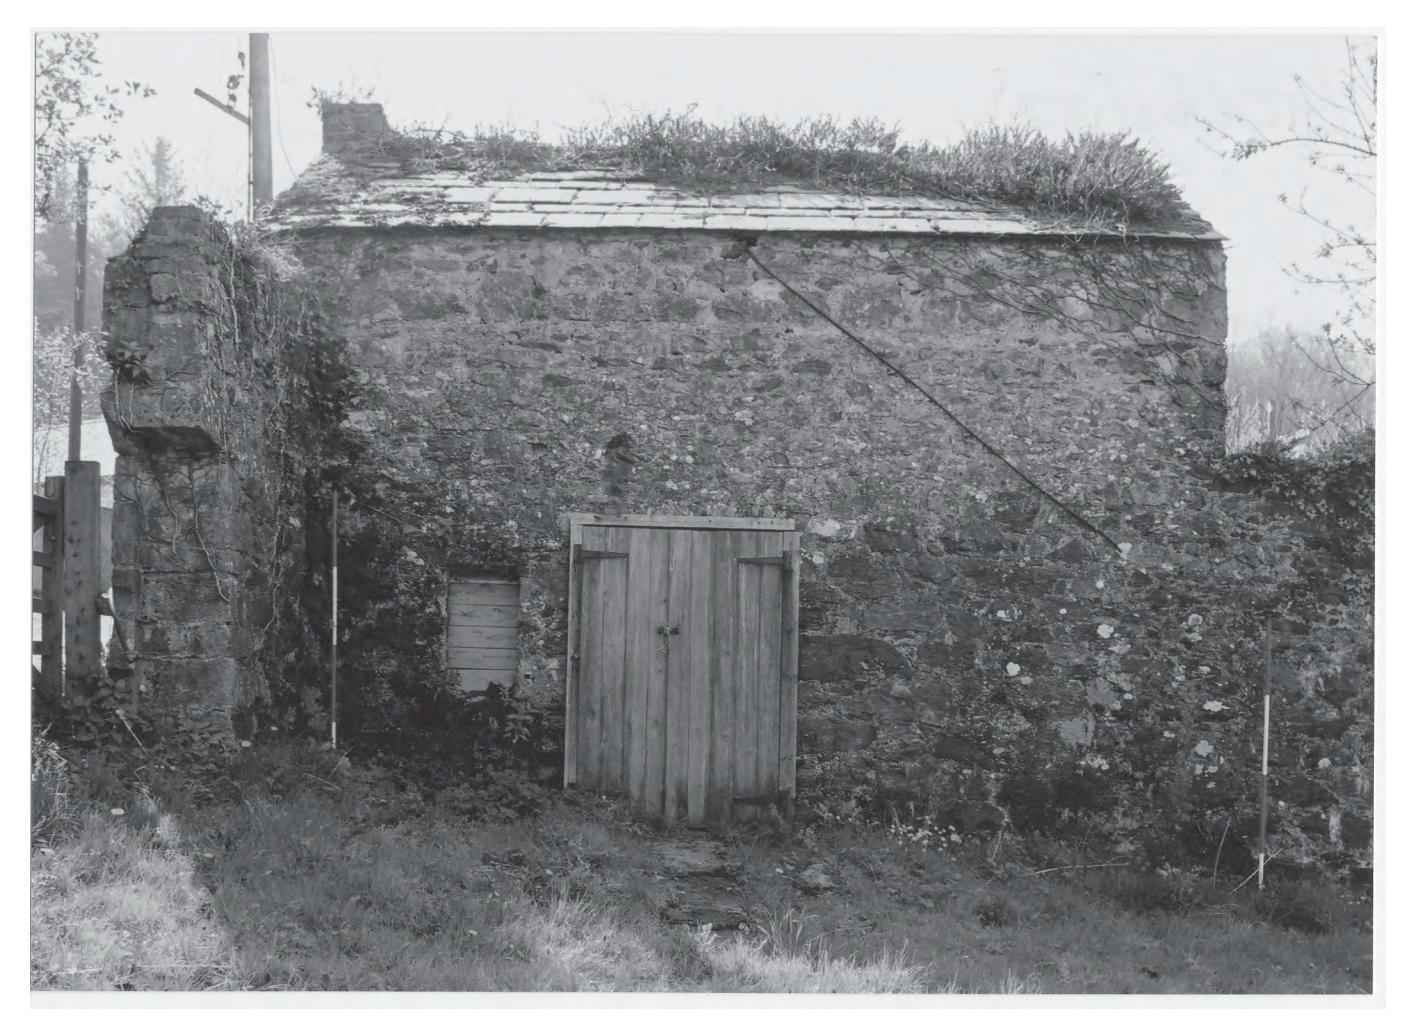
1830 map is still standing (Plate 1). The building incorporates the garden wall and may be contemporary with it. A change in the masonry style beneath the eaves suggests that the roof line has been lifted. The building is currently of two stories with a door in the west wall along with a window and door facing into the garden. A small fireplace and chimney can be seen in the eastern gable.

Plate 1 The building at the south of the garden

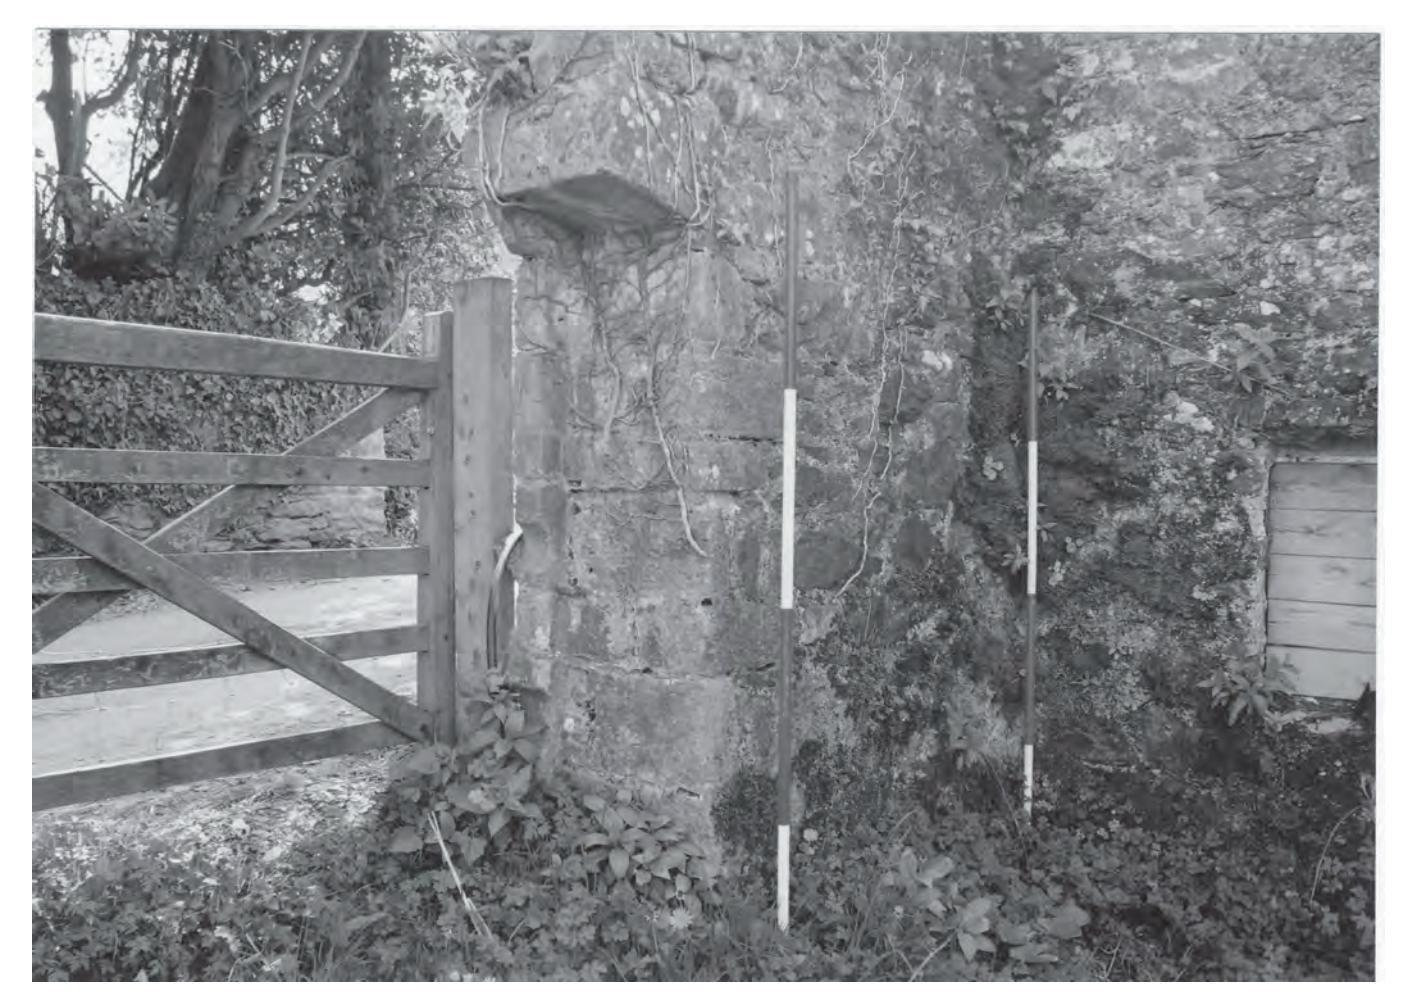
All three entrances shown on the 1889 map are still visible. The two southern entrances have been widened in recent years by demolition of lengths of the wall (Plate 2) but enough of the masonry surrounds have survived to suggest that all three were of a similar construction. The northern entrance (Plate 3) is a 1.8m high and 0.7 wide doorway constructed from dressed sandstone. This originally appears to have held a wooden frame and door but numerous holes and minor modifications suggest that a series of different gates have subsequently been used.

Plate 2 Detail of the south-eastern entrance

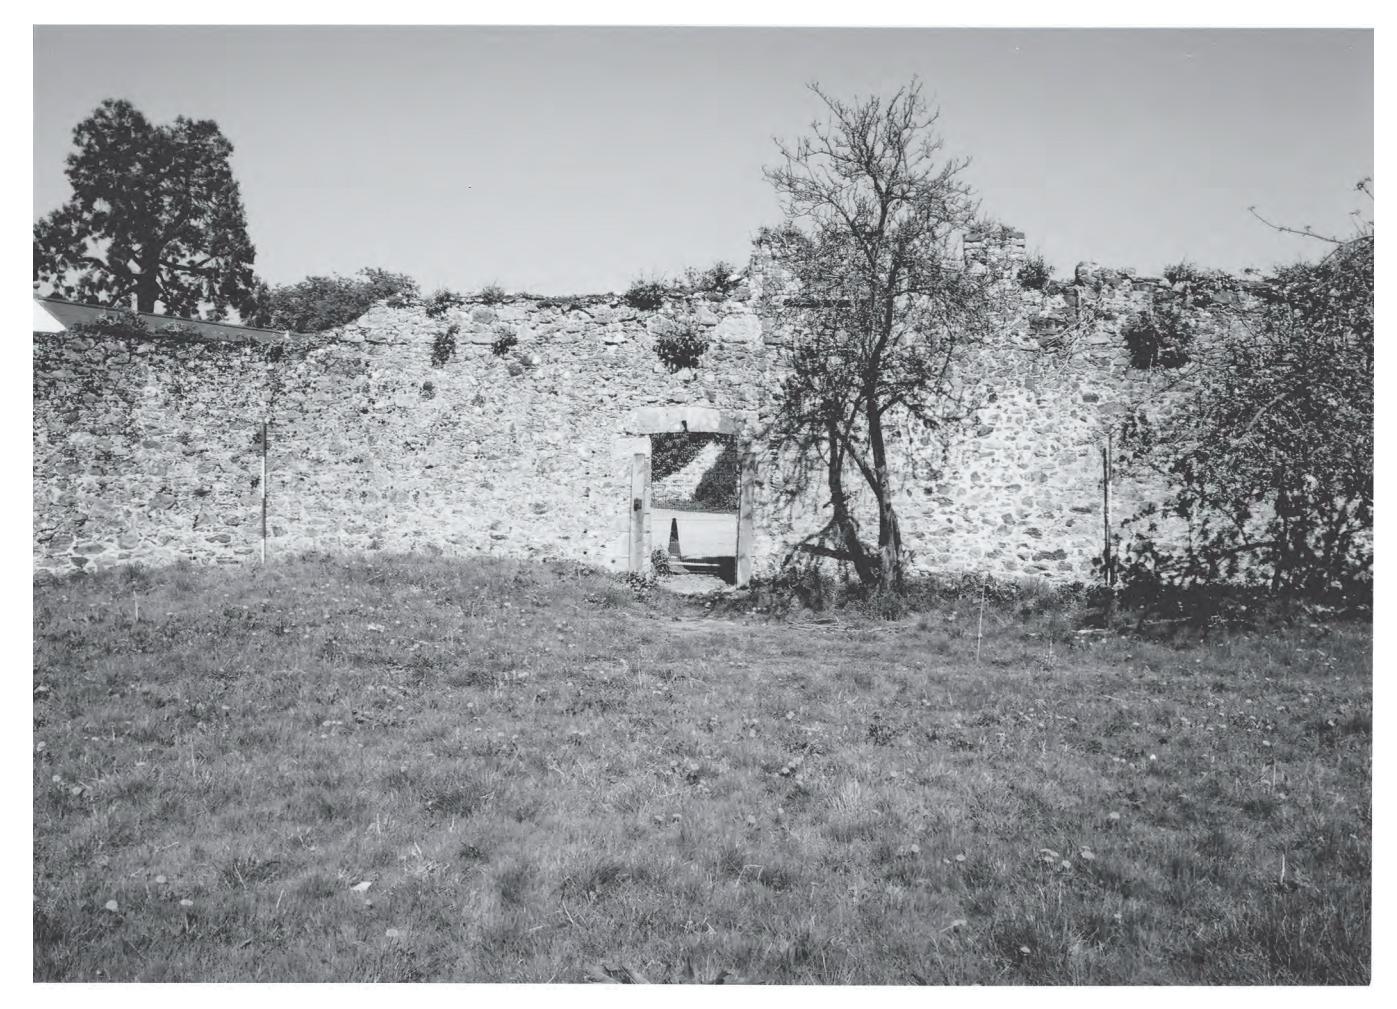
Plate 3 The northern entrance

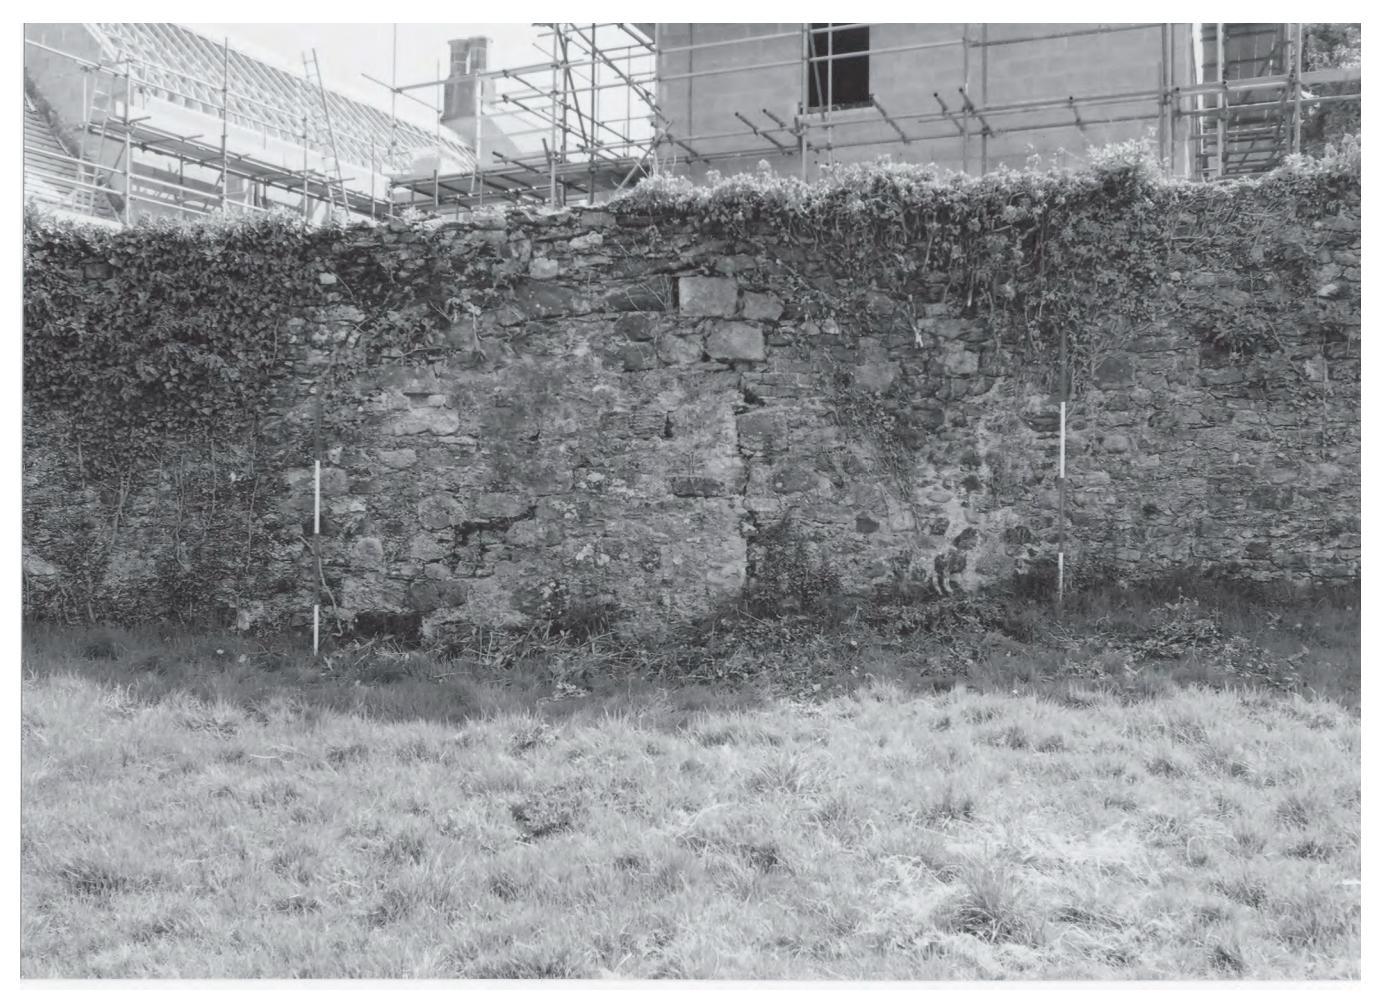
A prominent straight joint can be seen in the masonry close to the north-east corner of the garden (Plate 4). The upper half of the wall shows signs of repair with patches of reused dressed sandstone and brick. The function of the straight joint is open to debate. It may be one side of an early blocked entrance, the pattern of paths on the 1830 map do not respect the current entrances and these may be later insertions suggesting remodelling in the mid 19<sup>th</sup> century. It could alternatively represent the inclusion of an earlier masonry feature; the stonework to the north is more massive than to the south. This change in masonry style, however, continues for some distance and is more likely to represent two phases of garden wall. The eccentric shape of the garden suggests the reuse of earlier field boundaries or a modification of a more conventionally shaped enclosure. There is a slight break of slope running across the garden from the straight joint and it is possible that this represents an earlier line of the wall or a boundary predating the garden. This hypothesis was tested using a trial trench (see below).

Plate 4 The straight joint in the eastern wall

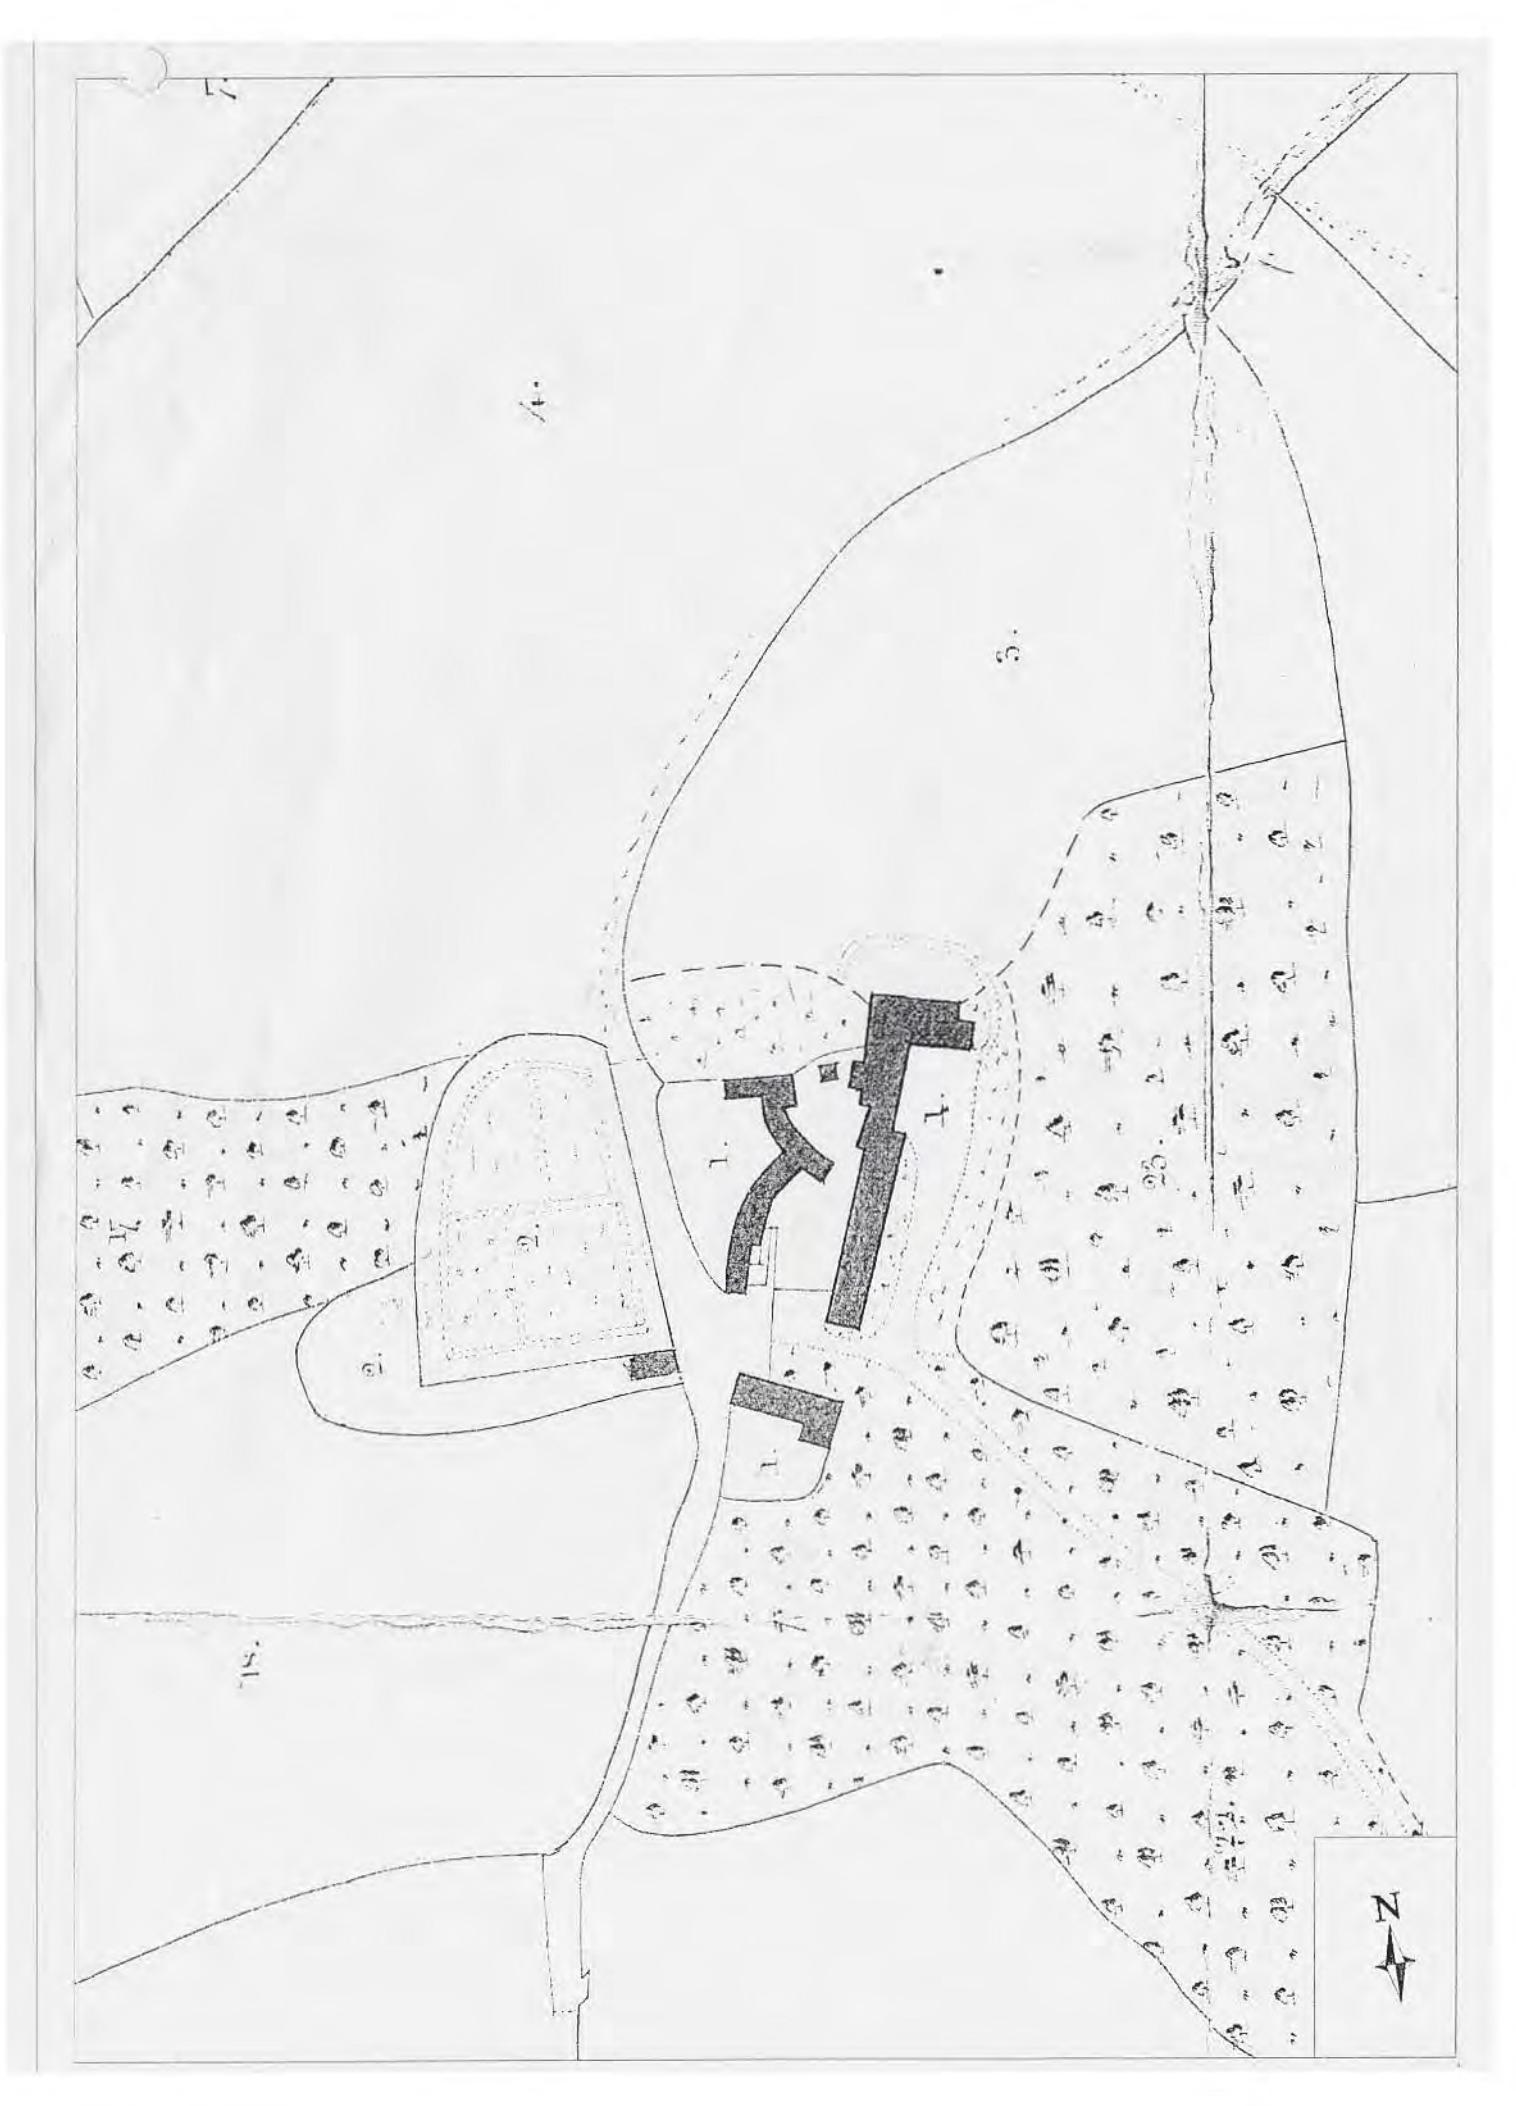
The garden is first recorded on a map of the Henllys Demesne of 1830 (UWB Henllys MS 1191). The garden is subrectangular in plan with curving north and east walls (Fig. 1). A path is shown running around the inside of the wall. The garden is bisected in an east/west direction by another path and two additional paths run north and south from this. A small building is shown abutting the outside of the eastern end of the southern wall. The garden is next portrayed in detail on the 1889 first edition 1:2500 OS map (Fig 2). A new building is shown on the outside of the north-eastern apex of the wall along with what appears to be a glasshouse in a corresponding position on the inside of the wall but offset slightly to the east. The paths have been modified and now run to three entrances; one in the southern corner, one in the western corner and one in the north east wall, to the west of the glasshouse and running into the building on the outside of the wall. Two east/west paths are shown along with deciduous trees. The layout is unchanged on the 1900 1:2500 map although the trees are not shown. The 1919 map shows no details of the interior apart from the glasshouse outline. Discussion with a local gardener suggests later use as a vegetable garden and the presence of peach houses on the north-western wall.

Fig. 1 Excerpt from the map of Henllys Demesne in the parish of Llan-faes (UWB Henllys MS 1191) (1830)

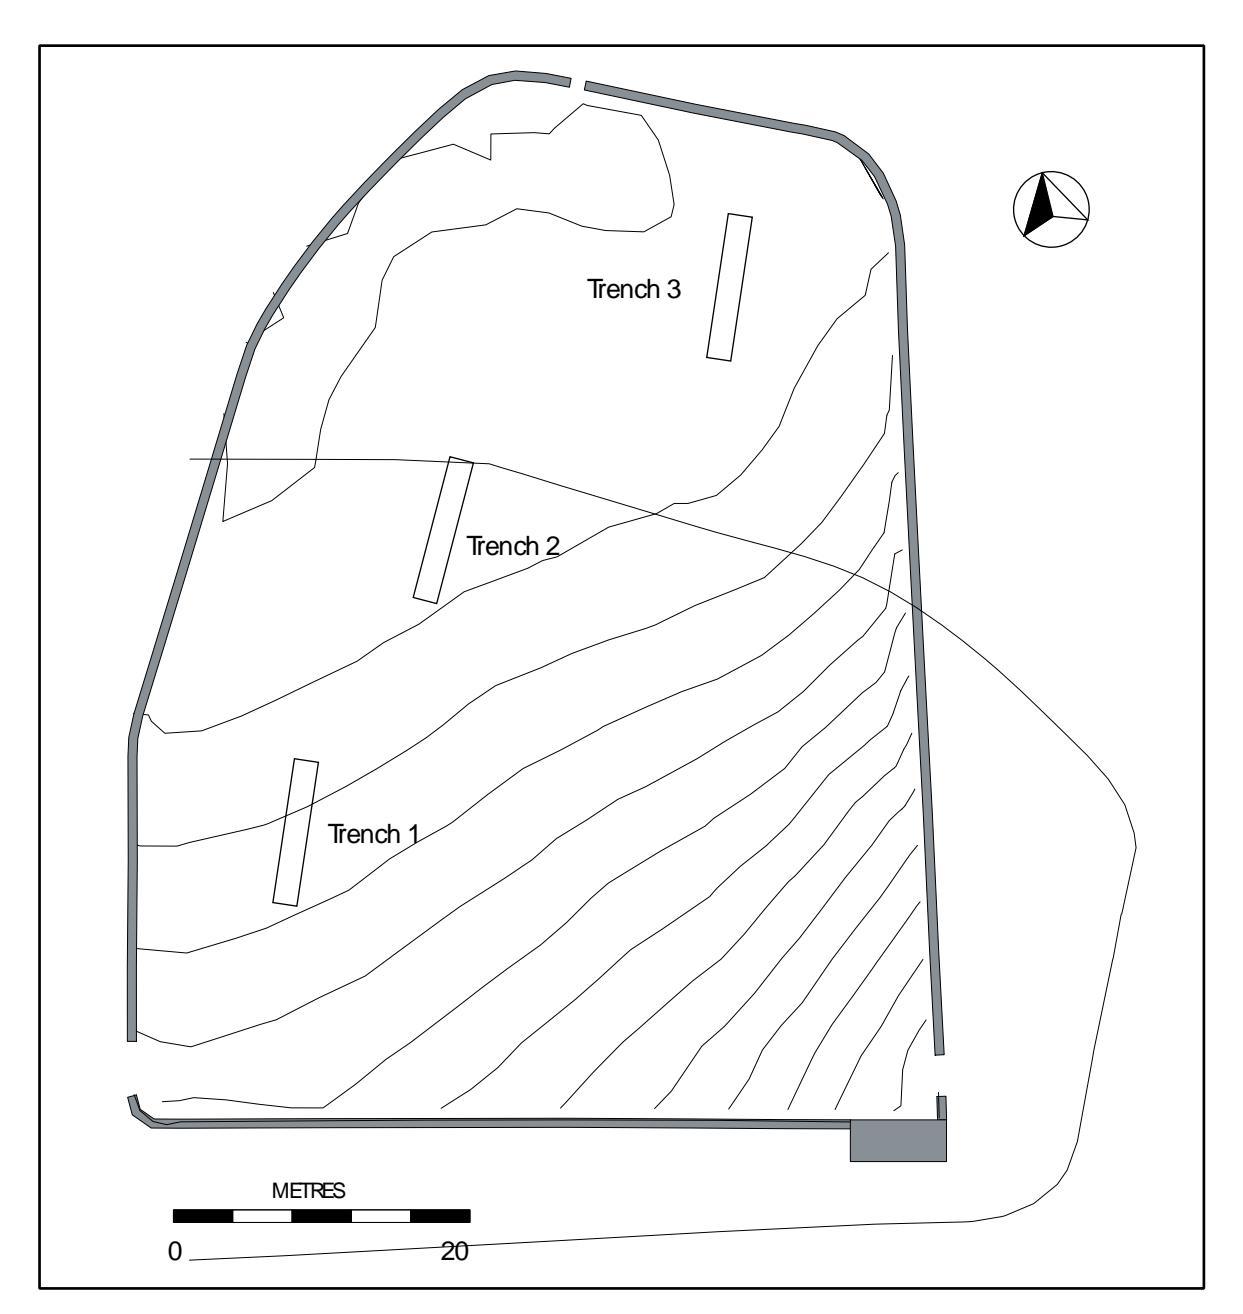
Three trenches were excavated, two within the proposed foundations of the new buildings and one to investigate the break of slope at the north of the garden.

Fig. 3 Henllys Walled Garden showing trench locations

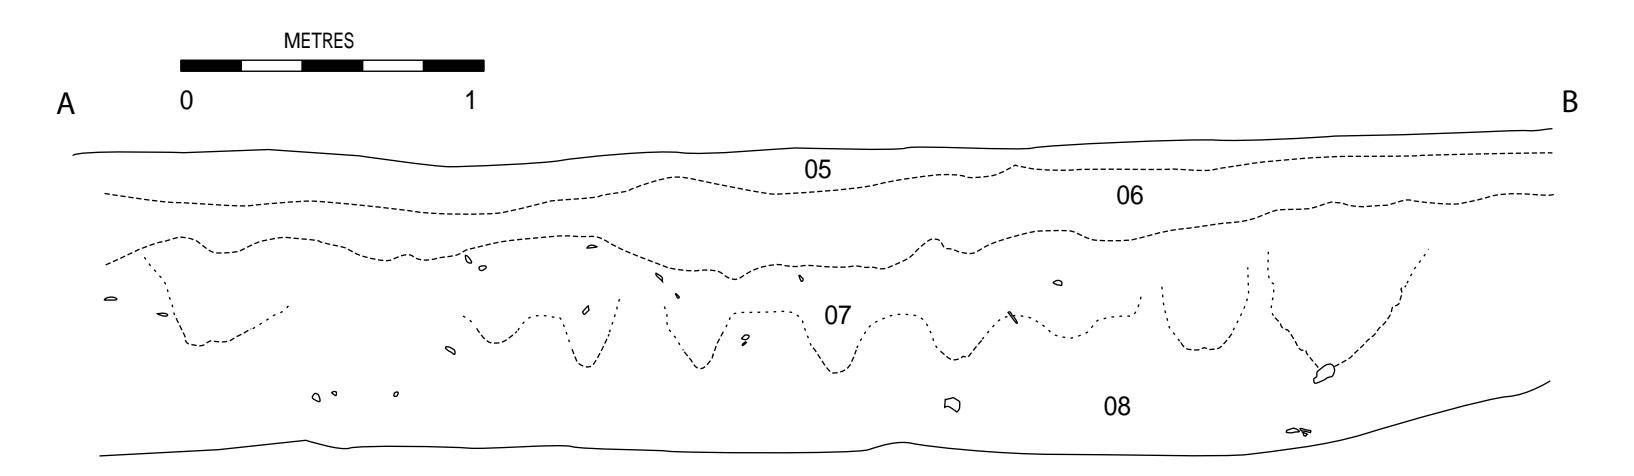
Topsoil (05) was removed to a depth of 0.2 to 0.3m revealing a brown loam (06) similar to that seen in trench 1 (02). This was again fairly uniform and featureless. This context however became more mixed with depth, containing patches of dark loam that eventually resolved into linear features (context group 07) at a depth of 0.55m (Fig. 6). These were found to be a series of round bottomed linear trenches filled with humic soil that was very similar to the topsoil. They were overlapping in places and the cuts could not be traced through upper part of brown loam 06. It was noted that 06 was much more mixed above the trenches than elsewhere. The bases of the features were cut through fairly clean brown loam (08). The features terminated in a straight line close to the south-east side of the trench. This series of parallel trenches are probably best interpreted as being the base of a bed in a vegetable garden. Their depth suggests a root crop such as potatoes was grown here. Later cultivation presumably disturbed the upper part of the trenches.

Fig. 6 Trench 2, ESE facing section

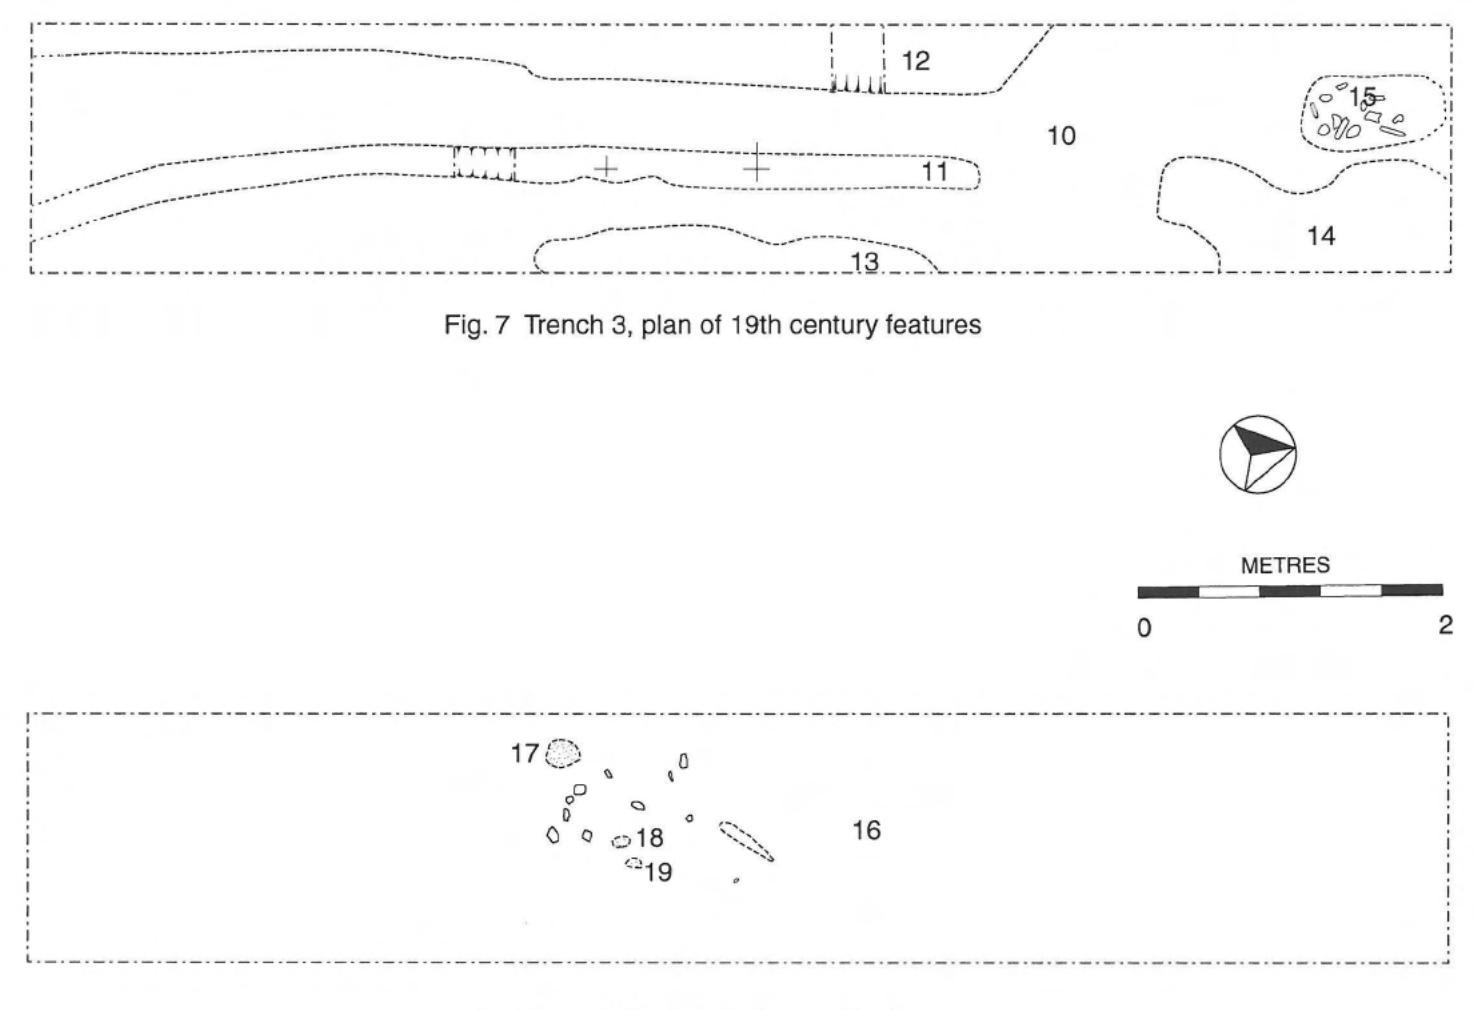
The trench was excavated down to the level of the subsoil at 1.1m below ground level. The limestone inclusions in the brown loam could not be traced below 0.75m suggesting a similar soil profile to the other trenches with a buried soil (16) overlying the subsoil. Three small patches of charcoal flecks (17, 18 and 19) amongst a few small stones was identified at the interface between context 16 and the subsoil. This area was carefully excavated but no artefacts or further features could be identified. The origin of the charcoal could not be determined and there was no evidence for *in situ* burning. The charcoal could have come from a nearby hearth but could equally be natural in origin.

Fig. 8 Trench 3, plan of charcoal feature

All archaeological features with the exception of the garden wall itself and the charcoal in trench 3 should be classified as category D – *Minor and damaged sites*. The charcoal deposit is of unknown significance and thus should be assigned to category E – *Sites needing further investigation*. In this case, it appears that there will be little disturbance within the garden area at this depth. The lack of any higher category sites or other residual material of interest suggests that further evaluation would be of little value. A watching brief is, however, recommended on any excavations, such as building foundations that extend to the depth of the subsoil (about 1.0m).
