NEFYN WASTE WATER TREATMENT SCHEME (REVISED ROUTE)

ARCHAEOLOGICAL ASSESSMENT:

GEOPHYSICAL SURVEY REPORT

G1760

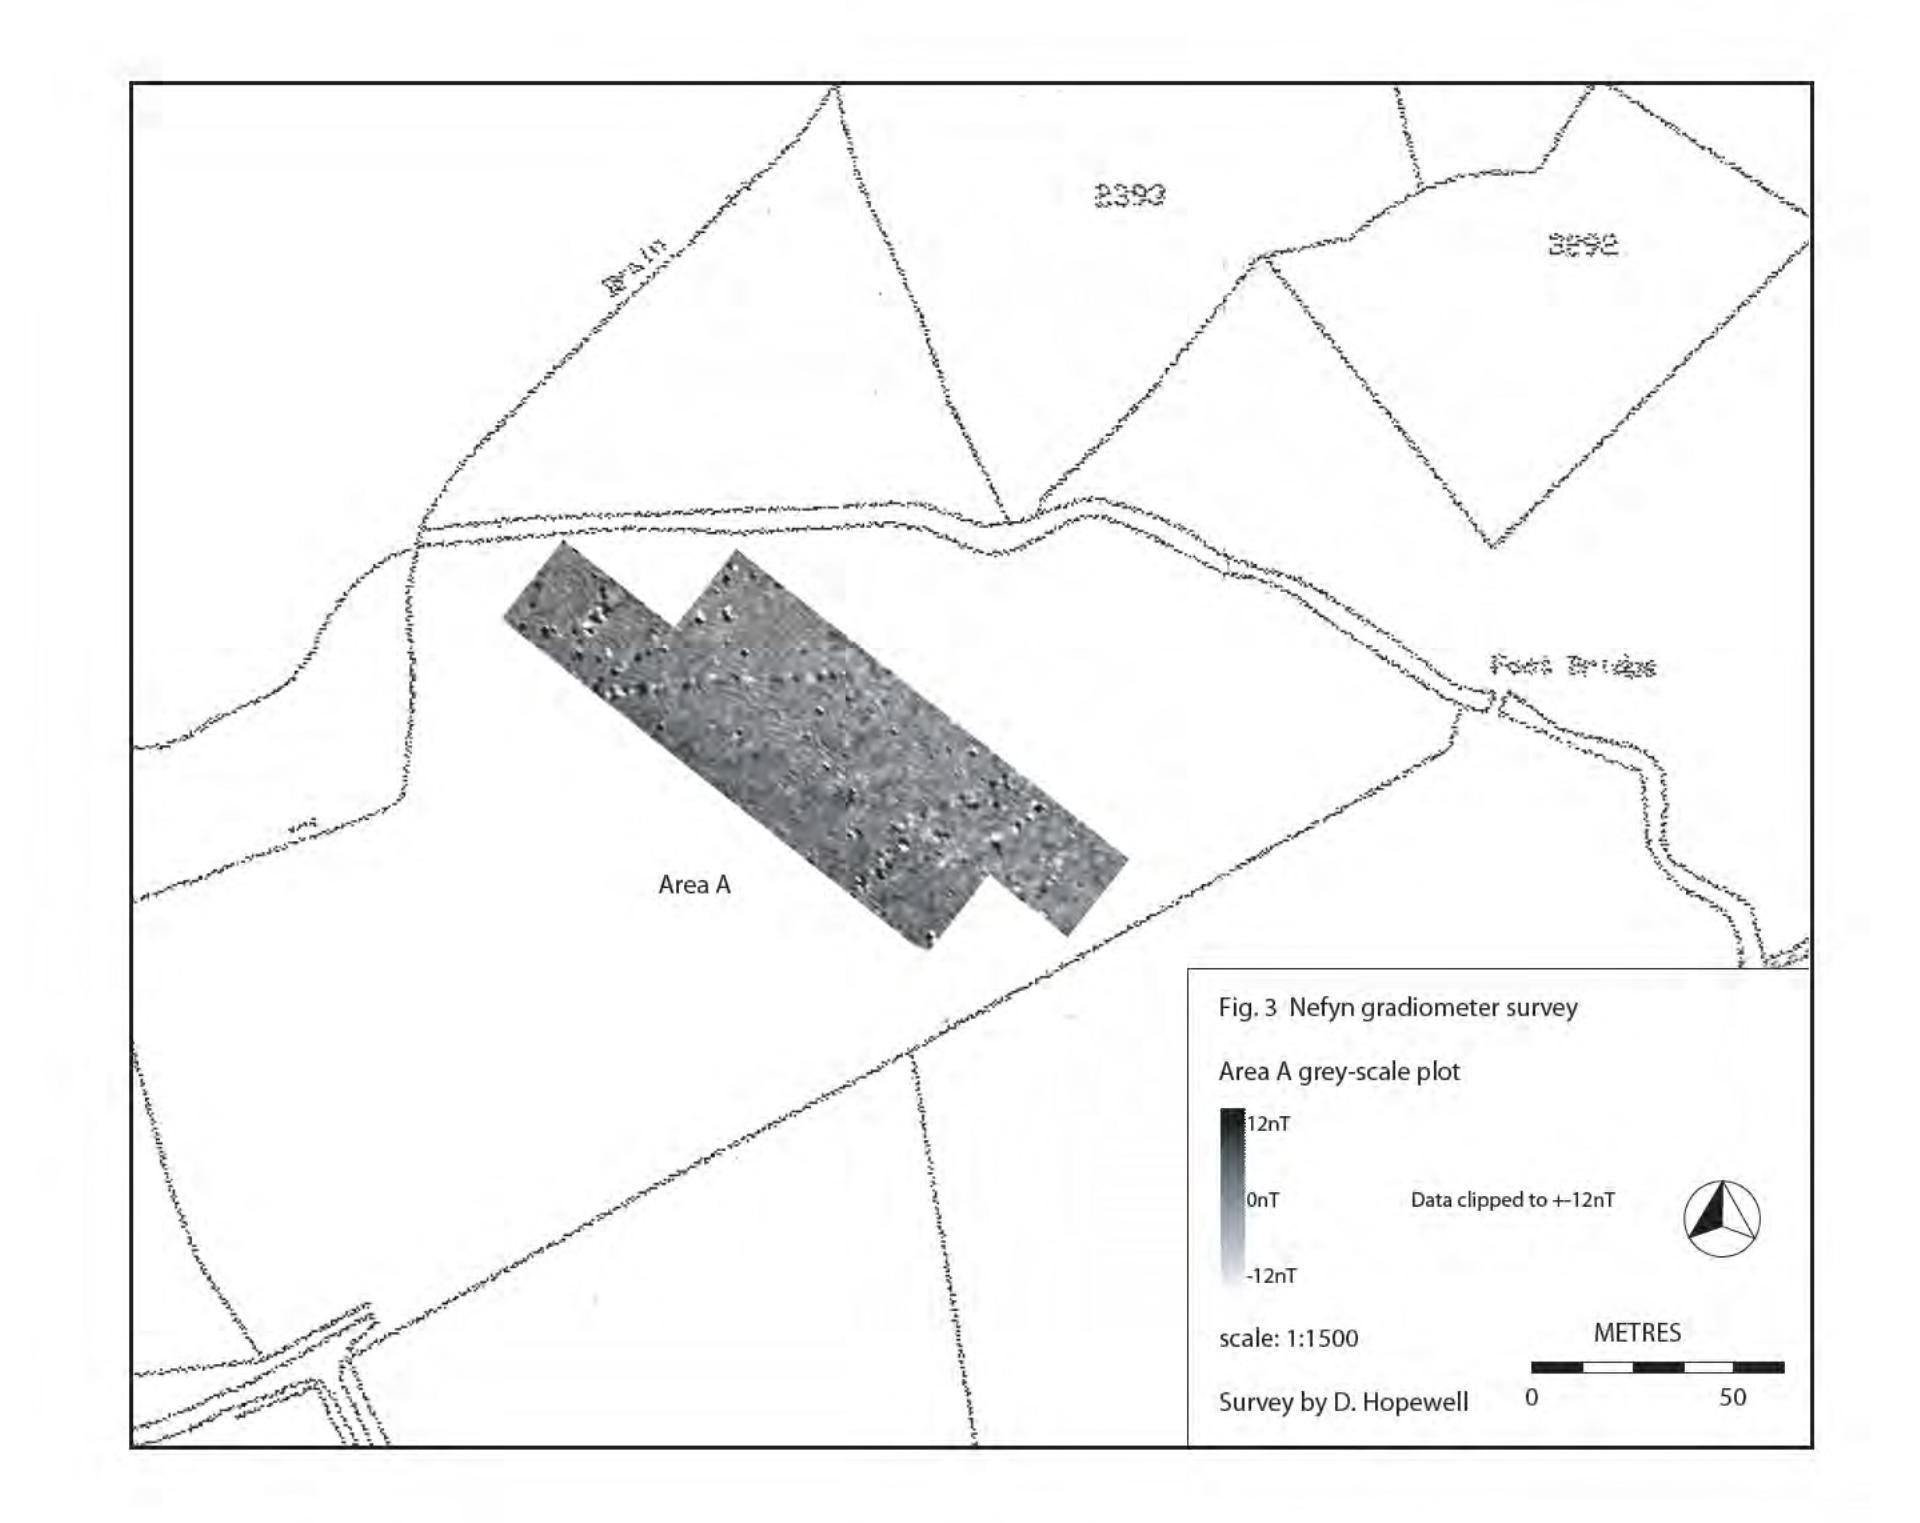
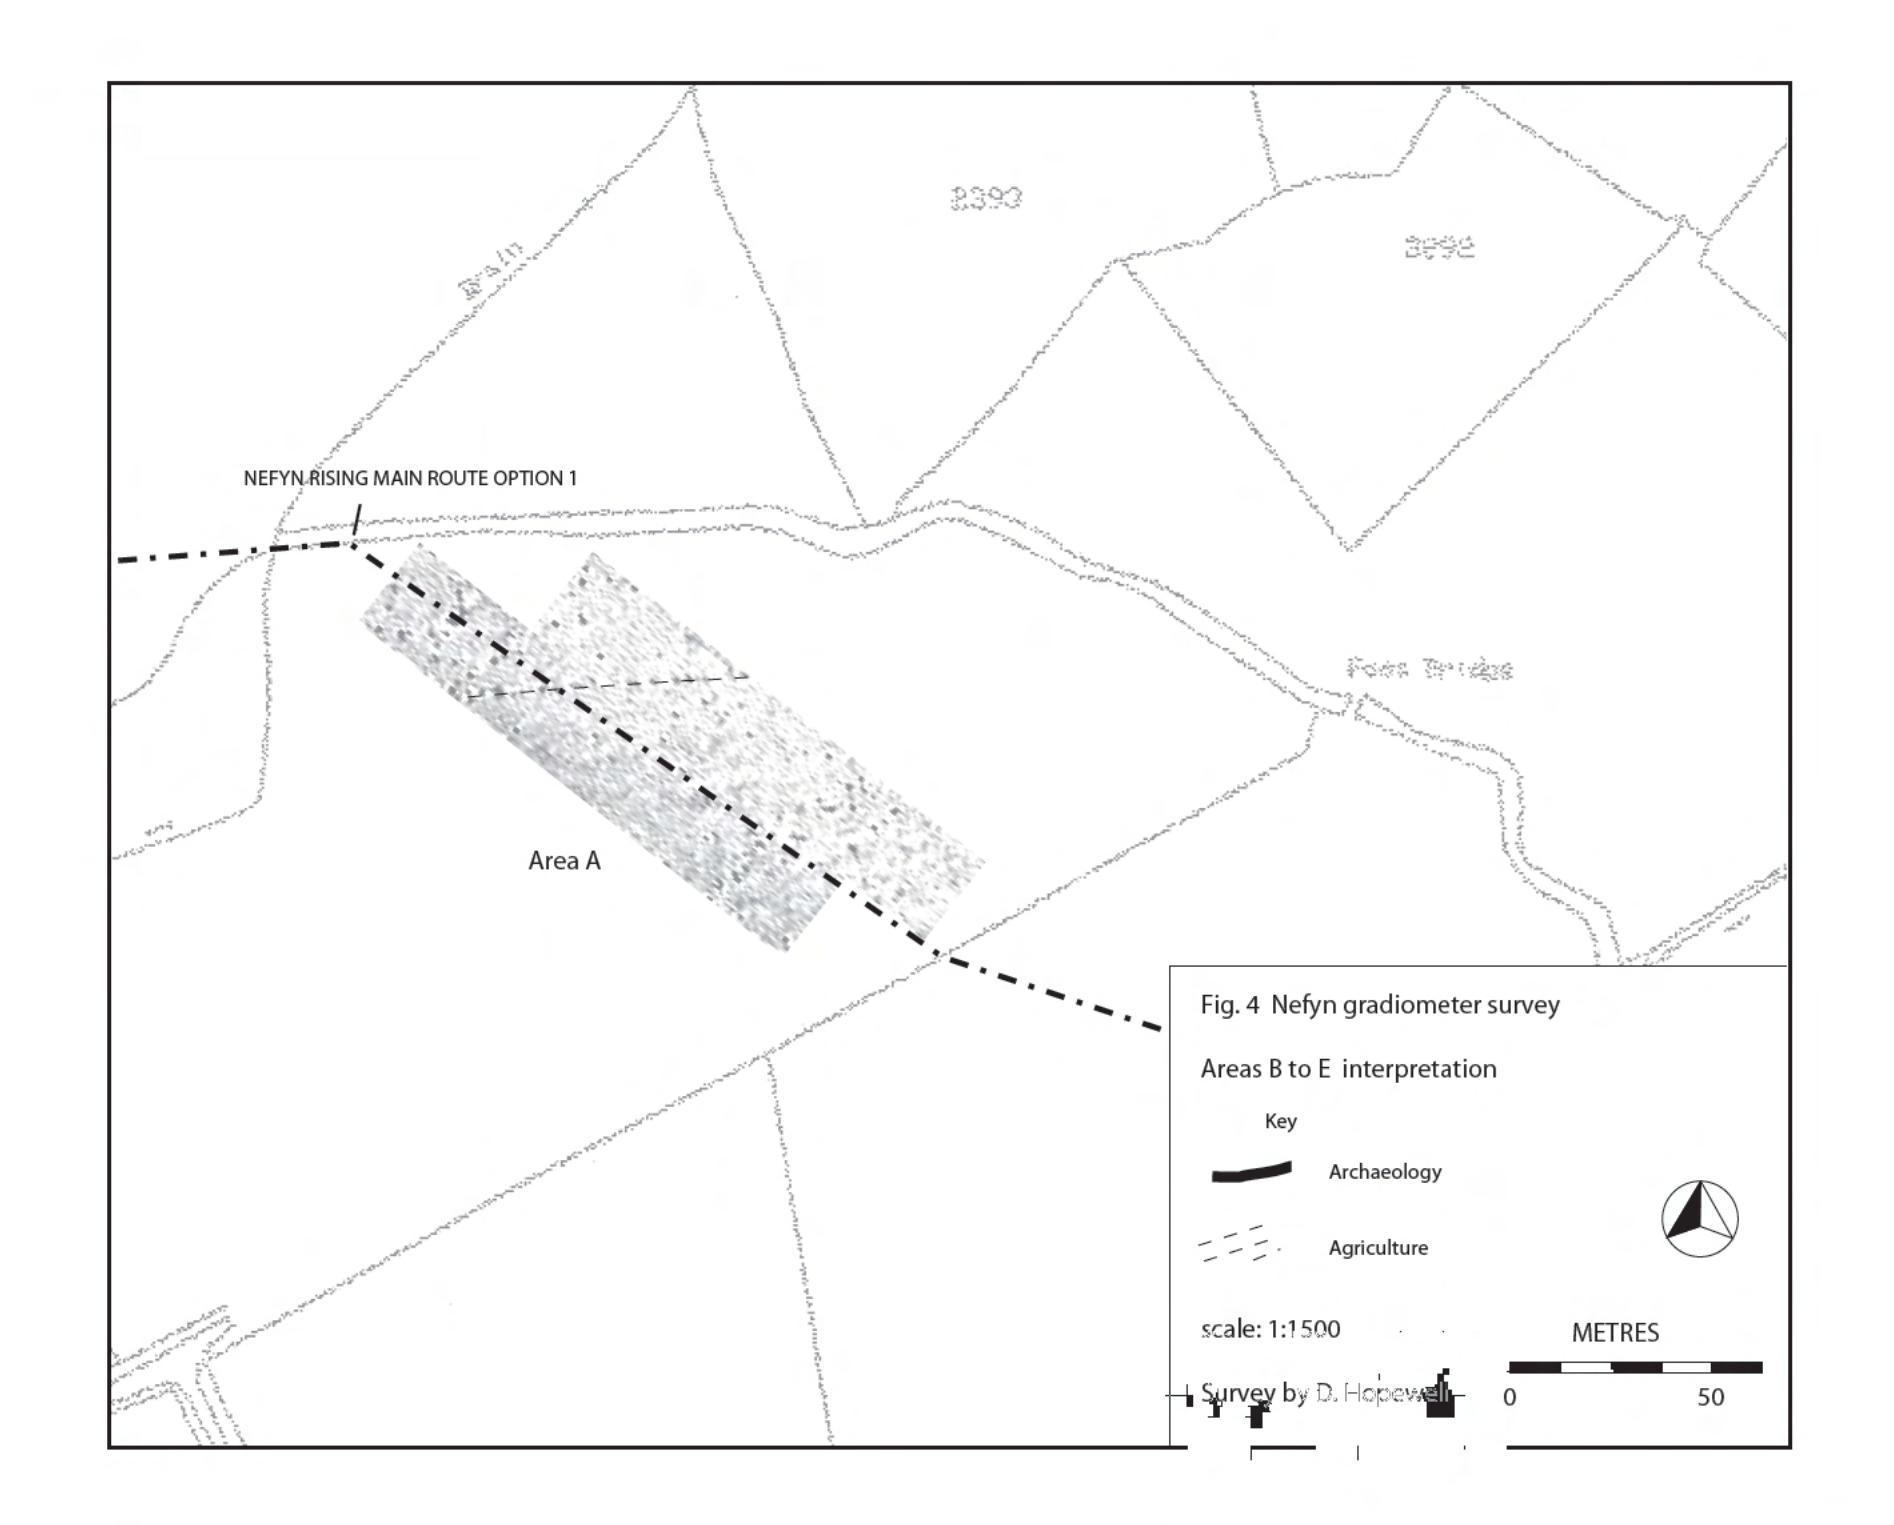
Area A survey results (Figs 3 and 4)

A single narrow linear anomaly was detected that is best interpreted as a land drain.

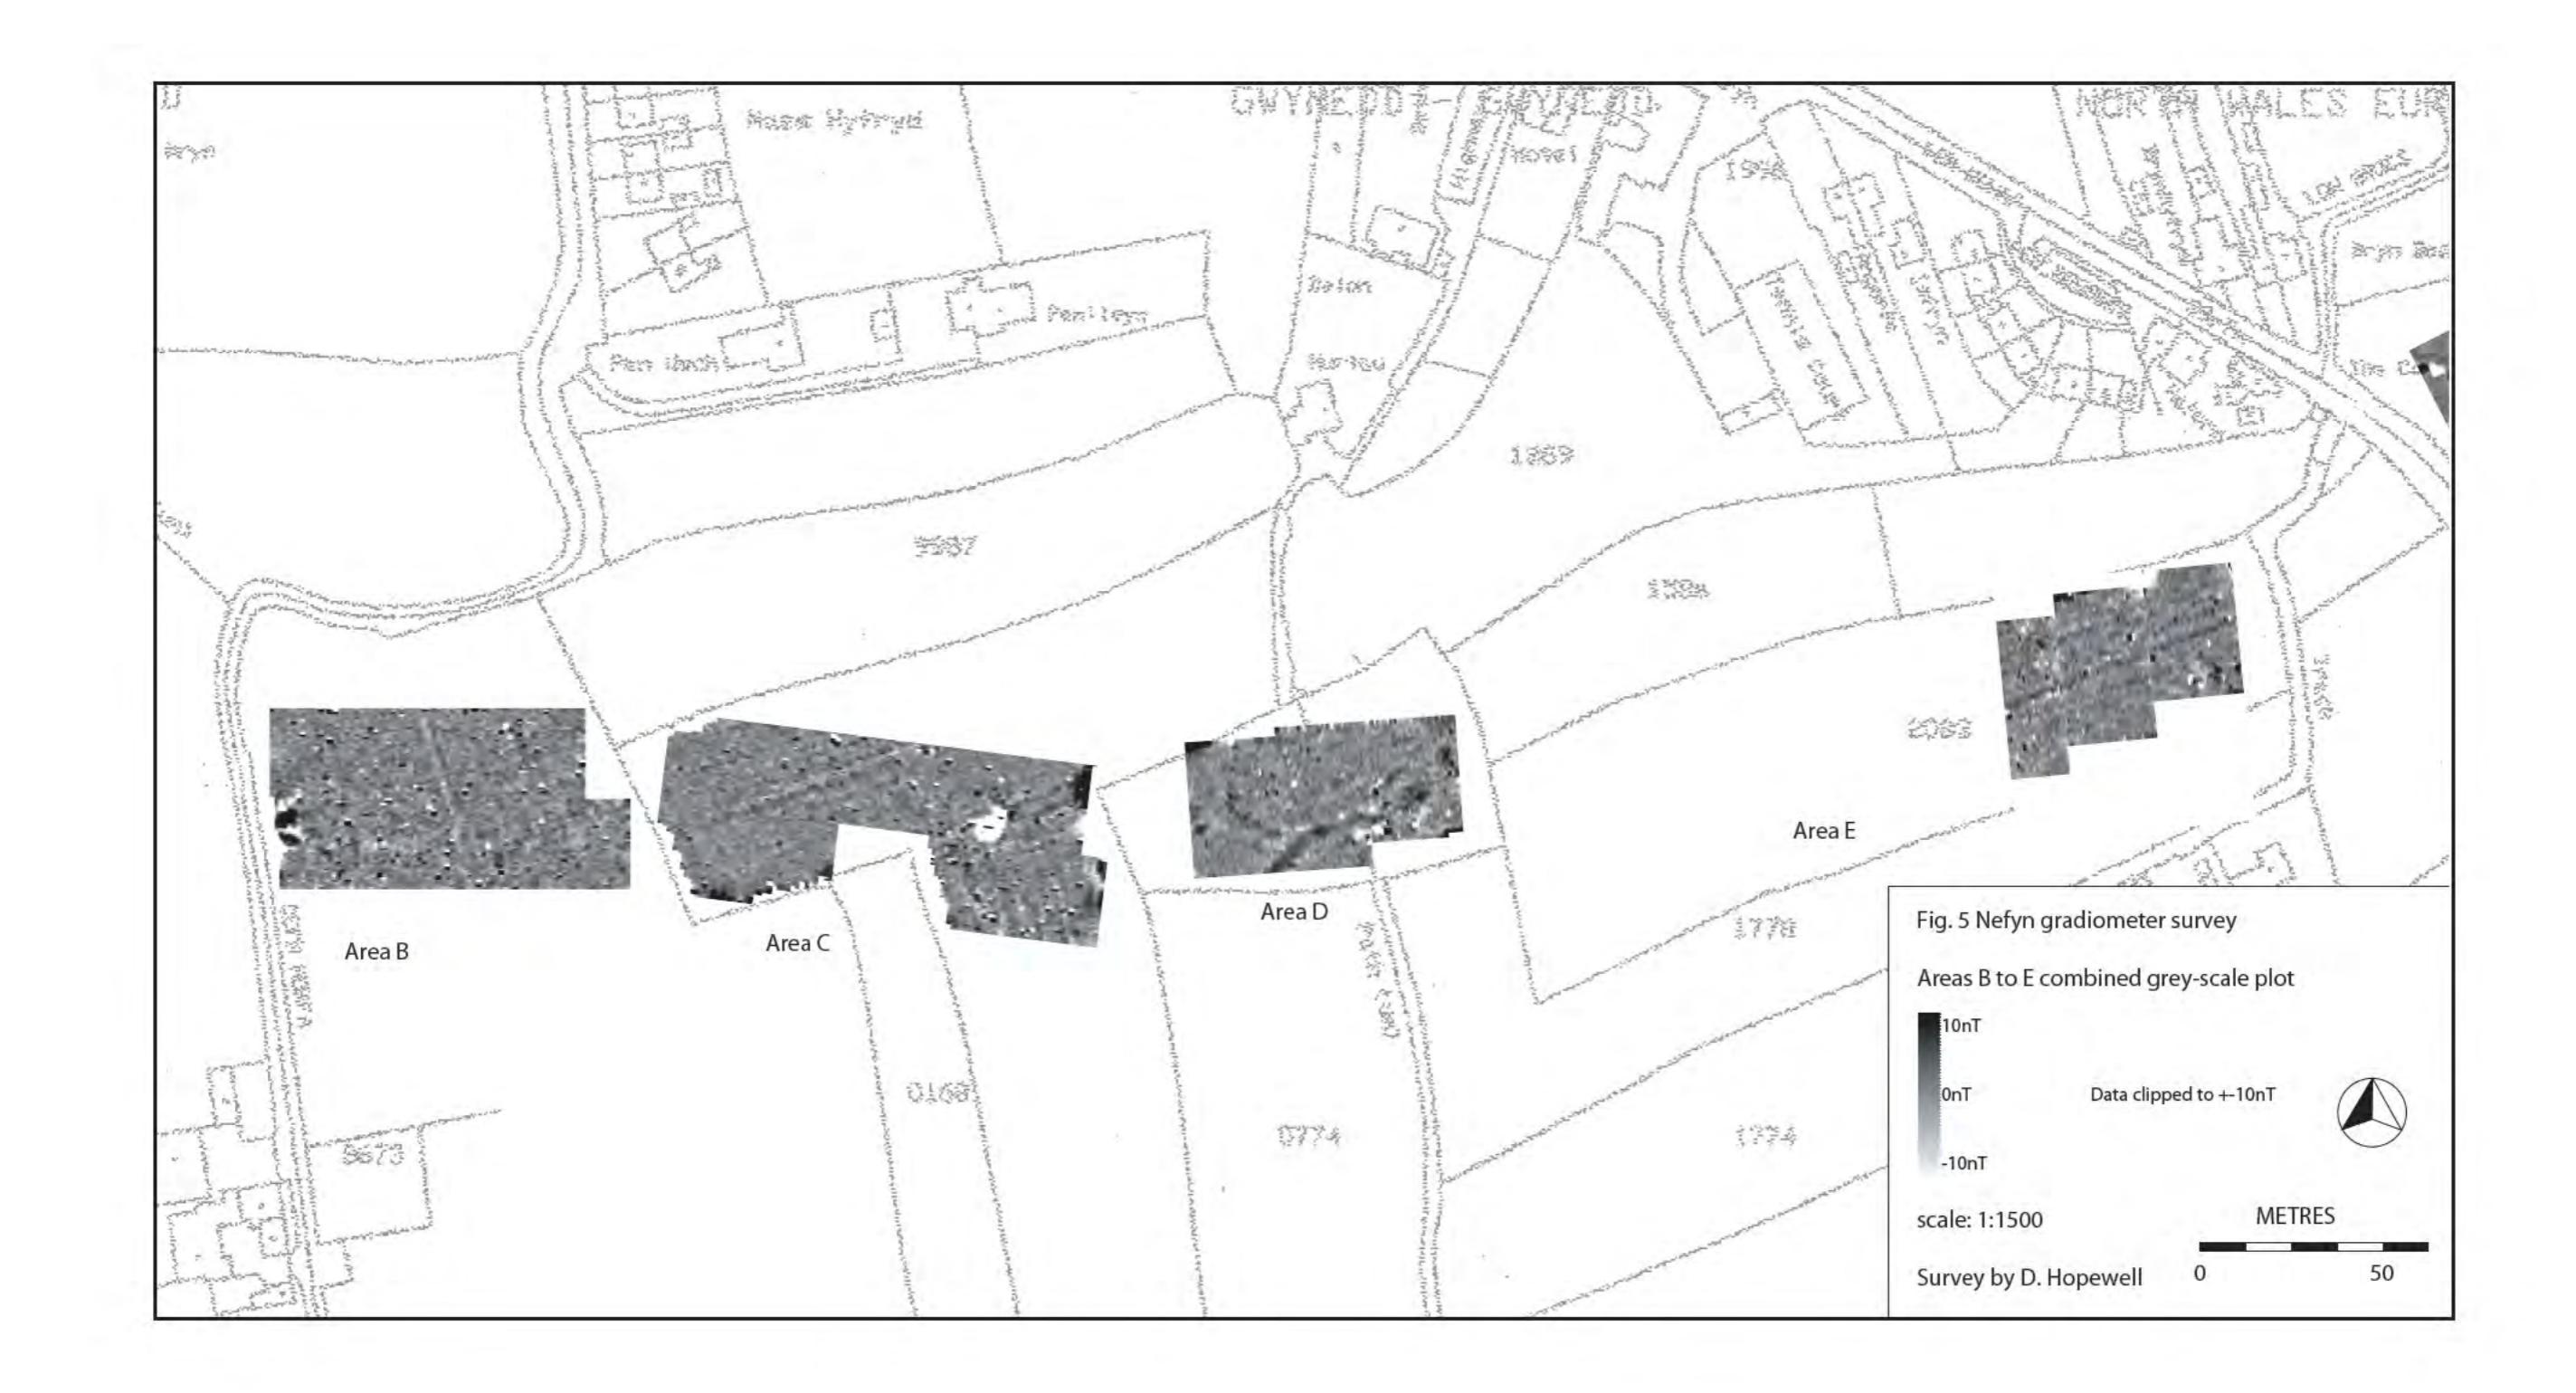
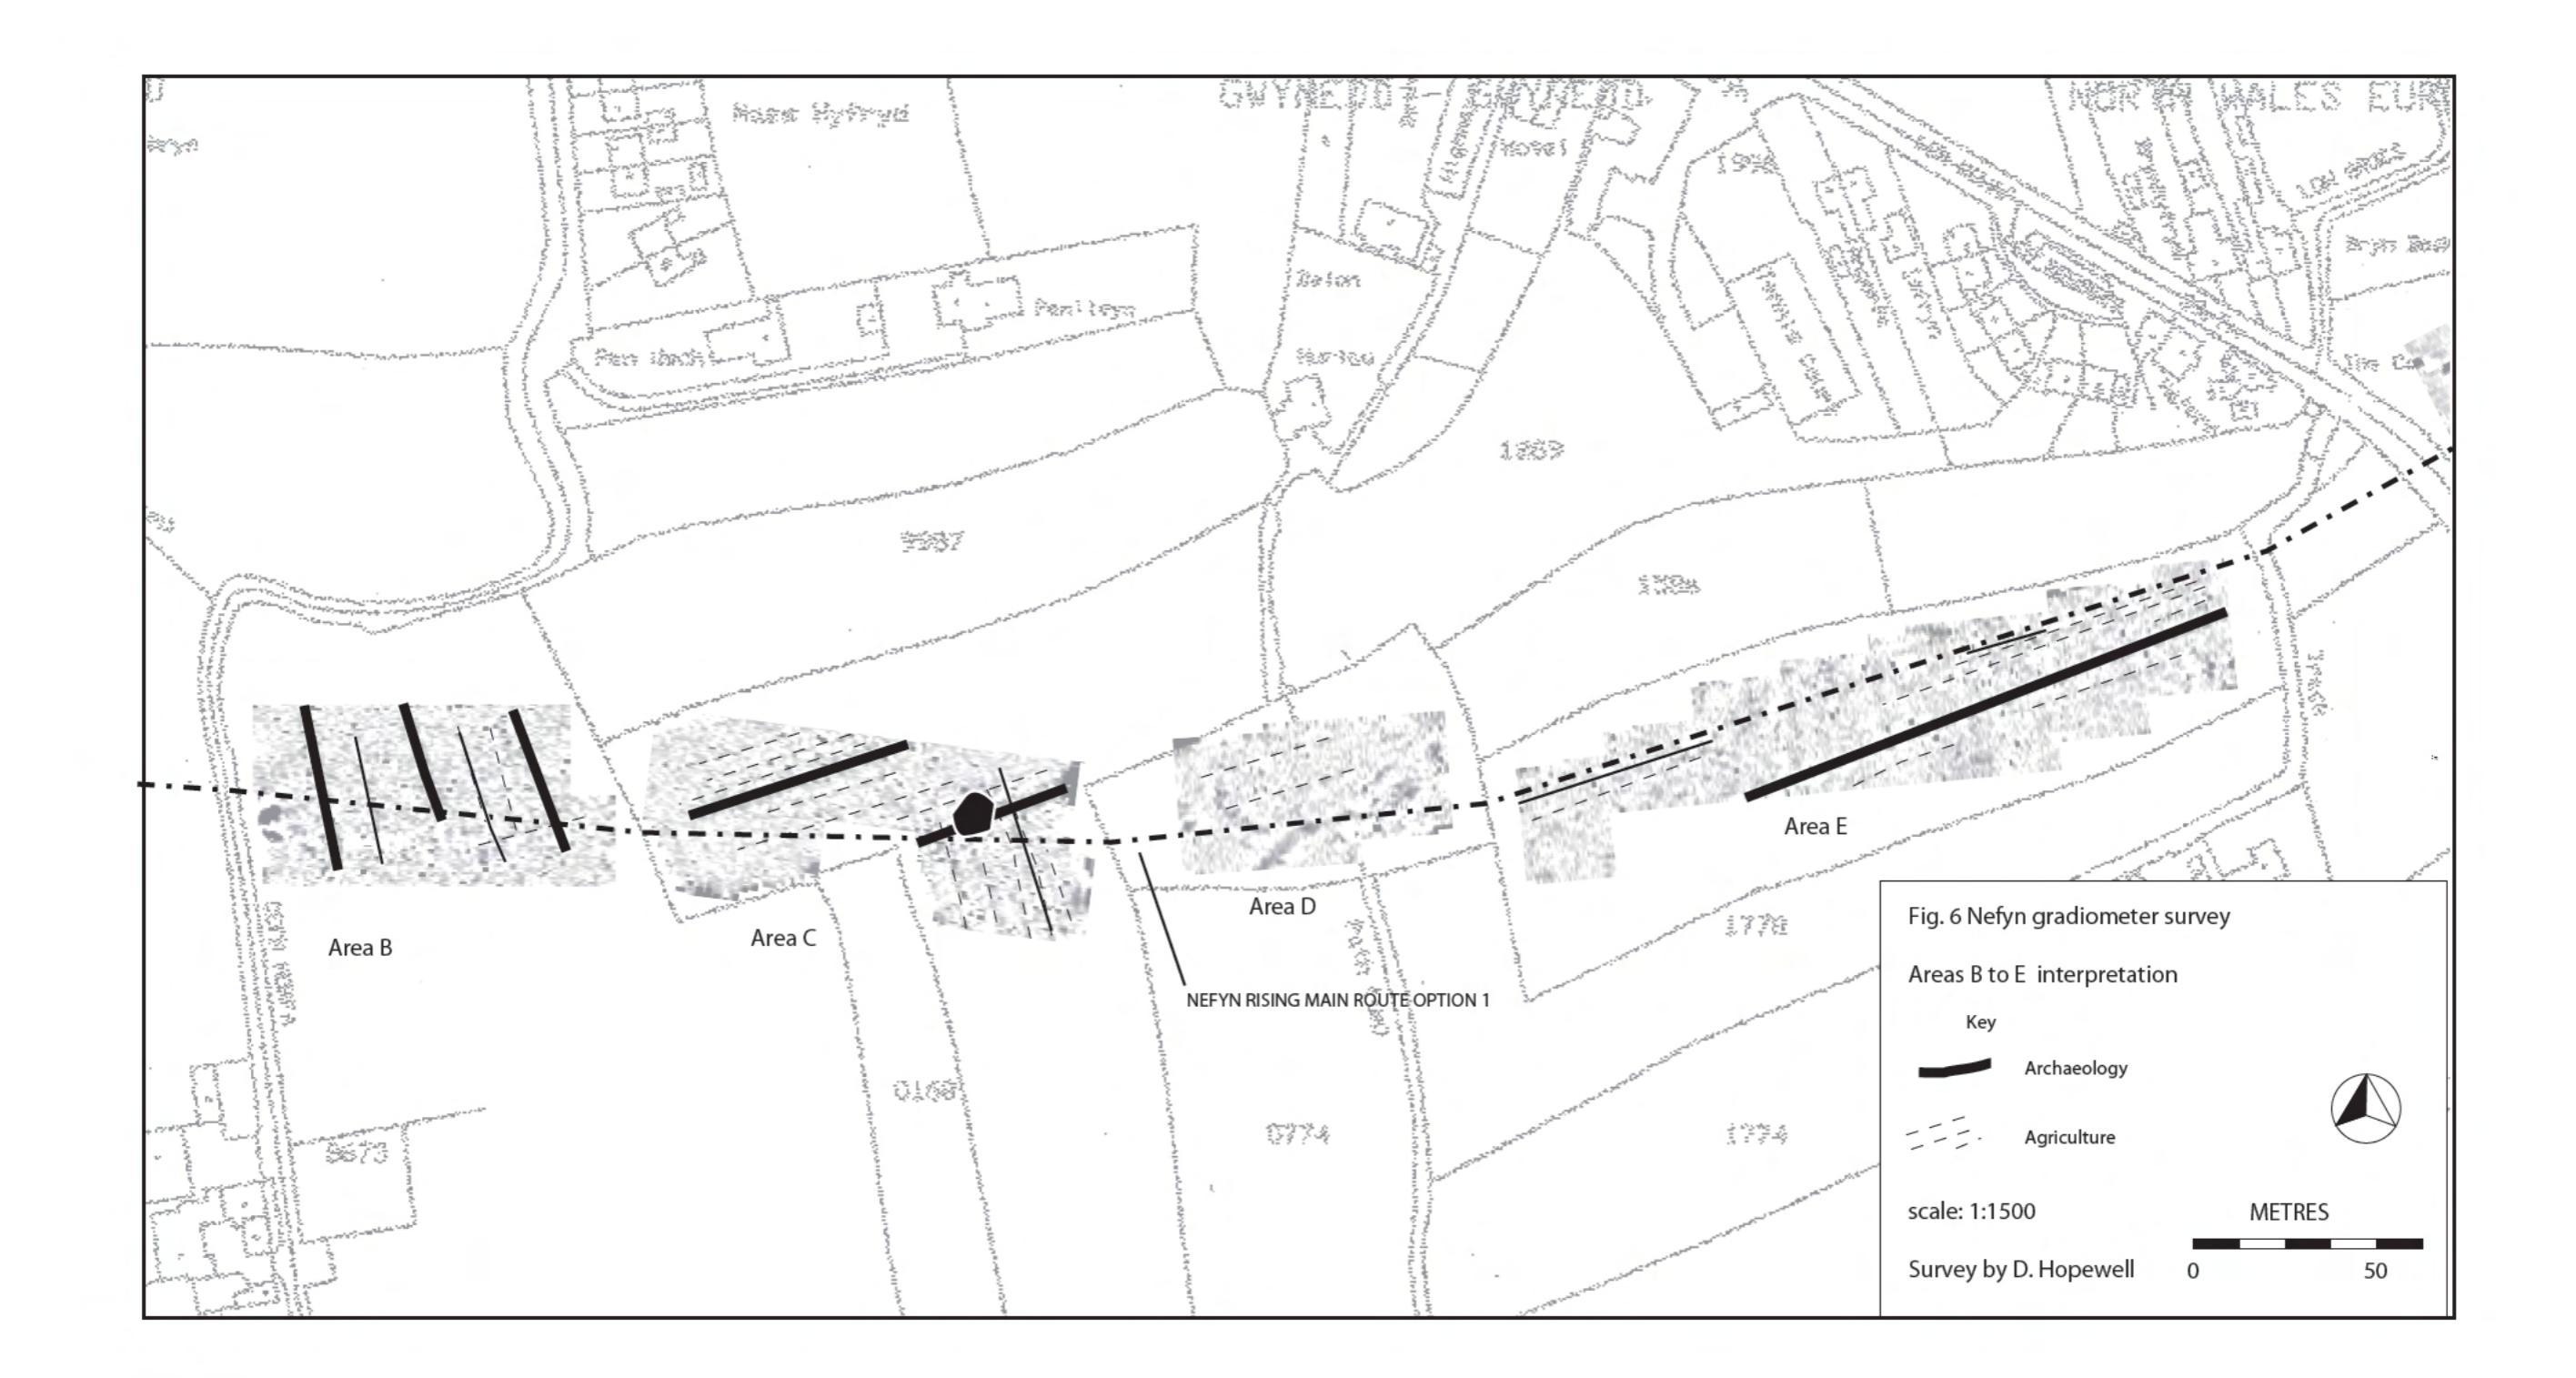
Area B survey results (Figs 5 and 6)

A series of three linear anomalies running approximately north south are visible on the grey-scale plot. The central anomaly corresponds to a field boundary shown on the 1839 tithe map (Fig 10, western side). The other two anomalies are not quite as clear but can probably also be interpreted as boundaries. A series of faint linear anomalies running parallel to the relict boundaries are the result of ploughing. Two of these anomalies are slightly better defined and could be interpreted as further divisions within the strip field system.

A single linear anomaly running approximately east-west can be seen to bisect the field longitudinally. This is very similar to the central anomaly in area B that can be shown to be a relict boundary. This feature should therefore be similarly interpreted. A further linear boundary type anomaly along with a strong anomaly corresponds to the obviously removed section of field bank on the south side of the field. The strong anomaly could be the result of a burning the wood from the hedgerow. Plough scarring is again

visible and one slightly stronger anomaly in the former southernmost field could represent a subdivision shown on the tithe map (Fig 10, western side).

The irregular anomalies on the grey scale plot are typical responses from underling bedrock or changes in the subsoil. A few very faint ploughscars are also visible.

A single linear anomaly running approximately east-west can be seen to bisect the field longitudinally. This can again be interpreted as a relict boundary. A further intermittent faint linear anomaly to the north of this could represent a further subdivision. Plough scarring is again visible, running parallel to the relict boundaries.

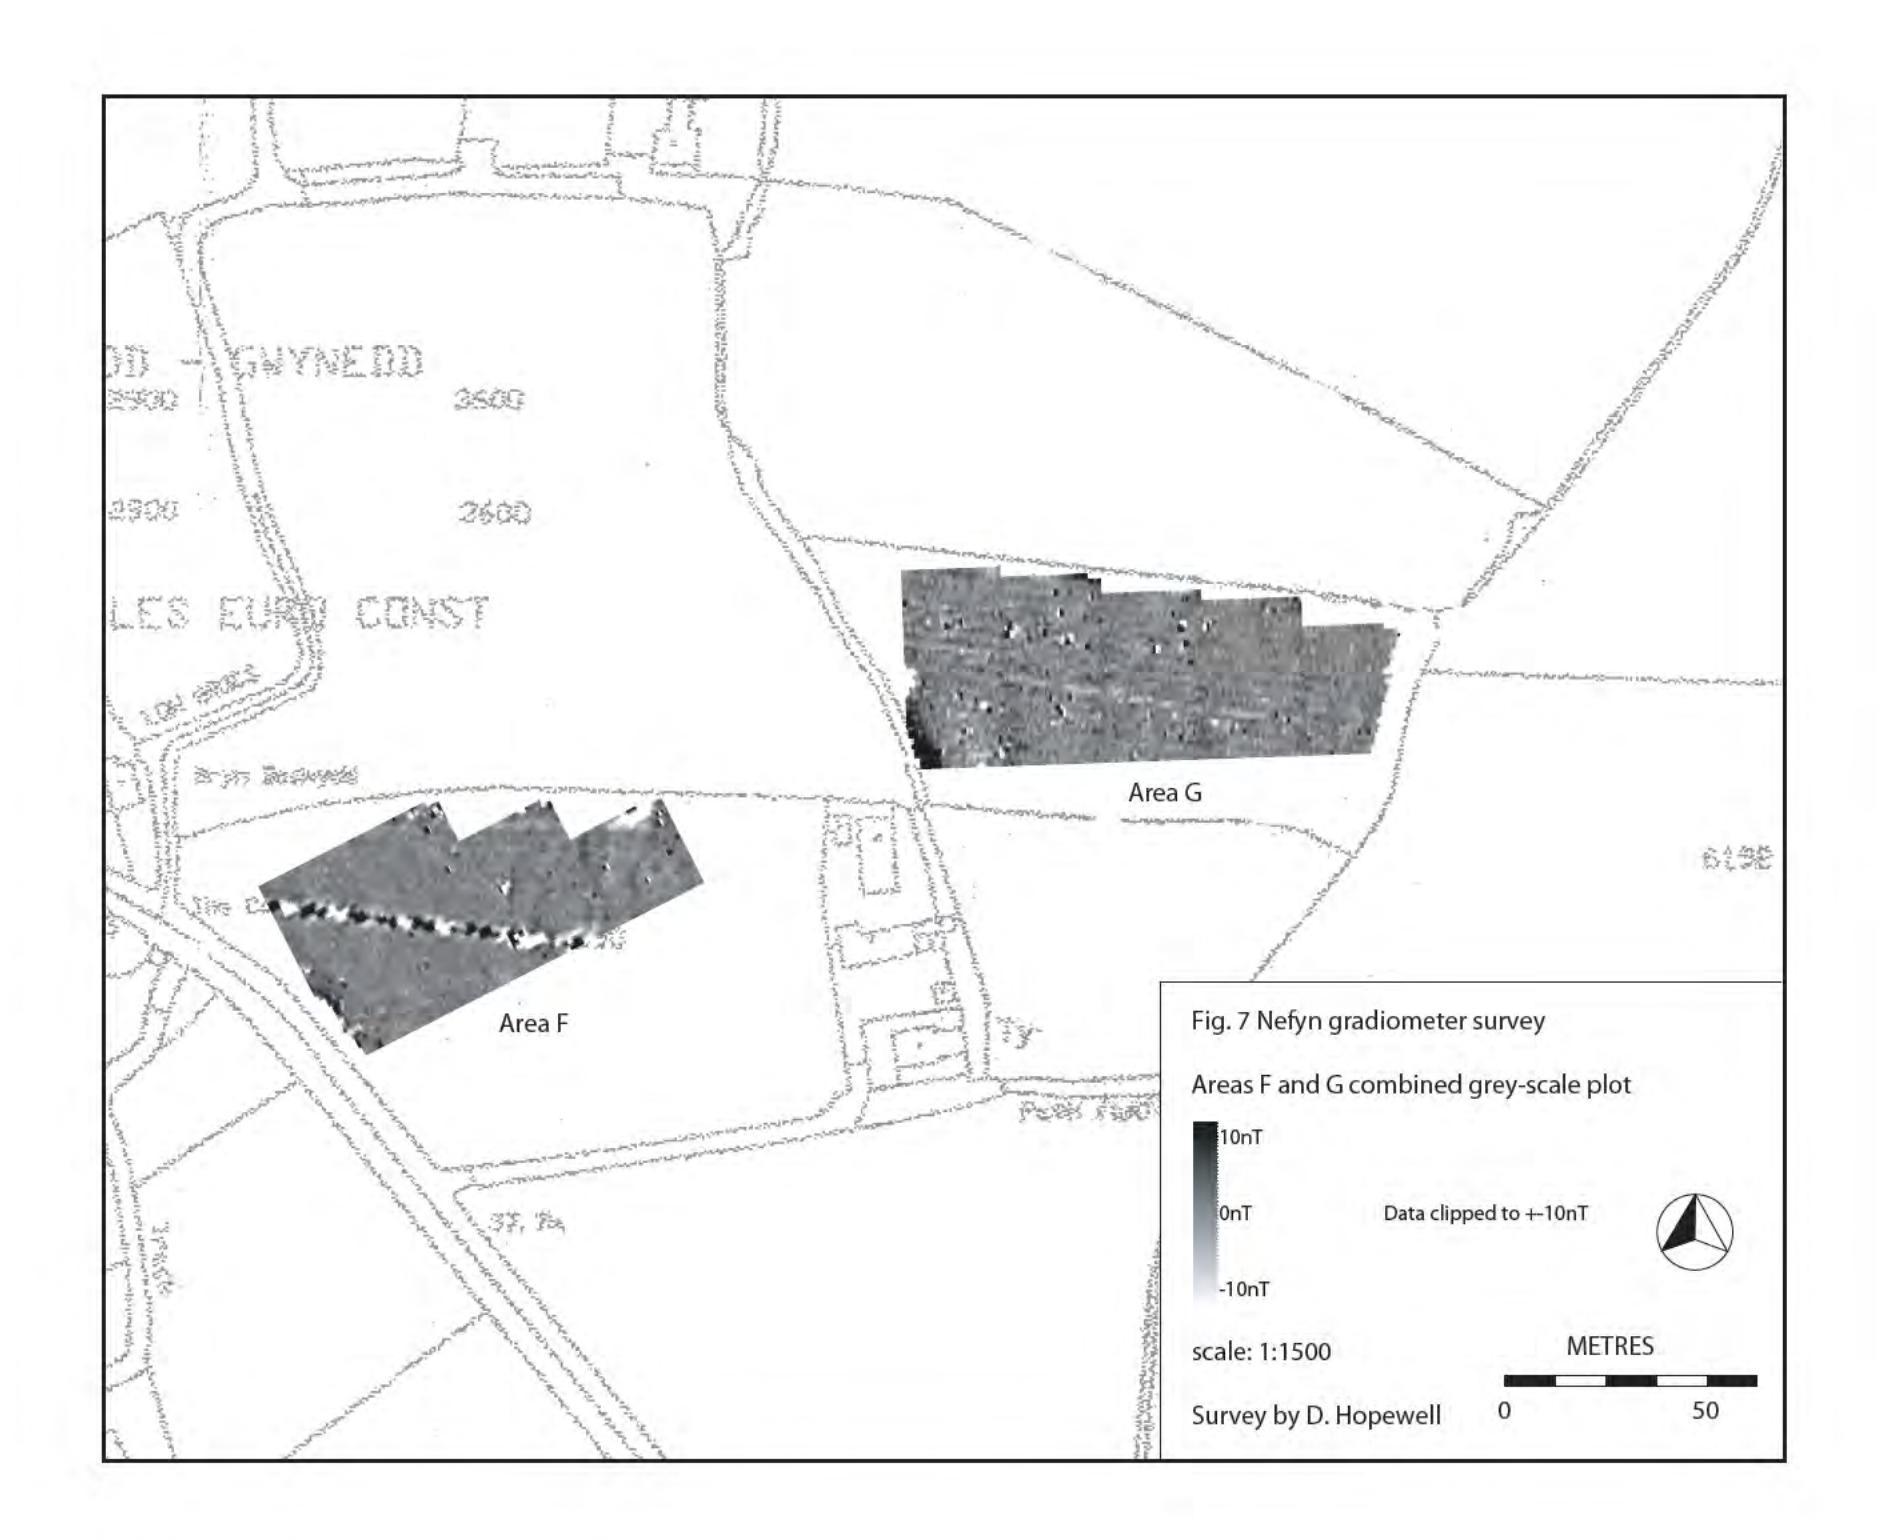
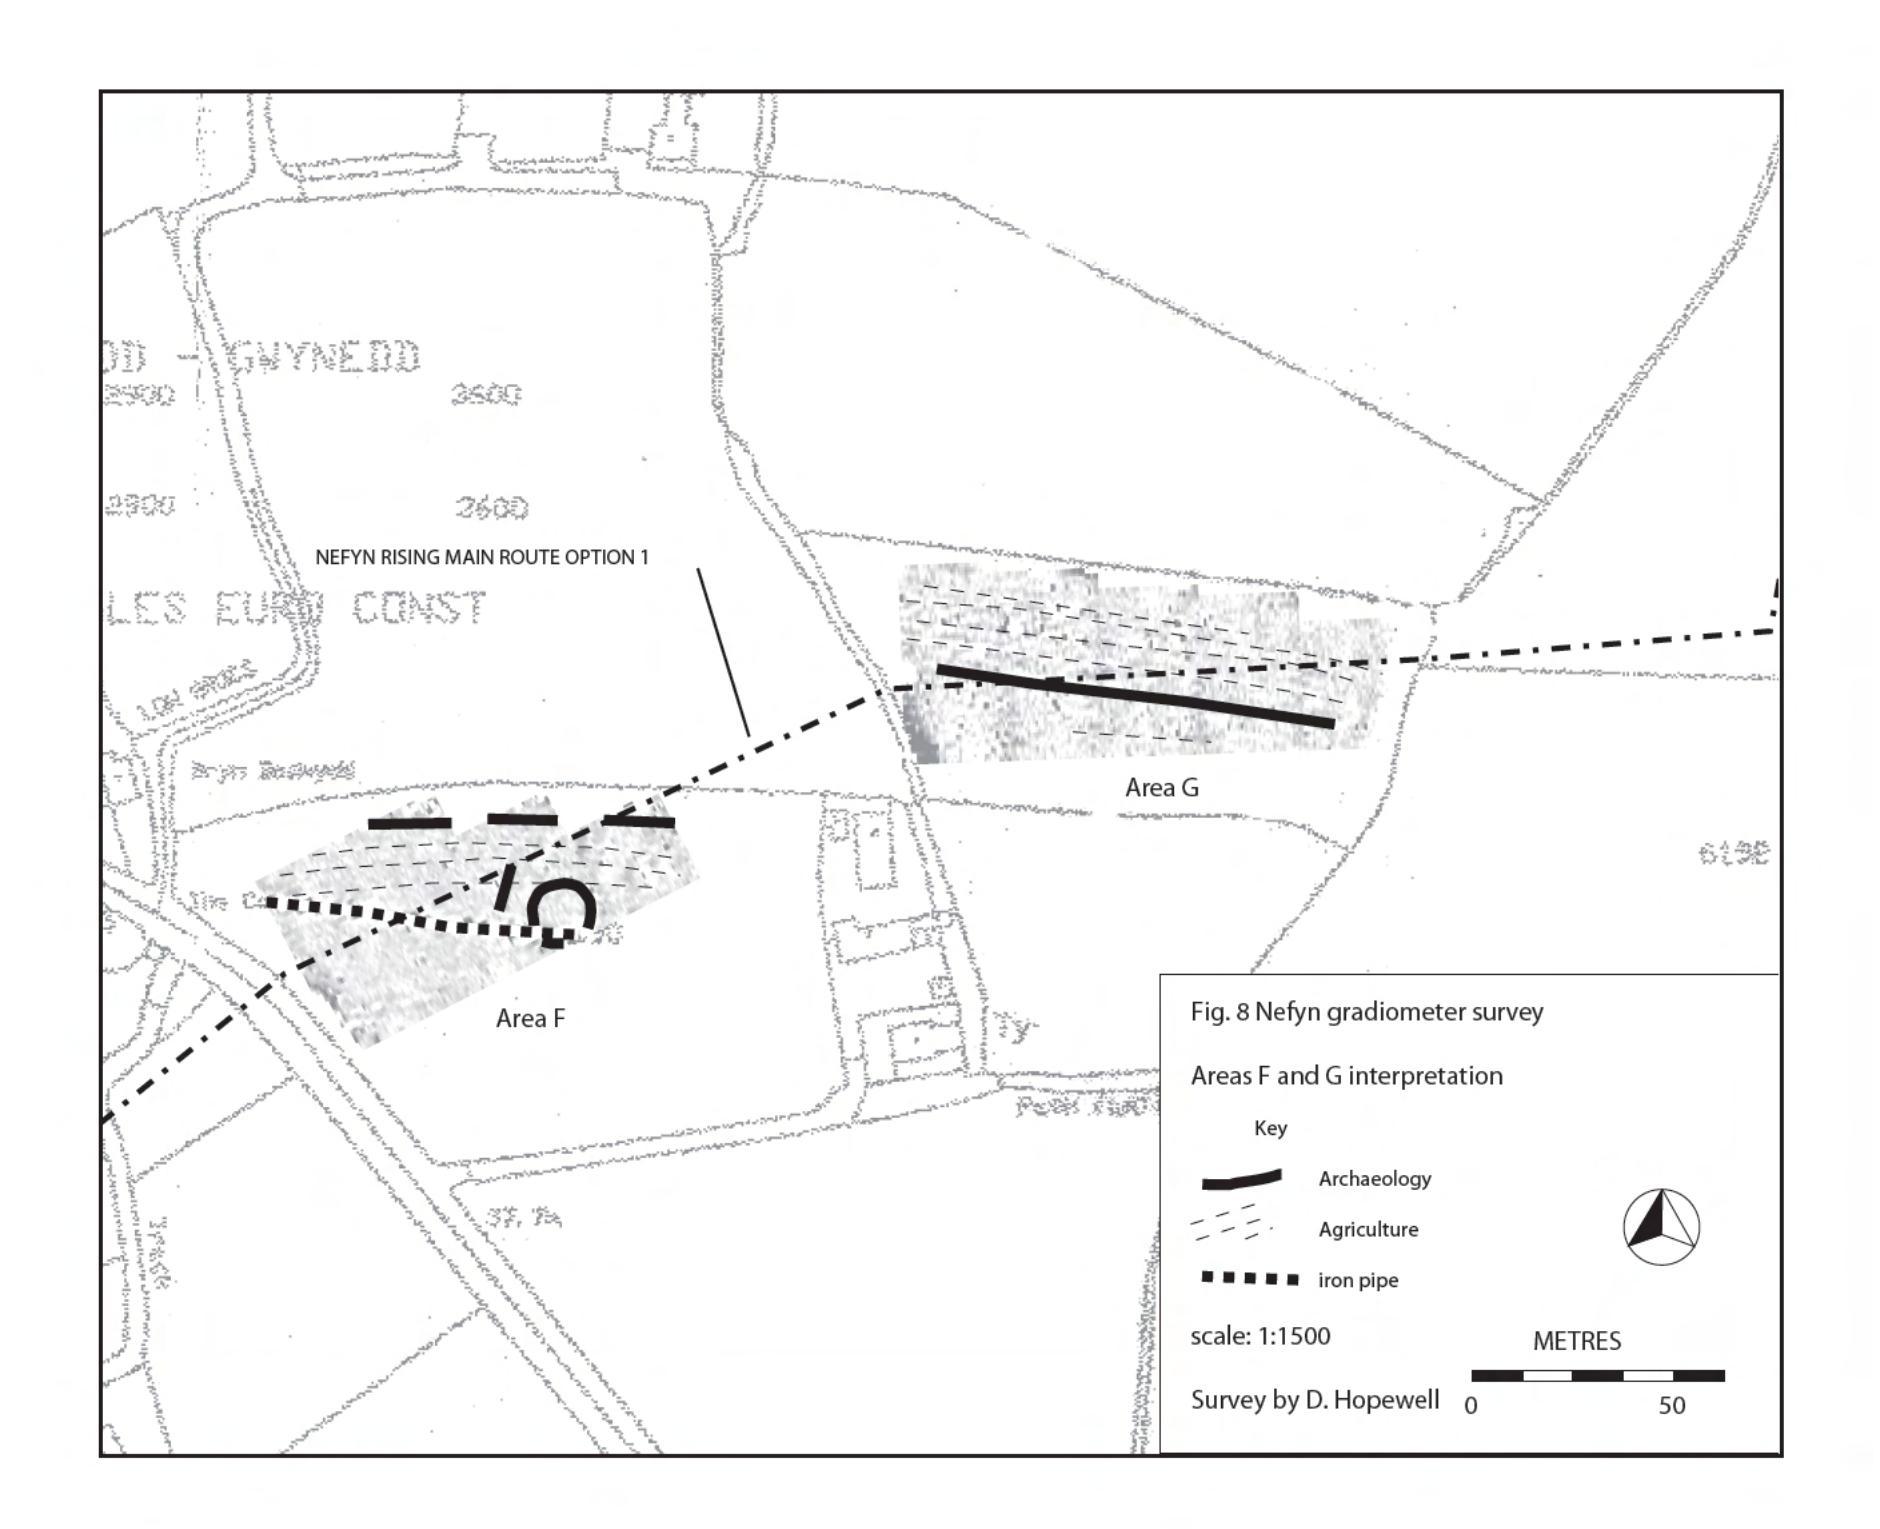
Area F survey results (Figs 7 and 8)

The most obvious feature in area F is a strong alternating positive and negative anomaly indicating a cast iron water pipe running to the farm. The eastern end of the pipe cuts a fairly well defined circular anomaly. This sits on the top of a break of slope in the field and could be a Bronze Age round barrow. This part of the field also contains another short linear feature suggesting further subsurface remains. Interpretation is however difficult because of masking by the strong readings from the pipe. A further linear anomaly at the north of the area could be a field boundary. Plough scarring is quite prominent in this field running in an east-west direction and curving towards the western boundary.

A single linear boundary-type anomaly running approximately east-west bisects the field and plough scarring is clearly visible in all but the northern part of the field.

The possible barrow in area F could reflect further Bronze Age funerary and ritual activity in the area around the previous discovery of a cist at Pen yr Orsedd (feature 38). It should be noted that this interpretation is unconfirmed and would have to be tested by excavation.

The possible barrow in area F could probably be avoided by the works and this is the preferred mitigatory recommendation. If this is not possible, excavation in advance of the works would be an acceptable alternative. It should be noted that trial trenching would be the initial requirement if avoidance is not possible in order to confirm the geophysical survey interpretation.

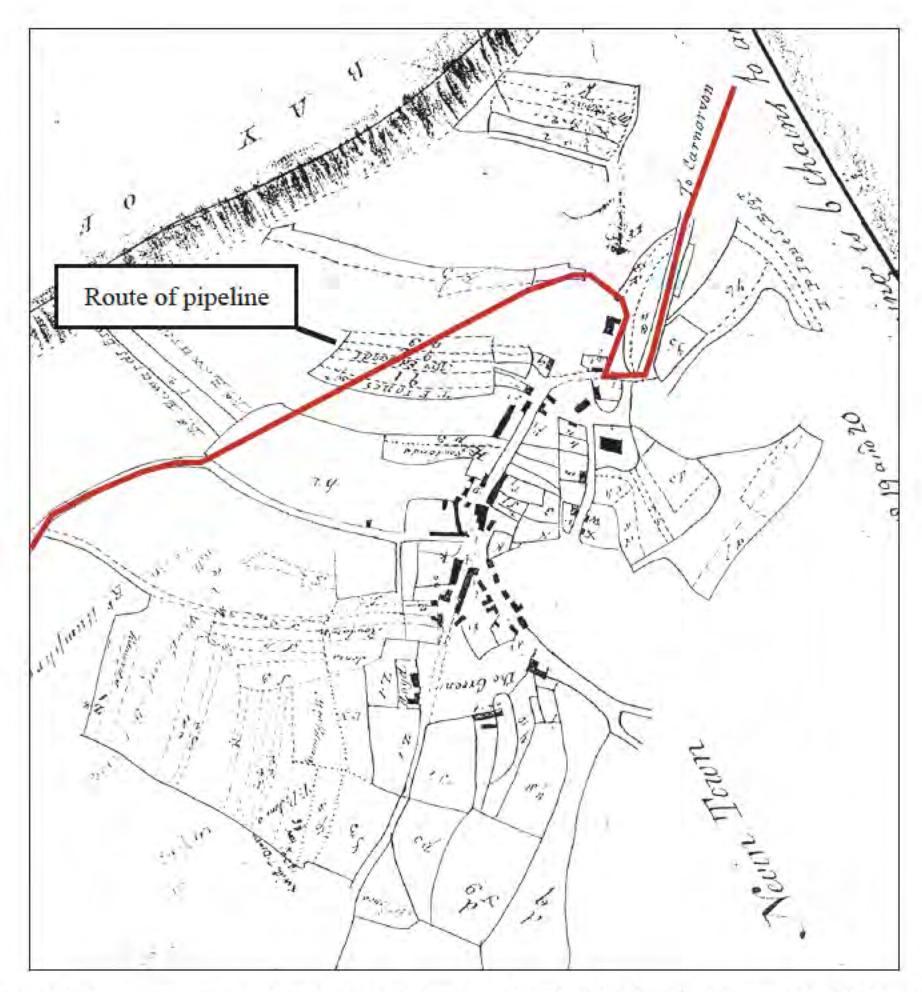
Fig. 9 Nefyn town, 1815, showing surviving Medieval strip field holdings (Glynllifon 1815). (North to top of map)

Further elements of medieval open strip fields (feature18) preserved within the present field system to the north of Nefyn (Fig. 9)

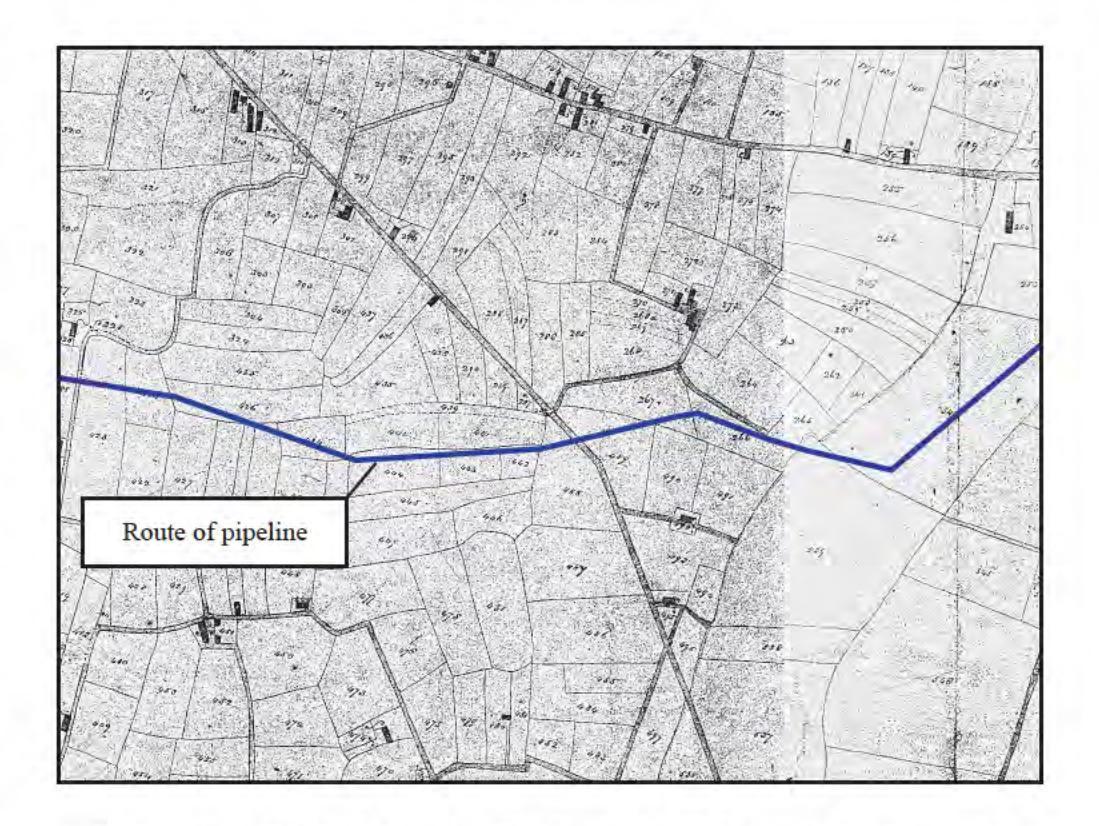
Fig.10 South of Morfa Nefyn, part of Nefyn parish tithe map, 1839, showing area of relict strip fields and route of pipeline (North to top of map).

Elements of medieval open strip fields (features 20 and 25 to 32) preserved within the present field system to the south of Morfa Nefyn (Fig. 10).

The tithe map (fig. 10) shows a different alignment for the northern boundary of the field (field no.266) and suggests that a track or road formerly ran into the northern part of it. The geophysical survey did not however detect any sign of the track or associated boundaries.
