ABERDYFI TO DYSYNNI FLOOD ALLEVIATION SCHEME - PENLLYN MARSHES, TYWYN

ARCHAEOLOGICAL ASSESSMENT

Report No. 516

GAT Project No. G1820

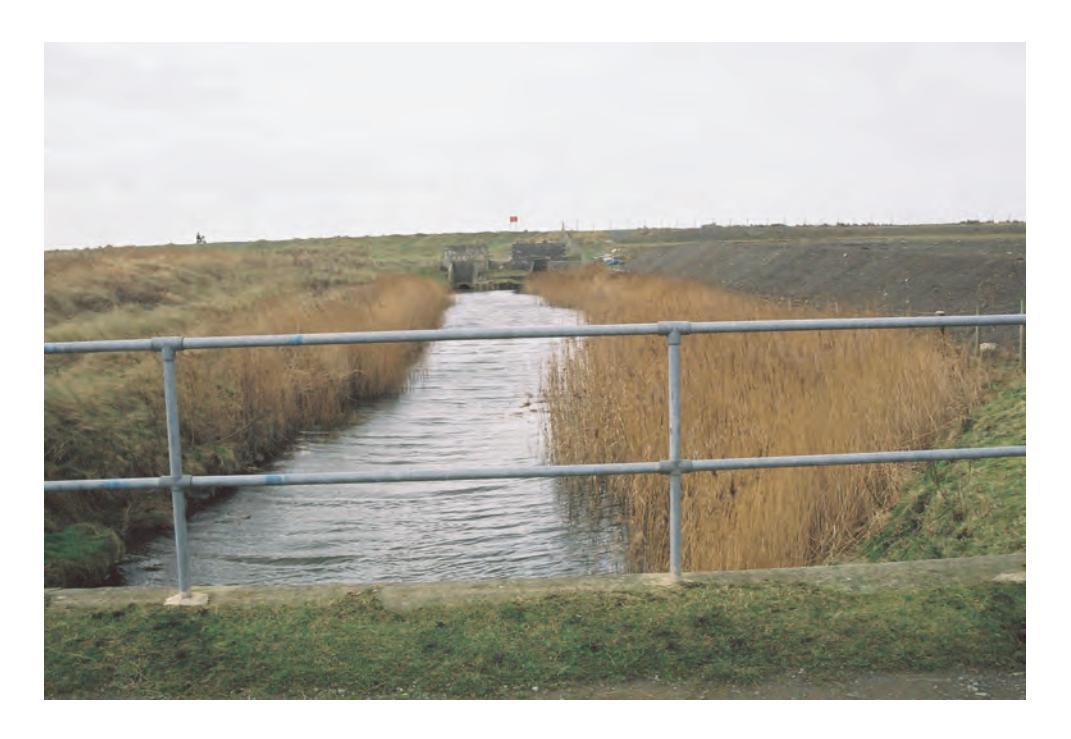
Fig. 8 Penllyn Marshes, Tywyn: Afon Dyffryn Gwyn tidal gate (Feature 2)

Feature 2 Afon Dyffryn Gwyn Tidal Gate and Culvert

SN 5835 9940 Period: 19th-20th century Category: C. Impact: Significant

The river has been canalised and runs into a cutting as it approaches the tidal gate and culvert (Fig. 8). The whole area must have been dug out when these were constructed. The area of the tidal gate has been much modified and repaired but there may be elements of the original 19th century work, including the culvert or pipe. Photographic recording is needed during replacement.

Recommendations for further assessment: None **Recommendations for mitigatory measures:** Basic recording

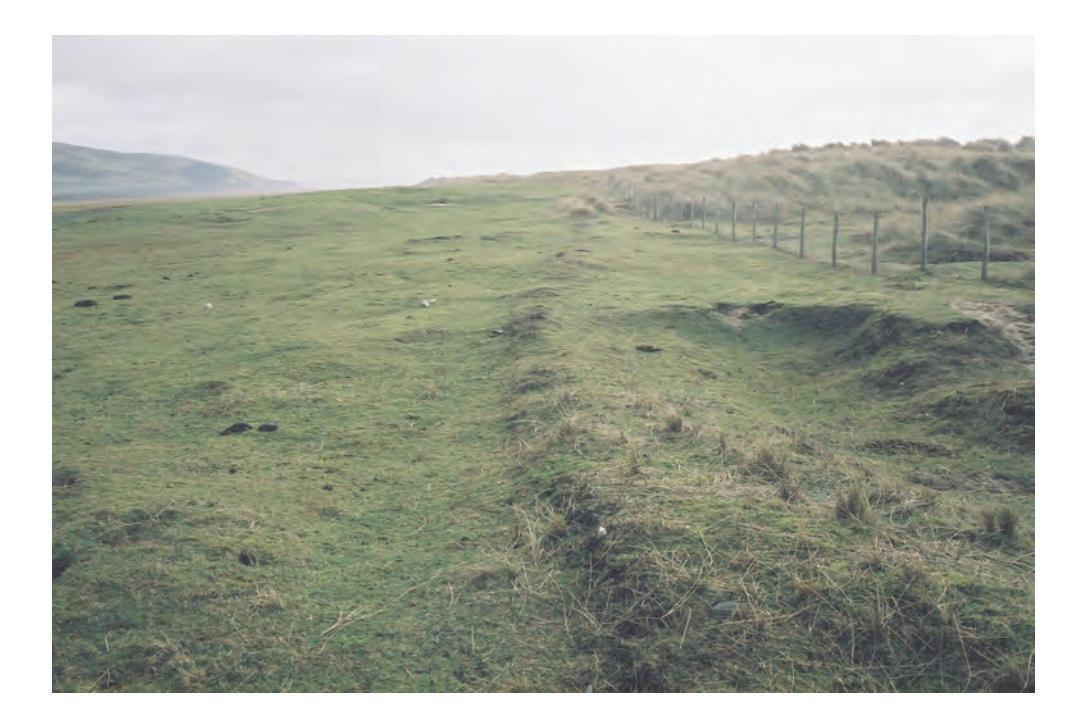
Fig. 9 Penllyn Marshes, Tywyn: Agricultural clearance bank (Feature 4)

Feature 4 Clearance bank

SN 5845 9925 (Centre) Period: 19th-20th century Category: D. Impact: Significant

The fields within the Penllyn Marshes are level and improved grassland. The east edge of the dunes has been bulldozed and spread out over a strip about 100m wide at the west edge of the fields. The belt of dunes was probably once rather wider than that seen now as suggested on the OS map of 1837, before drainage and improvement took place about 1862. The former Llyn-y-borth must have been infilled and levelled at this time. At the west edge of this area is a slight bank between the improved land and the (disturbed) dunes but it is of only minor interest (Fig. 9).

Recommendations for further assessment: None **Recommendations for mitigatory measures:** None

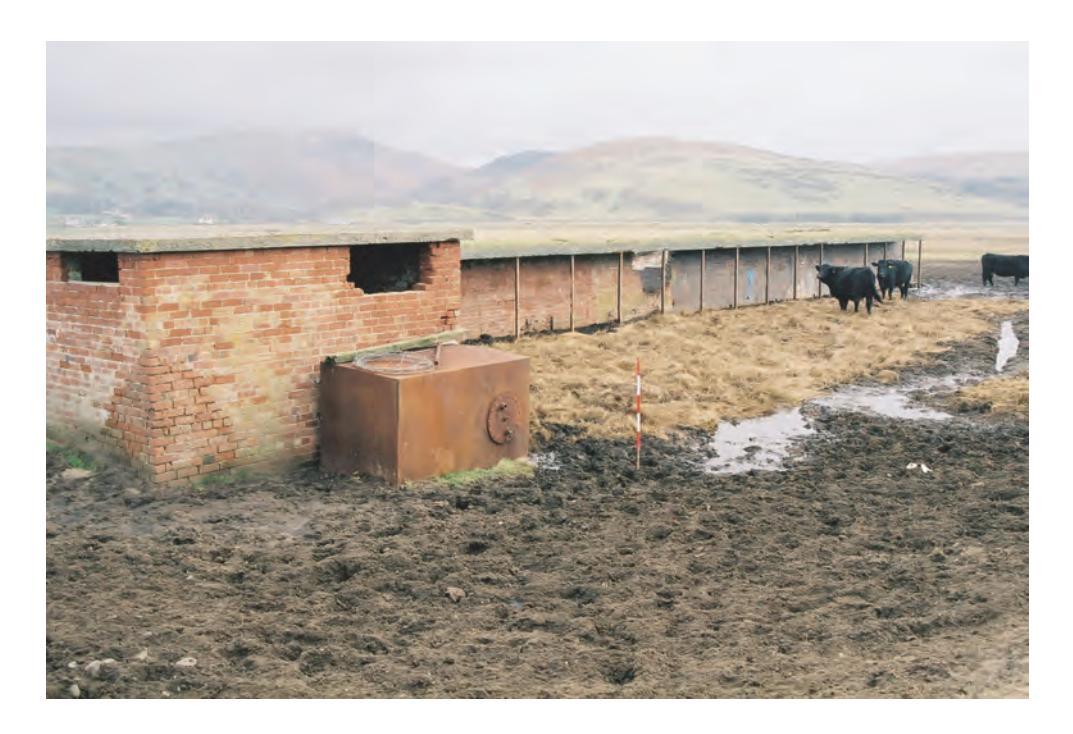
Fig. 10 Penllyn Marshes, Tywyn: Rifle range butts and command building (Feature 7), from the west. 1m scale

Feature 7 Rifle Range (GAT PRN 7287)

SN 5865 9878 Period: 19th-20th century Category: C. Impact: Considerable

The target area of a rifle range survives on the east edge of the dunes. It consists of two parts. First a long target area with brick wall fronted by a bank and a pentice-roofed protected walkway at the rear. Second a rectangular brick-built command post with a concrete flat roof (Fig. 10). The dunes at this point have been dug out around the targets and built up into a high bank at the west to provide a protective screen at the seaward side. The area is currently used as a cattle feeding point and is very trampled. The rifle range dates to between 1891and 1901 but in 1901 was just a line of targets, probably that still present The additional building seems to have been added during a period of re-use in about 1940. The survival of a 19th century military feature is unusual and is certainly of local and probably of regional importance and is worthy of recording.

Recommendations for further assessment: Desktop study of military records *Recommendations for mitigatory measures:* Detailed recording

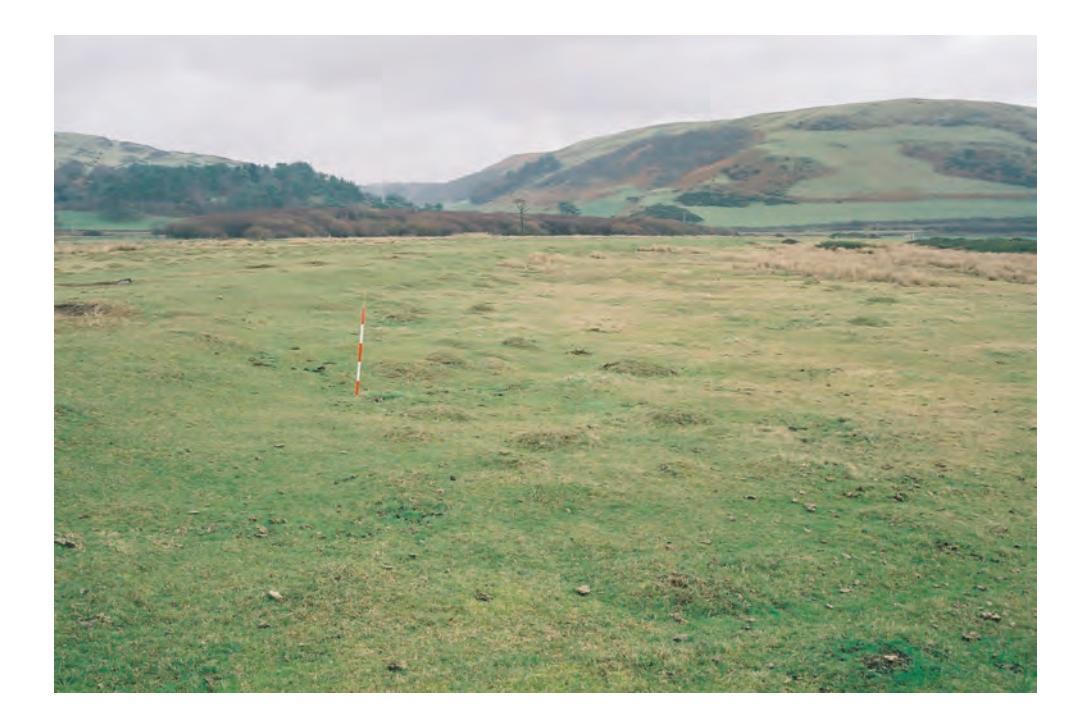
Fig. 11 Penllyn Marshes, Tywyn: Agricultural clearance terrace (Feature 8), from the west. 1m scale

Feature 8 Terrace

SN 5920 9800 (Centre) Period: 19th century Category: D. Impact: Considerable

At the south end of the survey area is a sudden dip of about 1.5m in the ground level, edged by a long curving terrace (Fig. 11). This dip marks the edge of an area marked on the 1837 OS map as *Gwerglodd Rhowniar* – Meadow (belonging to) Rhowniar (farm). The sharp terrace at its edge must have been created when the area to the north-west was drained and levelled. The lower area south of the terrace must be prone to flooding and is still unimproved of rougher vegetation and with several small pools.

Recommendations for further assessment: None **Recommendations for mitigatory measures:** None

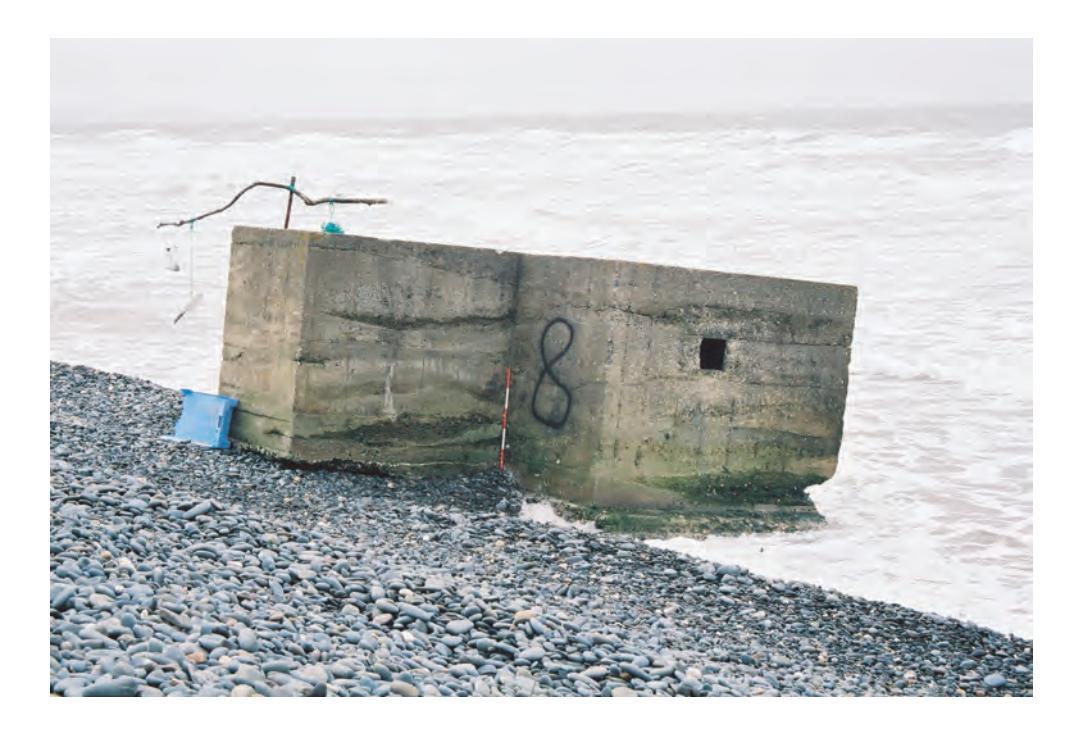
Fig. 12 Penllyn Marshes, Tywyn: Pill-box (Feature 9), from the north-east. 1m scale

Feature 9 Pill-box (RCAHMW NPRN 270343)

SN 5900 9776 Period: 20th century Category: C. Impact: Considerable

A line of seven World War II machine gun emplacement pillboxes has been recorded along the sea-front here by GAT (Gwyn and Dutton 1995) and the RCAHMW Defence of Britain Project of which three fall within the

survey area (Fig. 7). The Defence of Britain project has been started because of the realisation that there are relatively few surviving examples of military architecture and that those that do survive have not been recorded. These pill-boxes were probably built on the top of the shingle bank as then existed but the bank has been eroded by the sea and all are now collapsed or collapsing. Their position is now within the high tide line, which suggests that the shingle bank has retreated by at least 20m since their construction. That at the south is complete and roofed but has been undermined by the sea and is now set at an angle on the upper beach (Fig. 12). It has been recorded by the Defence of Britain Project but needs a full photographic record because the proposed coastal retreat poses an immediate threat to its survival.

Recommendations for further assessment: Desktop study of military records **Recommendations for mitigatory measures:** Basic recording

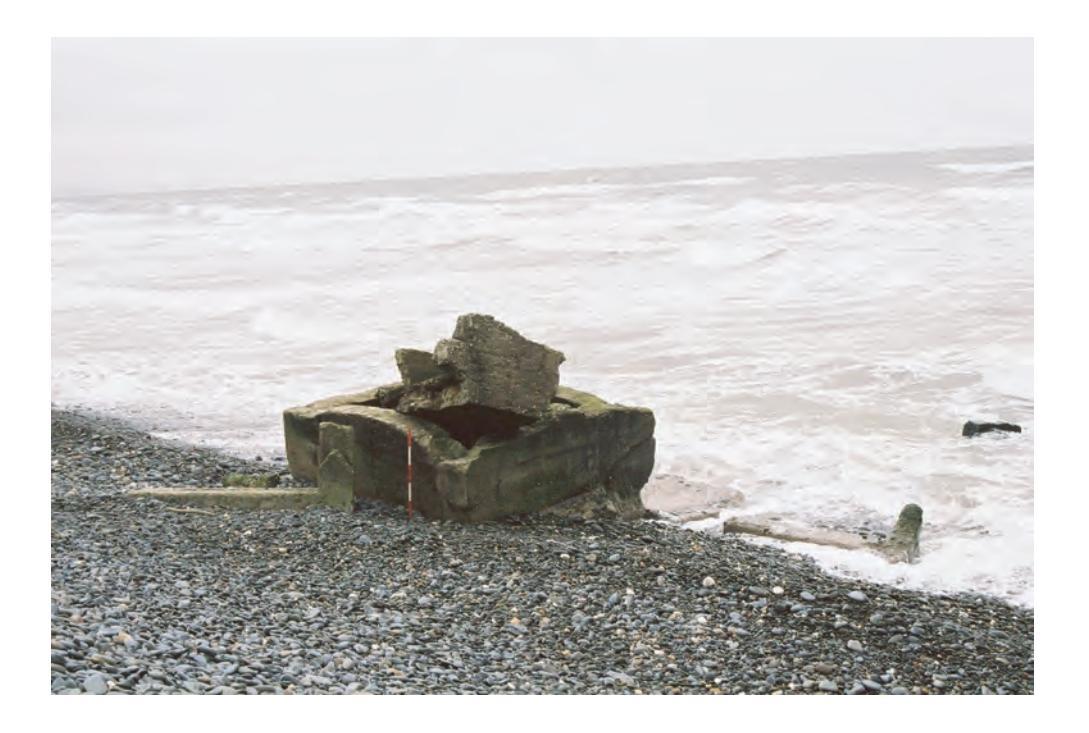
Fig. 13 Penllyn Marshes, Tywyn: Pill-box (Feature 11), from the north-east. 1m scale

Feature 11 Pill-box (RCAHMW NPRN 270340)

SN 5871 9846 Period: 20th century Category: C. Impact: Considerable

This pill-box, listed in the SMR and described by Gwyn and Dutton (1995) and the RCAHMW Defence of Britain Project as in good condition is now in a damaged condition with the roof missing, within the tidal reach and constantly being eroded (Fig. 13).

Recommendations for further assessment: Desktop study of military records *Recommendations for mitigatory measures:* Basic recording.

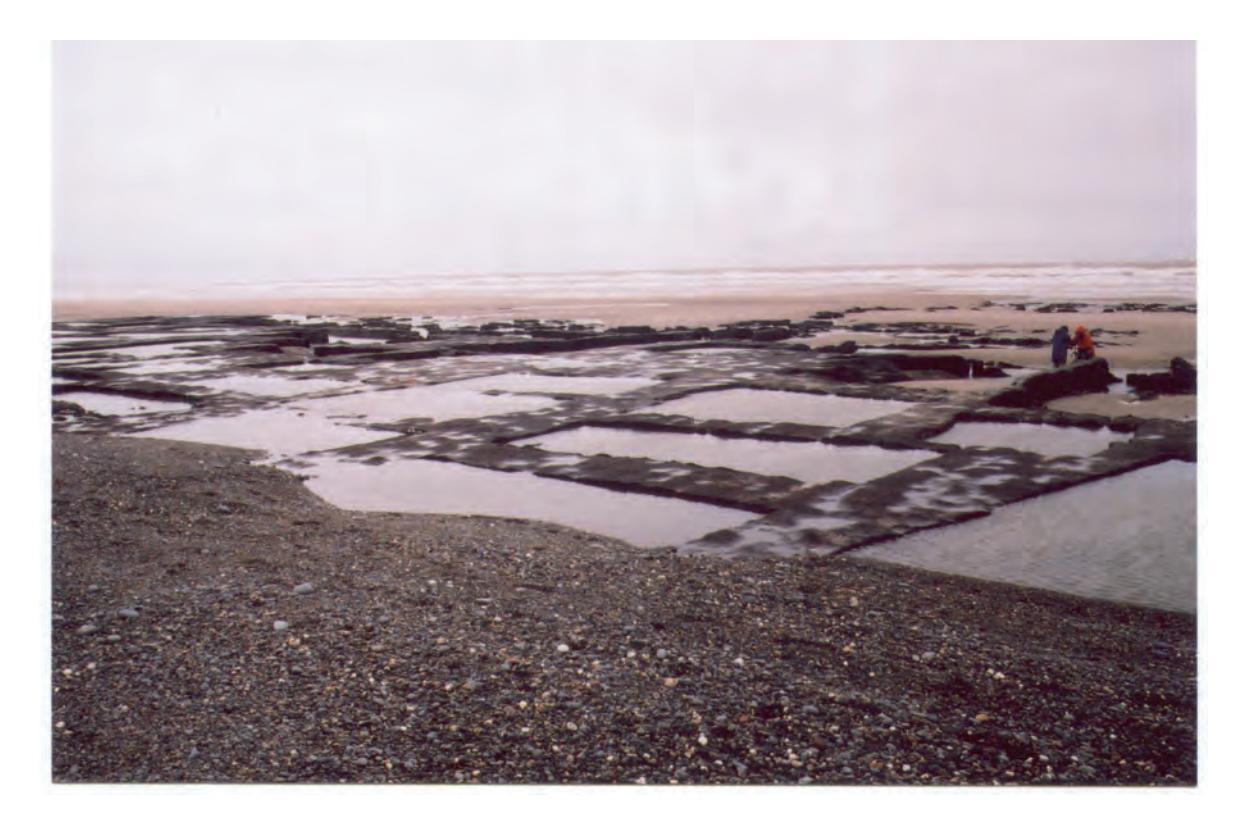
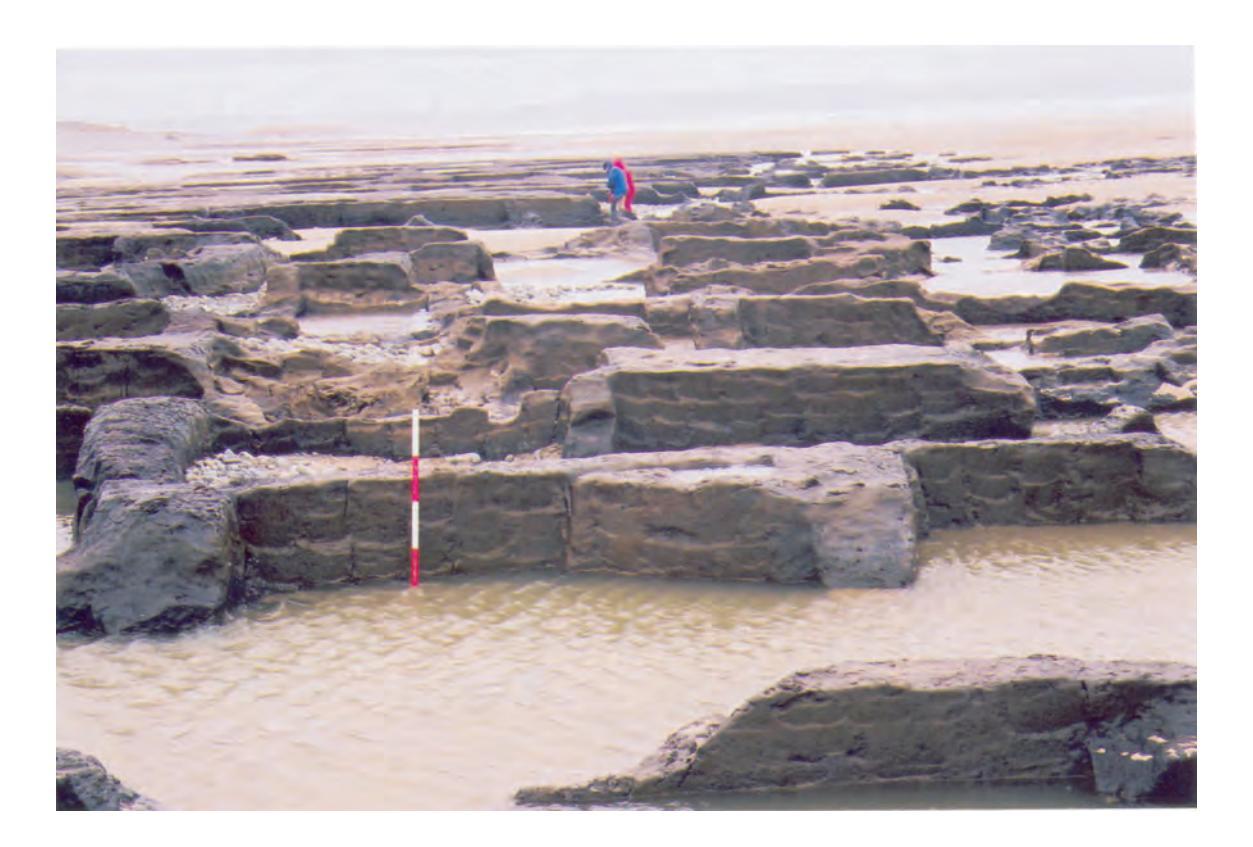
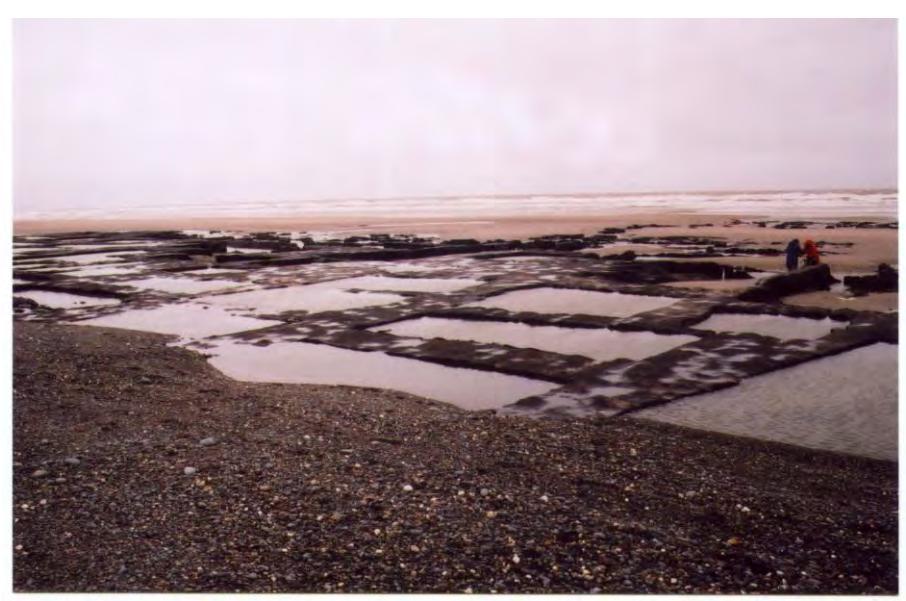
Fig. 14 Penllyn Marshes, Tywyn: Peat cutting beds (Feature 13), general view, from the north-east.

Peat-cutting beds in prehistoric land surface, Penllyn Marshes, Tywyn foreshore

Feature 13 Turbary (GAT PRN 7286)

SN 5818 9932 (Centre) Period: 18th-19th century Category: B. Impact: Considerable Beneath the beach shingle and dunes is a buried ancient peat-bed, discussed above and Feature 13, below. This was not visible during the visit on 28th January 2004 because of a near high tide but is in any case frequently hidden by sand and only visible after particular tide and wind conditions. However, it has been visited previously when it was exposed (Gwyn and Dutton 1995 and Smith 2002). The peat bed is at least 1m deep and in its surface are many neatly cut rectangular pits, the remains of peat cutting for fuel (Fig. 14). These are so well preserved that spade marks are still visible in some faces (Fig. 15). There have been no artefacts to date the pits and no specific historical records of their cutting. However, there are general mentions of exploitation of peat around Tywyn in the 18th century and like other parts of north Wales this probably continued into the mid-19th century when the construction of the railways meant that cheap coal became available. Peat cutting in moorland usually manifests as long advancing faces, which are sometimes visible as slight terraces. The pits here seem to have been cut as separate features in order to avoid water-logging so that each pit was separated by a peat 'wall' from its neighbour which would have been filled with water between tides. Some of the pits are even provided with neat drainage channels.

The best-preserved area of pits runs for some 200m south of the outfall of the Afon Dyffryn Gwyn. The peat beds can be seen to run back under the shingle bank but is uncertain if the peat-cutting pits do also. However, they approach quite closely to it. This causes a problem of interpretation as it has been suggested that the exposure of the outfall and the erosion of the pill-boxes shows that the coastline has eroded back come way over the last hundred years. If it is assumed that the outfall was once near the upper beach, as show on the 1901 map then the peat-cutting beds would have been hidden under the beach sand and shingle, suggesting that the beach had advanced not retreated since their excavation. However, as suggested above, it may be that the river outfall was modified to extend it further out to sea, beyond where it was shown on the 1901 map. Even so the position of the pits would indicate that the coastline had not retreated at all since their use.

Fig. 15 Penllyn Marshes, Tywyn: Peat cutting beds (Feature 13), showing spade-marks, from the north-west. 1m scale

Recommendations for further assessment: None *Recommendations for mitigatory measures:* Detailed recording

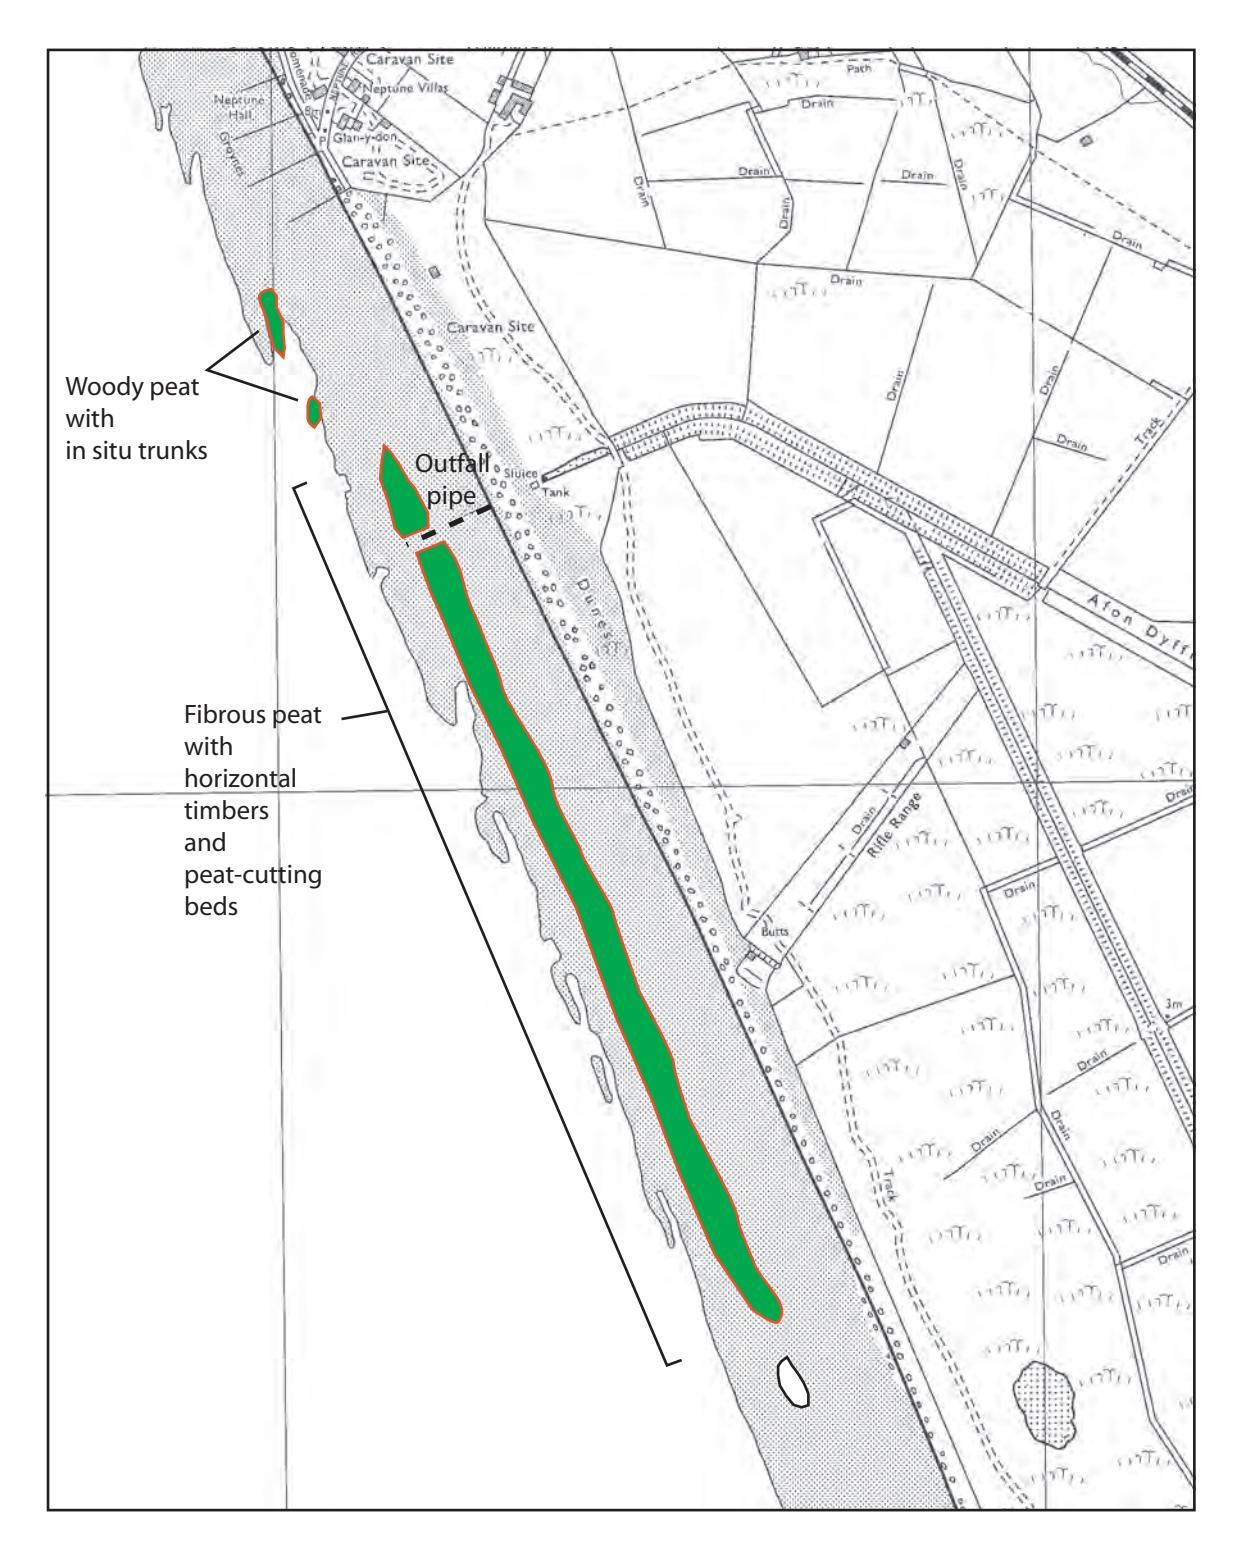
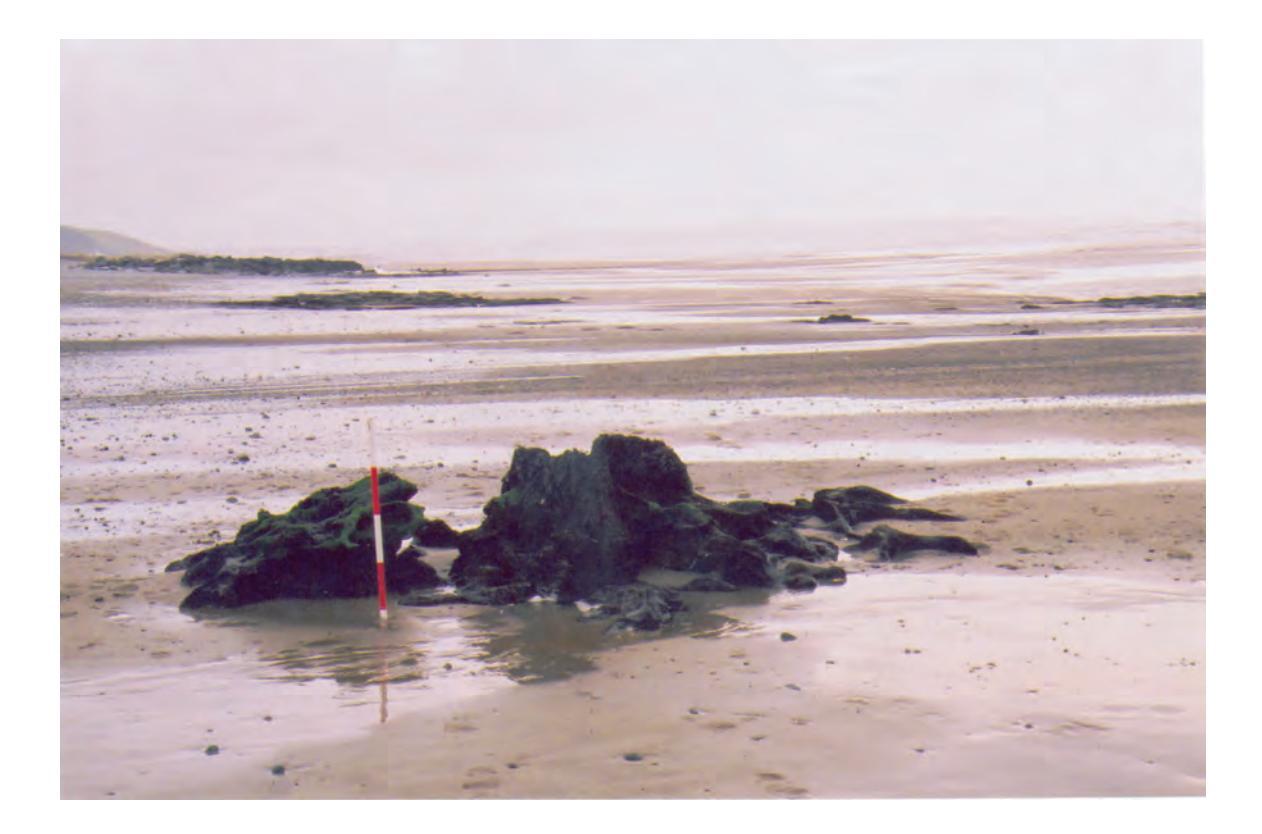
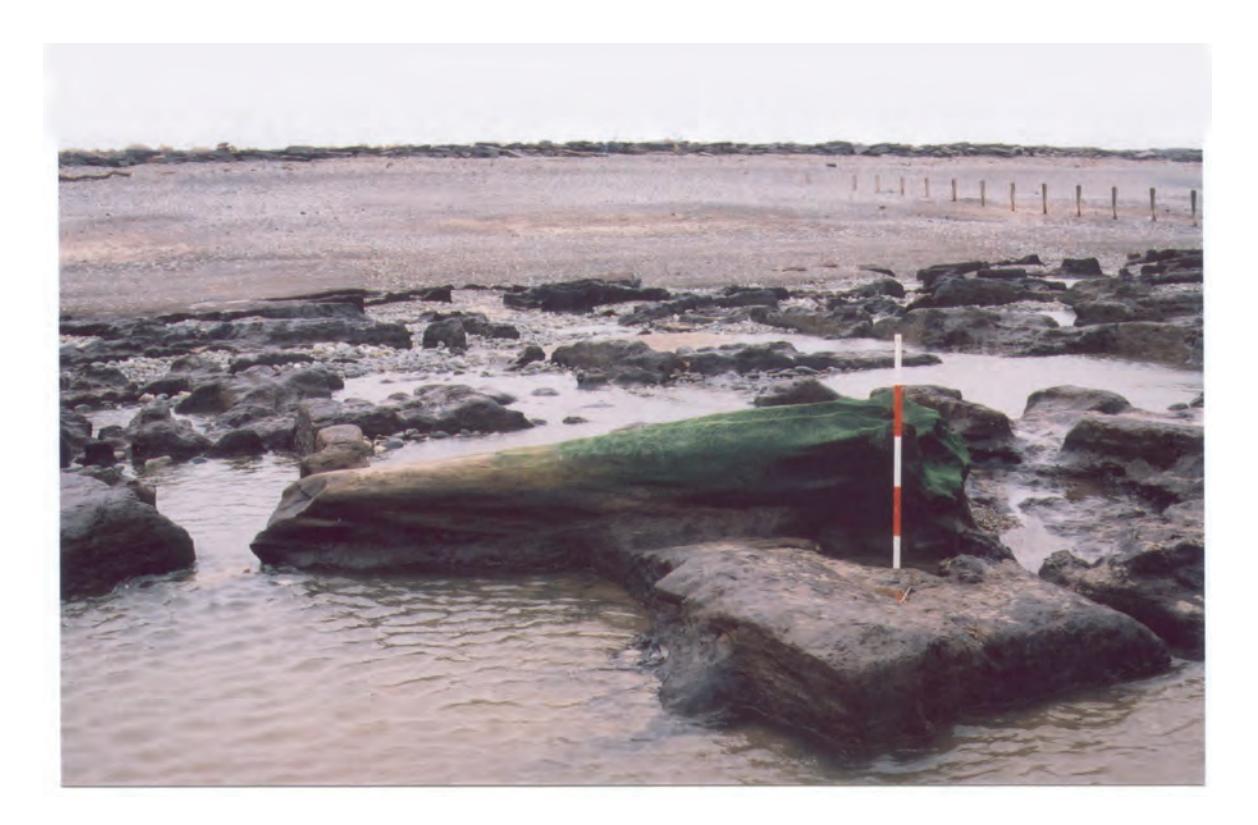
Fig. 16 Penllyn Marshes, Tywyn: Sketch location of intertidal peat exposures, PRN 16601. Scale 1:10,000. Based on OS 1:10,000 scale maps. © Crown copyright. All rights reserved. Licence number AL 100020895.

Feature 14 Ancient peat-beds (GAT PRN 16601)

SN 5855 9853 (Centre) Period: Prehistoric Category: B. Impact: Considerable

The peat beds have been discussed as part of the background, above. They extend for about a kilometre along the shore here (Fig. 16, from Smith 2002). North of the outfall they are badly eroded and occur as isolated patches. In places there are large in situ tree stumps (Fig. 17) and in others large fallen trunks that have been exposed by the peat cutting (Fig. 18). The peat is at least a metre deep and consists of more than one horizon, some of it woody and fibrous, other much finer. The peat beds can be seen to run back under the shingle bank and may continue under the Penllyn marshes. This might be confirmed if a bore-hole study is carried out prior to start of the managed retreat scheme. The peat represents a buried and preserved ancient landscape in which well-preserved archaeological remains may occur. Sometimes objects are discovered by chance that show the presence of human activity but there are none reported from here. However, samples were taken as part of a previous survey and these showed the presence of charcoal, taken to be a good indicator of probable human activity nearby (Caseldine in Smith 2002). There have been datable finds elsewhere not far away, at Borth, just south of the Dyfi Mesolithic flints and an antler tool (Sambrook and Williams 1996, 26) and from Llanaber, Barmouth, red deer antlers, deer and cattle bones (Kelly 1982) and a medieval timber trackway (Musson *et al* 1989).

The peat beds in themselves are very fragile but are currently protected to some extent by the build-up of sand on the foreshore against the shingle bank. Erosion may therefore happen quite rapidly if the single bank is breached. This area of submerged ancient land surface is the largest in extent and the best preserved of the thirty-one known or reported such exposures in north-west Wales (Smith 2002). It therefore has the greatest potential for research and deserves a programme of sampling and dating before the deposits are eroded away during the managed retreat scheme. The deposits would also need long term observation as the coast edge erodes and new areas of peat become exposed.

Fig. 17 Penllyn Marshes, Tywyn: Peat beds (Feature 14), ancient tree stump in situ, from the north-west. 1m scale

Fig. 18 Penllyn Marshes, Tywyn: Peat beds (Feature 14), ancient fallen tree trunk in situ, from the west. 1m scale

Recommendations for mitigatory measures: Detailed recording, to include scientific sampling and dating
