# A470 BLAENAU TO CANCOED IMPROVEMENT

# ARCHAEOLOGICAL RECORDING PHASE 1 PANT YR AFON GIRDER BRIDGES AND ROAD EMBANKMENT

G1874

Report number : 591

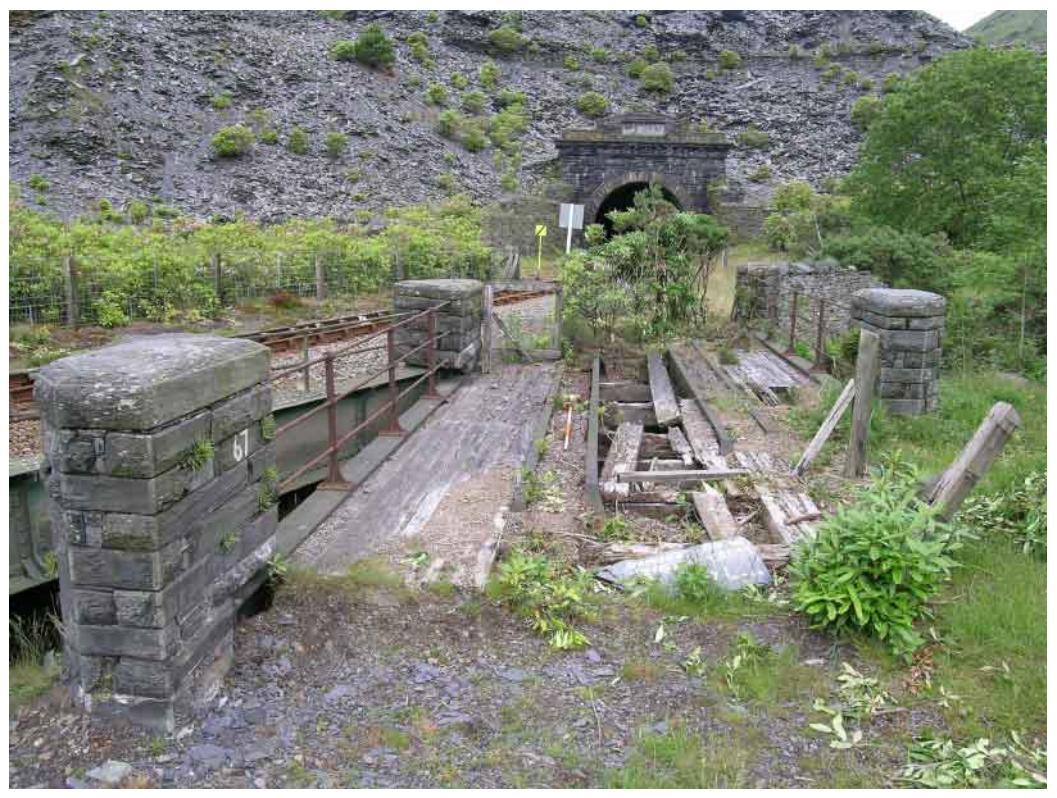
Plate 1 Bridge 67, general view

Bridge 67 (Plate 1) crosses the tramway cutting. The sides of the tramway cutting are revetted with dry slate walls. The abutment masonry of the bridge is of a similar type. The span of the bridge is 3.43m and it crosses at an angle of  $43^{\circ}30$ ' to the normal (Fitzgerald, *c*.2005). It is 4.57m wide (deck width). Parapet turrets of mortared, roughly dressed slate stand above the abutments

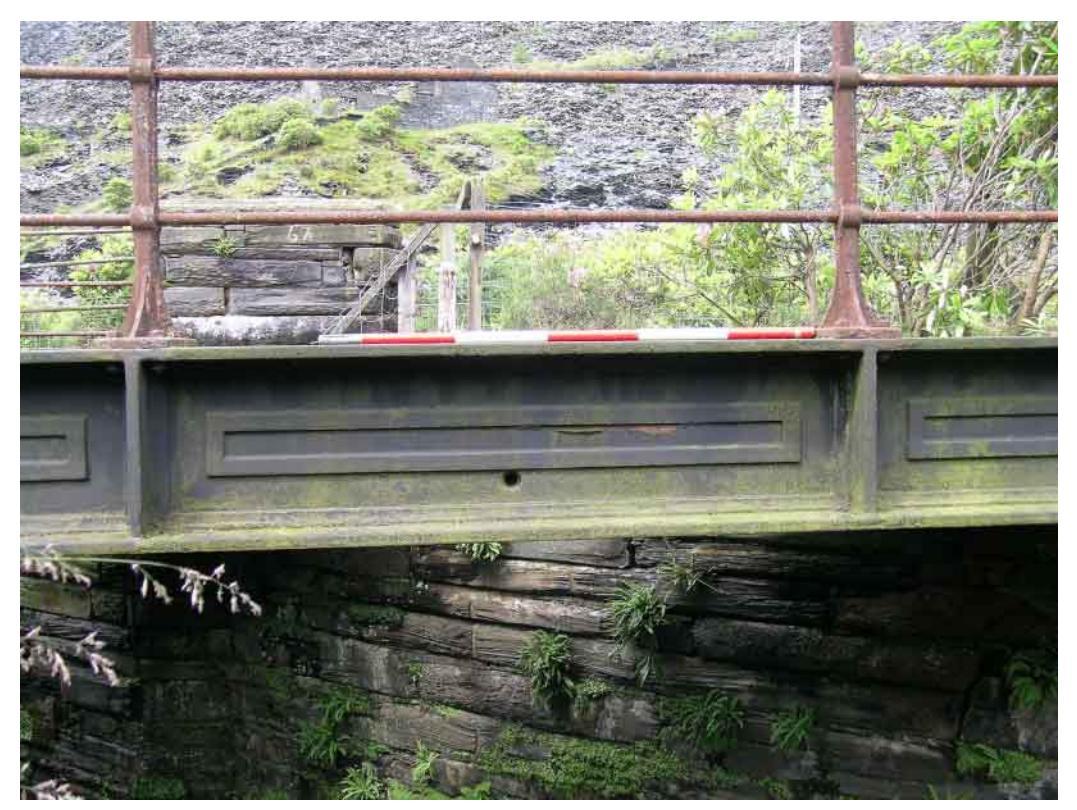
Plate 2 Bridge 67, girder panel E side

The bridge consists of six cast iron girders. The outer two girders are 7.01 long with an inverted T cross-section. The upper flange is 0.23m wide and 0.025m deep and the lower is 0.25m wide and 0.038m deep. The total depth of each girder is 0.42m. The outer face is divided into four equal sized, decorative panels, emulating wooden panel-work (Plate 2). Each panel is 1.52m long and they are divided by vertical stiffener ribs. Two further, smaller, panels project into the parapet turret masonry and are thus largely obscured. The girders support a parapet railing consisting of three cast iron stanchions (0.92m high) on the south-western side and five on the north-eastern. All are bolted onto the girder with the base straddling the stiffener ribs. Three railings run through holes in the stanchions. On the north-eastern side they terminate in the holes in the turrets and on the south-east they are free. Three of the turrets are hexagonal in plan along with an irregular pentagonal turret that is shared with the former LNWR line bridge. All have their longest side parallel to the track bed. They stand to a height of about 1.05m above the top of the girders and are typically 1.23m wide (Plates 3 and 4). They are built from roughly dressed slate blocks with distinctive chisel cut corners and a large capstone with chamfered upper corners. The turret adjacent to the former LNWR line is 1.6m long and stands above the girders of both bridge 67 and the LNWR line bridge.

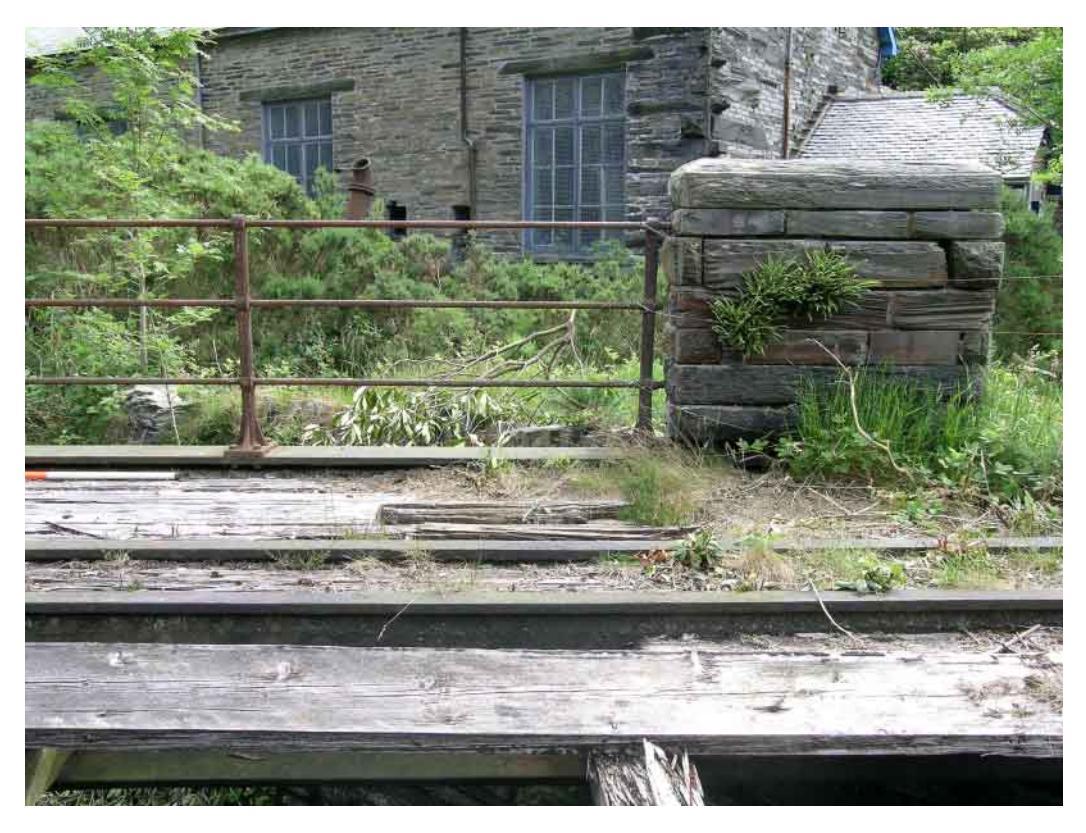
Plate 3 Bridge 67, parapet turret and railings E side, W facing

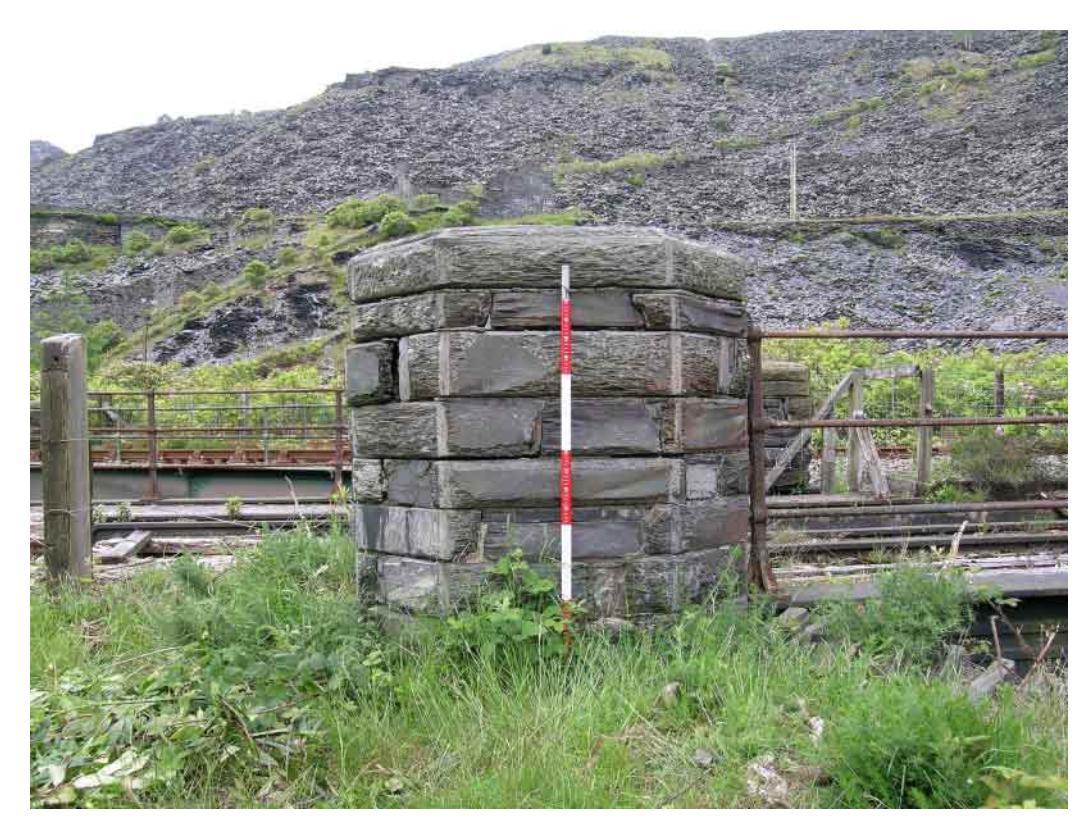
Plate 4 Bridge 67, parapet turret W side, E facing

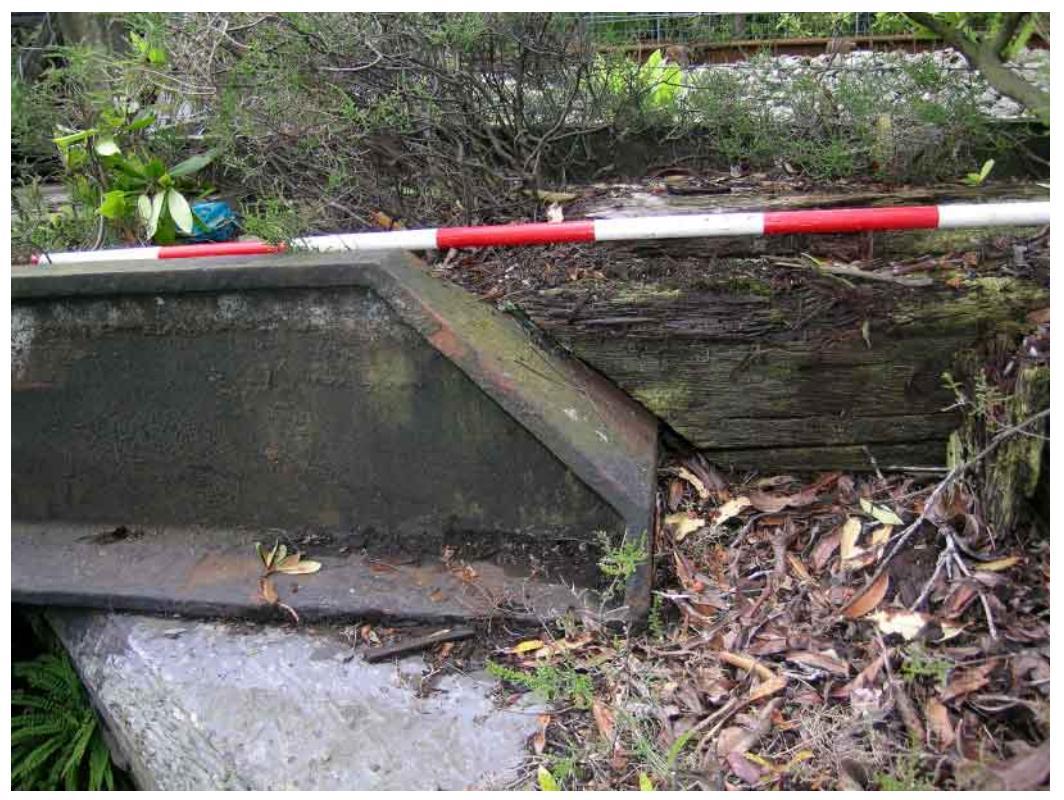
Plate 5 Bridge 67, girder end fitted to baulk

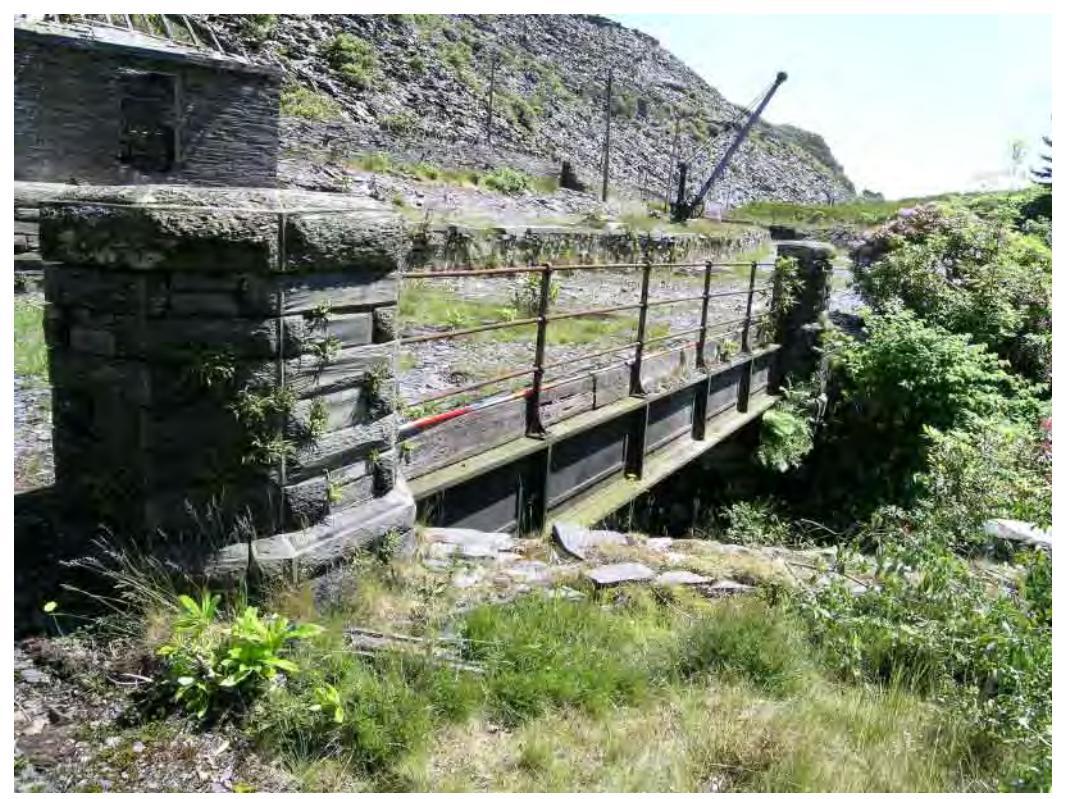
Plate 6 Bridge 68, general view

The superstructure (Plate 6) is more substantial than that of bridge 67 although they share many constructional details such as the presence of 6 cast iron girders. Bridge 68 is in much better condition and details of the 4 central girders carrying the line load are not visible due to the presence of crushed slate ballast above and brickwork below.

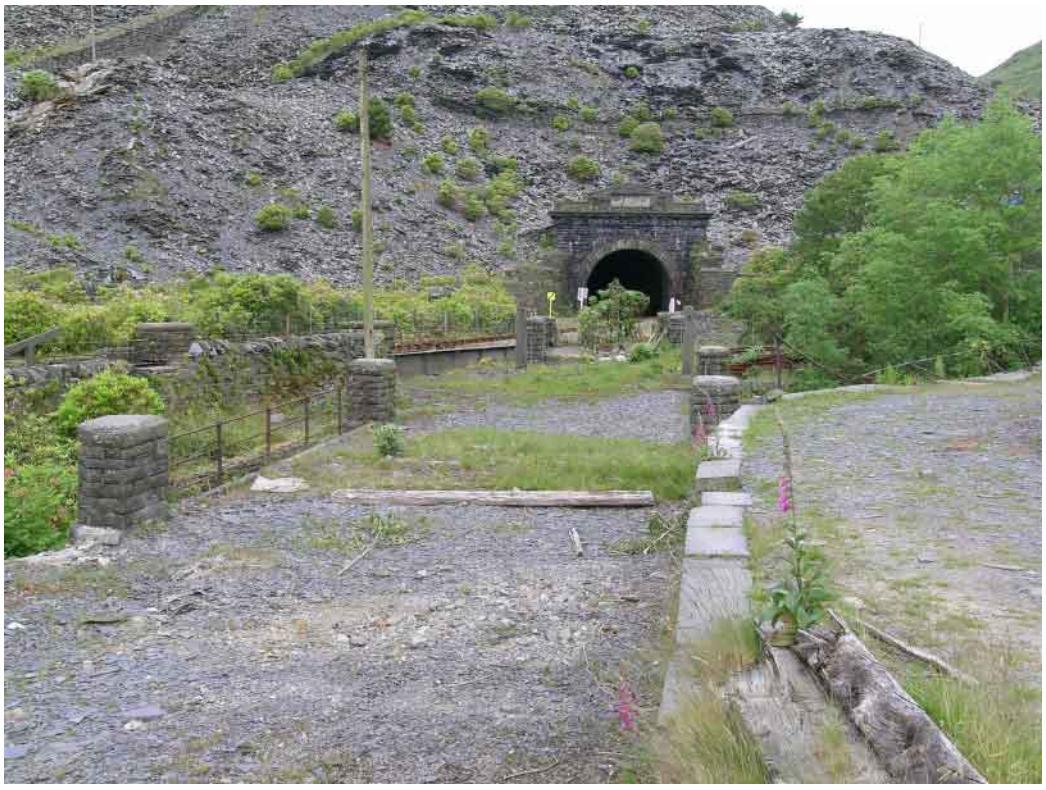
Plate 7 Bridge 68, general view

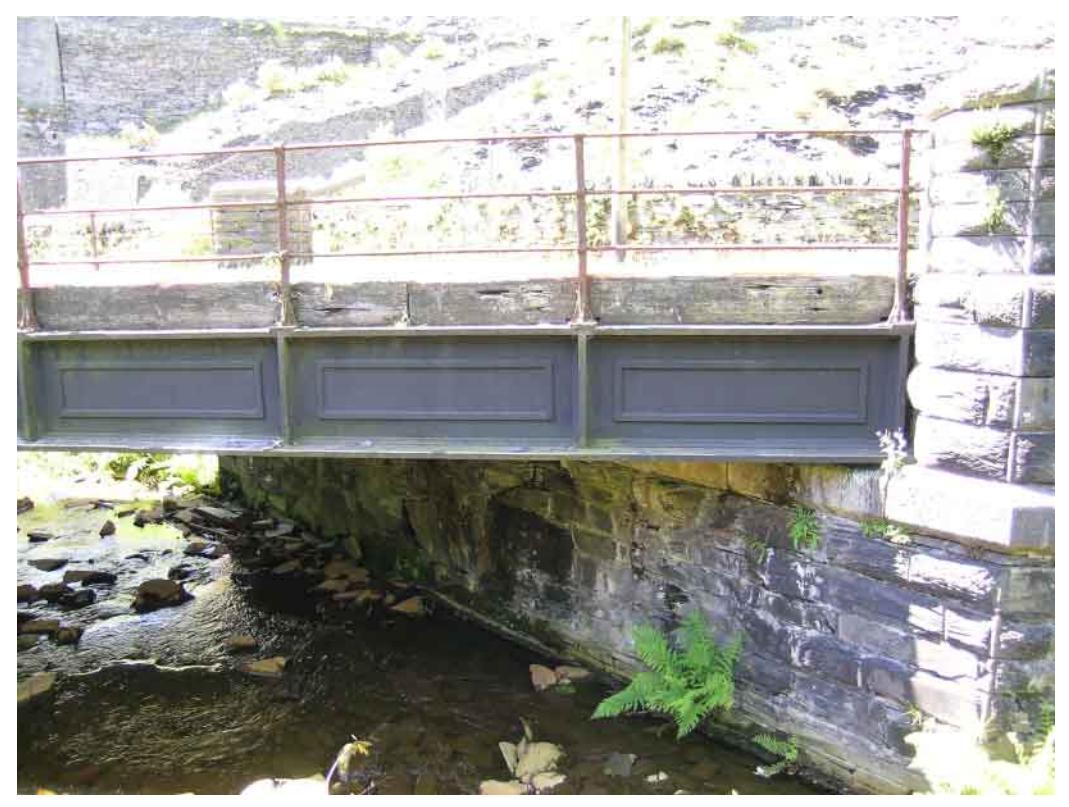
Plate 8 Bridge 68, girder panel E side

The outer pair of girders have a visible length of 6.91m (south-eastern side) and 7.17 (north-western side) and both extend into the masonry of the superstructure for an unknown distance. The upper flange of the girder is 0.2 wide and 0.04m deep and the lower flange 0.38m wide and 0.05 deep. The total depth of each girder is 0.72m. The outer faces of the girders are divided into five 1.67m wide decorative panels simulating wooden panel-work and are divided by vertical stiffener ribs (Plate 8).

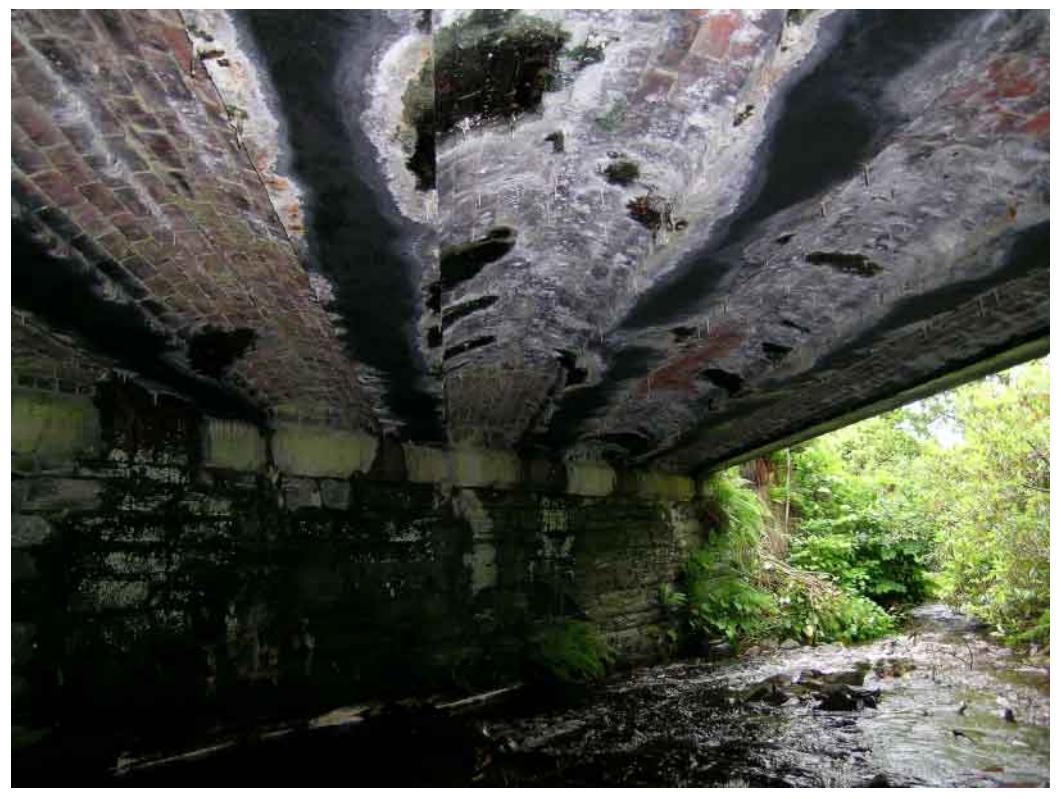
Plate 9 Bridge 68, underside

Only the bottoms of the inner 4 girders are visible (Plate 9). The lower flange is 0.46m wide and 0.05 deep indicating that the main load bearing girders are, as in bridge 67, of a different design to the outer. The 6 girders are equally spaced and are linked by brick

arches springing from their lower flanges. The rise of the arch is probably 6 inches (0.15m) (Fitzgerald, c.2005).

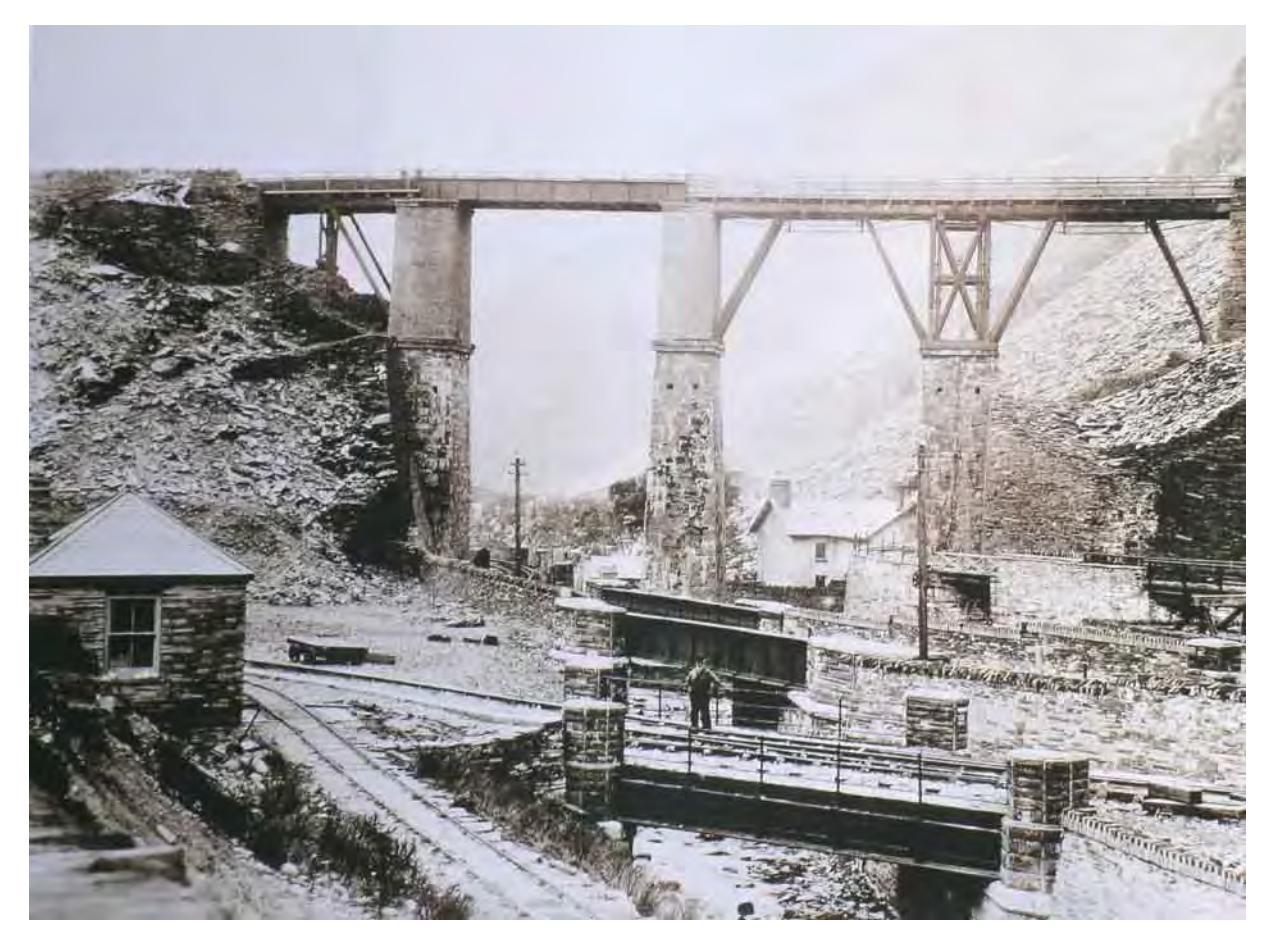
Plate 10 Bridge 68, by Bleasdale 1879

The outer girders are again surmounted by iron parapet railings. The railings are similar to those on bridge 67 but are 1.06m tall, the lower section having been extended in order to reach above a timber baulk laid on top of the outer girders. This retains the trackbed ballast. The current timbers are re-used sleepers but this arrangement dates back to when the siding was operational; an identical layout can be seen on Bleasdale's photograph of 1879 (Fig 10 from Spooner Album plate 38).

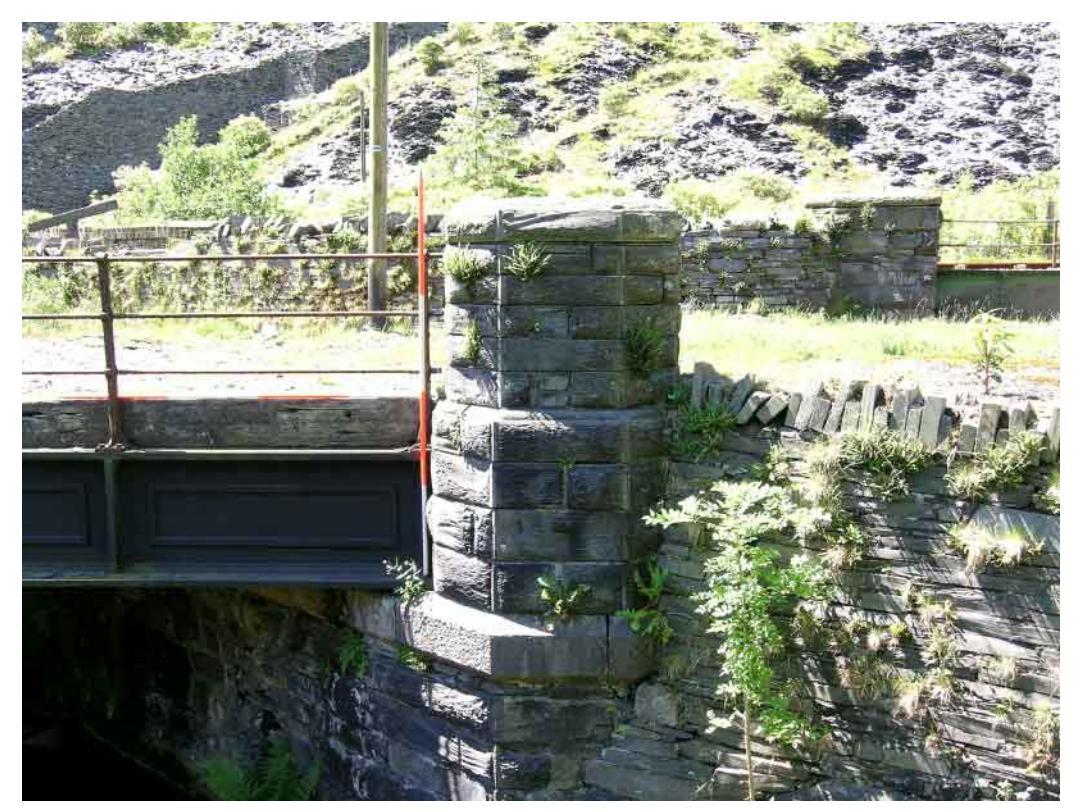
Plate 11 Bridge 68, parapet turret E side, E facing

The upper part of the parapet turrets are hexagonal and similar to those on Bridge 67. Below this level, however, the turrets step out by 0.08m at the height of the trackbed and again to form one side of the bridge abutment. A consistent masonry style is used throughout consisting of roughly dressed slate blocks with more ornate chiselled edges marking the corners of the various changes in width of masonry. The masonry is mortared although most of the joints have separated in the turrets of both bridges.

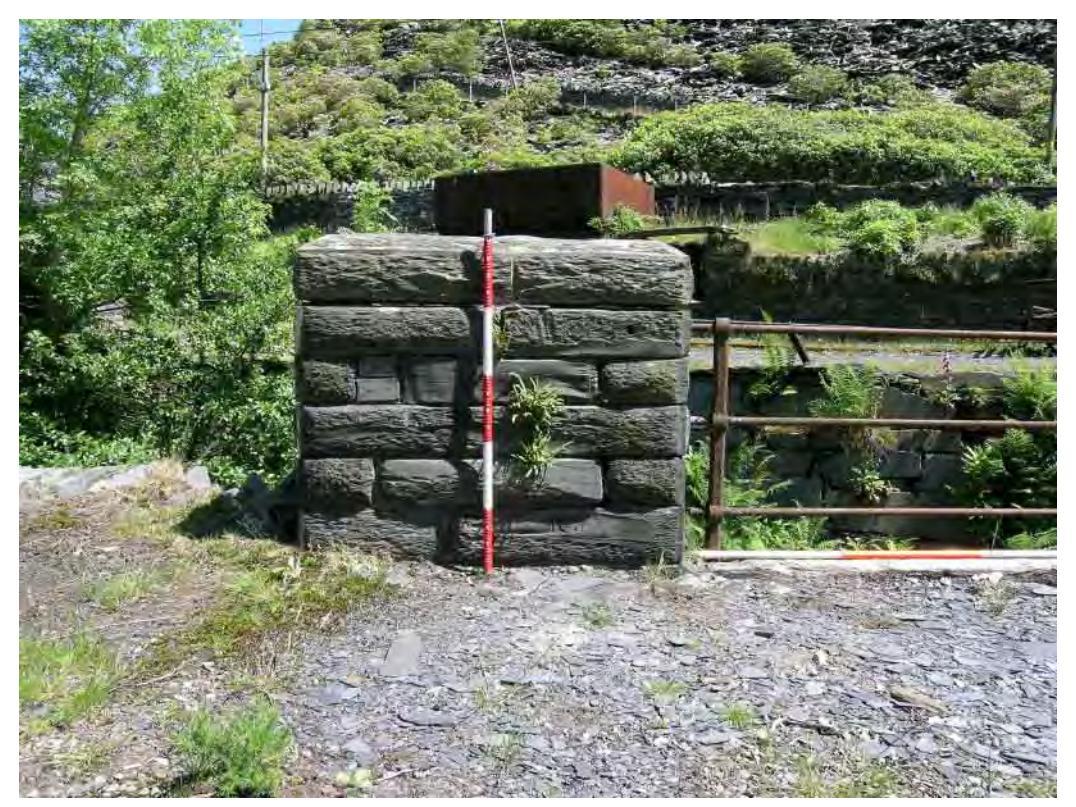
Plate 12 Bridge 68, parapet turret E side , W facing

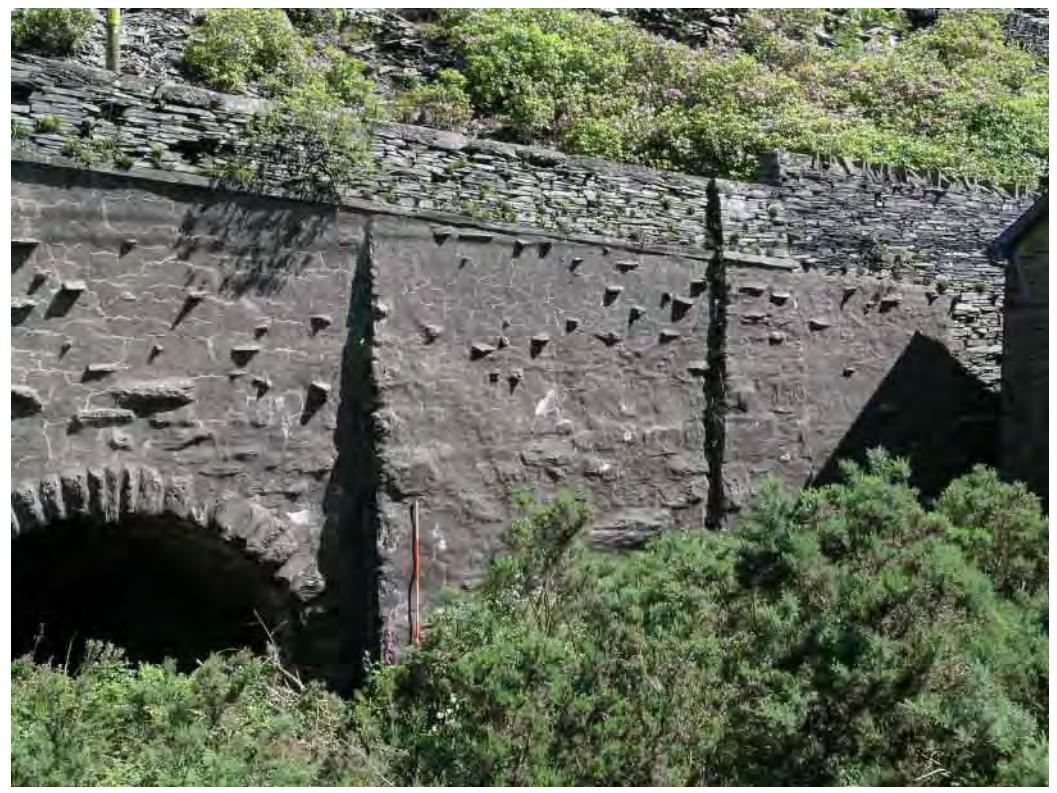
Plate 13 Road embankment, W side

The current A470 is carried through Pont yr Afon on a raised embankment standing to a maximum of 7.3m in height (Plates 13 and 14). The walls of the embankment contain two basic masonry styles (Plate 15) with later modifications. The lower 2 to 3 metres consists of large irregular blocks of mixed stone (mainly low-grade slate) built to a rough face. This is only visible on the western side because a later dwarf wall obscures the lower part of the eastern elevation. The upper part of the wall, up to the level of the roadbed consists of irregular slate slab masonry built to a good face but incorporating fairly regularly spaced, protruding stones. The roadside parapet is of dry-laid slate slab masonry but without the protruding stones (Plate 16). The coping varies between large flat slabs, edge-set blocks and irregular edge-set rough slabs. The parapet is a drystone construction but all of the rest of the masonry is either pointed or rendered with spray concrete (Plate 17). A part of the eastern elevation was, until recently obscured by slate spoil. This has been eroded away during recent floods revealing dry-slate-slab masonry with obvious signs of modern pointing above (Plate 18). The currently visible pointing is clearly not a feature of the original masonry and it is possible that the entire embankment was originally drystone and that it has been pointed and rendered fairly recently. The facing walls are built to a fairly pronounced batter. The top of the western side is estimated to be set back about 0.5m from the base. There are two pairs of shallow rectangular piers (see Plate 13) extending from the face of the embankment. These appear to mark straight unbonded joints in the facing and clearly extend into the body of the viaduct. These may indicate that the embankment, or at least its facing, was constructed in series of sections. A series of six narrow (0.22m wide) strips of unrendered facing (see Plate 14) on the eastern side of the embankment seem to indicate that structures or timbers were formerly attached to this face. Nothing remains to indicate their form or function.

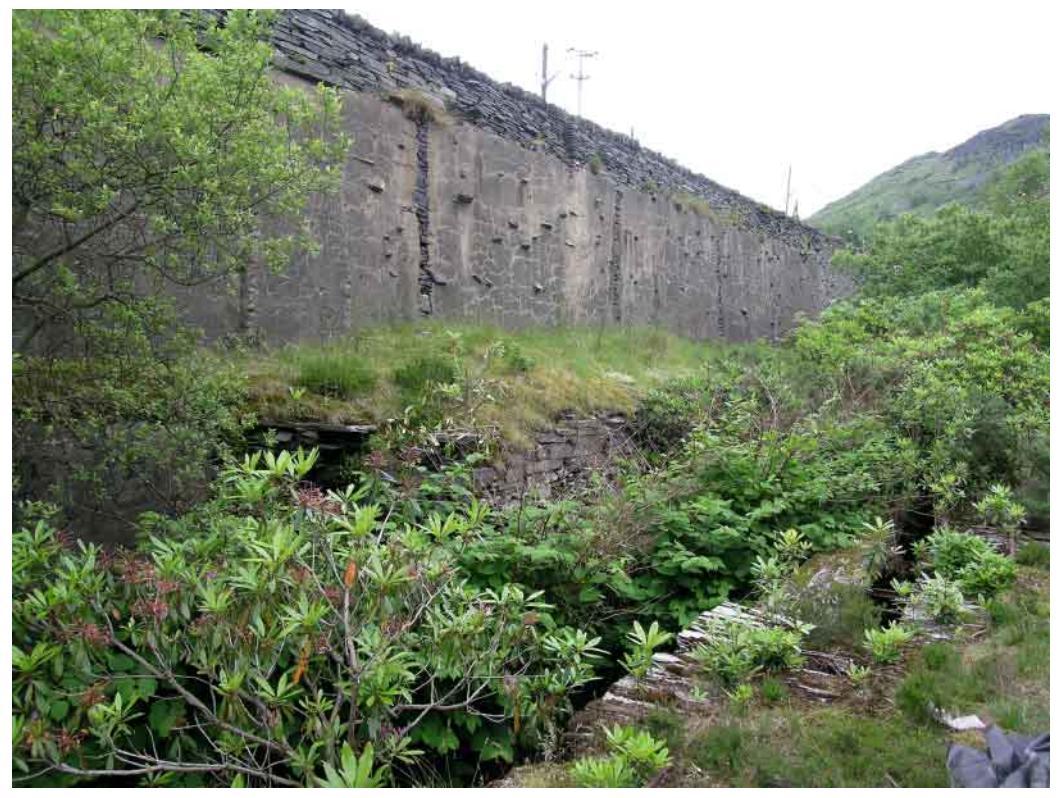
Plate 14 Road embankment, E side

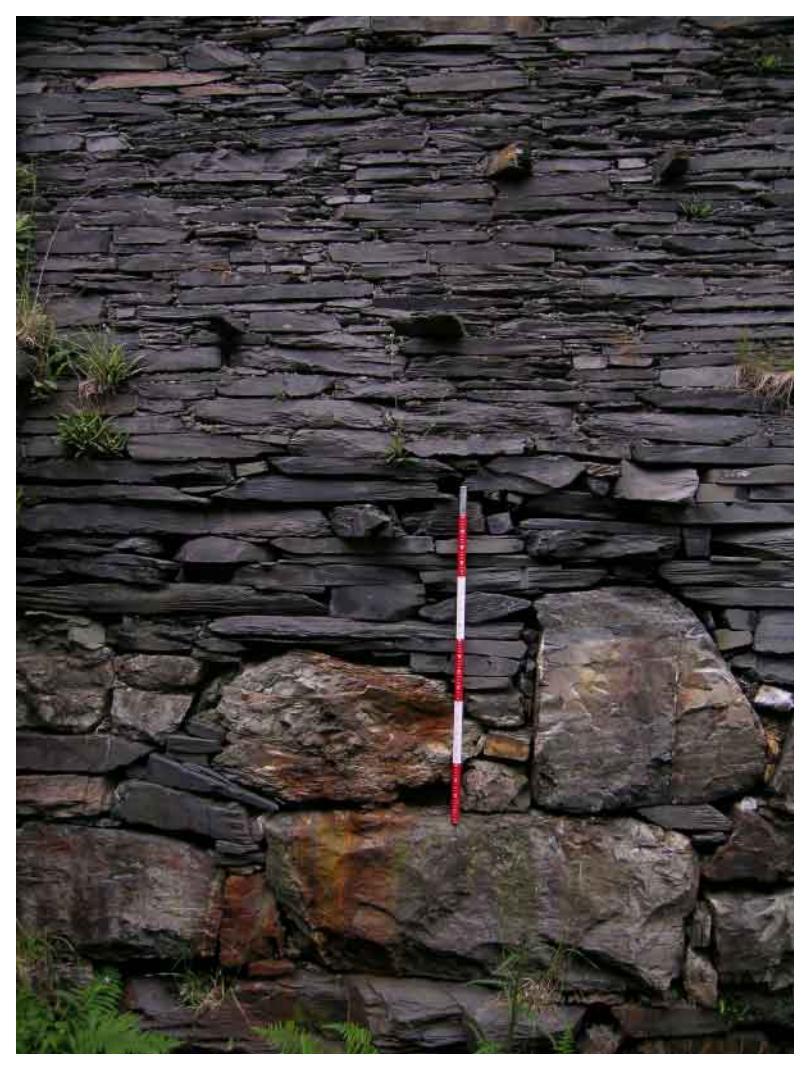
Plate 15 Masonry styles; mixed stone below, slate above

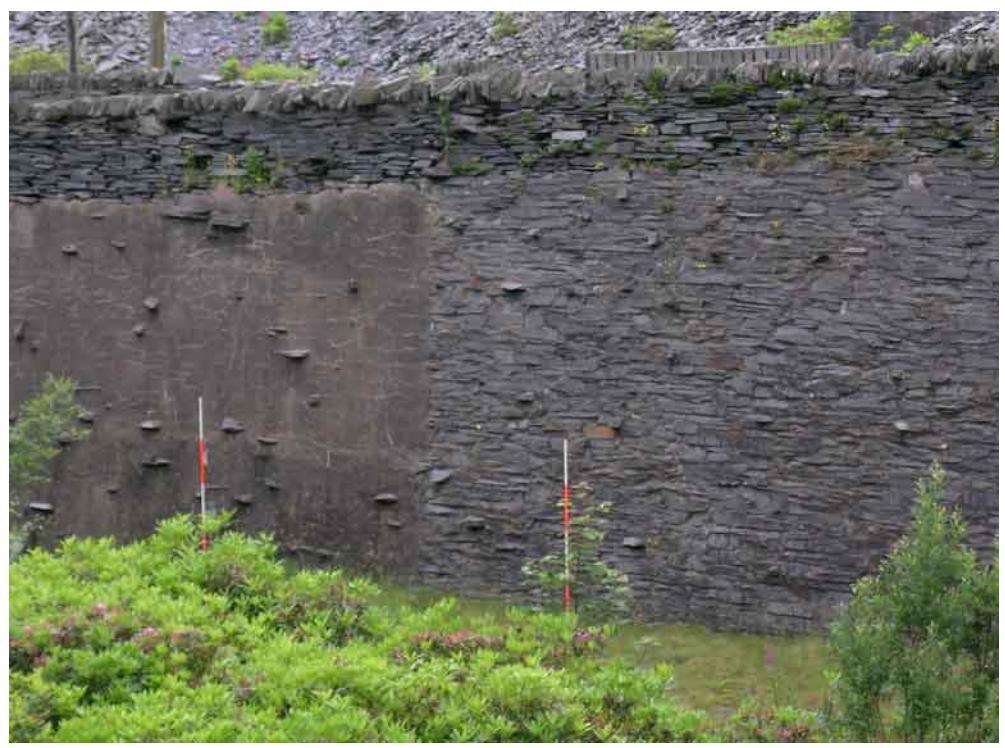
Plate 16 Masonry styles; slate with spray concrete render and pointing

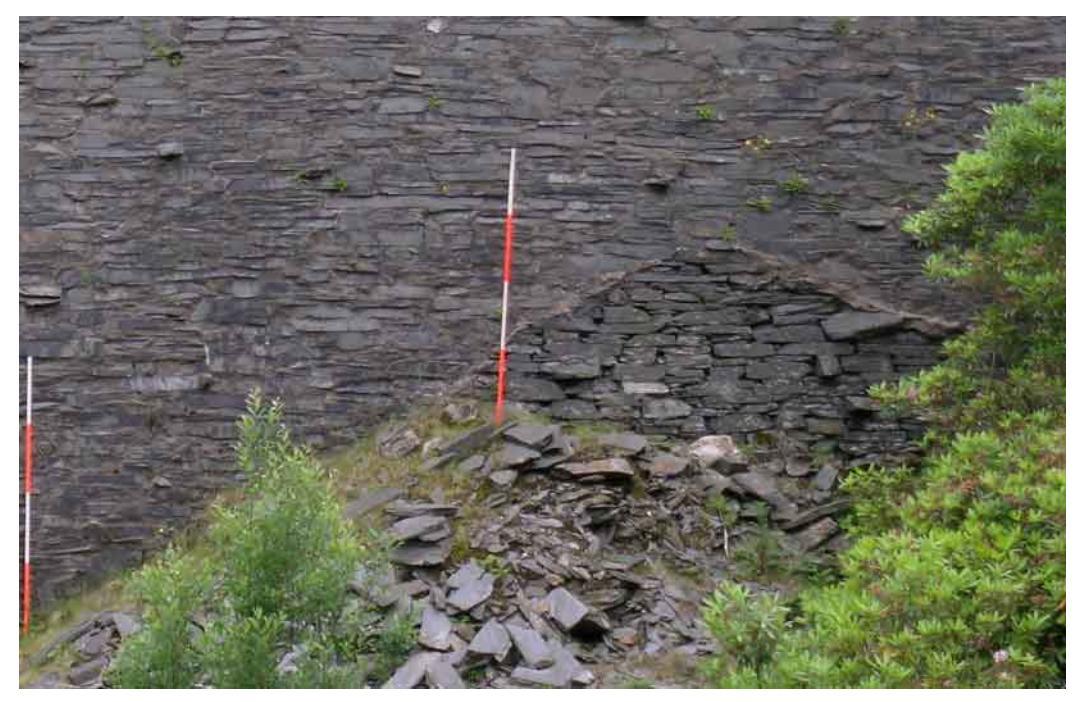
Plate 17 Masonry styles; earlier drystone masonry exposed by erosion

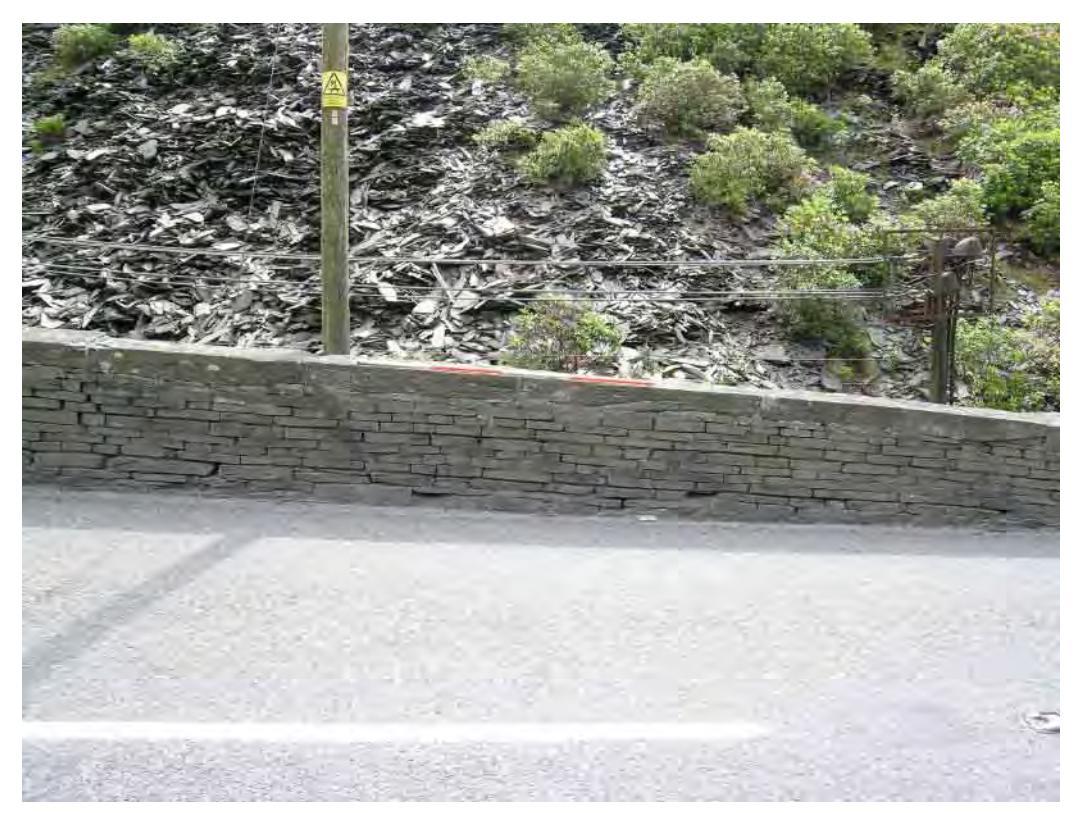
Plate 18 Masonry styles; roadside parapet, dry laid slate

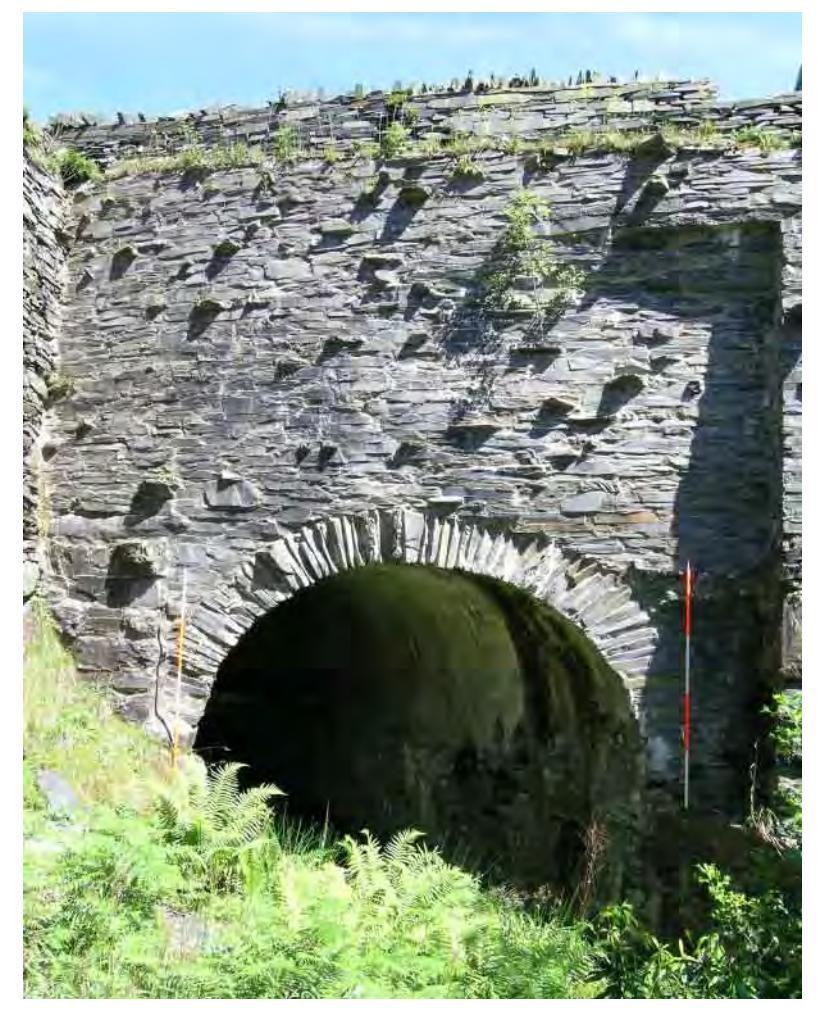
Plate 19 Incline tunnel, W side

This stands close to the base of the incline from the Llechwedd quarry and carried the 1'11½" railway to a link with the Ffestiniog Railway. The arch on the western side is still open (Plate 19). This consists of very rough uncut slate voussoirs (stones forming the arch) with an equally rough uncut keystone. The arch is set at a slight angle to the embankment wall, the southern side undercuts some of the masonry and is set back by 0.9m. The arch springs from rough black masonry of the same style as the lower 2m of the embankment. The inside of the tunnel has been spray concrete rendered and partially blocked 3.0m from the tunnel mouth by a reinforced concrete deck. This reduces the height of the tunnel to 1.5m. There are several pieces of ironwork protruding through the deck at the centre of the tunnel but their function is unknown. The space above the deck is apparently infilled with stone (Plate 20).

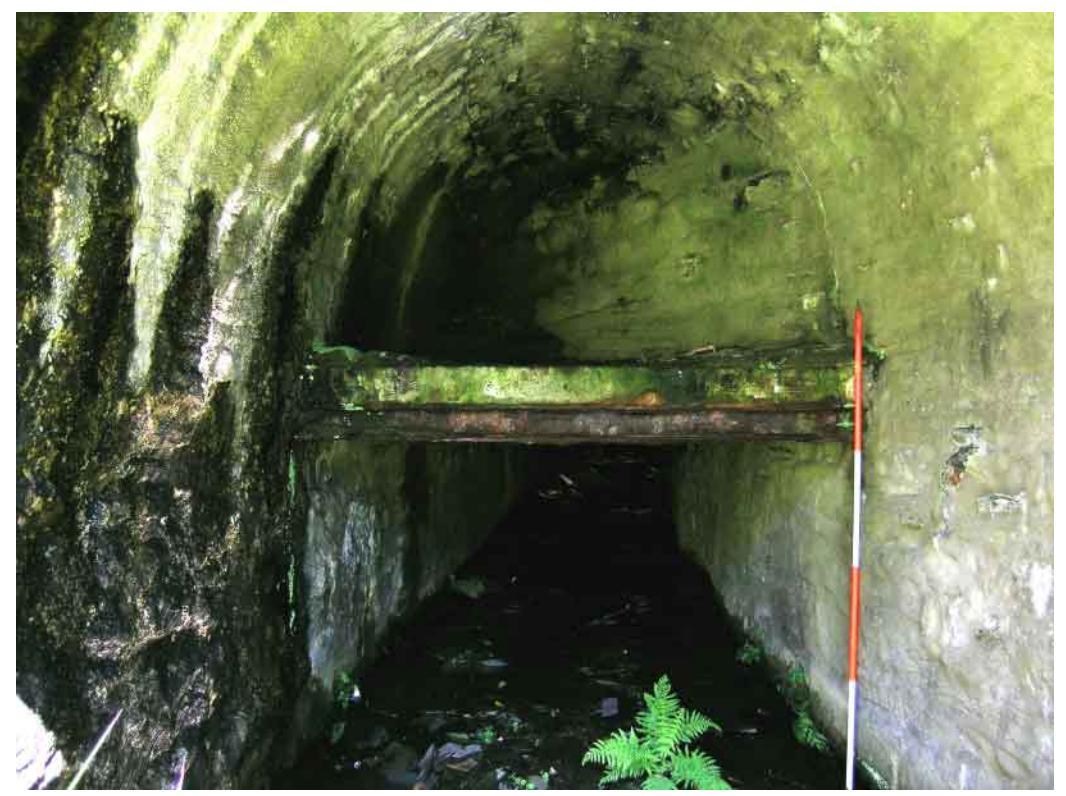
Plate 20 Incline tunnel, W side, partial blocking within tunnel

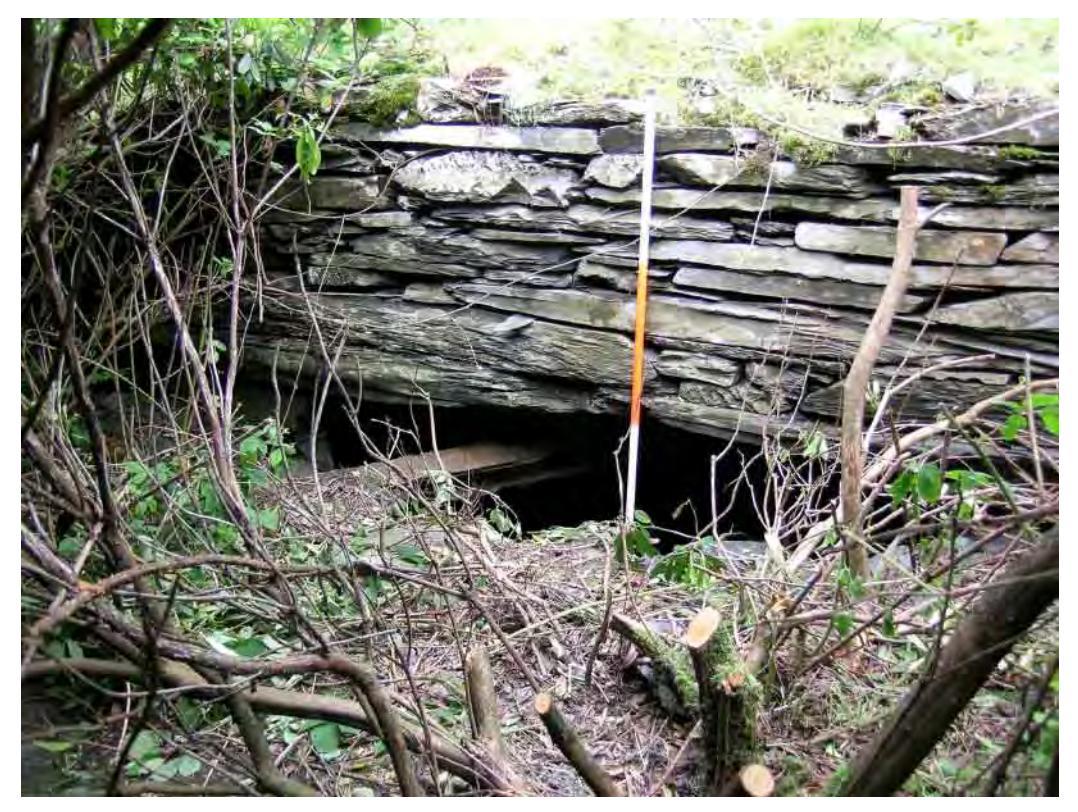
Plate 21 Incline tunnel, E side

The reduced tunnel can be followed until it emerges from beneath the dwarf wall (Plate 21). This end of the tunnel is 2m wide and mostly below the current ground level and is almost completely blocked with slate rubble. Only a small opening, level with the upper part the tunnel and the also the current ground surface is now present. The side-walls continue beyond the tunnel mouth but are now buried beneath slate waste. This indicates that access to the tunnel was through a cutting below the level of the current ground surface. The modification to the tunnel may have been a result of instability in the arch. A date of 1935 is painted on the tunnel roof close to the eastern end.

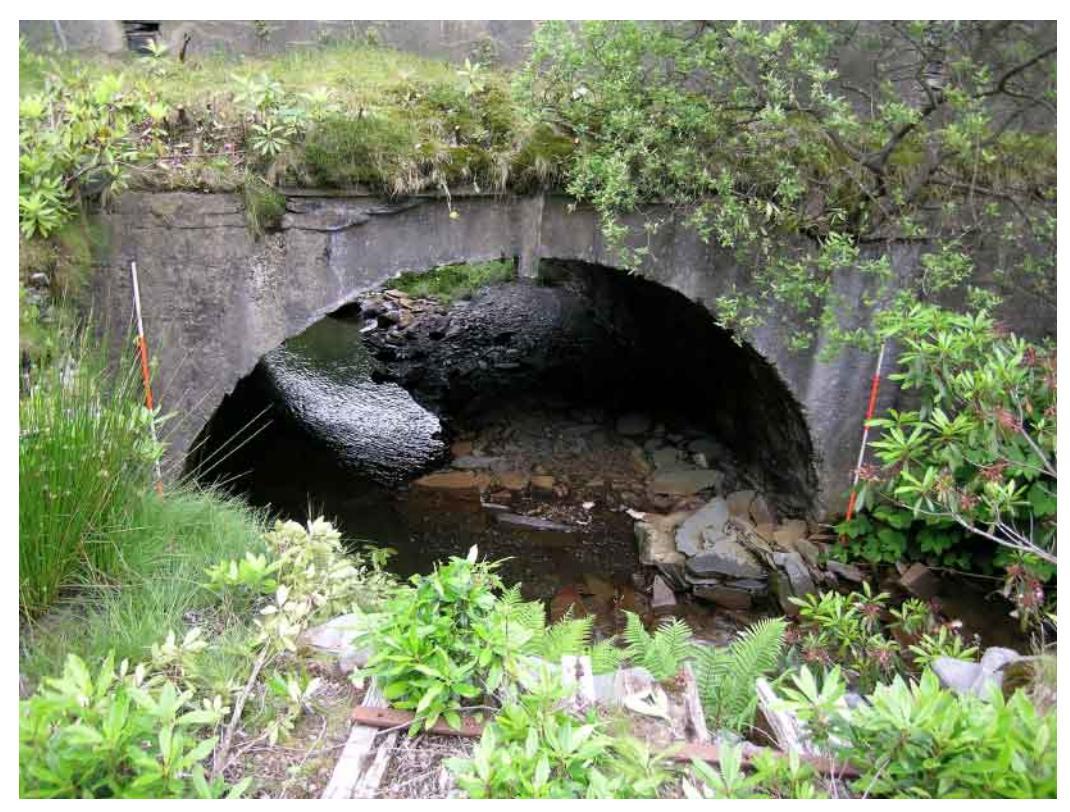
Plate 22 Afon Barlwyd tunnel, E side

The tunnel carrying the Afon Barlwyd beneath the viaduct consists of two phases of masonry. The arch on the eastern side lies at an angle to the road embankment and protrudes by around 3.5m from the main embankment wall (Plate 22). The masonry has

been spray rendered making it difficult to see details of the stonework. The most obvious element is a large protruding keystone. The arch is 5.5m wide and stands 2.95 above the river bed. The river bed consists of pitched slate blocks, presumable to minimise erosion. The interior of the tunnel has also been roughly rendered/pointed but a corresponding keystone and a straight joint in the masonry are clearly visible within the soffit 5.5m from the western mouth (Plate 23). The eastern half of the tunnel is clearly an earlier phase of building and the fact that the arch on the eastern side is not aligned to the embankment suggests that this may be the remains of an earlier bridge, perhaps indicating the line and level of the road before the embankment was constructed. Further documentary research will be needed in order to examine further the phasing of these features. Several stubs of iron protruding from the roof indicate that gratings had been fixed across the tunnel.

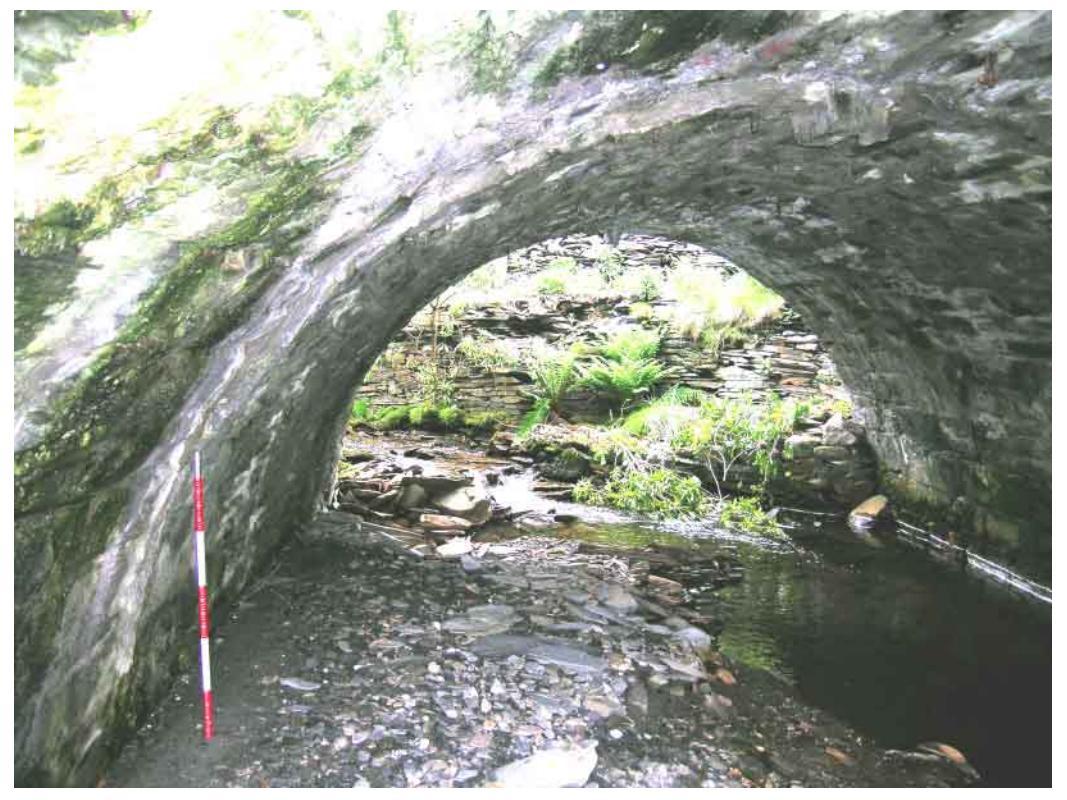
Plate 23 Afon Barlwyd tunnel, two phases of masonry within roof
