# A470 BLAENAU TO CANCOED IMPROVEMENT

# ARCHAEOLOGICAL RECORDING PHASE 1 PANT YR AFON GIRDER BRIDGES AND ROAD EMBANKMENT

G1874

Report number : 591

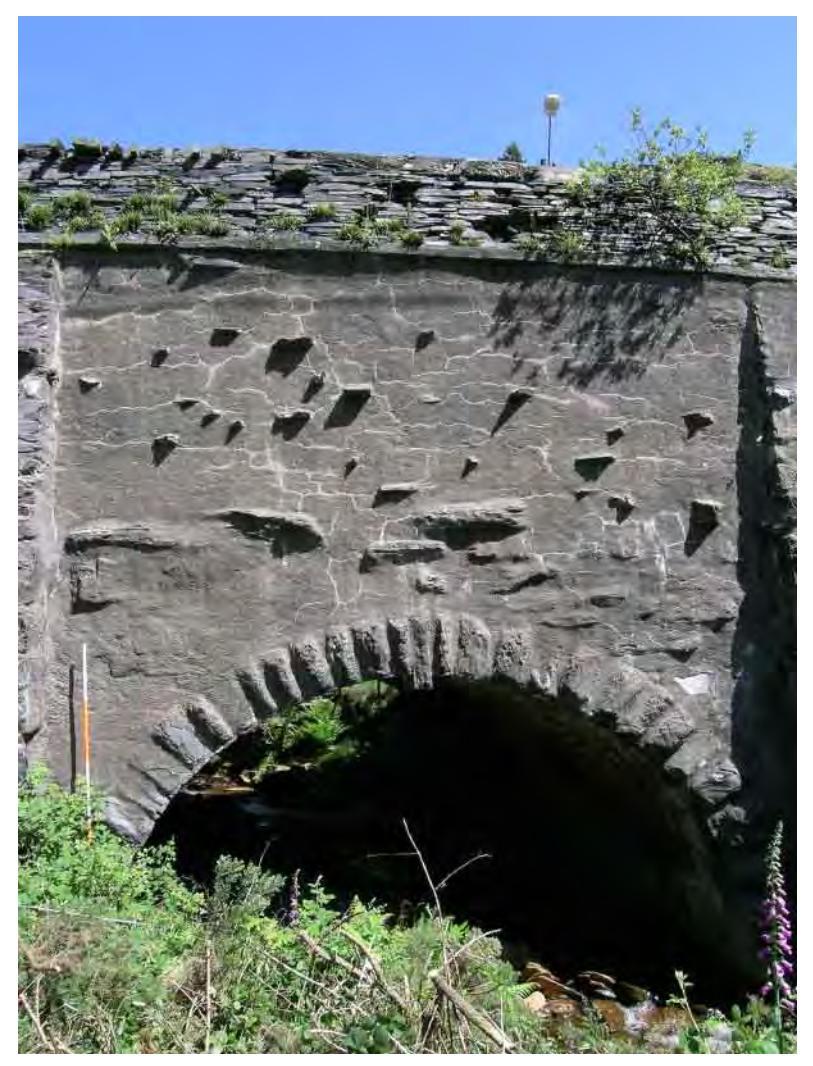
Plate 24 Afon Barlwyd tunnel, W side

The tunnel continues for a further 3.15m before exiting through an archway on the western side (Plate 24). This is of a different construction with prominent, regularly sized, either natural or roughly dressed, voussoirs and a smaller keystone than on the eastern side. The lower rough block masonry on the embankment face extends to above the archway. The embankment is not battered above the arch and is thus set back from the rest of the face by 0.5m at the base of the wall.

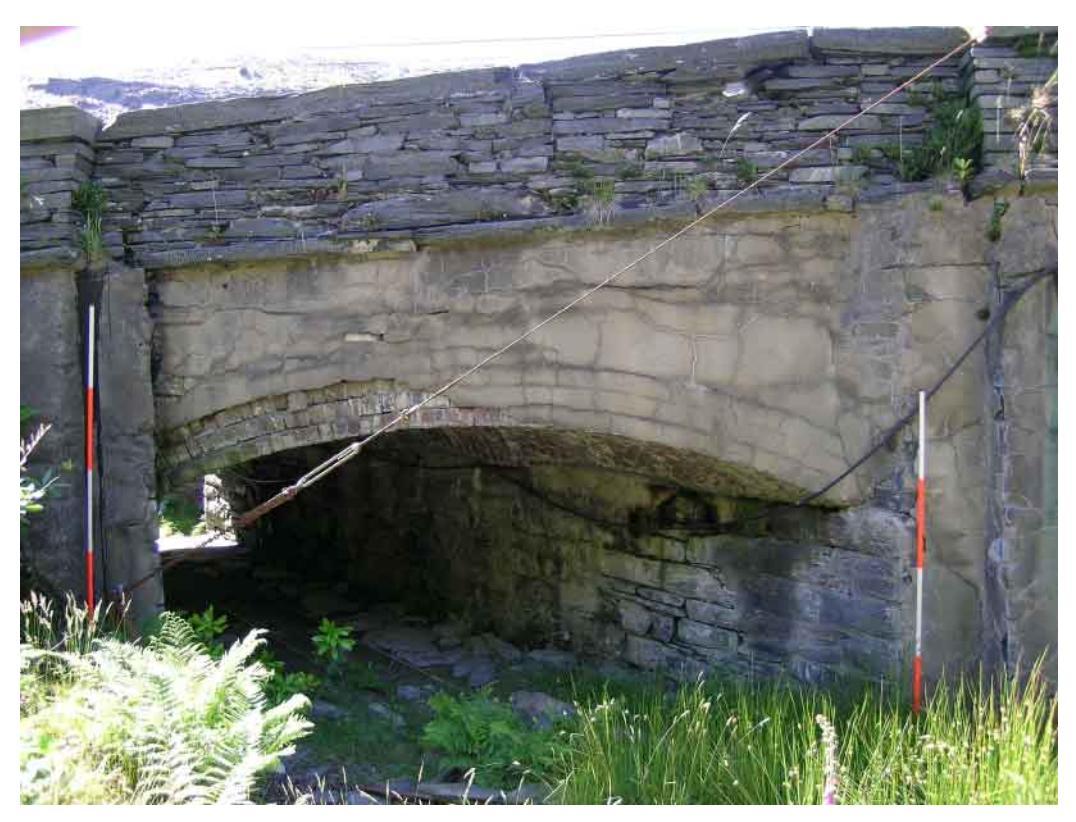
Plate 25 Llechwedd / sidings link tunnel, E side

This tunnel is of a markedly different construction to the other two. It consists of a segmented brick arch consisting of four unbonded courses, springing from stone piers (Plates 25 and 26). The tunnel runs at an angle through the embankment. Rectangular piers extend from the facing 0.45m to either side of the archways on both the east and west side and a series of slate slabs run above the brickwork on both sides. The tunnel is 2.02m high and 4.3m wide. The roof of the tunnel is showing signs of sagging in places.

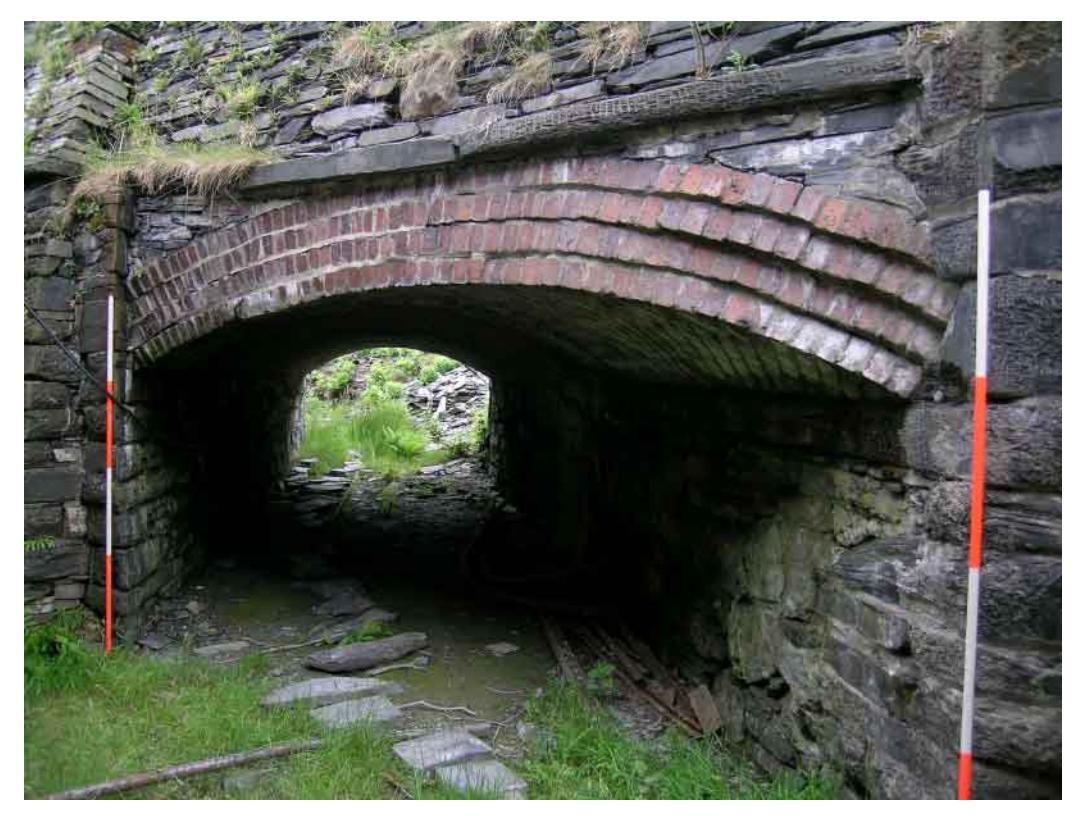
Plate 26 Llechwedd / sidings link tunnel, W side
