Archaeological Record

GAT Project No. 1917 Report No. 642 May 2006

Archaeological Record: Trac Ty Croes (G1917)

A Level II Archaeological Record has been undertaken in advance of proposed alterations and developments at the Anglesey Circuit, Ty Croes. The site was formerly a Ministry of Defence (MoD) Military Camp, established in 1942 and closed during the 1970's, which was used for the test firing of anti-aircraft (AA) weapons and surface-to-air missiles (SAM). In 1997 the Anglesey Circuit (Trac Môn) was opened as a fully licensed MSA (Motor Sport Association) and ACU (Auto Cycle Union) championship racing circuit, utilising much of the land formerly used as the military camp.

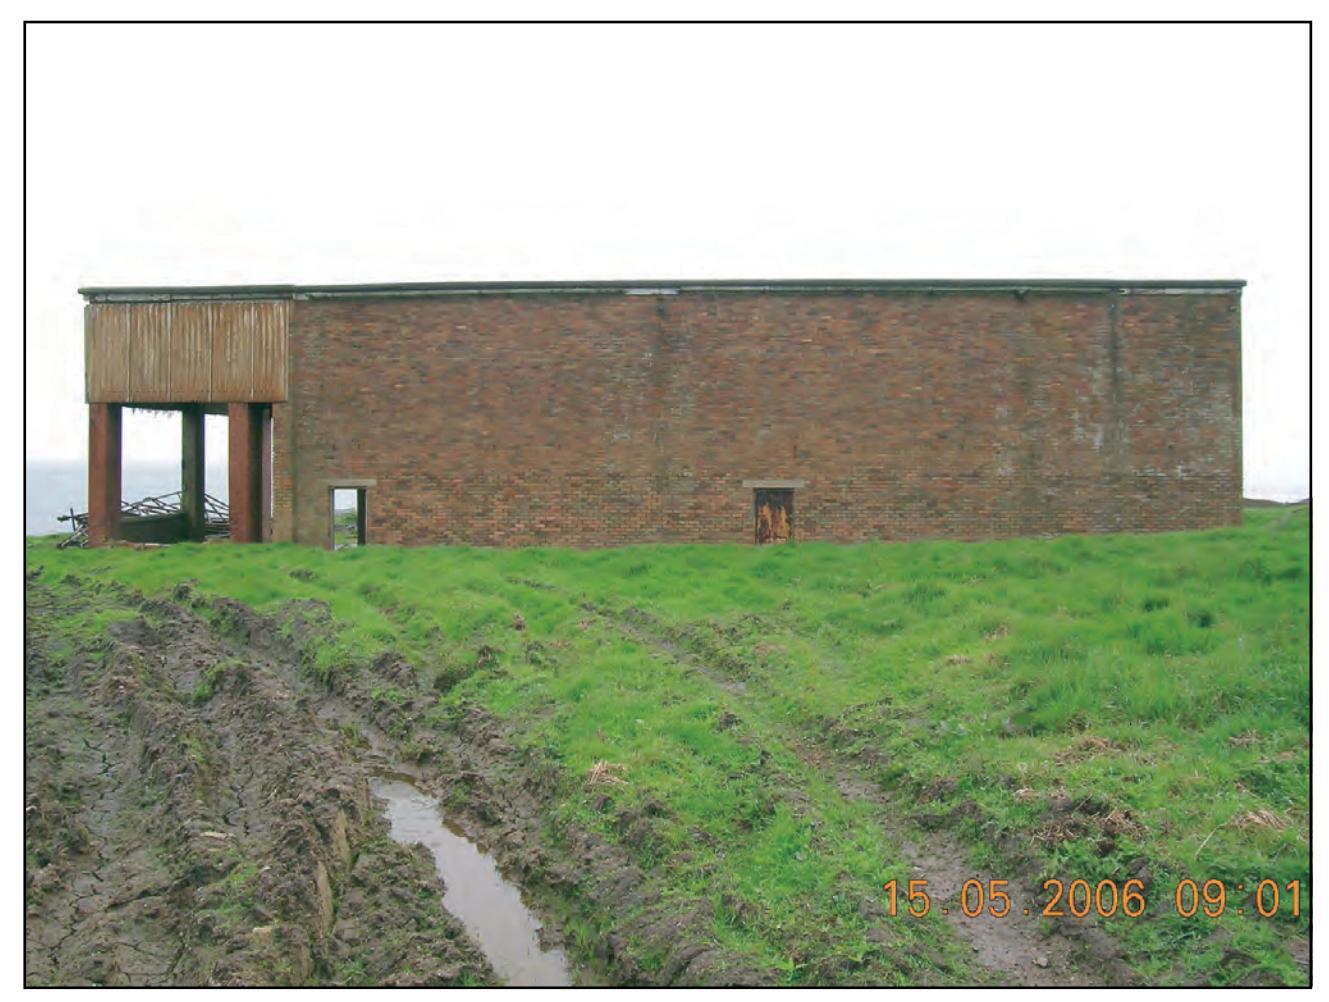
Plate 1: PRN 15160: East Facing Elevation

A rectangular building with a flat roof that is part of the former military complex at Ty Croes. The building measures 21.6m in length, 9.82m in width and 6.5m in height and is located at the southern end of the complex, *c*.99.0m north of the coastline. The building is aligned north to south and is built on an artificial terrace created from demolition material deposited to a height of several meters to level off the natural slope. It is surrounded by a narrow concrete path.

The structure is built from brick, which is stretcher bonded on the outside and english garden wall bonded on the inside. The walls are 0.60m thick. There are five door entrances: two on the west and east elevations and one on the north elevation. They are all the same size: 0.90m wide and 2.04m high with a concrete lintel and were presumably for personnel access. The southern elevation is partially open, allowing vehicular or machinery access into the building.

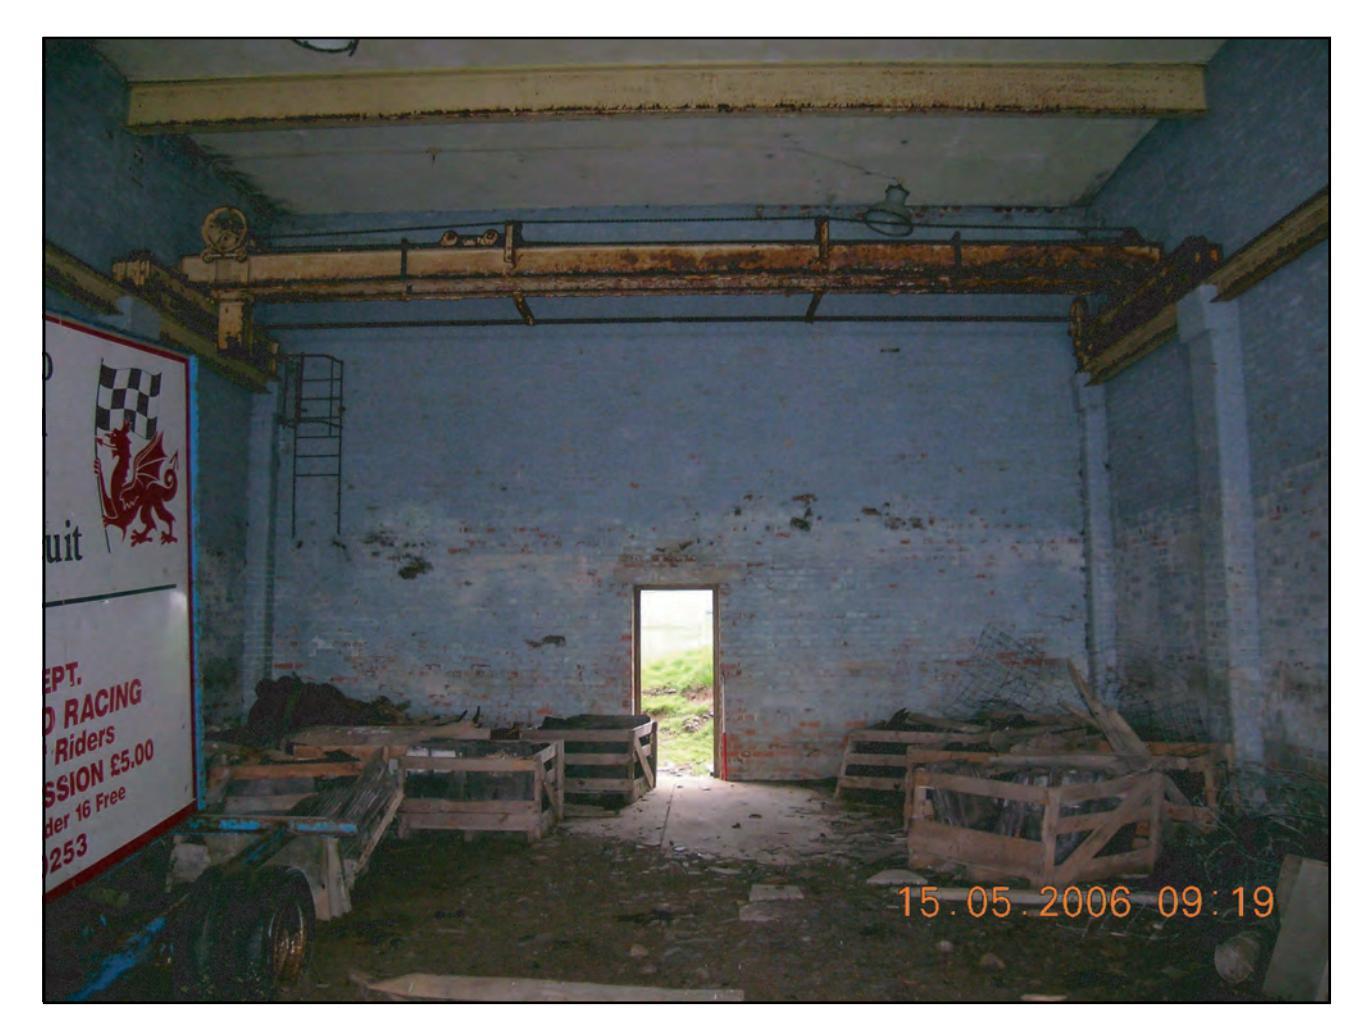
Plate 5: PRN 15160: Transporter Crane

At the northern end of the building is a crane, which is built from two RSJ's, *c*.7.00m long, attached by a set of wheels to the stanchion supported RSJ's (Plate 5). Each set of wheels is 4.00m long (Plate 6) and the crane is run between them via a chain link (Plate 8). There is a maintenance ladder bolted to the south-facing elevation, next to the crane (Plate 6). There is no evidence as to the power source for the crane but it is assumed to be electric, with the motor probably removed after decommissioning.

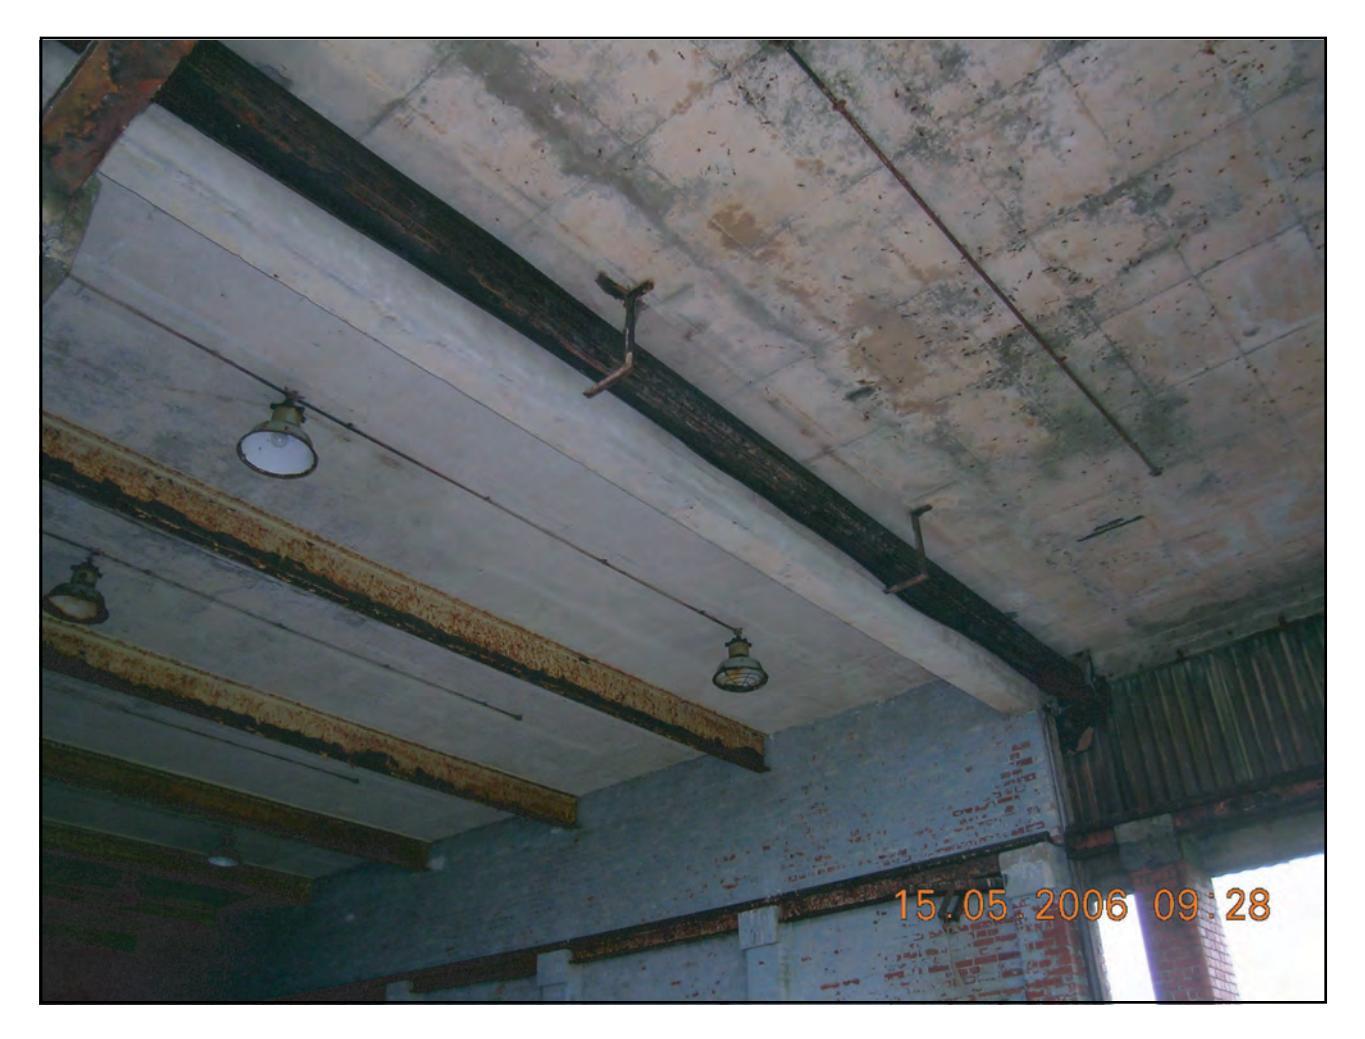
Plate 9: PRN 15160: Roller Blind and RSJ Roof Supports

The roof is supported by seven reinforced steel joists (RSJ's) that are equidistant: 2.60m apart. Between each RSJ is a pair of circular light fittings. The RSJ's are supported by brick stanchions on the east and west elevations. Each stanchion measures 0.40m wide, 4.10m high and 0.20m deep.

There is a large metal roller blind running the width of the building at the southern end of the building that descends from the roof via a wheel mechanism (Plate 9). The blind appears to have been used to secure the inside of the building when it wasn't in use, whilst still providing access to the partially open area for holding machines and/or vehicles. This holding area appears to always have been partially exposed to the elements, with corrugated sheeting and a low-rise brick wall providing partial shelter.

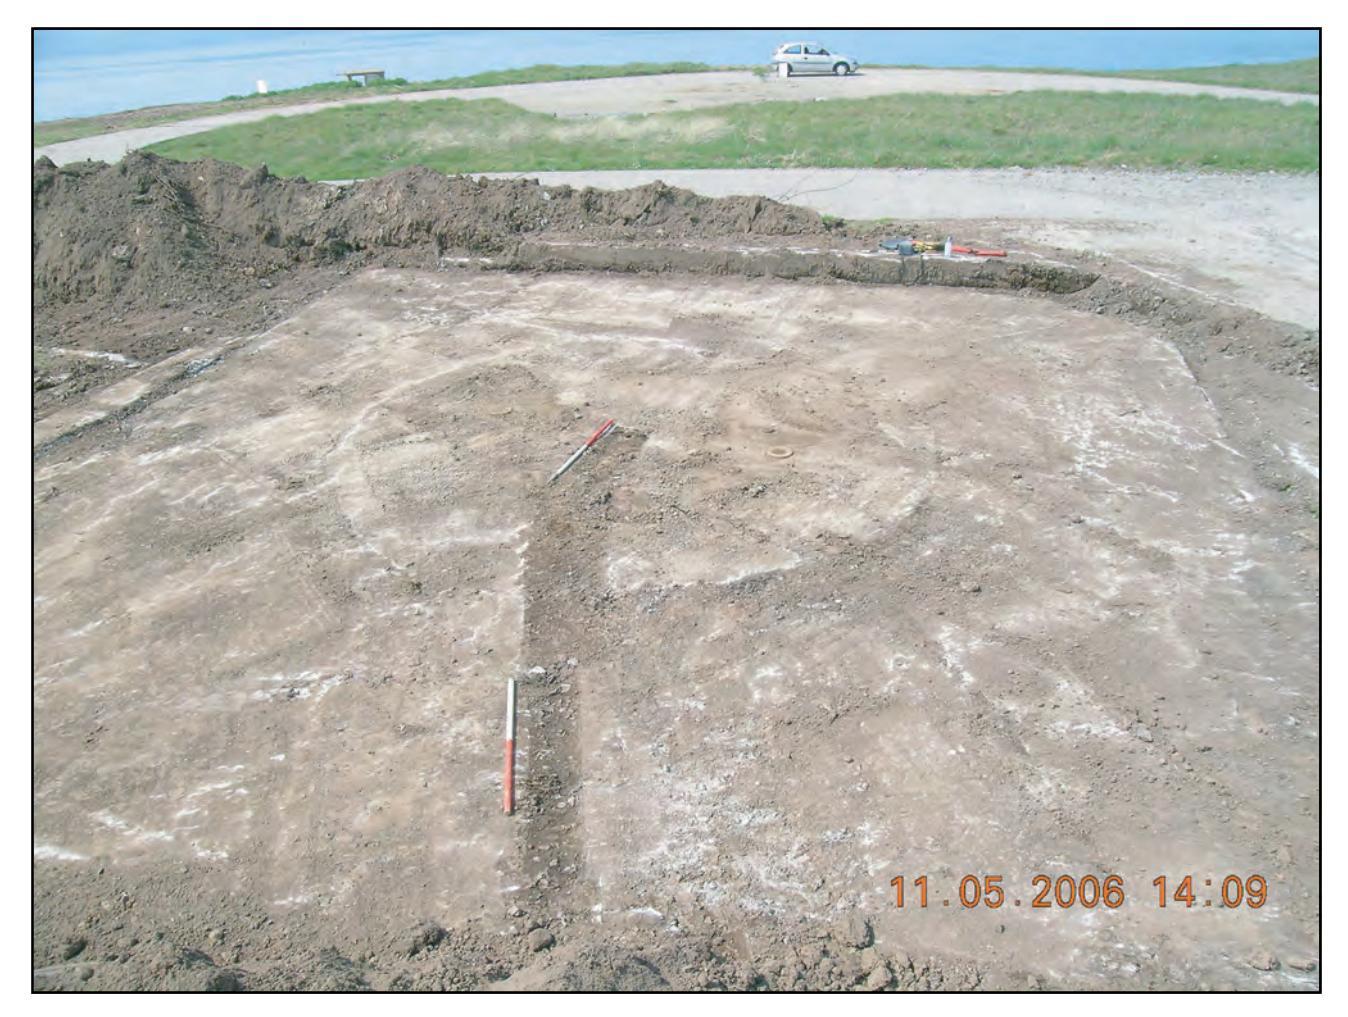
Plate 11: PRN 15161: Feature A (View West with Feature L in the Distance)

Mid to Late Twentieth Century gun emplacement built from concrete and breezeblock. The structure survives at foundation level and comprises a square concrete surface, 10.0m long and 10.0m wide with a set of concrete foundations to the south (Plate 12). At the centre of the square is the circular gun emplacement. It is a static emplacement built from concrete and set into the centre of the square. The circle measures 4.70m in diameter and contains a series of five metal fittings attached to the concrete forming a rough circle. These fittings surround a 0.30m wide "channel" which runs from the centre of the circle, eastwards to the road (length of channel: 5.0m; see Plate 11)).

There are two types of fittings present: a 0.16m wide circular metal fitting (Type d; cf. Feature D) and a 0.20m wide fitting (Type e; cf. Feature D), also circular. Their exact function is unclear but as the site was used for firing Thunderbird II and Bloodhound Surface to Air Missiles (SAM), the fittings were most likely anchor points for the missile base (the earlier 3.7" Anti-Aircraft Missiles and the later Rapier SAM's were transported and positioned by vehicle). This is corroborated by an inspection of available photographs for the two missiles, which show the radar controlled mounting system attached to a static base (Plates 27 to 30). The channel leading from the circle could also be identified as part of the static mount (Plate 27). The function of the concrete foundations are unclear as too little of any possible upstanding structure has survived. The only available evidence is the rectangular foundation, 6.80m long and 3.0m wide, built from breezeblock, with an internal concrete floor (Plate 12). The building is attached to the concrete square and it is assumed was part of the SAM operation.

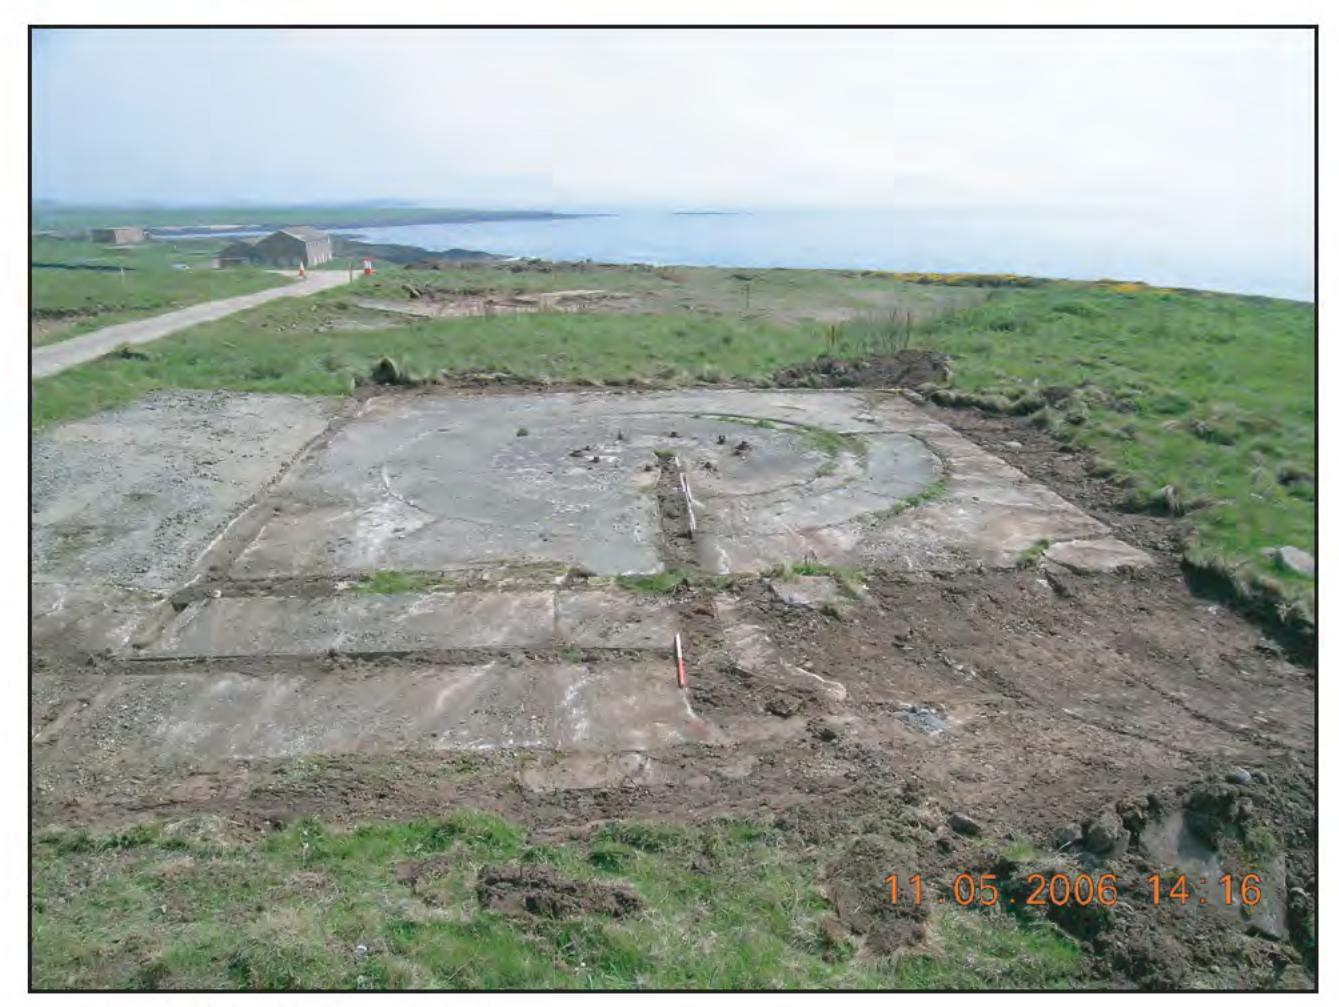
Plate 13: PRN 15161: Feature B (View South)

Rectangular concrete surface accessed from the road by a concrete slope, 13.22m southeast of Feature A. Similar in general appearance to Feature A so it is also thought to be a SAM emplacement (Plate 13). Concrete surface measures 11.0m in length and 10.0m in width, with a 7.80m wide concrete circle in the centre. As with Feature A, there is a 0.30m wide grove leading from the centre of the circle to the edge of the square. On this feature, the channel is orientated southeast to northwest, running into an ancillary structure. The concrete square is surrounded by a dilapidated breezeblock wall.

The circle within Feature B differs from A in its size and also the style of anchor points/fittings attached to it. The circle is in fact a series of three concentric circles decreasing in size, with the centre circle containing the fittings. The outer ring contains fifteen equidistant circular fittings, each 0.05m in width. Their function is unclear. In the centre of the circle are ten anchor points/fittings. They differ in style to those in Feature A, but are similar in size.

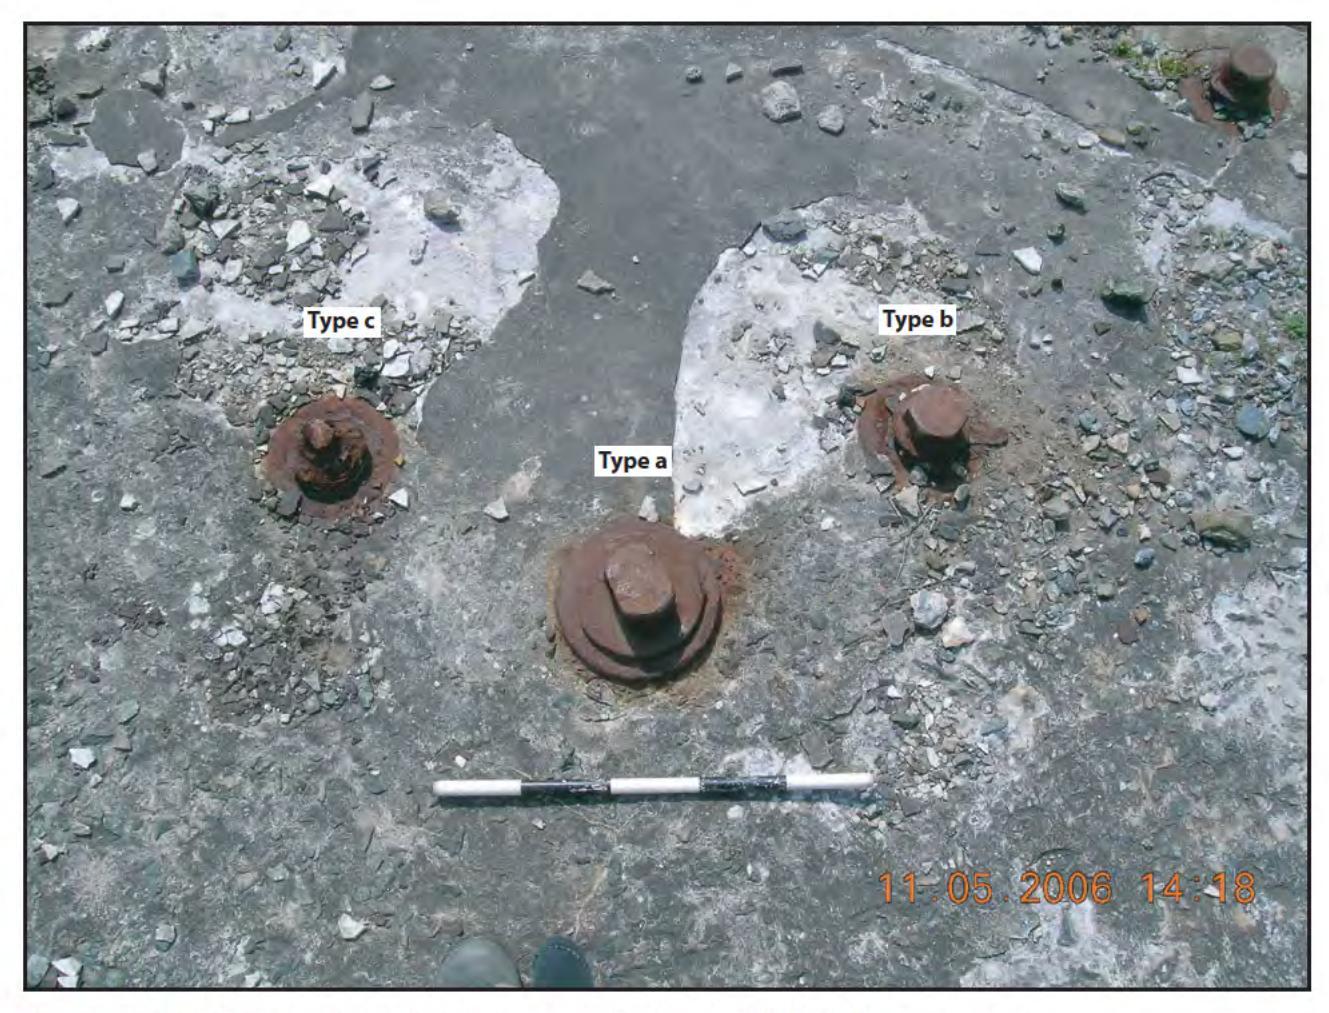
Plate 14: PRN 15161: Feature B (Detail of Anchor Points/Fittings for SAM Static Emplacements)

The anchor points/fittings can be divided into three different types (see Plate 14): Type (a), which is 0.20m wide and 0.10m wide with a rectangular fitting in the centre; Type (b), which is 0.18m wide and 0.08m high with a hexagonal central fitting; Type (c), which is 0.16m wide and 0.08m high with a circular central fitting. There are three examples of Type (a), three examples of Type (b) and four of Type (c) present. Again, their precise function is unclear, but they appear to be part of the static emplacement for the SAM launcher.

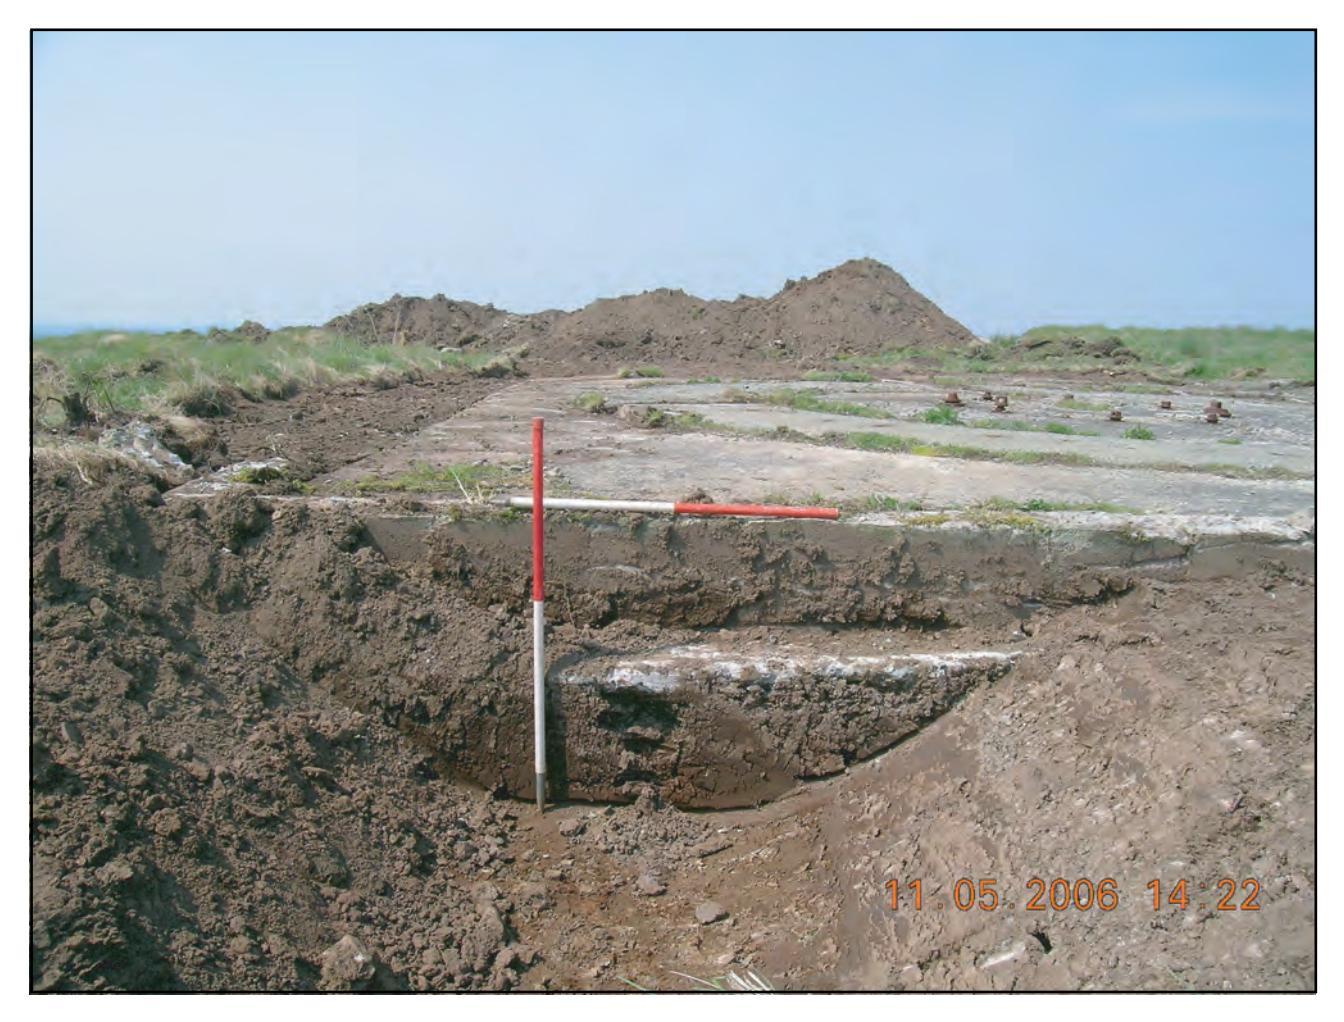
Plate 15: PRN 15161: Feature B (View North of Section Exposing Concrete Base)

The depth of the concrete square was 0.38m and it was placed upon a 0.10m thick sub-base of loose material (Plate 15). The concrete foundations comprise several slabs separated by internal partitions. They are attached to the concrete square and appear contemporary.

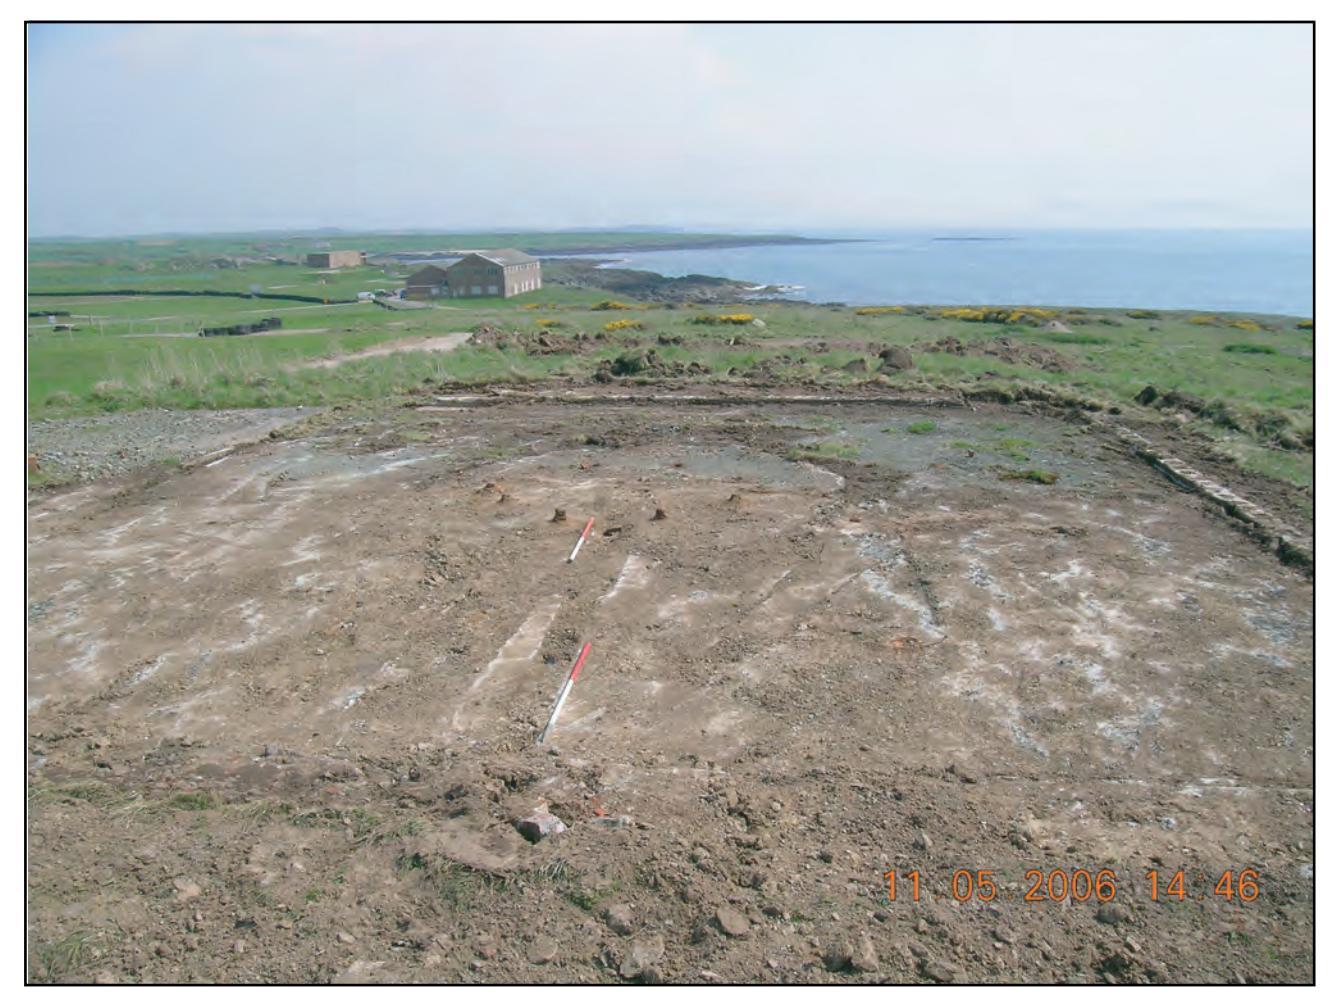
A square concrete emplacement located southwest of Feature C. The concrete surface is flat and measures 34.4m in length and 36.6m in width and is surrounded by a breezeblock wall, 0.30m wide (the breezeblock wall is partly demolished; see Plate 17). As with Features A and B, the structure comprises an outer square/rectangular structure with an internal circular structure set into the concrete.

Plate 17: PRN 15161: Feature D (View South: Note 0.30m wide, 5.00m long channel between the photographic ranging rods)

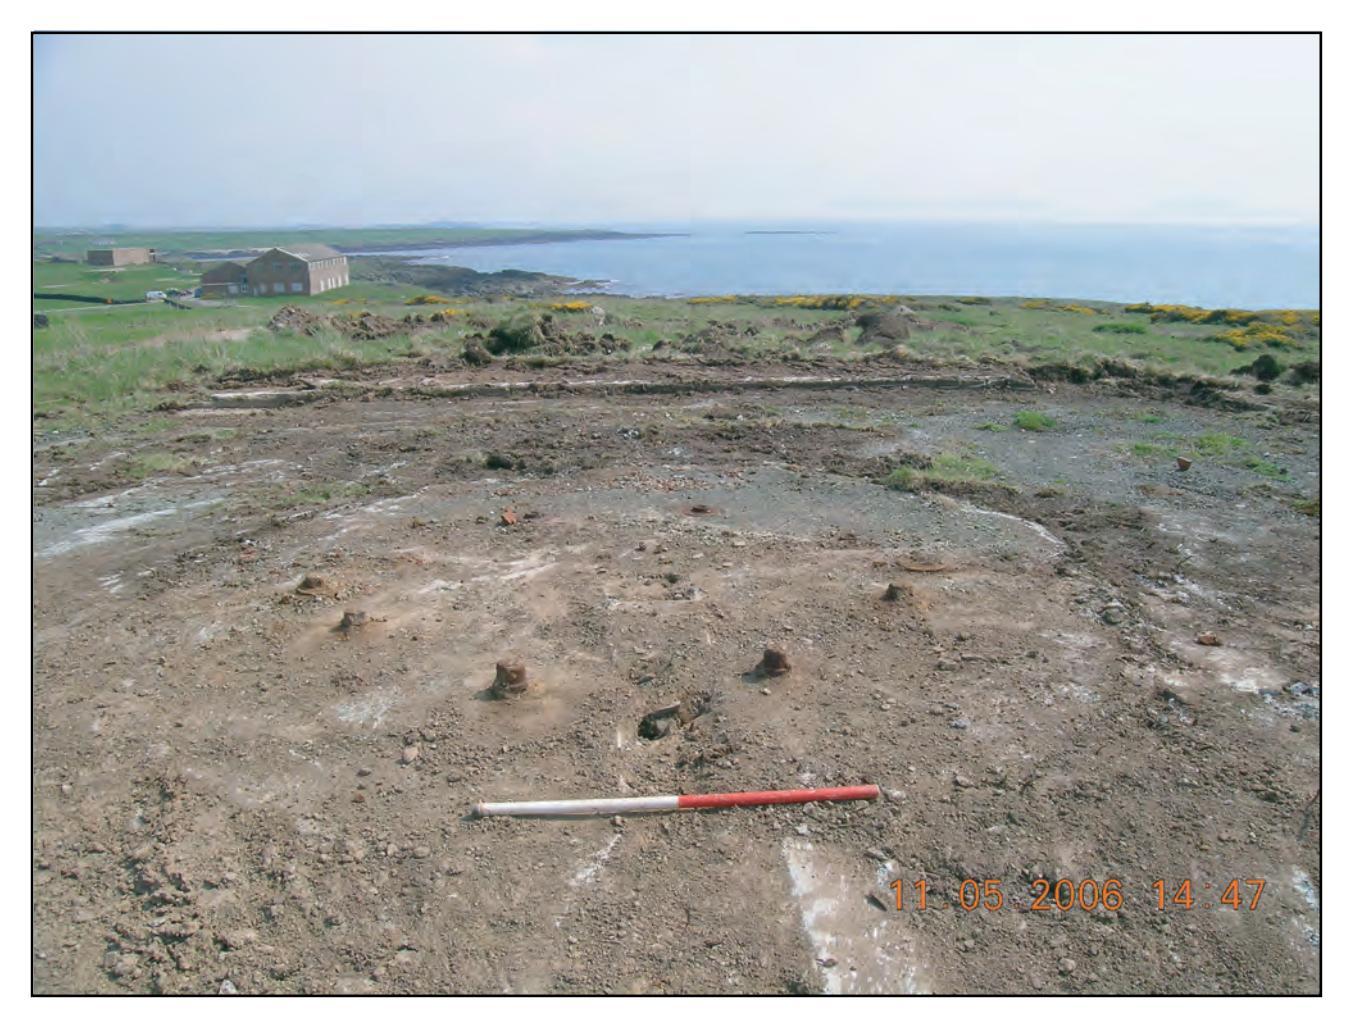
The circular structure measures 4.00m in diameter and has nine metal fittings attached to it forming a rough circle (Plate 18). These fittings surround a 0.30m wide "channel" which runs from the centre of the circle, southwestwards to the breezeblock wall (length of channel: 5.0m). The size and shape of the fittings/anchor, match those in Features A and B, with Types (a), (b), (d) and (e) present. (For their location and orientation, cf. Figure 5).

Plate 18: PRN 15161: Feature D (View South Detailing Anchor Points/Fittings for SAM Static Emplacements)

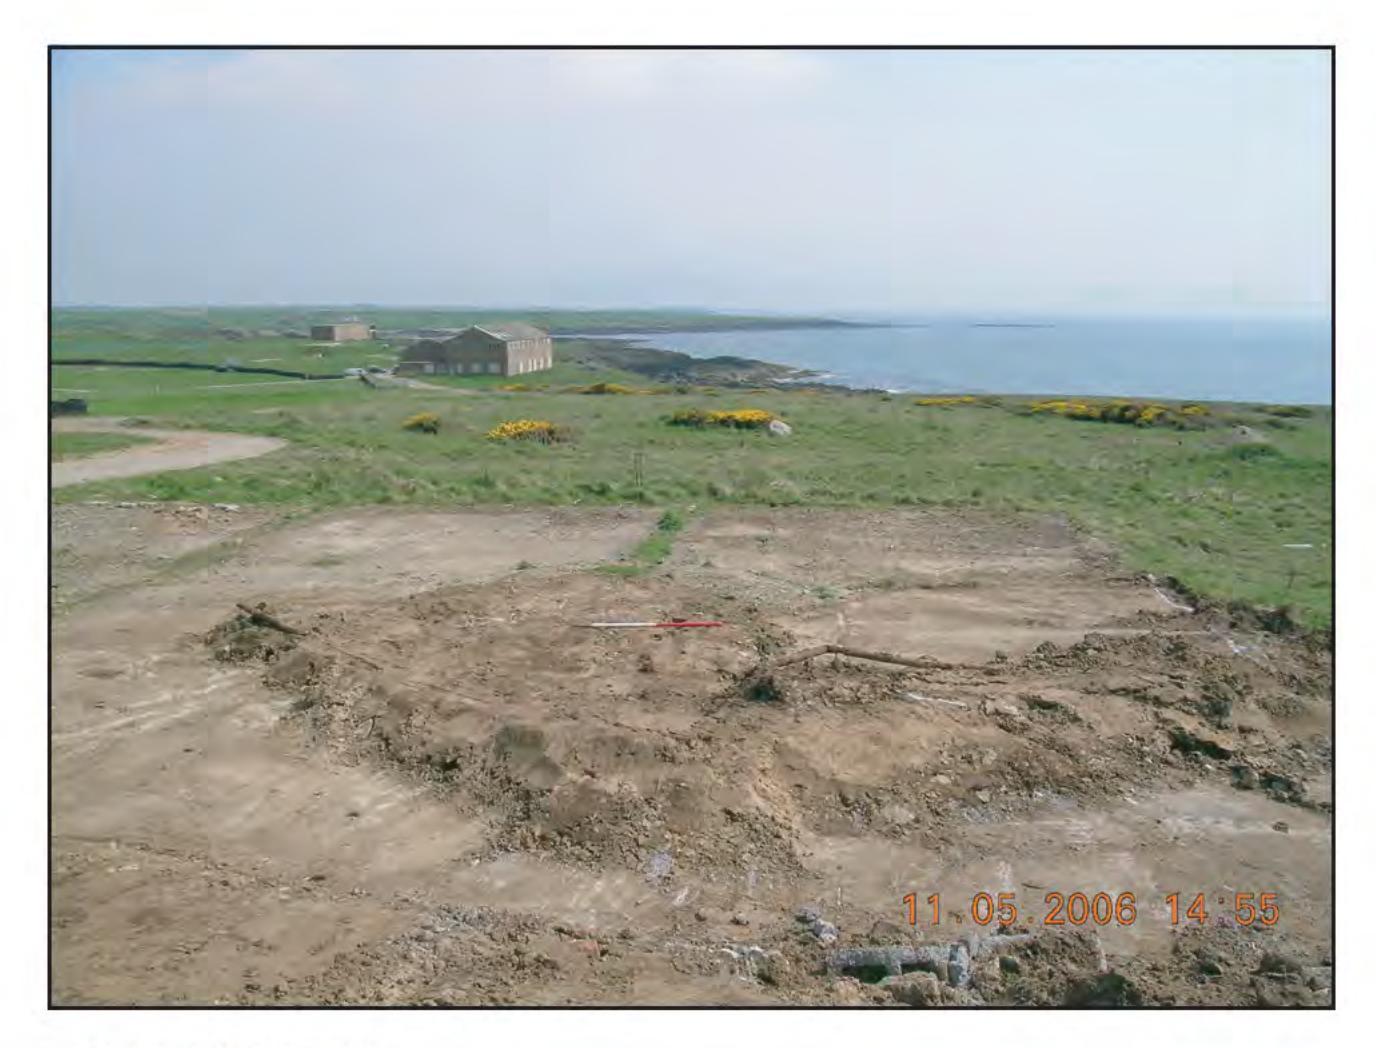
Plate 19: PRN 15161: Feature E

A square concrete emplacement located southwest of Feature D. The concrete surface is flat and measures 35.3m in length and 33.5m in width and is surrounded by a breezeblock wall, 0.30m wide (the breezeblock wall is partly demolished; see Plate 19). As with Features A, B and D, the structure comprises an outer square/rectangular structure with an internal circular structure set into the concrete.

The circular structure measures 4.00m in diameter and has metal fittings attached to it forming a rough circle (Plate 19). These fittings surround a 0.30m wide "channel" which runs from the centre of the circle, southeastwards to the breezeblock wall (length of channel: 5.0m). Not all of the fittings are visible but they include Type (a).

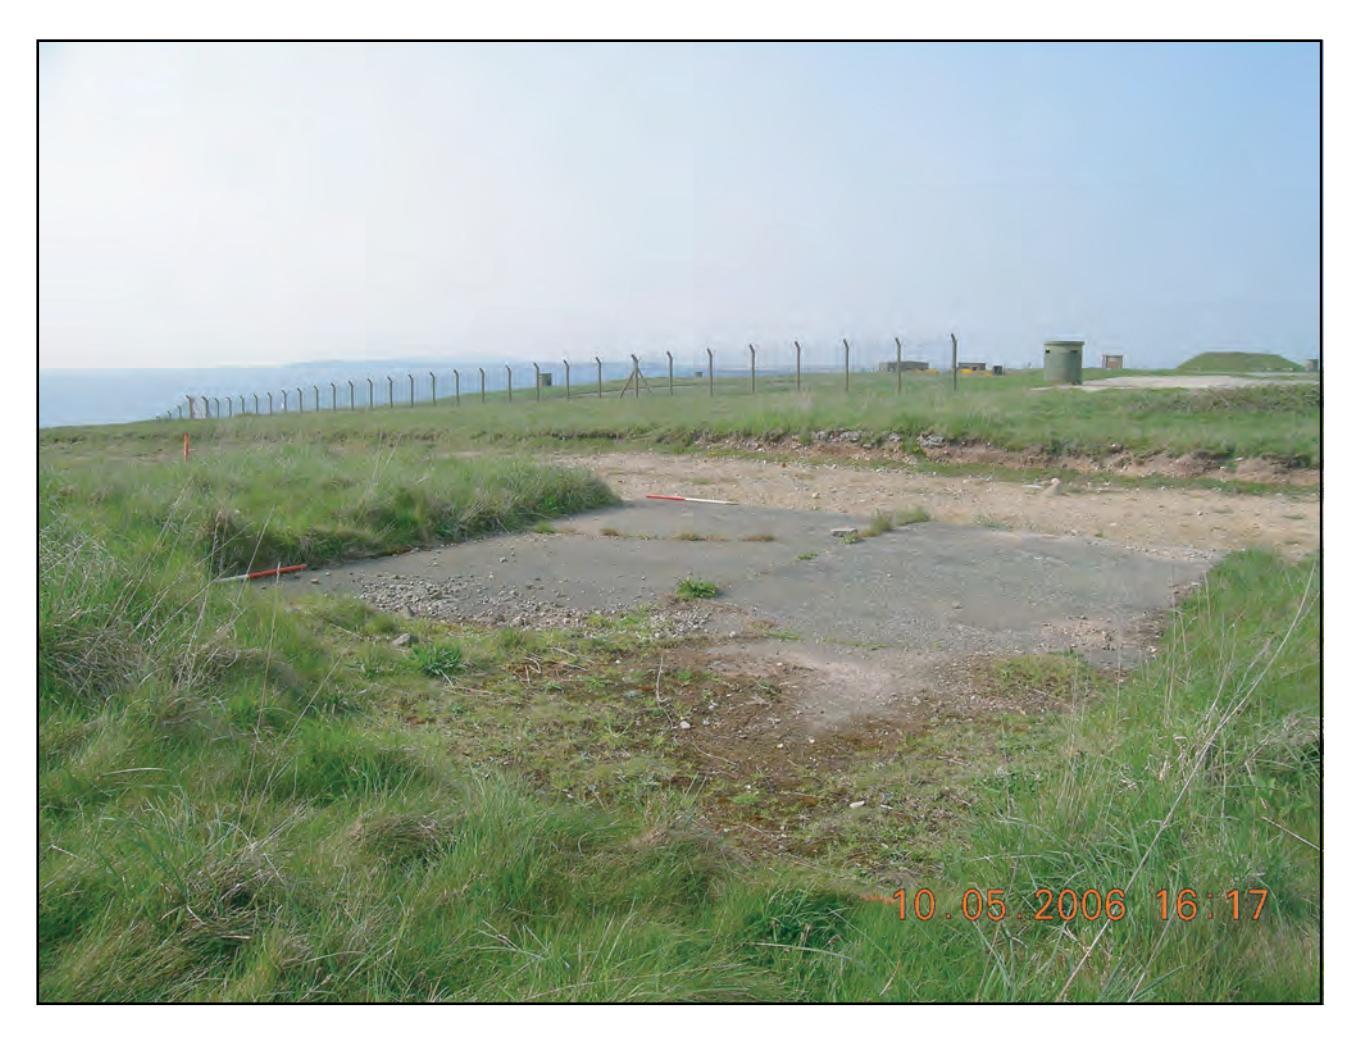
Two concrete platforms associated with the military buildings at the western end of the site. The concrete platforms both measure 22.5m in width and 6.0m in length. There are no apparent fittings/anchors attached to the surface and there is no indication as to their specific function, but they are most likely part of the concrete surface visible to the north that provides access to the various military buildings and have become separated as part of the general degradation of the military complex.

Plate 21: PRN 15161: Feature F Concrete Surface (Note the Military Compound Buildings in the Background)

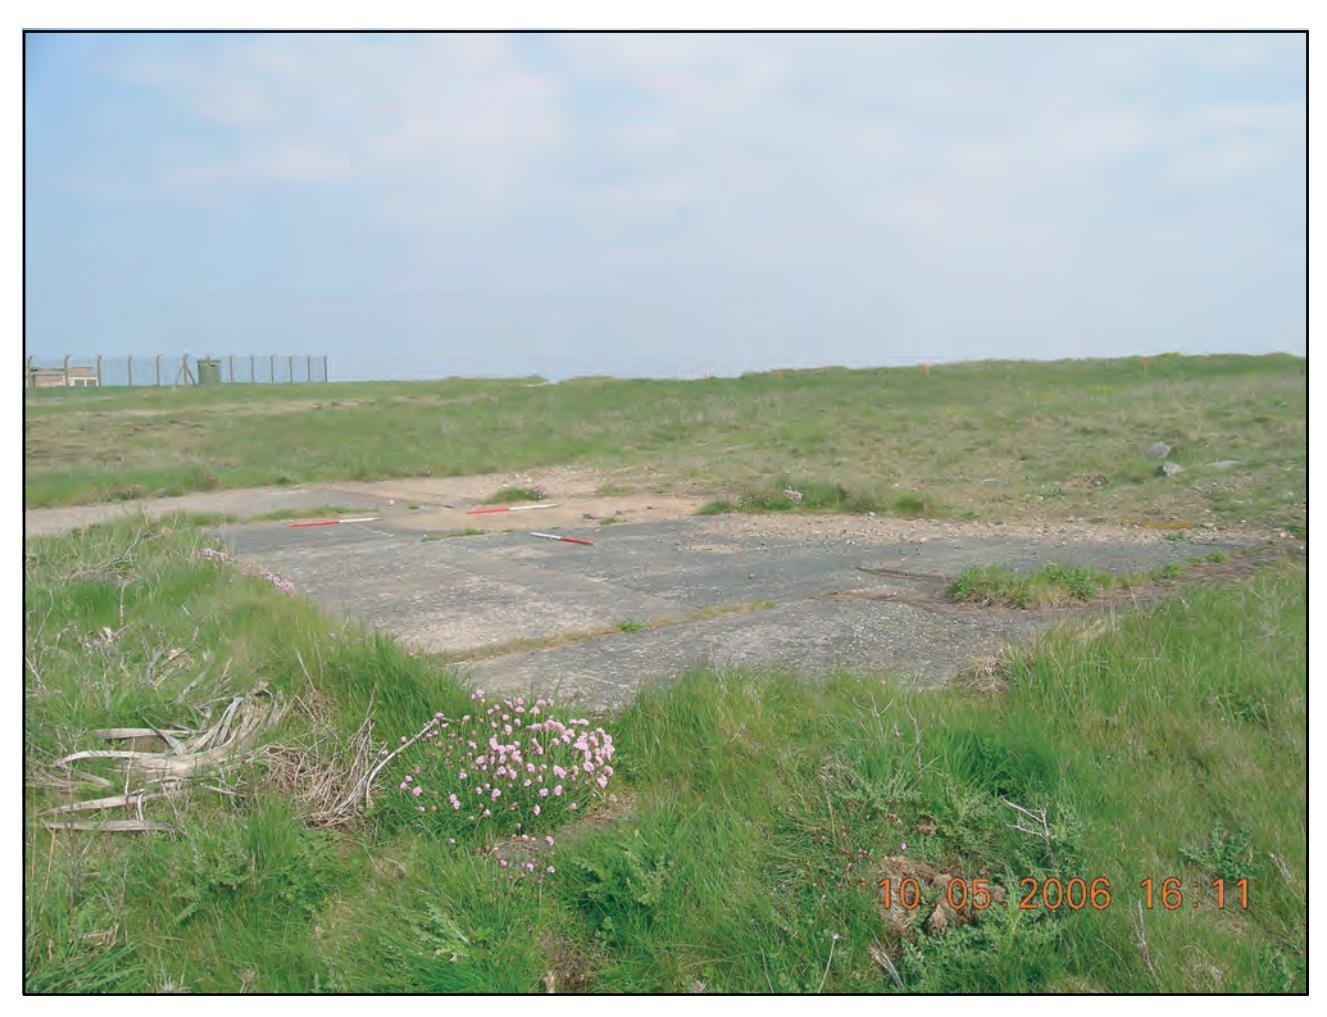
Plate 22: PRN 15161: Feature G Large Concrete Surface

Concreted area, 14.2m by 14.2m in size. This feature is located south of the military buildings and north of the SAM emplacements (Features A to E). It appears to be a storage area with several groups of iron fittings set into the ground suggesting the location of a former upstanding shelter. There are a series of circular markings across the concrete, which could either represent the storage of barrels

during the military complex period, or alternatively, the storage of tyres whilst the site has operated as a racing circuit.

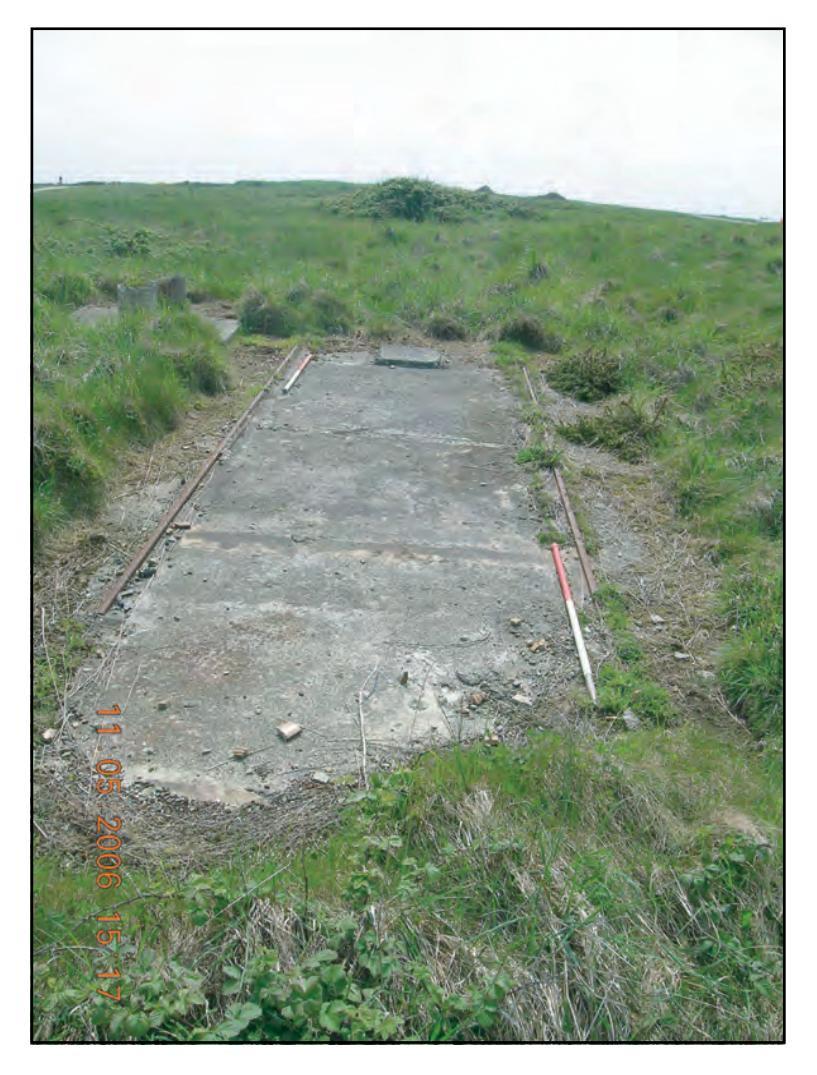
Plate 23: PRN 15161: Feature H (View East)

A concrete pad located north of the SAM emplacements. The feature comprises a concrete surface, 6.1m in length and 2.9m in width, with two inset metal rails, 1.8m apart running the length of the pad. The rails are both 0.03m wide. Adjacent to the pad, at the southeasern end of the feature, is a concrete square, 1.5m by 1.6m in size. Set into the concrete are two wooden posts, that have been broken into stumps.

The function of the concrete pad and posts is unclear: the metal rails don't appear to be part of a longer network of rails, linked to the military buildings (as with Feature I; below), but could represent an isolated feature supporting heavy machinery.

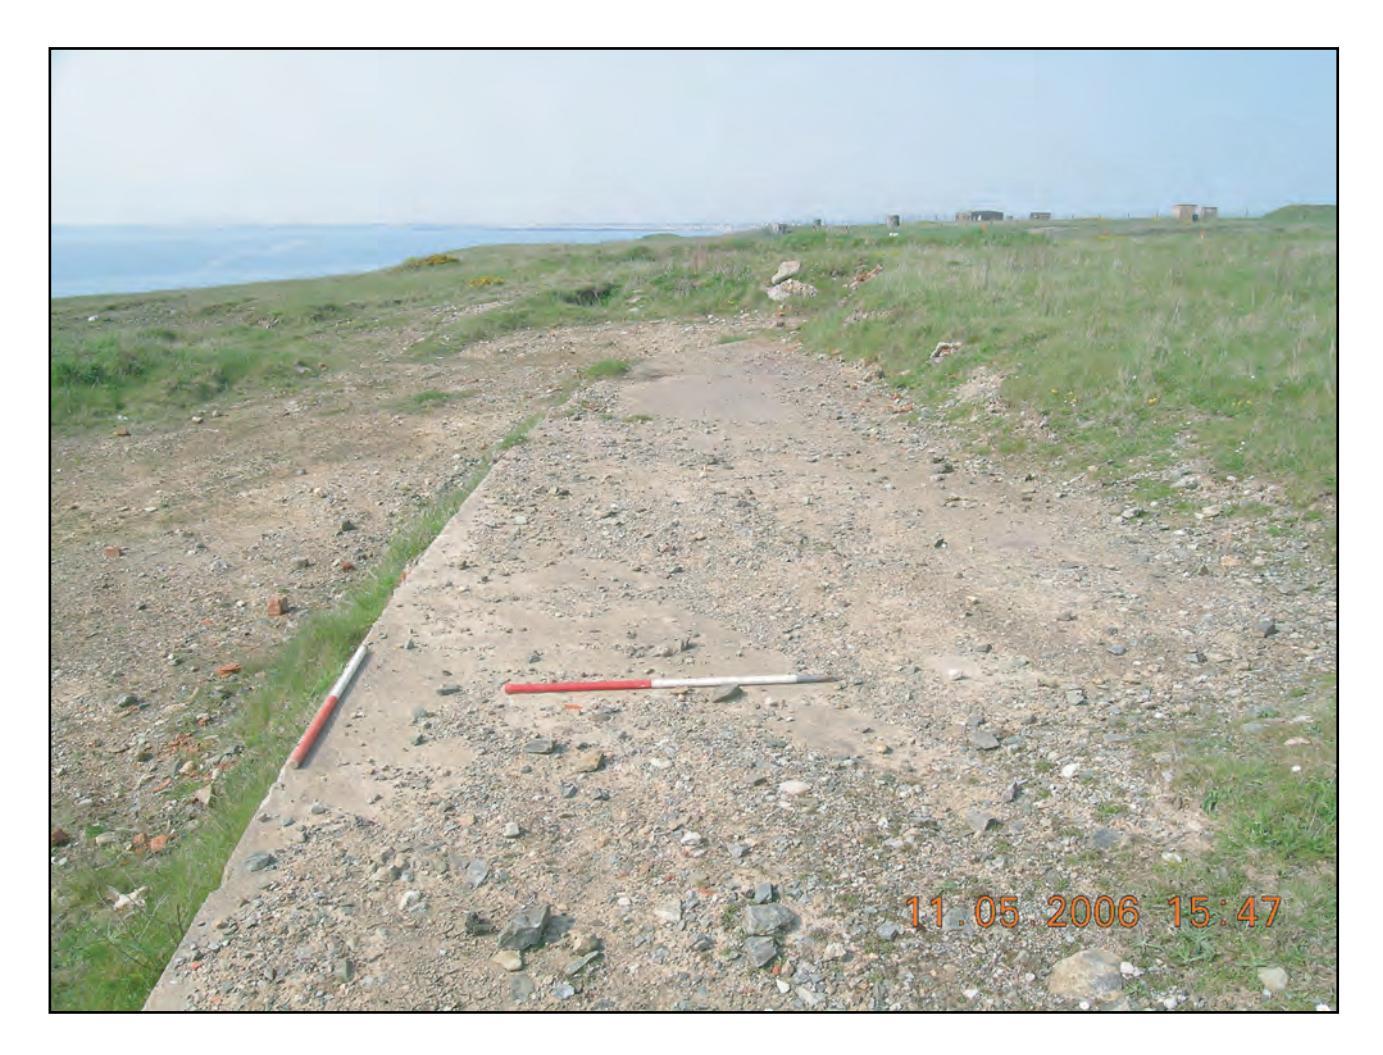
Plate 25: PRN 15161: Feature J Redundant Road Surface

A redundant stretch of road is visible, partially exposed, running from the road now used by the racetrack for access across the area west of the racetrack. It appears that the road currently in use was originally part of the transport network for the military complex and has been adopted by the racetrack since its inception.

The redundant piece of road measures 6.0m in width and c.15m in length. Its orientation suggests it continues from the current road northwards to Feature I. It therefore linked the concrete square to the SAM emplacements. The remaining length of the road is disguised by an overburden of topsoil.
