Archaeological Record

GAT Project No. 1917 Report No. 642 May 2006

Archaeological Record: Trac Ty Croes (G1917)

A Level II Archaeological Record has been undertaken in advance of proposed alterations and developments at the Anglesey Circuit, Ty Croes. The site was formerly a Ministry of Defence (MoD) Military Camp, established in 1942 and closed during the 1970's, which was used for the test firing of anti-aircraft (AA) weapons and surface-to-air missiles (SAM). In 1997 the Anglesey Circuit (Trac Môn) was opened as a fully licensed MSA (Motor Sport Association) and ACU (Auto Cycle Union) championship racing circuit, utilising much of the land formerly used as the military camp.

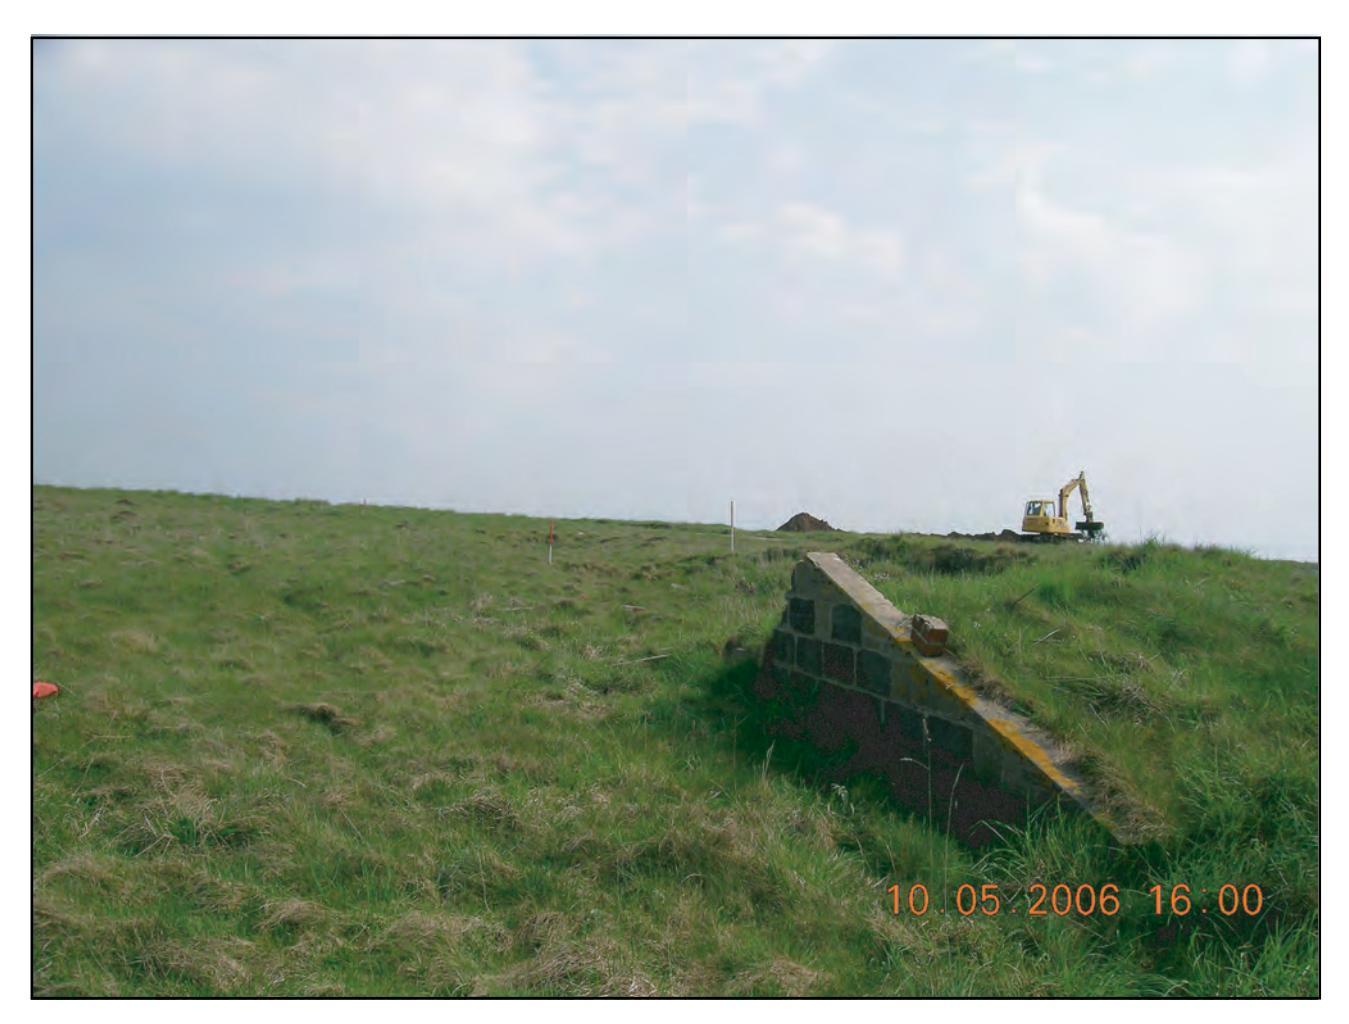
Plate 26: PRN 15161: Feature K Redundant Building

A rectangular feature located *c*.5m north of a large concreted area. The feature is partially hidden by overgrowth/overburden, but appears to be a redundant building, built from breezeblock, 28m in length and 3.7m in width. The breezeblock wall stands several courses high but is mostly demolished, whilst the outside of the building is defined by a concrete edge. The building is divided in half by a concrete partition and is accessed by a flight of concrete steps. The floor of the structure was disguised by overburden.

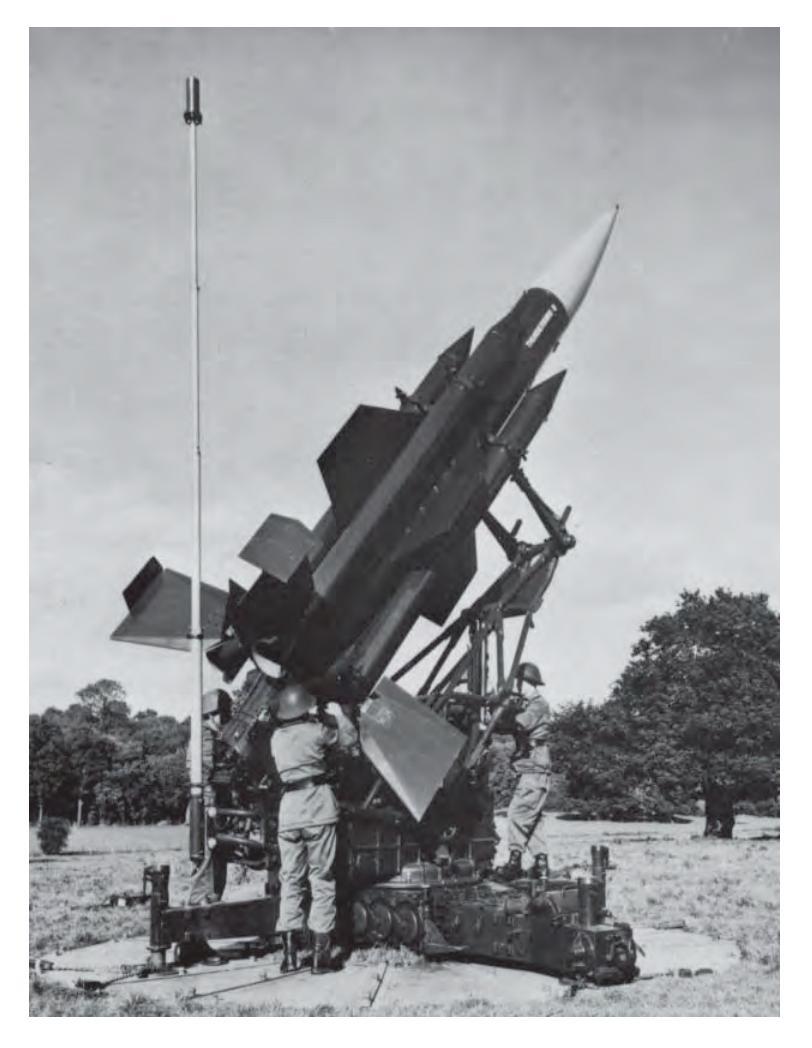
Plate 27:

Thunderbird II missile emplacement. Note how the missile base is anchored to the ground; specifically, the fittings either side of the artilleryman that match those from the gun emplacements at Ty Croes (PRN 15161) (Image courtesy of: www.braw.co.uk)

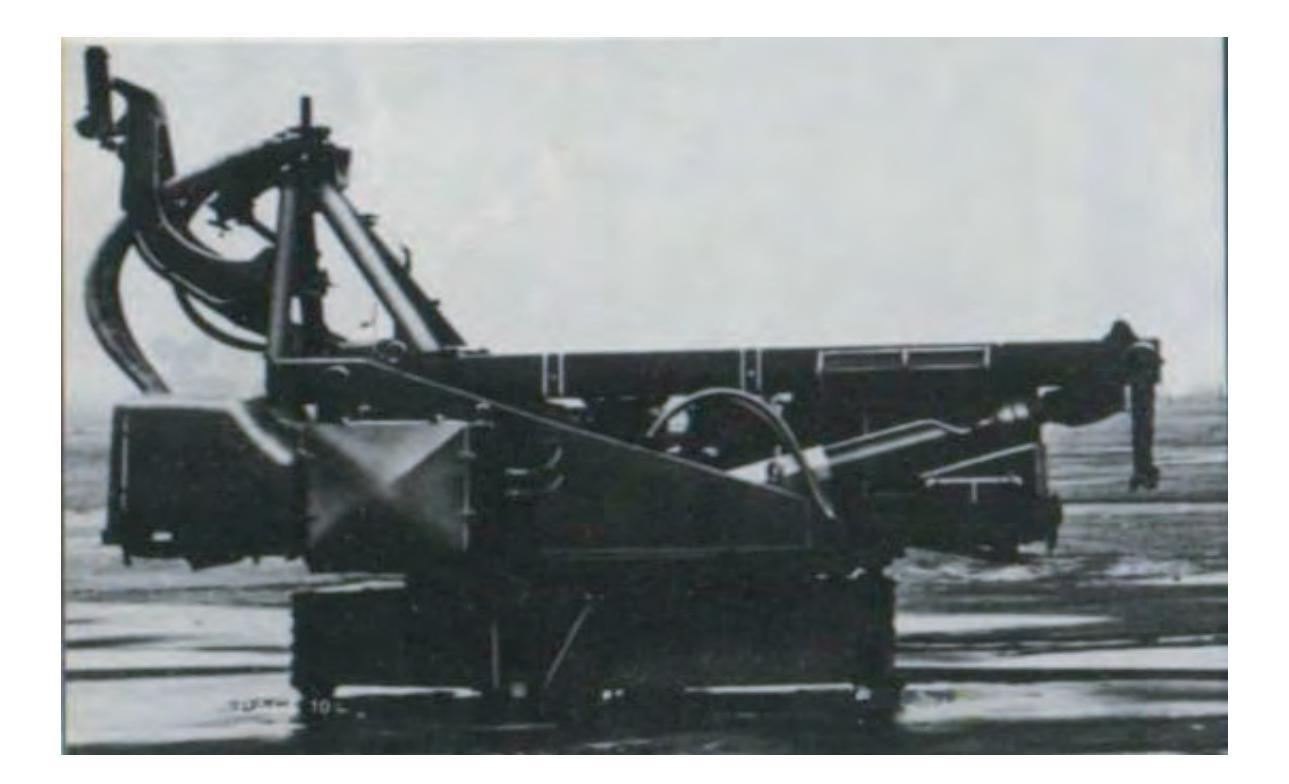
Plate 30: A close-up of the static emplacement for the Bloodhound II Missile. Note how it is anchored into the ground on a concrete base. (Image courtesy of: www.braw.co.uk)
