CAE TY GWYN PLAYING FIELD, LLANBEBLIG, CAERNARFON

Report on watching brief on test pits

GAT Project No. 2060 Report No. 783 March 2009

WATCHING BRIEF ON TEST PITS

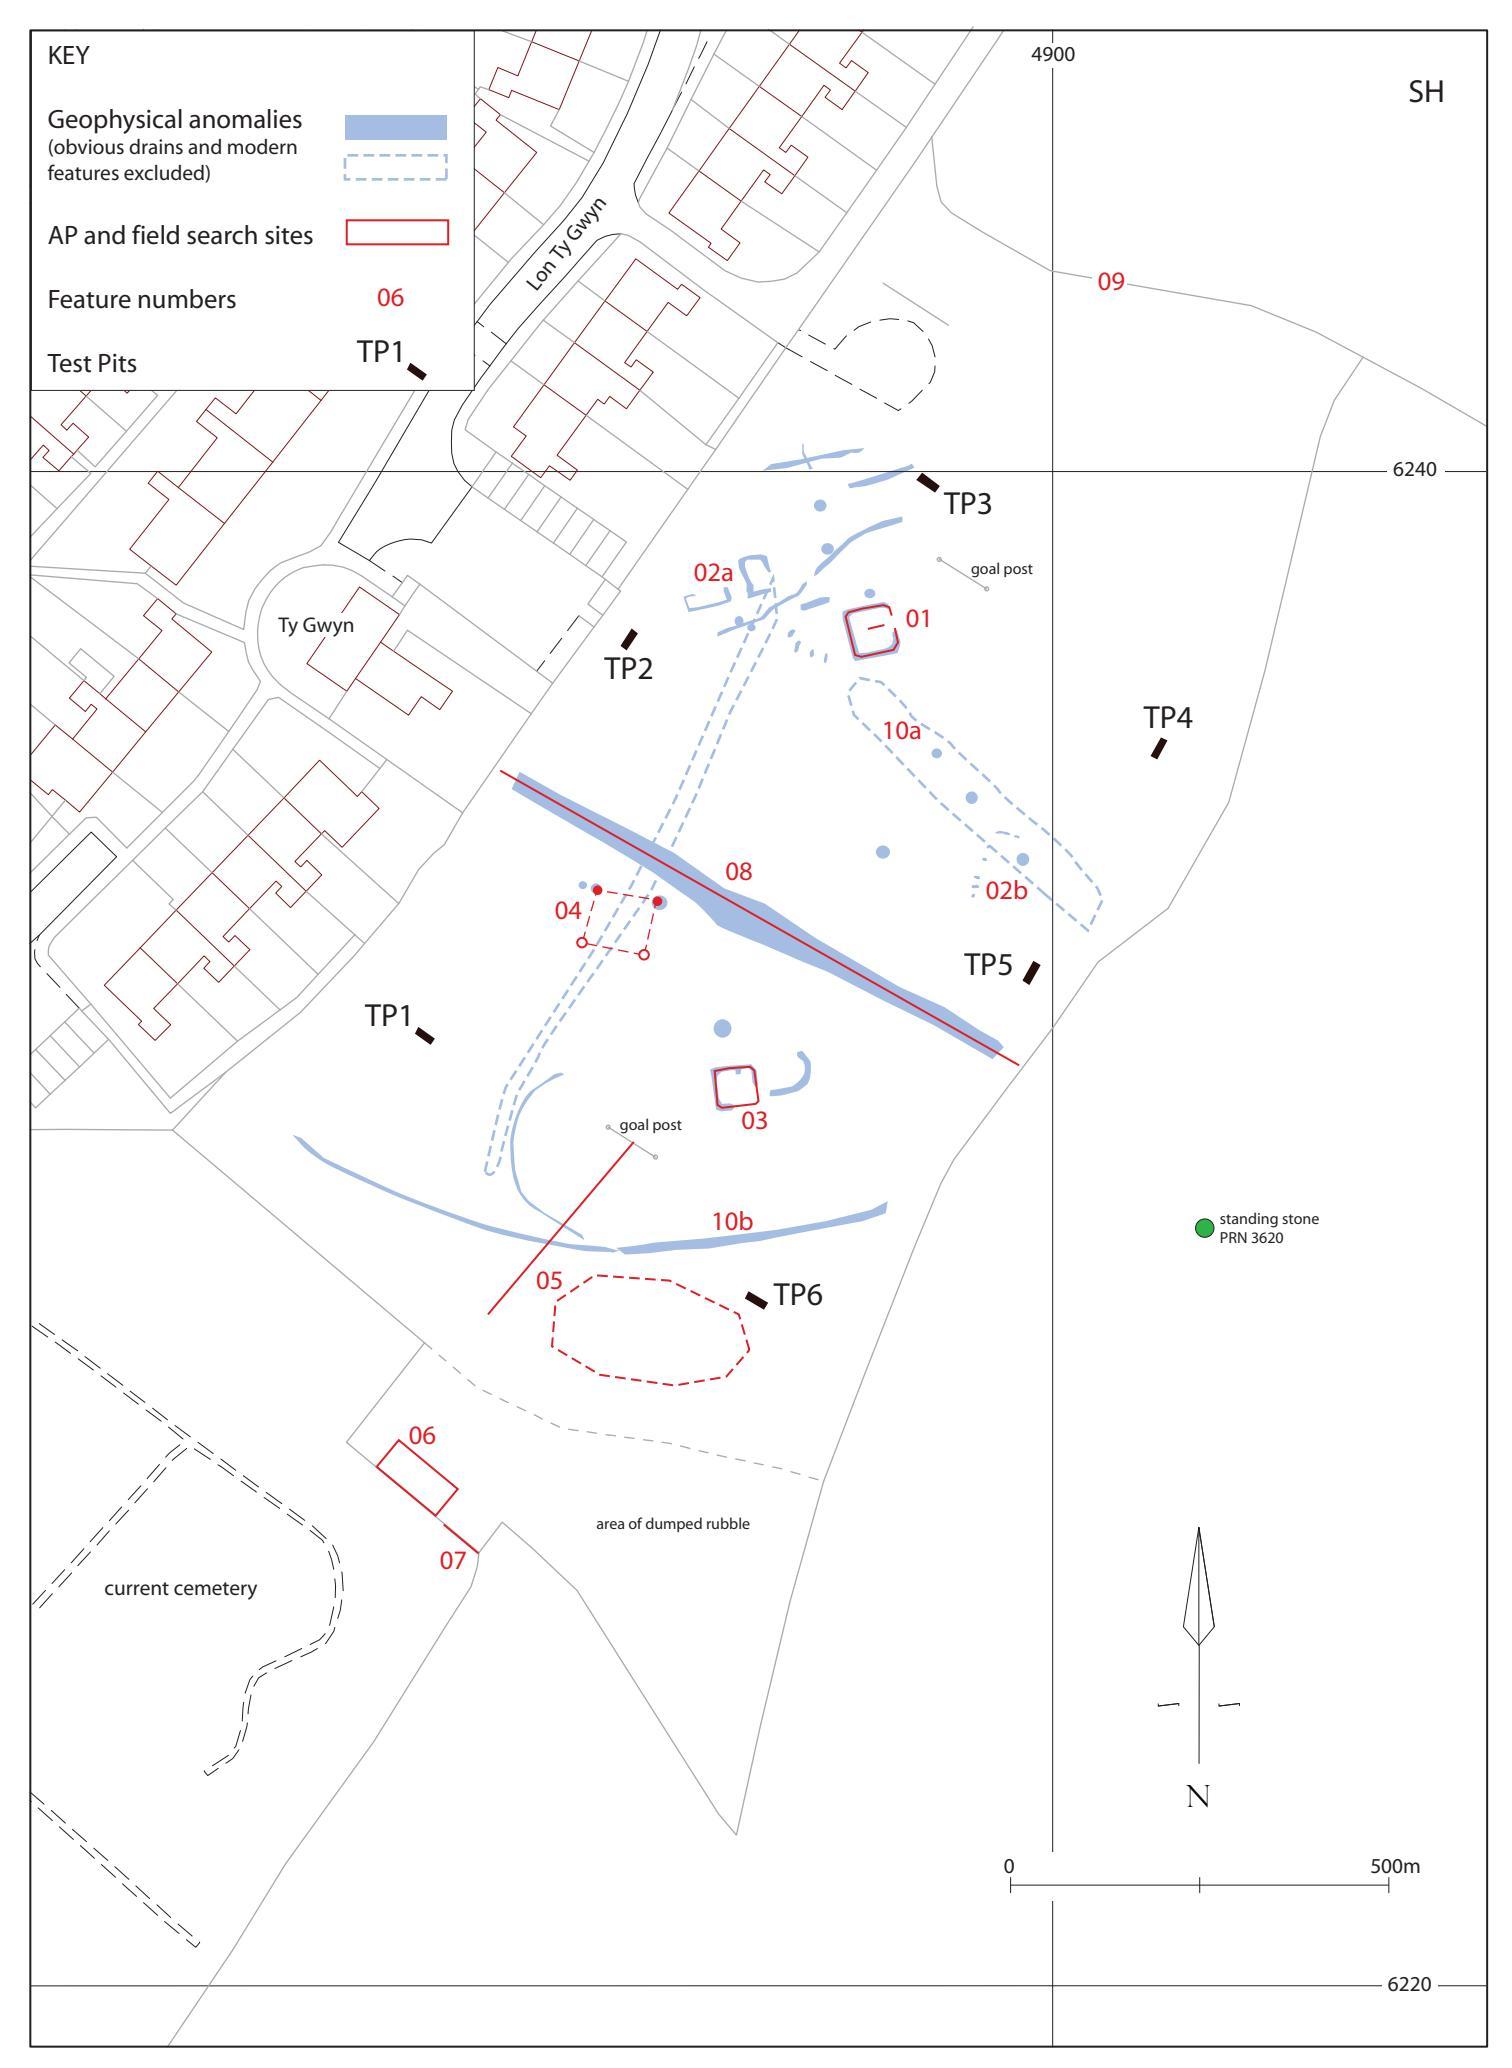
Figure 2. Test pits located in comparison to features identified in the archaeological assessment

Deposits in each test pit are described below and the results are summarised and conclusions discussed. The layers are defined by measurements from the present ground surface. The trenches are located on figure 2.

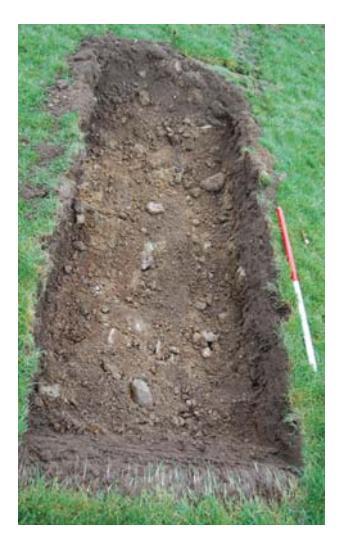
Test pit 1 (plate 1) Size: 2.5m by 1.0m, 2.5m deep max.

- 0-0.36m: Layer 101. Dark grey silty loam with few stones towards the top but about 20% stone along the base of the layer. The stones are occasionally up to 200mm in length. The smaller stones are generally sub-angular and the larger ones rounded. There are numerous roots and occasional fragments of coal or coke. Some 19th/20th century pottery was recovered but not retained. Topsoil, merging into ploughsoil.
- 0.36-2.5m: Layer 102. Friable sandy clay, mottled in colour, partly light grey/partly orange-brown. It contains about 30% stones, which are rounded or sub-rounded and up to 500mm in length. This deposit continued to the base of the trench, where the water level was reached. No bedrock was visible. Boulder clay.

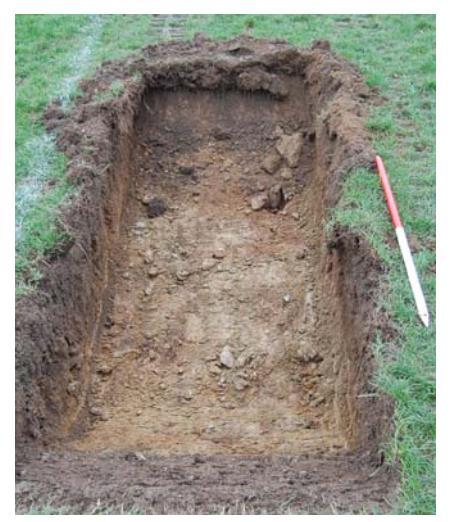
Plate 3: Test pit 2, top of natural

Test pit 2 (plate 2)

Size: 2.6m by 1.0m, 2.5m deep max.

- 0-0.25m: Layer 201. Friable, dark grey sandy loam, with about 20% small sub-rounded stones. Topsoil
- 0.25-0.38m: Layer 202. Friable, dark grey-brown silty loam, generally freer of stones than 201. Contains occasional coal/coke fragments. Ploughsoil, here distinct enough to record as a separate layer.
- 0.38-2.5m: Layer 203. Yellow/grey brown sandy clay, fairly friable with c.20% stones up to 200mm in length. The stones are rounded or sub-rounded. The surface of this layer is orange-brown coloured and loess-like in patches, but these are discontinuous and only 0.1m deep. Below this level this deposit continued to the base of the trench, where the water level was reached. No bedrock was visible. Boulder clay: noticeably less stony in this test pit than in others.

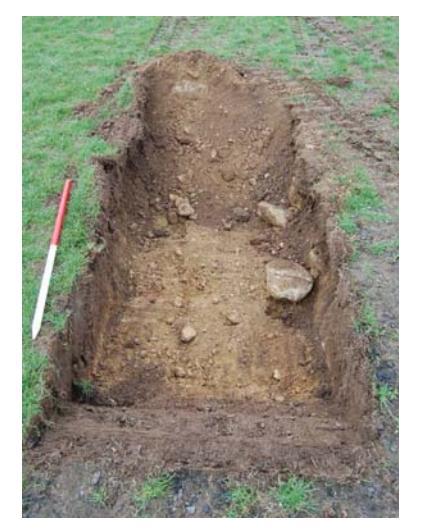
Plate 5: Test pit 3, top of natural

Test pit 3 (plate 3)

Size: 2.5m by 1.0m, 2.3m deep max.

- 0-0.3m: Layer 301. Friable dark grey silty loam with about 20% stones, mainly rounded and small but some larger stones project into this layer. Occasional fragments of coal or coke. Topsoil, merging into ploughsoil.
- 0.3-2.3m: Layer 302. Friable yellow-brown clayey sand, with about 30% stones, which are rounded or sub-rounded and up to 600mm in length. This deposit continued to the base of the trench, where the water level was reached. Boulder clay. It appears in this trench and others that the larger stones are present in the upper part of the boulder clay and stones further down are generally smaller.

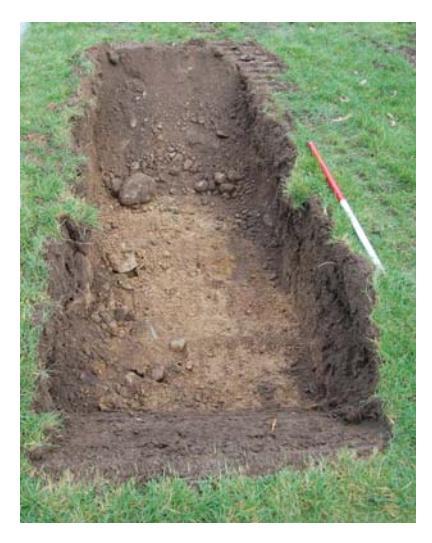
Plate 7: Test pit 4, top of natural

Test pit 4 (plate 4)

Size: 2.8m by 1.0m, 2.2m deep max.

- 0-0.4m: Layer 401. Friable dark grey silty loam with up to 40% stones, mainly towards the base of the layer. The stones are rounded and reach 600mm in length. Topsoil, merging into ploughsoil.
- 0.4-2.2m: Layer 402. Friable yellow-brown clayey silt, with about 40% stones, which are rounded or sub-rounded and up to 500mm in length. Some manganese mottling. This deposit continued to the base of the trench; the water table was reached at about 1.1m. Boulder clay.

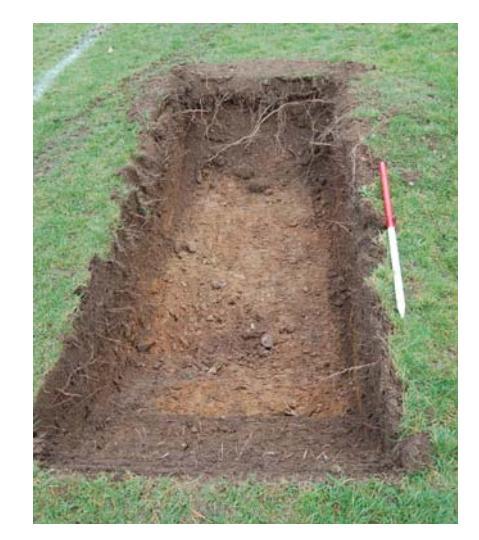
Plate 8: Test pit 5, top of natural

Test pit 5 (plate 5)

Size: 2.9m by 1.0m, 2.2m deep max.

- 0-0.25m: Layer 501. Friable dark grey silty loam with up to 20% small stones, and numerous roots. Topsoil.
- 0.25-0.45m: Layer 502. Friable dark grey-brown silty loam with 30% stones up to 300mm in length. Ploughsoil. At the base of this a shallow linear feature was noticed but inspection showed this to be very slight and irregular and the result of root action.
- 0.45-2.2m: Layer 503. Pale orange-brown gritty clayey silt, with about 20% stones, up to 200mm in length. Noticeably less stony than some other test pits. This deposit continued to the base of the trench; the water table was reached at about 1.0m. Boulder clay.

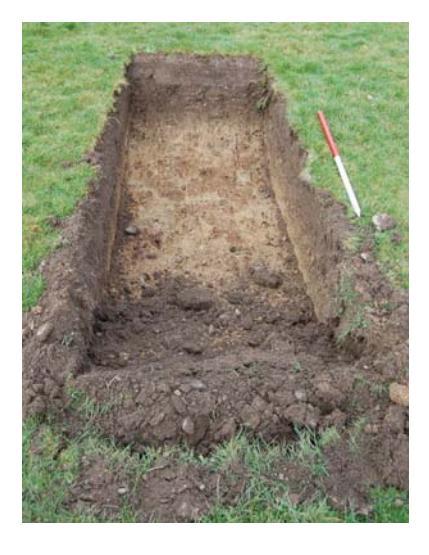
Plate 9: Test pit 6, top of natural

Test pit 6 (plate 6)

Size: 2.8m by 1.0m, 2.5m deep max.

- 0-0.16m: Layer 601. Friable dark grey silty loam with few stones, and flecks of coal/coke. Topsoil.
- 0.16-0.34m: Layer 602. Friable dark grey-brown silty loam with c.30% stones up to 300mm in length. Ploughsoil.
- 0.34-2.5m: Layer 603. Yellow-brown clayey silt, with about 20% stones, up to 300mm in length. Mottled by iron oxides. This deposit continued to the base of the trench, where the water table was reached. Boulder clay. A very large boulder was seen about 1m below the ground surface.
