Snowdon Mill: Porthmadog

Level 3 archaeological building record

GAT Project No. 2057 Report No. 806 May, 2009

Prepared for Q Williams Construction on behalf of Belgrave Homes

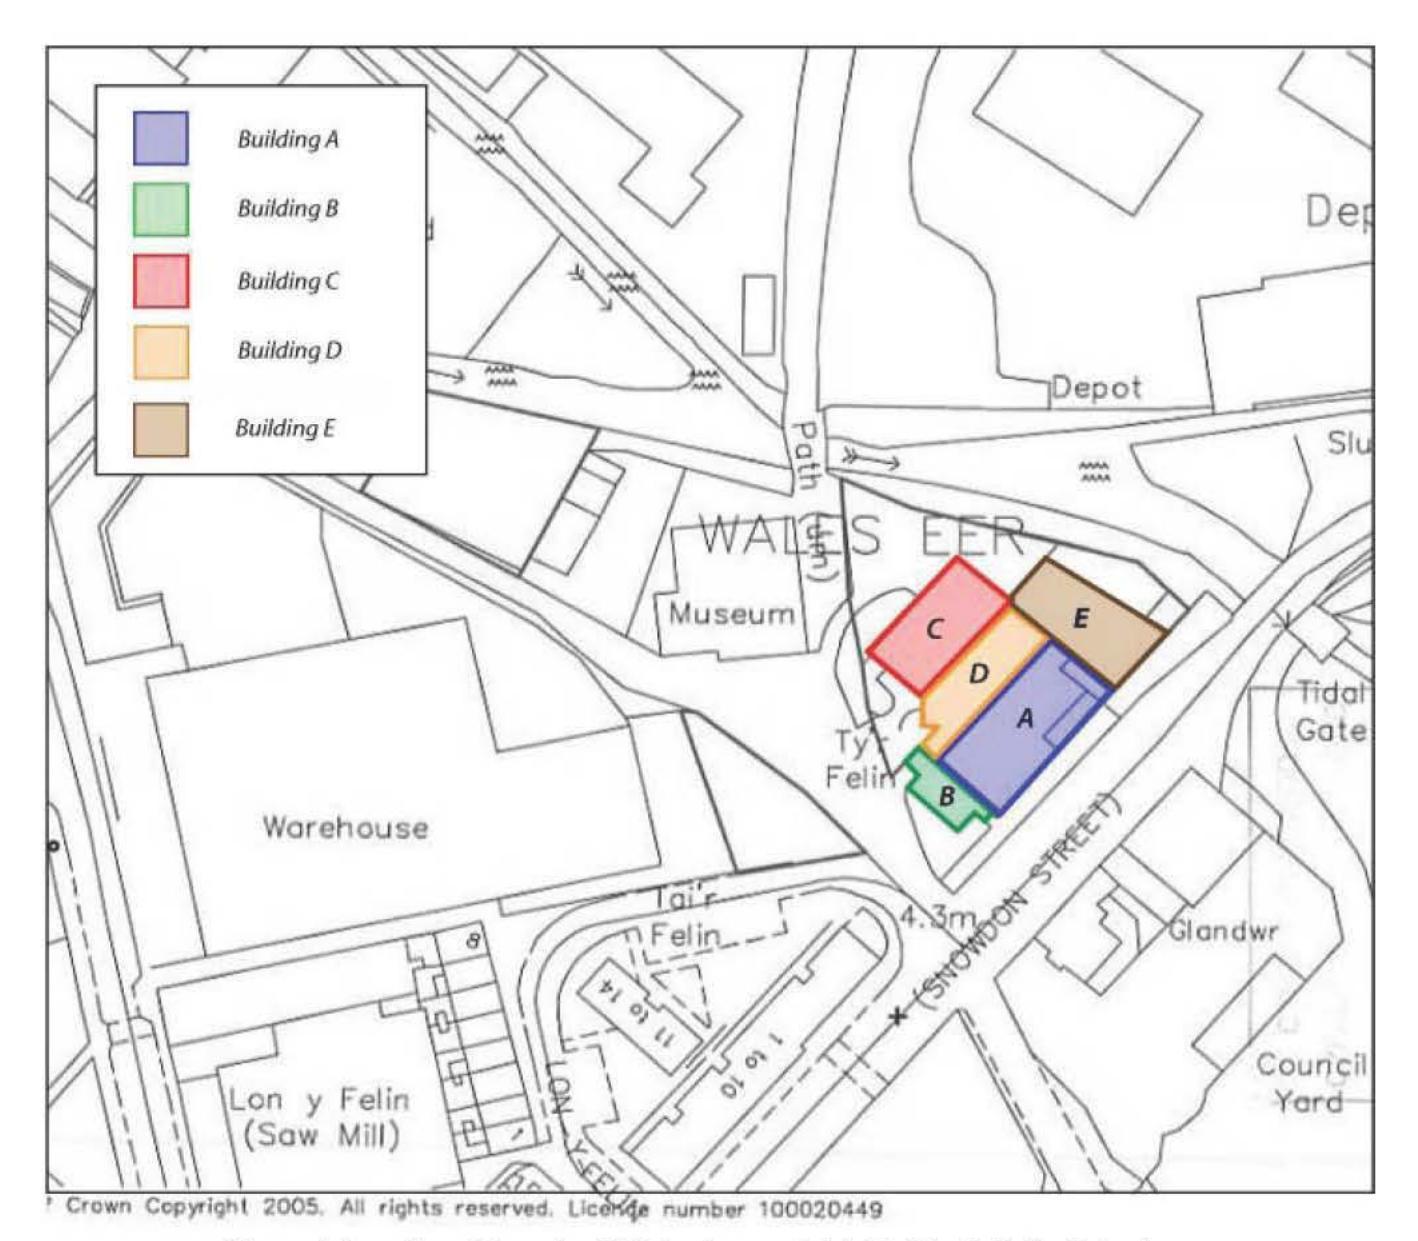
Figure 1: Location of Snowdon Mill development plot detailing individual structures

Gwynedd Archaeological Trust has been asked by Q Williams construction on behalf of Belgrave Homes to provide an archaeological record in advance of a development at Snowdon Mill, Porthmadog NGR SH57063895. The development is located the north-eastern edge of Porthmatowards dog. It is proposed to convert the former mill buildings at Snowdon Mill into 21 residential units. The former mill, originally known as Portmadoc (sic) Flour mill, grade II listed (Record No. 4431) listed for its is industrial archaeological interest as a rare surviving mid-nineteenth century steam-powered flour mill. The building comprises two parallel ranges with ancilliary structures (Figure 1):

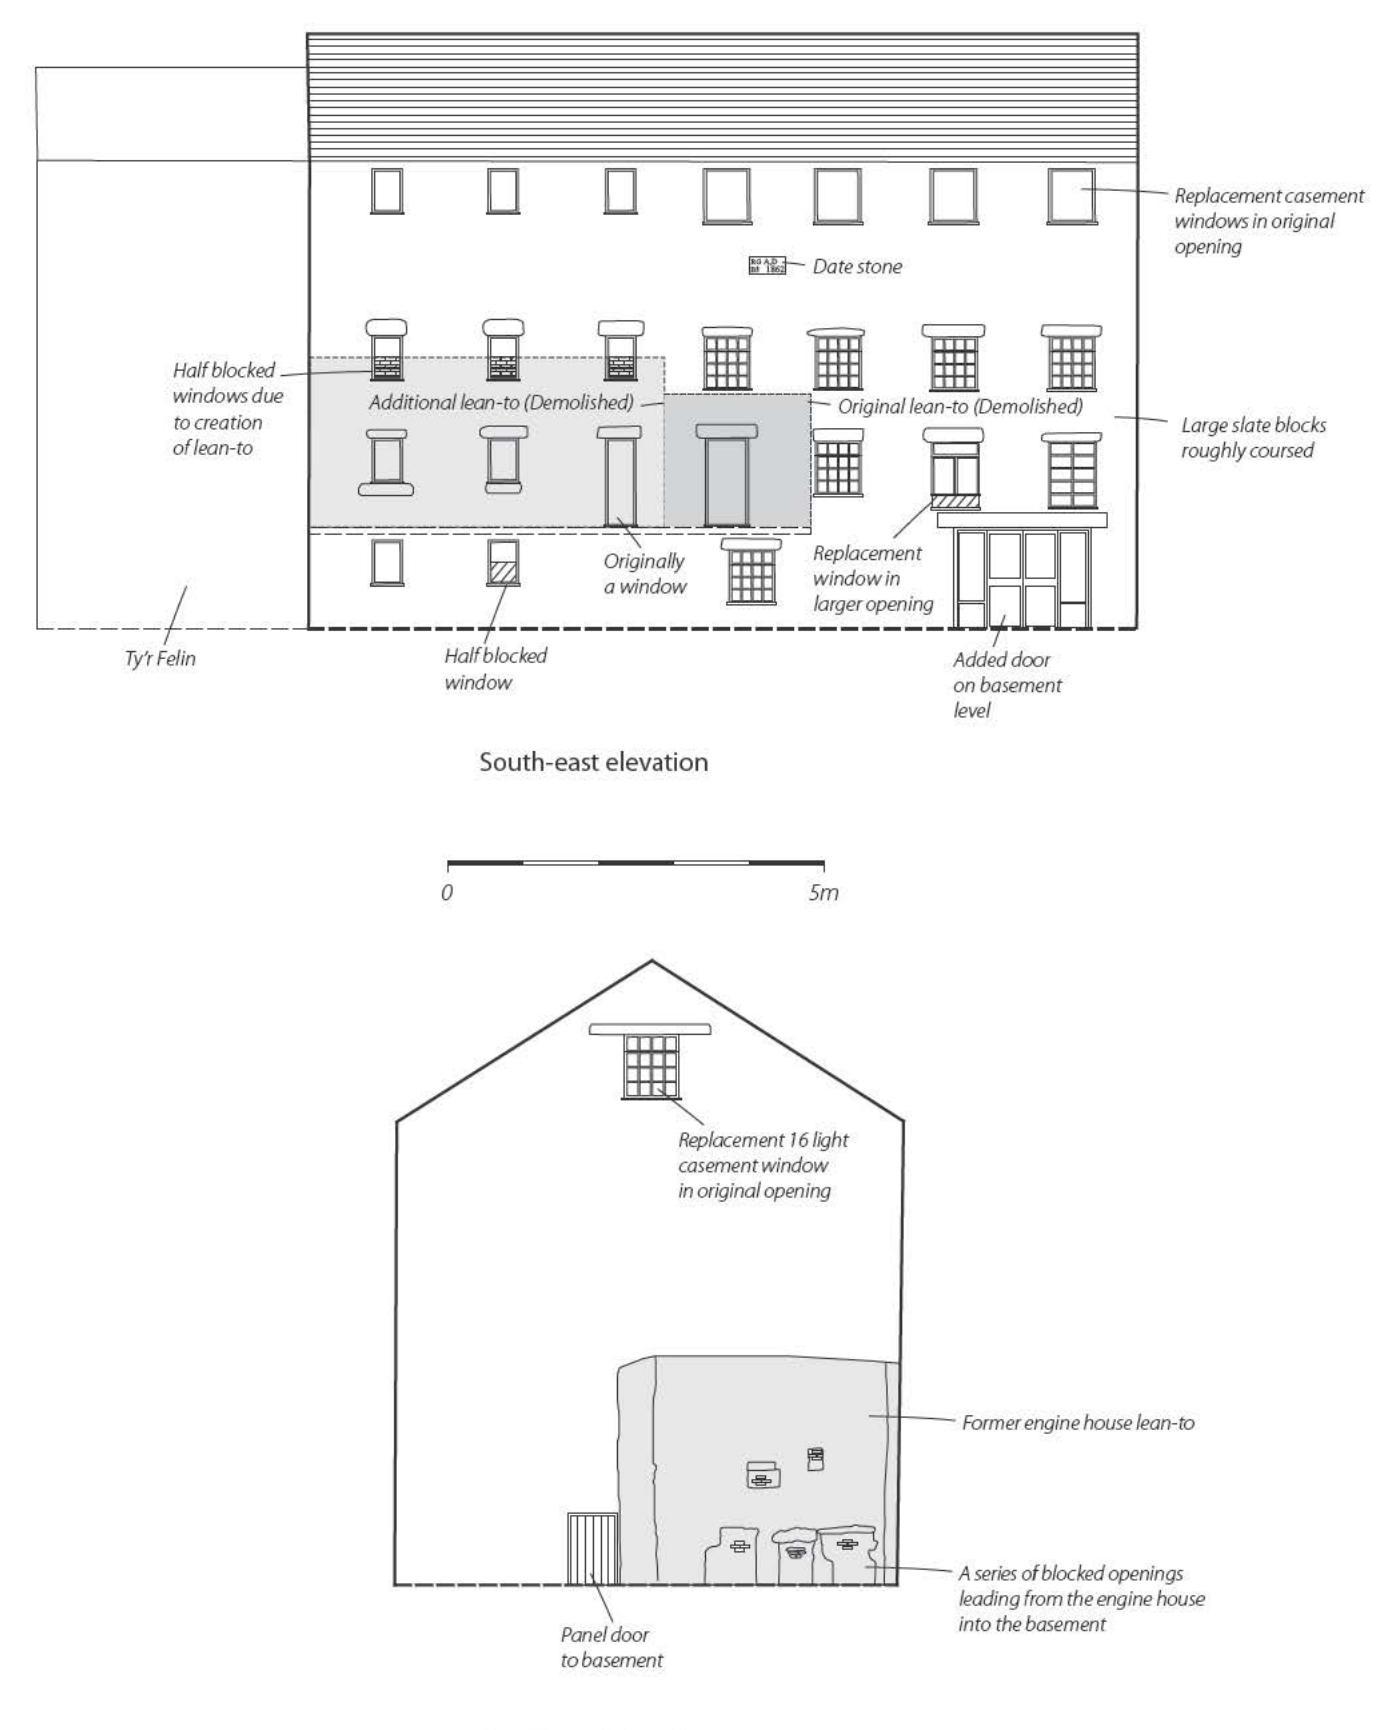
Figure 5: Elevations of south-east side and north-east gable, Building A

The south-east elevation contains regular rows of seven replacement casement windows in original openings, three smaller to the south west and four larger to the north west. The replacement windows are all of either single light or 12 lights. Three middle windows to the south-west have been partly blocked due to the construction of the later lean-to. The second ground floor window to the north-west was originally a larger opening. A date stone above the door reads: "RG BR AD 1862".

The north west elevation, is of less regular blocks than the front, but still roughly coursed. The link building was constructed to join the two mills together, and covered much of this wall, apart from the south end, which was lit by a pair of windows on the first floor, and a single window and a door (used in association with an internal winch) on the second floor. There is a blocked window on the ground floor, and a door through the link building into the basement. Prior to the construction of the link building the OS map shows extensions on this side, one of which was contemporary with the main building and tied in to it, as shown by the remains of quoins are still visible. The openings have been changed over the years, but a door to each floor was located one above the other in the north-west corner with two regularly spaced windows south of each, and smaller windows south again, as on the front of the building.

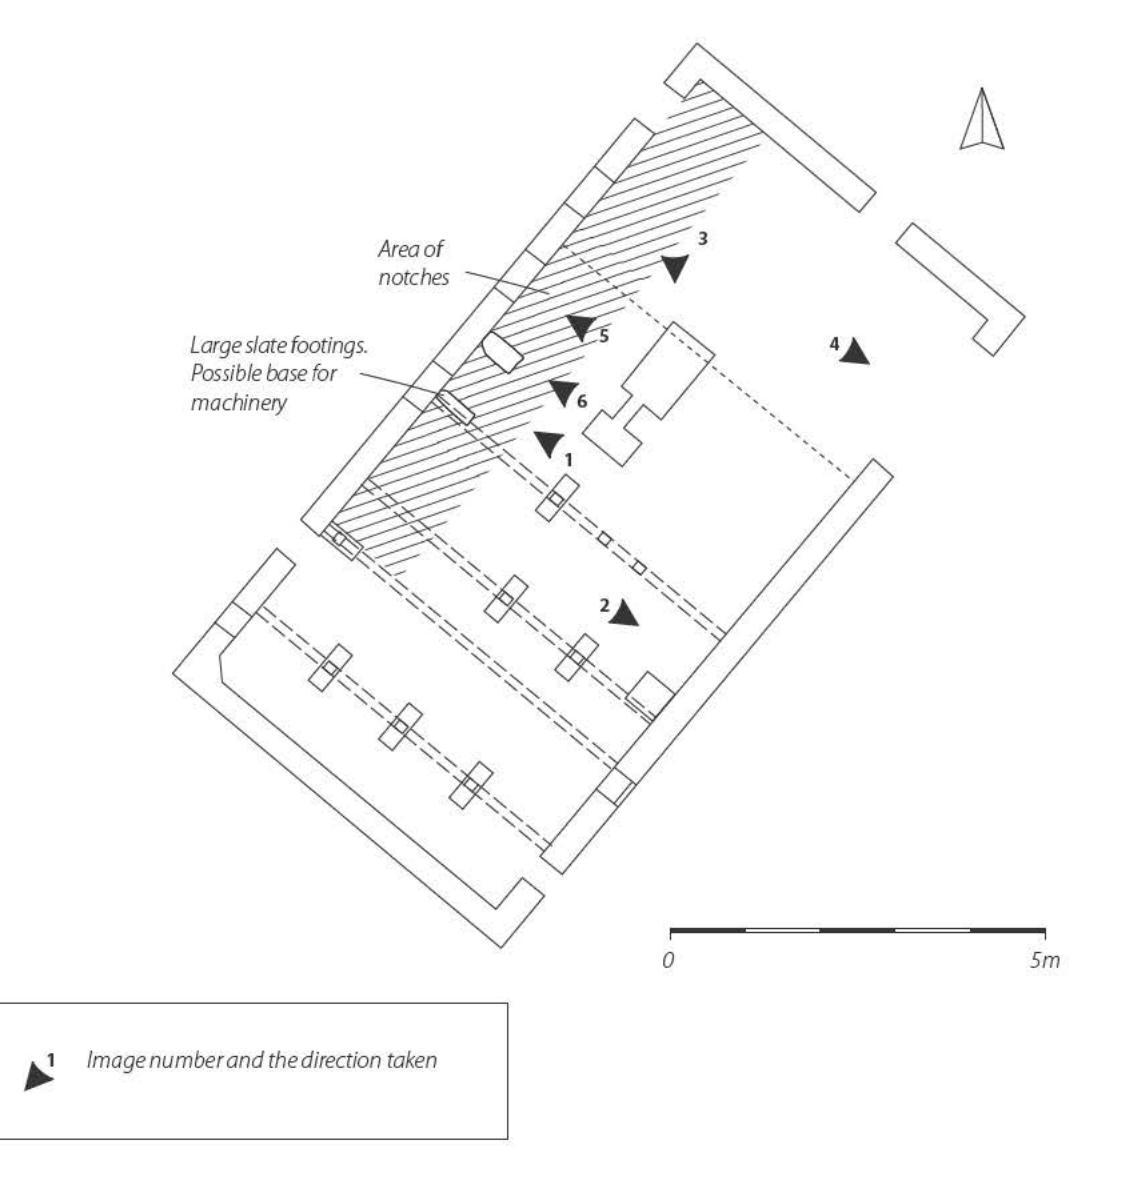
Figure 6: Basement plan of building A

Against the west wall are two massive masonry blocks (image 2), certainly used for supporting machinery as bolts still protrude from them, and may well at some time have supported a primary drive wheel or possibly an engine. An opening in the wall lies above the blocks. There are also a large concentration of notches on the north-west ceiling of the basement.

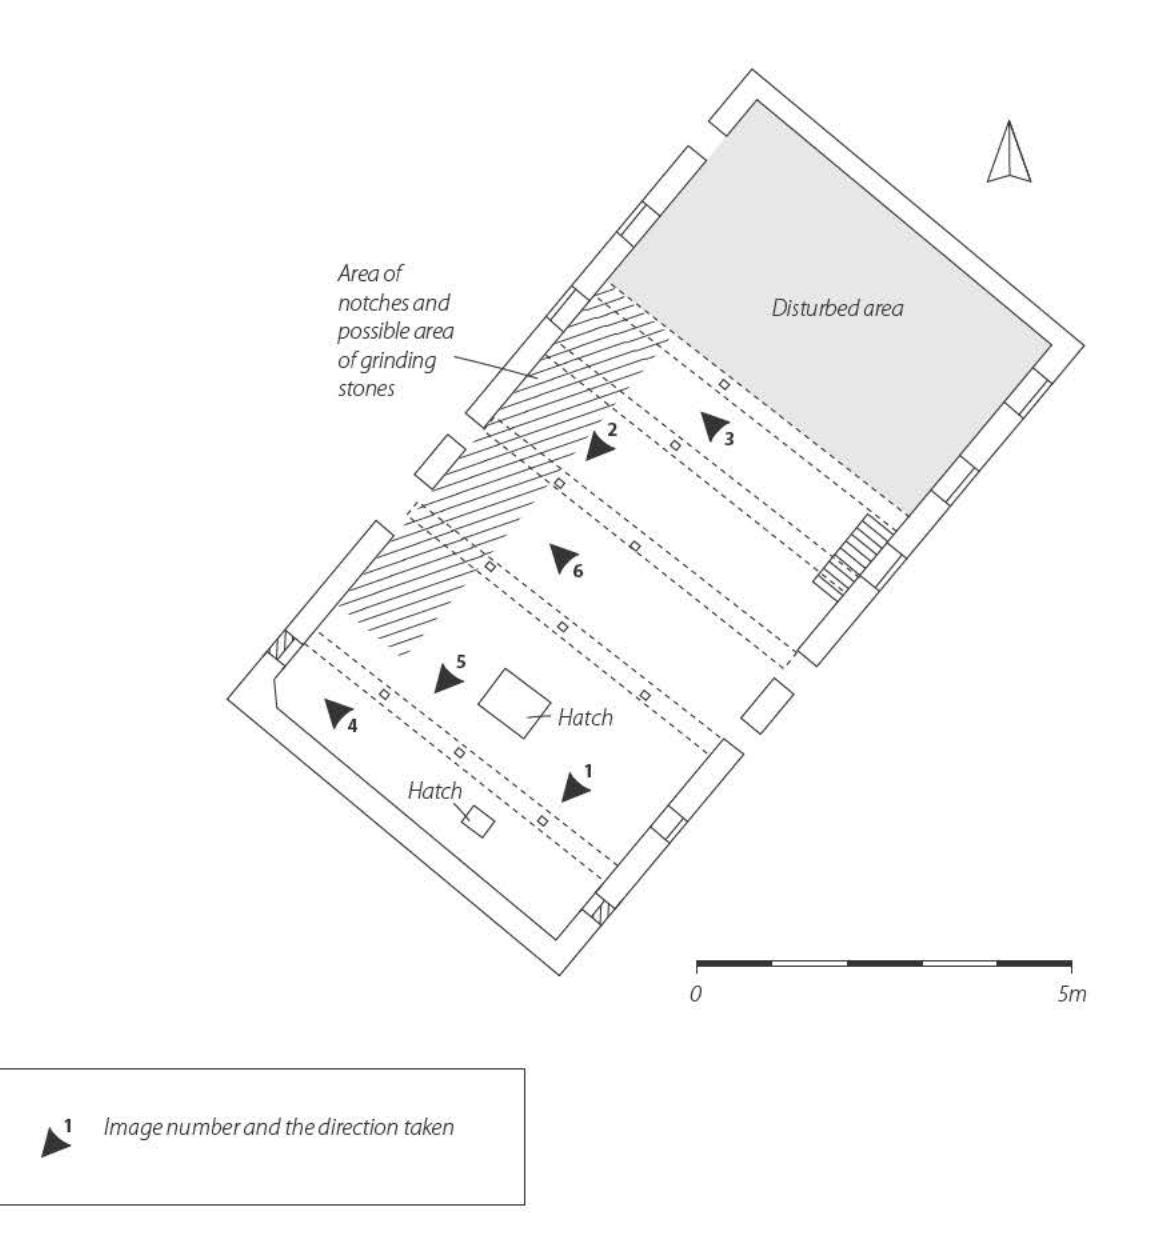
Figure 7: Ground floor plan of building A

Two hatches are seen in the south west of the ceiling. One of which links to the winch on the second floor.

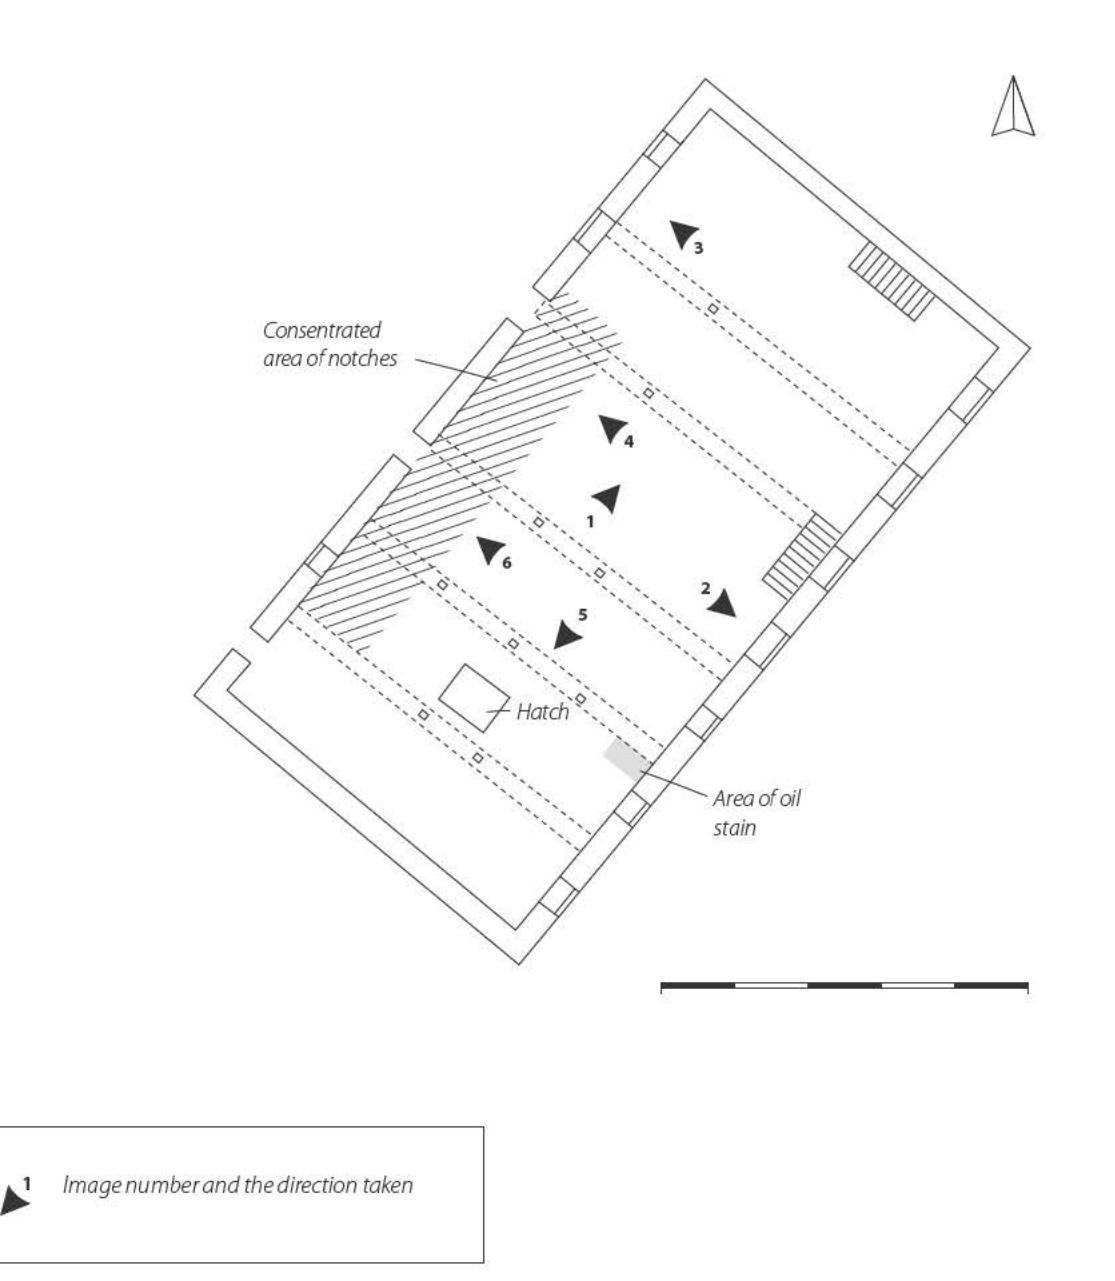
Figure 8: First floor plan of building A

On the south-west of the first floor there is an area of oil stain on the ceiling suggesting machine activity in this area.

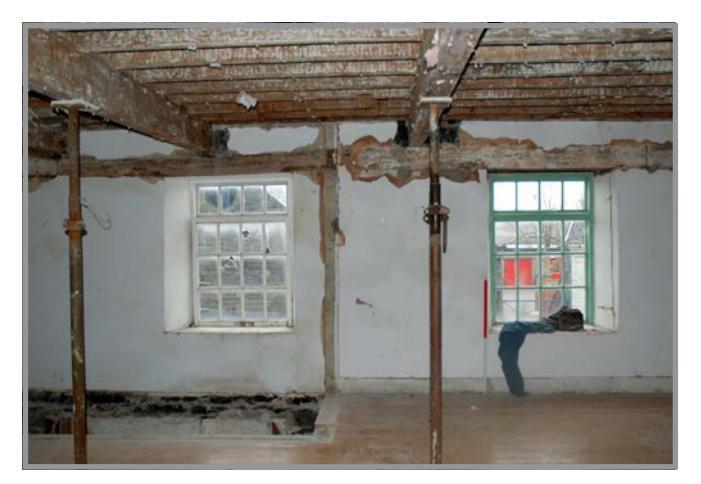
Image 2: First floor. South-east view of 16 light replacement windows in original openings

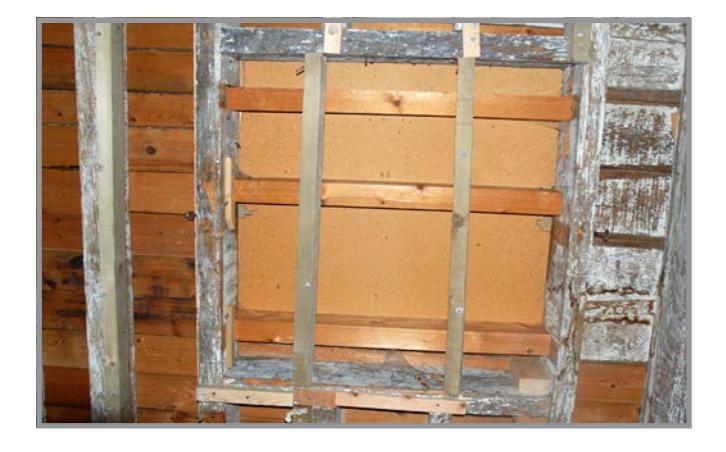
Image 5: First floor. Hatch in the south-west of the ceiling which links to the winch on the second floor

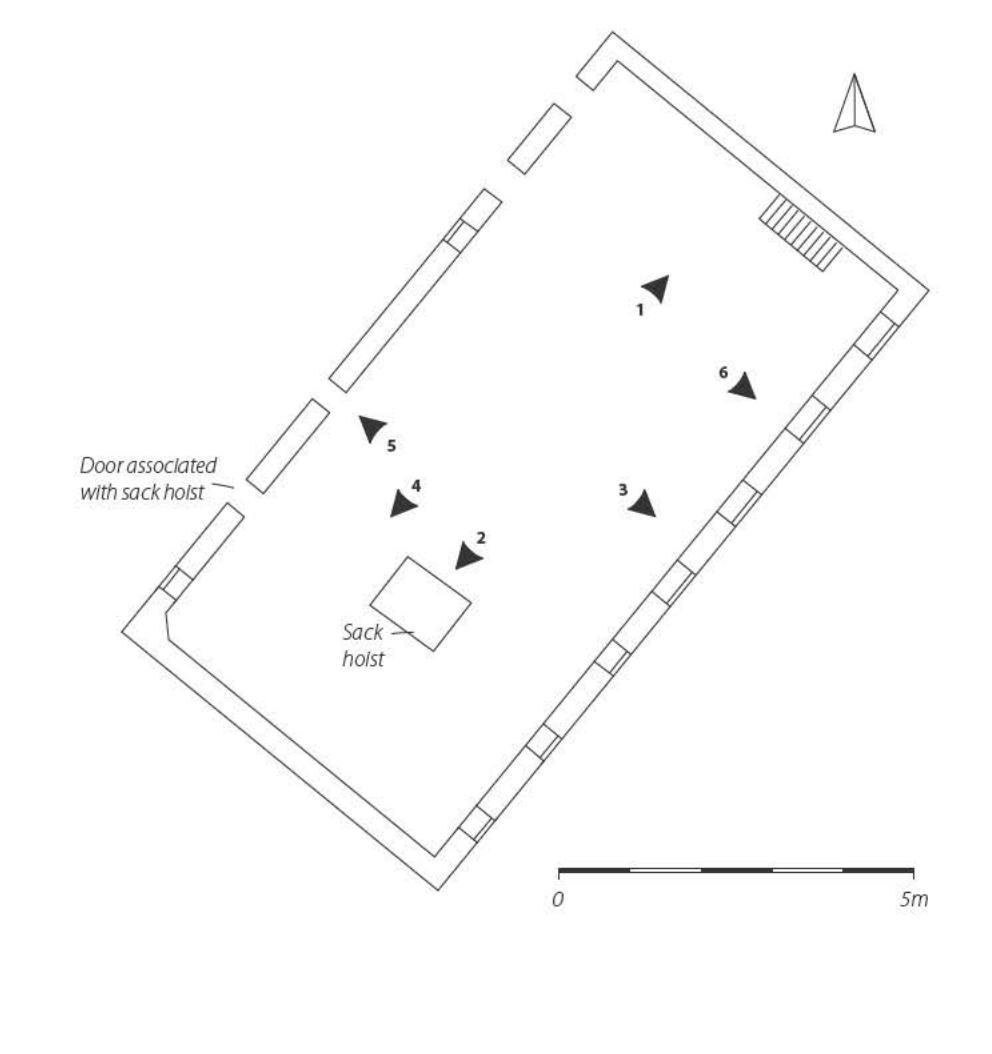
Figure 9: Second floor plan of building A

This floor appears to have been a single open space, and would traditionally have been used for storage of grain and flour in sacks. Entrance was via internal stairs in the north-east corner, or through a door out into the link building. The roof trusses are principally of a king-post type, with diagonal braces, though two are of the queen-post type. A winch (see 5.1.2.5) lay supported on the tie-beams, to winch items up through the trapdoors visible in each floor.

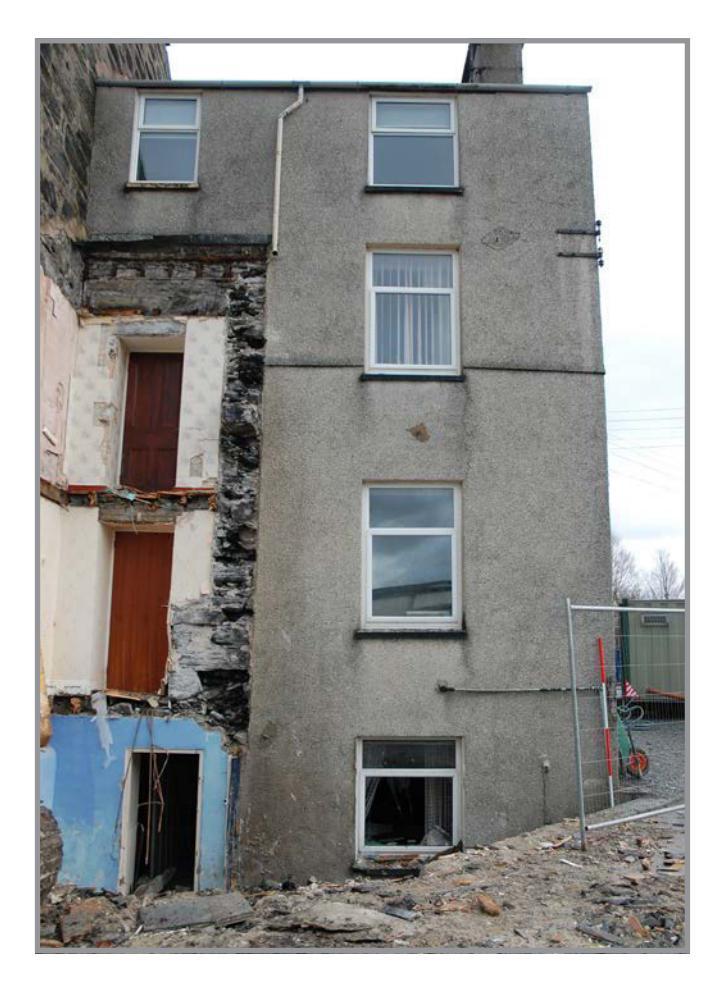
A 3-storey extension built on to the south-west elevation, containing bathrooms and access to the basement, had already been demolished before the survey was carried out. The remainder of the elevation contains five 2- light casement windows in original openings (plates 4 and 5).

Plate 4: South-west elevation showing the demolished 3 storey extension

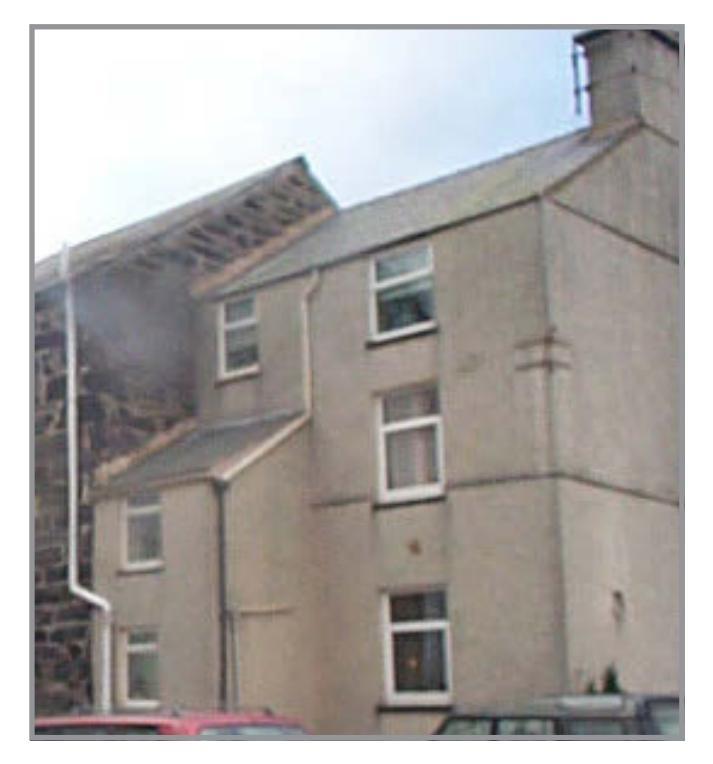
Plate 5: South-west elevation prior to the demolished of the 3 storey extension

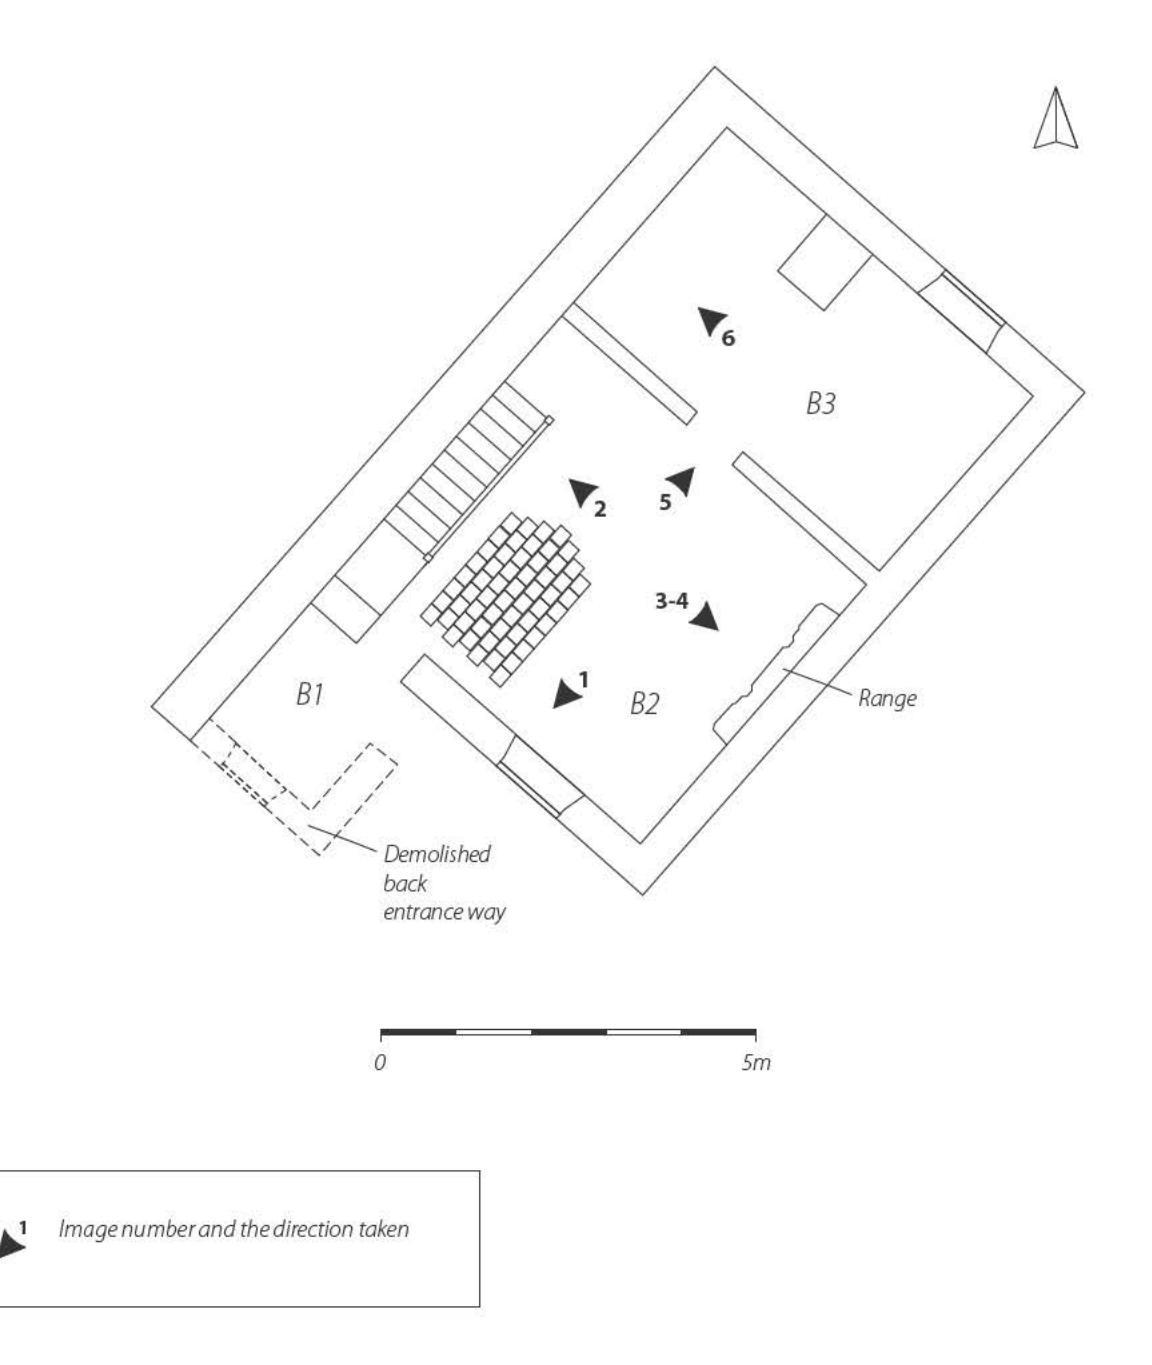
Figure 12: Basement plan of building B

The basement consists of three rooms, the entrance (B1) which is now demolished. Room B2 has replacement 2 light casement windows and a boarded door in original openings. All walls but the south-east are panelled up to 1.5m. On the south-east wall is a range made by Owen Roberts & Co of Porthmadog. Either side of this range are built in moulded cupboards. The

B3 has been used as a wet room and contains concrete plinths. It has a replacement 2 light casement window in an original opening

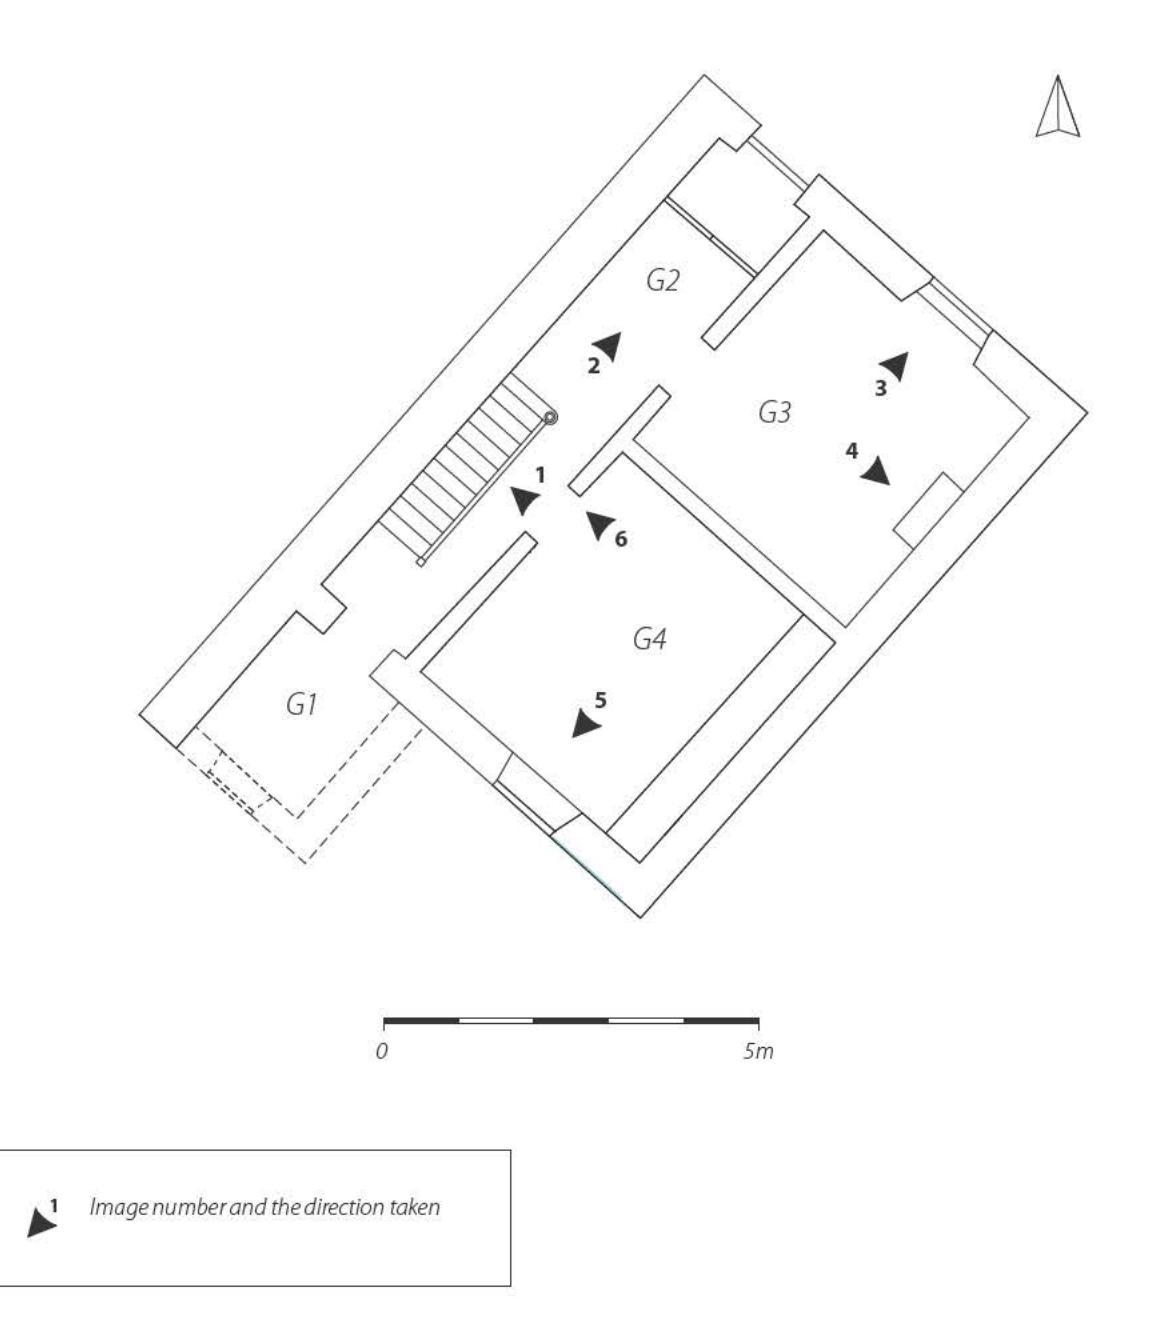
Figure 13: Ground floor plan of building B

The ground floor consists of four rooms, one of which (G1) which is now demolished. Ty'r Felin is accessed through the front door in the north-east elevation into the hallway G2, where decorative moulded stairs (image 1) lead up to the first floor. The double door halfway through the hallway contains stain glass.

G3 contains moulded skirting boards and door surrounds. The window is a replaced casement window

G4, which is the location of the kitchen and therefore the work surfaces mask many of the features, contain moulded skirting boards and door surrounds. The window in the south-west wall is a replaced casement window in an original opening.

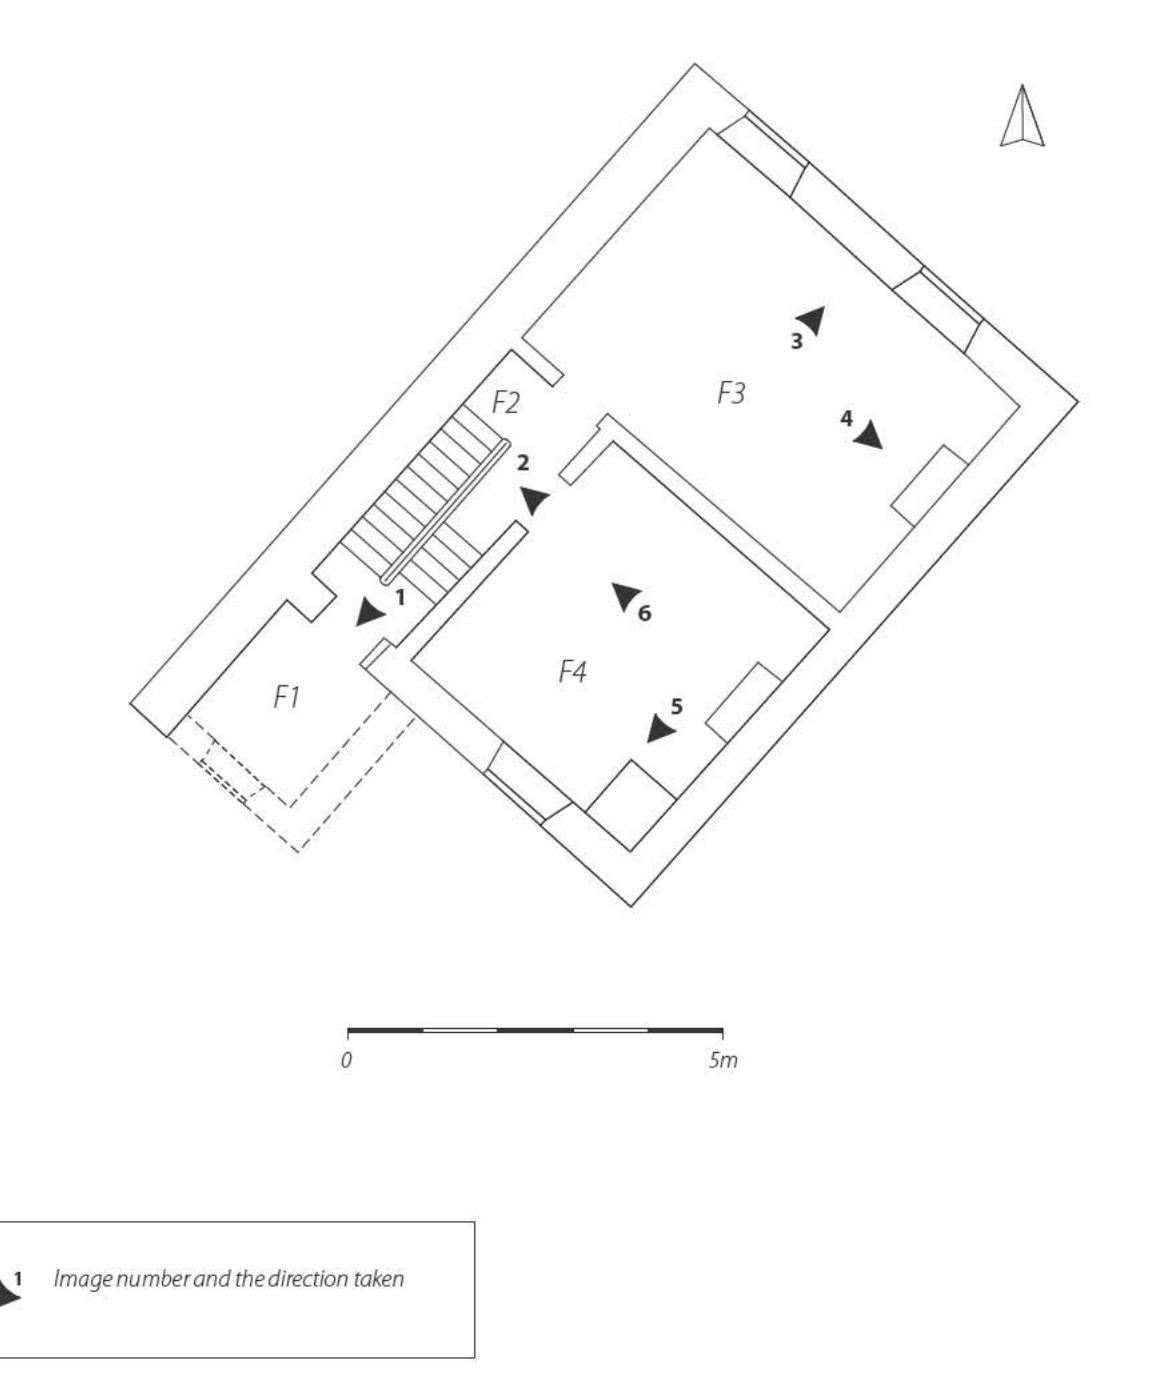
Figure 14: First floor plan of building B

F3 contains 2 replacement casement windows in there original moulded and panelled opening. The original location of the fireplace can be seen in the area of decorative hearth tiles. The skirting boards have been replaced and the door in the south-east wall has been replaced but it retains it's original moulded opening.

F4 contains a replacement casement windows in there original moulded and panelled opening. The door in the north-west wall has been replaced but it retains it's original moulded opening. The skirting boards are original and moulded

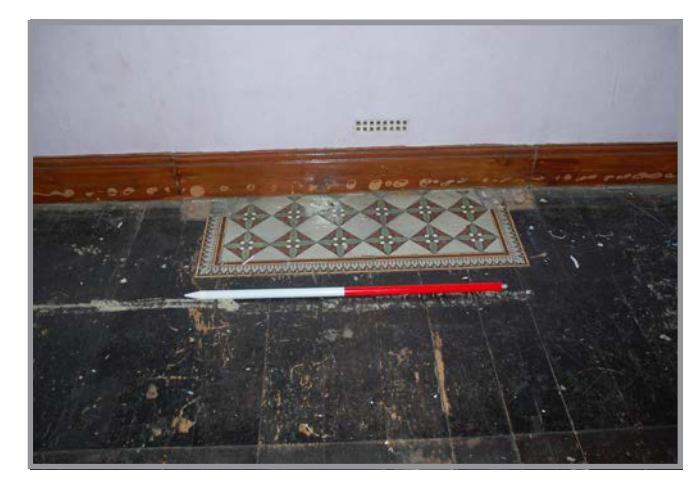
Image 4: First floor room 3 (F3). South east view tiled fire surround.

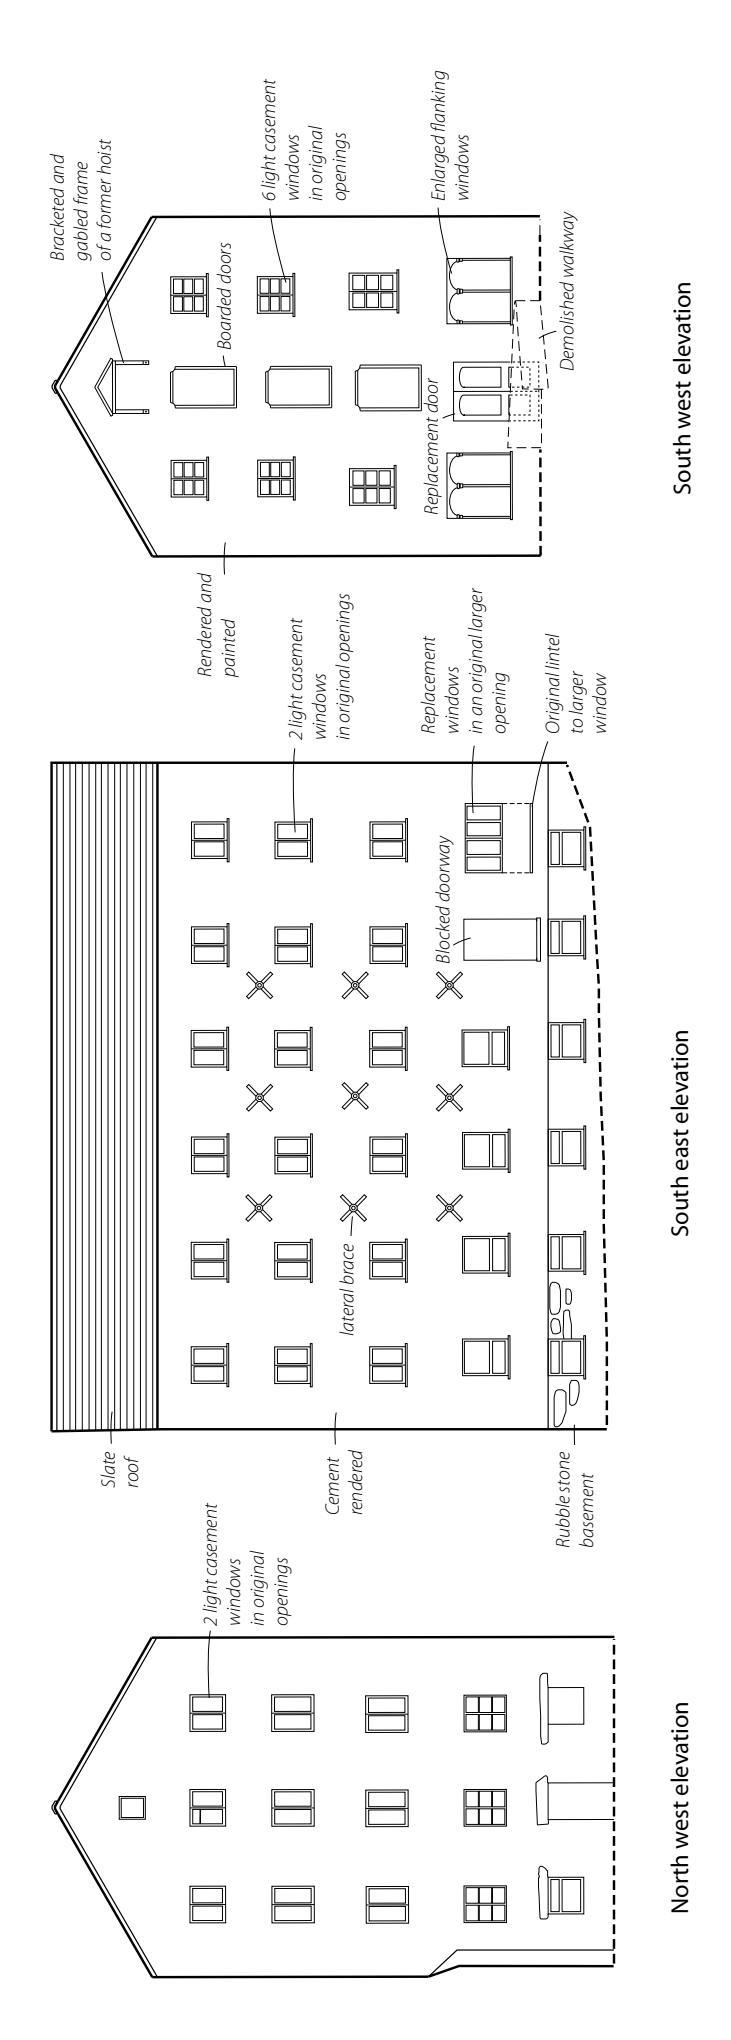
Figure 16: Elevations of building C

The south west gabled elevation is rendered and painted white. On its ground floor it has a replacement door and enlarged flanking windows. On the three floors above this are 3 superimposed boarded doors under shoulder heads with 6 light casement windows on either side. A bracketed and gabled former hoist can be seen above the third floor.

The north east gable end has exposed slate stone rubble laid in rough courses and larger rectangular quoins. A replacement door is flanked by casement windows one of which (right) is blocked. The ground floor has three 6-light windows in original openings and the two upper floors have nine casement windows in the original openings.

The south east elevation is of roughly coursed blocks and has been greatly disturbed by the edition of the link building. The upper floor windows are all blocked and nine doors have replace windows due to the creation of the link building.

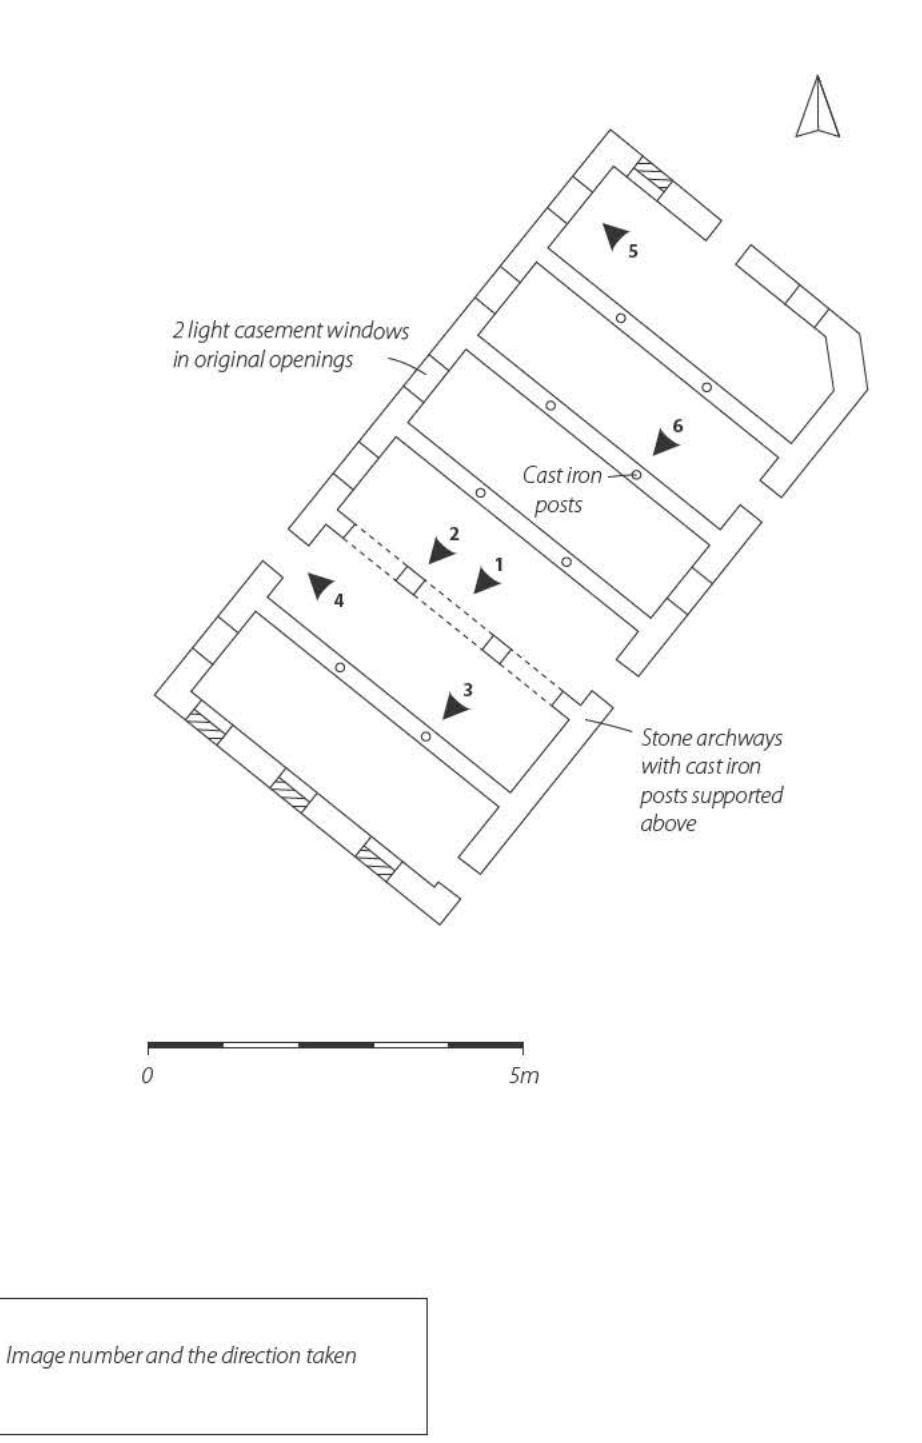
Figure 18: Basement plan of building C

The basement is divided by cast iron columns which continue through the full height of the building. Six bays are divided by two equally spaced columns across the building. The two columns within the second bay from the south of the basement are replaced by a segmental arched arcade of two stone pillars, which in turn support the iron posts above. The floor of the basement is of large slate slabs.
