Snowdon Mill: Porthmadog

Level 3 archaeological building record

GAT Project No. 2057 Report No. 806 May, 2009

Prepared for Q Williams Construction on behalf of Belgrave Homes

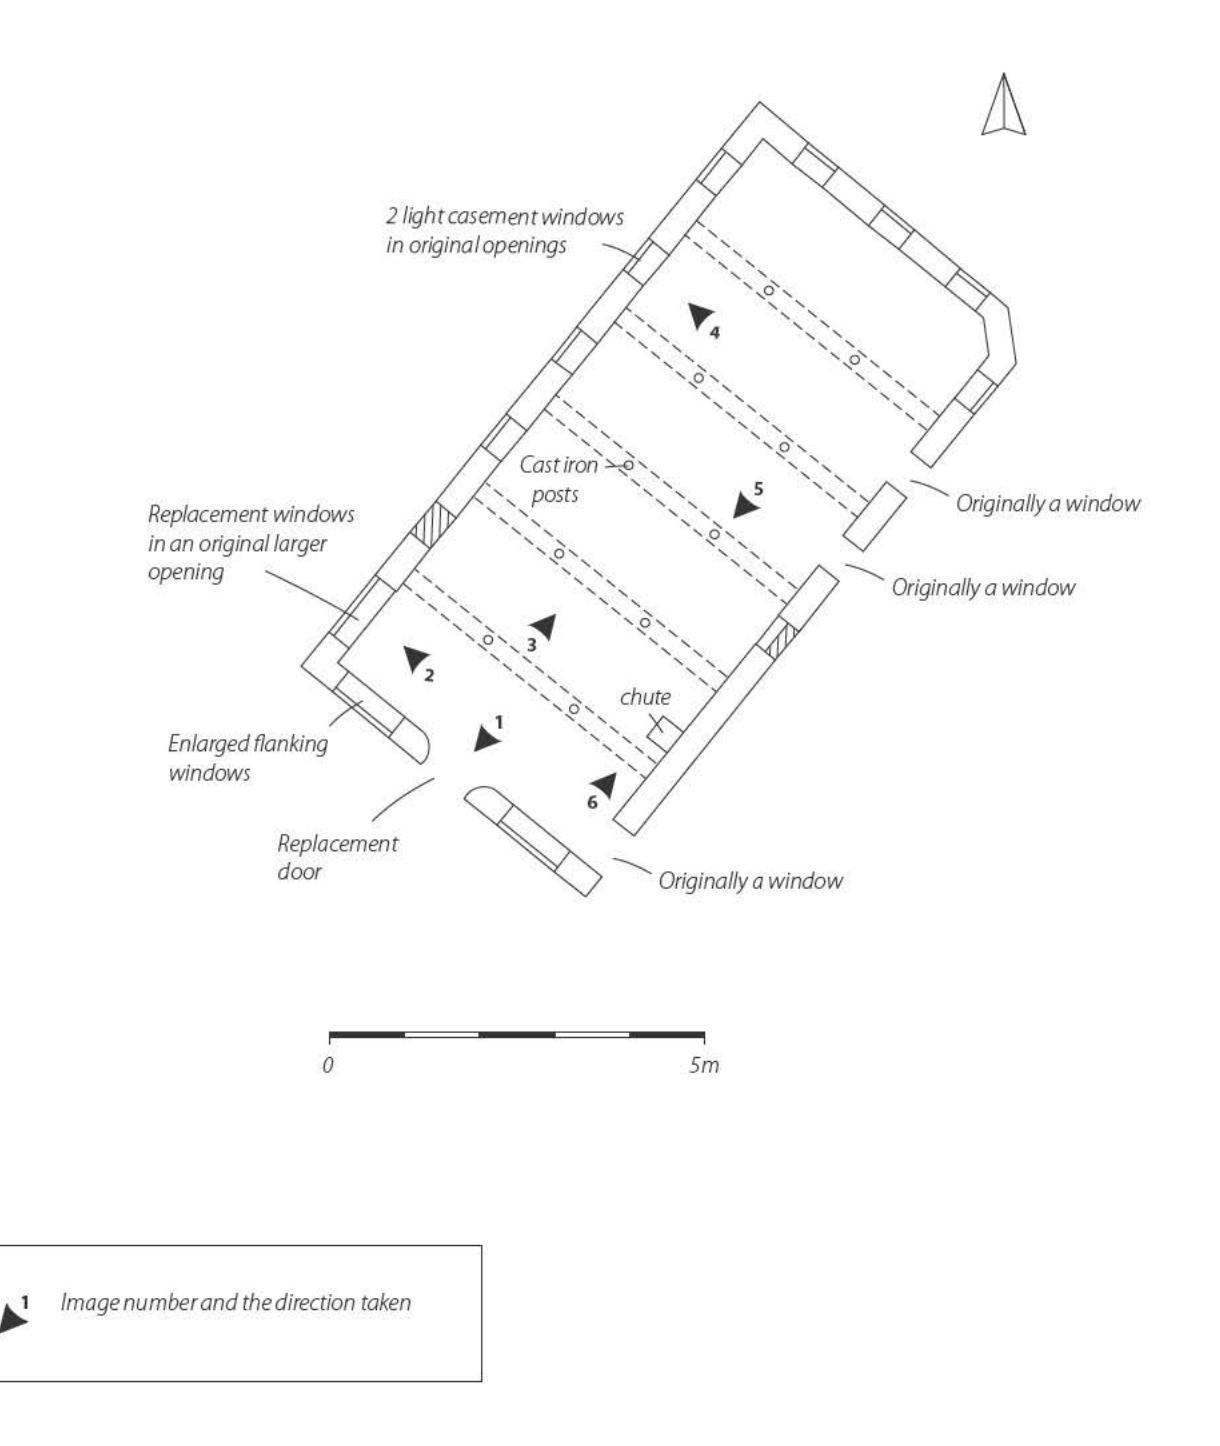
Figure 19: Ground floor plan of building C

The ground floor is divided by cast iron columns which continue through the full height of the building. The south west wall has replacement door and enlarged flanking windows. On the north west wall there are replacement windows in larger openings on its far right and a blocked doorway to the left of this. The windows are replacement casement windows in original openings. 3 windows in the south east wall have been converted to doors with the addition of the link building.

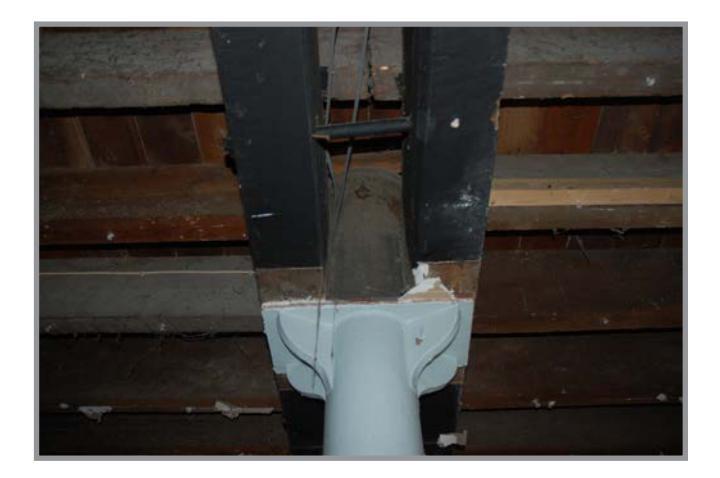
Image 5: Detail of cast iron posts with double beams for reinforced support

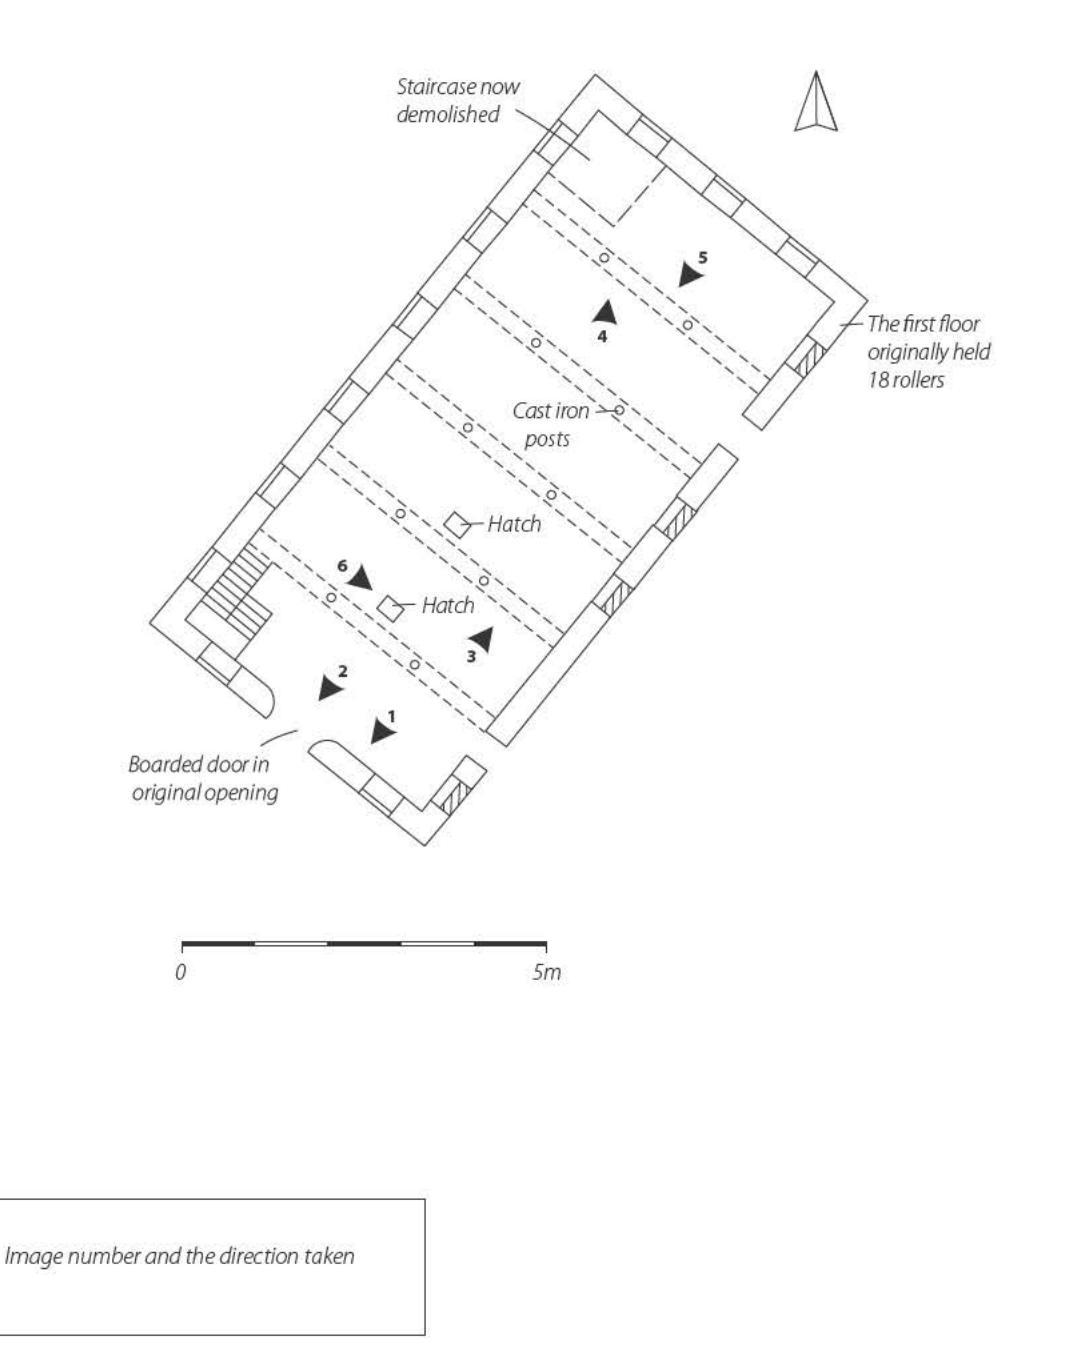
Figure 20: First floor plan of building C

This floor contains replacement casement windows in original openings, 4 of these windows have been blocked in the south-east elevation and 2 in the same elevation converted to doors.

There are 2 hatches to the south-west which relate to the hoist on the third floor.

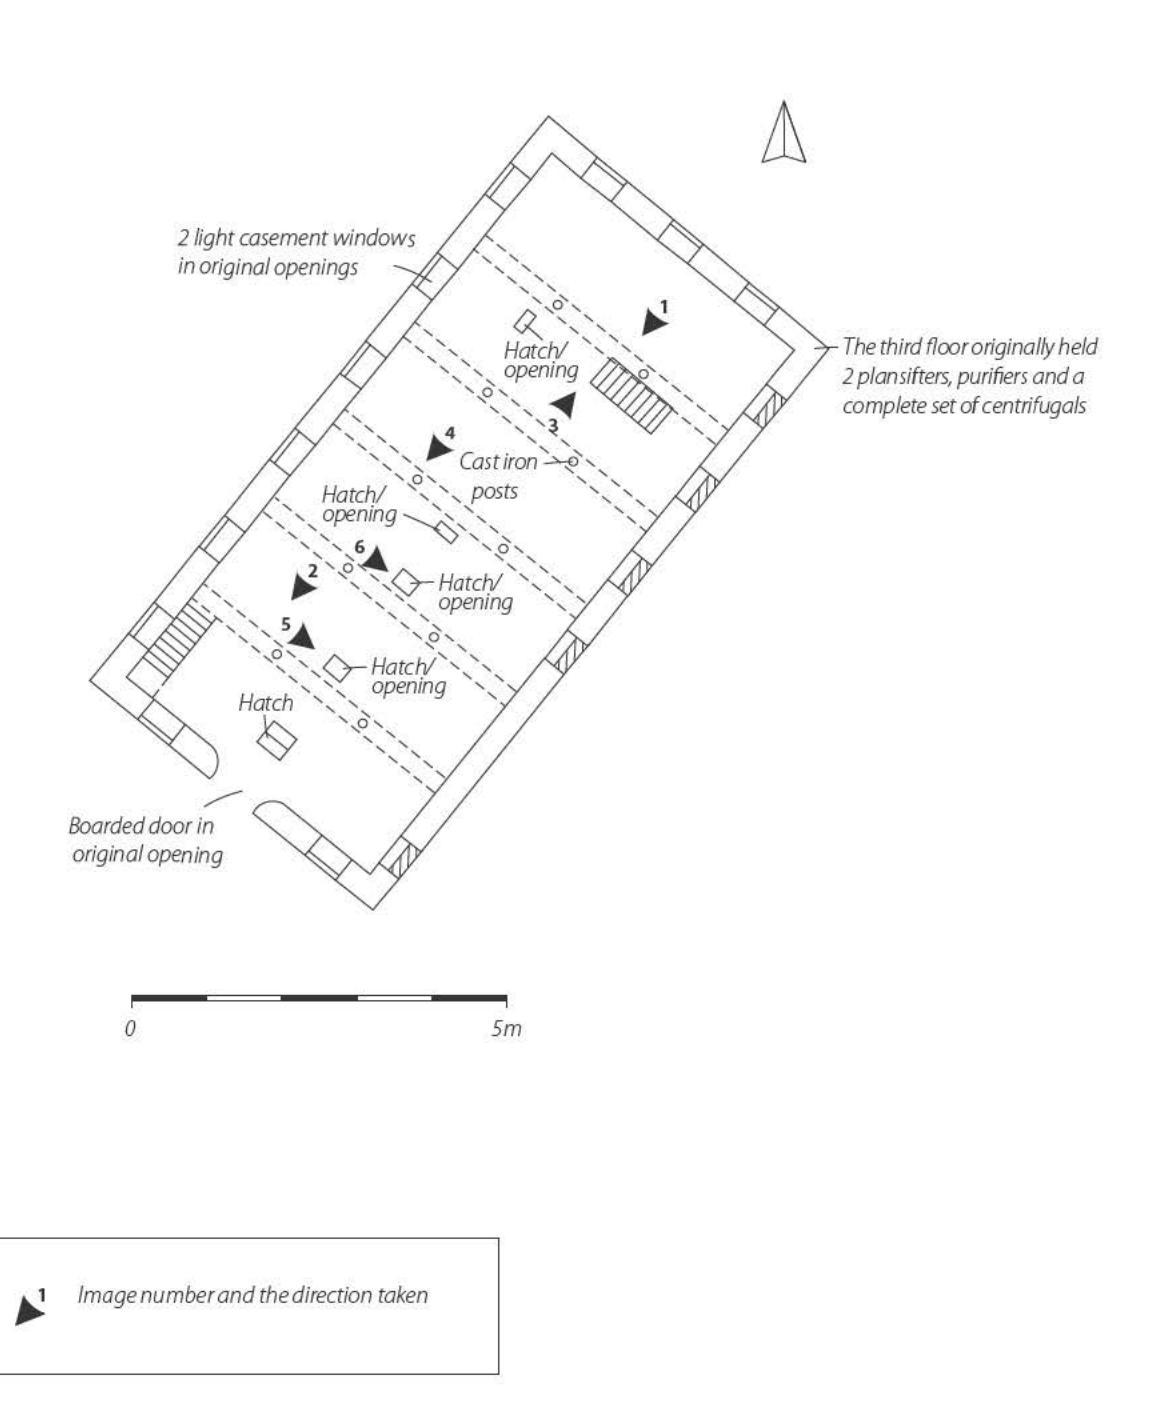
Figure 22: Second floor plan of building C

Archive evidence suggests that this floor originally contained 2 plansiffers, purifiers and a complete set of centrifugals. This floor contains replacement casement windows in original openings, 5 of these windows have been blocked in the south-east elevation.

There are a variety of hatches and openings to the south-west, one of which is a double door hatch, which relate to the hoist on the positioned above.
