# PRS REPLACEMENT, MENAI BRIDGE, YNYS MÔN

# SERVICE TRENCH WATCHING BRIEF

Archaeological Watching Brief

GAT Project No. 2061 Report No. 833 October 2009

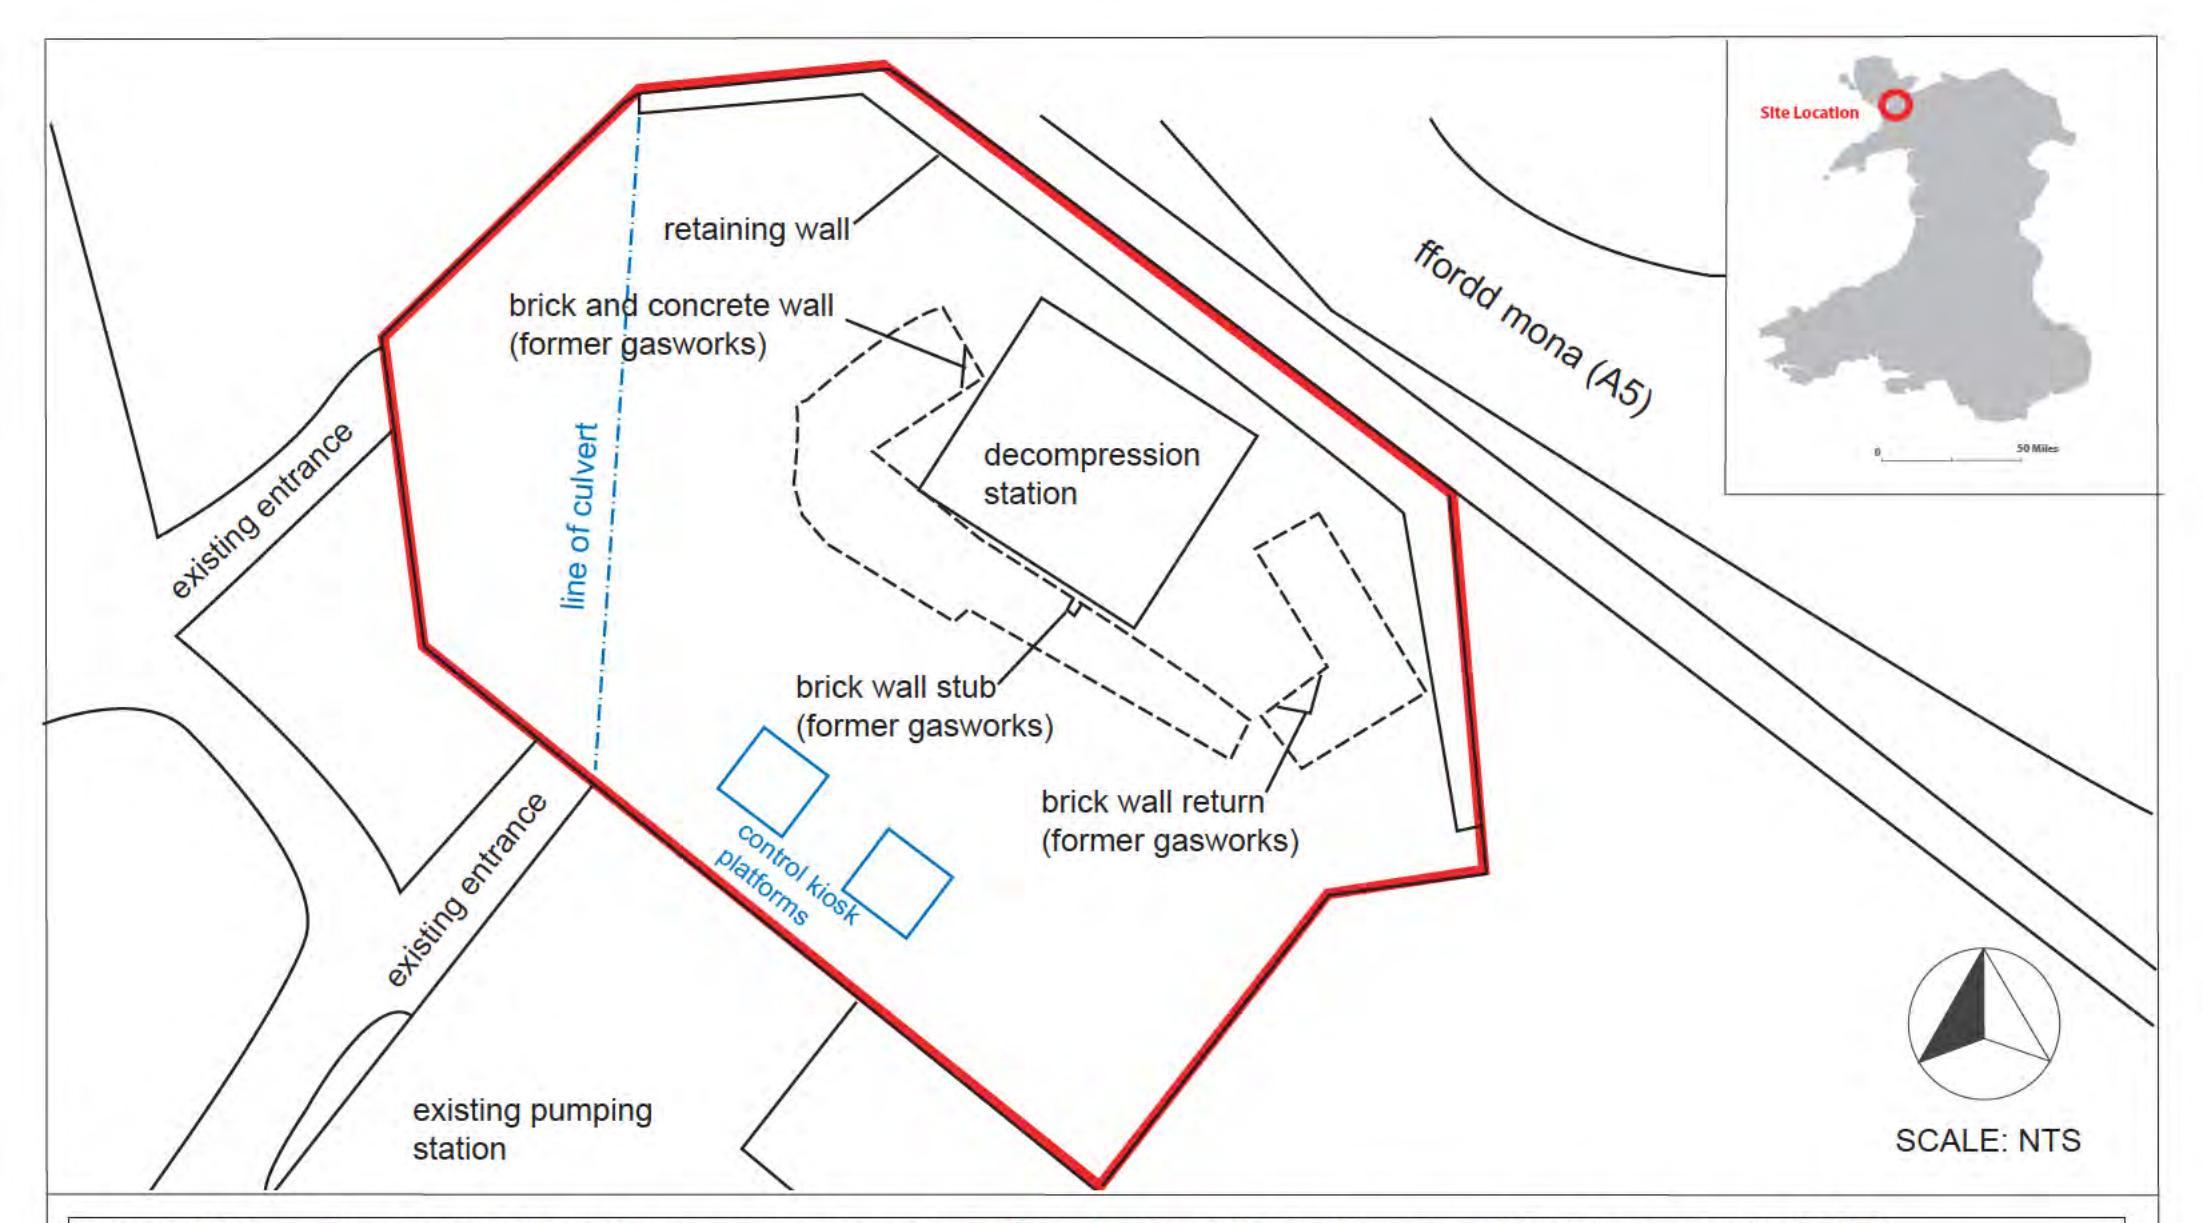
Figure 05: Location of the PRS replacement area based on client drawing "District Governors MP & LP Outlet: Ref. 006". The outline of the decompression station is highlighted in RED. A return wall associated with the gasworks was identified at the eastern end of the decompression station during groundworks. The return may represent the southeastern corner of a building attached to the main building block (cf. figure 04 & plate 15). A stub of brick wall was identified south of the unit beneath 0.60m of demolition/levelling material (plate 13). The brick wall stood eight courses high and was of English bond (frogged). A similar course of brickwork was identified c.2.0m to the southeast, within the same excavated area (plate 13). This portion was faced with concrete on the northeast facing elevation. The bricks did not match those used for the decompression station and were interpreted as part of the former gasworks. Note: dashed lines equal groundwork areas

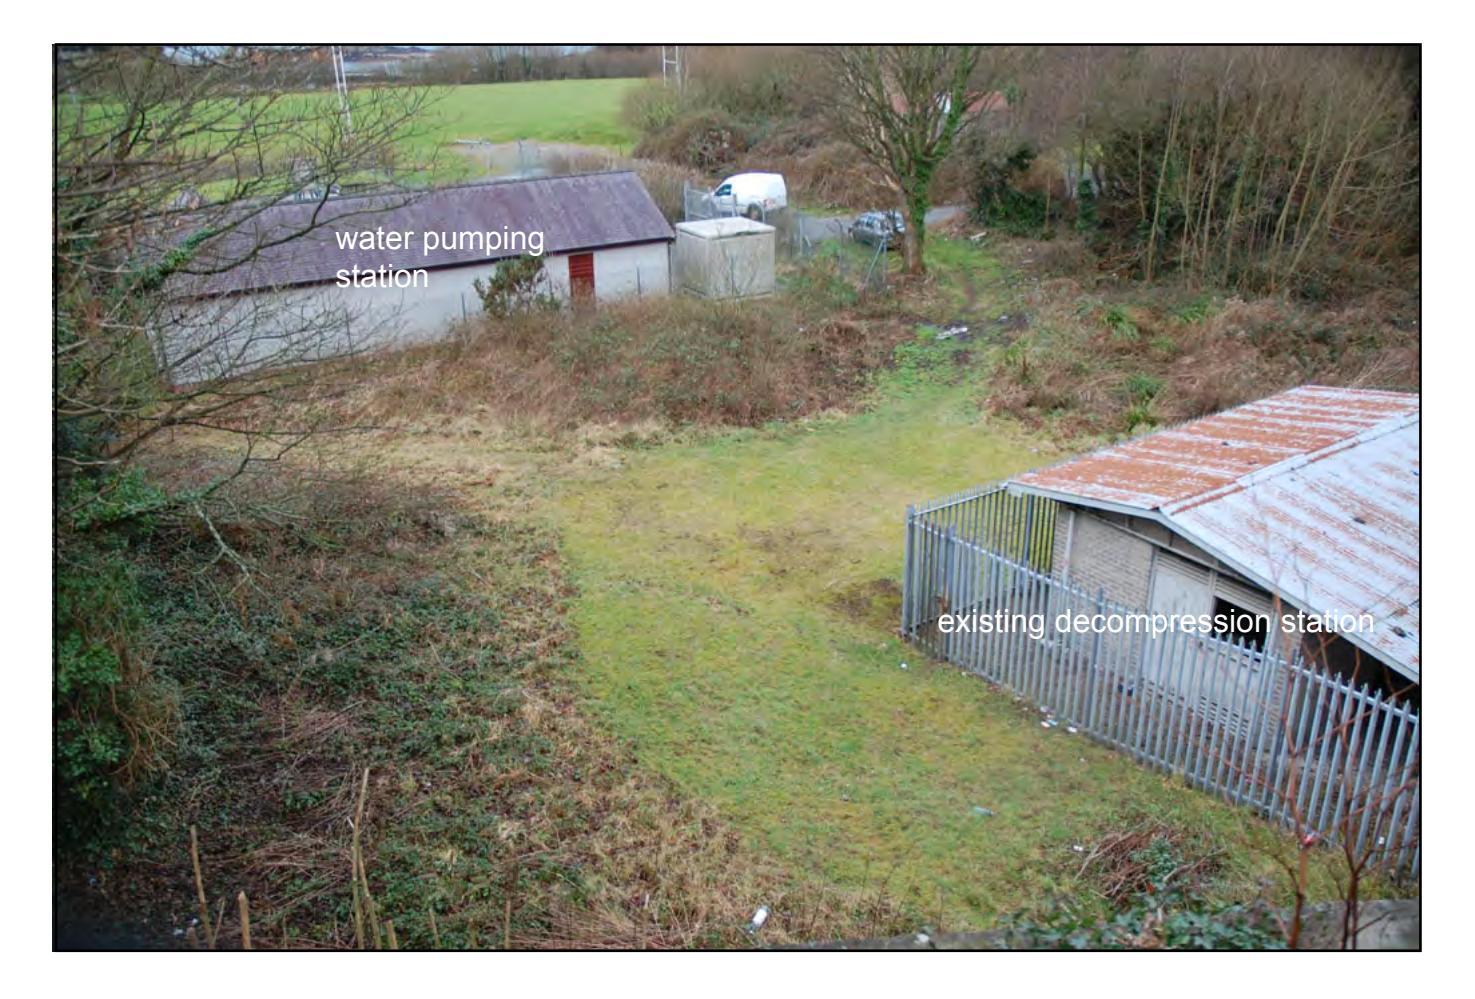
Plate 01: view southwest of site prior to PRS replacement works. The former gasworks is located within the centre of the image and the location of the decompression station

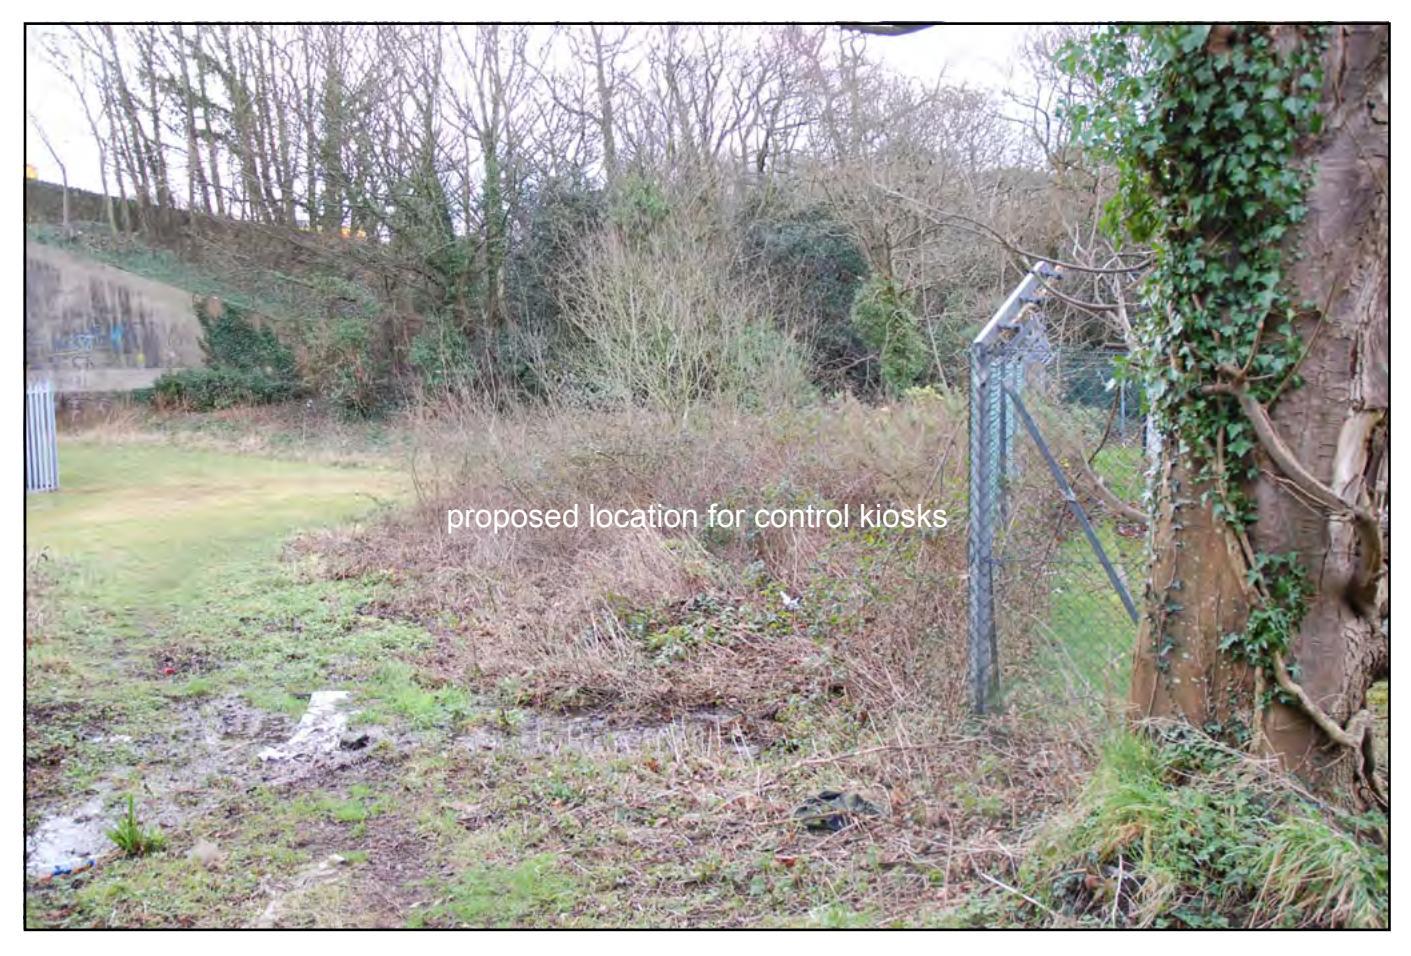
Plate 02: view east of proposed location for control kiosks assocaited with the PRS replacement works. No known gaswork structures were identified at this location. The former retort house was located within the fenced area at the right of image, in what is now a pumping station compound.

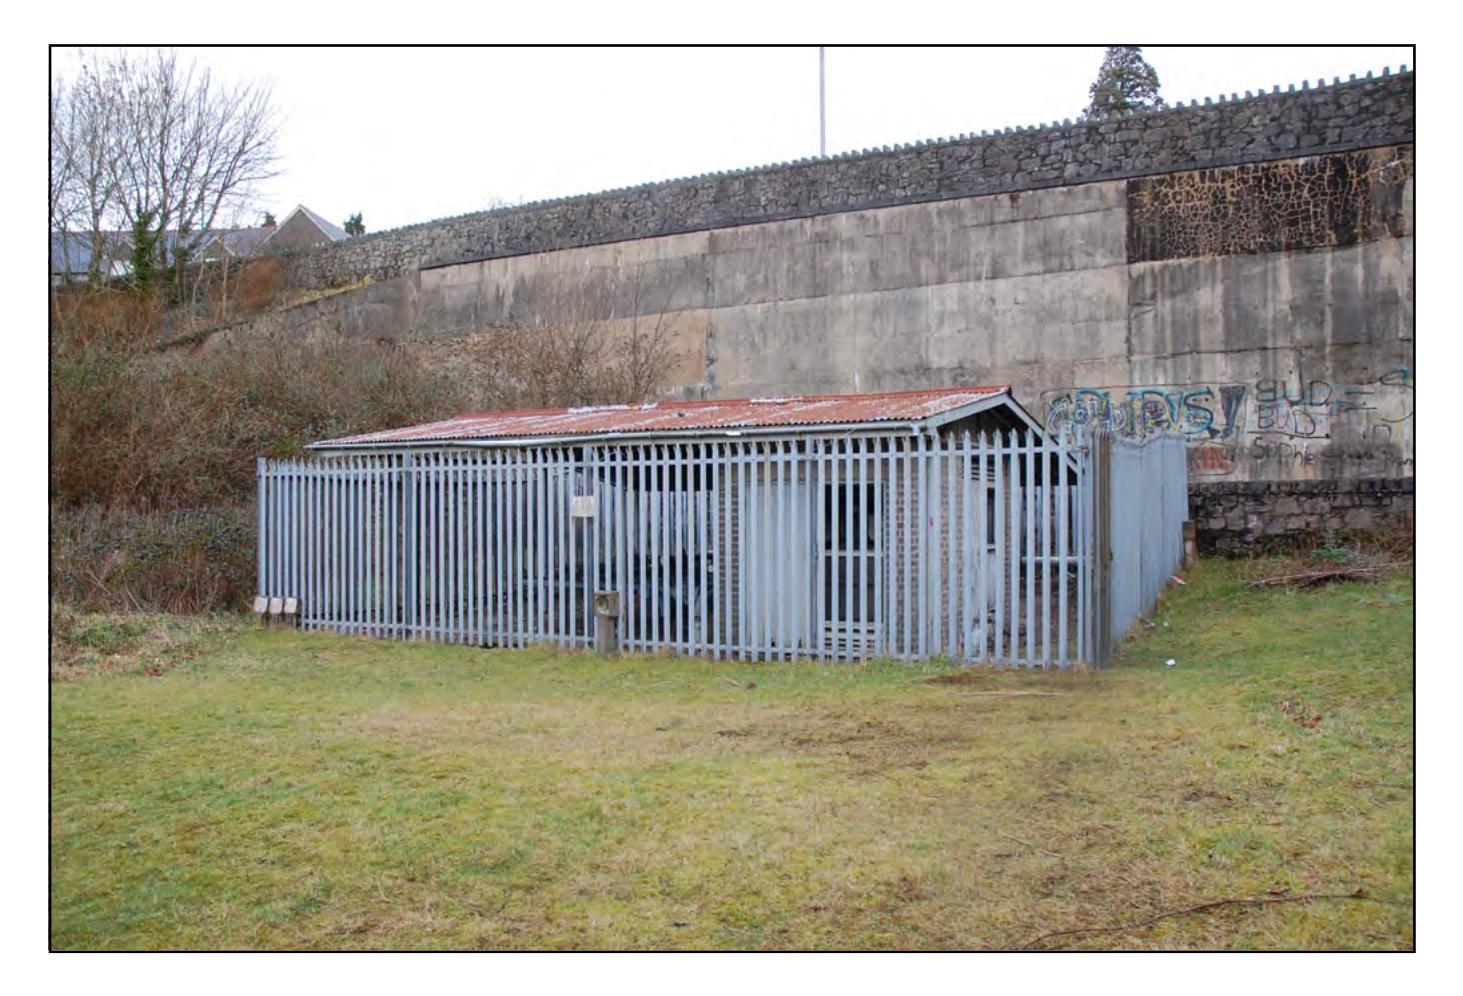
Plate 03: view northwest of existing decompression station. Former location of the majority of the gaswork structures. The large retaining wall is associated with twentieth century road improvements and was not extant during the operation of the gasworks

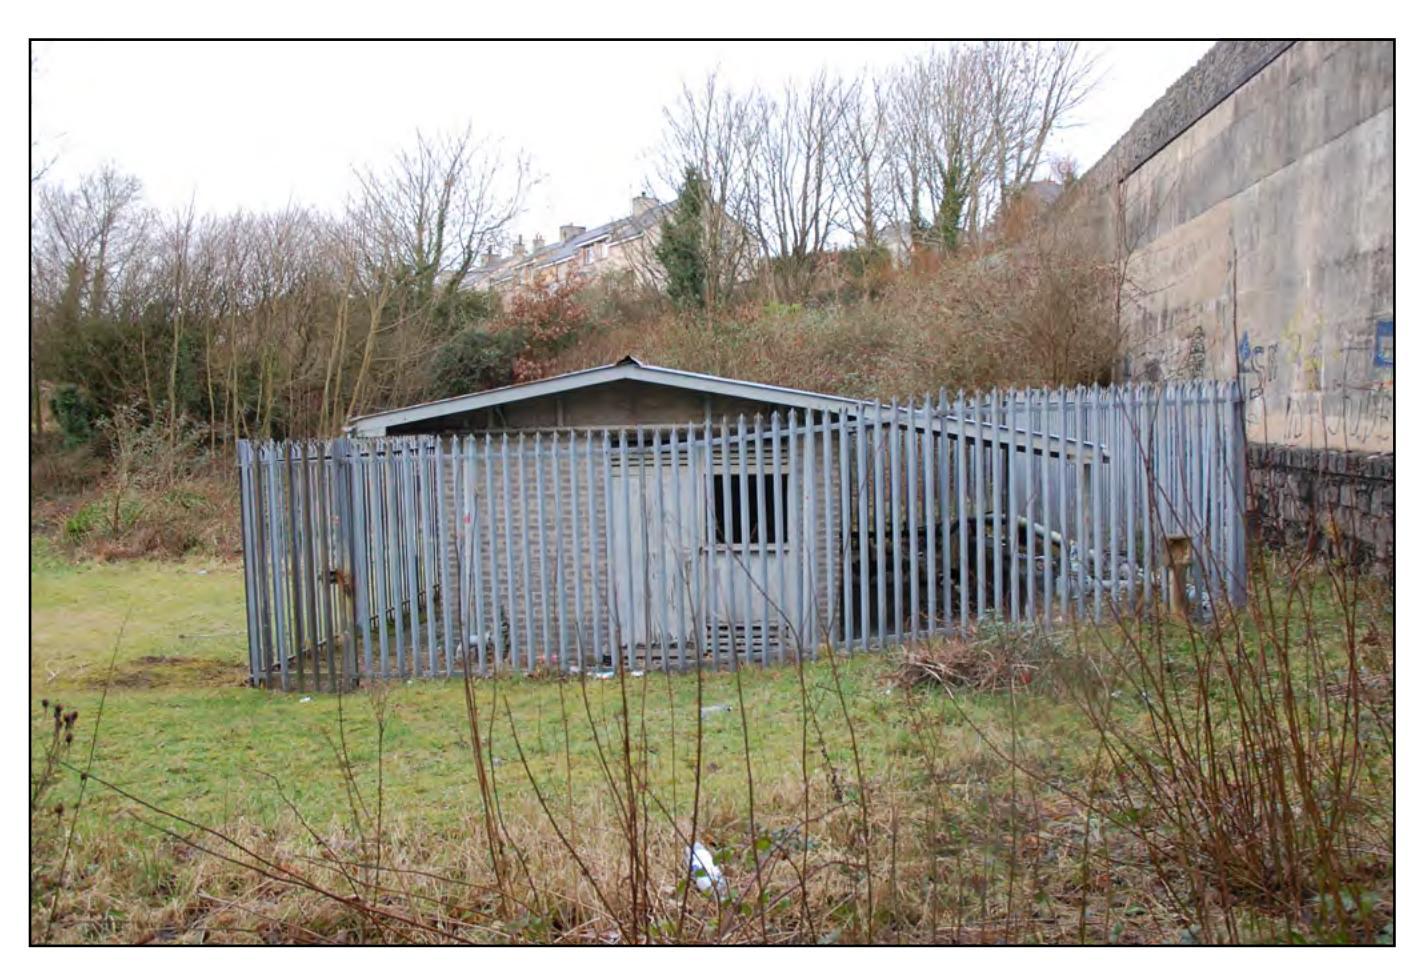
Plate 04: view west of existing decompression station. Former location of the majority of the gaswork structures

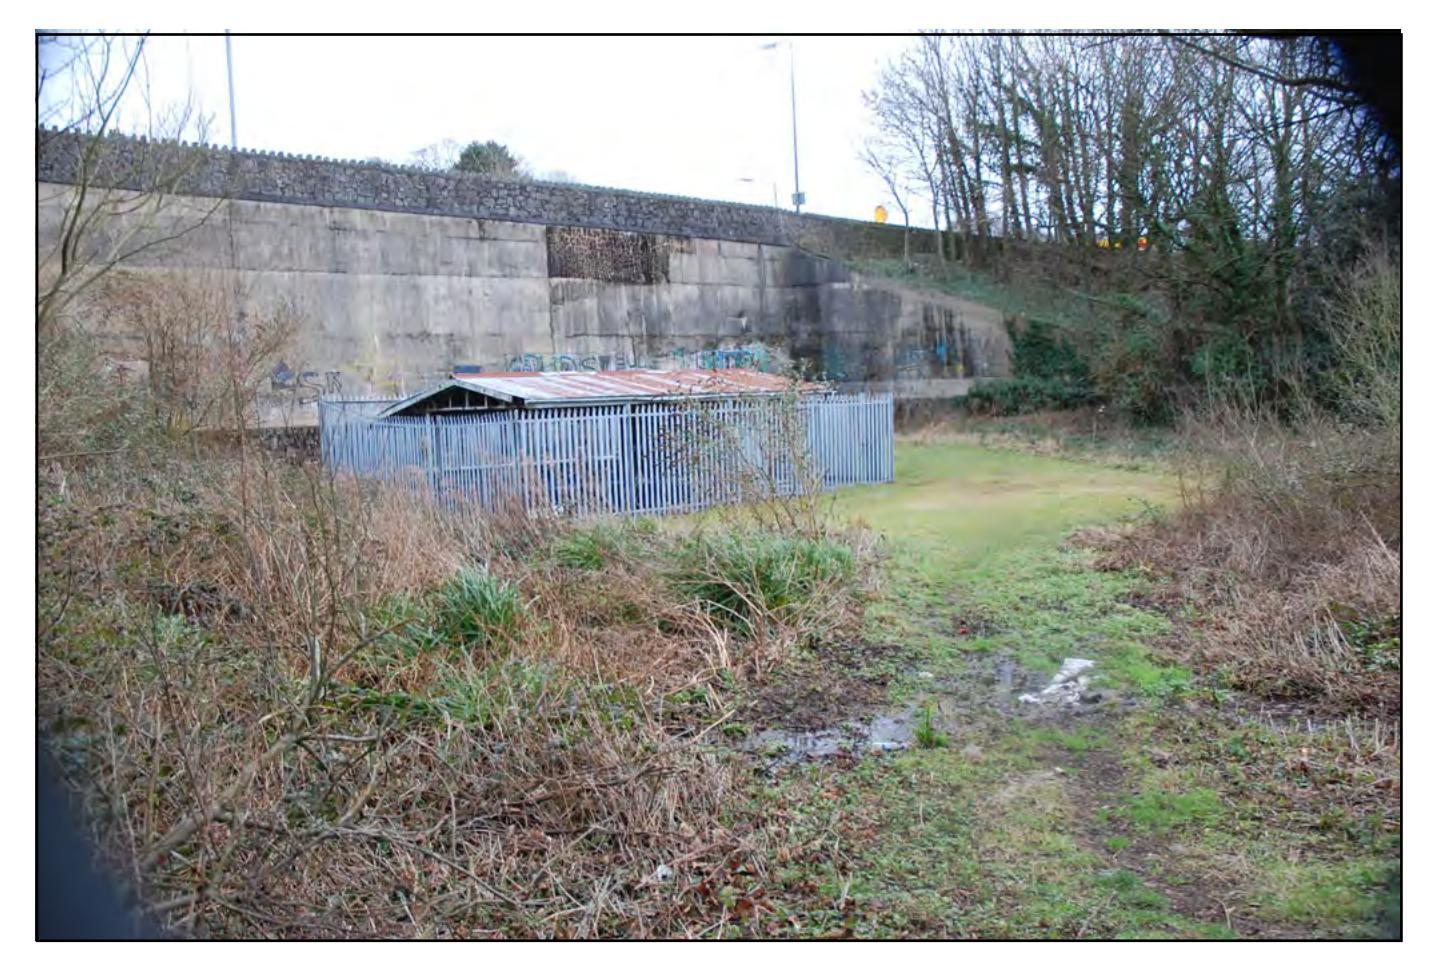
Plate 05: view northeast of existing decompression station prior to start of the groundworks, detailing former location of the gaswork structures. The large retaining wall is associated with twentieth century road improvements and was not extant during the operation of the gasworks.

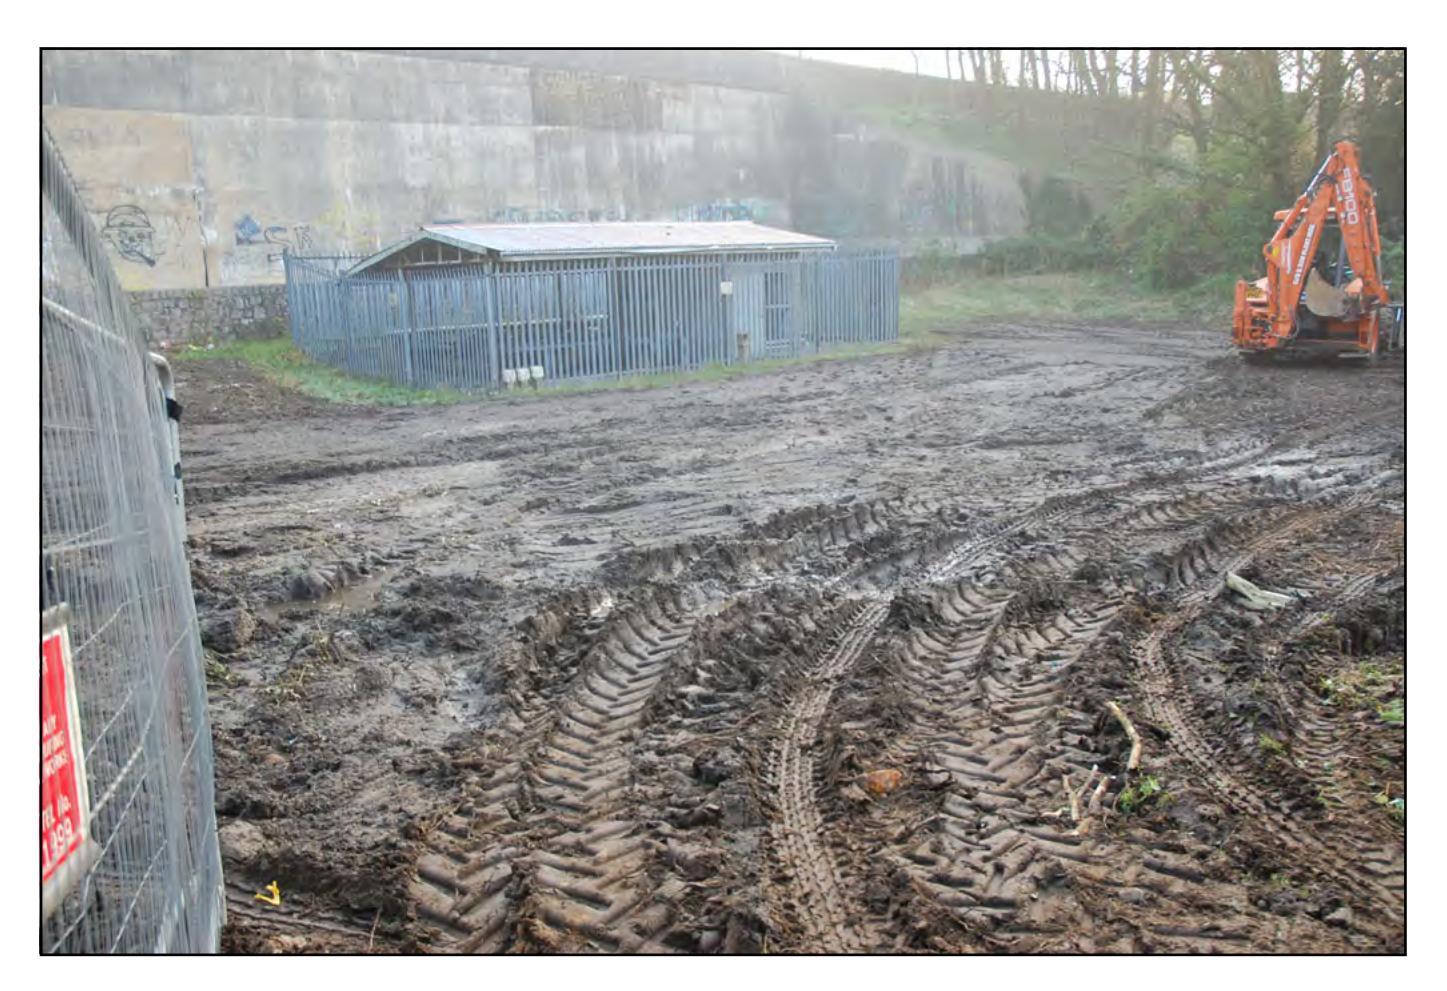
Plate 06: view northeast of existing decompression station during initial groundworks, detailing vegetation clearance and topsoil removal.

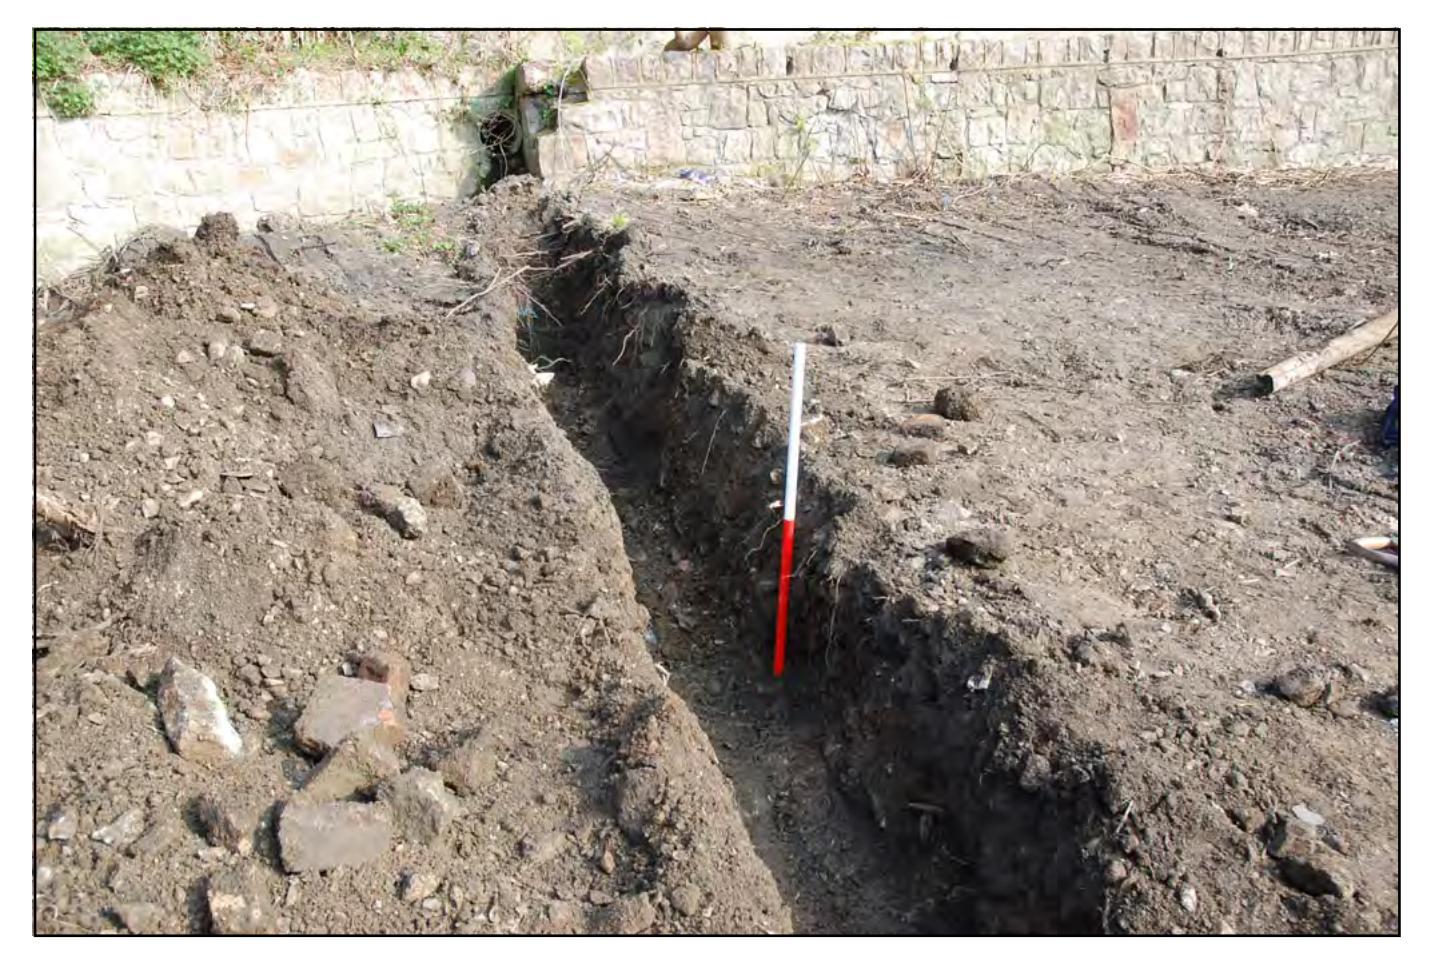
The culvert was designed to replace an existing open culvert that ran from the western end of the site to the southern end, starting from the western of the retaining wall (plate 07). The replacement culvert was excavated to a depth between 0.50m and 0.80m (plates 07 and 08), terminating at a large soakaway at the southern end of the site, excavated to a depth of 1.50m (plate 09).

The initial 3.50m length of the culvert excavtion comprised soft made ground with fragmented brick and stone building material infill (plate 07). Two redundant steel pipes

Plate 07: excavation of culvert trench detailing full depth. The initial 5.0m of the culvert was outside the original gasworks enclosure; the retaining wall was built for the decmpression station. The stratigraphy comprised made ground, including demolition material possibly associated with the former gasworks. (Scale: 1.0m)

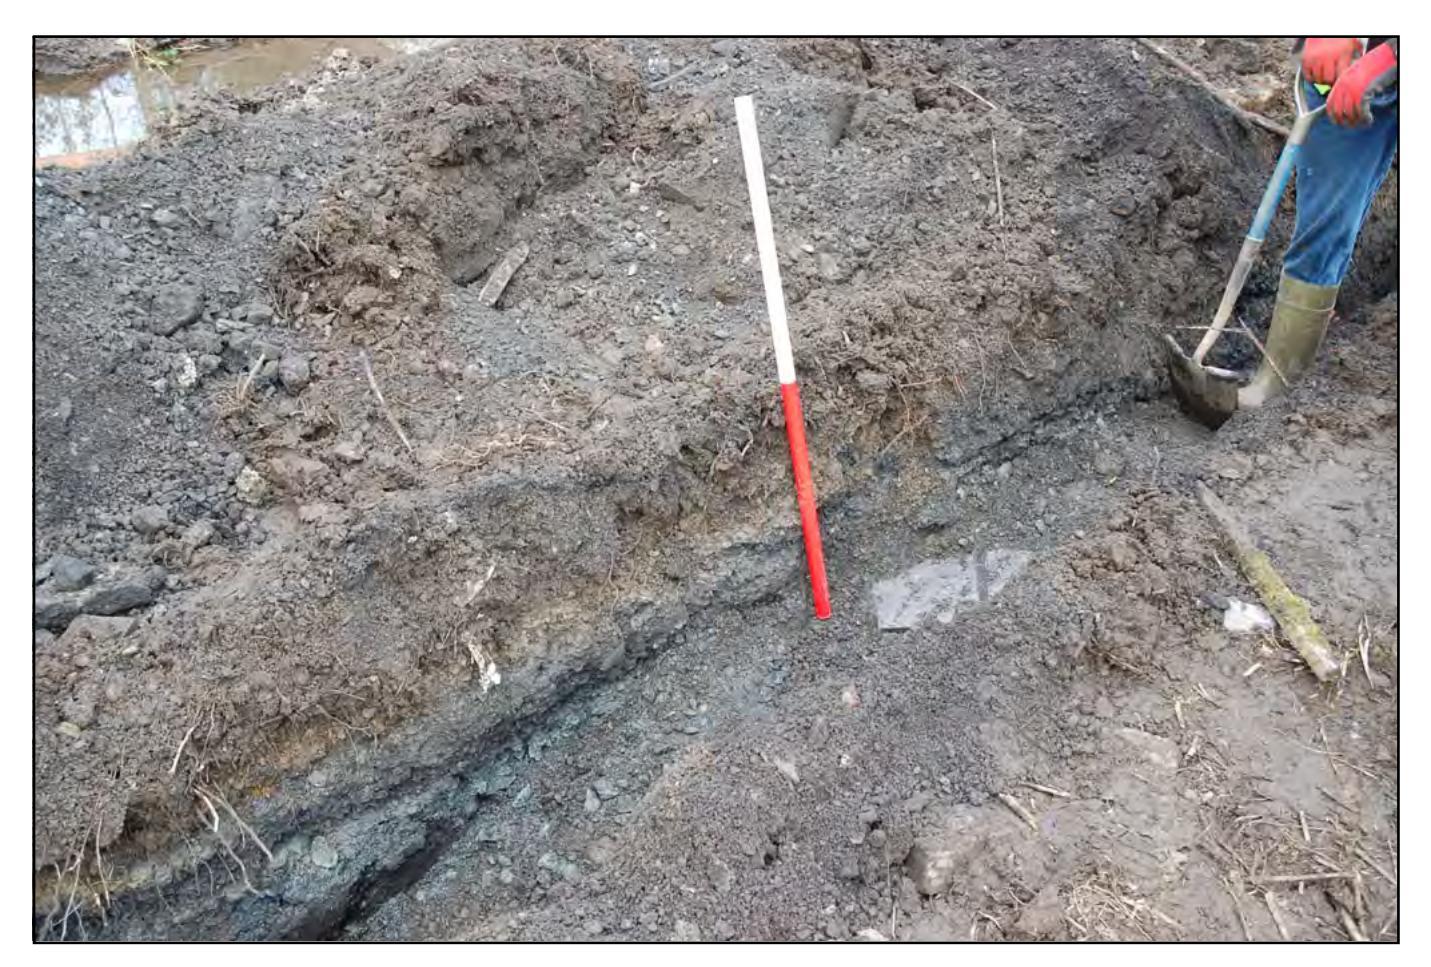
Plate 08: view southwest of culvert excavation within former gasworks plot, detailing full excavation depth. Stratigraphy comprised made ground, including imported gravel. Note the slate capped culvert close to the ranging pole; this culvert was blocked by silt. The photograph was taken at the former location of a gas holding tank, suggesting the culvert was laid after the tank was decommissioned (post-1947) (Scale: 1.0m)

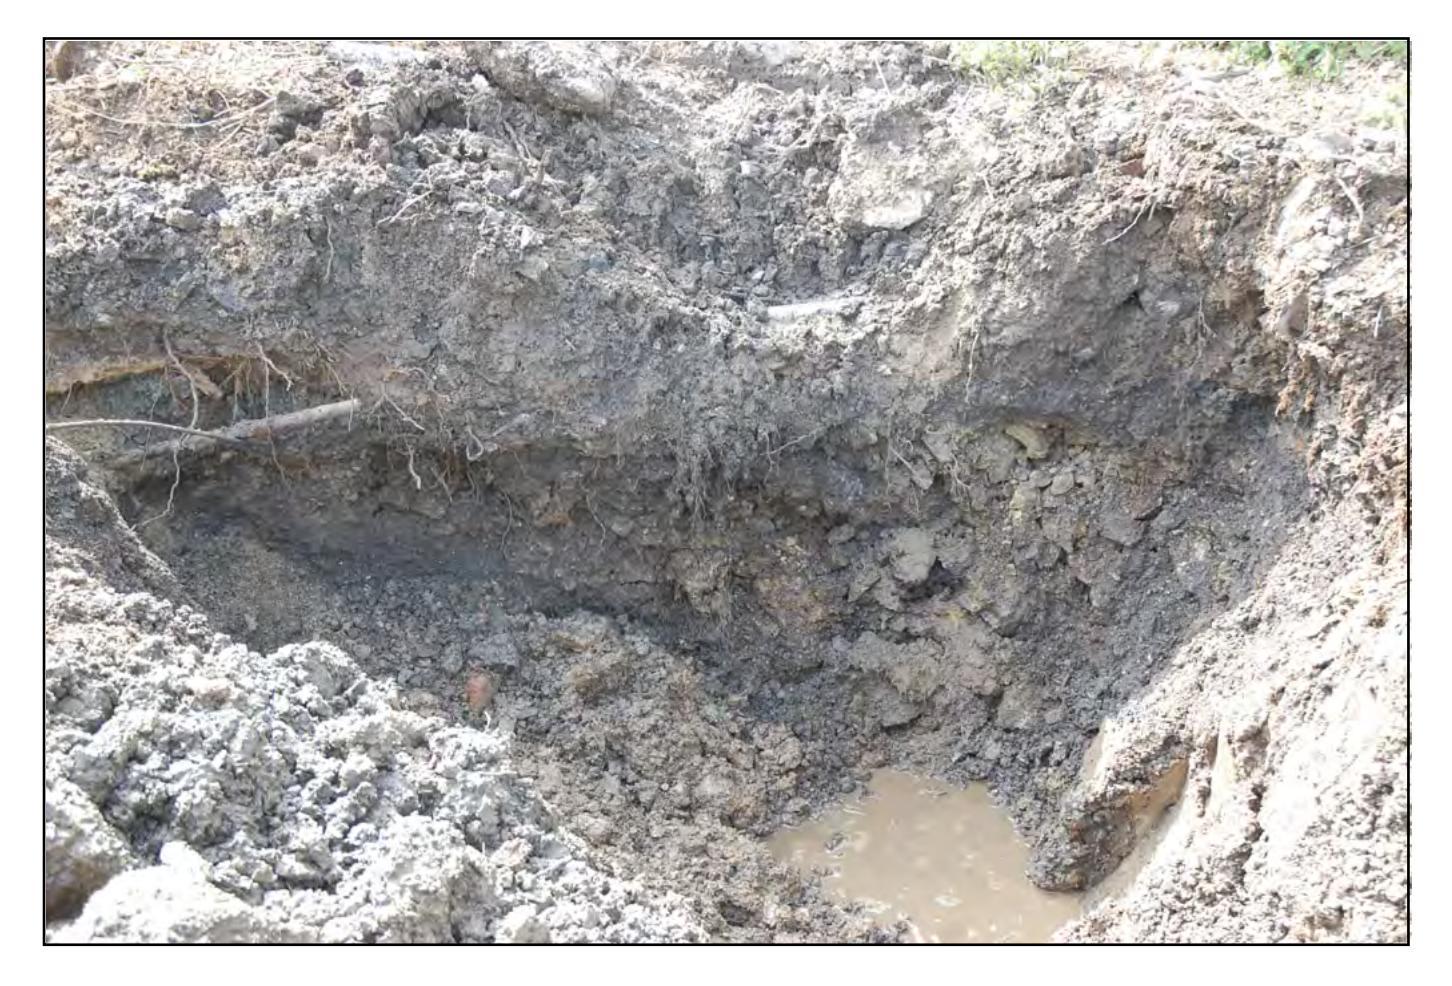
The remainder of the culvert excavation contained made ground, including redundant brick and stone building material and imported gravel. The former were interpreted as remnants of the gasworks, but were demolition rubble and not foundation material. No evidence of the gas holders were identified within the confines of the excavated area. The soakaway at the southern end of the culvert route contained infill/levelling material throughout, to the limit of excavtion at 1.50m (plate 09).

Plate 09: soakaway at the southern end of the culvert excavation route, which contained infill/levelling material throughout, to the limit of excavtion at 1.50m

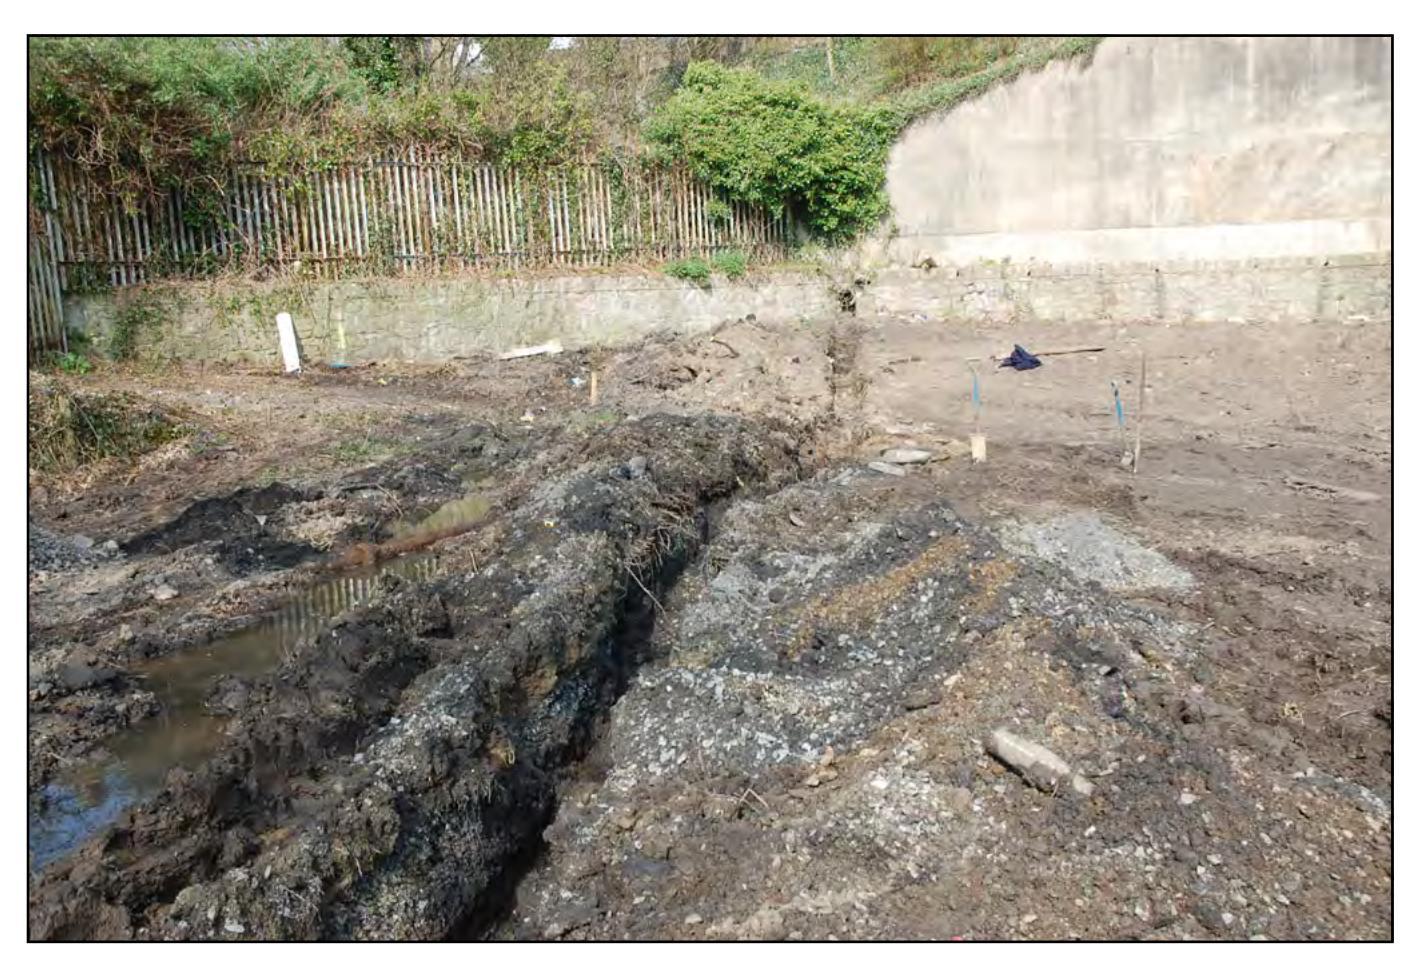
Plate 10: view northwest of culvert excavation route detailing total length and full excavation depth. Former location of gas holding tank in foreground: no evidence for the tank was identiifed within this area to the limit of excavation and the stratigraphy comprised made ground (including imoported gravel). The initial 5.0m of the culvert, leading from the retaining wall, was located outside the former gasworks enclosure (cf. plate 07)

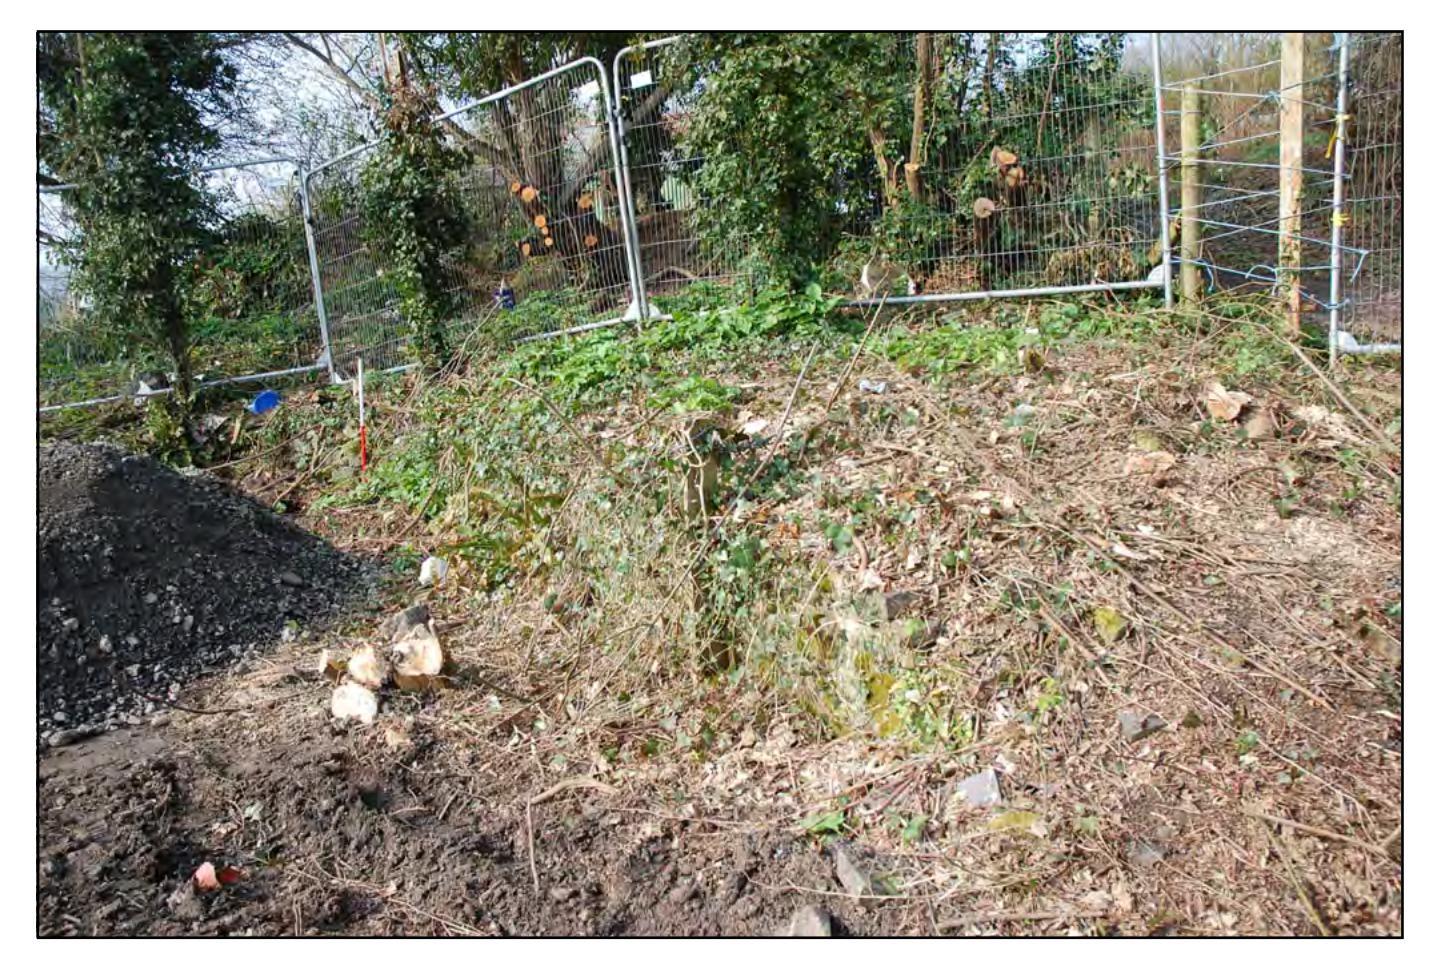
A remnant of the gasworks enclosure wall was still visible during the groundworks, however, to the south of the culvert, extant as a 6.0m long and 0.50m high stub (plate 11), built from irregular shaped stone (unbonded) and engineering brick, partially overgrown (plate 12). This wall had been breached to accommodate the larger decompression station enclosure (plate 12), but was still extant in this truncated form.

Plate 11: view southwest of redundant boundary wall associated with the former gasworks. The boundary wall appears to have been breached during the construction of the decompression station, post-1965, which extended the original plot of the gasworks. It was unclear whether the wall stood at an original height, due to vegetation overgrowth. (Scale: 1.0m)

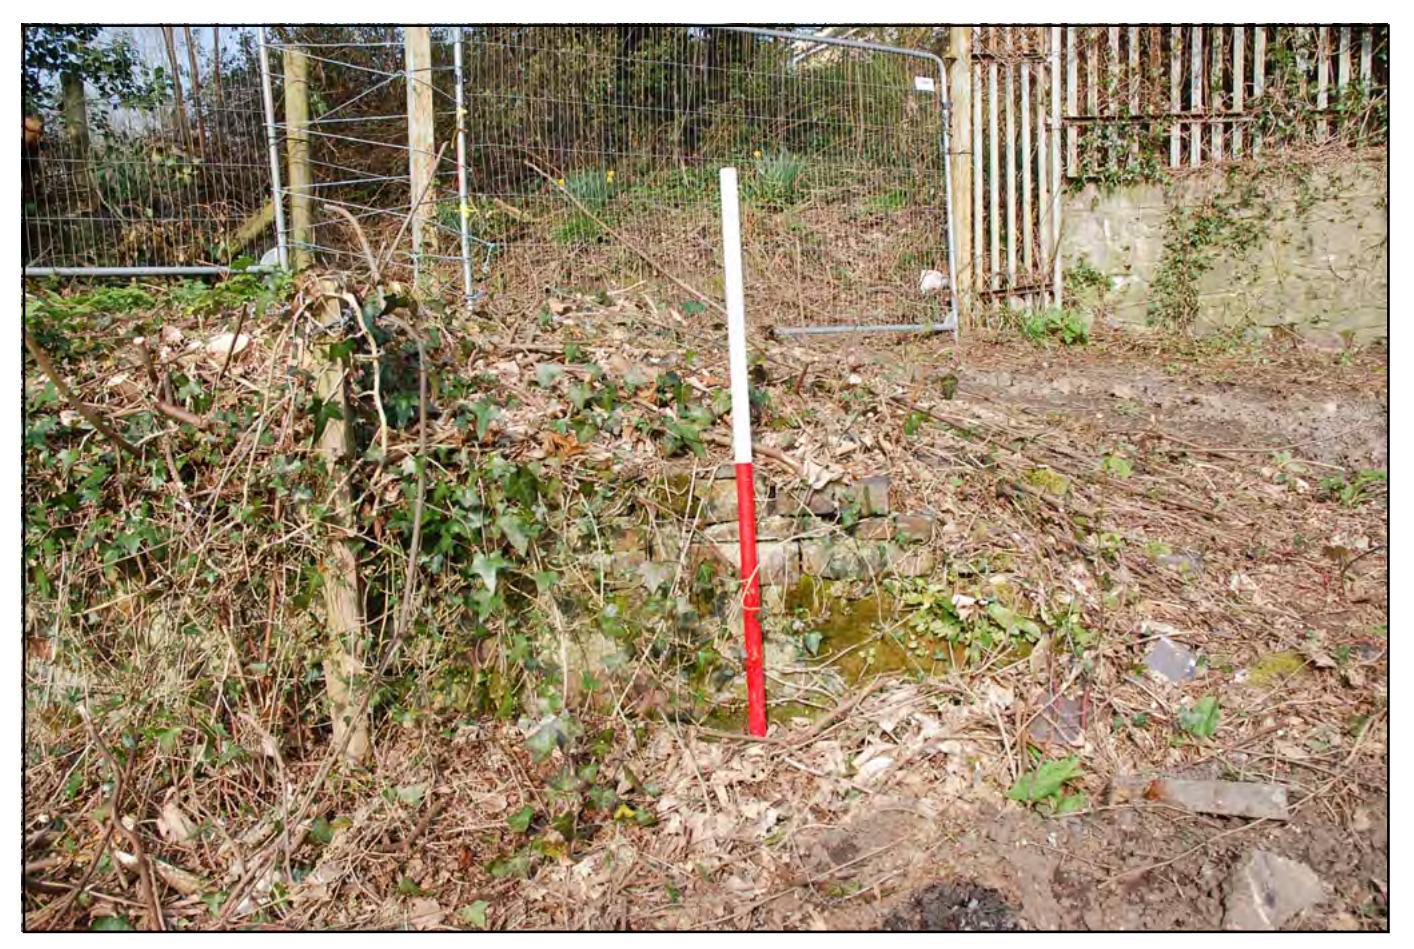
Plate 12: view west of redundant boundary wall associated with the former gasworks. The boundary wall appears to have been breached during the construction of the decompression station, post-1965, which extended the original plot of the gasworks. It was unclear whether the wall stood at an original height, due to vegetation overgrowth. The wall measured 6.0m in length and 0.50m in height and was built from irregular shaped stone (unbonded) and engineering brick. (Scale: 1.0m)

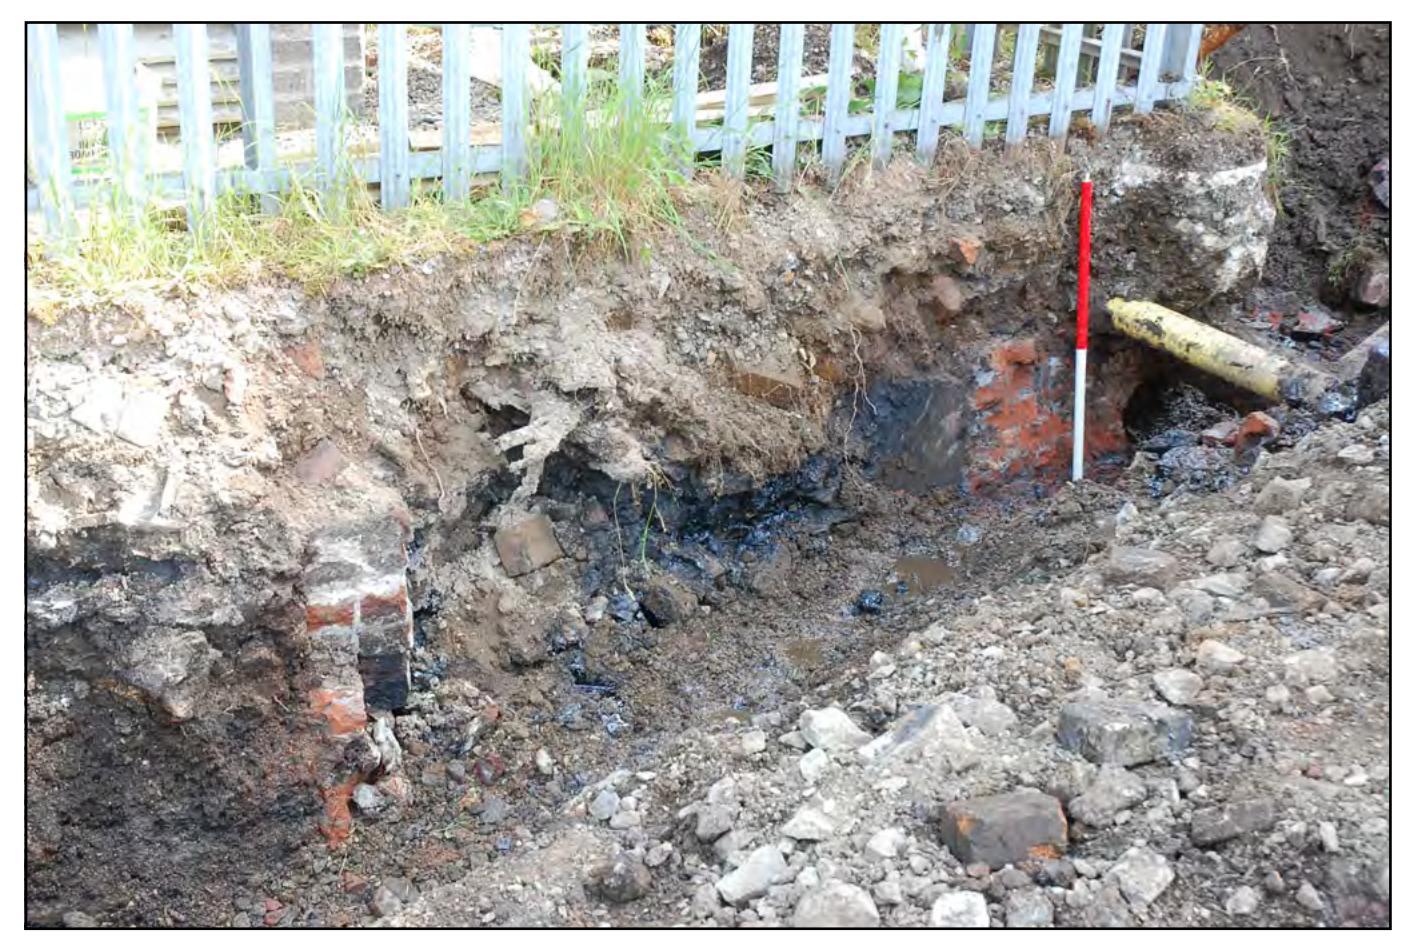
A stub of brick wall was identified south of the unit beneath 0.60m of demolition/levelling material (plate 13). The brick wall stood eight courses high and was of English bond (frogged). A similar course of brickwork was identified *c*.2.0m to the southeast, within the same excavated area (plate 13). This portion was faced with concrete on the northeast facing elevation. The bricks did not match those used for the decompression station and were interpreted as part of the former gasworks. The excavated area was contaminated and could not be safely accessed.

Plate 13: view north of exposed section parallel to the decompression station and visible during the groundworks, detailing truncated brick-built foundations interpreted as remnants of the former gasworks. The function of the building could not be determined, but it was identified as part of a series of buildings occupying the northern end of the gasworks plot, visible on the First to Third Edition 25" Ordnance Survey maps of the area (cf. figures 02 to 05) (Scale: 1.0m)
