# PRS REPLACEMENT, MENAI BRIDGE, YNYS MÔN

# SERVICE TRENCH WATCHING BRIEF

Archaeological Watching Brief

GAT Project No. 2061 Report No. 833 October 2009

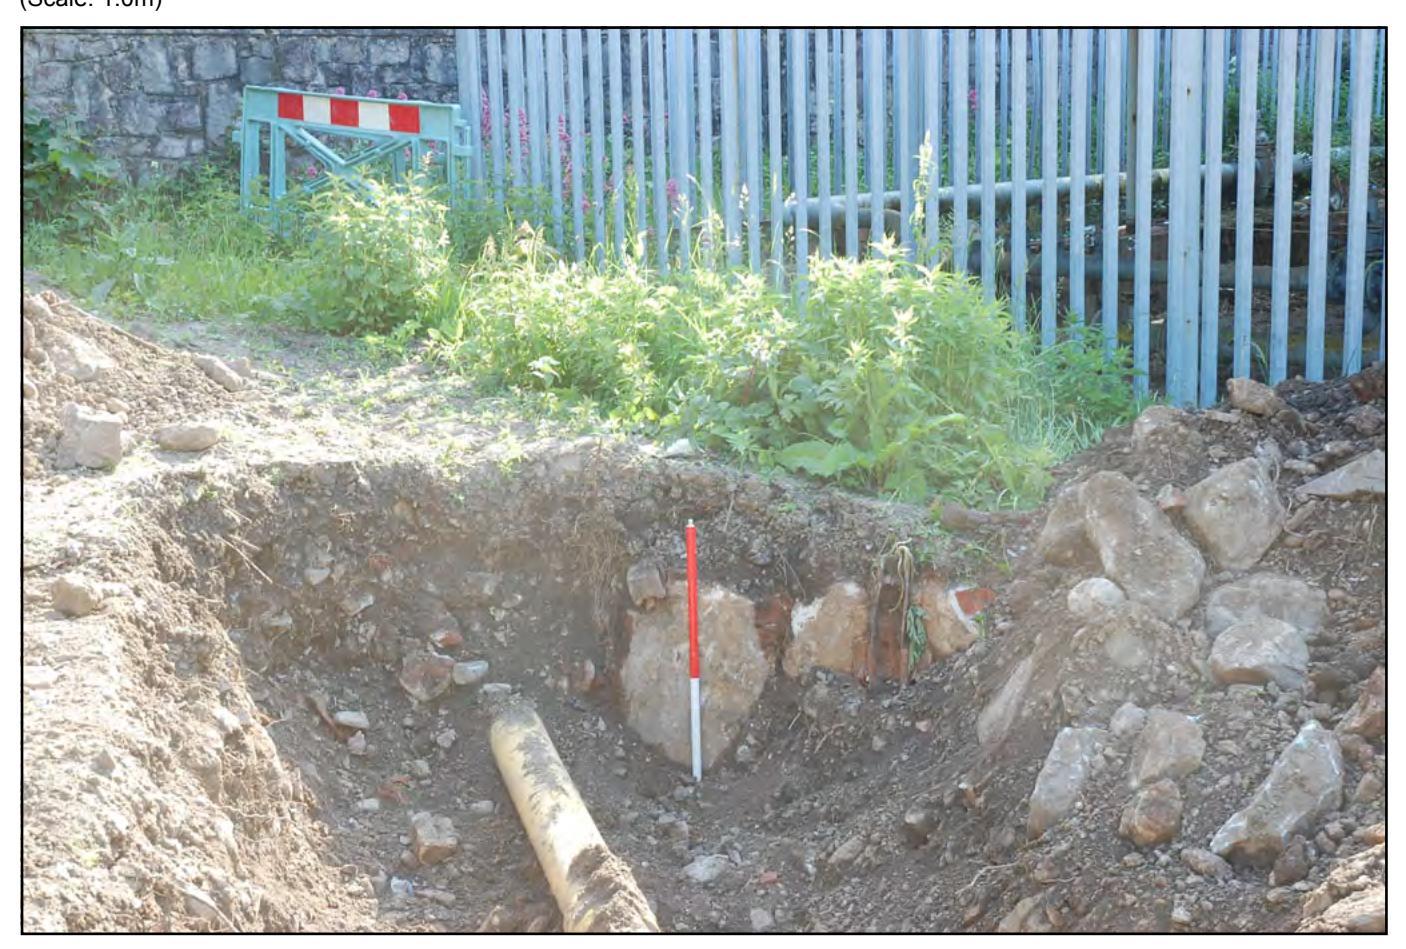
A truncated portion of brick walling/foundation was also identified along the northwestern end of the decompression station during the excavation (plate 14). The brickwork measured 1.0m in height and 1.50m in width and was faced with cement; an iron girder was attached to the cement. This feature was also interpreted as part of the former gasworks. The excavated area was contaminated and could not be safely accessed.

Plate 14: view northeast of exposed section parallel to the decompression station and visible during the groundworks, detailing truncated brick-built foundations interpreted as remnants of the former gasworks; note, a truncated iron "girder" is visible to the right of the ranging pole. The function of the building could not be determined, but it was identified as part of a series of buildings occupying the northern end of the gasworks plot, visible on the First to Third Edition 25" Ordnance Survey maps of the area (cf. figures 02 to 05) (Scale: 1.0m)

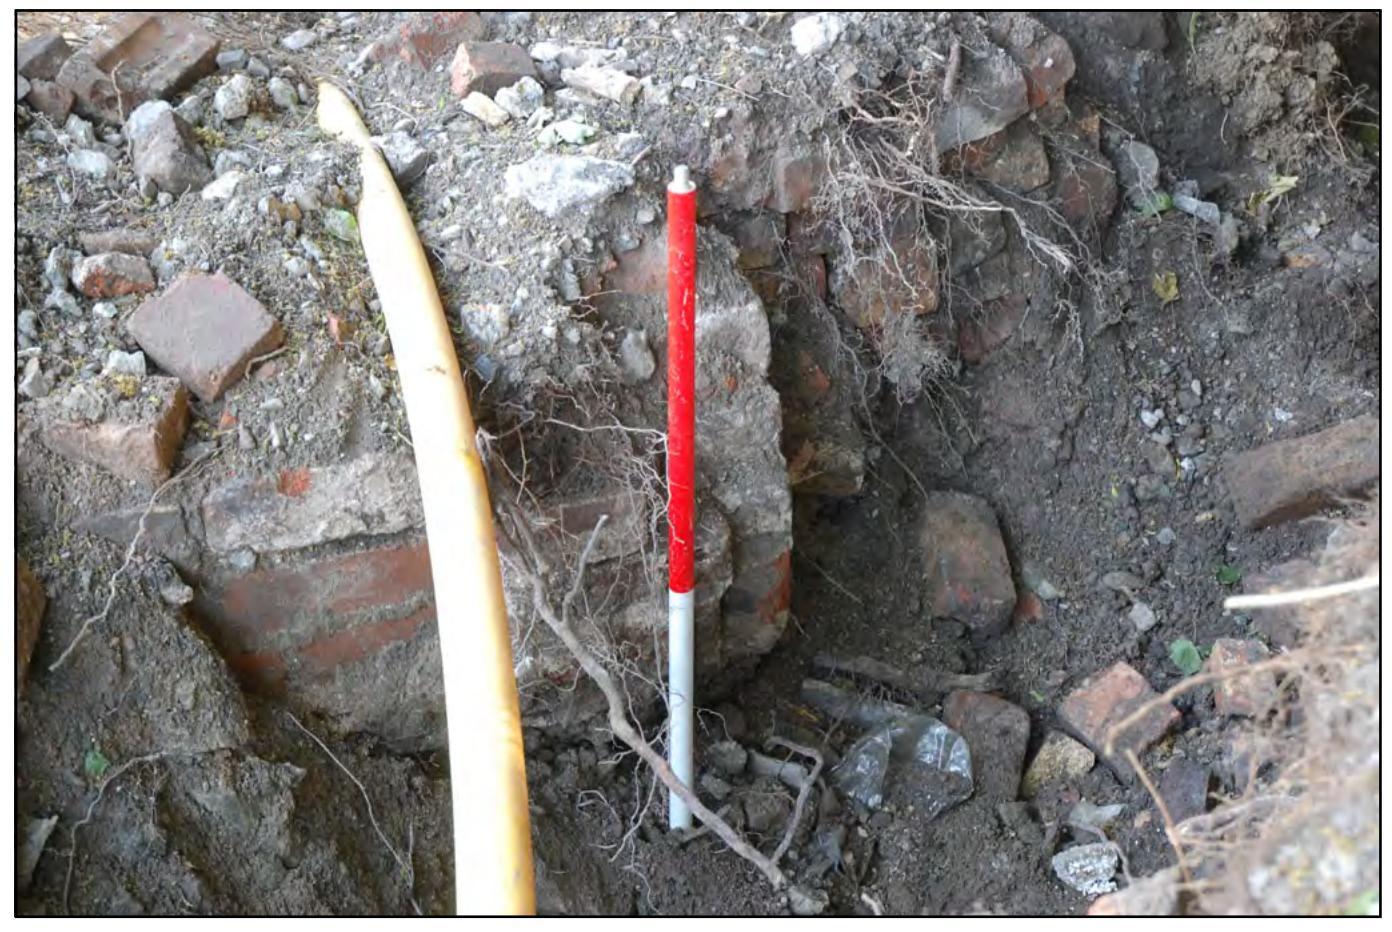
A brick-built wall return was identified *c*.10.0m to the southeast of the decompression station unit within an excavated area (plate 15). The wall stood six courses high (visible) and appeared to be of similar construction to the examples closer to the decompression station. The wall return was also identified as part of the former gasworks, specifically, the corner of one of the structures that formed the series of interlinked buildings in the northern portion of the gasworks (figures 02 to 04).

Plate 15: view northeast of exposed section parallel to the decompression station and visible during the groundworks, detailing truncated brick-built foundations interpreted as remnants of the former gasworks. The function of the building could not be determined, but it was identified as part of a series of buildings occupying the northern end of the gasworks plot, visible on the First to Third Edition 25" Ordnance Survey maps of the area (cf. figures 02 to 05), possibly the southeastern corner of a gasworks building (Scale: 1.0m)

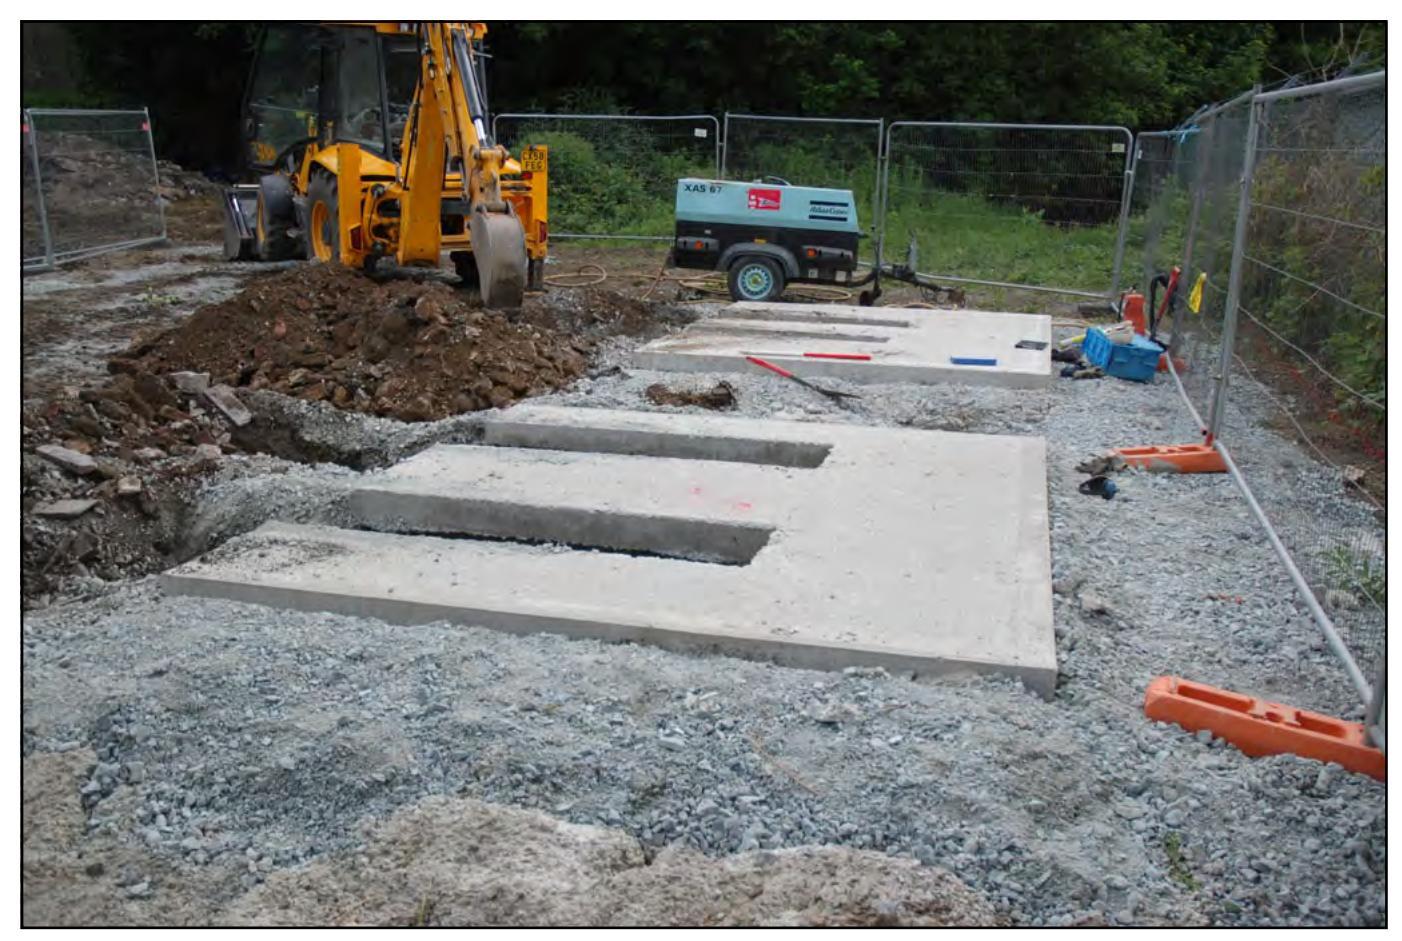
The kiosk foundations were laid within very shallow excavations within the imported hardcore for the temporary access road (plate 16). Both kiosk foundations had a W-shape in plan and measured 3.1m in length and 3.3m in width. A series of 1.20m deep pipe trenches were excavated within the kiosks (plates 17 and 18). As with the neighbouring culvert excavation, this area contained redundant brick and stone building material used for levelling the site after demolition of the gasworks (plate 18). A concrete pad was identified within the kiosk excavation (plates 17 and 18): this pad was interpreted as a remnant of the decompression station construction phase and/or operation phase and not part of the gasworks.

Plate 16: view east of control kiosk platforms during groundworks. The kiosk platforms were laid atop an imported gravel that sealed this area after the removal of vegetation and topsoil (cf. plates 05 and 06). The "grooves" within each kiosk platform were then excavated to accommodate service pipes

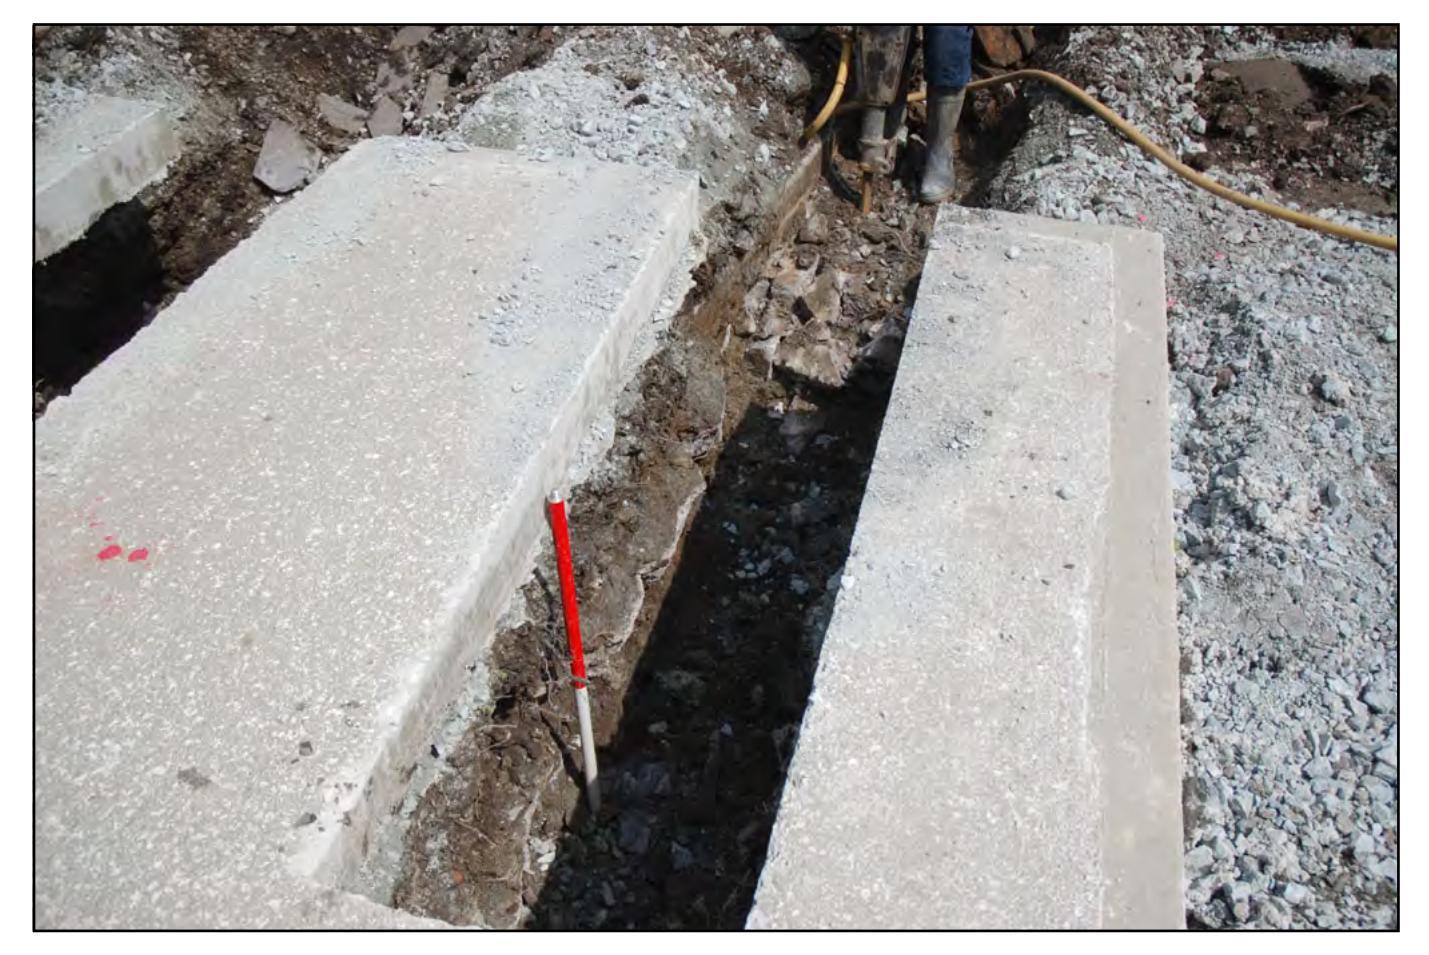
Plate 17: view north of control kiosk platforms during groundworks detailing full excavation depth. The kiosk platforms were laid atop an imported gravel that sealed this area after the removal of vegetation and topsoil (cf. plates 05 and 06). The concrete visible within the excavated area was extant prior to the start of groundworks; the function of the concrete could not be determined as examination of the available map evidence suggests that no gaswork buildings were extant in this area (cf. figures 02 to 04). (Scale: 1.0m)

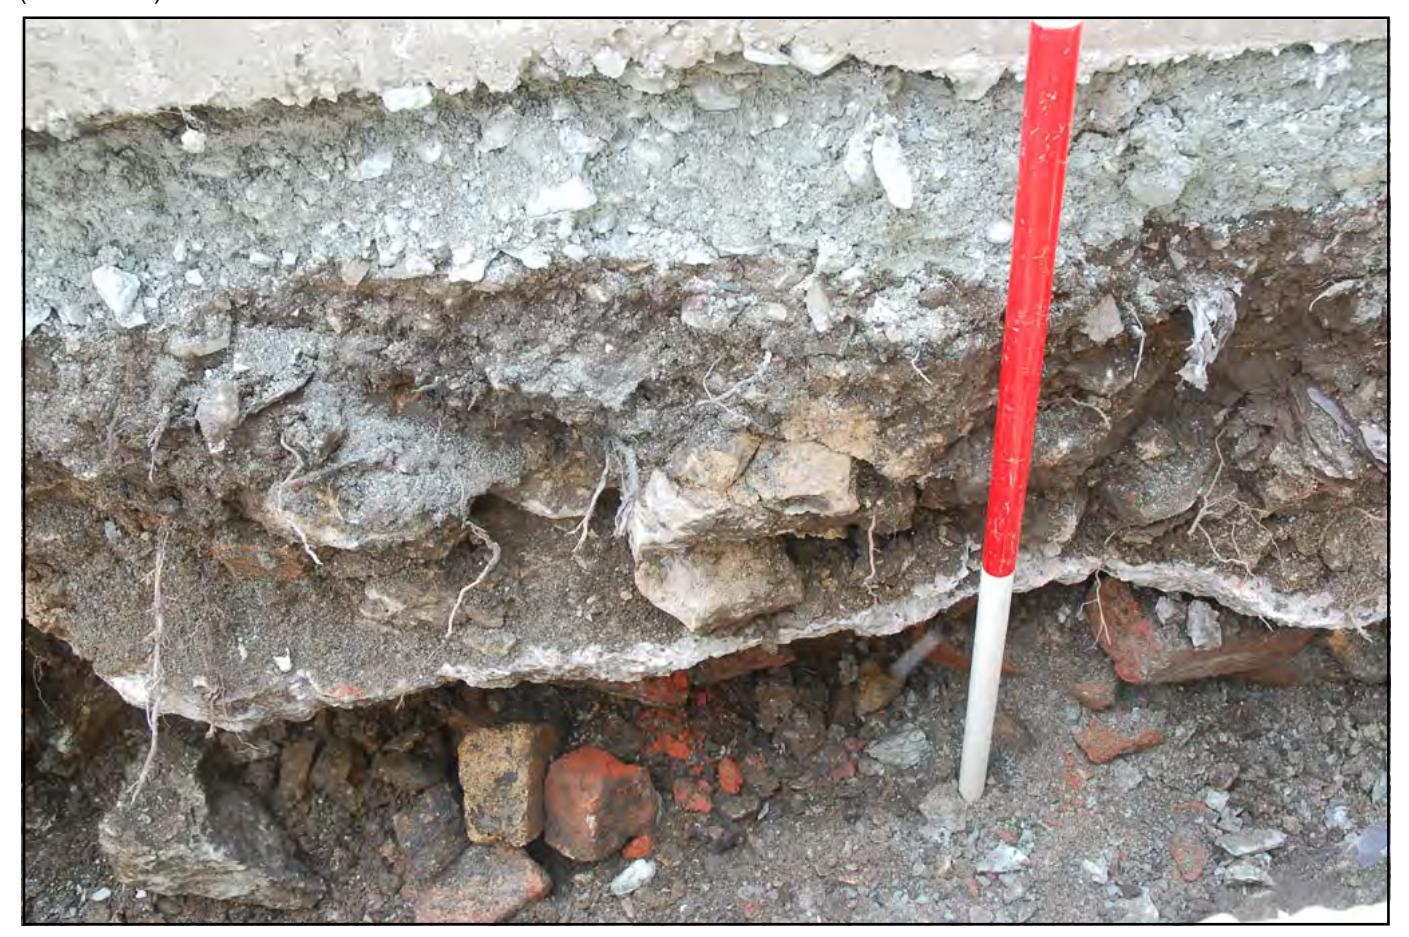
Plate 18: close-up view of control kiosk groundworks detailing full excavation depth. Note concrete layer which was extant prior to start of groundworks. The function of the concrete could not be determined as examination of the available map evidence suggests that no gaswork buildings were extant in this area (cf. figures 02 to 04), but it may be associated with the construction or operation of the decompression station and/or pumping station. Note the demolition material beneath the concrete layer, interpreted as the remains of the former gasworks, utilised as a levelling deposit.
