# Arfordir/Coastal Heritage: Gwynedd

#### **Progress Report**

GAT Project No. 2072 Report No. 861 April, 2010 Revised June 2010

Report No. 861

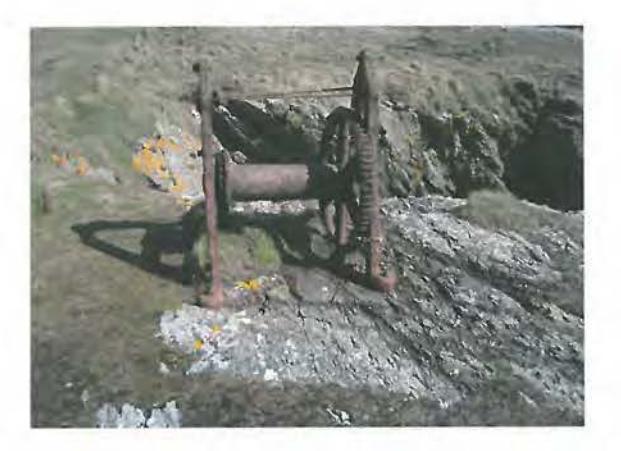
Winch on coast close to Aberffraw, erected following a shipwreck early 20th century.

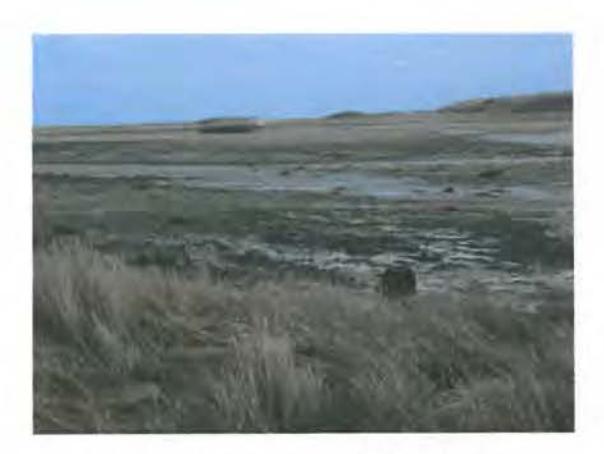
Wreck at Traeth Dulas, Anglesey

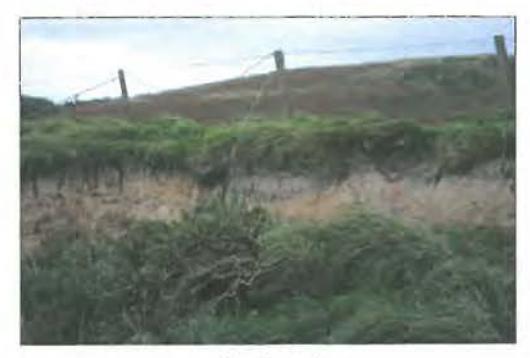
Feature 2 Possible Pit SH 29032571 Period: Possibly Prehistoric

A possible pit noted in the section of the eastern bank of the stream immediately west of the prehistoric burnt mound (Feature 1). It is possibly associated with wider prehistoric activity close to the burnt mound, and may indicate the presence of a more substantial prehistoric site.

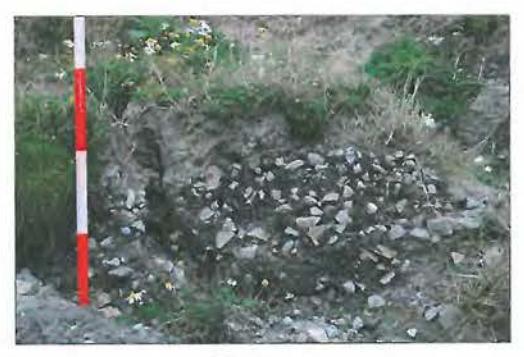
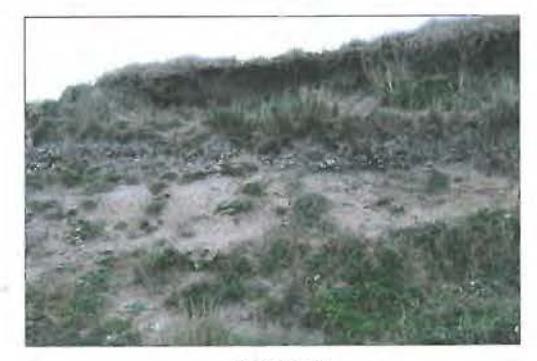
Feature 1 Burnt Mound SH 29002570 Period: Prehistoric

Bronze Age Burnt Mound with associated trough. This area was investigated in March 2008 By George Smith of GAT by cleaning and recording the cliff exposure, and found to be a Bronze Age burnt mound with a well-preserved timber-lined pit or trough. Oak heart wood from the trough was radiocarbon dated to about 1650 BC and assessment of a sample of soil from the burnt mound produced a good assemblage of carbonised and preserved (waterlogged) palaeo-botanical material. This showed the presence of alder woodland (used for the burning), of local wetland and evidence of cultivation including. The remains of the trough were found at the very edge of the cliff and so were at immediate risk from erosion, possibly in the following winter storms. Cadw provided funding for a rescue excavation with support from the National Museum, Cardiff and work was carried out in November 2008 with staff from GAT and the National Museum. The central area of the burnt mound was excavated, uncovering a rectangular, timber slab-built trough with an adjoining water channel made from a hollowed-out log. Two phases of burnt mound were identified, the earlier associated with another timber-built trough, of which most had already been lost to cliff erosion.

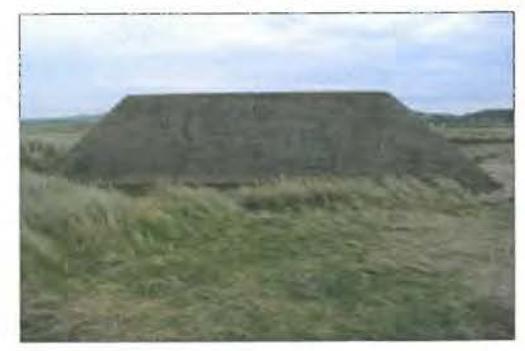
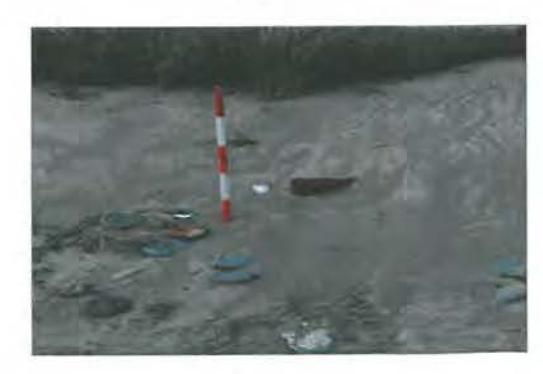
Feature 3 RAF Hells Mouth SH 2778 4192 Period: Modern

Reinforced rectangular concrete military structure. Blast protection for the firing range to the north. Blast holes are seen in the northern elevation. The polygonal brick pillbox described in coastal survey (gat 1996) no longer exists except for evidence of loose bricks on the beach. The sand dunes are eroding up to this structure. There is considerable evidence of vandalism at the site.

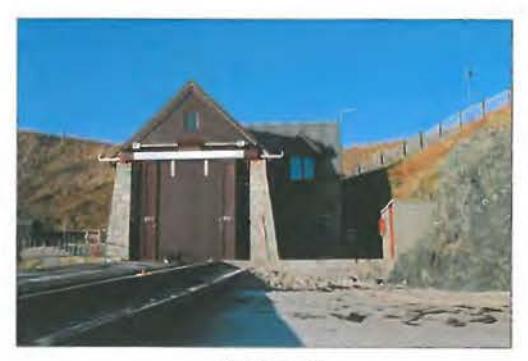
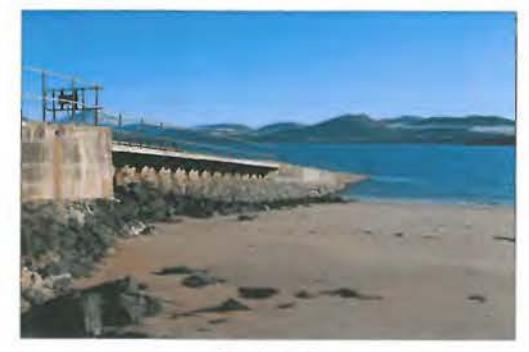
Feature 1 Lifeboat House and Sliway SH 2778 4192 Period: Modern

A lifeboat house and slipway, built originally in 1864, however most of the surviving material dates from a substantial rebuild of the station in 1925 to 1926. It is a rectangular building with a cross gable, built of granite from Trefor quarry. It has undergone a number of phases of significant redevelopment and alterations, the most recent being in 1993.

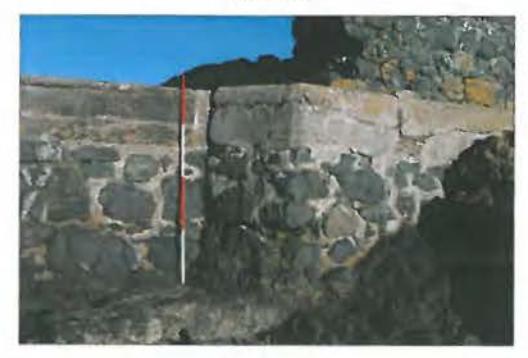
Feature 8 Former pier or slipway SH 2775 4164 Period: Modern

A double line of stones extending eastwards into the bay. It is visible on the aerial photographs examined (106G/UK/469 frame 3009) dating back to 1945 (Fig. 9), and is located on the 2nd edition Ordnance Survey map of 1900 (Fig. 6) but not the first edition of 1889 (Fig. 5). A pier can be seen at this location on the tithe map of 1841 (Fig. 4), and the earlier Glynllifon estate map (Fig. 3), where it is referred to as the 'old pier'. There is a building located on the foreshore on the tithe and subsequent maps that was probably formerly a warehouse. It is likely that the origins of this pier date to the early 19th century and was constructed by the Porthdinllaen Harbour Company.

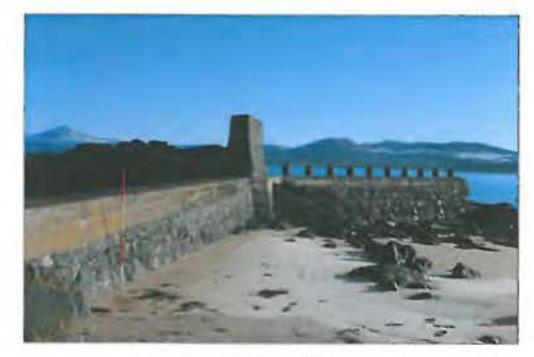
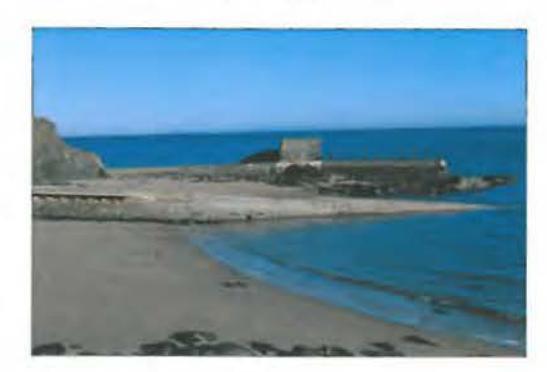
Feature 2 Breakwater SH 2783 4194 Period: Modern

A substantial breakwater, situated approximately 50m north of the lifeboat station, and built to protect it between 1918 and 1927. It is constructed of irregular coursed shale blocks, approximately 1m high, capped with concrete, adding an additional 1.2m to its height. It has a substantial batter on its northern side. At approximately 3.3m from the low water mark, it incorporates a fragment of walling that formed part of an early 19th century pier towards its seaward end.

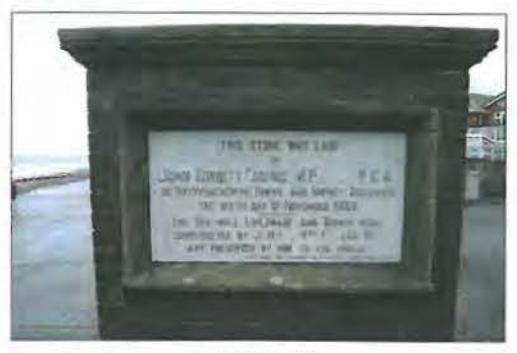
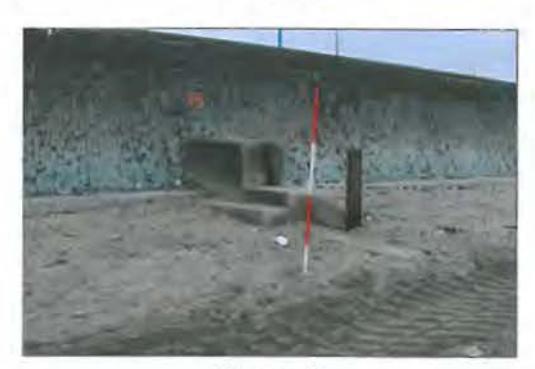
Feature 6 Promenade, Tywyn sea-front (GAT PRN 7285) SH 5792 0010 to 5775 0058 Period: 19th century

The Tywyn sea-front between Pier Road and Neptune Road was gentrified by the construction of the Marine Parade and Promenade, inaugurated in 1889 by the Corbett family. It was to have been supplemented by the construction of a pier at the end of what is still Pier Road. The promenade has been more recently improved in 1977. A plaque recording the inauguration of the original promenade has been preserved in a wall (see plate). The current parapet to the promenade is of late 20th century construction.

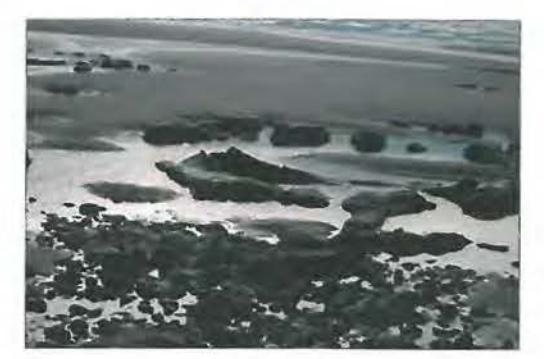
Feature 7 Ancient peat-beds (GAT PRN 16601) SN 5810 9960 (Centre) Period: Prehistoric Description taken from Smith (2004)

The peat beds have been discussed as part of the background, above. They extend for about a kilometre along the shore here. North of the outfall they are more eroded than south of the outfall. Previous visits only identified isolated patches north of the outfall. However, during the recent visit in November 2004 for the current study, the area north of the outfall happened to be better exposed that previously. The peat surface was seen to extend further north than previously seen and almost certainly still continues further north under the sand because in three place in situ pieces of ancient trees were seen protruding through the sand. The creation of the promenade wall probably means that the foreshore in front of the promenade has probably been subjected to greater erosion than it might otherwise and it is possible that any peat beds have been eroded away. There are patches of eroded cemented shingle and occasional glacial

erratic boulders close to the low water mark, but no evidence of any peat or ancient timbers. This is almost certain to be true around the slight rise in ground around Bryn-y-mor. However, there is still a possibility of peat surviving below the sand in the intertidal area north of Bryn-y-mor.

In the exposure as a whole there are, in places, large in situ tree stumps and in others large fallen trunks that have been exposed by the peat cutting. The peat is at least a metre deep and consists of more than one horizon, some of it woody and fibrous, other much finer. The peat beds can be seen to run back under the shingle bank and may continue under the Penllyn marshes to the east. The peat represents a buried and preserved ancient landscape in which well-preserved archaeological remains may occur. Sometimes objects are discovered by chance that show the presence of human activity but there are none reported from here. However, samples were taken as part of a previous survey of intertidal remains and these showed the presence of charcoal, which is taken to be a good indicator of human activity nearby.

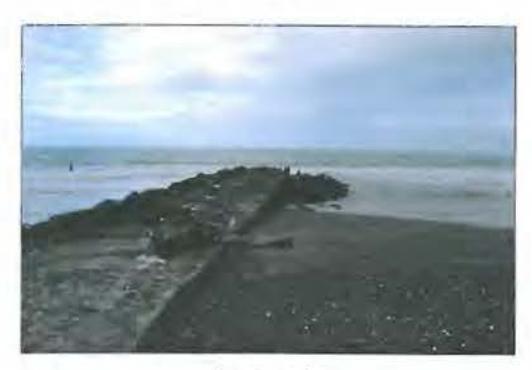
Feature 4 The Afon Dysynni Low Level Outfall SH 5706 0185 Period: 19th century

The construction of the Cambrian Coast Railway was preceded by drainage of the marshes north and south of Tywyn in 1862. This was achieved by construction of drainage channels, tidal gates and outfalls.

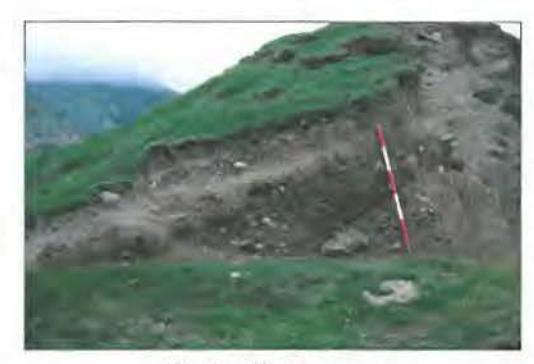
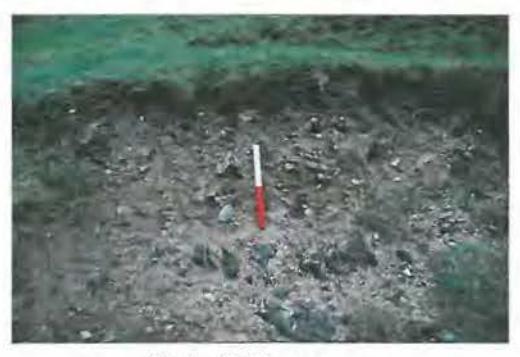
Worked flint exposure

The finds have come from the sloping end of a grassed-over rocky ridge that lies parallel to the sheer cliff edge here. The end of the ridge overlooks a small, shallow valley that has been partly infilled with rubble to provide a storage area for granite that was brought from the nearby guarry before being loaded on ships at the 'new'

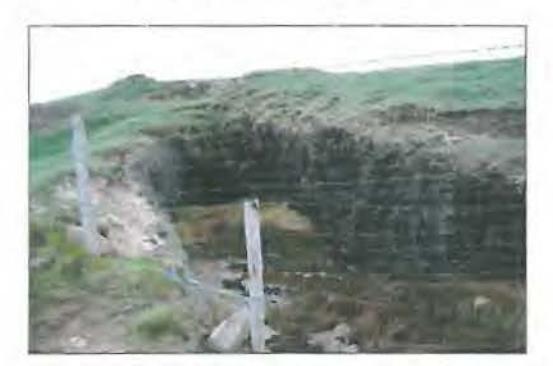
Adit/industrial area with flint spread behind

pier to the east of the valley. At an earlier and smaller scale phase of quarrying the stone was brought down on a tramway closer to the flint site and loaded onto smaller ships from a small pier at the west of the valley. The finds have come from three places within a small area: first from the rocky surface of the cliff edge, second from eroding colluvium at the foot of the slope and third, from eroding colluvium in the exposed section of an old mining trial level.
