AFON GANOL TIDAL GATES, PENRHYN BAY ARCHAEOLOGICAL WATCHING BRIEF: GI PROGRAMME

Archaeological Watching Brief

GAT Project No. 2143 Report No. 882 August 2010

Black & Veatch Ltd

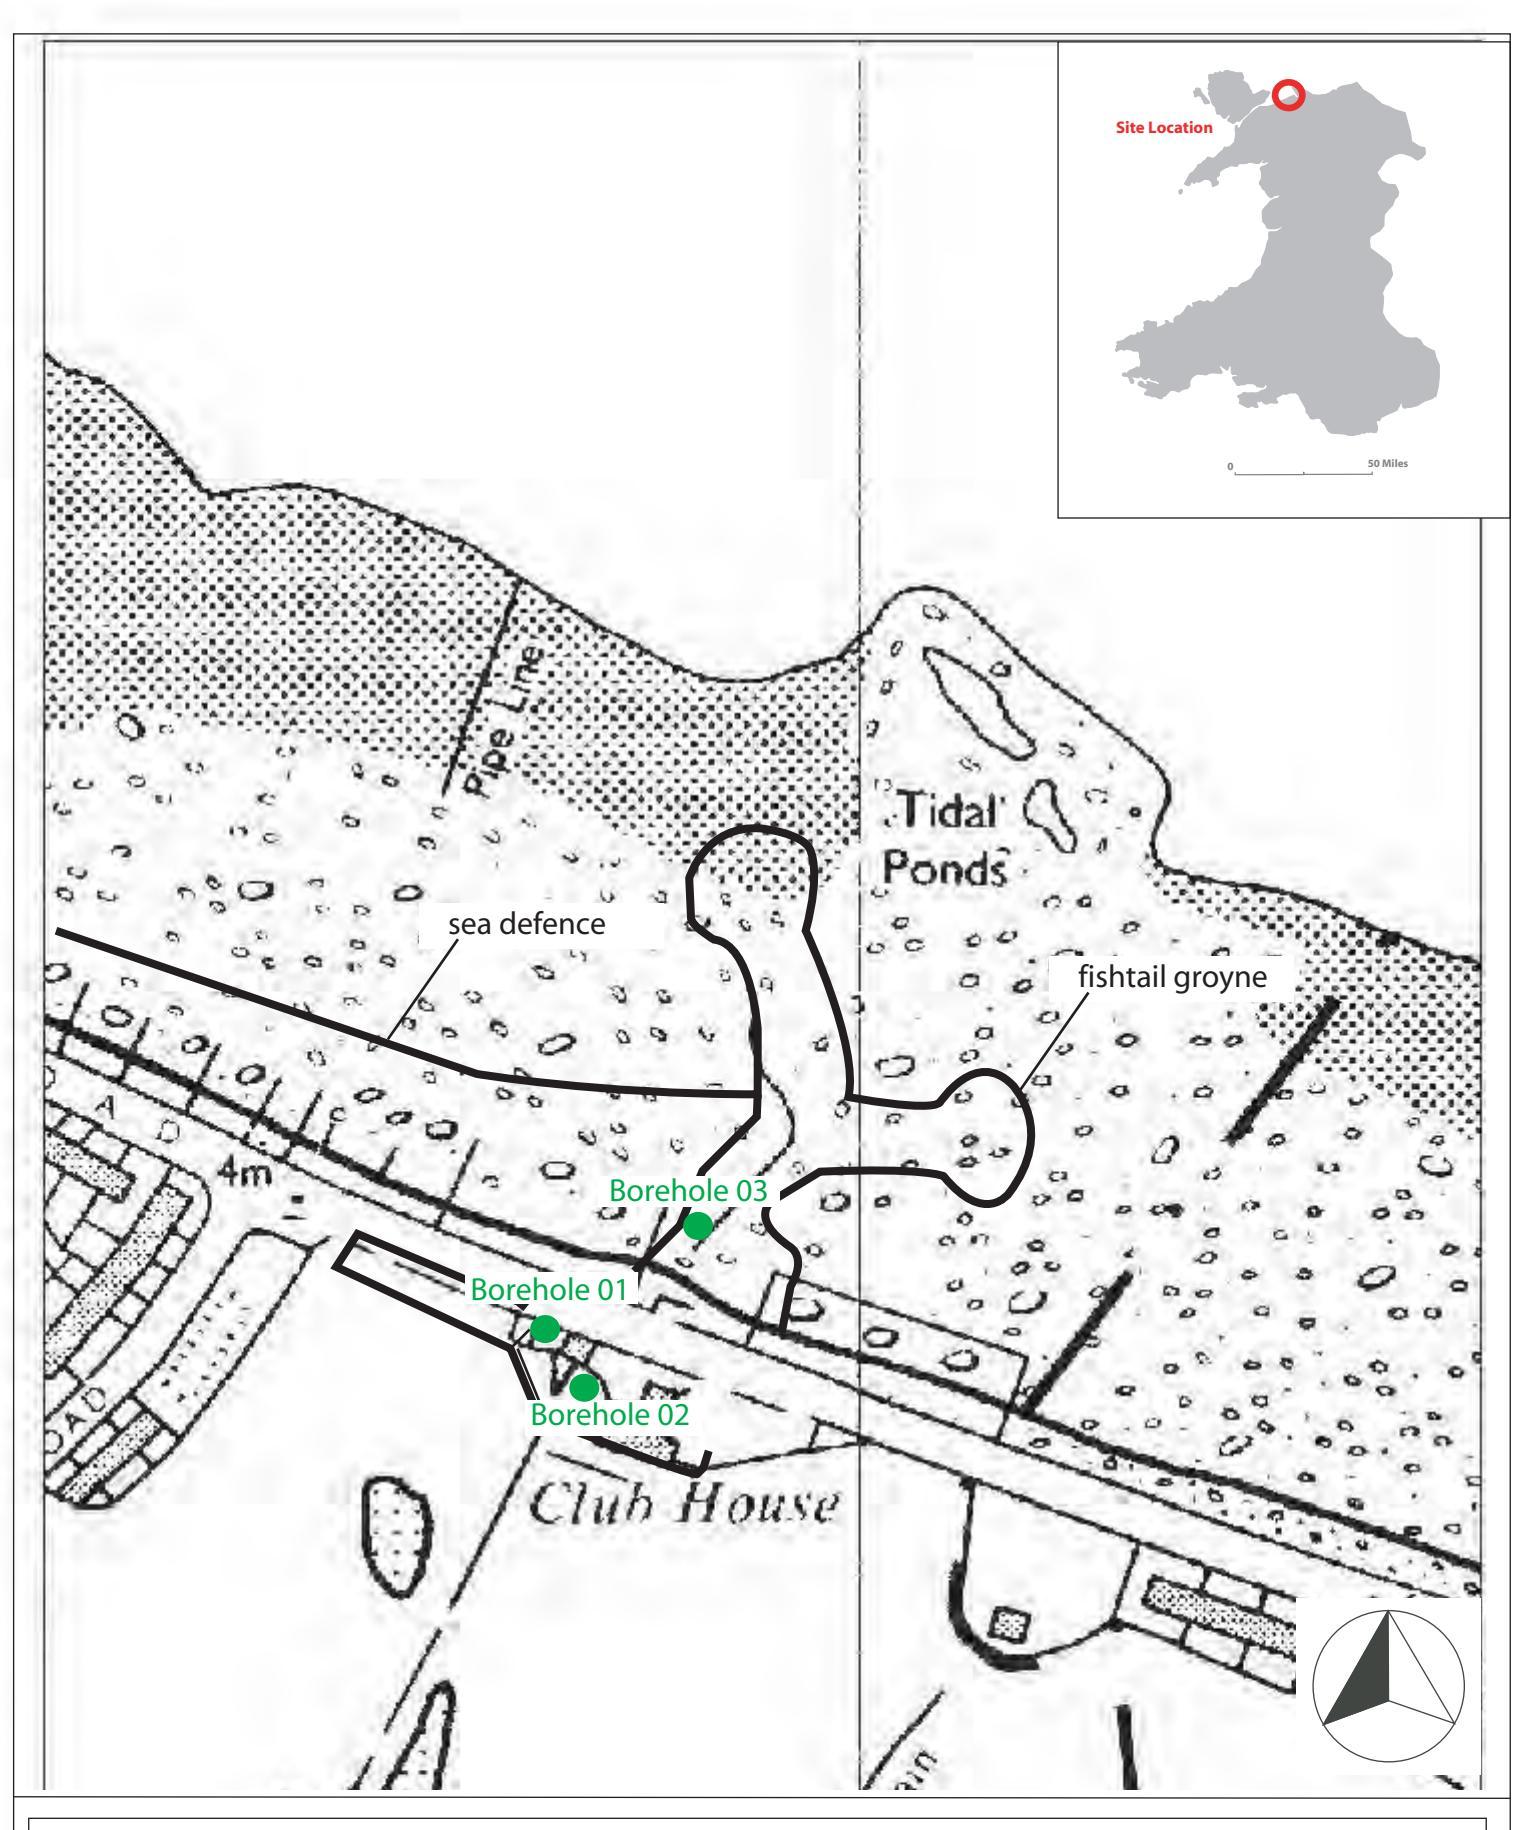
Figure 01: Location of Ground Investigation area monitored by Watching Brief G2143. The Borehole locations are highlighted in GREEN. Boreholes 01 and 02 were located within the Rhos-on-Sea glof club, either side of the canalised river/tidal gates; Borehole 03 was located on the fishtail groyne sea defence.

The GI investigation area was located at the Afon Ganol Tidal Gate, Penrhyn Bay, Conwy County Borough (centred on NGR SH82968156; figure 01).

Borehole 03 was located within the fishtail groyne on the foreshore (figure 01).

The location of the individual boreholes monitored by GAT as an archaeological watching brief can be found in Figure 01. Boreholes 01 and 02 (BH01 and BH02) were located either side of the outfall chamber/tidal gates within a landscaped area belonging to the Rhos-on-Sea golf club. Borehole 03 (BH03) was located atop the fishtail groyne on the foreshore, next to the outfall.

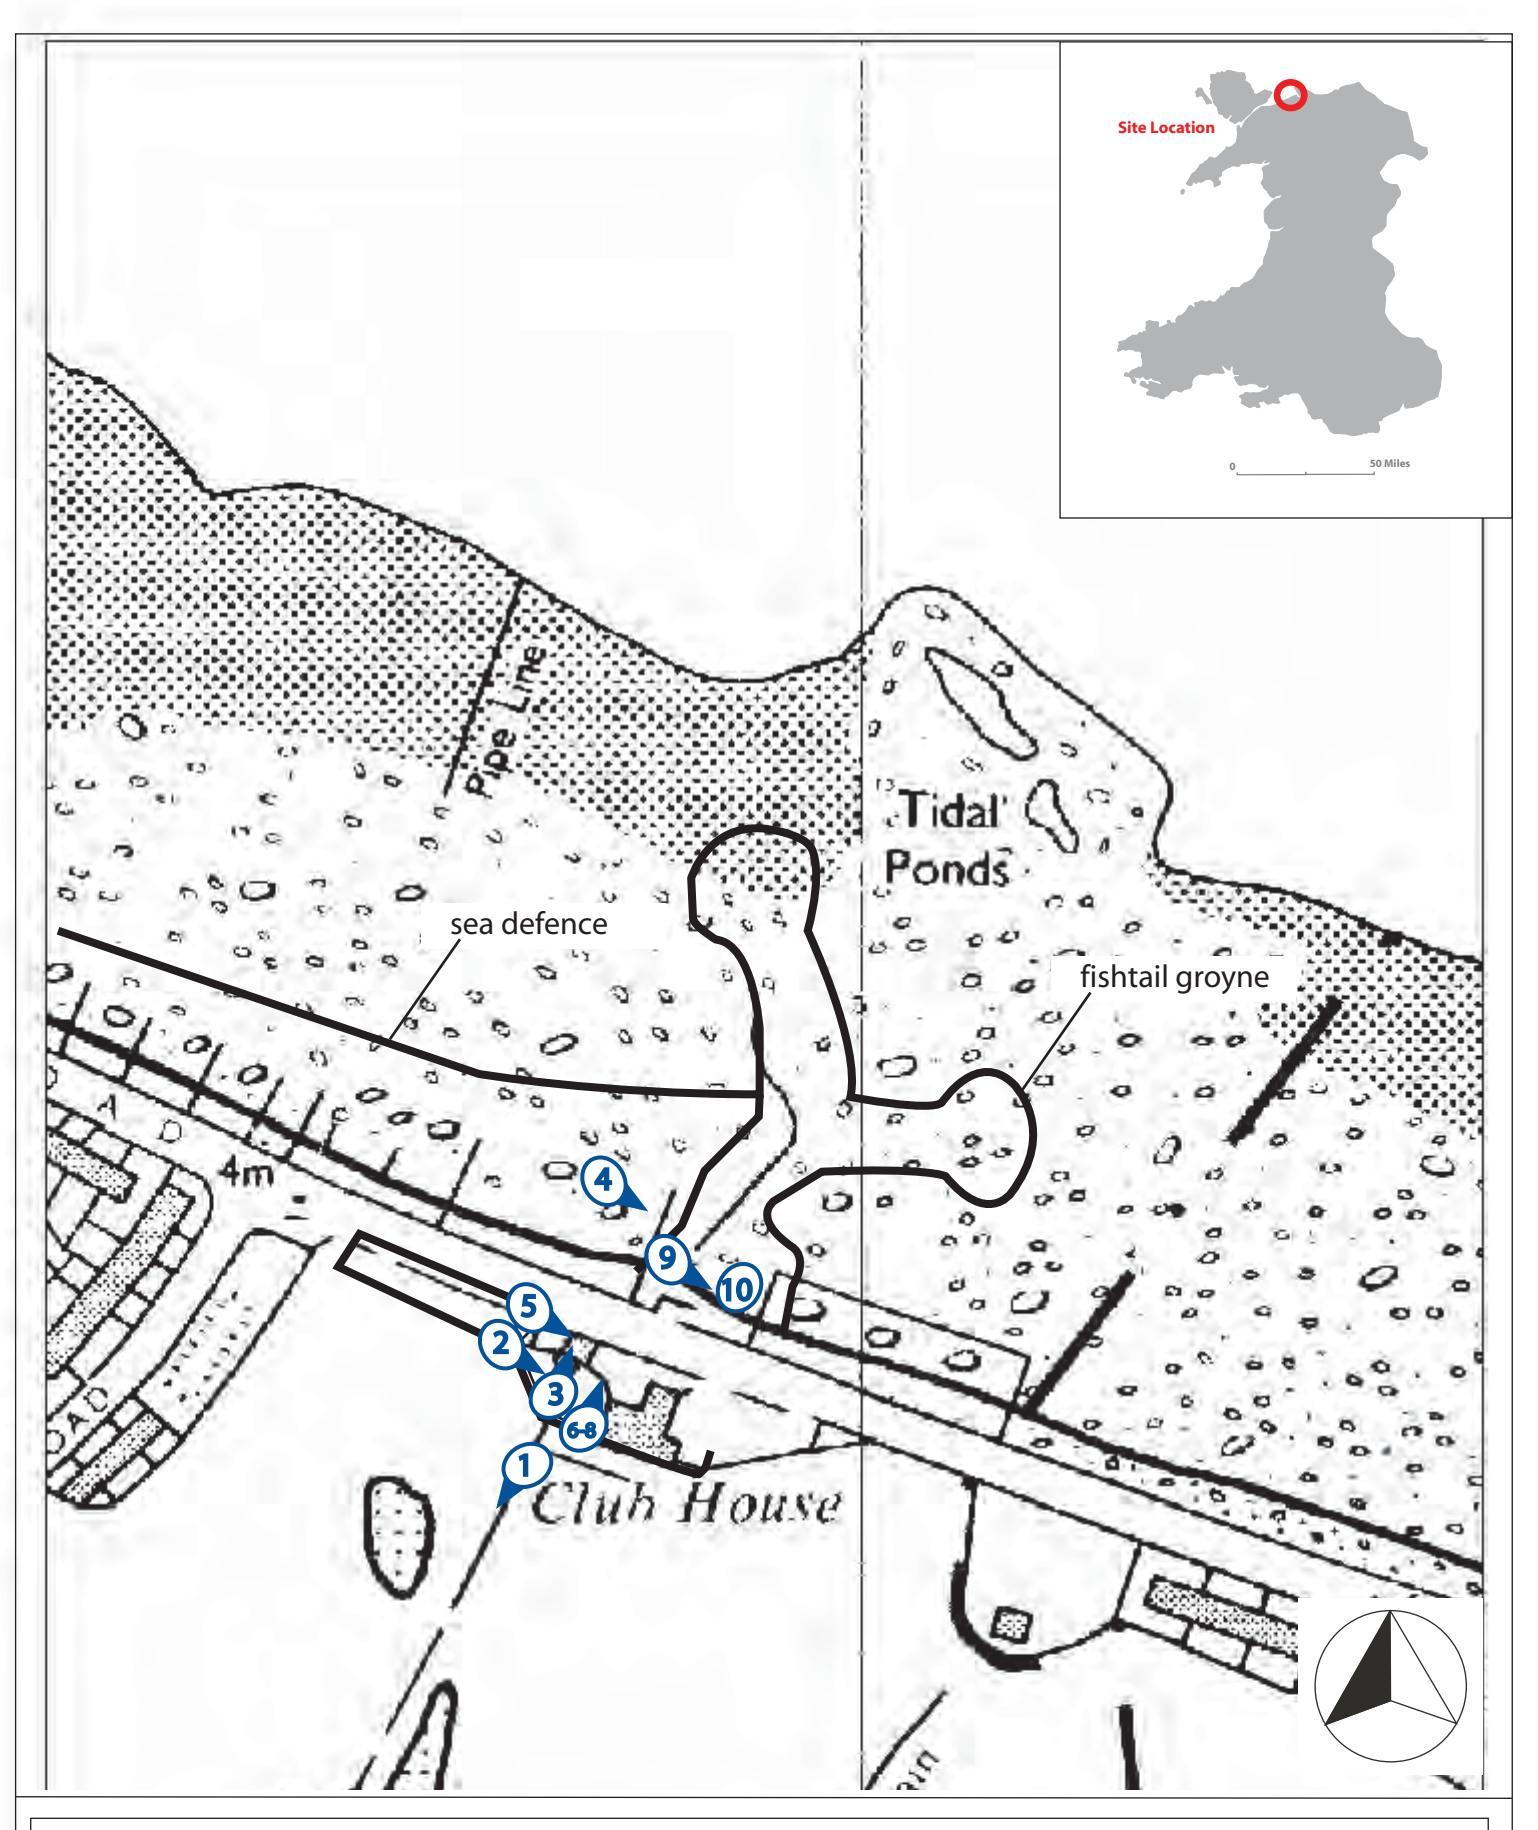
Figure 02: Location of plates within Ground Investigation area monitored by Watching Brief G2143.

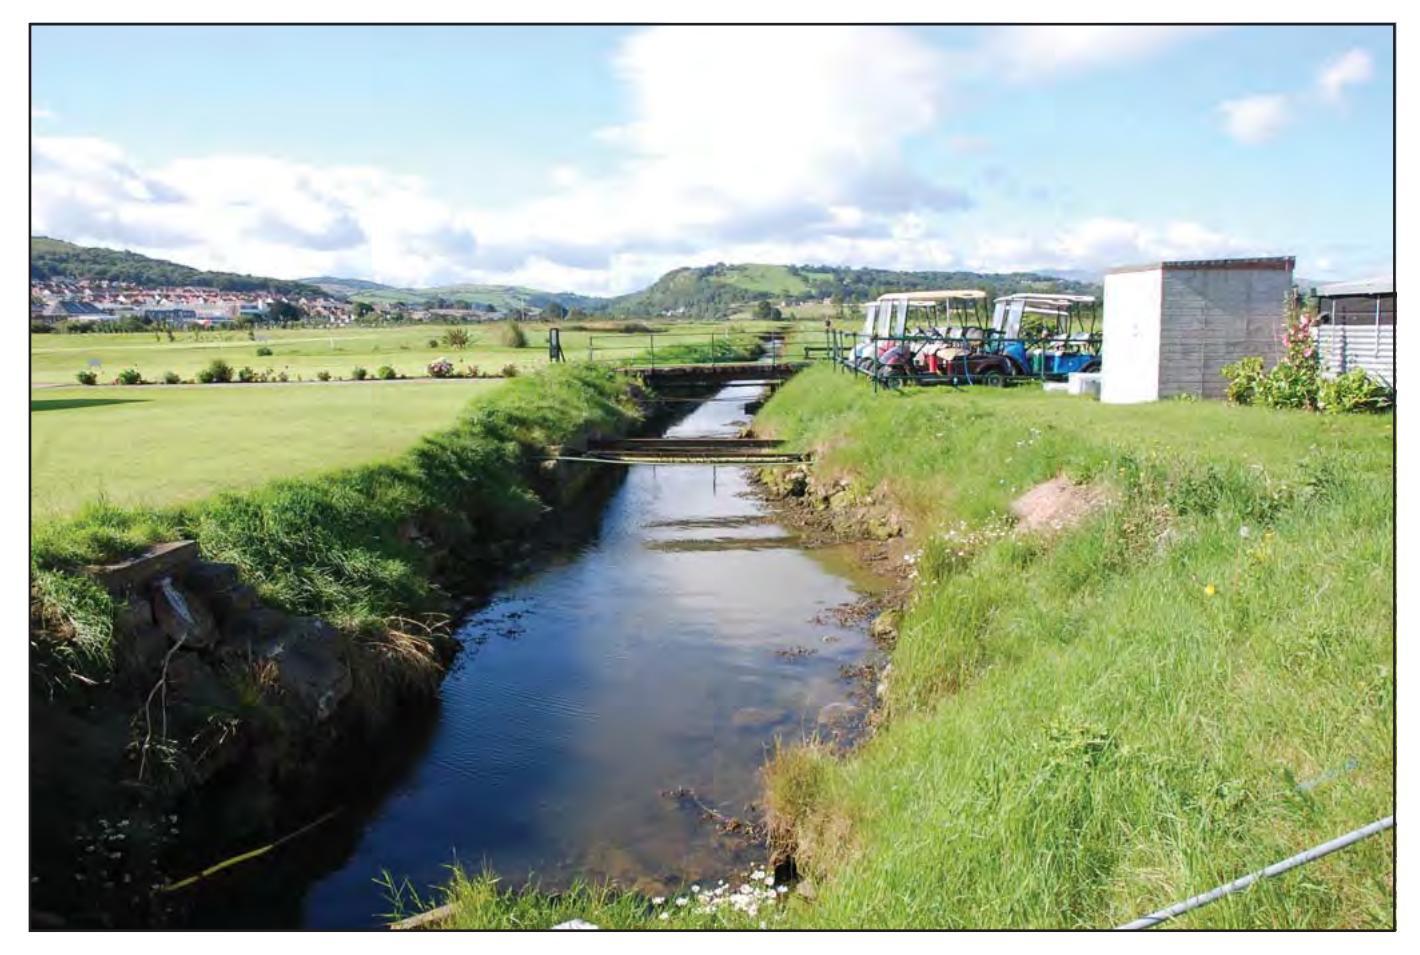
Plate 01 - View south of the canalised Afon Ganol that leads to the tidal gates. The Rhos-on-Sea golf club can be seen either side of the river

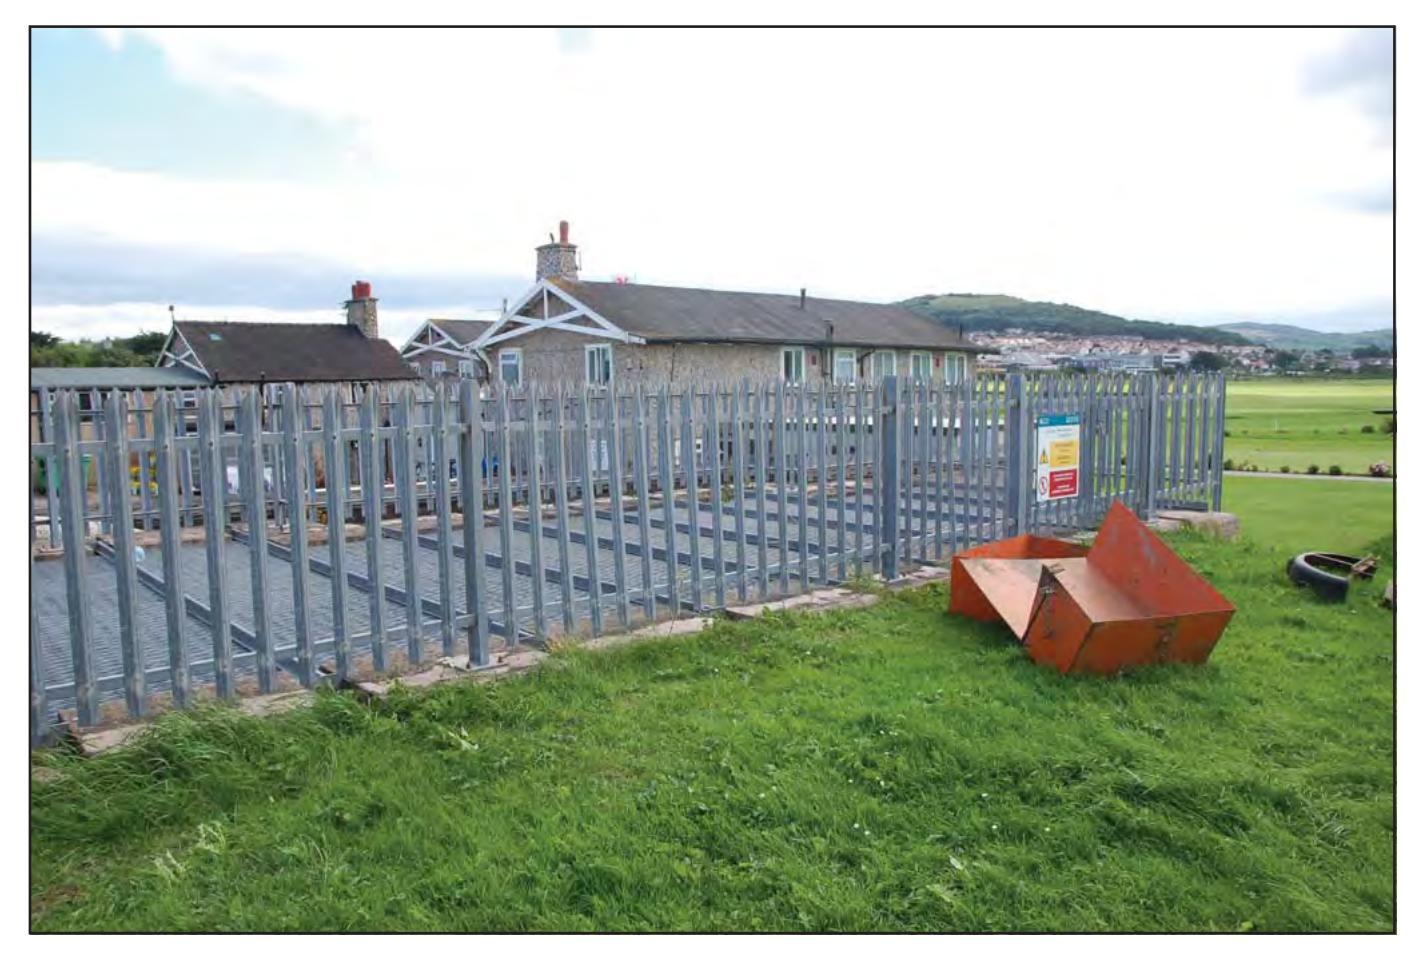
Boreholes 01 and 02 were located either side of the tidal gate structure, within the Rhos-on Sea golf club (figure 01). The tidal gate (NPRN **308,563**) includes an outfall chamber enclosed in concrete with a mesh decking (plate 02), secured form public access via a 1.2m galvanised palisade fence. The chamber is partitioned in two with timber gates and is linked to a precast concrete pipe that continues under Marine Drive Road and along a fishtail groyne into the sea (plate 04).

Plate 02 - View southeast of the current tidal gates/outfall chamber structure. The mesh decking is an early 1990s addition and masks the original structure

In addition to the boreholes, GAT was commissioned by the Environment Agency to inspect the tidal gates, if accessible. GAT was unable to access the gate at this time; it is recommended that the tidal gate/outfall chamber structure is investigated further during the main engineering works as part of the watching brief mitigation.

The tidal gates/outfall chamber were inaccessible at this time and no additional information was recovered that updated the CAP Ltd. report from 2001 (CAP Ltd. Report **206**). It is recommended that the tidal gate/outfall chamber structure is investigated further during the main engineering works as part of the watching brief mitigation. Discussion with *Black & Veatch Ltd* has confirmed that these works will include structural alterations to the existing gate structure and an associated excavation on the west site of the gate to accommodate the engineering programme. This excavation will include a batter several metres wide, excavated from the existing ground level.

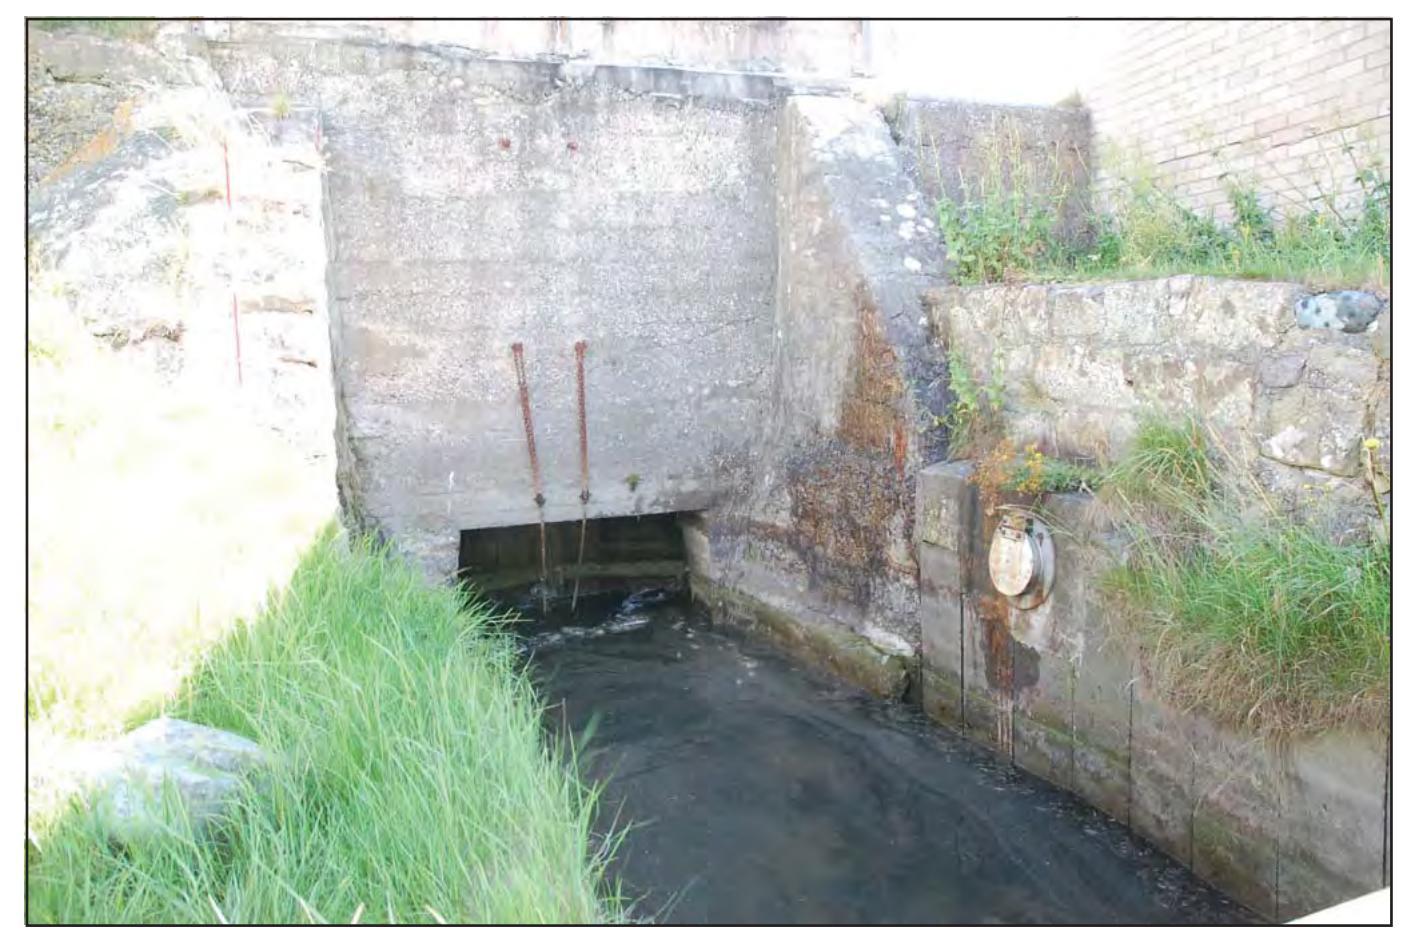
Plate 03 - View north of tidal gates/outfall chamber, detailing the timber mitre gates that the lead into the outfall chamber. The canalised Afon Ganol drains into this chamber. The outfall chamber is sub-divided into two smaller chambers by a partition wall (not visible). The second chamber is entered through a timber flap gate hung from a timber frame mounted on the downstream face of the partition wall.

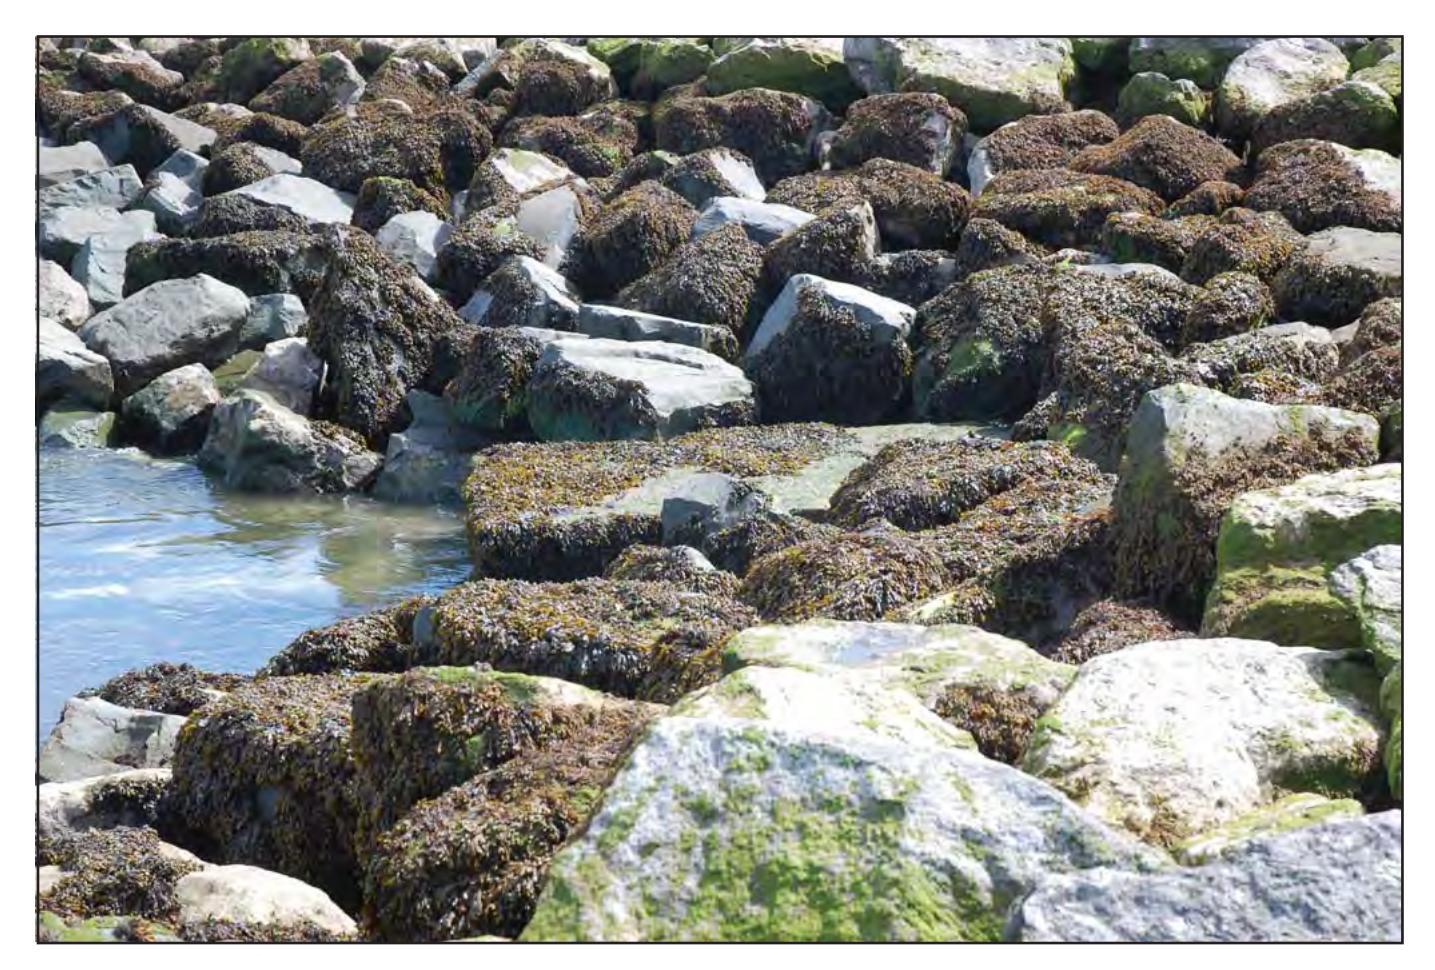
Plate 04 - View east of the outfall pipe that is linked to the tidal gates, as it enters the sea via the foreshore

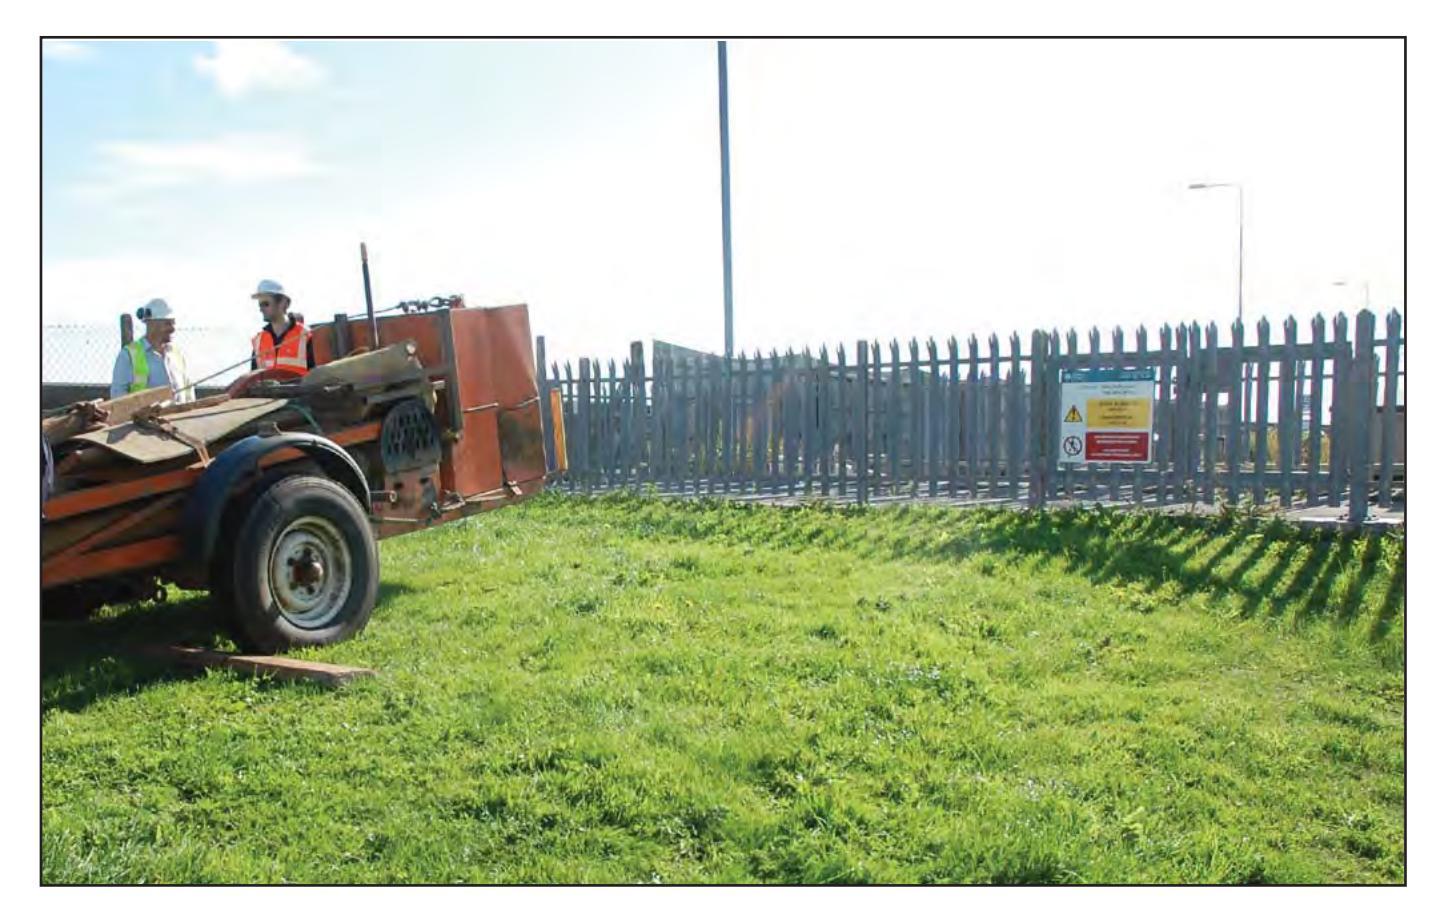
BH01 was located *c.*7.0m west of the outfall chamber (plate 05). The initial 5.0m within the borehole comprised imported material/sea wall defences. No organic material was identified

The borehole indicated the extent of landscaping/sea defence material extant at this location. Due to the confined nature of the borehole, the composition of the sea wall could not be determined. No archaeological activity or organic material were identified within the confines of the borehole.

Plate 05 - View south of the location of Borehole 01, which was located within a landscaped area within the golf club. The cable percussion rig can be seen on the left side of the image. The borehole contained imported seawall defence material.

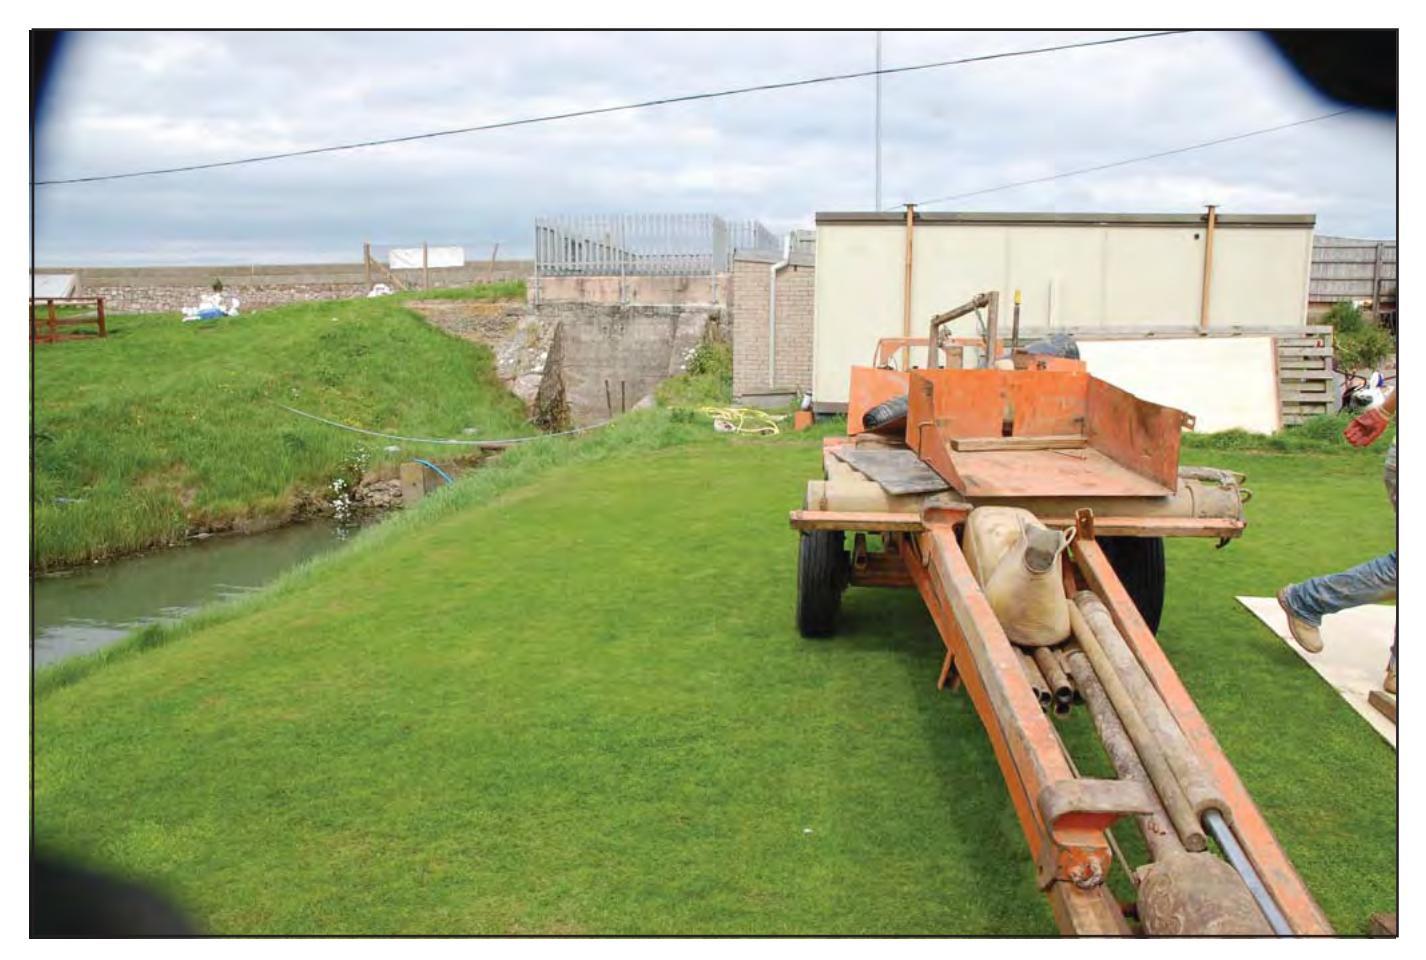
BH02 was located *c*.15.0m west of the Rhos-on-Sea golf club clubhouse within a lawned area (plates 06 and 07). The borehole was initially hand dug to a depth of 0.80m: the upper 0.25m was a dark grey-brown topsoil, followed by a 0.10m depth of gravel-rich hardcore (imported material), above a course orange-yellow sand that continued past the 0.80m depth to 1.50m below ground surface level (BGL). Between 1.50m and 3.50m was a yellow-grey sand-clay, followed by sand and gravel to 4.00m

Plate 06 - View north of Borehole 02 prior to excavation. The cable percussion rig can be seen in the foreground, the tidal gates in the background. Afon Ganol is on the left side of the image.

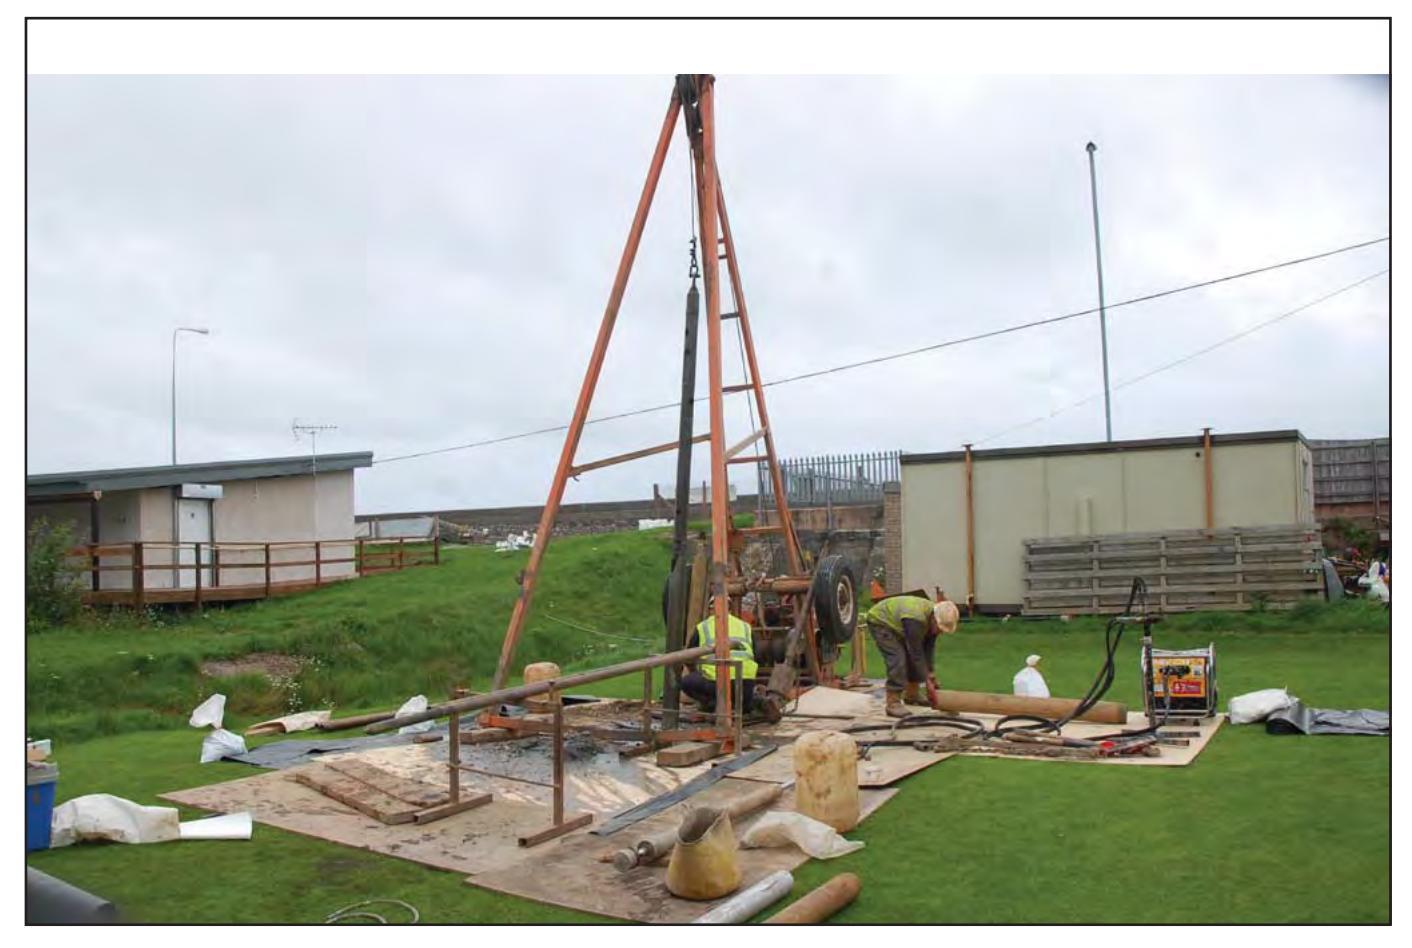
Plate 07 View northeast of Borehole 02, detailing the cable percussion rig in action. The initial 0.35m was topsoil and imported hardcore, followed by tidal and/or fluvial sand/silts

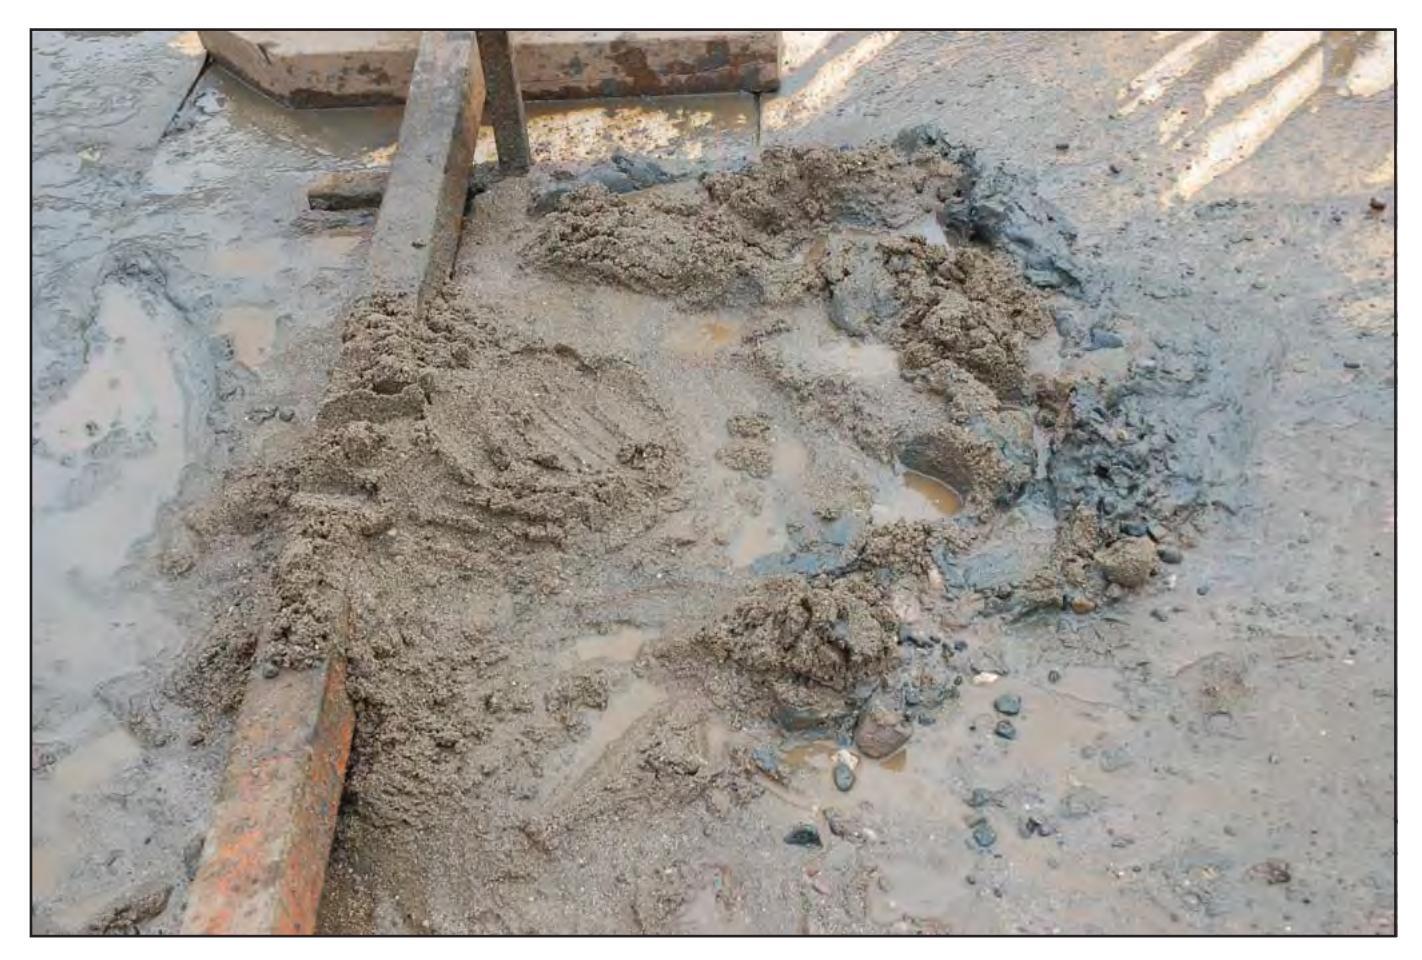
BGL. The remainder of the borehole contained medium to coarse grained sand from 4.00m to 8.00m BGL (plate 08). No peat deposits were identified within the borehole.

No archaeological activity or organic material were identified within the confines of the borehole. All identified deposits beneath the imported hardcore were tidal and/or fluvial in origin.

Plate 08 - Close-up view of material from borehole: detailing a deposit of sand recovered from 7.0m bellow ground level. All identified deposits beneath the imported hardcore were tidal and/or fluvial in origin associated with the river mouth.

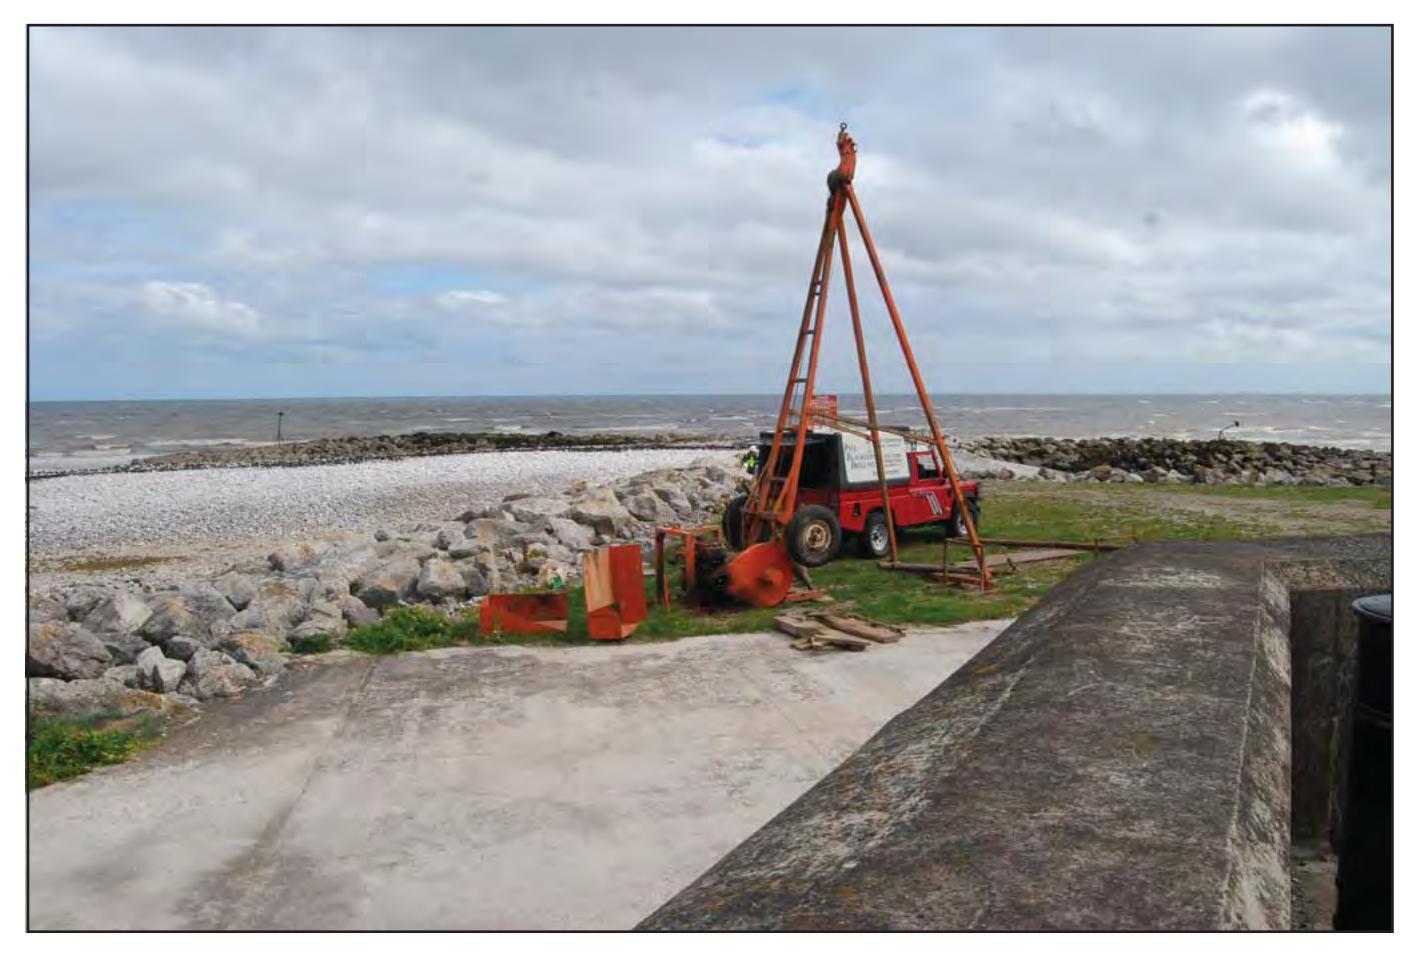
Plate 09 - View northeast of Borehole 03 location with the cable percussion rig in situ. Borehole 03 was located on a fishtail groyne sea defence to the east of the tidal gates.

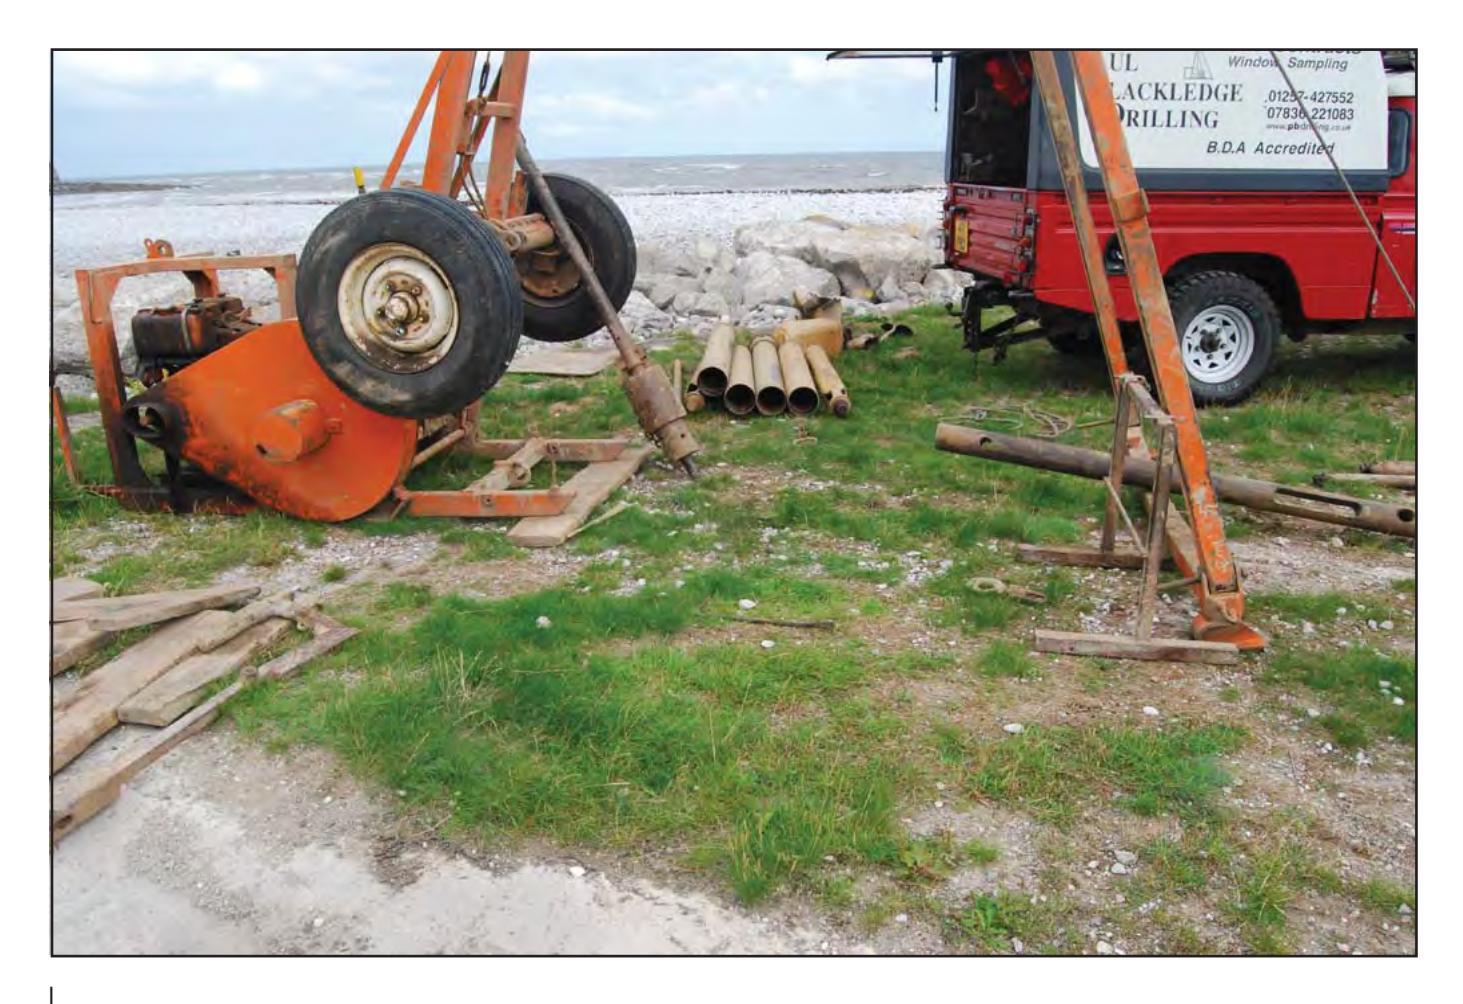
Borehole 03 was not completed due to the presence of rock armour that prohibited the use of the cable percussion rig.

Plate 10 - Close-up detail of Borehole 03 prior to excavation, with the cable percussion rig in situ. The borehole was not completed due to the solidity of the rock armour that formed the groyne.
