Penrhyn Terrace, Bwlchtocyn. Water Mains Renewal Sceme: Ground Investigation Programme

Archaeological Watching Brief

GAT Project No. 2147 Report No. 884 November 2010

Report No. 884

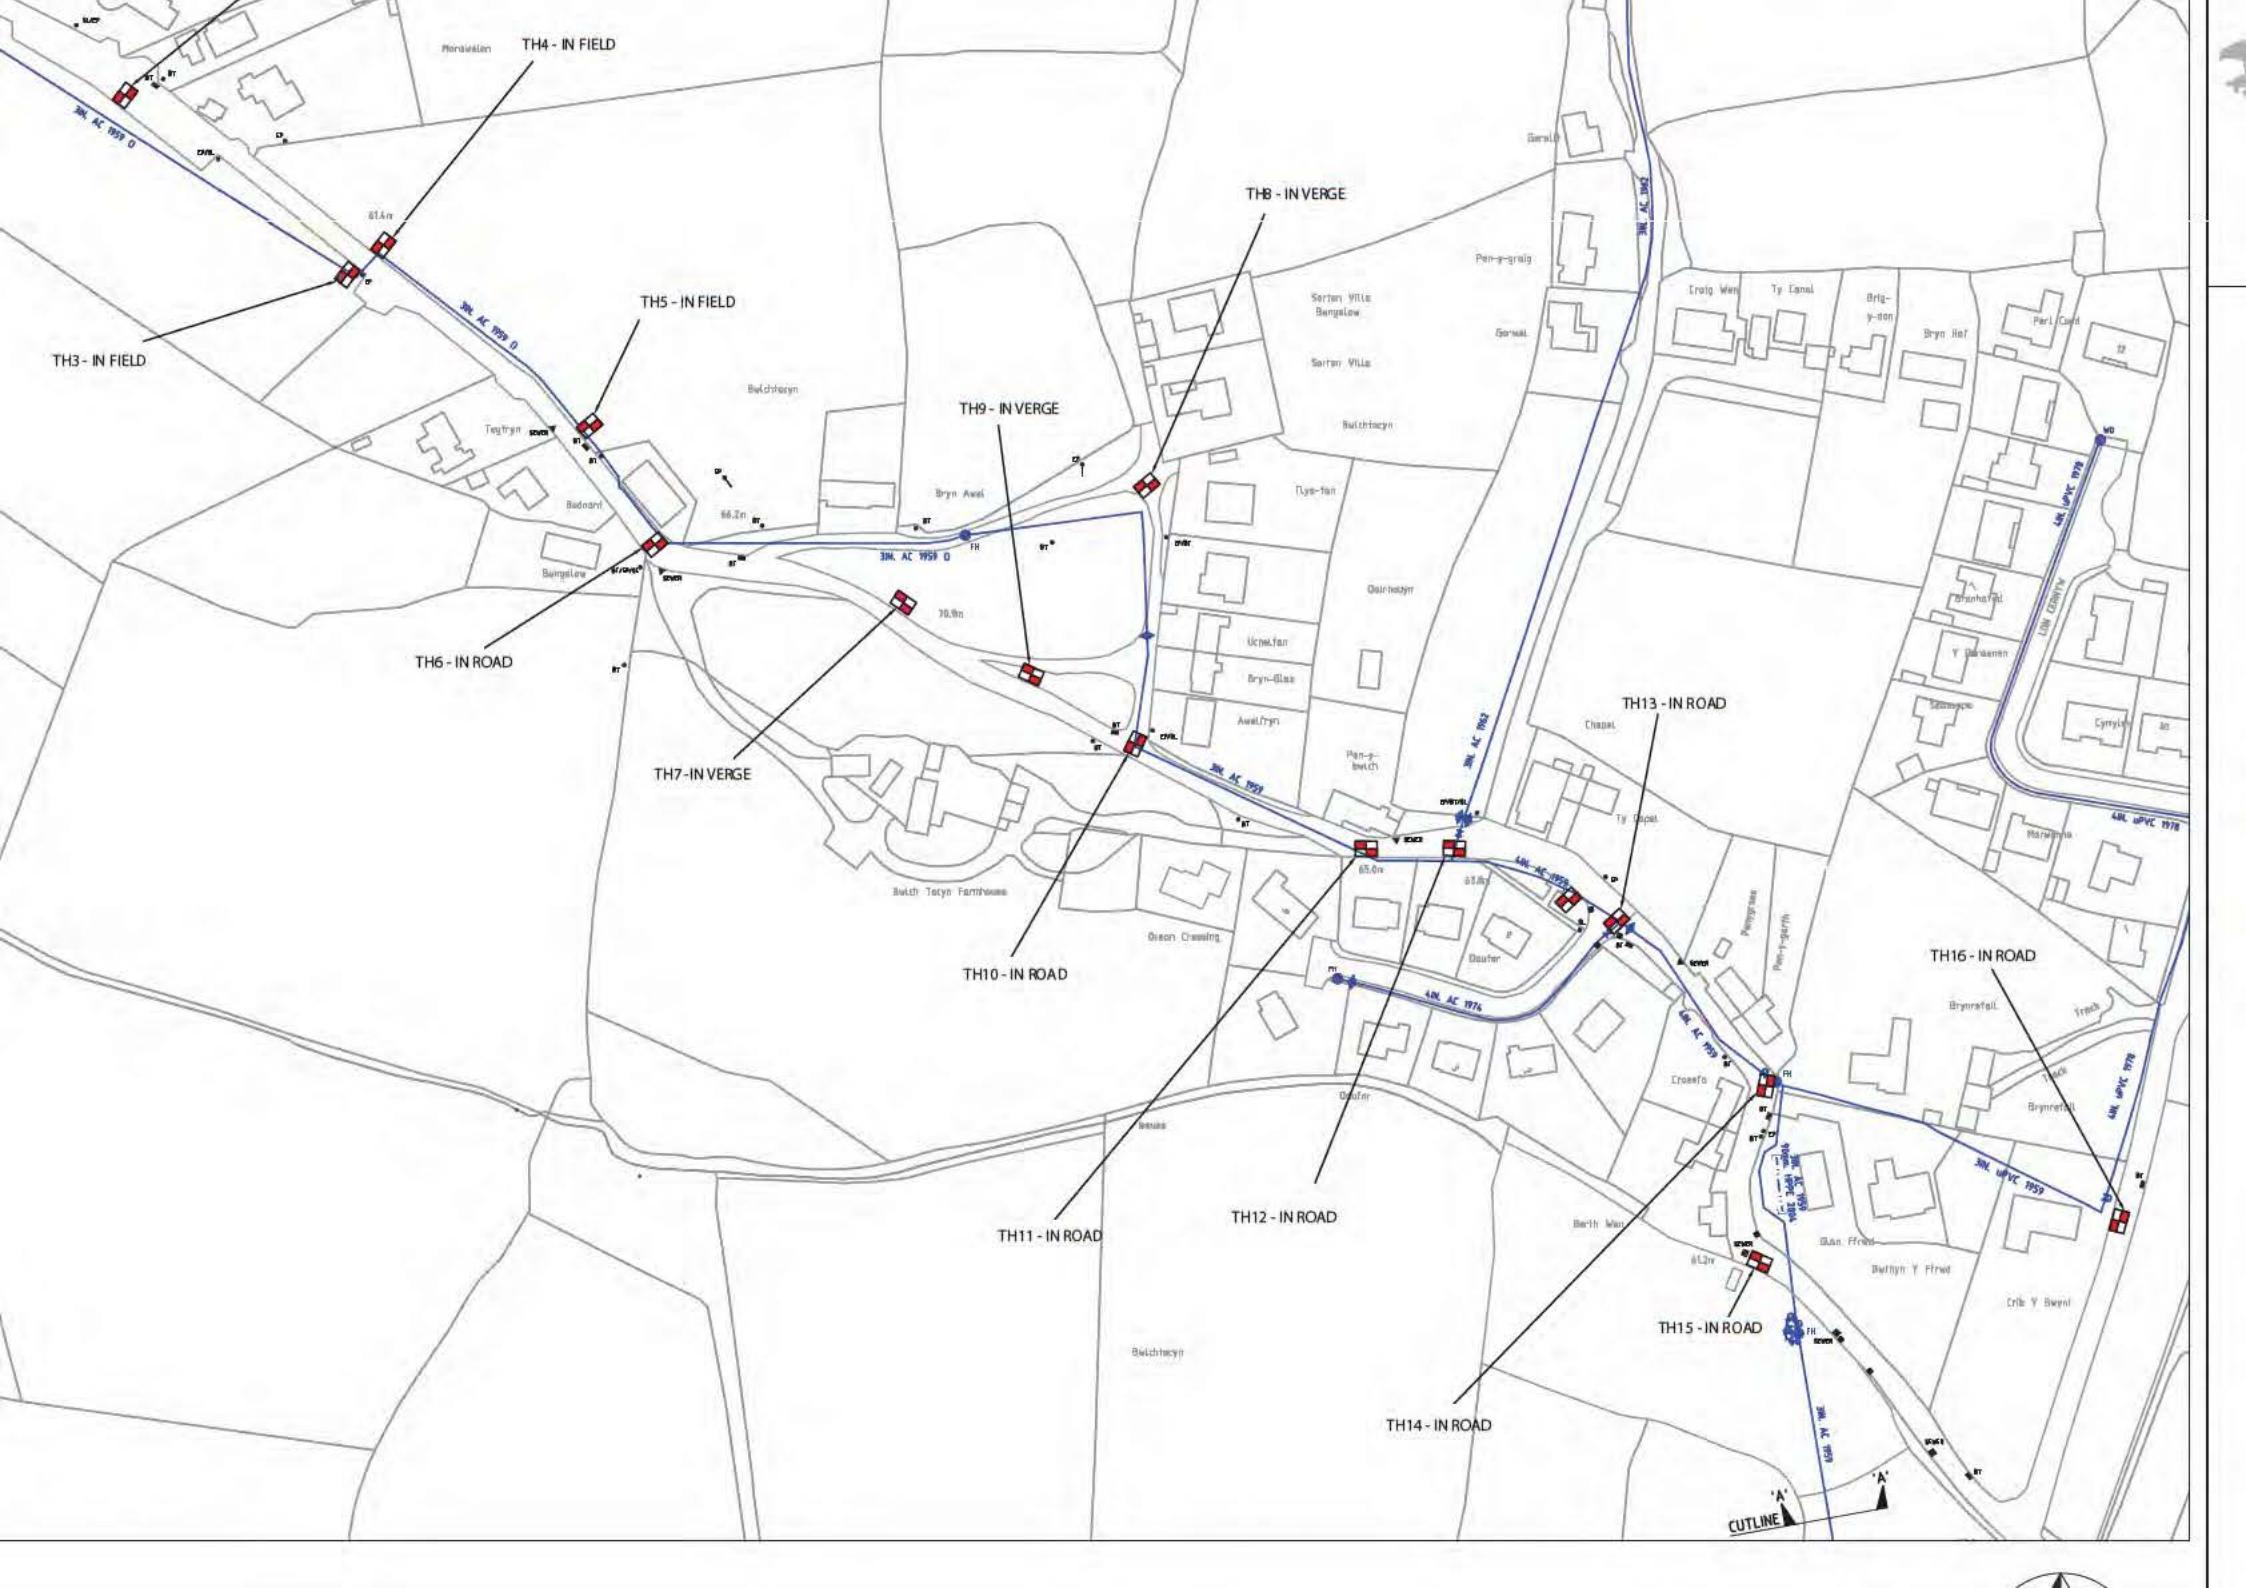
Figure 01:

Reproduction of client drawing B1362200/GI/100 "Proposed Exploratory Hole Location Plan" showing site location and location of Trial Holes TH1 - TH16.

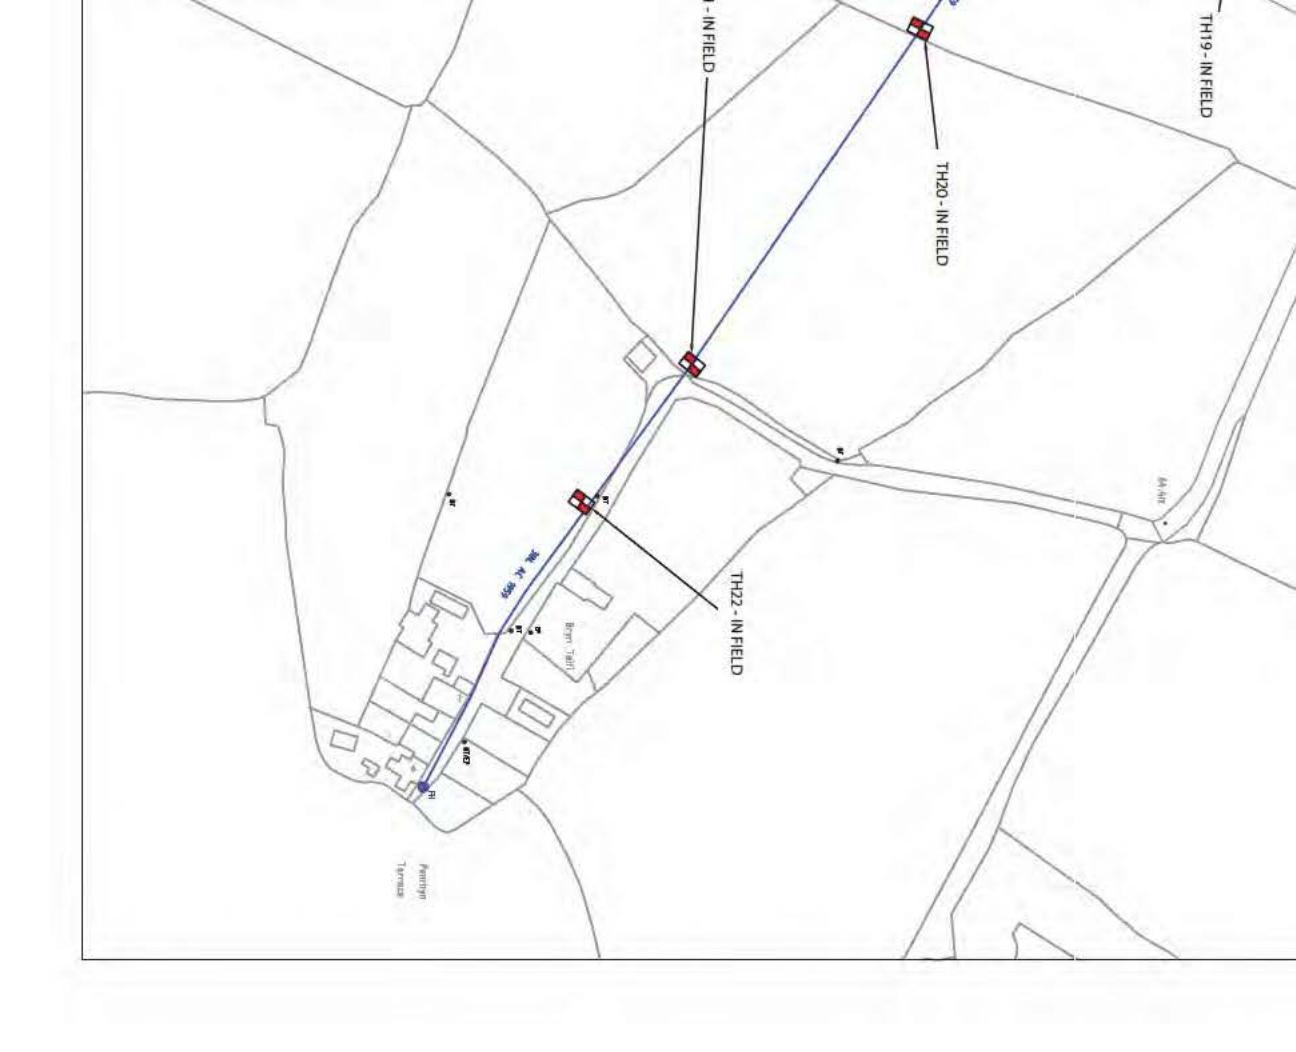
Figure 02:

Reproduction of client drawing B1362200/GI/100 "Proposed Exploratory Hole Location Plan" showing site location and location of Trial Holes TH17 - TH22.

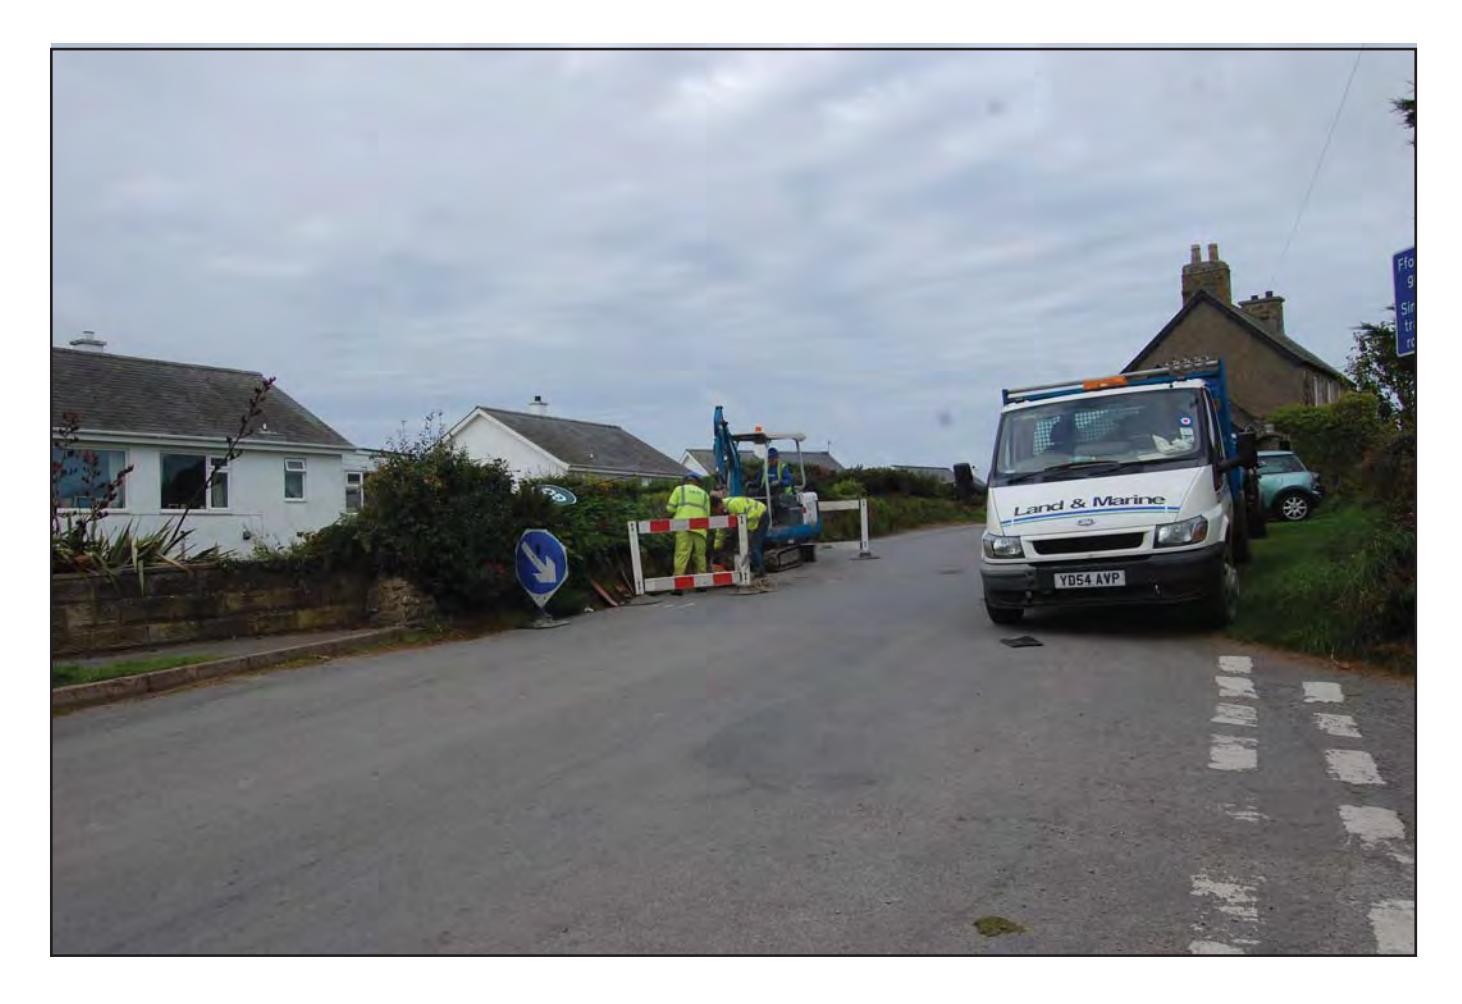
Plate 01 - Location of TH12 in Bwlchtocyn, opposite 18thC chapel.

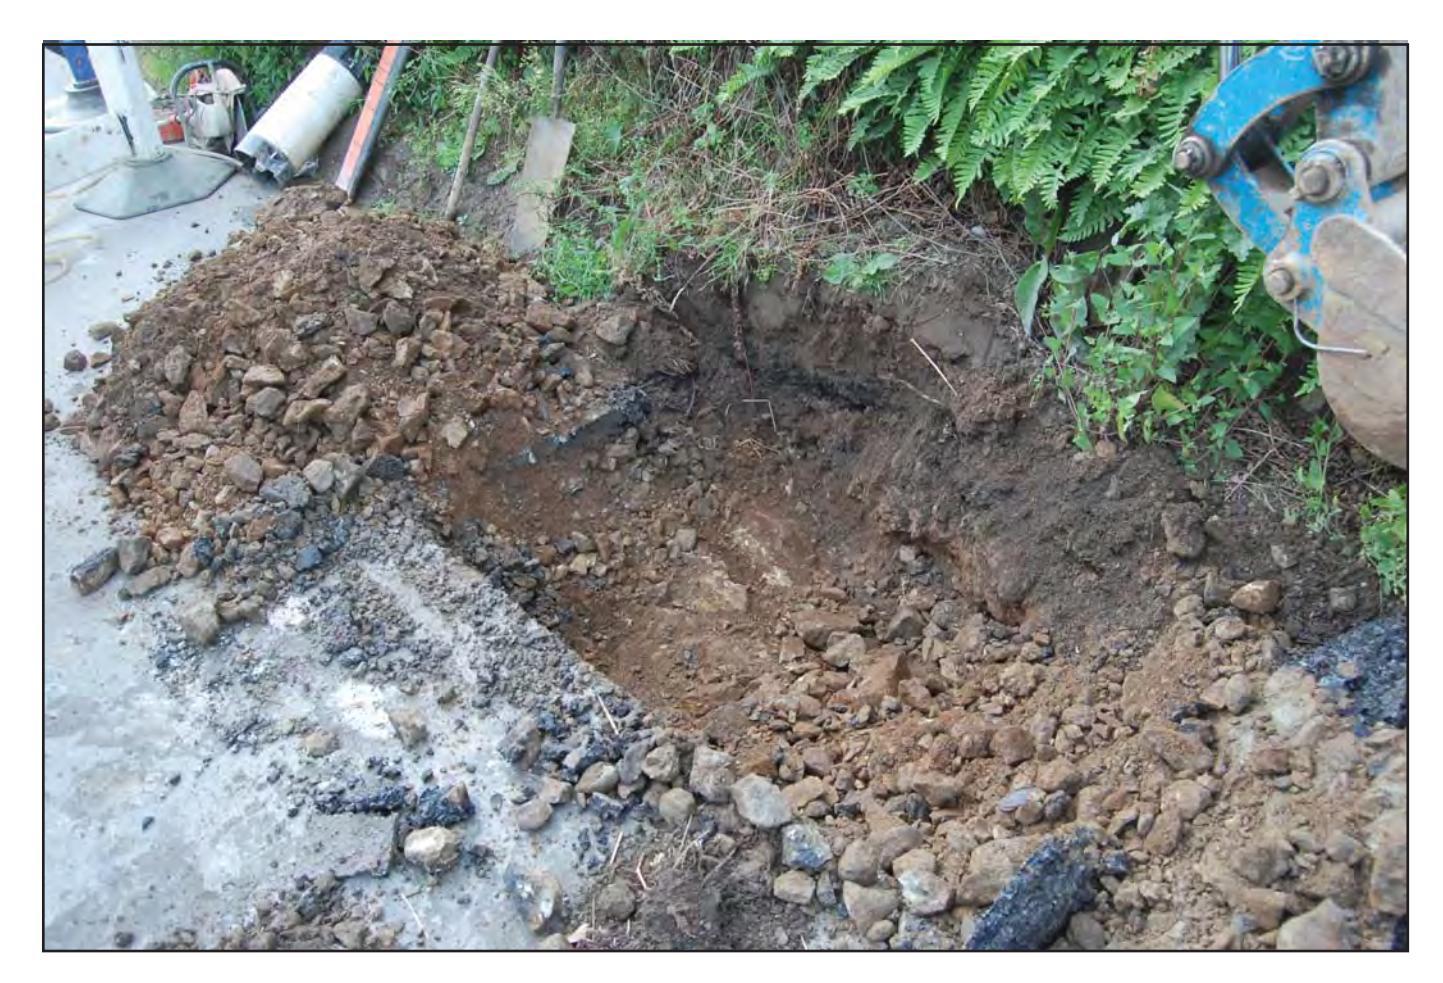
The test hole included the modern tarmac road surface (0.10m deep), followed by a sub-base of loose stone (0.10m deep). Bedrock was identified beneath the sub-base layer at 0.20m below ground level.

Plate 02 - Excavated test hole, water mains not located.

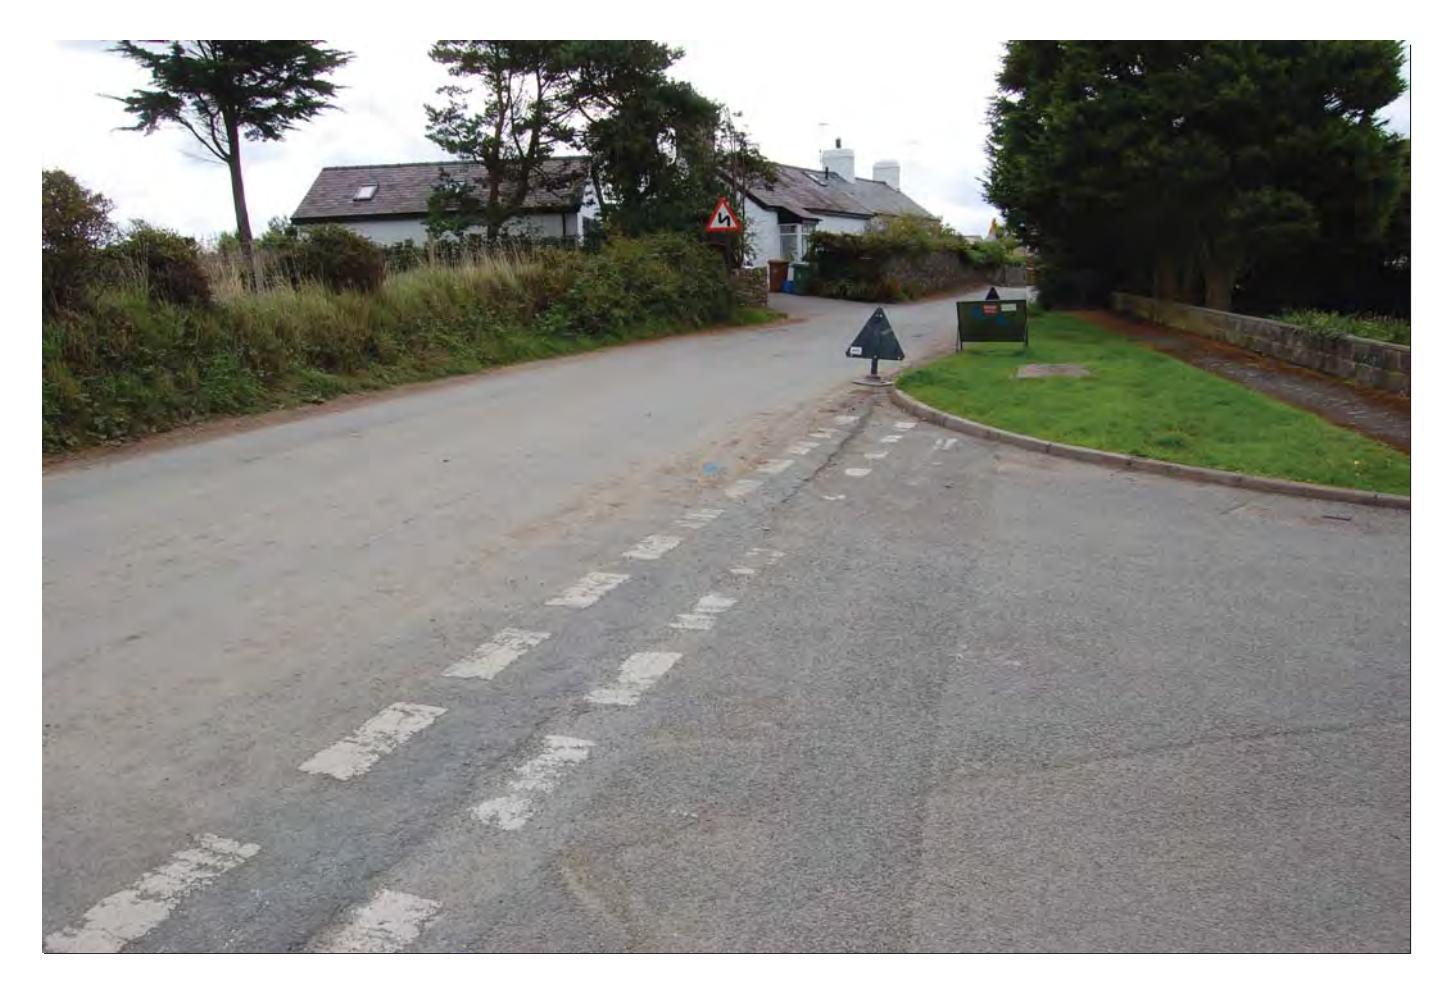
Plate 03 - Location of TH13a, on corner of entrance to housing estate.

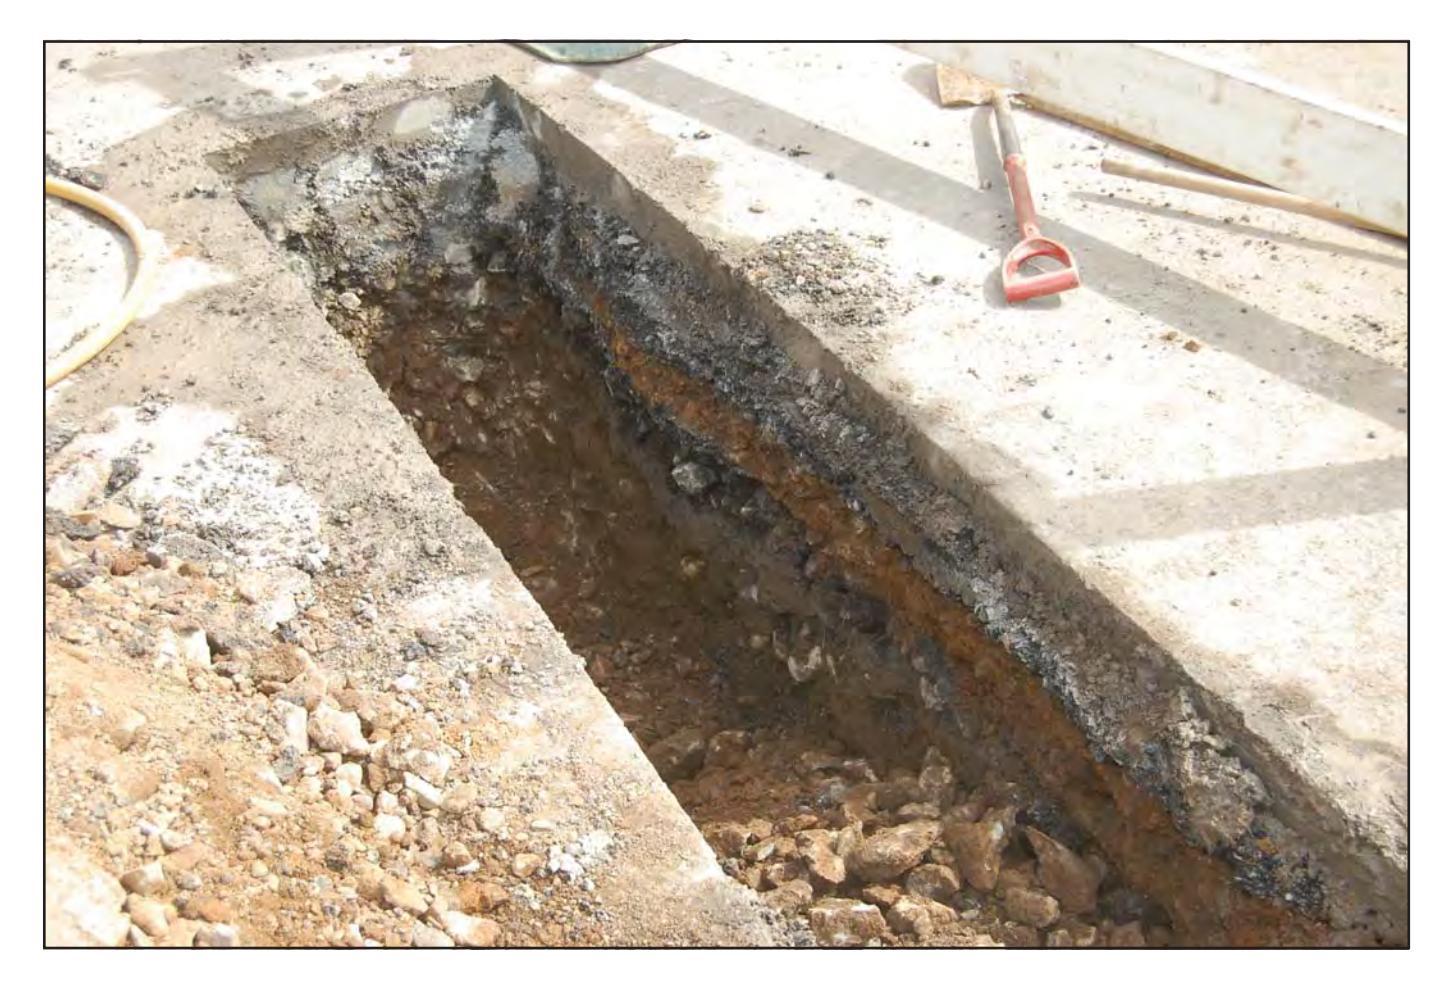
The test hole was excavated to a maximum depth of 0.75m: the test hole contained evidence for road re-surfacing with the original sub-base (large fragmented stones) sealed by two tarmac layers. The test hole was then relocated on the modern grass verge, in which no mains were identified. The main were located in test hole TH13c, to the immediate south of 13b.

Plate 04 - Post excavated section of TH13a.

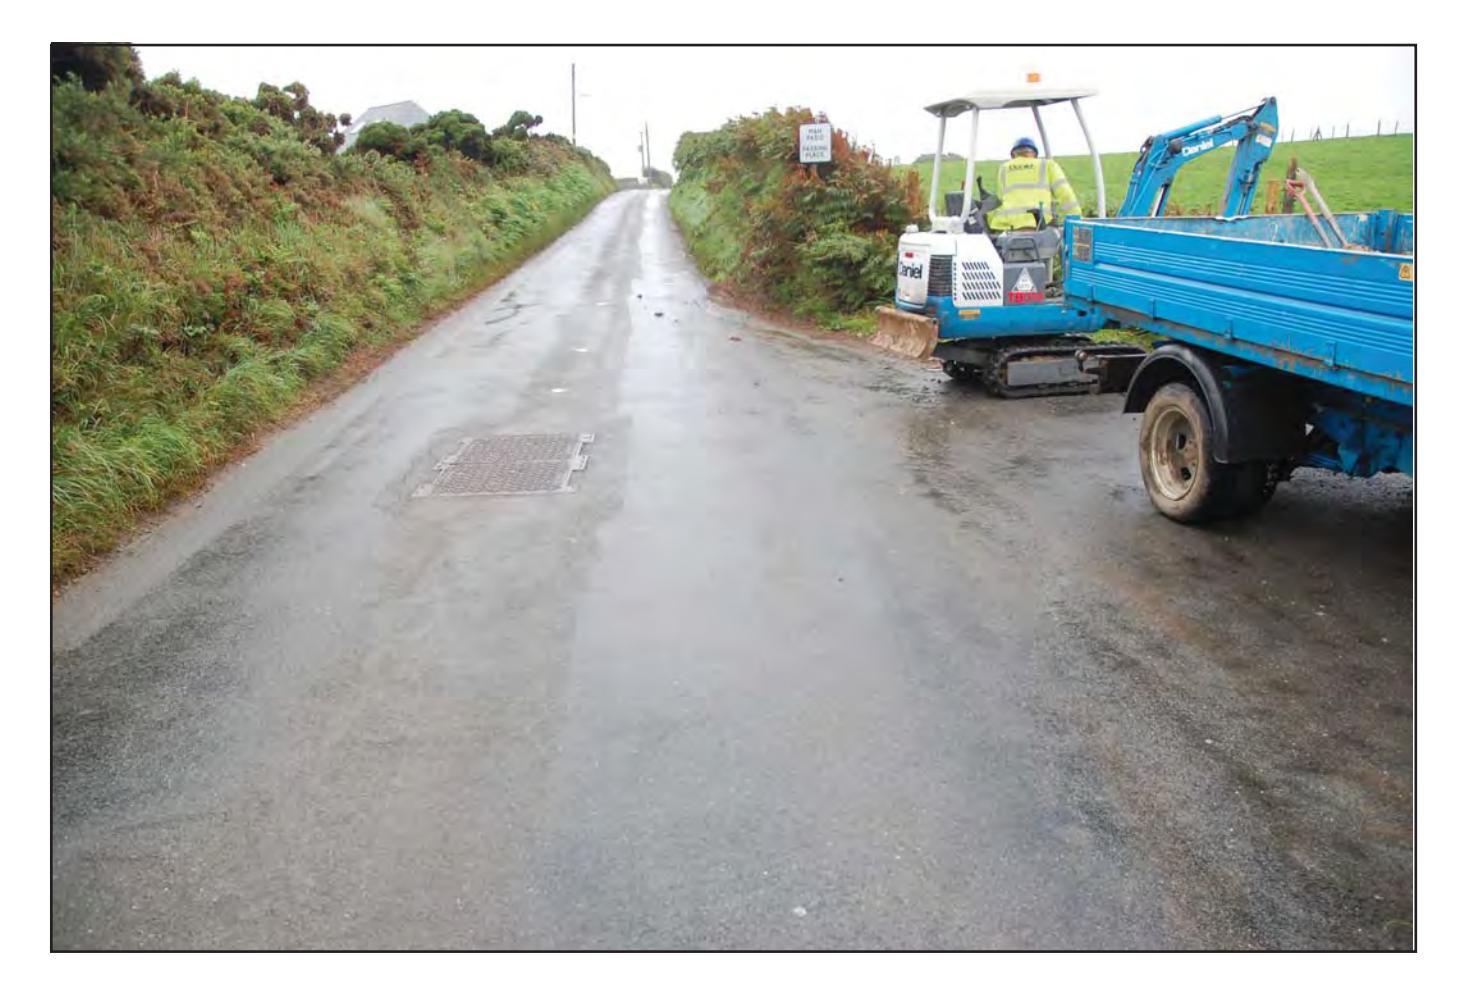
Plate 05 - Location of TH01, on the road leading to Bwlchtocyn.

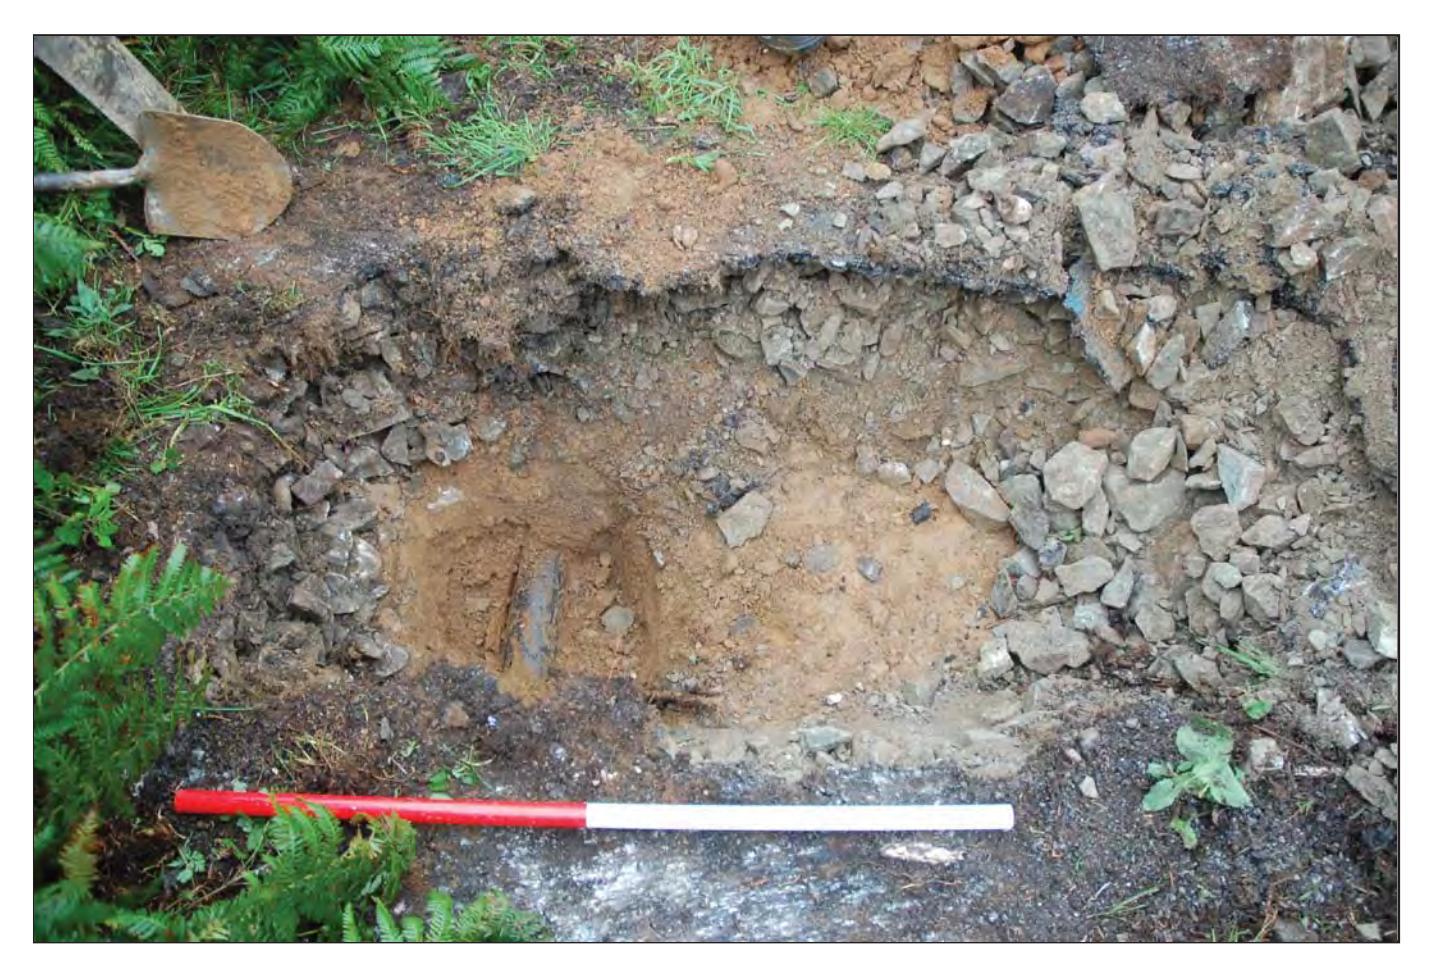
The test hole was excavated on a car passing area on a narrow road leading to Bwlchtocyn. Tarmac road surface with depth of 0.08m, below which was a stone road foundation material with a maximum depth of 0.32m. Below which was a natural orange yellow medium course sand, which was excavated to a depth of 0.25m and abandoned.

Plate 06 - Excavated section of TH01 with exposed water main.

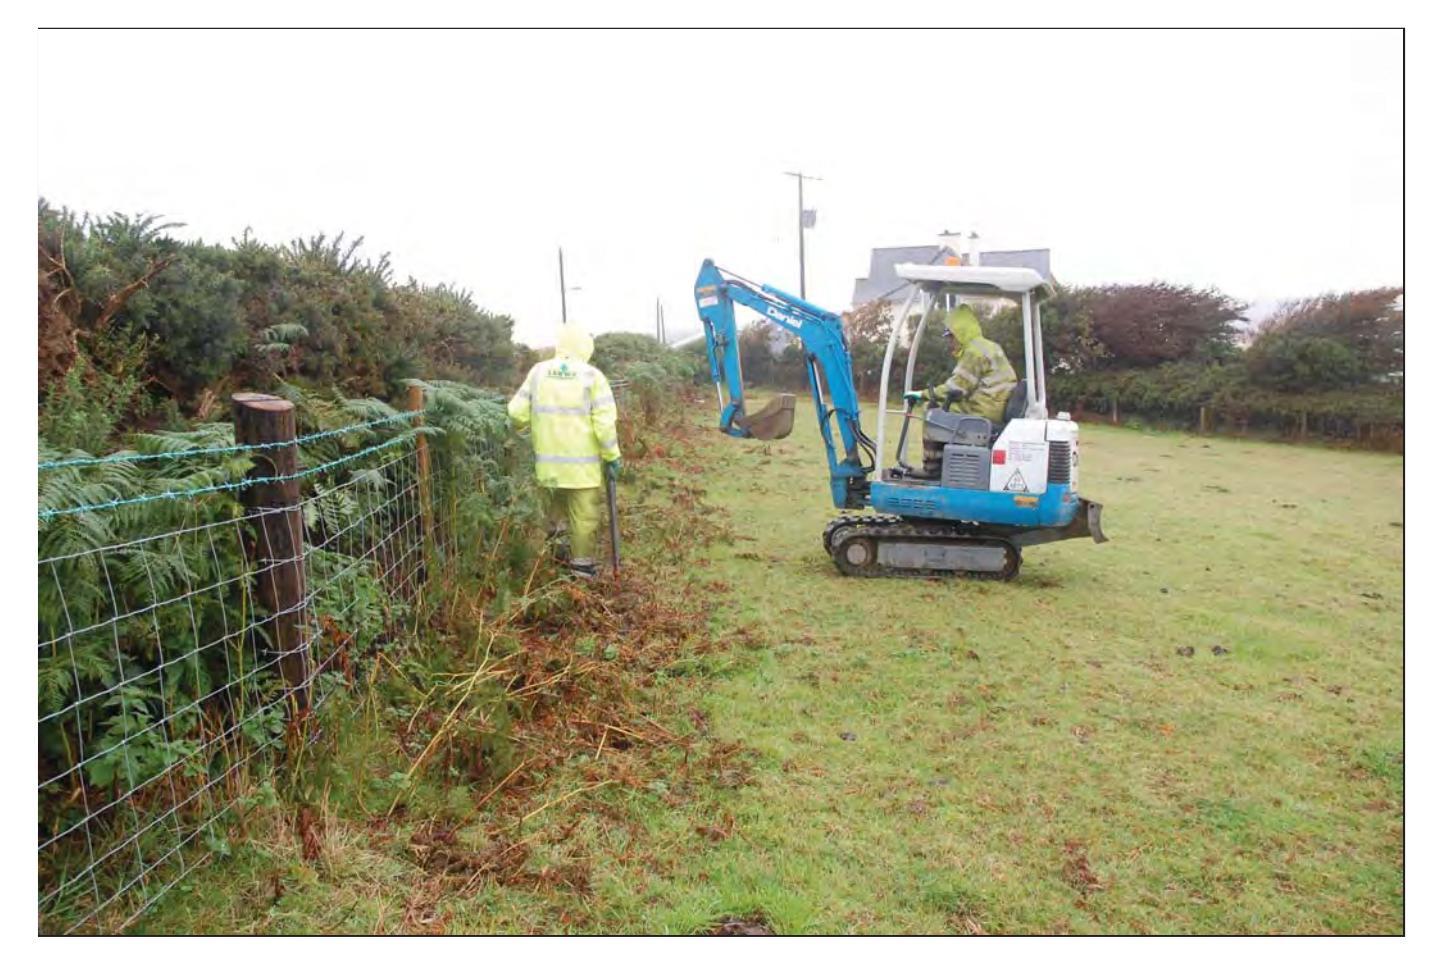
Plate 07 - Location of TH04, within a field adjacent to the road leading to Bwlchtocyn.

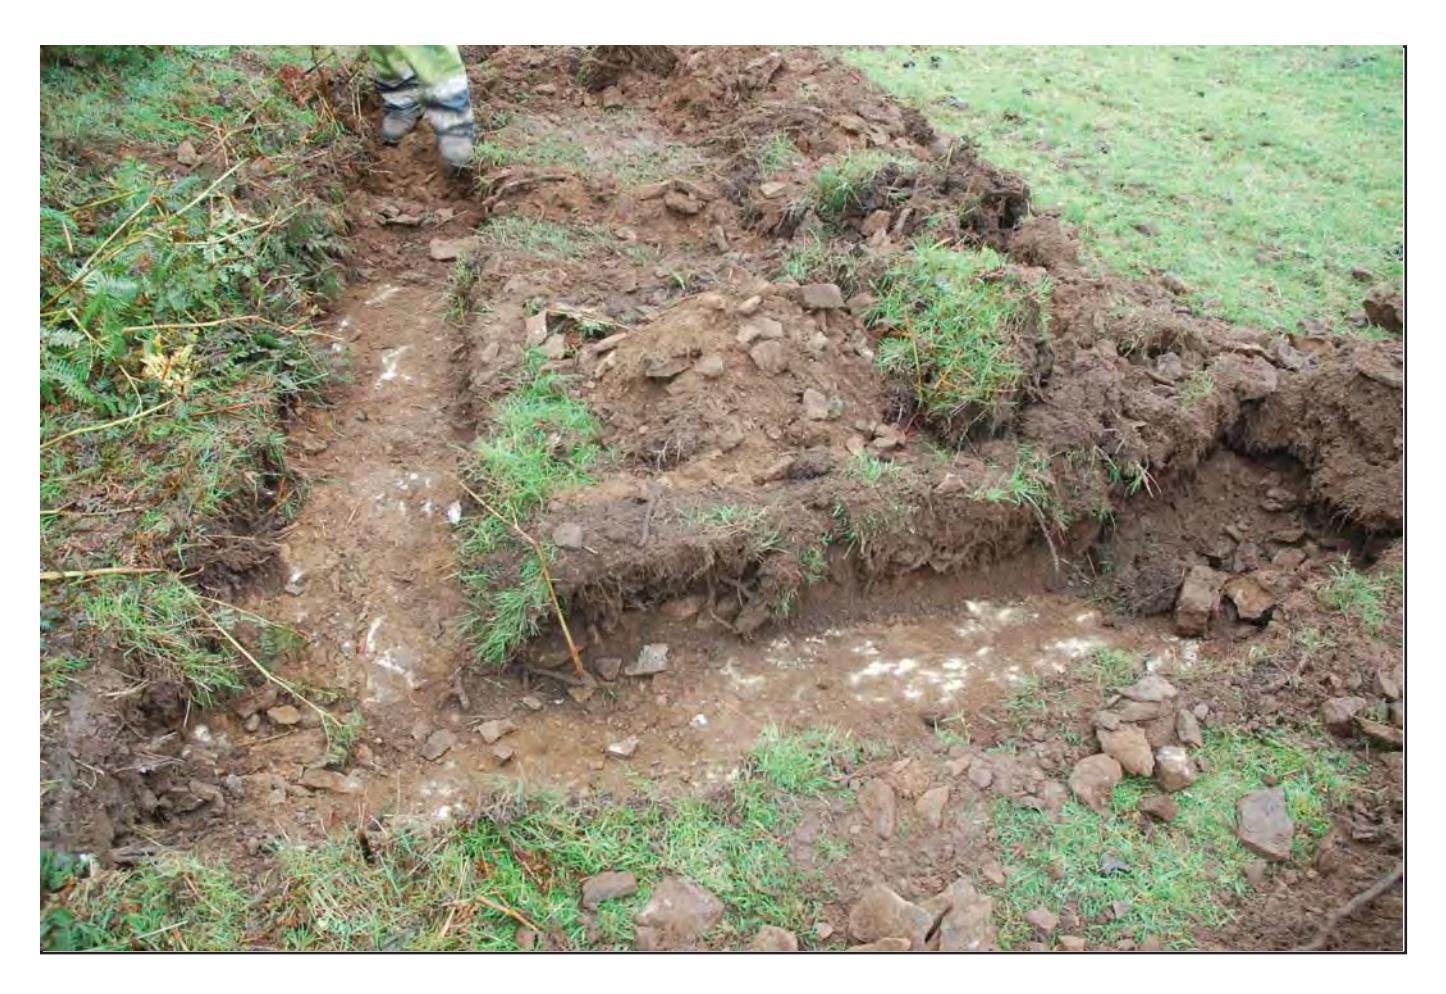
The initial test hole did not locate the water main but did expose the bedrock, extant at 0.27m below surface level. Stratigraphy comprised a thin layer of topsoil (0.15m deep) above a shale-rich subsoil (0.12m deep). A second test hole (TH04b) was excavated 10.0m to the SE: the water main was identified at 0.60m below surface level.

Plate 08 - TH04, exposed bedrock close to surface. The water main was not found at this location.

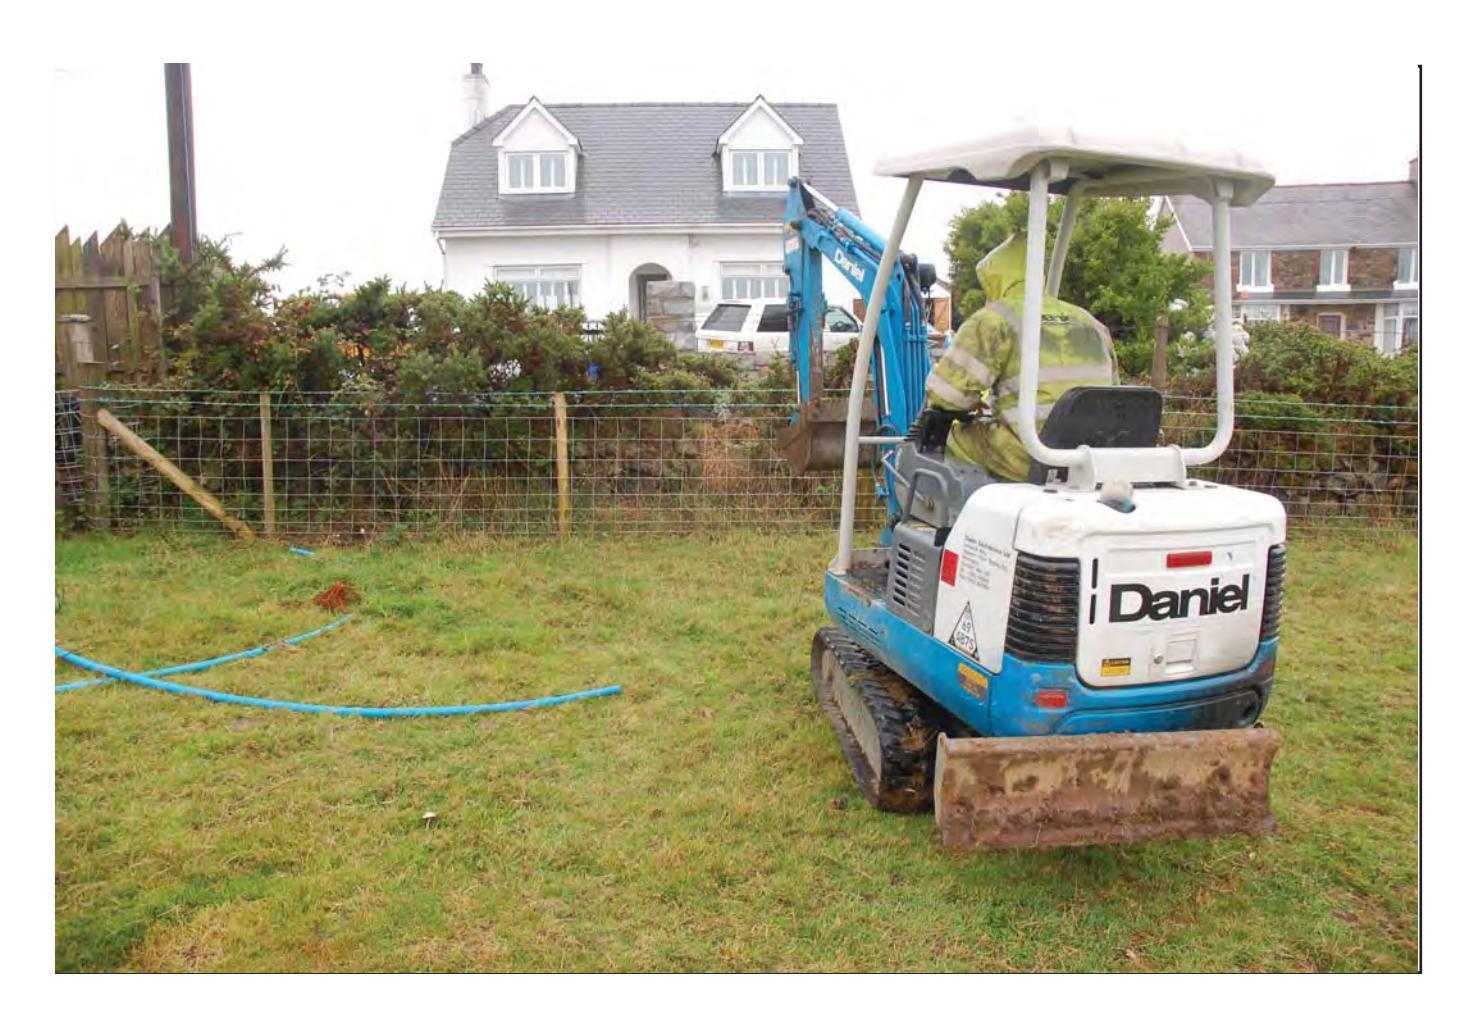
Plate 09 - Location of TH05, on entering the village of Bwlchtocyn.

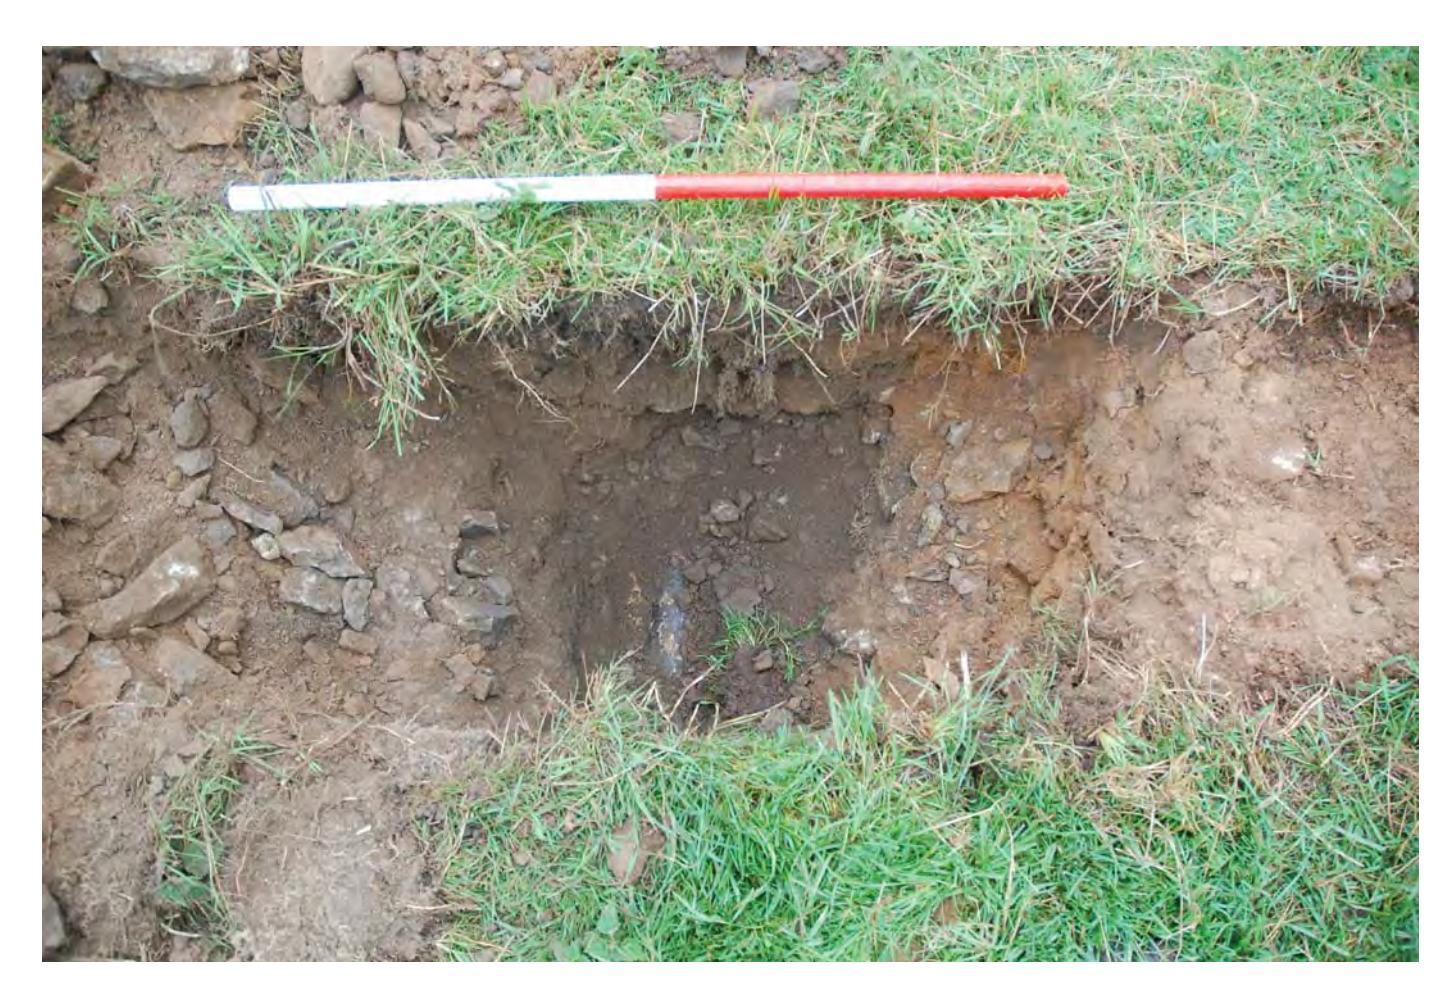
The test hole contained a very thin band of topsoil (0.05m deep), above a moderate shale-rich subsoil; the glacial natural was an orange yellow silt-sand drift deposit. The water main was located within the test hole at 0.70m below ground level.

Plate 10 - Post excavated section of TH05, the water mains at the base.

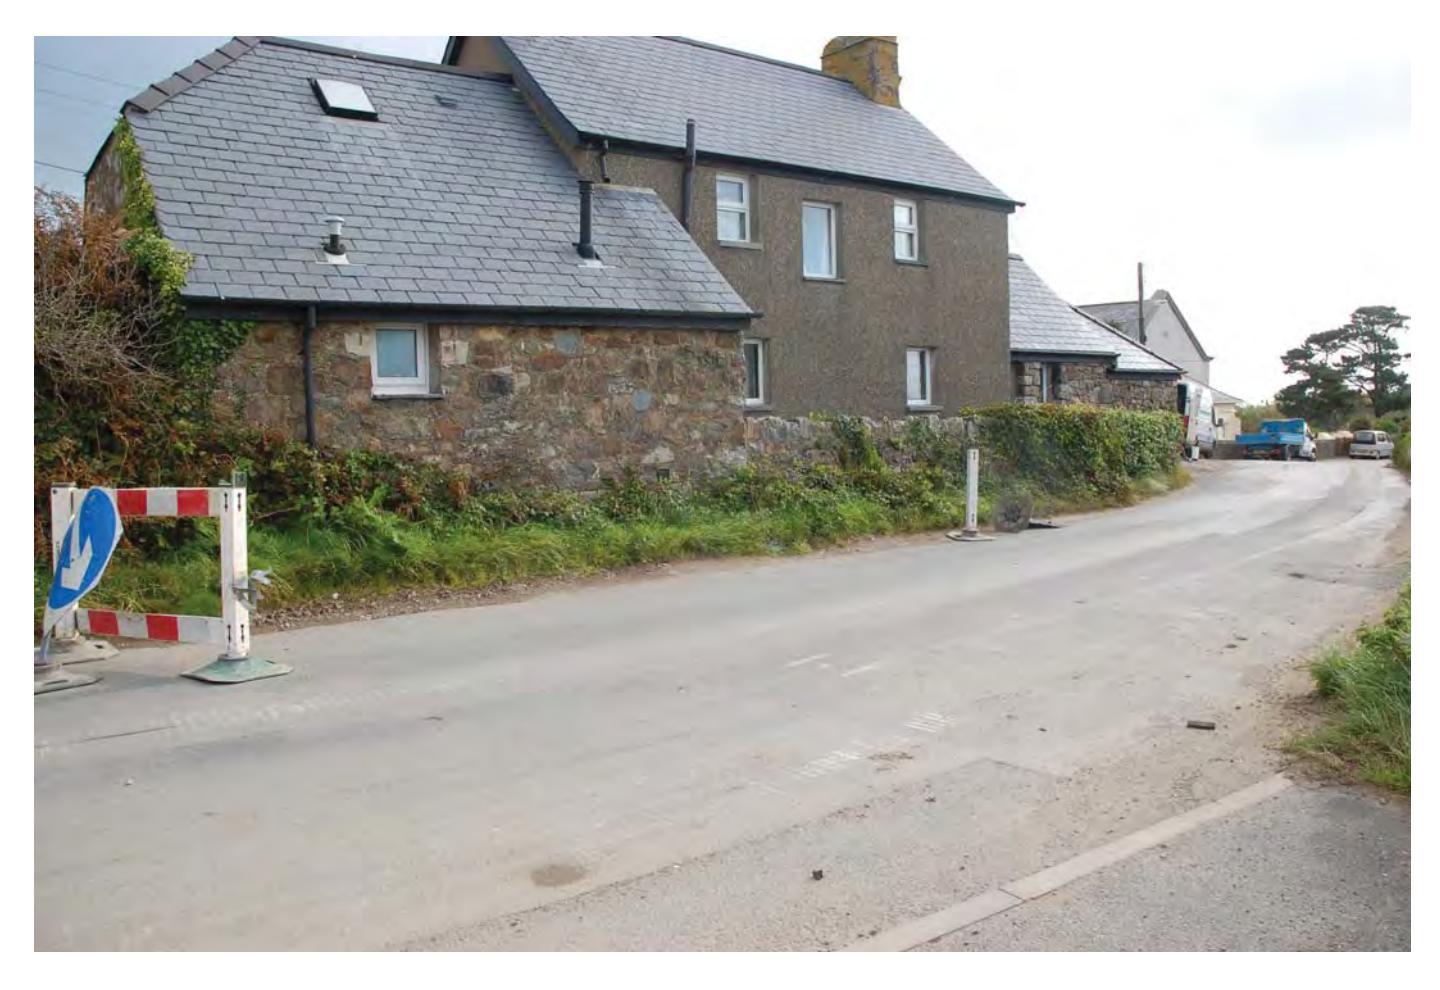
Plate 011 - Location of TH11b, near the southern wall of Pen y Bwlch cottage.

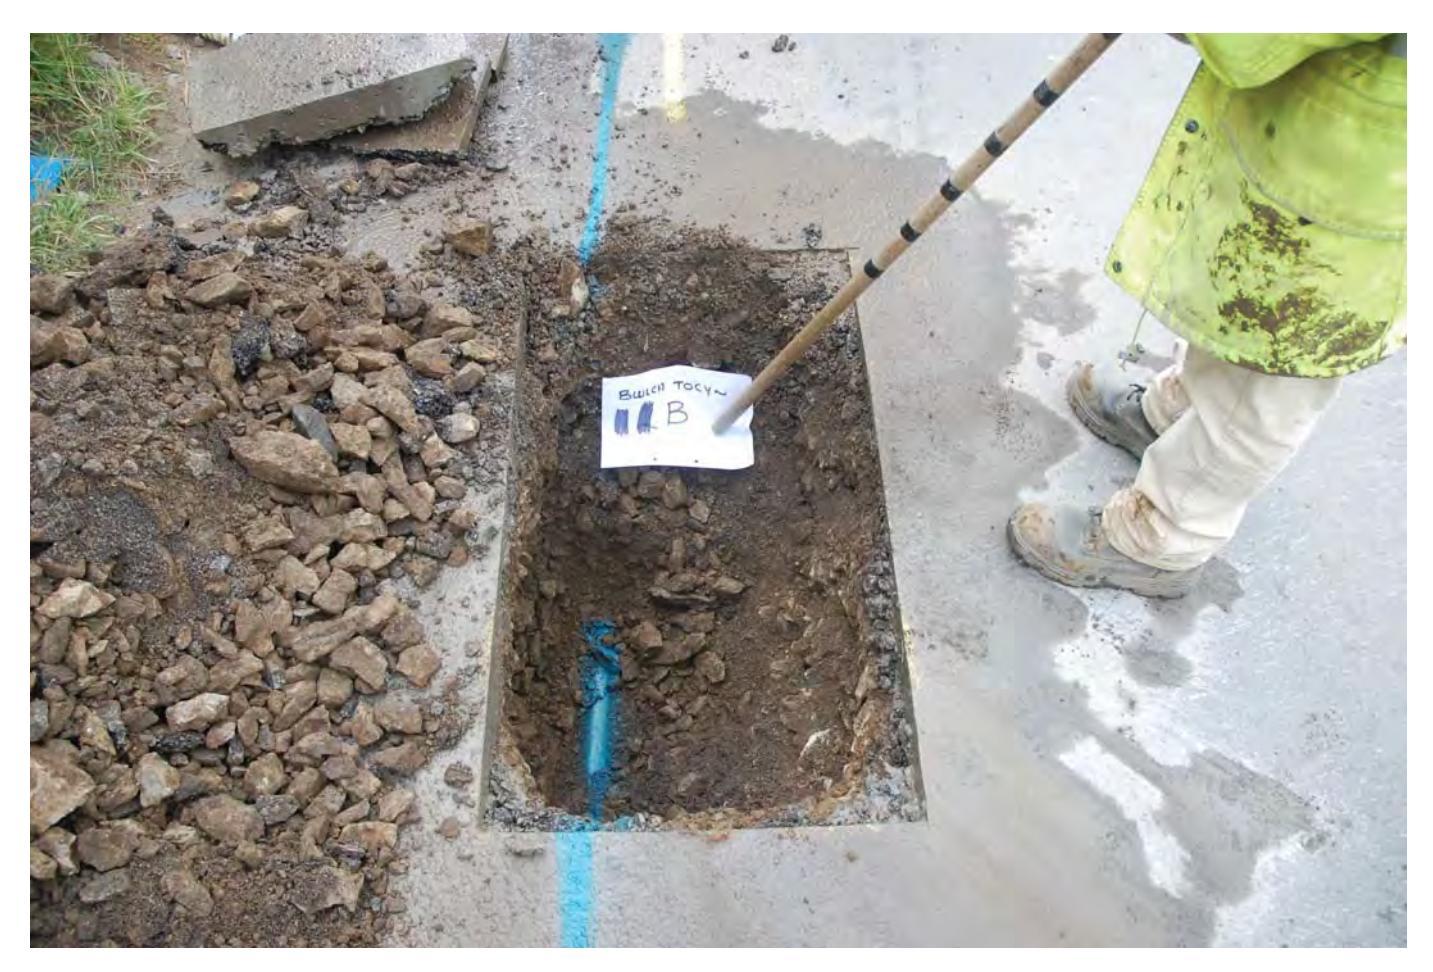
The test hole was excavated on the direct line of the previous (1959) water main, the trench did not disturb any virgin ground surface and only disturbed soils were observed. The water main was observed at a depth of 0.70m, with the test hole being very close to Pen y Bwlch cottage. The trench was excavated into the tarmac road surface, which was underlain by roadstone, with a joint depth of 0.23m. The only other material observed was the backfill of the previous water main.

Plate 12 - Excavated section of TH11b, water main located at the base of trench.
