Penrhyn Terrace, Bwlchtocyn. Water Mains Renewal Sceme: Ground Investigation Programme

Archaeological Watching Brief

GAT Project No. 2147 Report No. 884 November 2010

Report No. 884

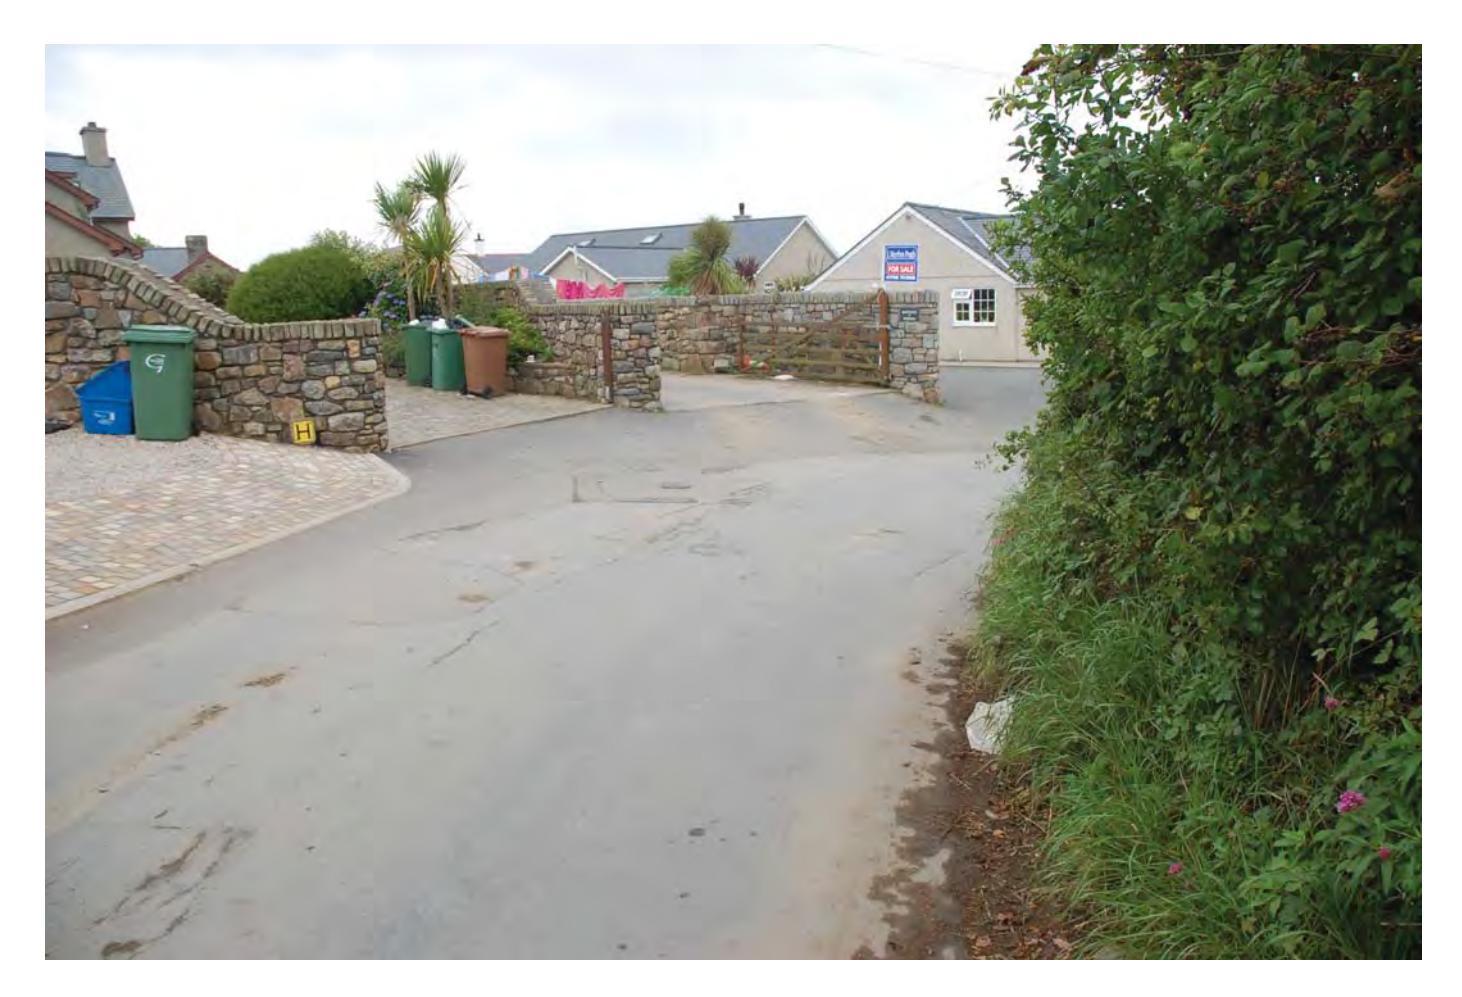
Plate 13 - Location of TH14.

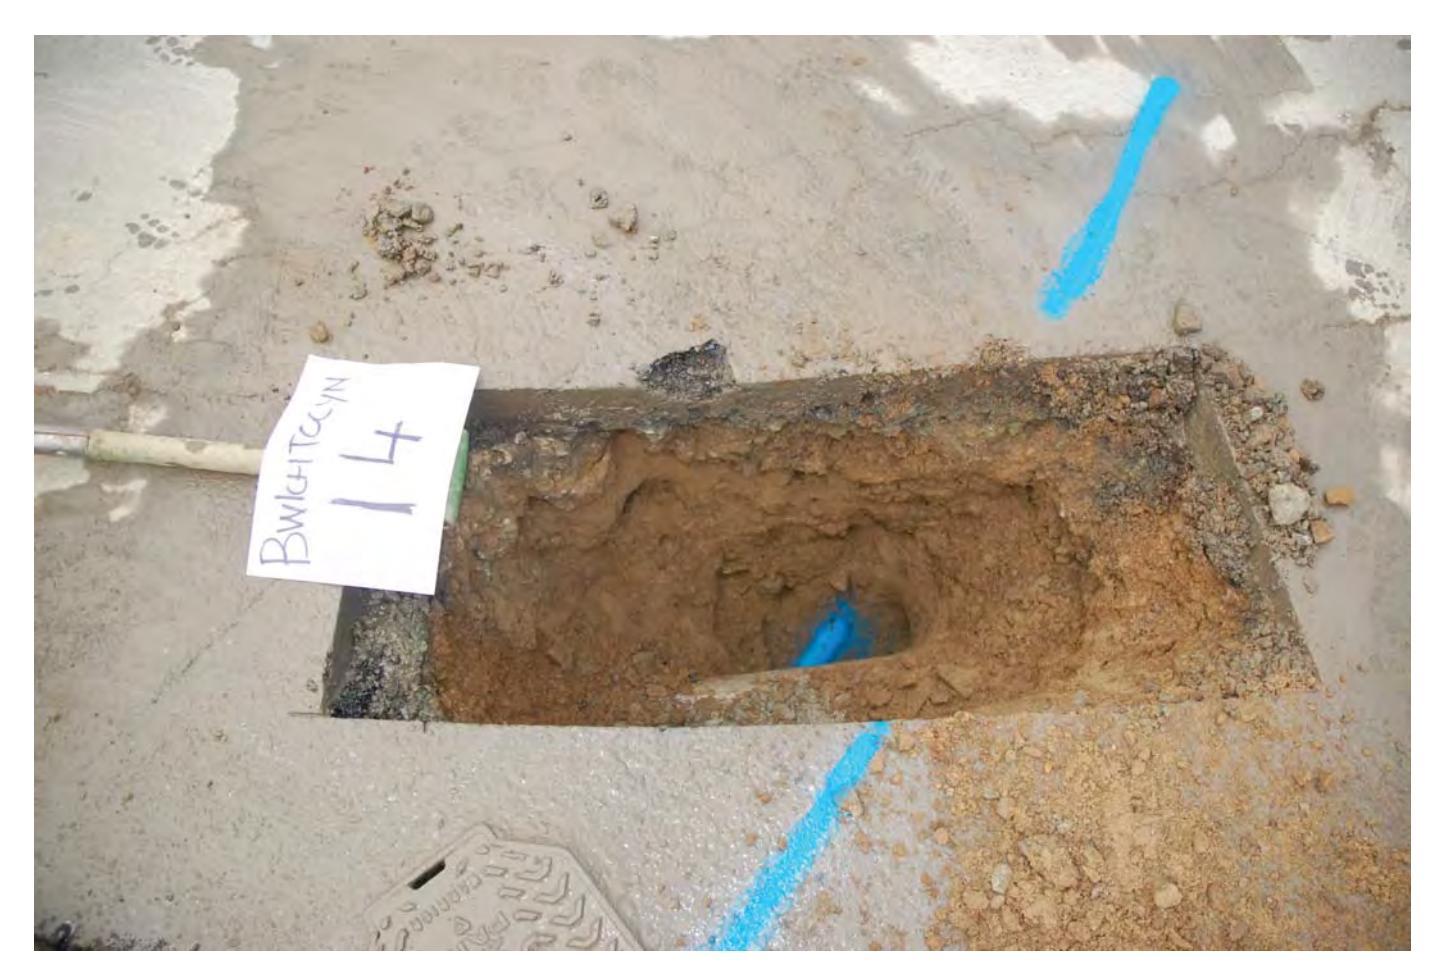
The test hole was positioned to identify the location of the existing main (the main was identified). A BT cable had been laid over the water main in this trench with a NE-SW orientation.

The test hole contained a tarmac road surface overlying a stone-rich road foundation with a joint depth of 0.22m. The backfill associated with the existing water main trench consisted of a mid orange-brown sand-silt with frequent pebble and cobble sized stone. Total depth to the water main was 0.80m.

Plate 14 - Excavated section of TH14, showing the water main below the BT cable.
