# Understanding corrugated iron buildings in north west Wales

University of Birmingham The Ironbridge Institute MA Historic Environment Conservation Dissertation: 09 20346 Student ID Number: 1062396 November 2011 Tutor: Harriet Devlin Academic Year of Enrolment: 2009-10

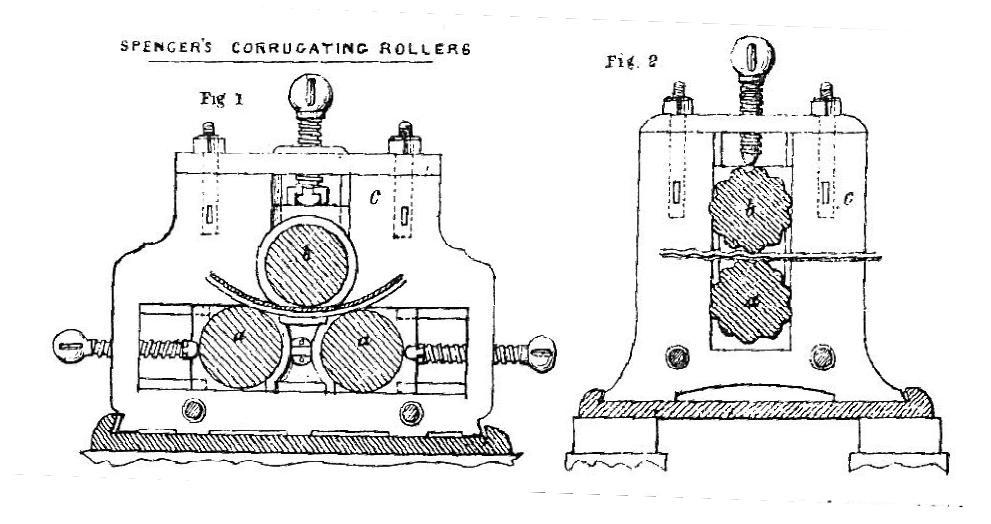
The process of hot-dip galvanizing was not developed until 1837 when Craufurd took out a British patent whilst Sorel patented a similar technique in France. The process was not applied to corrugated iron until 1843 when Morewood and Rogers developed a zinc coated product resistant to corrosion and oxidation (*ibid.*). The product was further perfected in 1844 by Thomas Edington of the Phoenix Iron Works, Glasgow who created the first efficient cold process using a fluted rolling machine (Figure 2). The process then remained relatively unchanged into the modern era.

Figure 2 – Illustration of Thomas Edington's machinery for making corrugated iron, 1844 from *The Civil Engineer and Architect's Journal 1845* (from Herbert 1978, 38)

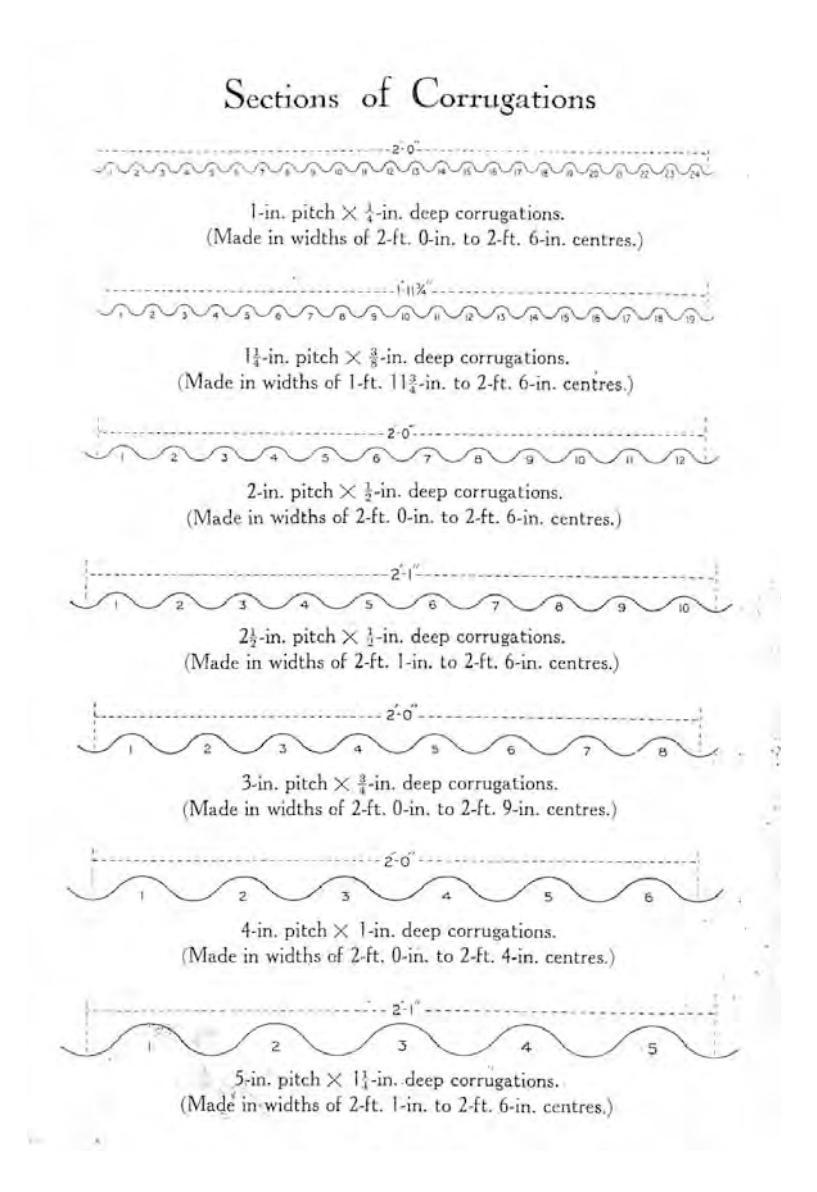
Figure 3 – Illustration of corrugated sheets and profiles (Wolverhampton Corrugated Iron Company sales catalogue n.d.)

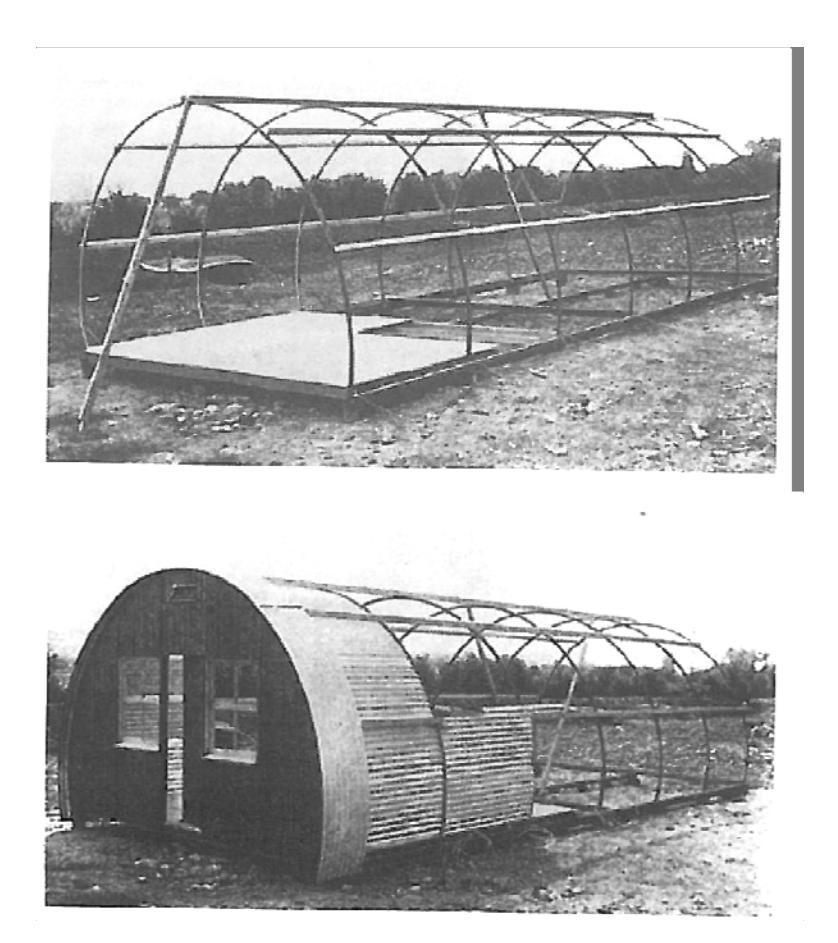
#### Plate 2 – Construction of a Nissen Hut (www.nissens.co.uk)

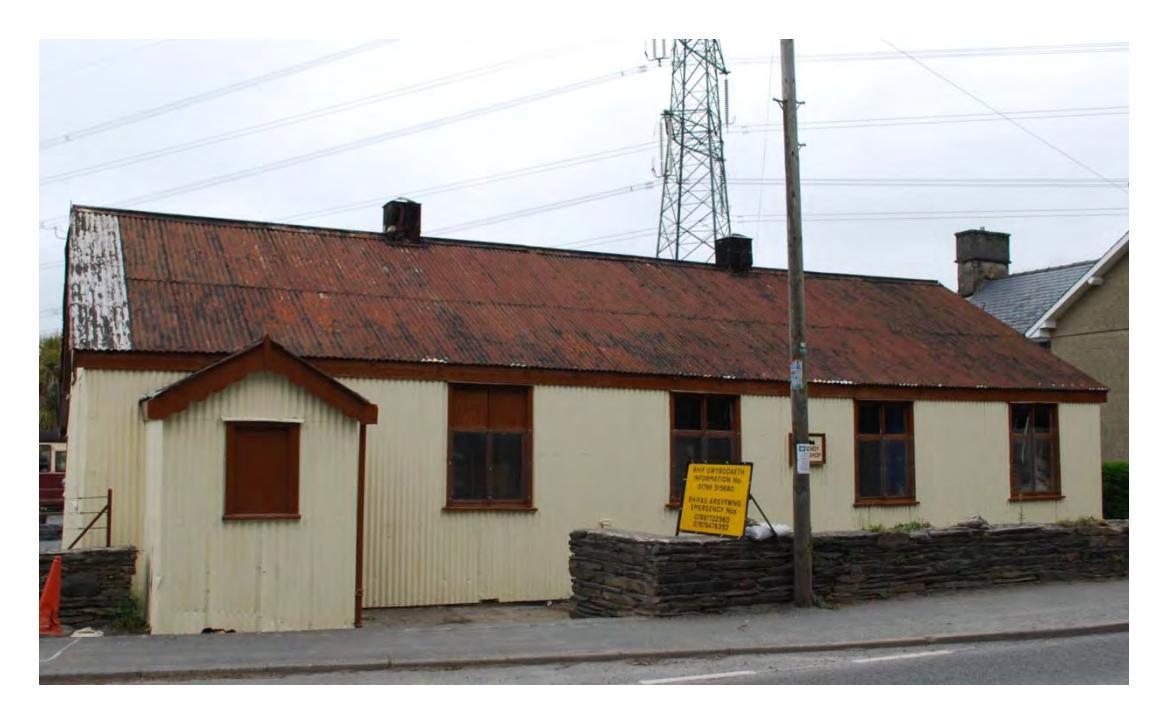
Plate 9 – PRN 33350 Gweithdy early 20<sup>th</sup> century prefabricated corrugated workshop on the Welsh Highland Railway (Author 2011). The building was most likely brought into Porthmadog by sea and then up the railway to Minffordd.

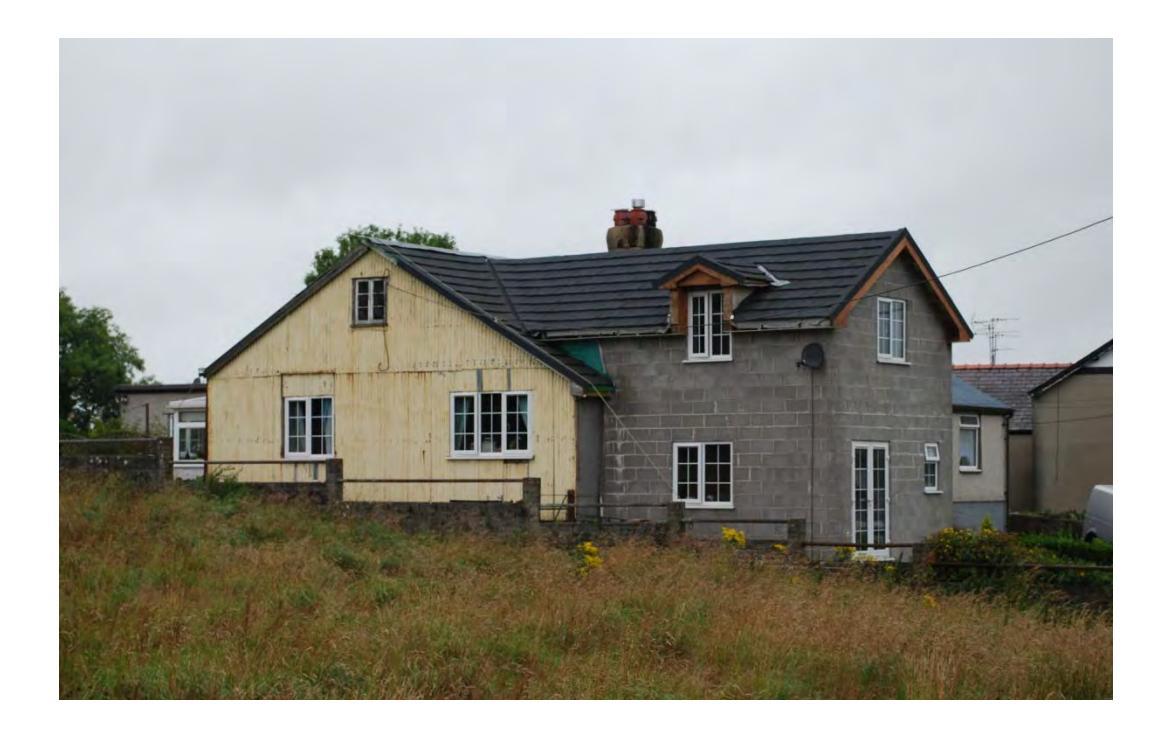
Plate 38 – PRN 33340 An almost unrecognisable corrugated house at Llanrug, Gwynedd (Author 2011)

The wholesale replacement of corrugated roofs with 'traditional slate' is commonplace and normally justified using the erroneous rationale that the corrugated iron is an inefficient roofing material that is not contemporary with the construction of the building.

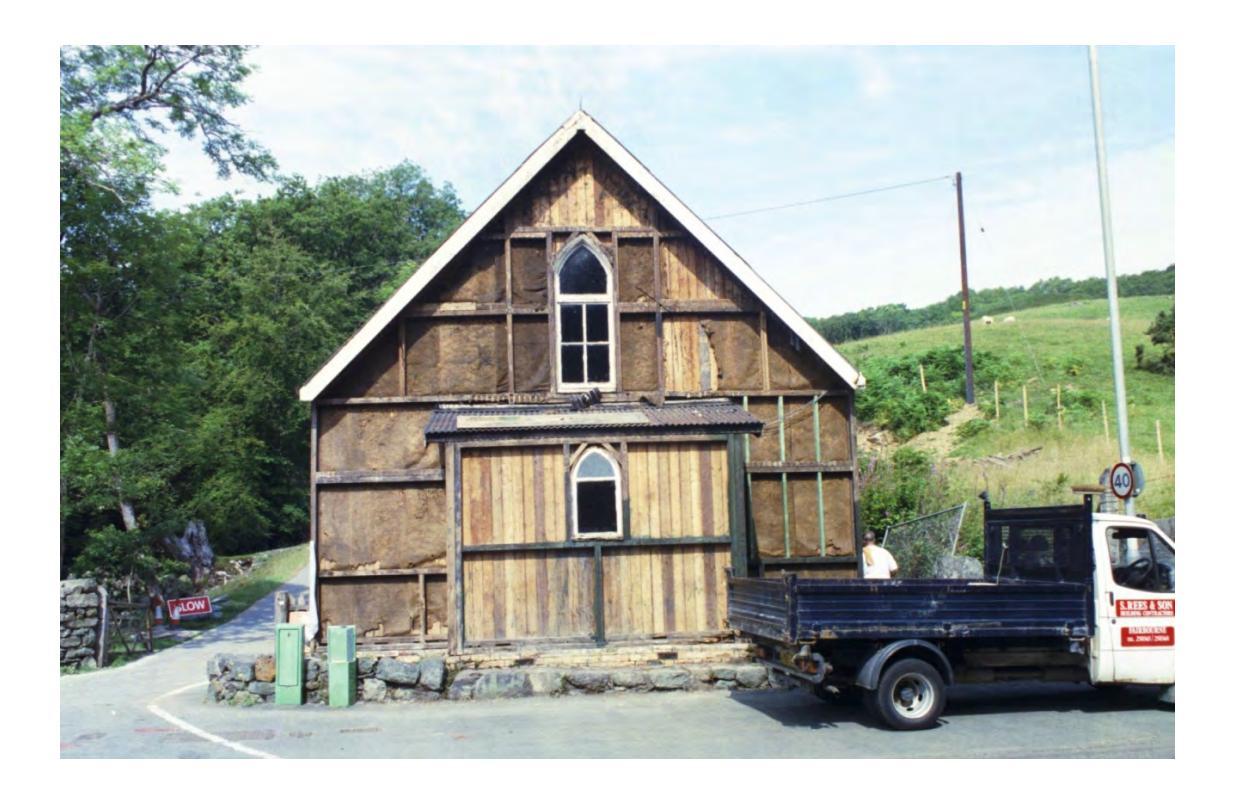
Plate 39 – PRN 33370 Mission Hall, Ganllwyd during conservation work in 2006 (image provided by the National Trust)

There are few examples of good practice, however the National Trust-owned Ganllwyd Mission Hall (plates 39 & 40) presents a useful case study following the principles of the Historic Scotland guidance. During 2006 the building was overhauled, the insulation was upgraded and the usability and functionality of the space was improved to meet the future needs of the building as an asset to the local community. In accordance with the guidance set out by Walker (2004) the corrugated iron sheets were removed by hand, repaired, treated and reinstated.
