CPAT Report No. 1838

Anglesey 33kV Reinforcement Works

ARCHAEOLOGICAL MITIGATION

Client name:	Scottish Power Energy Networks
CPAT Project No:	2454
Project Name:	Anglesey 33kV Reinforcement Works
Grid Reference:	SH 4454 6814 to SH 5343 7265
County/LPA:	Gwynedd Council/Anglesey Council
Planning Application:	N/A
CPAT Report No:	1838
Report status:	Draft
Confidential until	December 2021

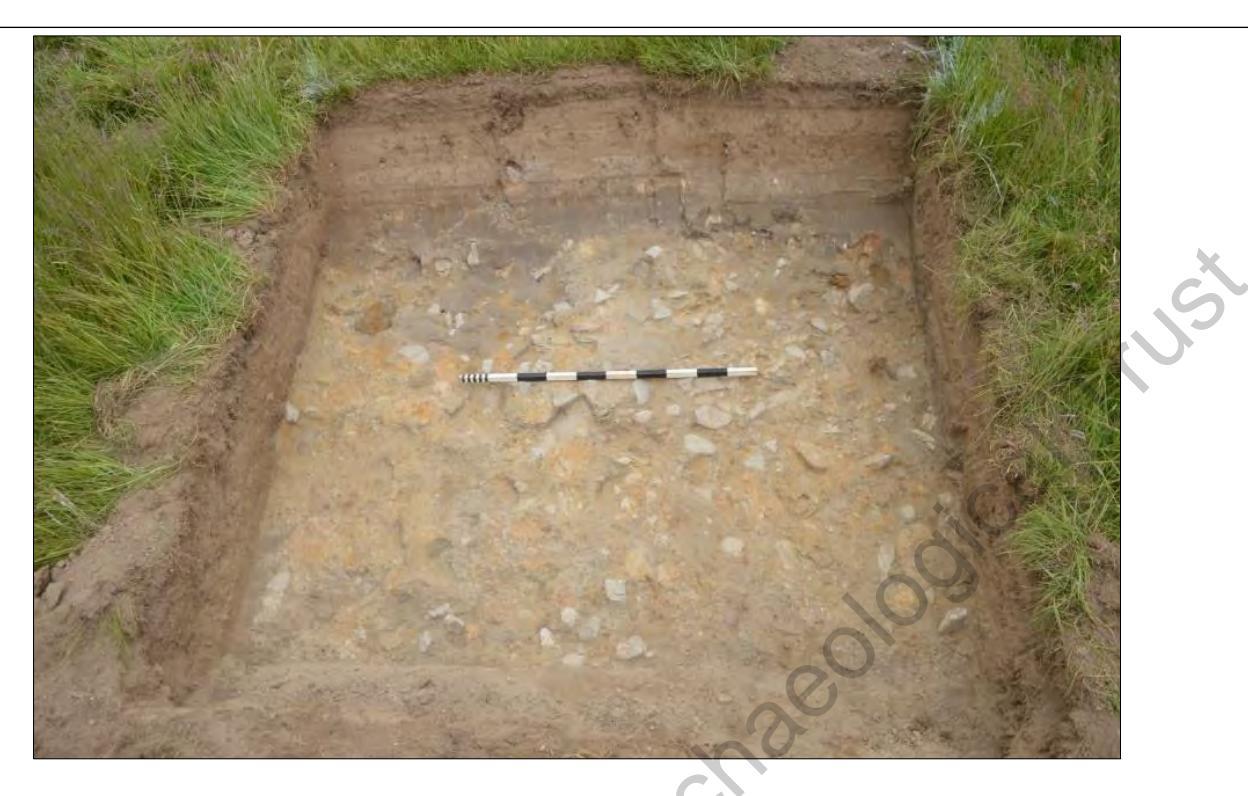
- 3.4. The site was located at the base of a west-facing slope pasture field, overlooking a stream valley and registered bogland. The village of Llangaffo lies to the west. A pit, 2m x 2m, was machine excavated to a depth of 0.45m.
- 3.5. The undisturbed natural subsoil, a firm yellow orange clay with pale grey patches, was revealed at the base of the pit. The deposit contained inclusions of fragmented schist rock and sandstone. This was sealed by a deposit of stiff dark grey clay, 0.09m thick, which appeared to be outwash from the bog to the west. This was sealed by a deposit of colluvium, a firm mid brown silty clay 0.24m thick, and topsoil (Fig. 3)
 - No deposits or features of archaeological significance were recorded.

Fig. 3 Test Pit 11 viewed from west. Photo CPAT 4786-0130

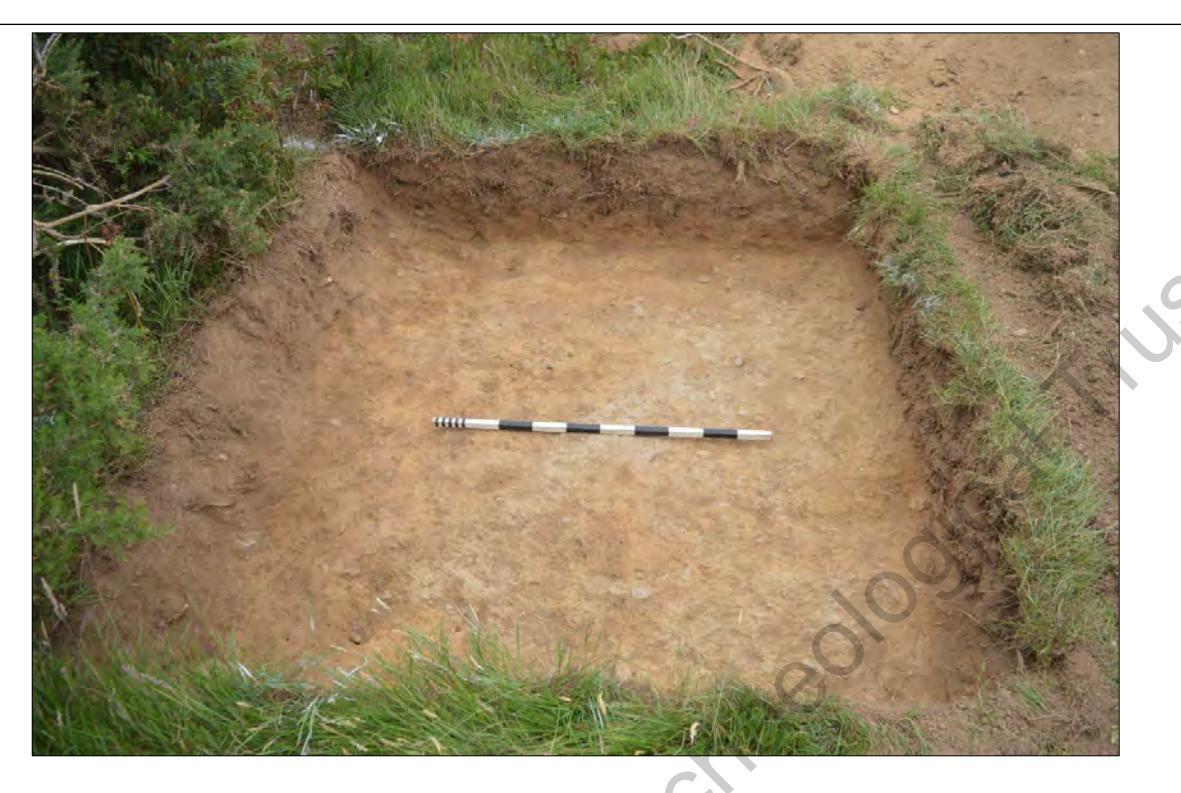
- 3.7. The site was located east and upslope of Test Pit 11, located alongside the northern boundary of the field (an upstanding bank constructed from stone and earth). Two pits, 12a 2m x 2m and 12b 1.3m x 2.3m, were machine excavated to a depth of 0.45m and 0.3m respectively. The pit 12b was located 7m south of pit 12a.
- 3.8. Undisturbed natural subsoil was revealed at the base of both pits. This consisted of a firm yellow orange clay with pale grey patches containing fragmented schist rock and sandstone. The natural subsoil was sealed by a plough-soil deposit of firm mid brown silty clay up to 0.35m thick, containing occasional small pebbles. The overlying topsoil was 0.1m thick (Fig. 4 and 5).
- 3.9. No deposits or features of archaeological significance were recorded.

Fig. 4 Test Pit 12a viewed from the west. Photo CPAT 4786-0127

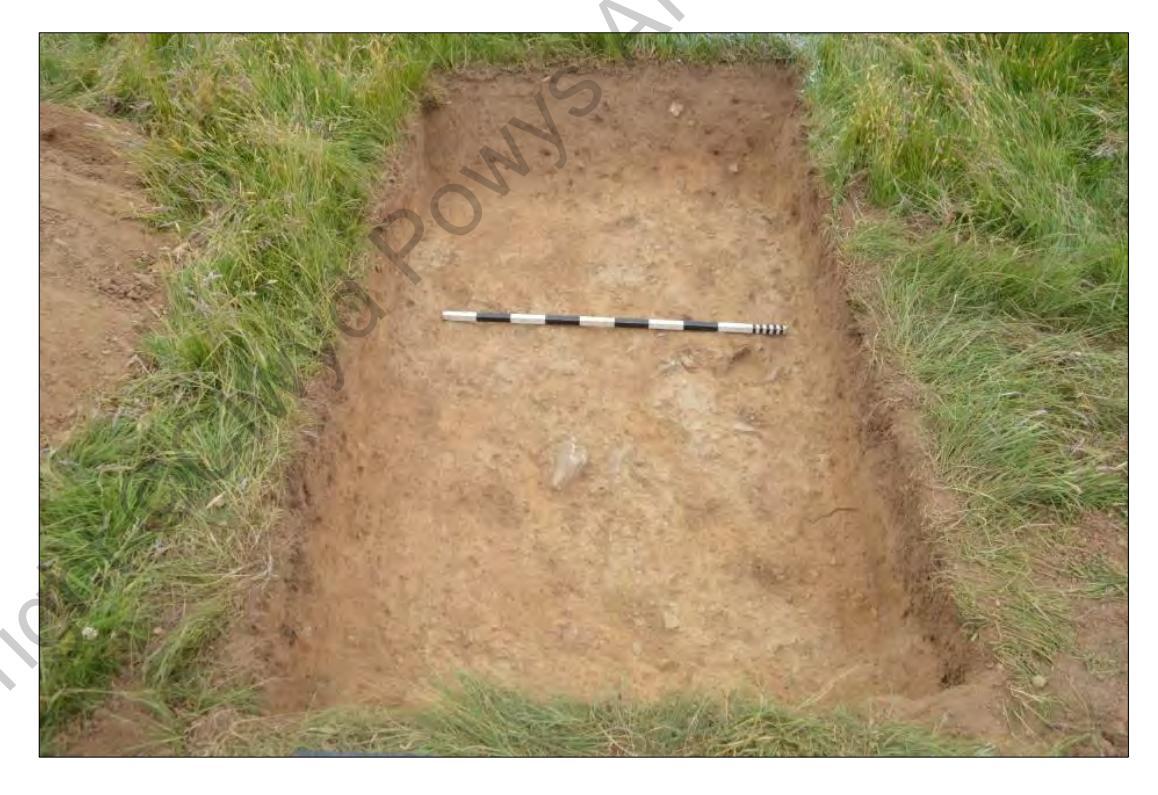
Fig. 5 Test Pit 12b viewed from the north-west. Photo CPAT 4786-0125

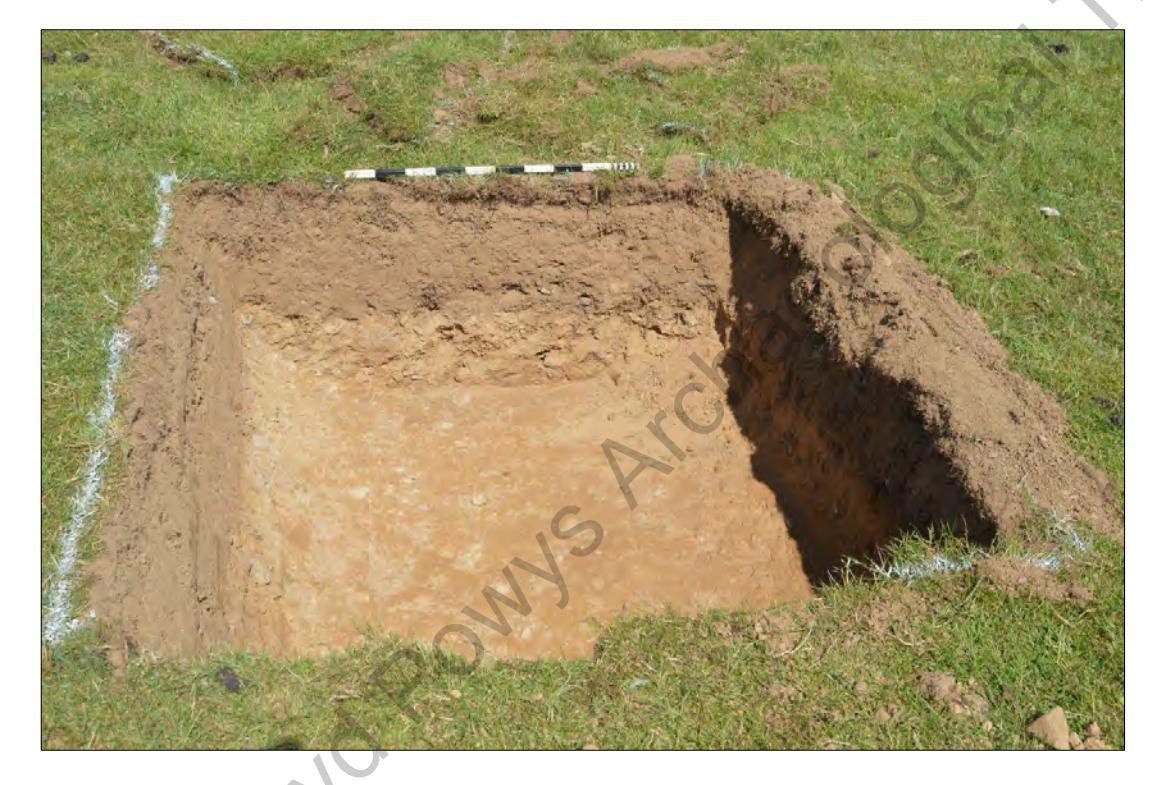
earthwork, orientated north-west to south-east, lay adjacent to the test pit. The test pit, 2m x 2m, was machine excavated to a depth of 0.83m (Fig. 6).

- 3.11. The undisturbed natural subsoil, a soft yellow brown silty clay alongside compacted schist stone, was revealed at the base of the pit. This was sealed by a deposit of firm pale orangebrown silty clay, 0.13m thick, containing occasional fragments of schist stone and pebbles. This was sealed by a thin, 0.15m, soft deposit of dark grey, brown silty clay. The combined thickness of the overlying plough-soil and topsoil was 0.3m thick.
- 3.12. No deposits or features of archaeological significance were recorded.

Fig. 6 Test Pit 13 viewed from the east. Photo CPAT 4786-0141

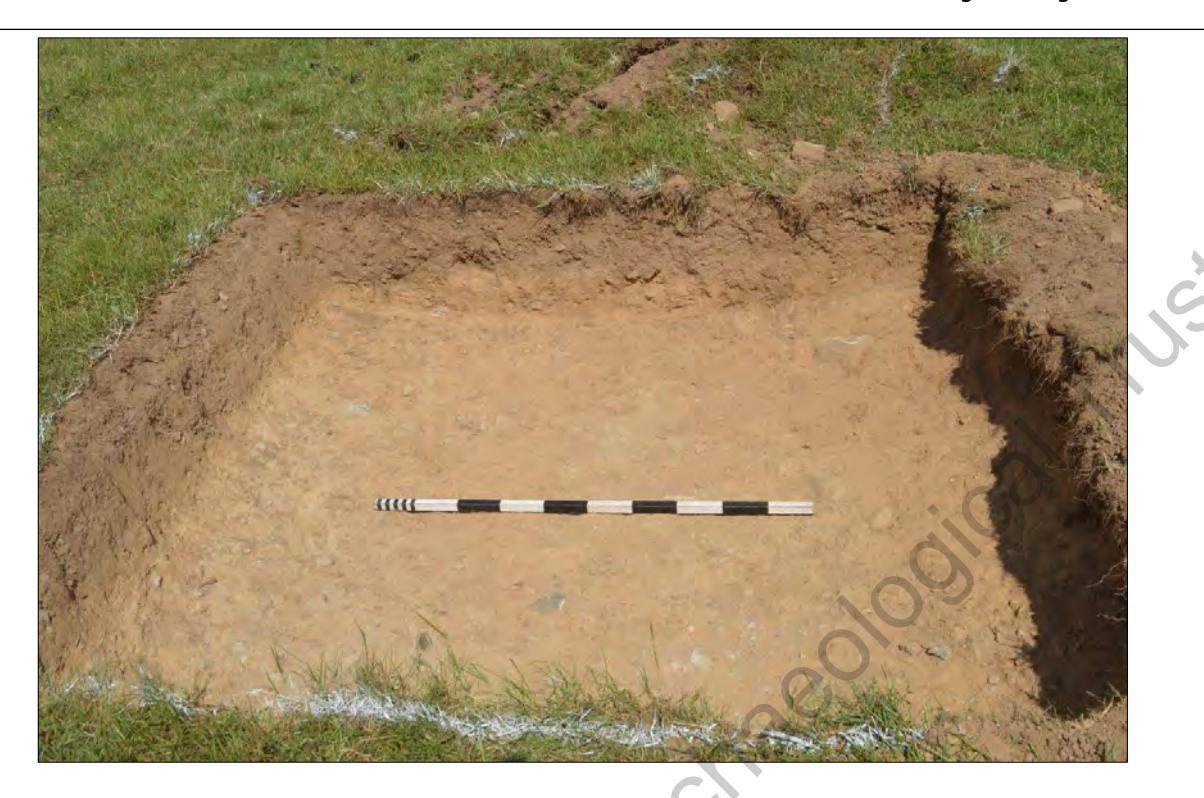
3.13. The site was located in open pasture, upslope and north-east of Test Pit 13. To the south-east were the ruined remains of the farmhouse, *Cae Meini*. The test pit, 2m x 2m, was machine excavated to a depth of 0.4m (Fig. 7). Of note was a low-lying stone cairn, 5m in diameter, located between the test pit and the farmhouse. No previous record exists of this feature.

The undisturbed natural subsoil, a firm pale-yellow brown silty clay alongside compacted schist stone and bedrock was revealed at the base of the pit. This was sealed by a deposit of firm pale orange- brown silty clay, 0.12m thick, containing occasional fragments of schist stone and pebbles. The combined thickness of the overlying plough-soil and topsoil was 0.28m thick.

3.15. No deposits or features of archaeological significance were recorded. However, the low-lying stone cairn could possibly be part of the missing Bronze Age cemetery recorded in 1882 (See 3.5).

Fig. 7 Test Pit 14 viewed from the south-west. Photo CPAT 4786-0138

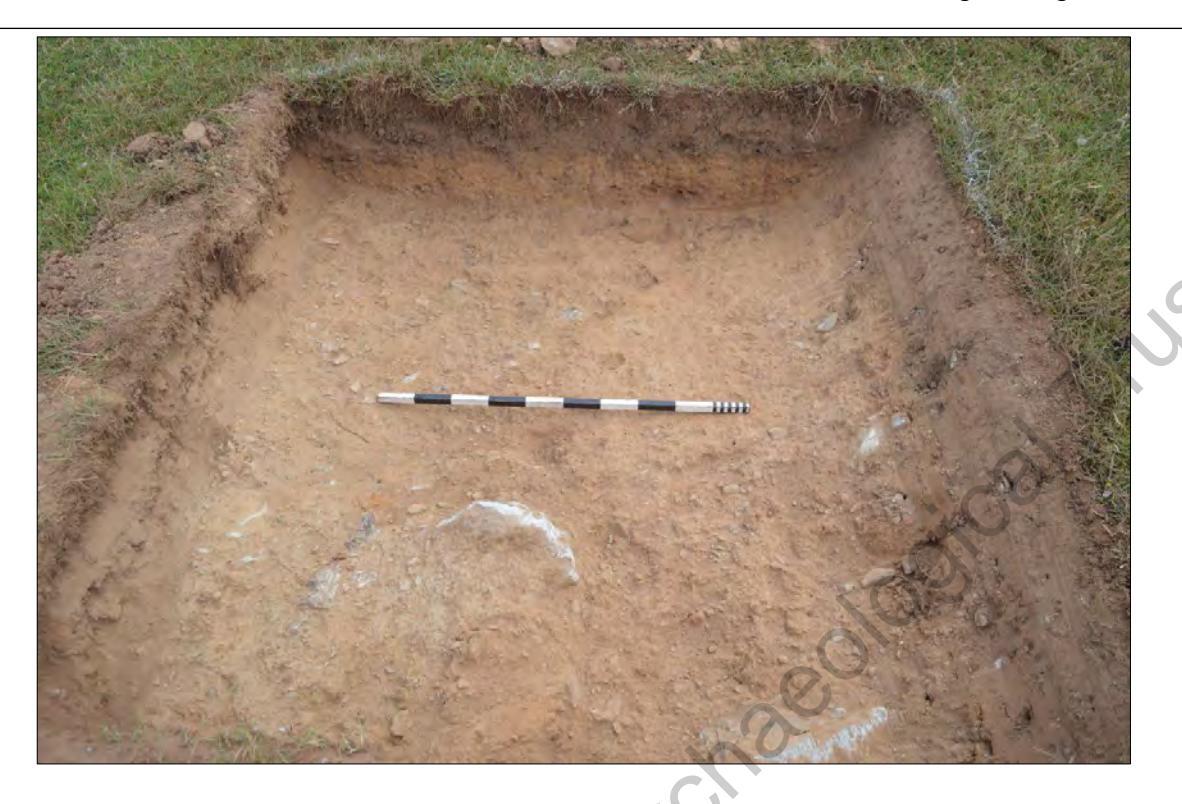
- 3.16. The site was located in open pasture, upslope and north-east of Test Pit 14. The test pit, 2m x 2m, was machine excavated to a depth of 0.50m (Fig. 8).
- 3.17. The undisturbed natural subsoil, a firm pale orange-brown silty clay alongside compacted schist stone and bedrock was revealed at the base of the pit. This was sealed by a deposit of orange-brown silty clay, 0.27m thick. The combined thickness of the overlying plough-soil (a greyish brown silt clay) and topsoil was 0.23m thick.
- 3.18. No deposits or features of archaeological significance were recorded.

Fig. 8 Test Pit 15 viewed from the north-west. Photo CPAT 4786-0136

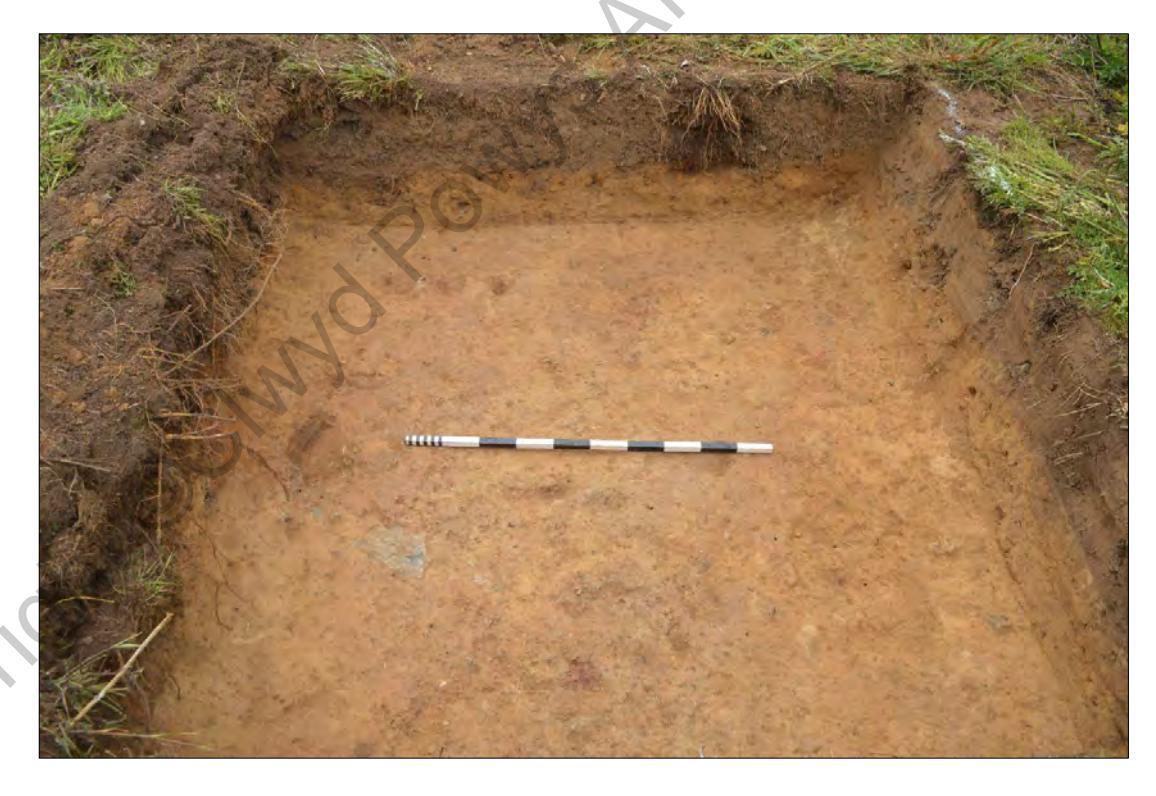
Fig. 9 Test Pit 16 viewed from the south. Photo CPAT 4786-0134

3.19. The site was located in scrubland surrounded by small outcrops of bedrock, near the summit of the hillslope north-east of Test Pit 15. The test pit, 2m x 2m, was machine excavated to a depth of 0.50m (Fig. 9).

- 3.20. The undisturbed natural subsoil, a firm pale orange-brown silty clay with patches of pink marl clay, gritstones and schist bedrock, was revealed at the base of the pit. This was sealed by a soft deposit of orange-brown silty clay, 0.14m thick. The combined thickness of the overlying relic plough-soil (a greyish brown silt clay) and topsoil was 0.36m thick.
- 3.21. No deposits or features of archaeological significance were recorded.

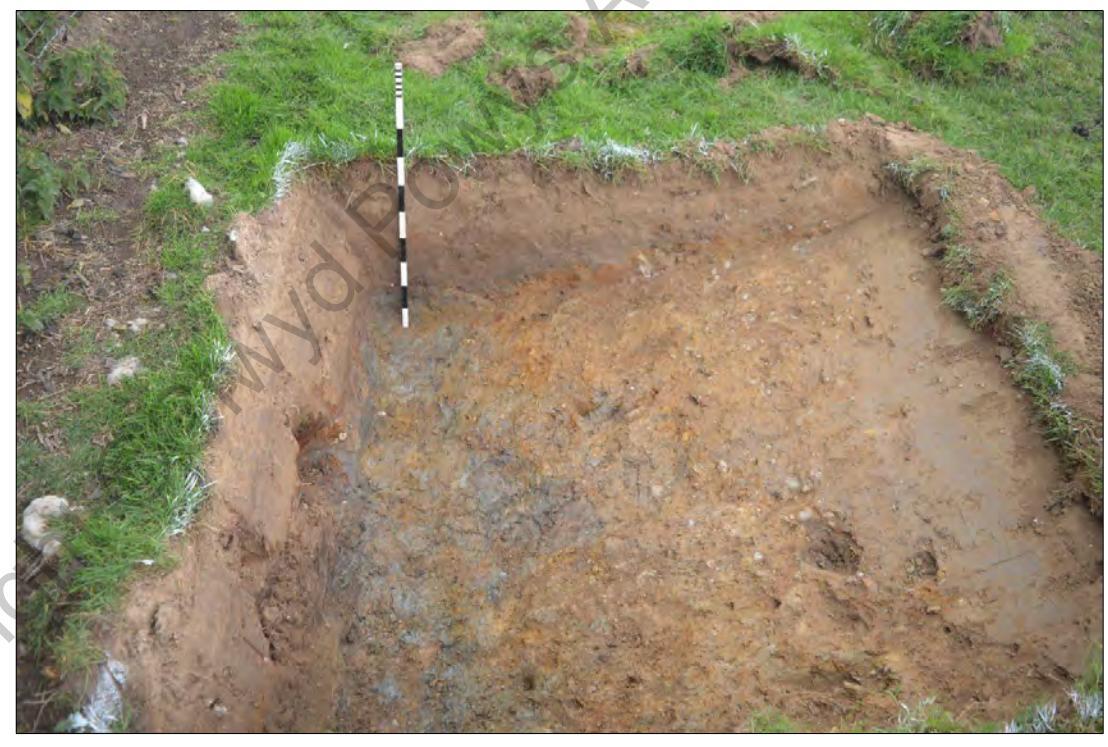
- 3.22. The site was located north-east of Test Pit 16, alongside (0.8m east of) the eastern boundary of a pasture field. The boundary, a substantial upstanding bank constructed from stone and earth, may be classified as an historic asset. To the east of the pit was a large rock outcrop and clearance cairn and beyond this the farmstead *Bodowyr*. The test pit, 2m x 2m, was machine excavated to a depth of 0.67m (Fig. 10).

- 3.23. The pit revealed a boundary ditch (0.31m deep), orientated north-north-west by south-southeast parallel with the bank to the west. The ditch contained two fills; a bluish orange iron mineral-stained soft silty clay, 0.11m thick, sealed by a dark grey soft silty clay 0.2m thick. The combined thickness of the overlying plough-soil (a firm brown silt clay) and topsoil was 0.36m thick. The low lying remains of a counterscarp bank, 2m wide, were evident along the eastern edge of the ditch.

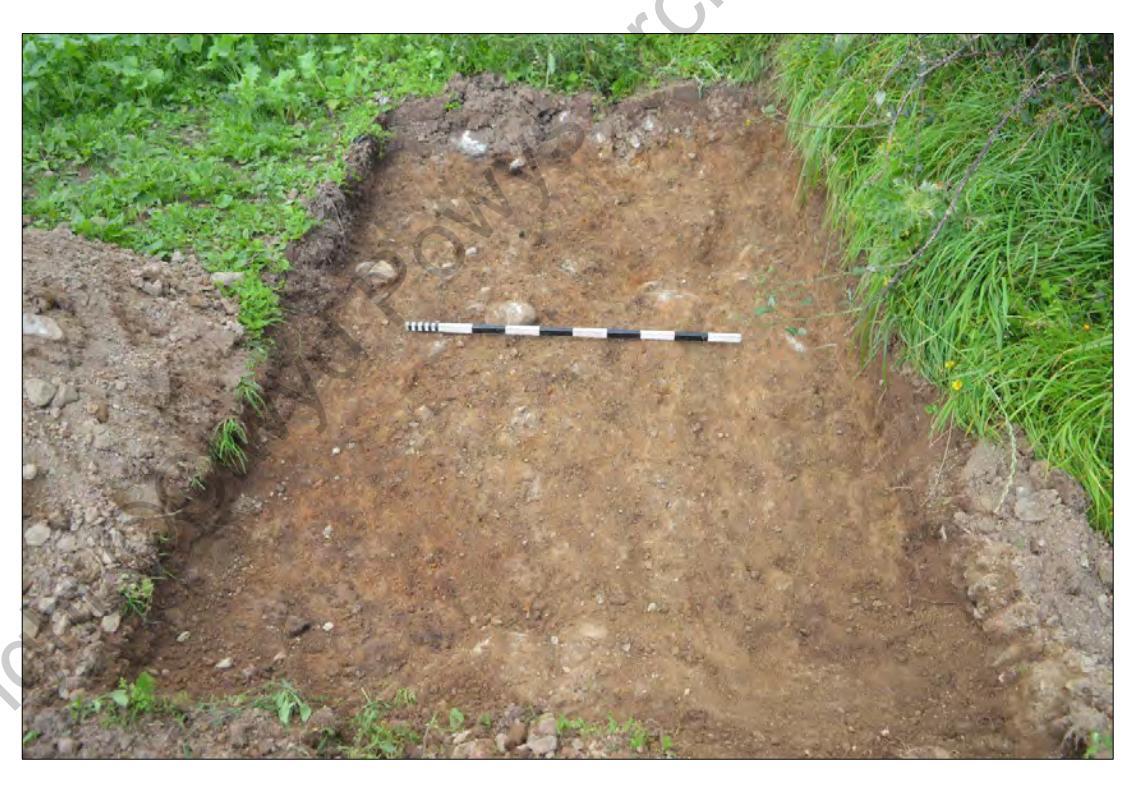
- 3.26. The site was located in an arable field on the north-west side of an established dry-stone wall and bank, orientated north-west to south-east, south and downslope of *Bodlew* farmhouse. The test pit, 2.6m x 1.6m, was machine excavated to a depth of 0.2m (Fig. 11).
- 3.27. The undisturbed natural subsoil, a firm pale orange-brown silty clay with occasional rounded schist stone, was revealed at the base of the pit. This was sealed by a severely truncated plough-soil, a greyish brown silt clay, 0.2m thick.
- 3.28. No deposits or features of archaeological significance were recorded.

Fig. 11 Test Pit 46 viewed from the south-east. Photo CPAT 4786-0192

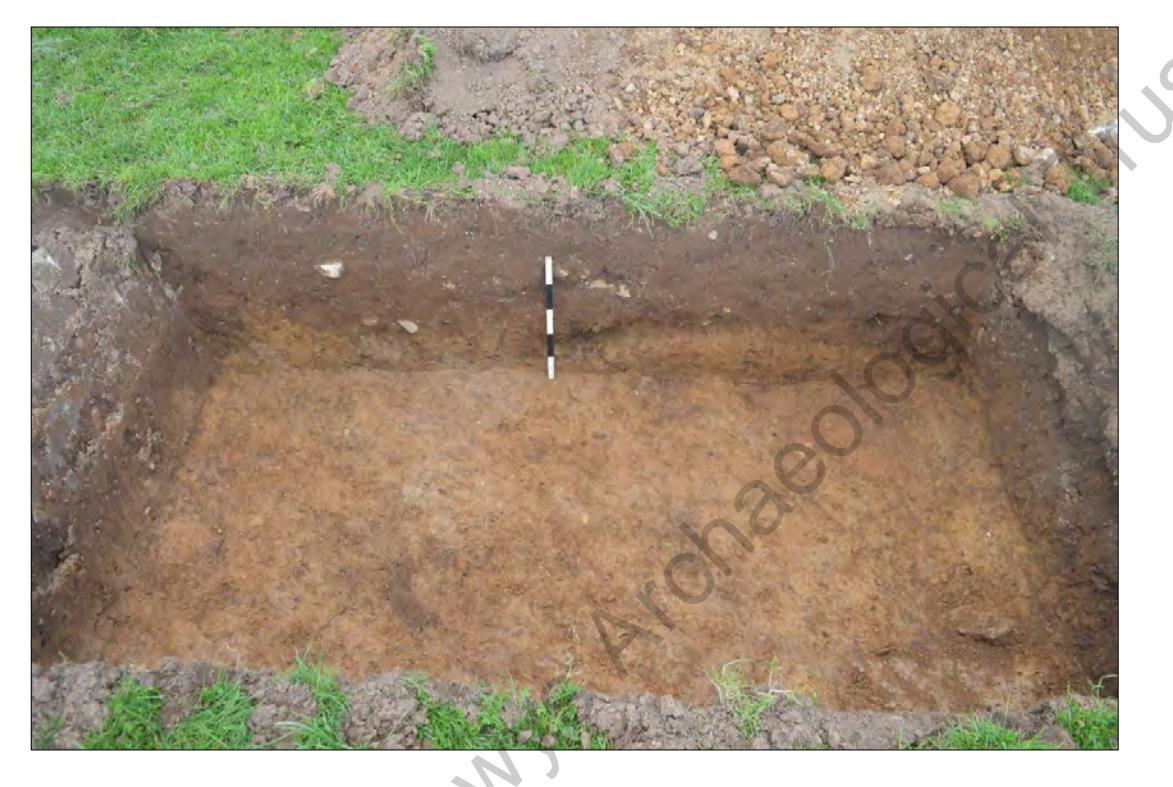
- 3.29. The site was located in open pasture on a gentle south-facing hillslope, south of *Bodlew* farmhouse. The test pit, 3m x 1.6m, was machine excavated to a depth of 0.7m (Fig. 12).
- 3.30. The undisturbed natural subsoil, a very soft mottled pale orange-brown silty clay with occasional patches of pink marl clay and fragmented schist stone, was revealed at the base of

the pit. This was sealed by a deposit of soft silty clay, 0.2m thick, variable in colour from yellowish brown to pale grey. The deposit, containing patches of charcoal flecked sooty brown humic material, resembled a relic ground surface although there were no obvious associated features within the vicinity. This was sealed by the modern plough-soil and topsoil, 0.5m thick. No further deposits or features of archaeological significance were recorded.

Fig. 12 Test Pit 47 viewed from the south. Photo CPAT 4786-0190

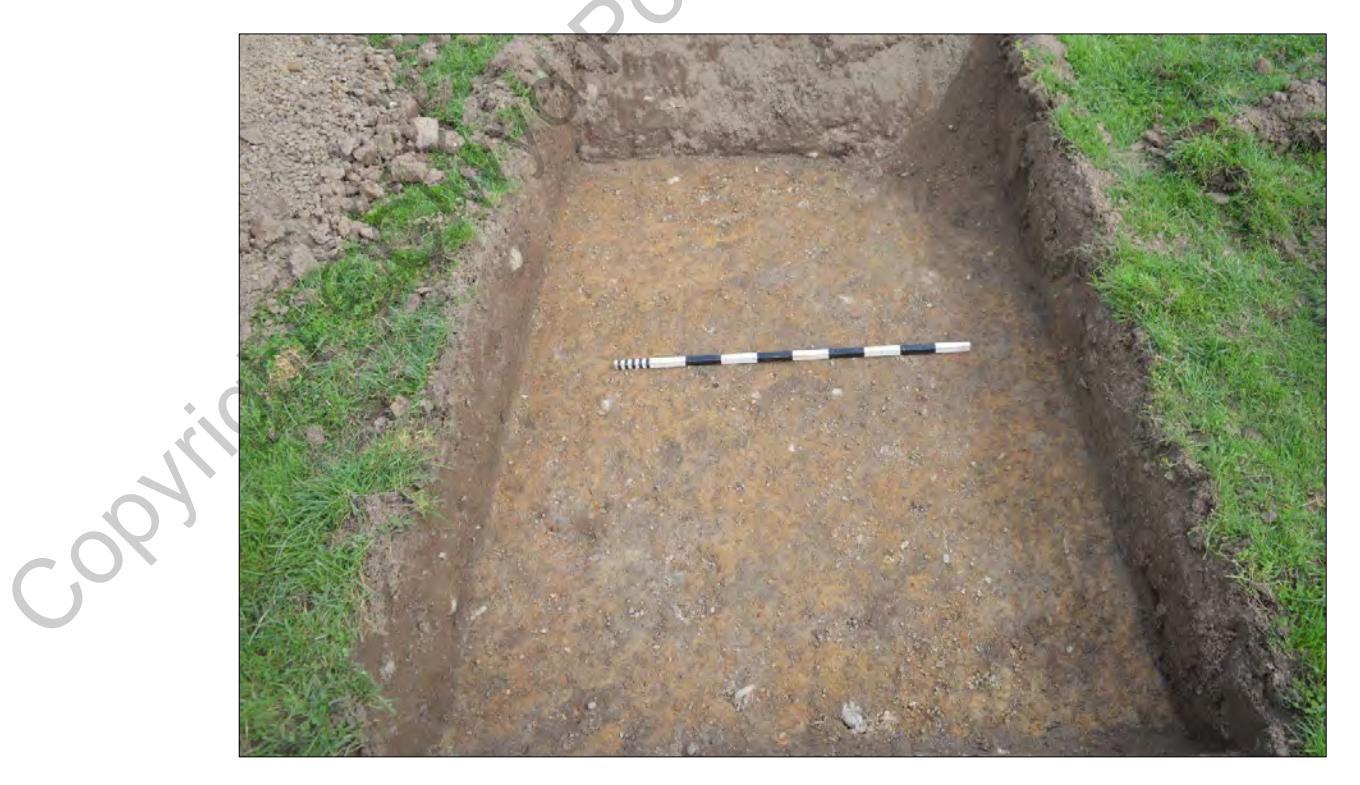
Fig. 13 Test Pit 48 viewed from the west. Photo CPAT 4786-0187

- 3.31. The site was located in open pasture on a gentle south-facing hillslope, south-east of Test Pit 47. The test pit, 2.6m x 1.6m, was machine excavated to a depth of 0.36m (Fig. 13).
- 3.32. The undisturbed natural subsoil, a fairly firm mottled pale-orange-brown silty clay with fragmented schist stone, was revealed at the base of the pit. There was some slight evidence of the remains of flecked charcoal overlying the deposit. This was sealed by a deposit of plough-soil, a firm greyish brown silty clay 0.26m thick, and topsoil, 0.1m thick.
- 3.33. No deposits or features of archaeological significance were recorded.

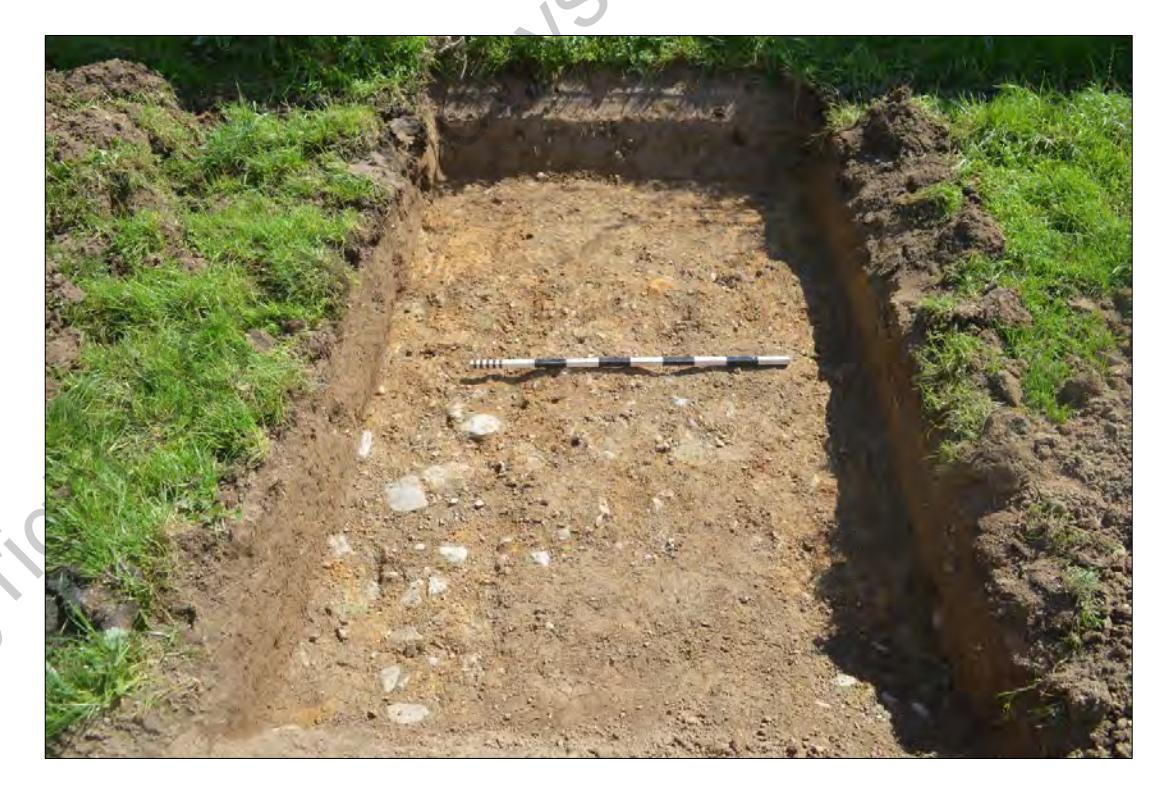
- 3.34. The site was located in open pasture on a gentle south-facing hillslope, south-east of Test Pit 48. Two pits, 49a and 49b both 2.6m x 1.6m, were machine excavated to a depth of 0.4m and 0.3m respectively. The pits were separated by a field boundary (a dry-stone wall and hedge orientated north-east to south-west), and 49b was located 9m south of pit 49a.
- 3.35. Undisturbed natural subsoil was revealed at the base of both pits. This consisted of a mottled pale grey and orange silty clay containing fragmented schist stone. There was some evidence of flecked charcoal on the surface of the deposit. The natural subsoil was sealed by a plough-soil deposit of firm mid grey-brown silty clay up to 0.3m thick, containing occasional shist stone. The overlying topsoil was 0.1m thick (Fig. 14 and 15).
- 3.36. No deposits or features of archaeological significance were recorded.

Fig. 14 Test Pit 49a viewed from the north-west. Photo CPAT 4786-0185

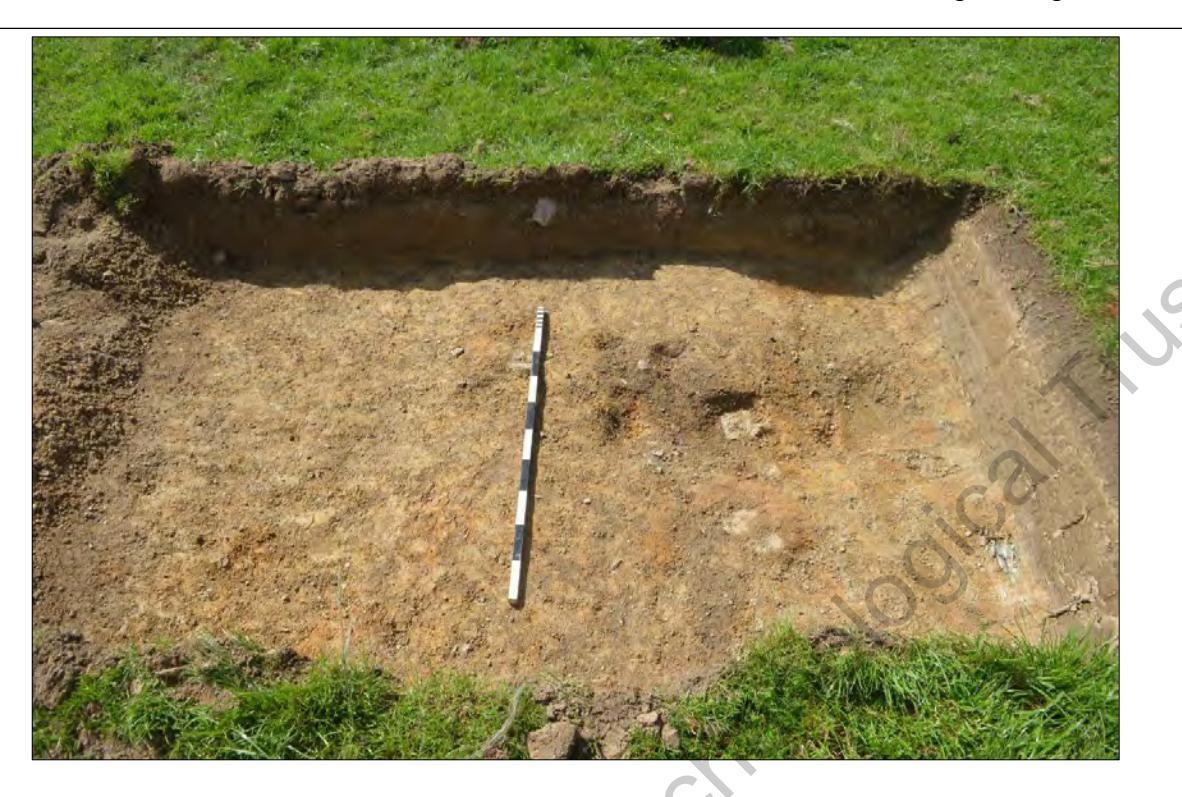
Fig. 15 Test Pit 49b viewed from the east. Photo CPAT 4786-0183

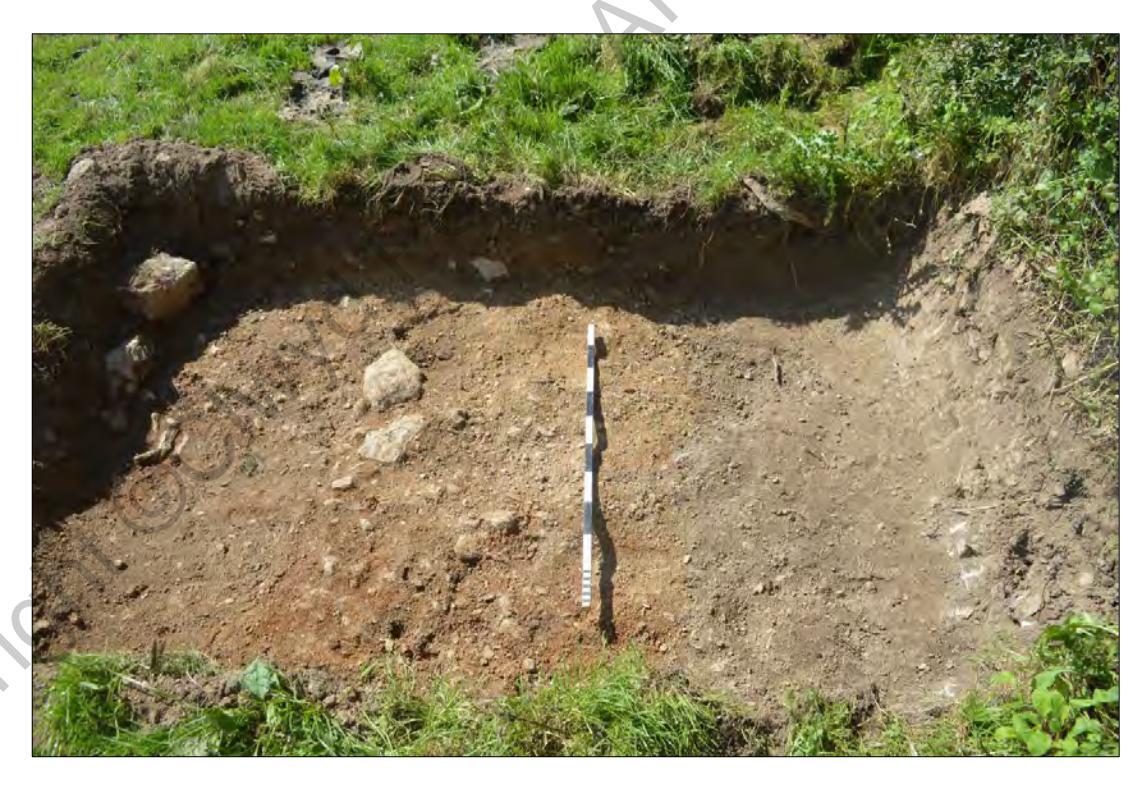
Fig. 16 Test Pit 50 viewed from the north-east. Photo CPAT 4786-0181

3.37. The site was located north-east of Test Pit 49b, adjacent to and south of a dry-stone wall and hedge orientated north-east to south-west. The test pit, 2.6m x 1.6m, was machine excavated to a depth of 0.36m (Fig. 16).

- 3.38. The undisturbed natural subsoil, a mottled pale grey and orange silty clay containing fragmented schist stone, was revealed at the base of the pit. An infilled boundary ditch, 1.1m wide and associated with the upstanding field boundary, truncated the natural subsoil along the north-western edge of the pit. The natural subsoil and the ditch were sealed by a plough-soil deposit of firm mid grey-brown silty clay, 0.26m thick, containing occasional shist stone. The overlying topsoil was 0.1m thick (Fig. 16).
- 3.39. No deposits or features of archaeological significance were recorded.

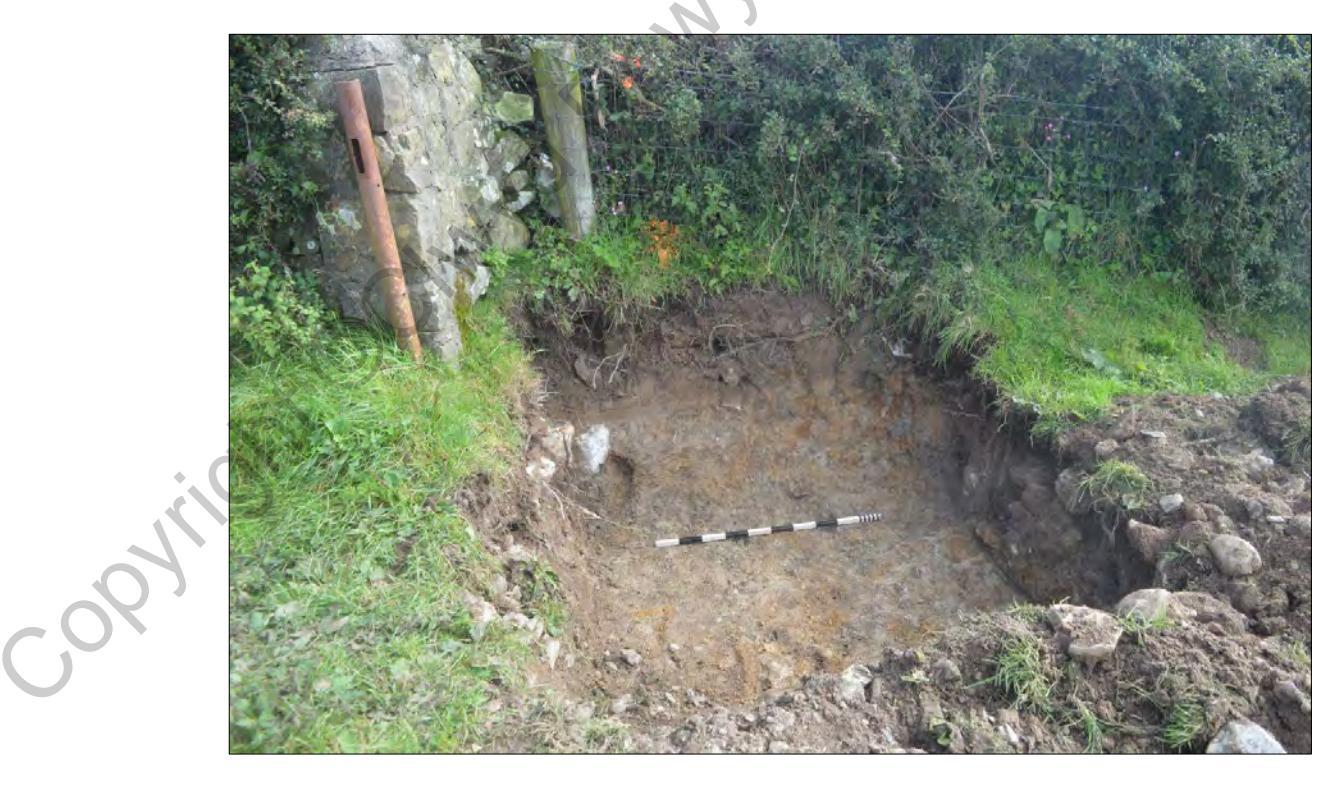
- 3.40. The site was adjacent to a gateway north-east of Test Pit 50, in the corner of the field. Two pits, 51a, 2m x 2m, and 51b, 2.3m x 1.6m, were machine excavated to a depth of 0.65m and 0.55m respectively. The pits were separated by a field boundary and gateway, and 51b was located 7m north-west of pit 51a (Fig. 17 and 18).

- 3.41. Undisturbed natural subsoil was revealed at the base of both pits. This consisted of a mottled orange bluish-grey silty clay containing fragmented schist stone. A stone filled ditch, 2m wide and 0.55m deep and recorded in pit 51a, was probably an infilled field boundary ditch. The fill, consisting of large cobbles and fragments of house brick, formed the foundation for a causewayed track.

Fig. 17 Test Pit 51a viewed from the south-west. Photo CPAT 4786-0177

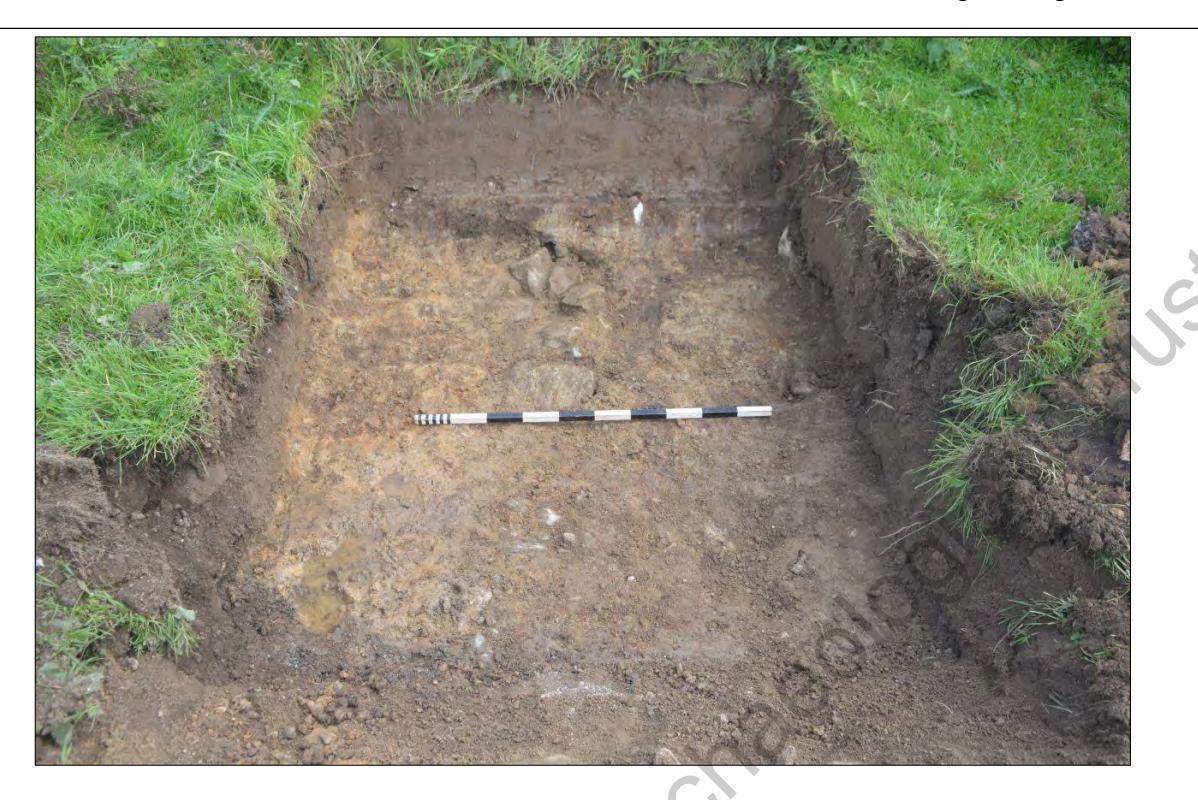
- 3.42. Within pit 51b the natural subsoil was sealed by a plough-soil deposit of firm mid grey-brown silty clay up to 0.2m thick, containing occasional shist stone. The overlying causewayed track material and topsoil was 0.35m thick (Fig. 14 and 15).

Fig. 18 Test Pit 51b viewed from the south-west. Photo CPAT 4786-0179

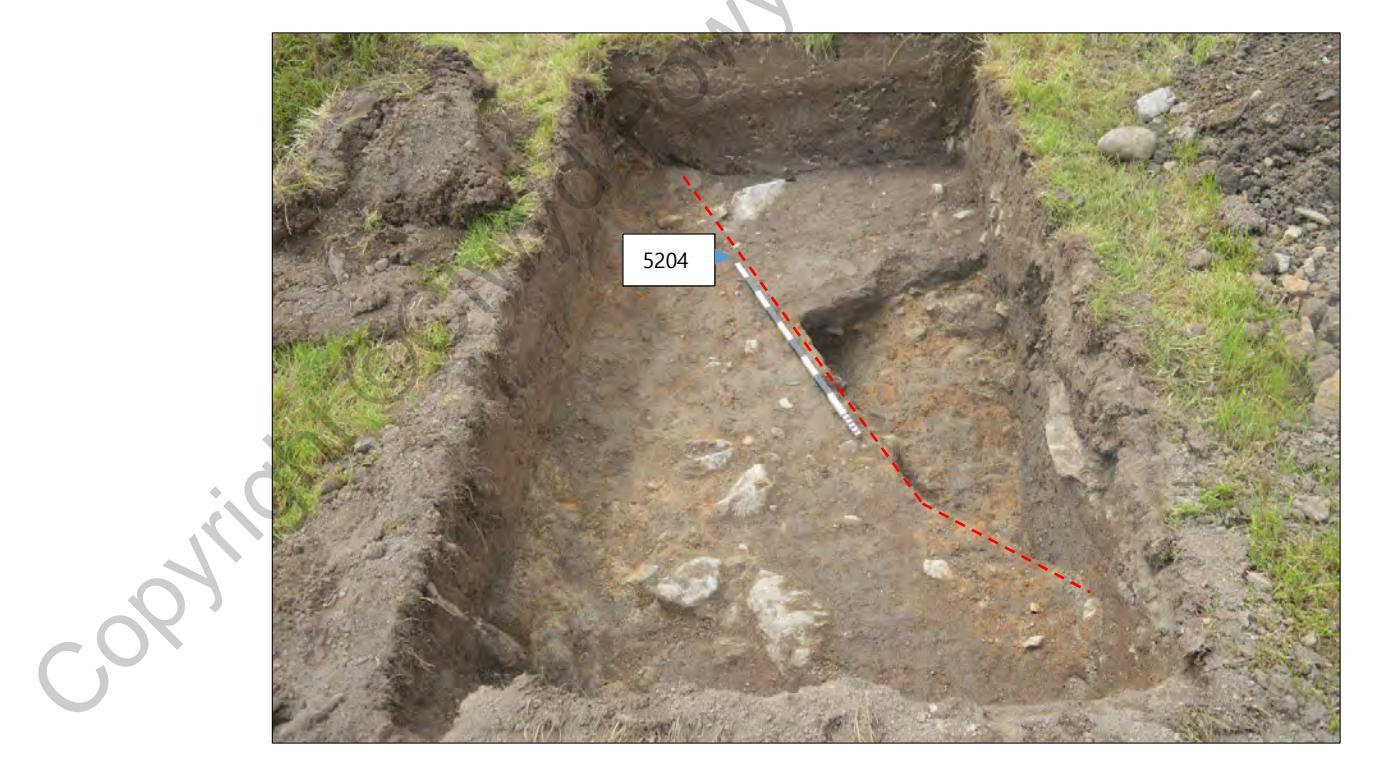
- 3.45. A deposit (5205) of mottled buff yellow-brown sandy silt with large cobbles of shist stone, was revealed at the base of the test pit. The deposit, believed to be re-deposited natural subsoil, was truncated by a broad linear feature [5204] orientated north to south. An excavated section through the feature revealed the eastern edge of a possible ditch at least 1.1m and 0.4m deep containing a fill (5203) of stiff dark grey clay. The western side of the ditch lay beyond the bounds of the test pit.

The orientation of the ditch, north to south, is of note. The surrounding field boundaries are orientated north-west to south-east. Therefore, it is possible that the ditch pre-dates the post-medieval landscape and could be part of an earlier enclosure.

Fig. 20 Test Pit 52 viewed from the north-east. Eastern edge of ditch feature [5204] outlined. Photo CPAT 4786-155

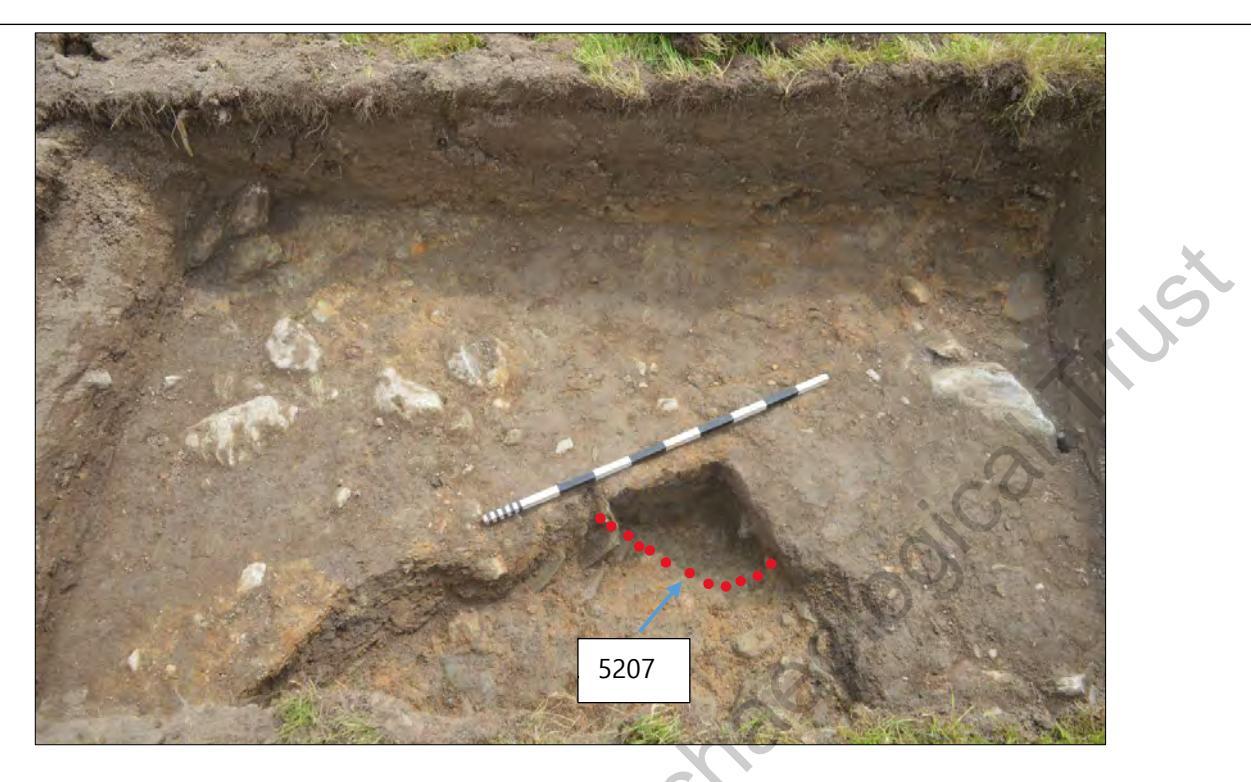
- 3.46. Underlying both the ditch [5204] and the deposit (5205) was a small, possible pit feature [5207], the extent of which was not visible within the limit of excavations. The feature, at least 0.4m wide, contained a fill (5206) of soft dark grey silty clay 0.15m thick. The ditch [5204], surrounding deposit (5205) and underlying pit [5207] remain undated (Fig. 22).

Fig. 21 Test Pit 52 viewed from the west. Partial outline of earlier feature [5207] indicated. Photo CPAT 4786-0166

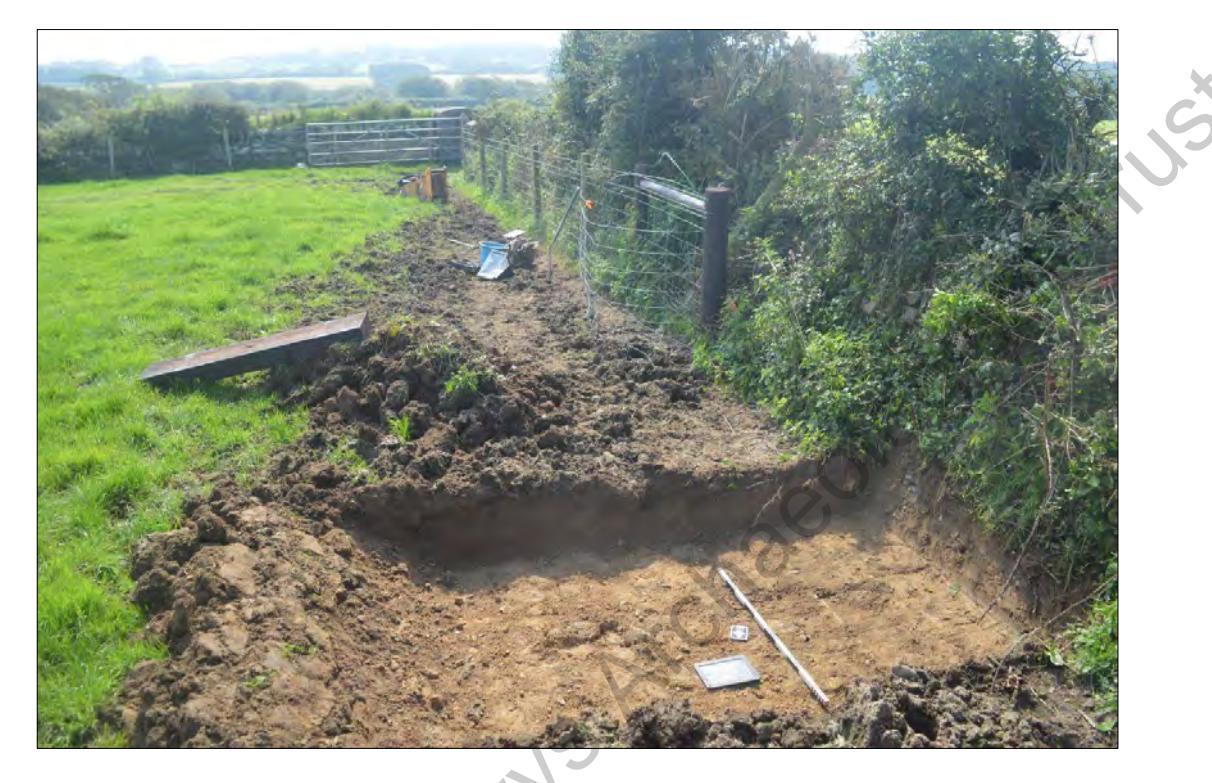
3.50. The undisturbed natural subsoil, a pale buff and orange silty clay containing fragmented schist sandstone rock, was revealed at the base of the pit. An infilled boundary ditch, 0.8m wide and associated with the upstanding field boundary, truncated both the natural subsoil and the

overlying plough-soil along the south-western edge of the pit.. The overlying topsoil was 0.1m thick (Fig. 23).

Fig. 23 Test Pit 53 viewed from the north. Photo CPAT 4786-0151

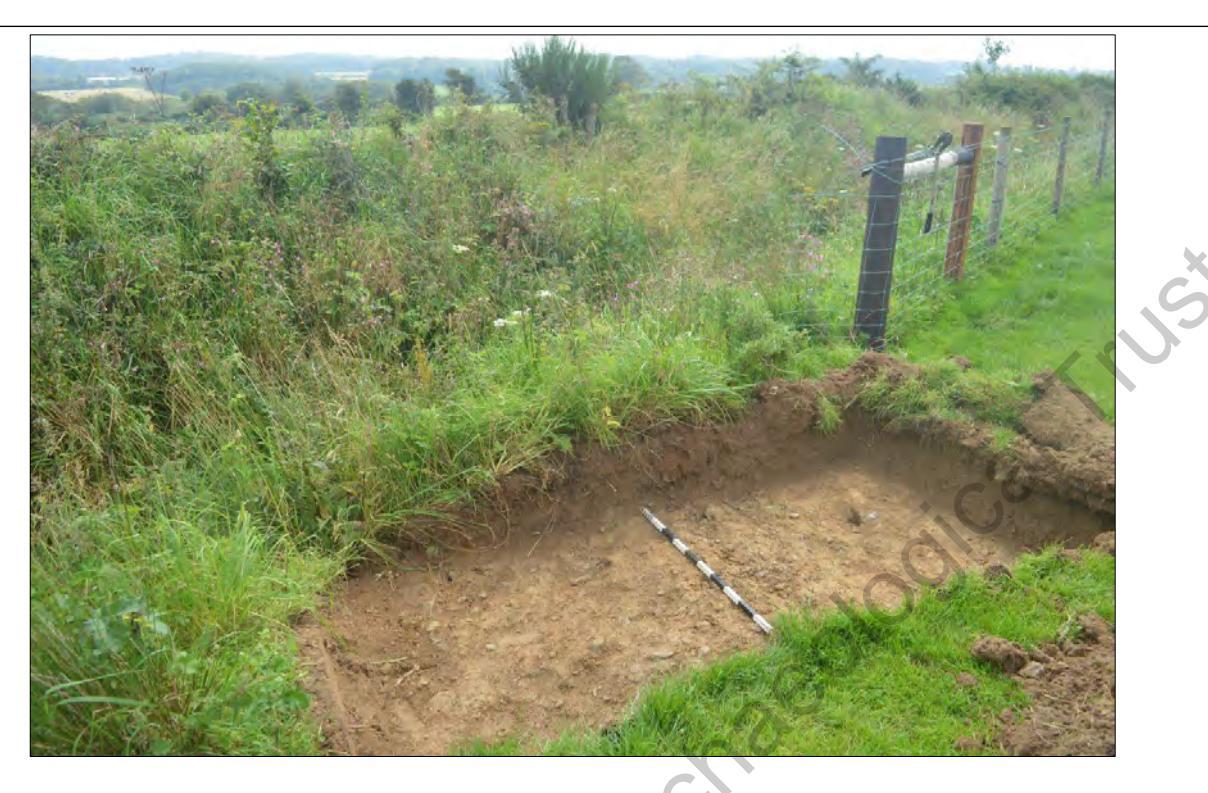
Fig. 24 Test Pit 54a viewed from the north. Photo CPAT 4786-0160
