CPAT Report No. 1838

Anglesey 33kV Reinforcement Works

ARCHAEOLOGICAL MITIGATION

Client name:	Scottish Power Energy Networks
CPAT Project No:	2454
Project Name:	Anglesey 33kV Reinforcement Works
Grid Reference:	SH 4454 6814 to SH 5343 7265
County/LPA:	Gwynedd Council/Anglesey Council
Planning Application:	N/A
CPAT Report No:	1838
Report status:	Draft
Confidential until	December 2021

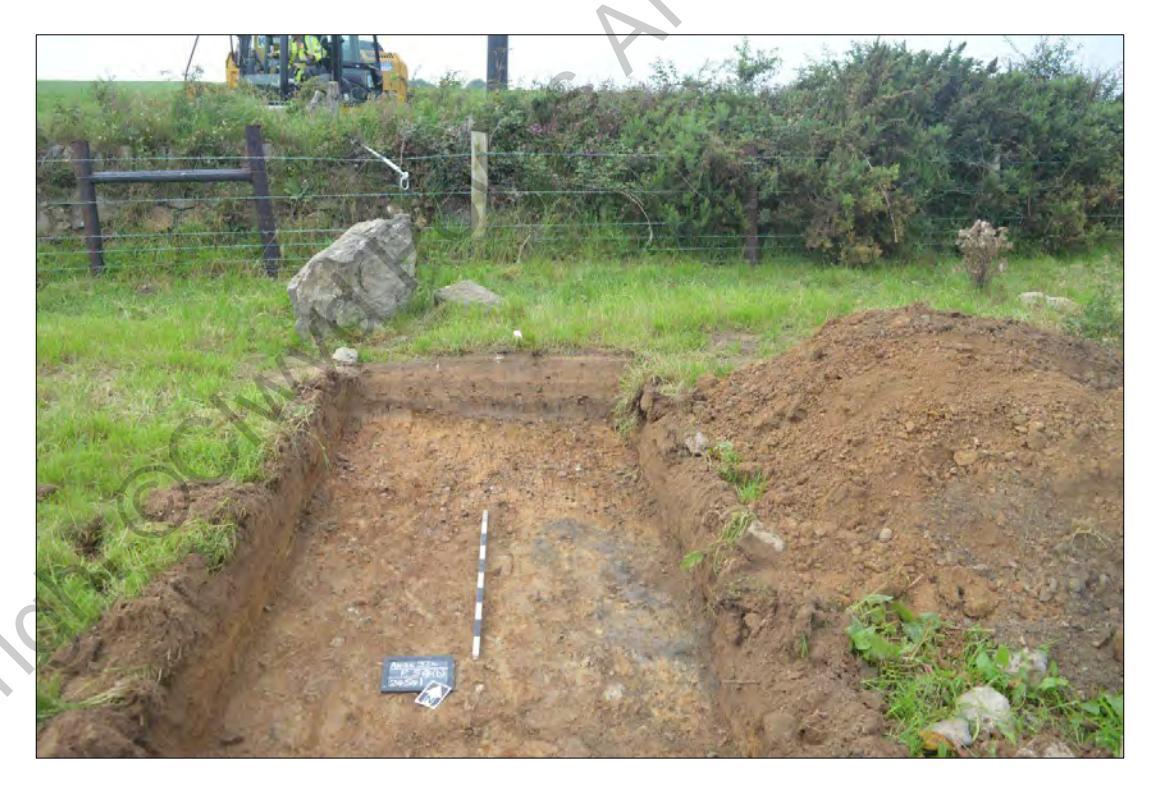
Fig. 25 Test Pit 54b viewed from the south-east. Photo CPAT 4786-0162

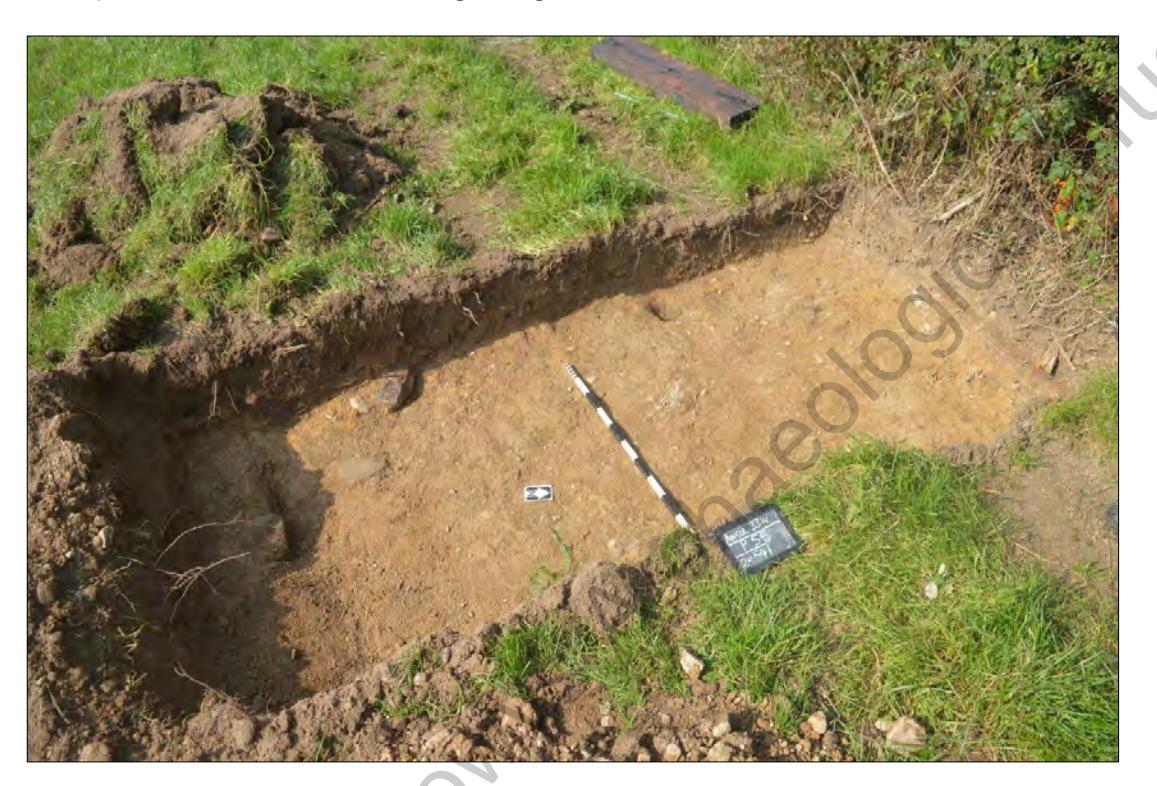
- 3.56. The undisturbed natural subsoil, a pale buff and orange silty clay containing fragmented schist stone and pebbles, was revealed at the base of the pit. The natural subsoil was sealed by a thin deposit of mottled pale buff silty clay, 0.12m thick. This was sealed by a plough-soil deposit of mid yellow brown silty clay, 0.18m thick. The overlying topsoil was 0.1m thick.
- 3.57. No deposits or features of archaeological significance were recorded.

Fig. 26 Test Pit 55 viewed from the east. Photo CPAT 4786-0165

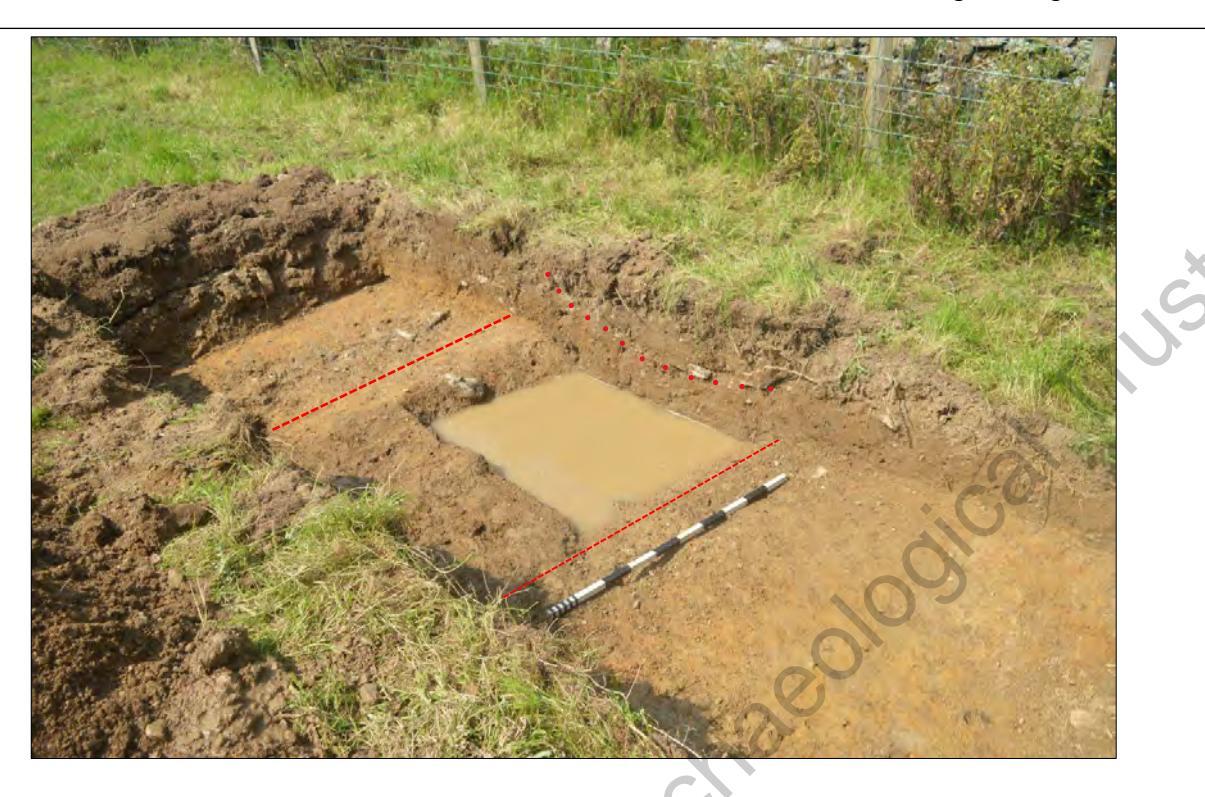
- 3.59. Undisturbed natural subsoil was revealed at the base of both pits. This consisted of a soft pale buff and orange silty clay containing fragmented schist stone and small pebbles. The Test pit 56a revealed a broad drainage ditch, 1.2m wide and at least 0.22m deep, orientated north to south. Owing to the ingress of water the full depth of the ditch was not recorded. The upper fill consisted of a soft mottled mid-brown silty clay. The possible line of a denuded bank, 0.6m wide, was also noted aligned along the east side of the ditch.

Fig. 27 Test Pit 56a viewed from the east. Ditch and gully indicated. Photo CPAT 4786-0169

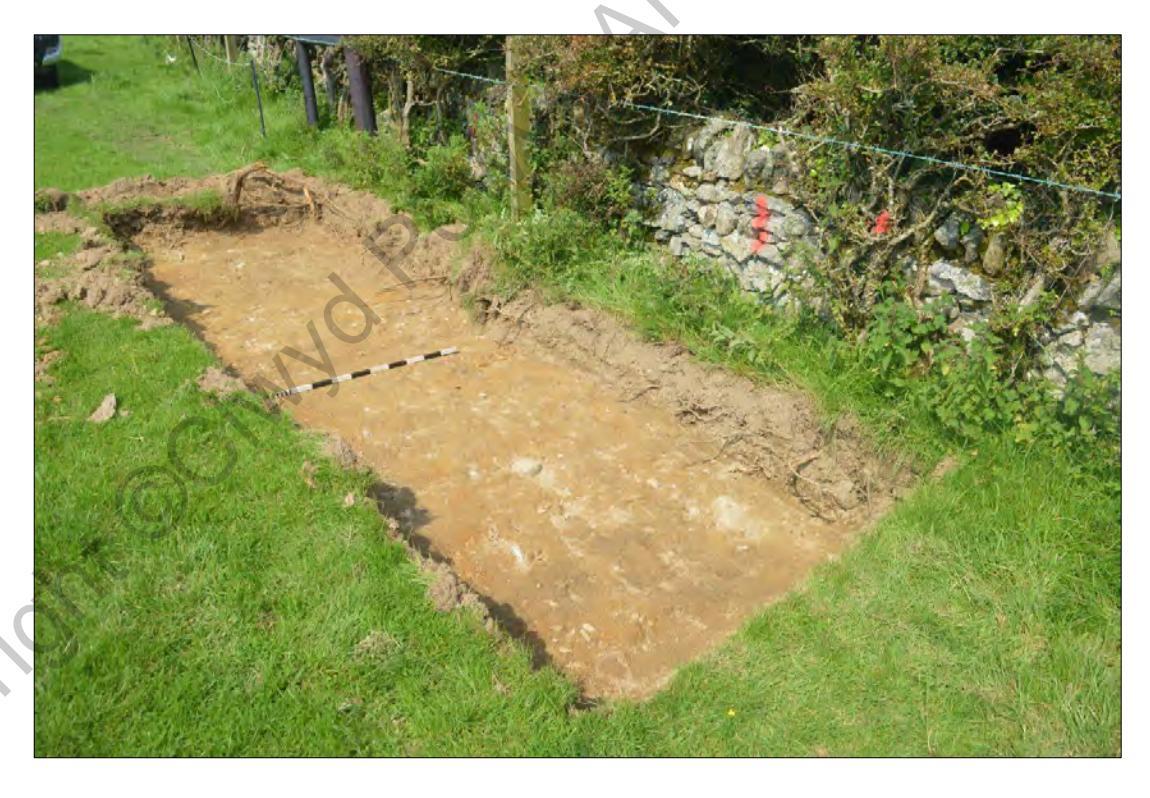
- 3.61. The deposits within Test pit 56b consisted of a plough-soil 0.15m thick sealed by a topsoil 0.1m thick (Fig. 28). No further deposits or features of archaeological significance were recorded in either pit.

Fig. 28 Test Pit 56b viewed from the south. Photo CPAT 4786-0175

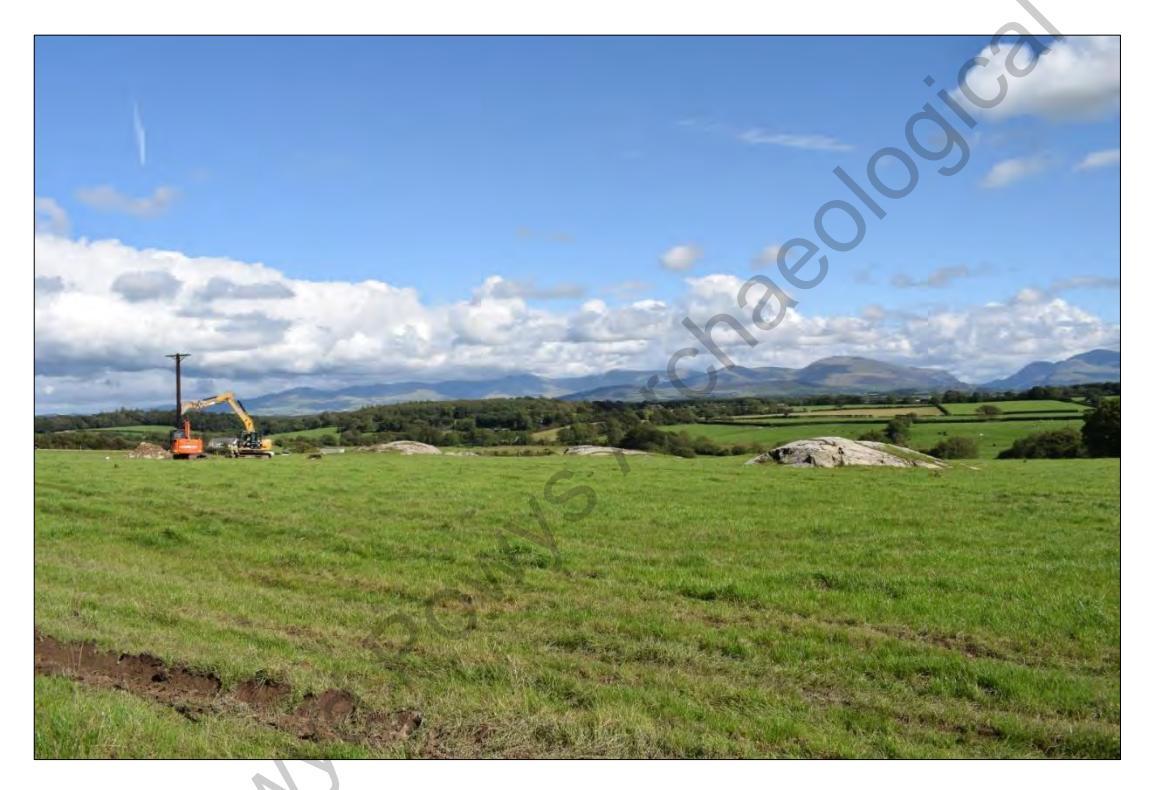
Fig. 29 General view, from the north-west, of the rock outcrops between poles 70 and 72. Location of the prehistoric rock art. Photo CPAT 4786-0016

3.64. Two groups of rock art (RA 1 and RA 2) were subsequently identified on outcrops of glacial smoothed shist rock located between Poles 70 and 72 (Figs. 29-30). The better defined 'cup marks' had a black halo on their circumference which probably signified an alteration of the rock related to the creation of the marks. The rock consisted of a mica shist with quartz inclusions.

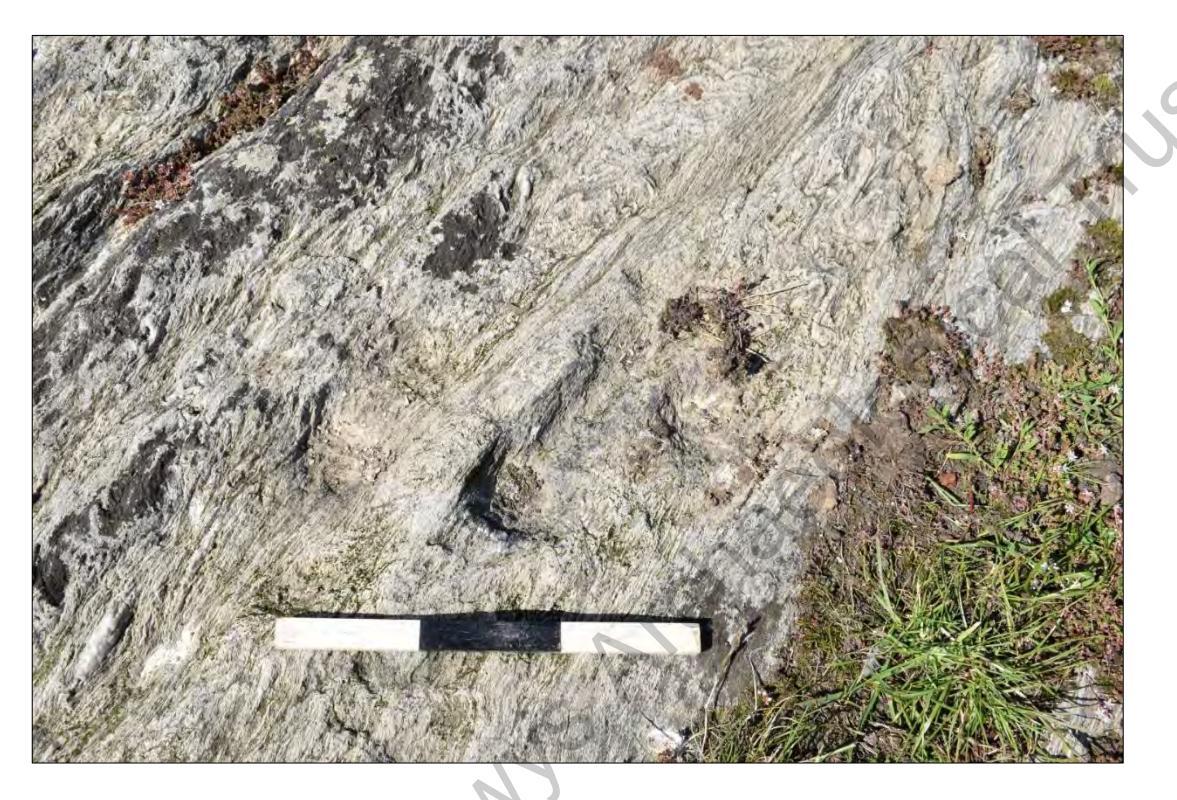
3.65. The group consisted of two cup marks (**i** and **ii**), 0.6m apart, approximately 0.1m in diameter and 0.03m deep. A third cup mark (**iii**) of similar size was located 1.5m to the south-west (Figs. 32-34).

Fig. 32 Cup mark I, viewed from the south. Photo CPAT 4786-0007

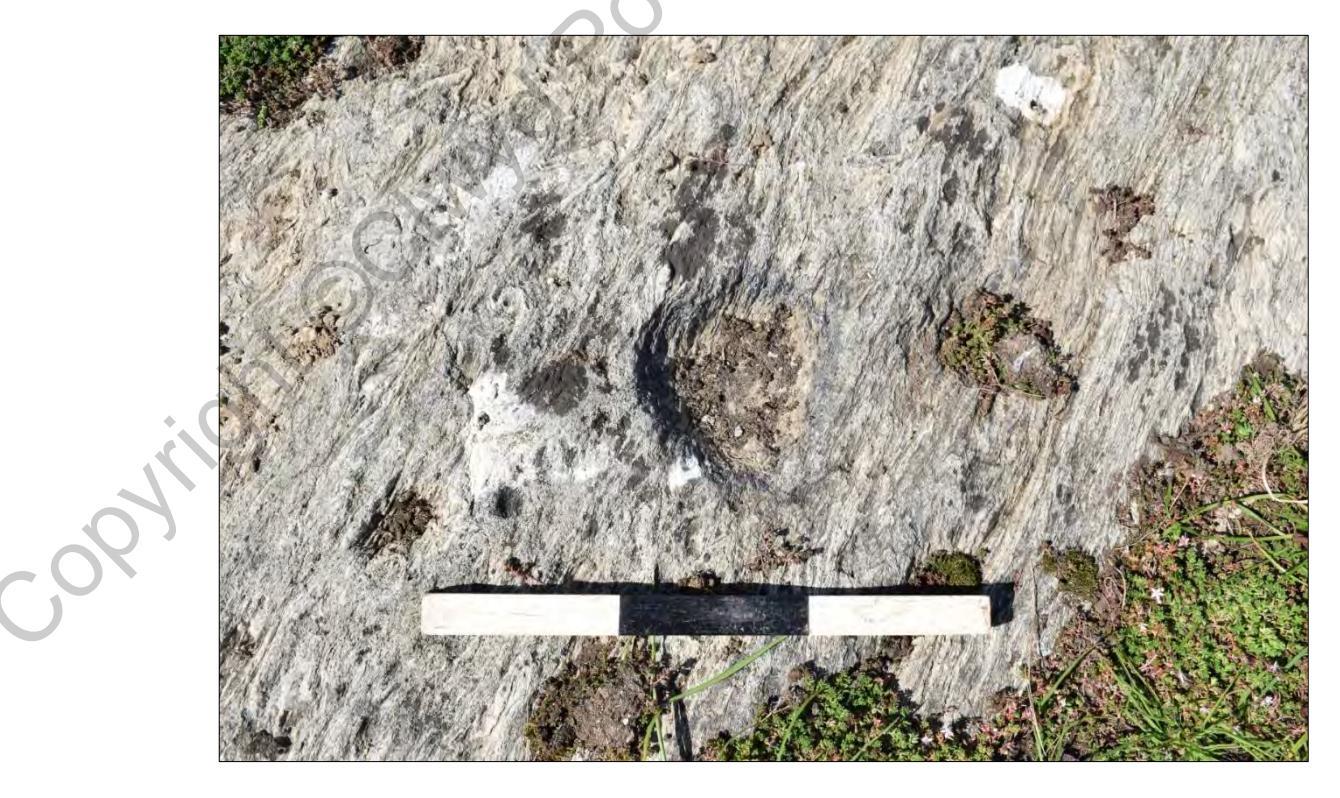
Fig. 33 Cup mark II, viewed from the south. Photo CPAT 4786-0008

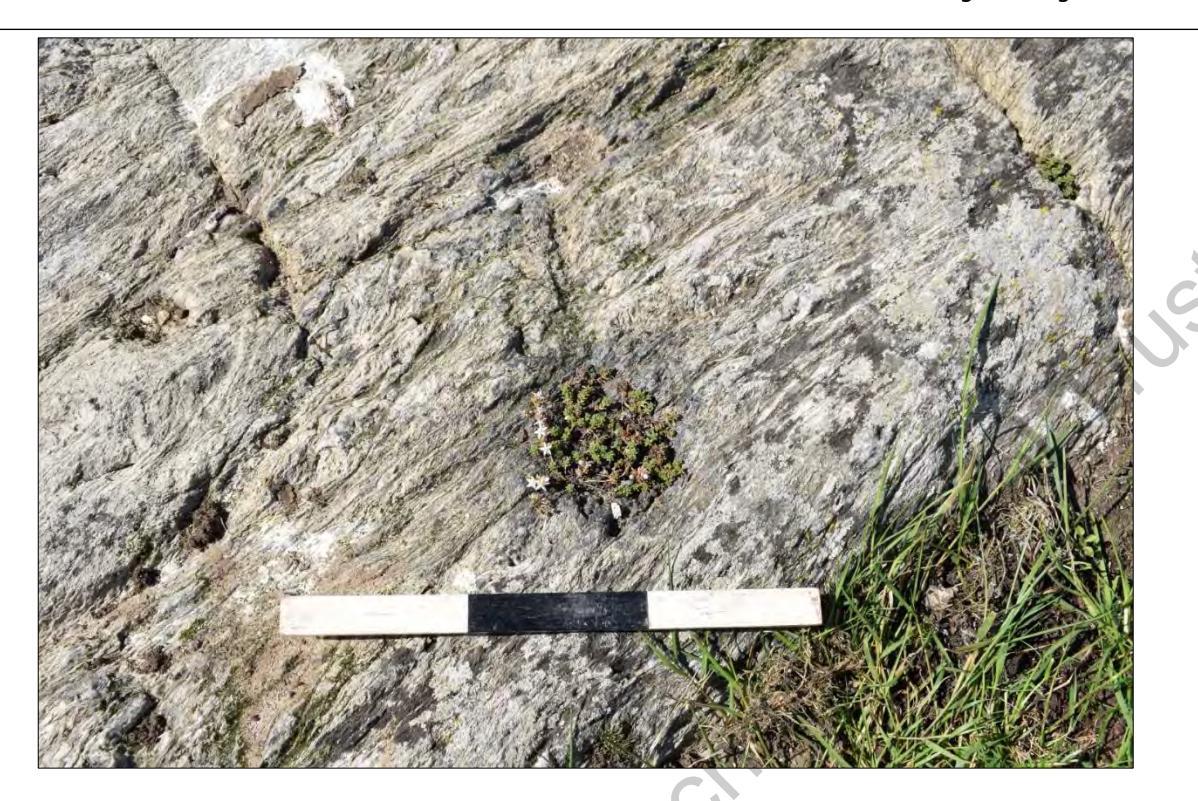
Fig. 34 Cup mark III, viewed from the south. Photo CPAT 4786-0009

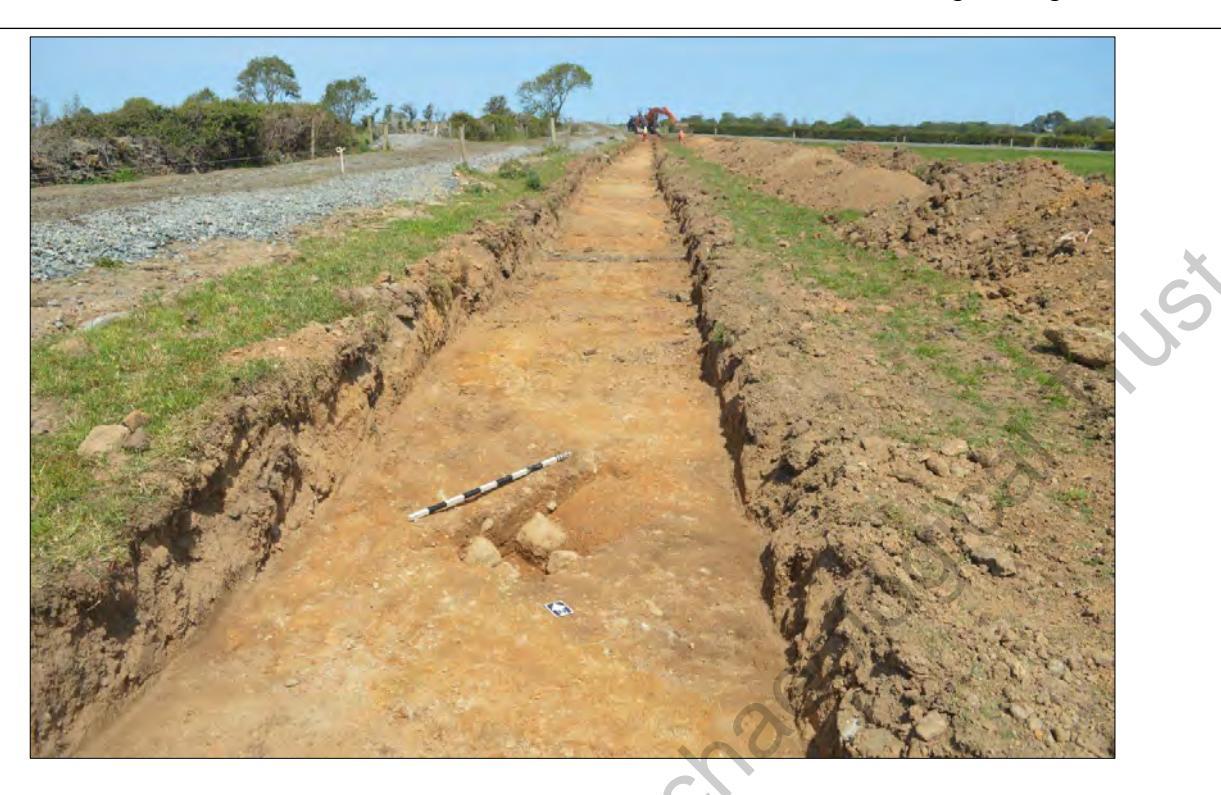
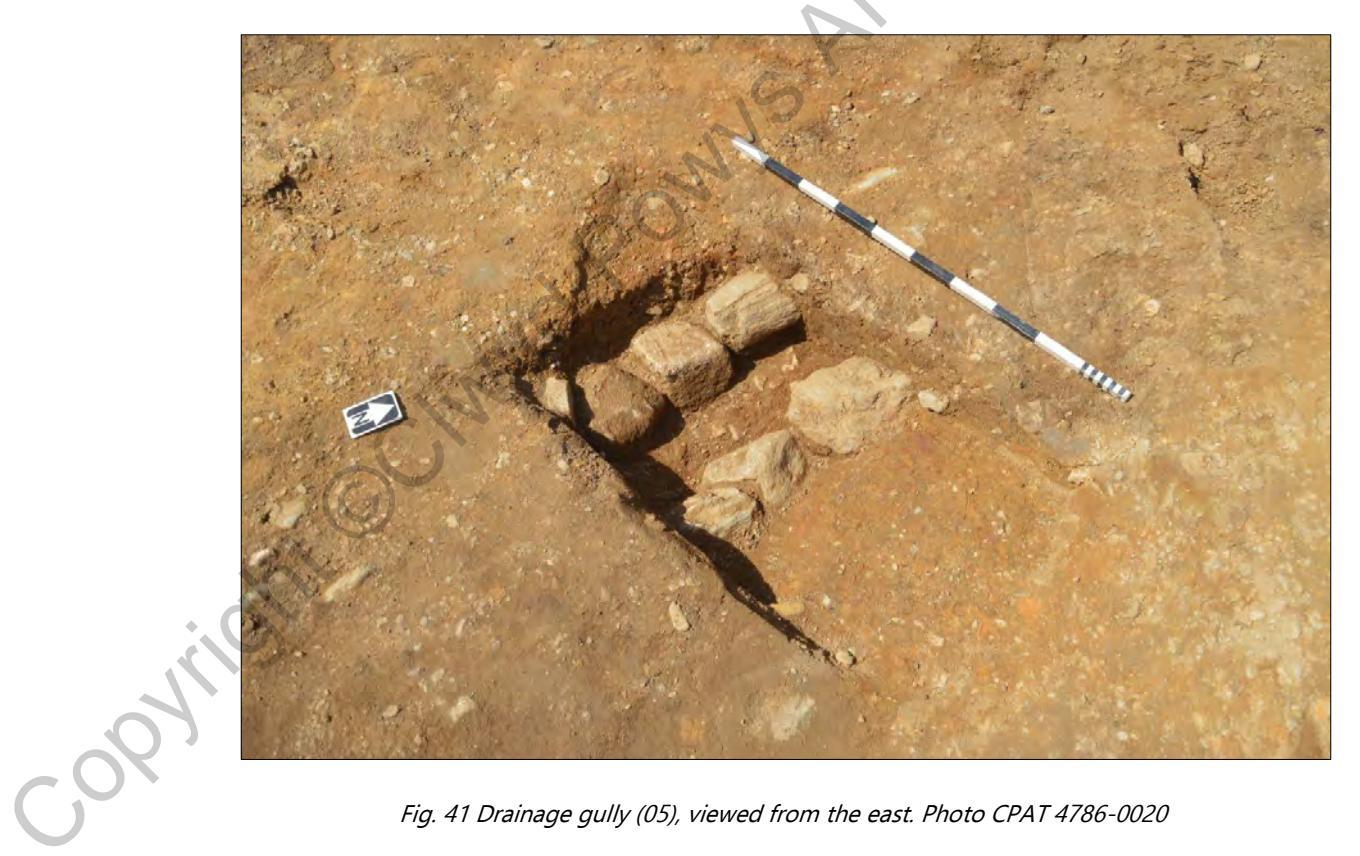
Fig. 40 Drainage gully (05), viewed from the south-west. Photo CPAT 4786-0019

Fig. 41 Drainage gully (05), viewed from the east. Photo CPAT 4786-0020

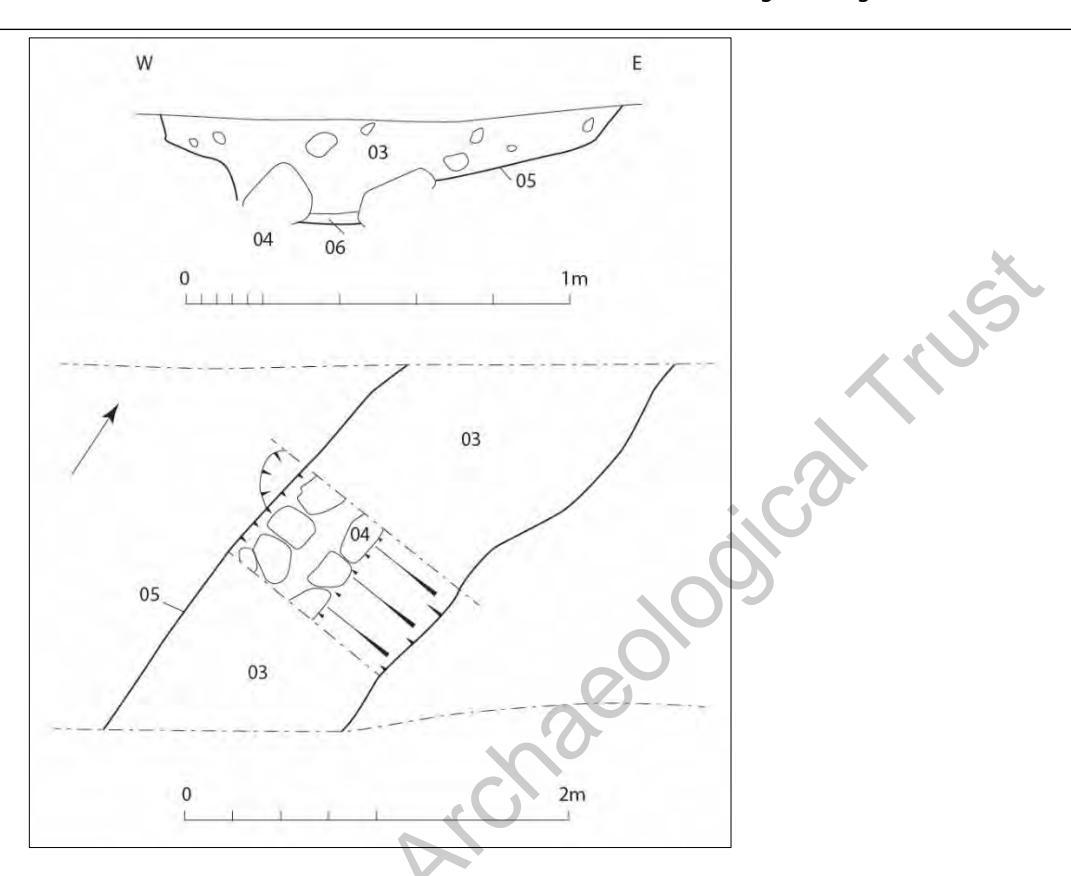
Fig. 42 Section and plan of drainage gully (05).

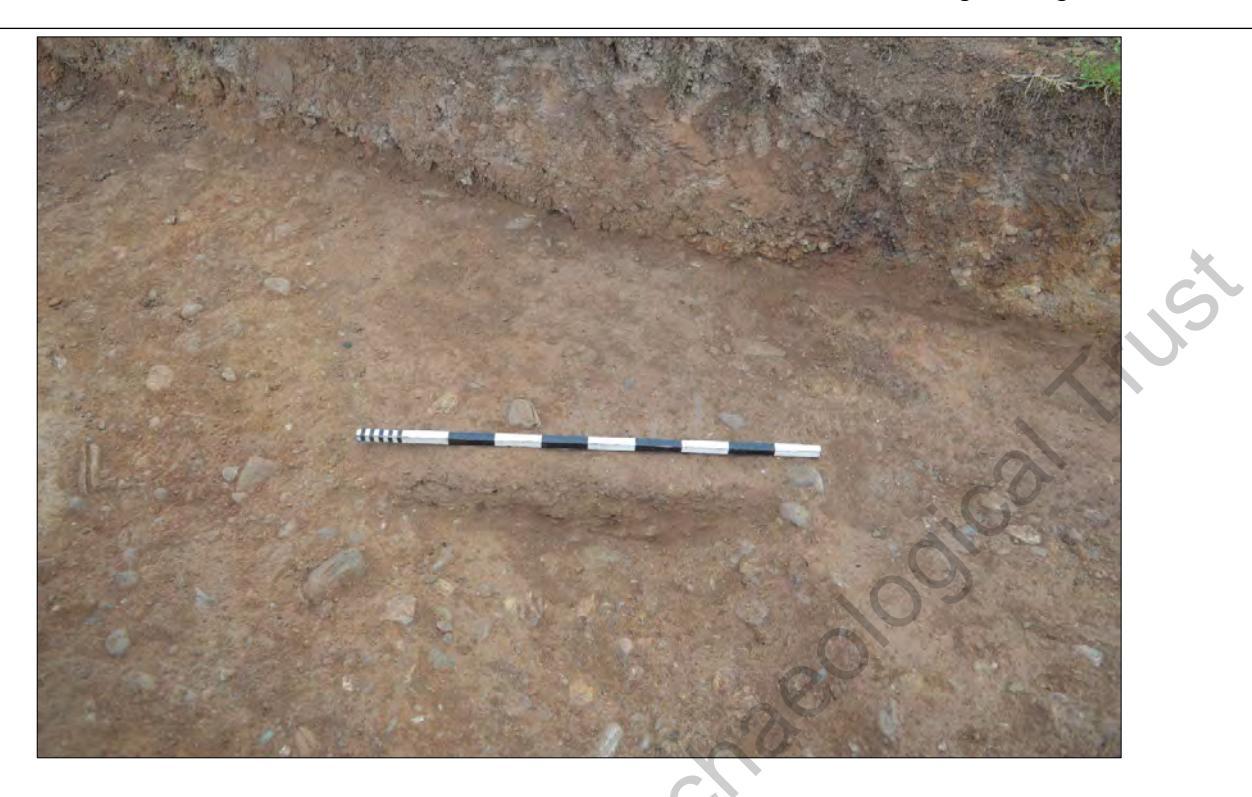
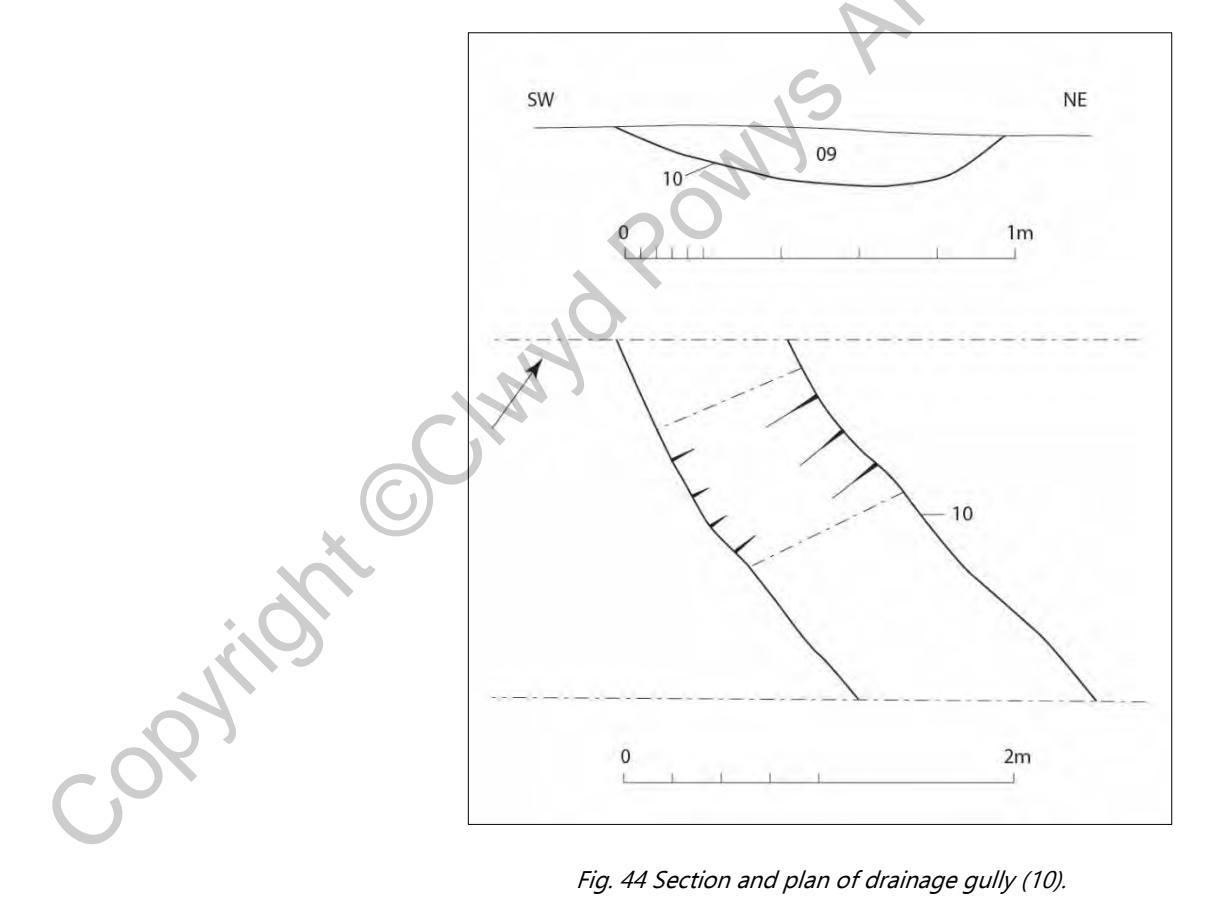
Fig. 43 Drainage gully (10), viewed from the south-east. Photo CPAT 4786-0054

Fig. 44 Section and plan of drainage gully (10).

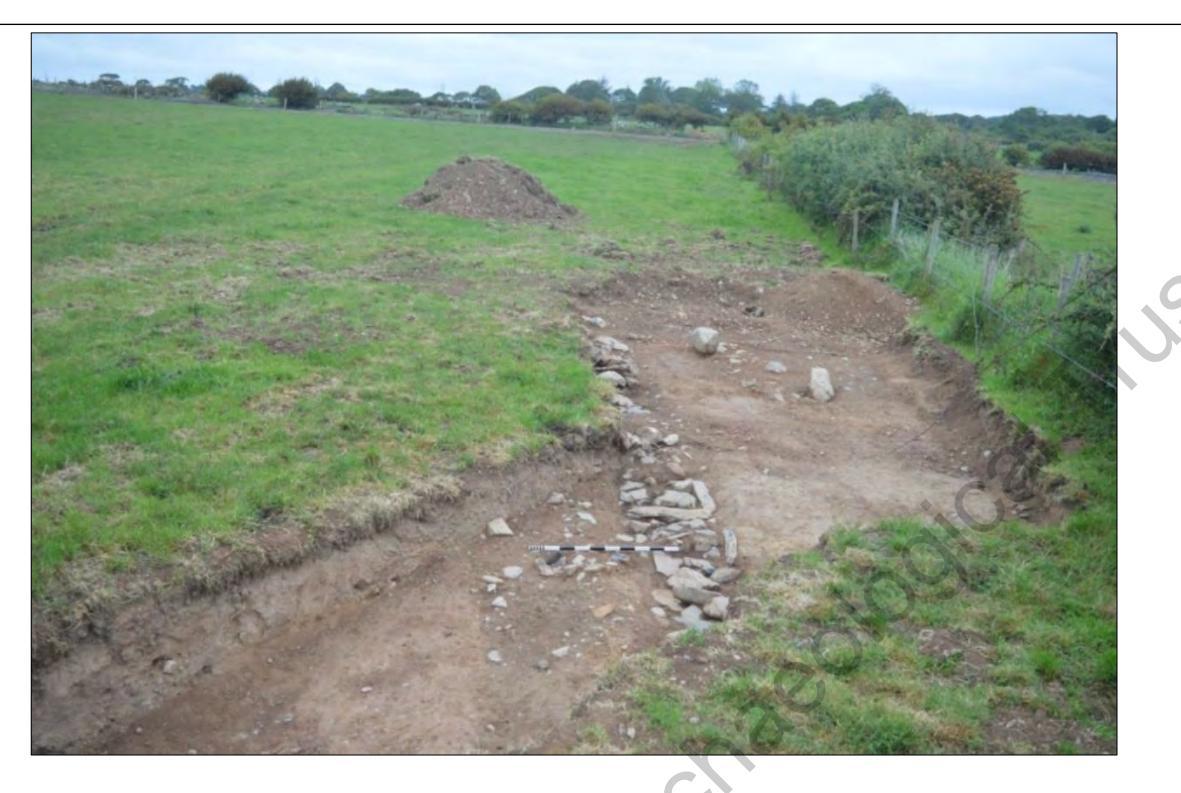
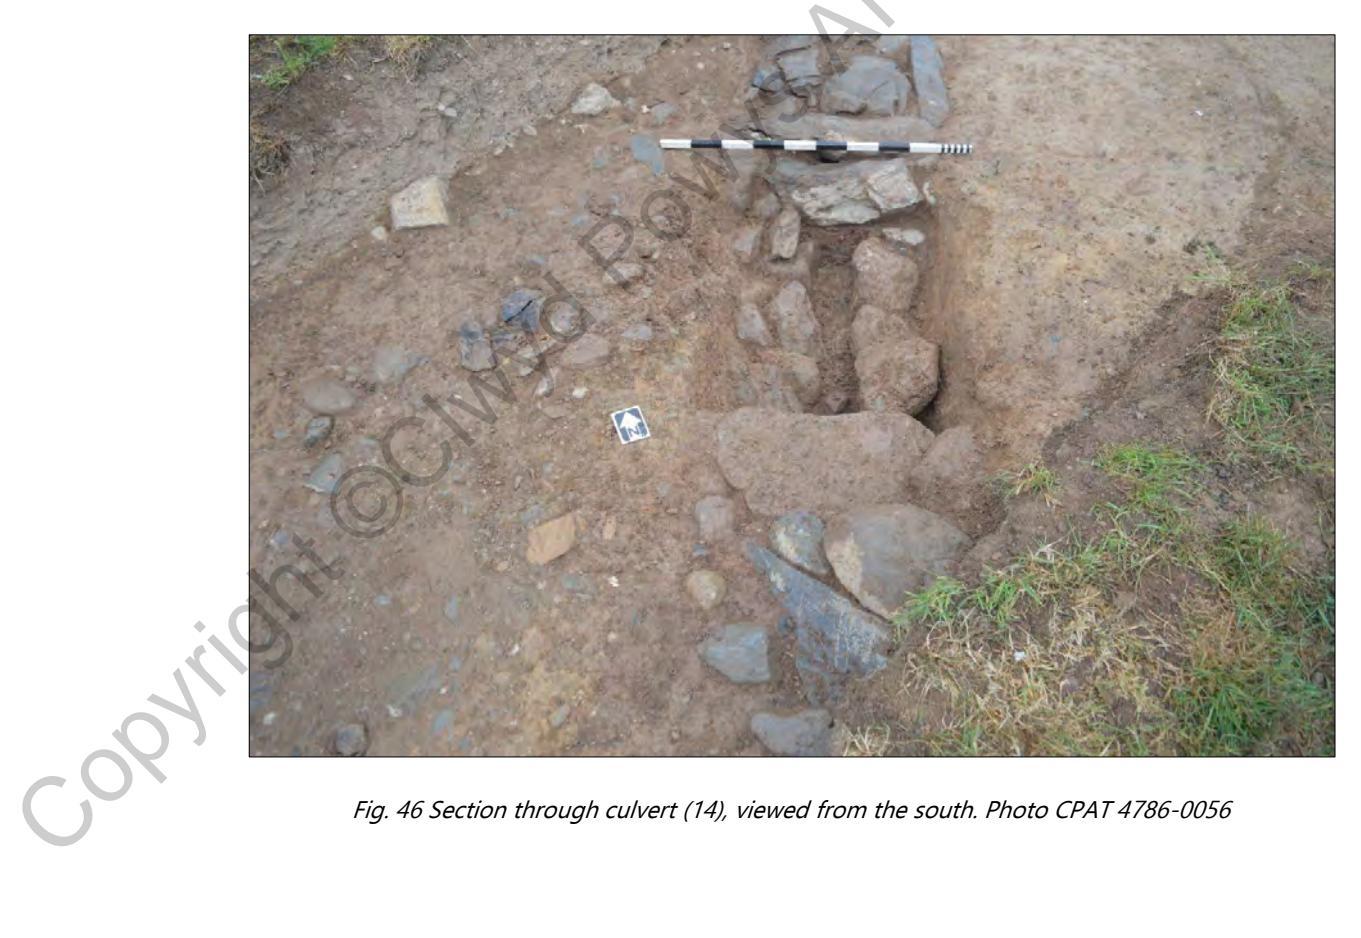
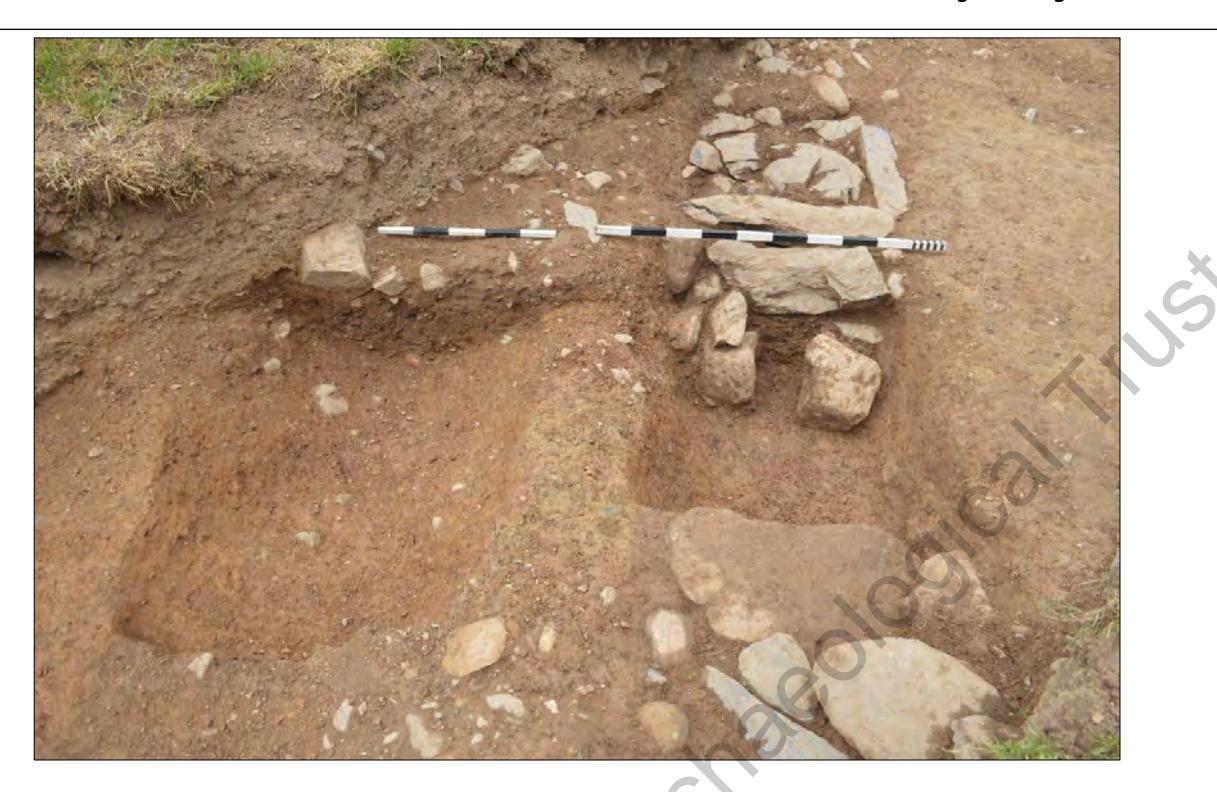
- 3.74. The gully [18], 0.8m wide and 0.15m deep, contained a basal fill (17) of weathered yellowgreen silty clay sealed by a soft friable grey clay (16) and a firm dark grey clay with occasional large shist stone (15). The uppermost fill (15) was truncated along the eastern edge by the culvert [14]. The cut for the culvert, 0.95m wide and 0.4m deep, contained a stone-built structure, 0.6m wide and 0.2m deep. The drain consisted of two lines of upright cobbles (03) capped with angular shist stone (08) (Fig, 46-48).

Fig. 45 Culverts 18 and 14, pre-excavation, viewed from the south. Photo CPAT 4786-0043

Fig. 46 Section through culvert (14), viewed from the south. Photo CPAT 4786-0056

Fig. 47 Culverts 18 and 14, post excavation, viewed from the south. Photo CPAT 4786-0073

- 3.75. The gully [18] and culvert [14] were sealed by a deposit (12) that consisted of large rounded cobbles within a matrix of loose brown silty clay capped by a firm thin lens of yellow puddled clay. The deposit, which was spread all over the general vicinity, could possibly be the ploughed down remains of a structure that appears to be located immediately to the north and north-west of the features.
- 3.76. It should be noted that at the time of excavation, following consultation with GAPS, a decision was made not to investigate the area outside the established route of the wayleave. No further investigation was undertaken and the gully, culvert and surrounding environ remain undated.

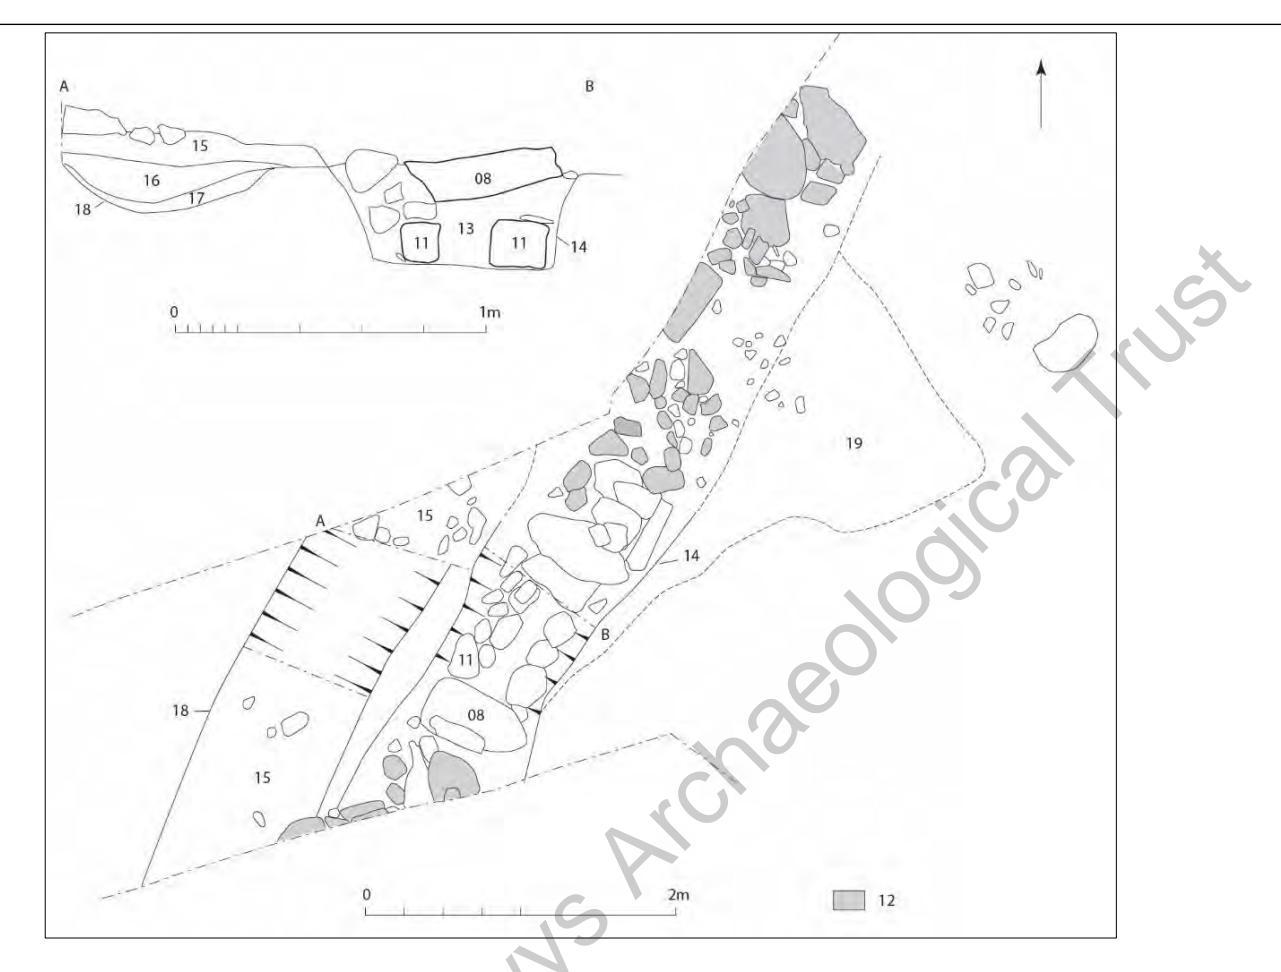
Fig. 48 Section and plan of culverts 18 and 14.

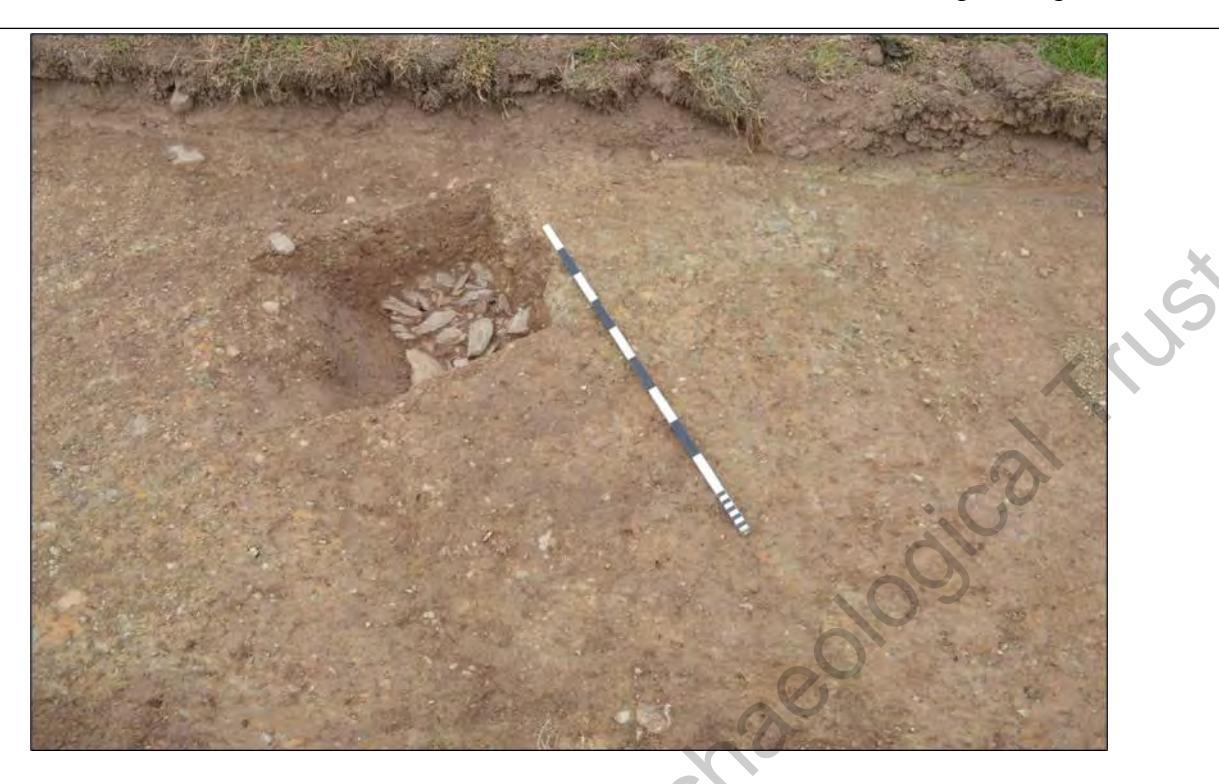
3.77. A stone lined gully [21] was recorded at a point 30m (NGR SH 50714 70473) to the west of the culvert [14]. The gully, 0.75m wide x 0.2m deep and orientated north to south, was only partly excavated revealing a basal fill of deliberately broken shist stone sealed with compacted pink clay (Fig. 49). The gully, one of seven drains forming part of an extensive field drainage system recorded in the area, remains undated but is presumed to be of 18th-19th century origin.

Fig. 49 Section through drainage gully (21) viewed from the south. Photo CPAT 4786-0091

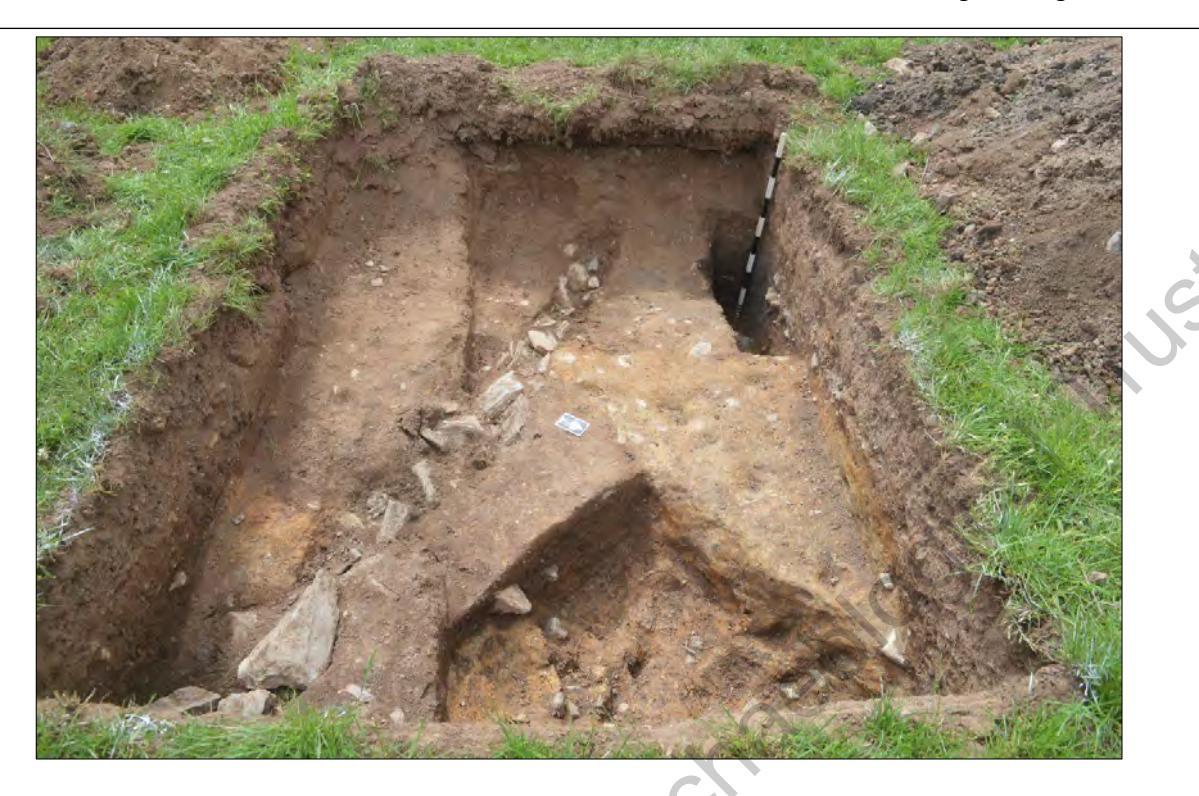
Fig. 56 Test Pit 79, features 7905,6 and 7, viewed from the north-east. Photo CPAT 4786-0120

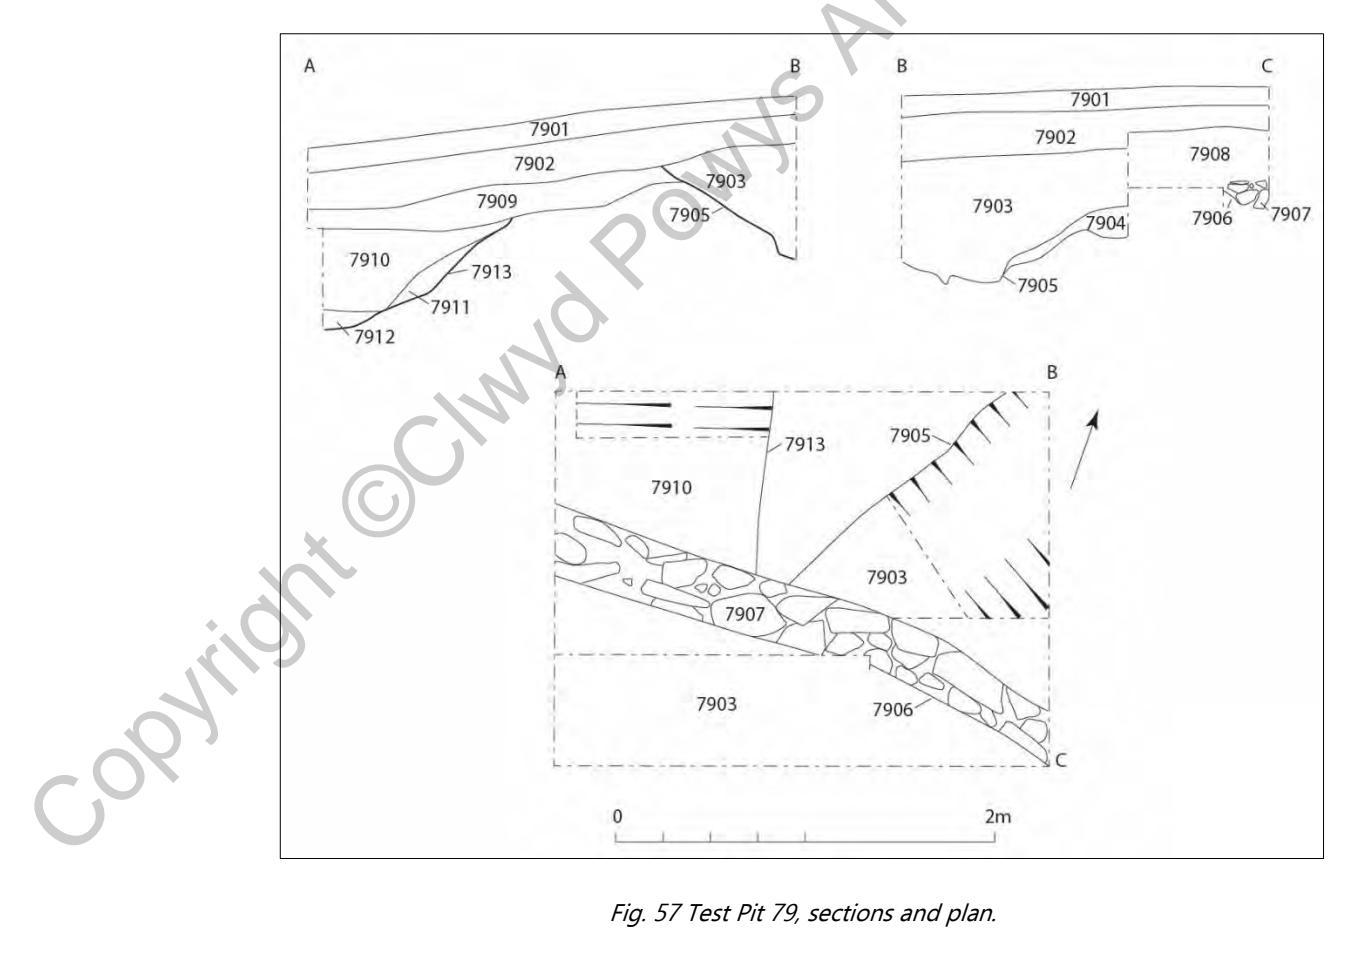
Fig. 57 Test Pit 79, sections and plan.
