Results of Desk-based Assessment & Walkover Survey at

Afon Cwm Mynach, Near Dolgellau

C.R Archaeology Compiled by M. Jones & C. Rees on Behalf of NB Hydro Services

M. Jones & C. Rees CR43-2013 28/06/2013

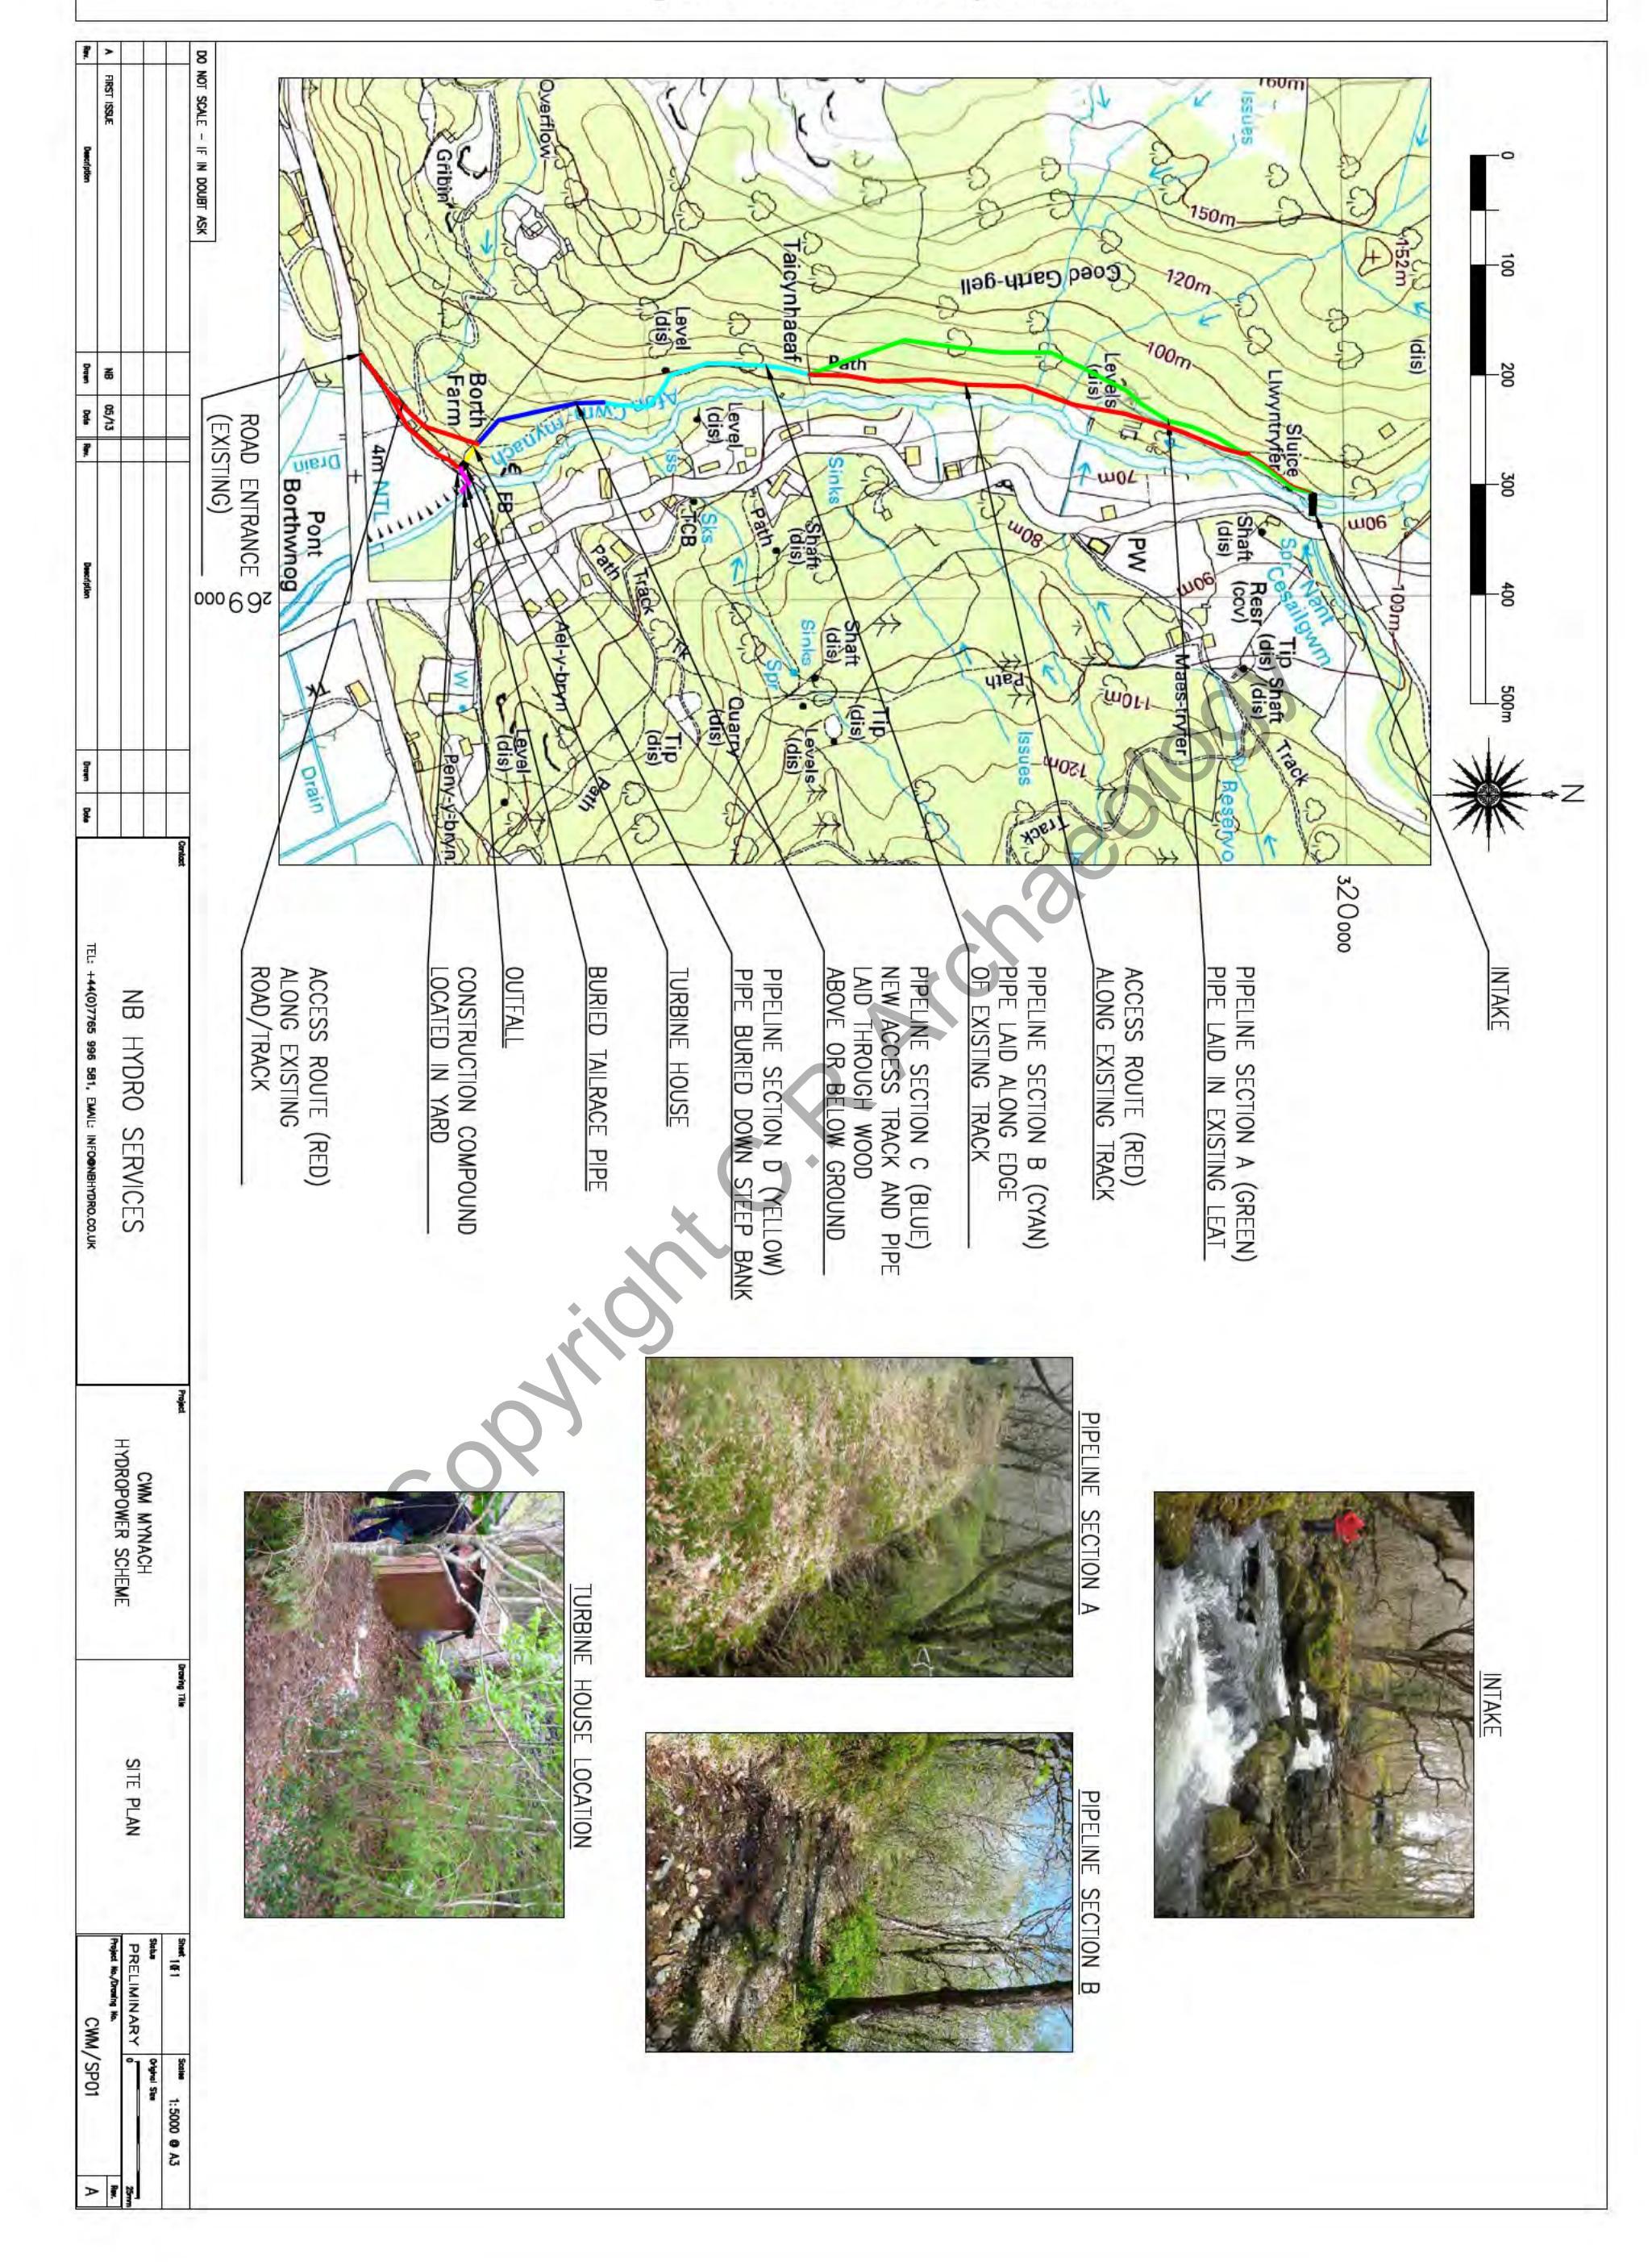
Figure 2. Route & Details of Proposed Scheme

The development area (figure 1) is situated in a small north-south orientated river valley and terminates at Borthwnog Farm. It runs along the old parish boundaries of Llanaber and Llanelltyd, within the county of Gwynedd and is located within the Snowdonia National Park and RSPB Nature Reserve. Figure 2 details the route of the proposed works.

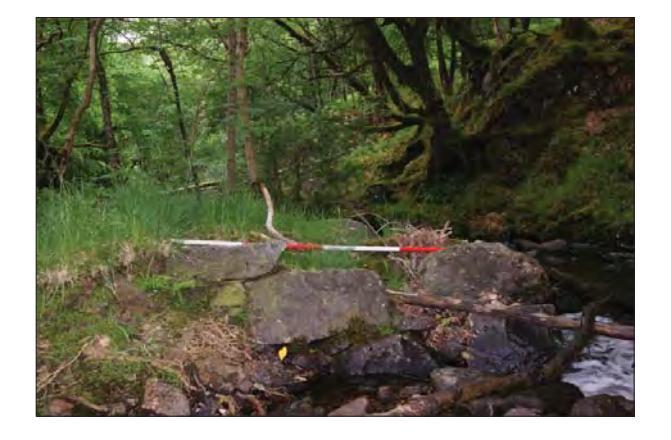
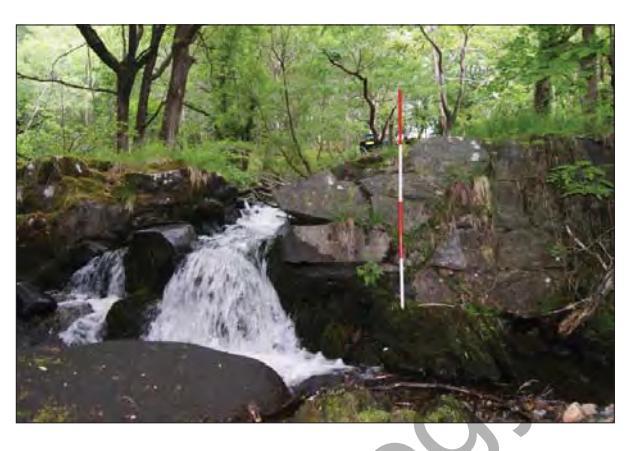
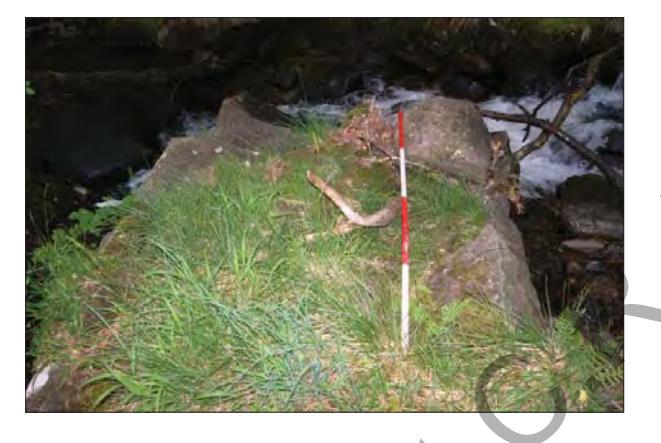
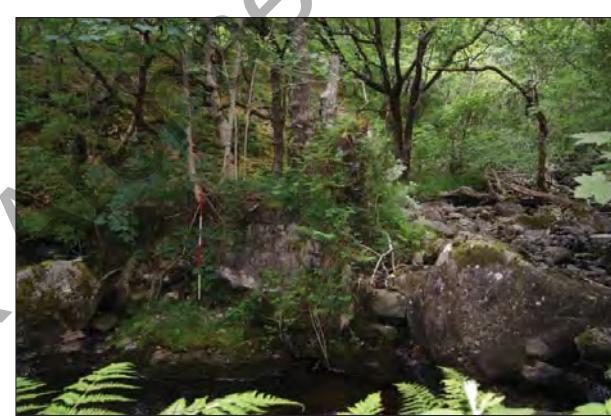
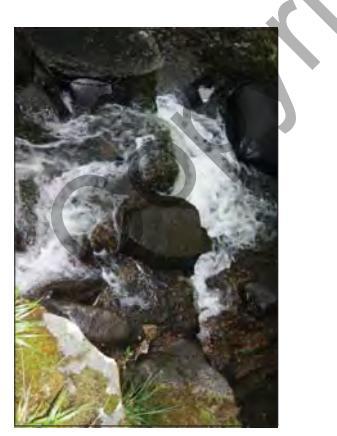
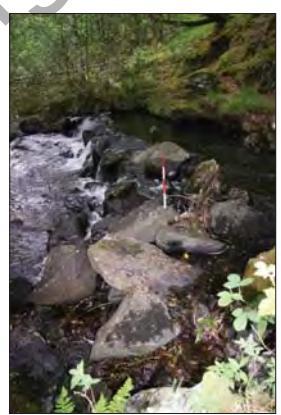
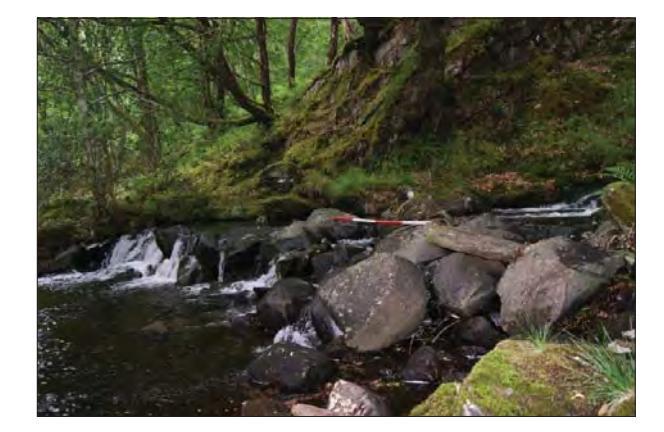
The first structural element was a dry stone wall which had been constructed using large blocks of local stone up to 1.5m in length (Plates 1-5). One segment of the wall was built at a right angle to the water flow (east-west axis) and was located between the two streams. There was a gap in the east-west element but this was thought to be due to erosion by the river rather than being a deliberate characteristic. This section of the weir has been damaged by trees and is covered in moss but is in good condition. There was a return which was orientated north-south and ran upstream. Due to the dense vegetation it was not possible to determine the length of this wall beyond approximately 9m.

Plate 1. Dry Stone Weir at Beginning Of Route. See Figure 5 for Location

Plate 2. Dry Stone Weir at Beginning Of Route. See Figure 5 for Location

Plate 3. Dry Stone Weir at Beginning Of Route. See Figure 5 for Location

Plate 4. Dry Stone Weir at Beginning Of Route. See Figure 5 for Location

Plates 5 & 6. Dry Stone Weir at Beginning Of Route. See Figure 5 for Location

Plate 7. Dry Stone Weir at Beginning Of Route. See Figure 5 for Location

The original proposal states that this feature will be rebuilt in reinforced concrete and this course of action would involve damage to much of the original structure. This has however been revised – see section 8.

Section A – The weir at the northern extent of the proposed development is marked for replacement with a concrete structure of the same dimensions. It is a strong possibility that this weir was associated with the gold mining activities in the area and therefore its removal/replacement as noted in the project proposal would be directly at odds with the "*Conservation Priorities and Management*" laid out in GAT Report 537 which states "*retention of mining remains*" as one of its three priorities.

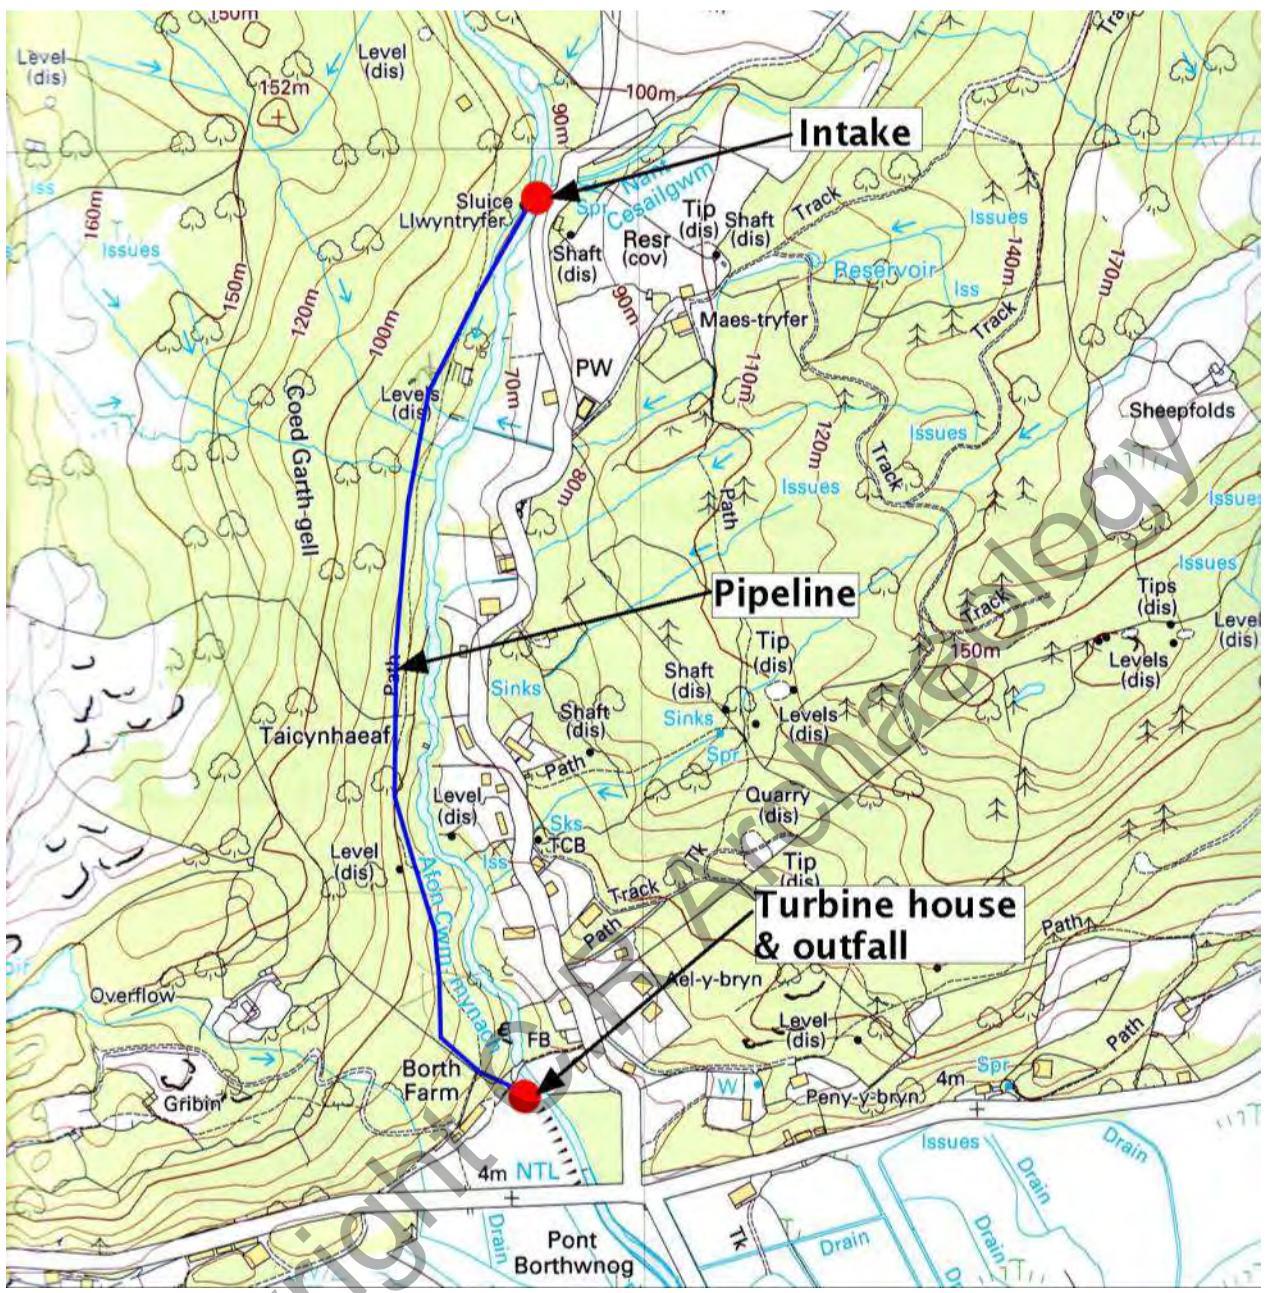
Figure 2 – Basic Layout

The initial proposed layout is shown on Figure 2 below. A more detailed version is shown in the Site Plan drawing CWM/SP01. This drawing also features some photos of the site. The proposed design has been chosen to minimise impact on the nature reserve and SAC. It is expected that the scheme will have a minimal impact on that area.

As shown in the figure, the project would involve the diversion of water from the stream using an intake at SH 68901995. A pipeline (or penstock) would transfer the water down the hill to a powerhouse (or shed) built at the bottom of the hill. Inside this small building the water would pass through a turbine causing it to rotate. The turbine would be connected to a generator which would turn the kinetic energy into electrical energy. The water would exit beneath the floor of the powerhouse and return to the stream via a tailrace pipe.

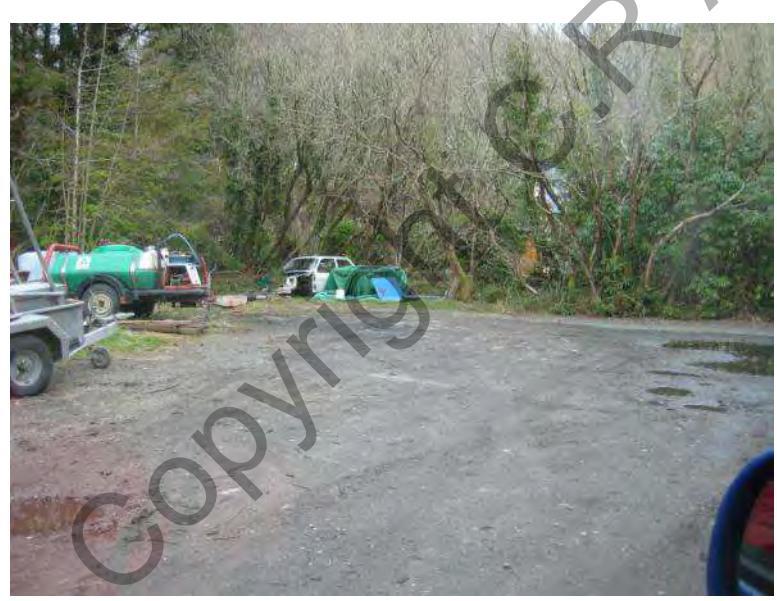
Figure 3 - Yard

The tailrace is a channel which returns water from the sump below the turbine. A short length of twin wall culvert is proposed of approximately 600mm diameter. This will be buried beneath the yard. The yard is shown in Figure 3 below.

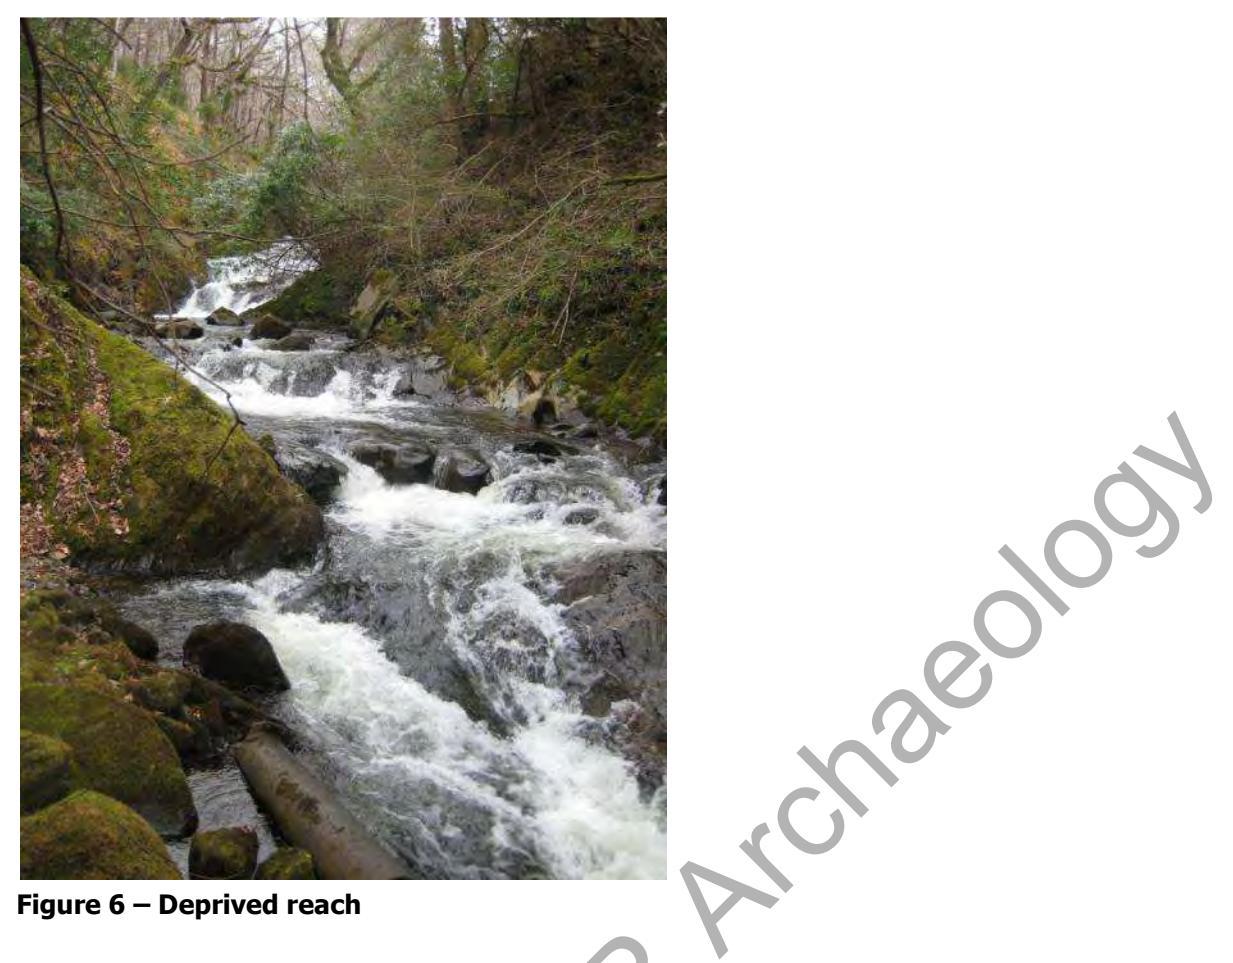
Figure 6 – Deprived reach

It is proposed to carry out a qualitative fish habitat survey of the deprived reach as well as the area upstream and downstream of the hydro project. Advice is sought as to whether electrofishing is necessary and the level of detail required.
