Survey Commissioned by R.W Jones.

Ty Mawr West Desktop Study and Survey

February 2002

EAS Client Report 2002/2

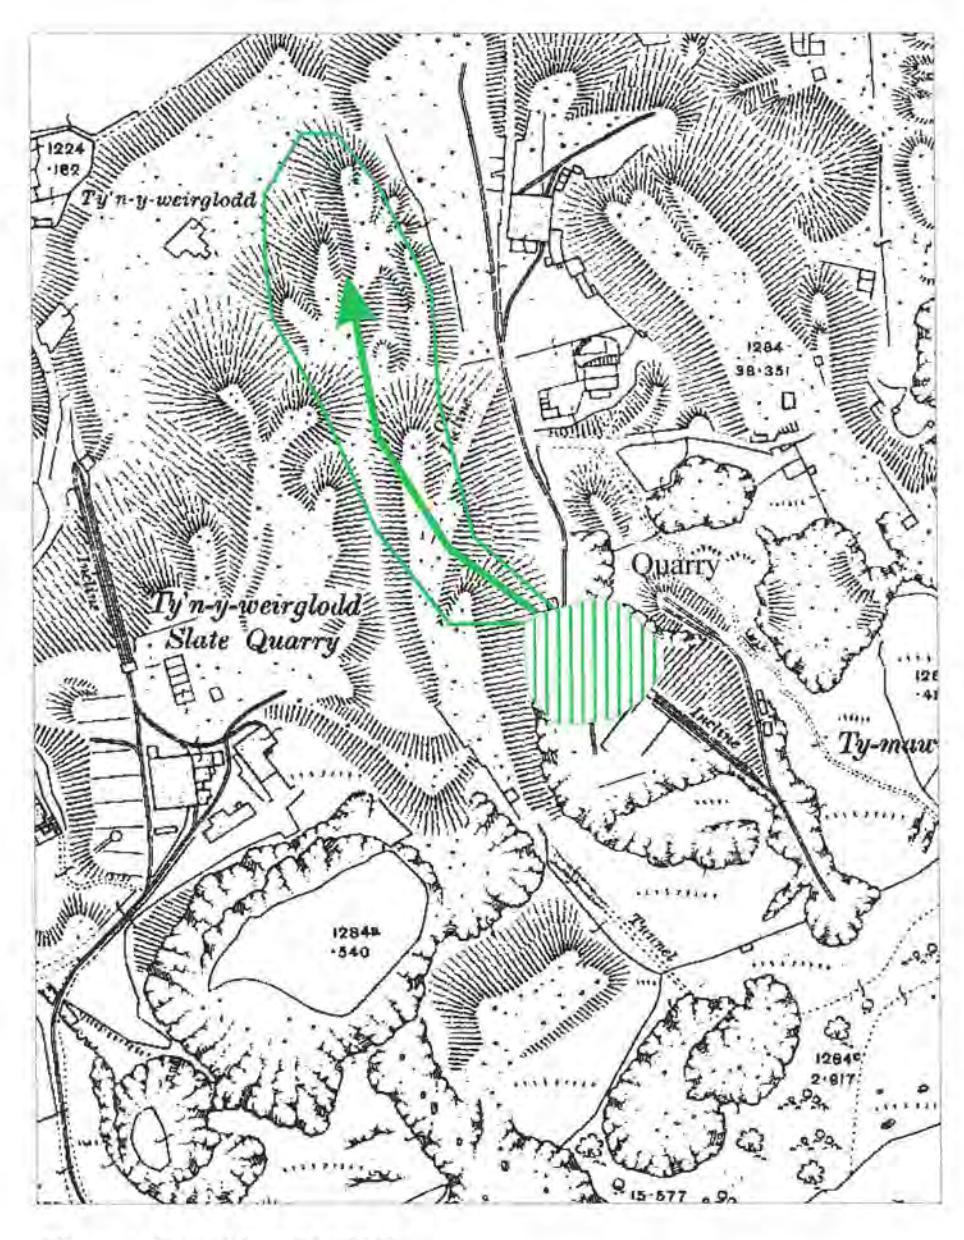
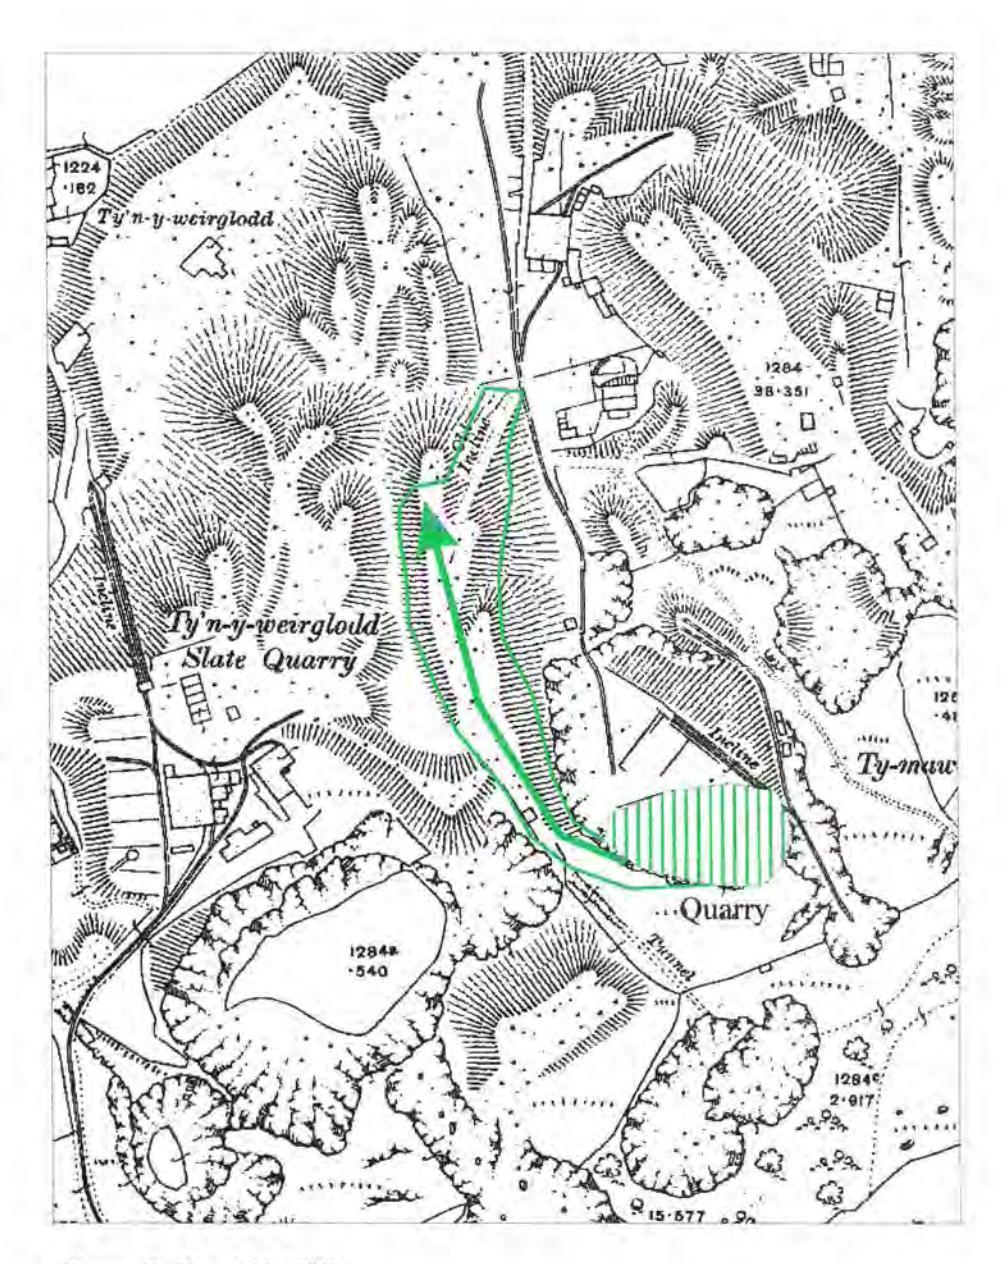
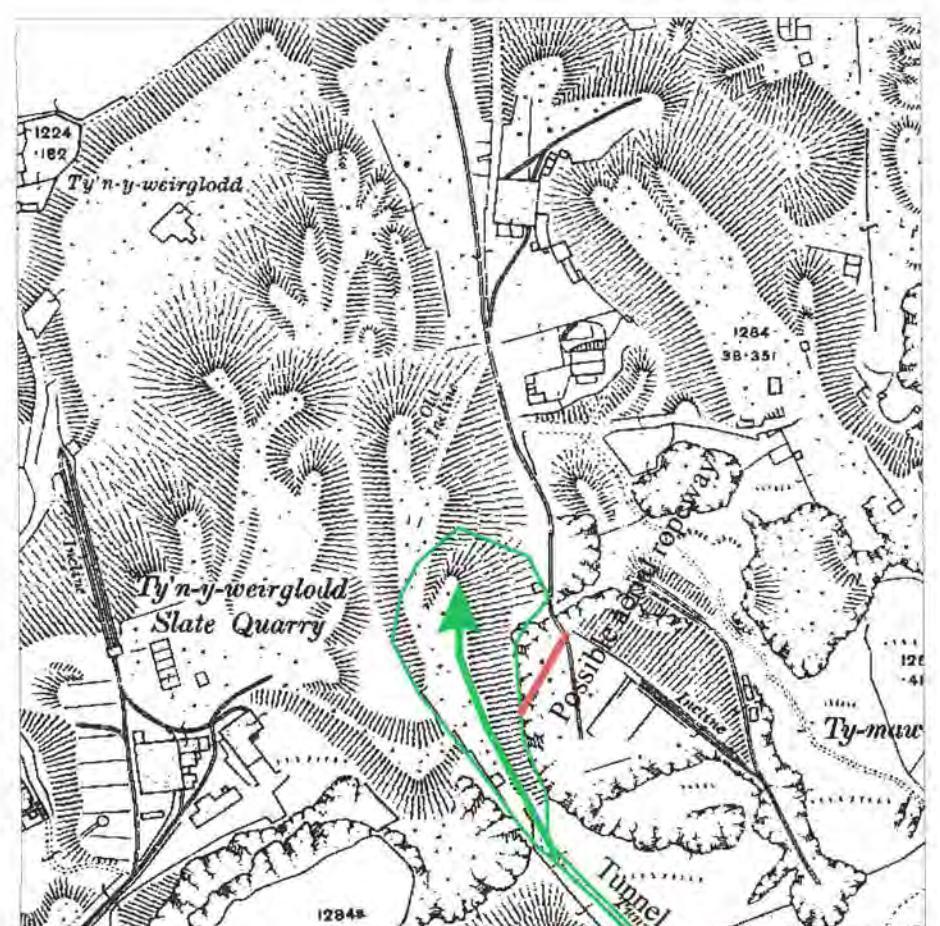
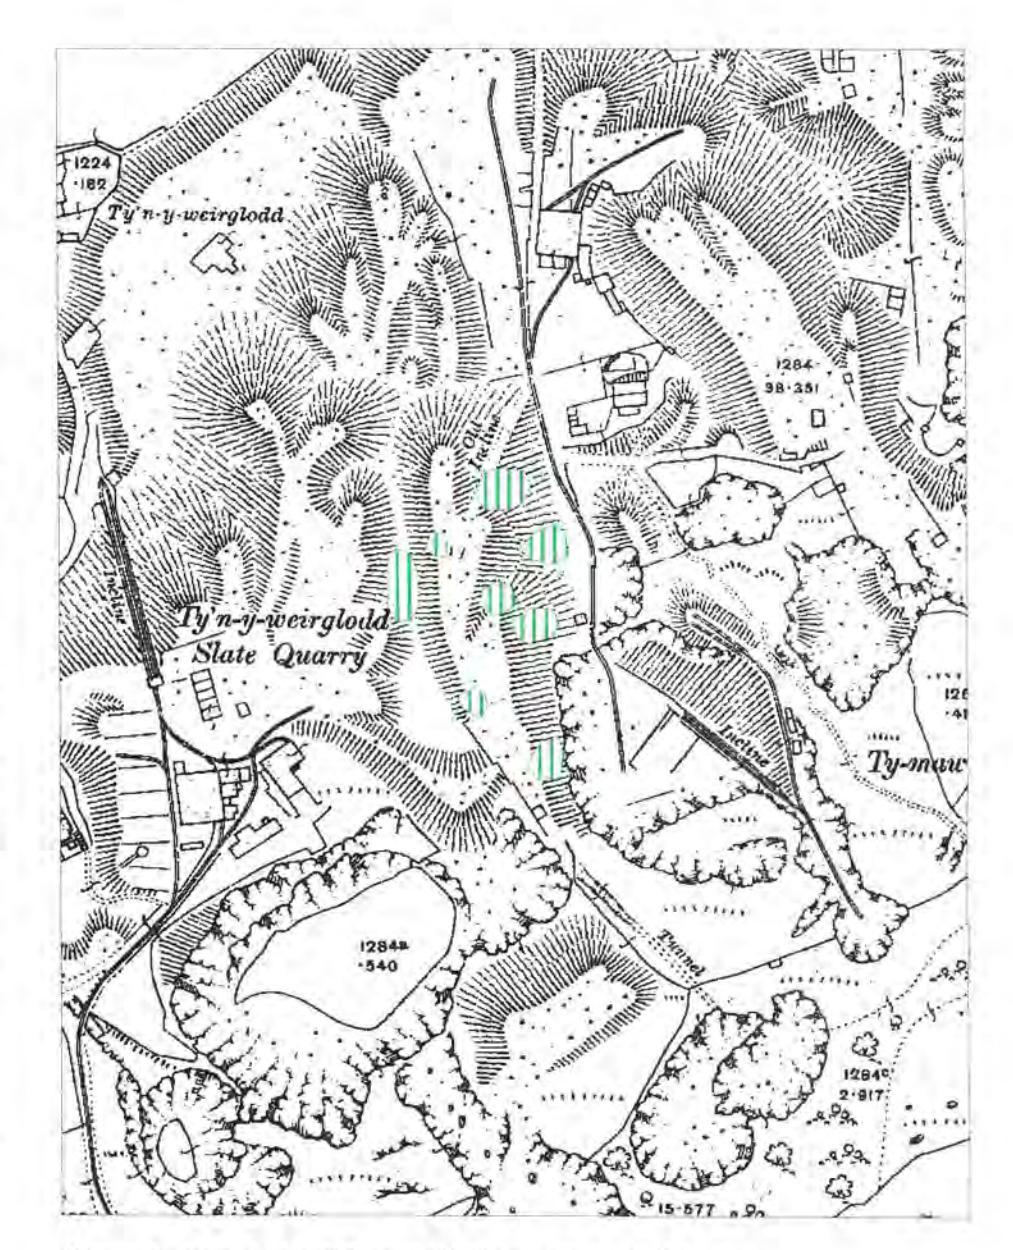
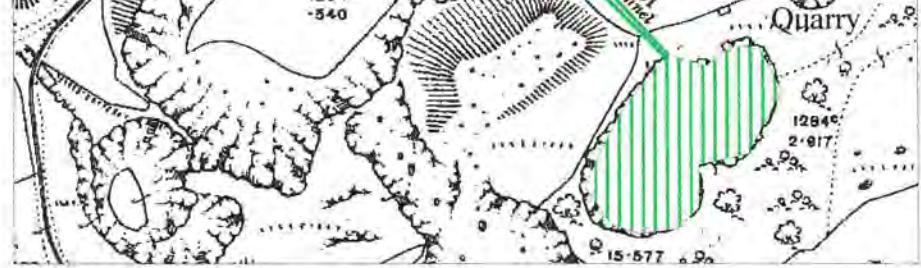
Figure 9: Summary of the phases of deposition on the spoil heap

Phase 1: Possibly AD 1860's

Phase 2: Pre AD 1889

Phase 3: AD 1905 - AD 1908, Frederick Davies

Phase 4: Post AD 1908 exploitation of the spoil heap.

The development of the spoil heap is summarised in Figure 9.

The spoil heap would appear to have a fairly complex history, with at least three phases of dumping followed by a phase of reworking. Most of the structures recorded are associated with the reworking, although some details of the earlier phases survive. A limited number of structures associated with an adjoining quarry will also be affected.

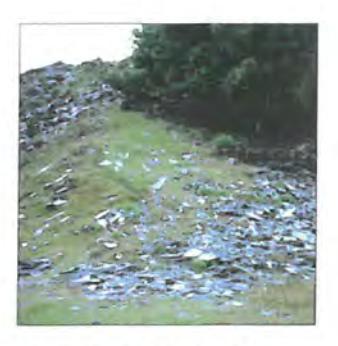
Plate 3: PRN 16021

The heap acted not only as an area for the dumping of spoil, but also as a route from an upper level to the processing area. To facilitate this an incline (PRN 16021) was constructed (Plate 3). This structure is in a very eroded state, the position is marked by a broad sweep of grass mounting the end of the spoil heap. A small area of the original revetment for the side of the incline survives (Plate 4), however most of this and much of the incline structure has been robbed out at a later date, probably from the gwâl (a temporary working shelter or shed) PRN 16009. The incline is further disturbed by fallen rubble and a tree growing approximately half way up.

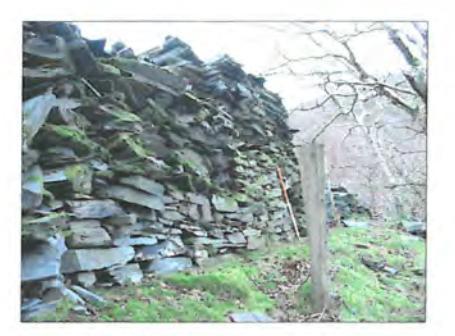
Plate 5: PRN 16002

The western side of the spoil heap was revetted (PRN 16002 and 16018) (Plates 5 and 6), presumably to confine the tip from spilling onto the adjacent property. At the southern end, just outside the development area, this revetment would appear to be in two phases, with an initial well built dry stone wall being heightened with a less well built wall (Plate 5). It is assumed that the lower wall is a marker wall built to define the extent of the dumping area. The upper portion was then built as the spoil heap developed to confine the dumping. PRN 16002 also contained a section of well built section above the lower wall. This is directly below a building (PRN 16001) on the present ground surface and may represent an earlier building buried within the structure of the heap. It would seem likely that both of these structures were associated with the management of the spoil heap, or control of products coming from the quarry.

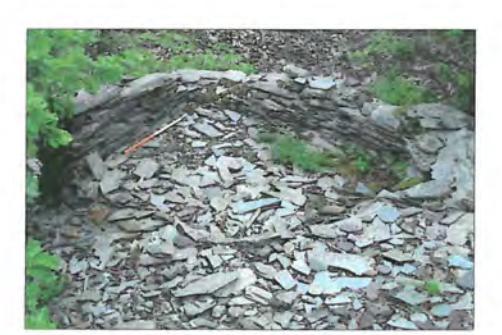
rlate 7: 16004

Only two other major structures may have been associated with the development of the spoil heap, rather than the reuse of the spoil heap. PRN 16004 (Plate 7) sat immediately above the quarry area on a slight platform at the base of the spoil heap. The low level of this structure and its construction on a rock platform may suggest this was related to an early phase of the development of the spoil heap. It is possible that an assumed aerial ropeway associated with Frederick Davies' exploitation of the site was based in this area. The spread of split slate around the structure suggest that it was probably reused as a gwal in the reuse of the spoil heap as a source of slate. The structure is three sided with the open side facing NW.

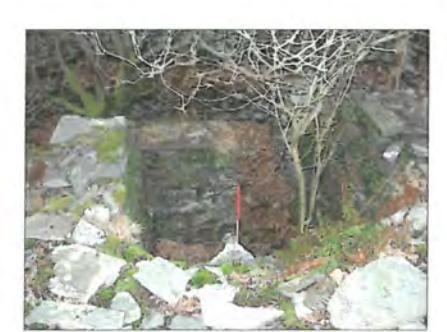
Plate 8: PRN 16013

PRN 16013 was a well built building, 2.10 m square and standing to 2.40 m (Plates 8 and 9). The door was in the south east corner overlooking the rock cut entranceway to quarry. No windows were within the structure, although a long, iron handle found on top of the western wall may suggest that it originally had a sky light. The outer surface of the wall was partly rendered and three of the roof slates survive along the western wall. The function of this building is uncertain, it is not sufficiently robust to be an explosive store and its position close to the quarry would also tend to preclude this. Other options would include a "caban" or tea-hut or an office monitoring the products leaving the quarry.

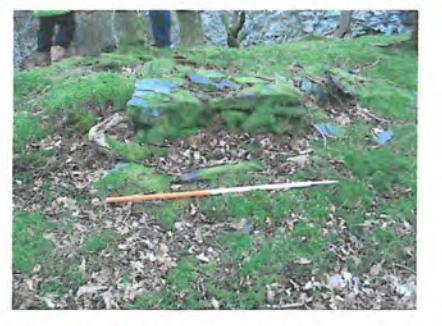
Figure 11: PRN 16029

This group is similar to the well built stone piles noted at the eastern foot of the spoil heap. Two blocks were noted (PRN 16029 and 16030) (Plates 11 and 12) within the development area, although more were noted, particularly within the quarry area. These form a clear line and are assumed to be the supports for an air line linking a compressor in the mill buildings to the air powered tools in the quarry. PRN 16030 is built into the revetting wall on the eastern side of the spoil heap. This confined the spoil heap and provided a clear passage to the quarry.

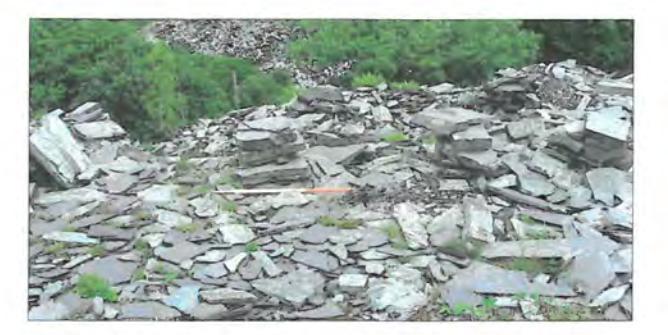
Plate 13: PRN 16022

The second group on the spoil heap (Plates 13) consisted of nine square piles of blocks (PRN 16022) extending the line of an inner wall of a tip end buttress (PRN 16016). Each of the piles were approximately 0.50 m square and stood to a maximum height of 0.60 m. They were marked in being less well built than PRN 16013, 16030 and 16031 and it is assumed that they may represent a temporary field boundary along the top of the spoil heap.

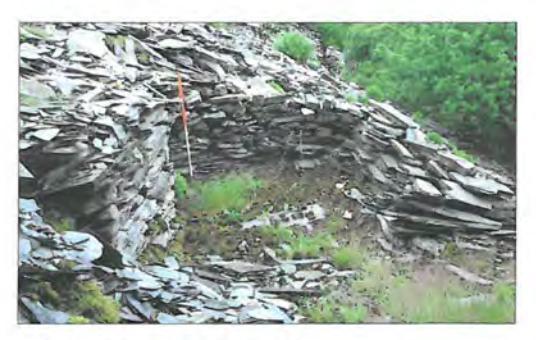
PRN 14: PRN 16003

PRN 16003 (Plate 14) consisted of three low walls with the open side to the south. The area above

this gwâl was disturbed and a spread of split slate waste around the structure suggest that blocks of slate were being extracted from the side of the spoil heap and being reduced on site.

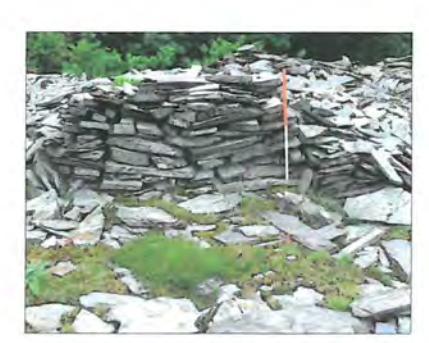
Plate 15: PRN 16005

PRN 16005 (Plate 15) consisted of a short "L" shaped wall with a smoothed area in front. It was close to the transway on the top of the spoil heap and was probably extracting slate blocks from the side of the transway. Split slate waste was also around this structure.

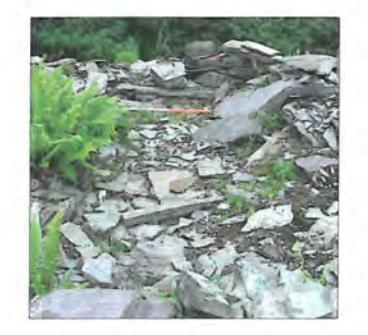
Plate 16: PRN 16006

PRN 16006 (Plate 16) A short length of very eroded dry stone walling along the western break of slope of the soil heap. In front of this wall was a rectilinear hollow with a possible entrance way in the south east corner. The base of the hollow was worn and contained sherds of split slate suggesting increased use of this area.

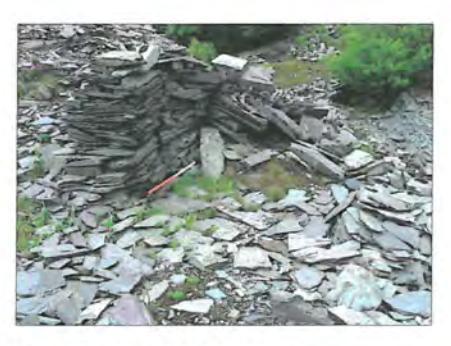
Plate 17: PRN 16008

PRN 16008 (Plate 17) was adjacent to the main tip top tramway and is assumed to be part of its management system Two walls stood to a maximum height of 1.20 m, although a third wall was buried in the spoil heap and stood to less than 0.30 m. The open face of this structure faced north. Within the structure the floor was smoothed and worn and contained sherds of split slate.

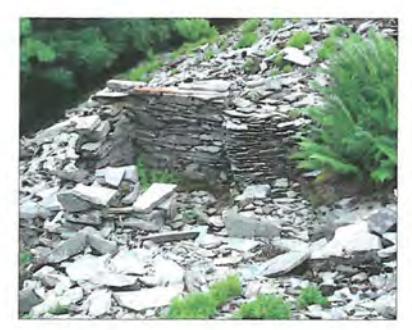
Plate 18: PRN 16009

PRN 16009 (Plate 18) was the most complete structure, with internal dimensions of 1.20 x 1.40 m. It had a "doorway" 0.50 m wide in its NW corner and stood to a maximum height of 1.20 m. The spoil heap above this gwâl was highly disturbed and contained the remains of the incline (PRN 16021) This structure would appear to be associated with the exploitation of the larger blocks of slate used in the construction of the incline. The form of the gwâl may suggest that it was intended to exploit this source of slate throughout the year.

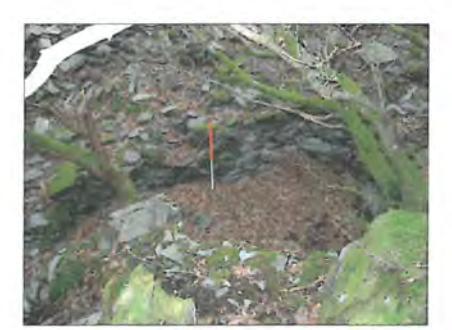
Plate 19: PRN 16029

PRN 16029 (Figure 19) A polygonal structure with an entrance passage built into the base of the spoil heap. The structure was 2.90 m x 4.30 m in size and stands to a height of 1.20 m in places. It was constructed of dry stone walling, although the western side is partly formed by a natural rock exposure.

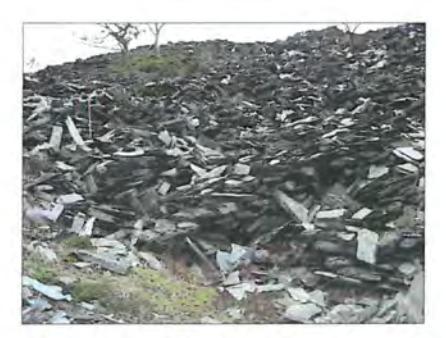
Plate 20: PRN 16011 and 16012

Two short lengths of dry stone walls (PRN 16011 and 16012) (Plate 20) set into the eastern side of spoil heap and surrounded with split slate waste would appear to mark the position of gwâliau.

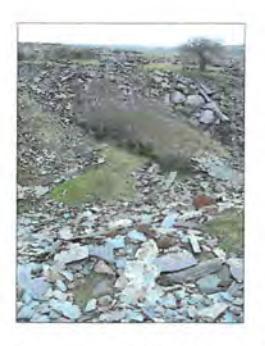
Plate 21: PRN 16007

Not within the development area, but immediately below the spoil heap on the western side was a another gwâl (PRN 16007) (Plate 21). The form of these structures is difficult to determine because of the scrub and tips partly obscuring these structure. At the north east end of these structure, however, remnants of a slate slab roof survive. The gwâl was surrounded with split slate, particularly green slate, it is was therefore constructed after the exploitation of the Green Pit by Frederick Davies between AD 1905 and AD 1908

- 1. The proposed position of the crusher be moved to avoid the possible stacking yard.
- 2. The gwâl, to the west of spoil heap to be removed, be protected during the course of the work.
- 3. The standing buildings at the heart of the quarry complex be protected from accidental damage

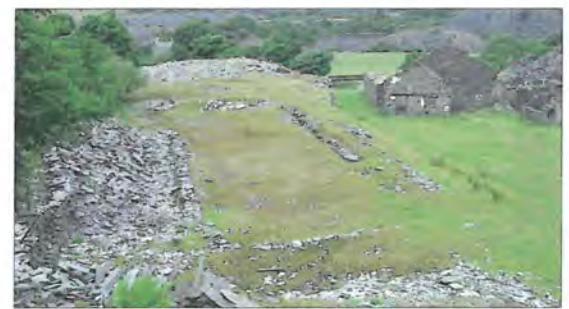
Plate 22: PRN 16023 and 16024.

The proposed area of the crusher is on a flat area near to the base of the incline. The eroded remains of a stacking yard (PRN 16023) (Plate 22) 11 x 30 m was recorded (Plate 10). Two walls survive and to a maximum height of 0.30 m. The eastern face of this structure is marked by a tramway, up to 1.70 m wide on a slight mound (PRN 16024). The area to the east of this stacking yard contains the upstanding remains of two ranges of quarry building (Plate 12). It is assumed that these building will not be effected by the proposed development and are not, therefore part of this report.

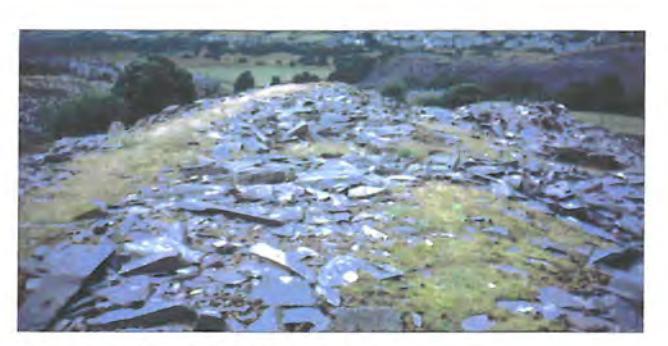
Plate 23: PRN 16025 - 16026

The proposed route for the products of the recycling is over the spoil heap to the east of quarry buildings to join in with a track which has already been carved into the eastern side of the spoil heap and leads towards the Ty-mawr East quarry complex. The construction of this track has already disturbed the top and eastern side of the spoil heaps and the dumping of the resultant rubble further obscured any details. To the north of the proposed track a series of tip to tramways (PRN 16025 - PRN 16028) were noted (Plate 14).

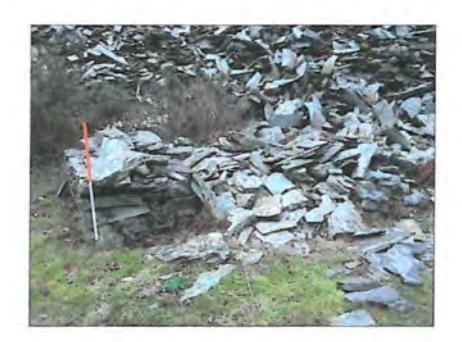
Plate 26: Possible base of aerial ropeway

Green Pit by Frederick Davies. The quarry would appear to be to the south of the spoil heap to which it was linked by a tunnel (Plate 25). It is clear from the waste on the tip that Davies only worked the green slate of the area. The small size of this tunnel and low numbers of workers employed suggest that this was a somewhat speculative, or under resourced attempt to work the green slate. Tipping took place on the previous spoil heap extending both the width and length of the heap. The system used to remove usable slate from Ty Mawr Green Pit is not clear. The incline does not appear to have been renovated, it is therefore possible that an aerial ropeway was used joining the spoil heap to the floor of the adjacent quarry. A large block of dry stone walling in the base of the quarry may suggest the position of the base of any aerial ropeway (Plate 26).
