Watching Brief Commissioned by Black and Veatch

Fieldwork by I.P. Brooks Engineering Archaeological Services Ltd.

Penybont WTW Watching Brief EAS Client Report 08/09

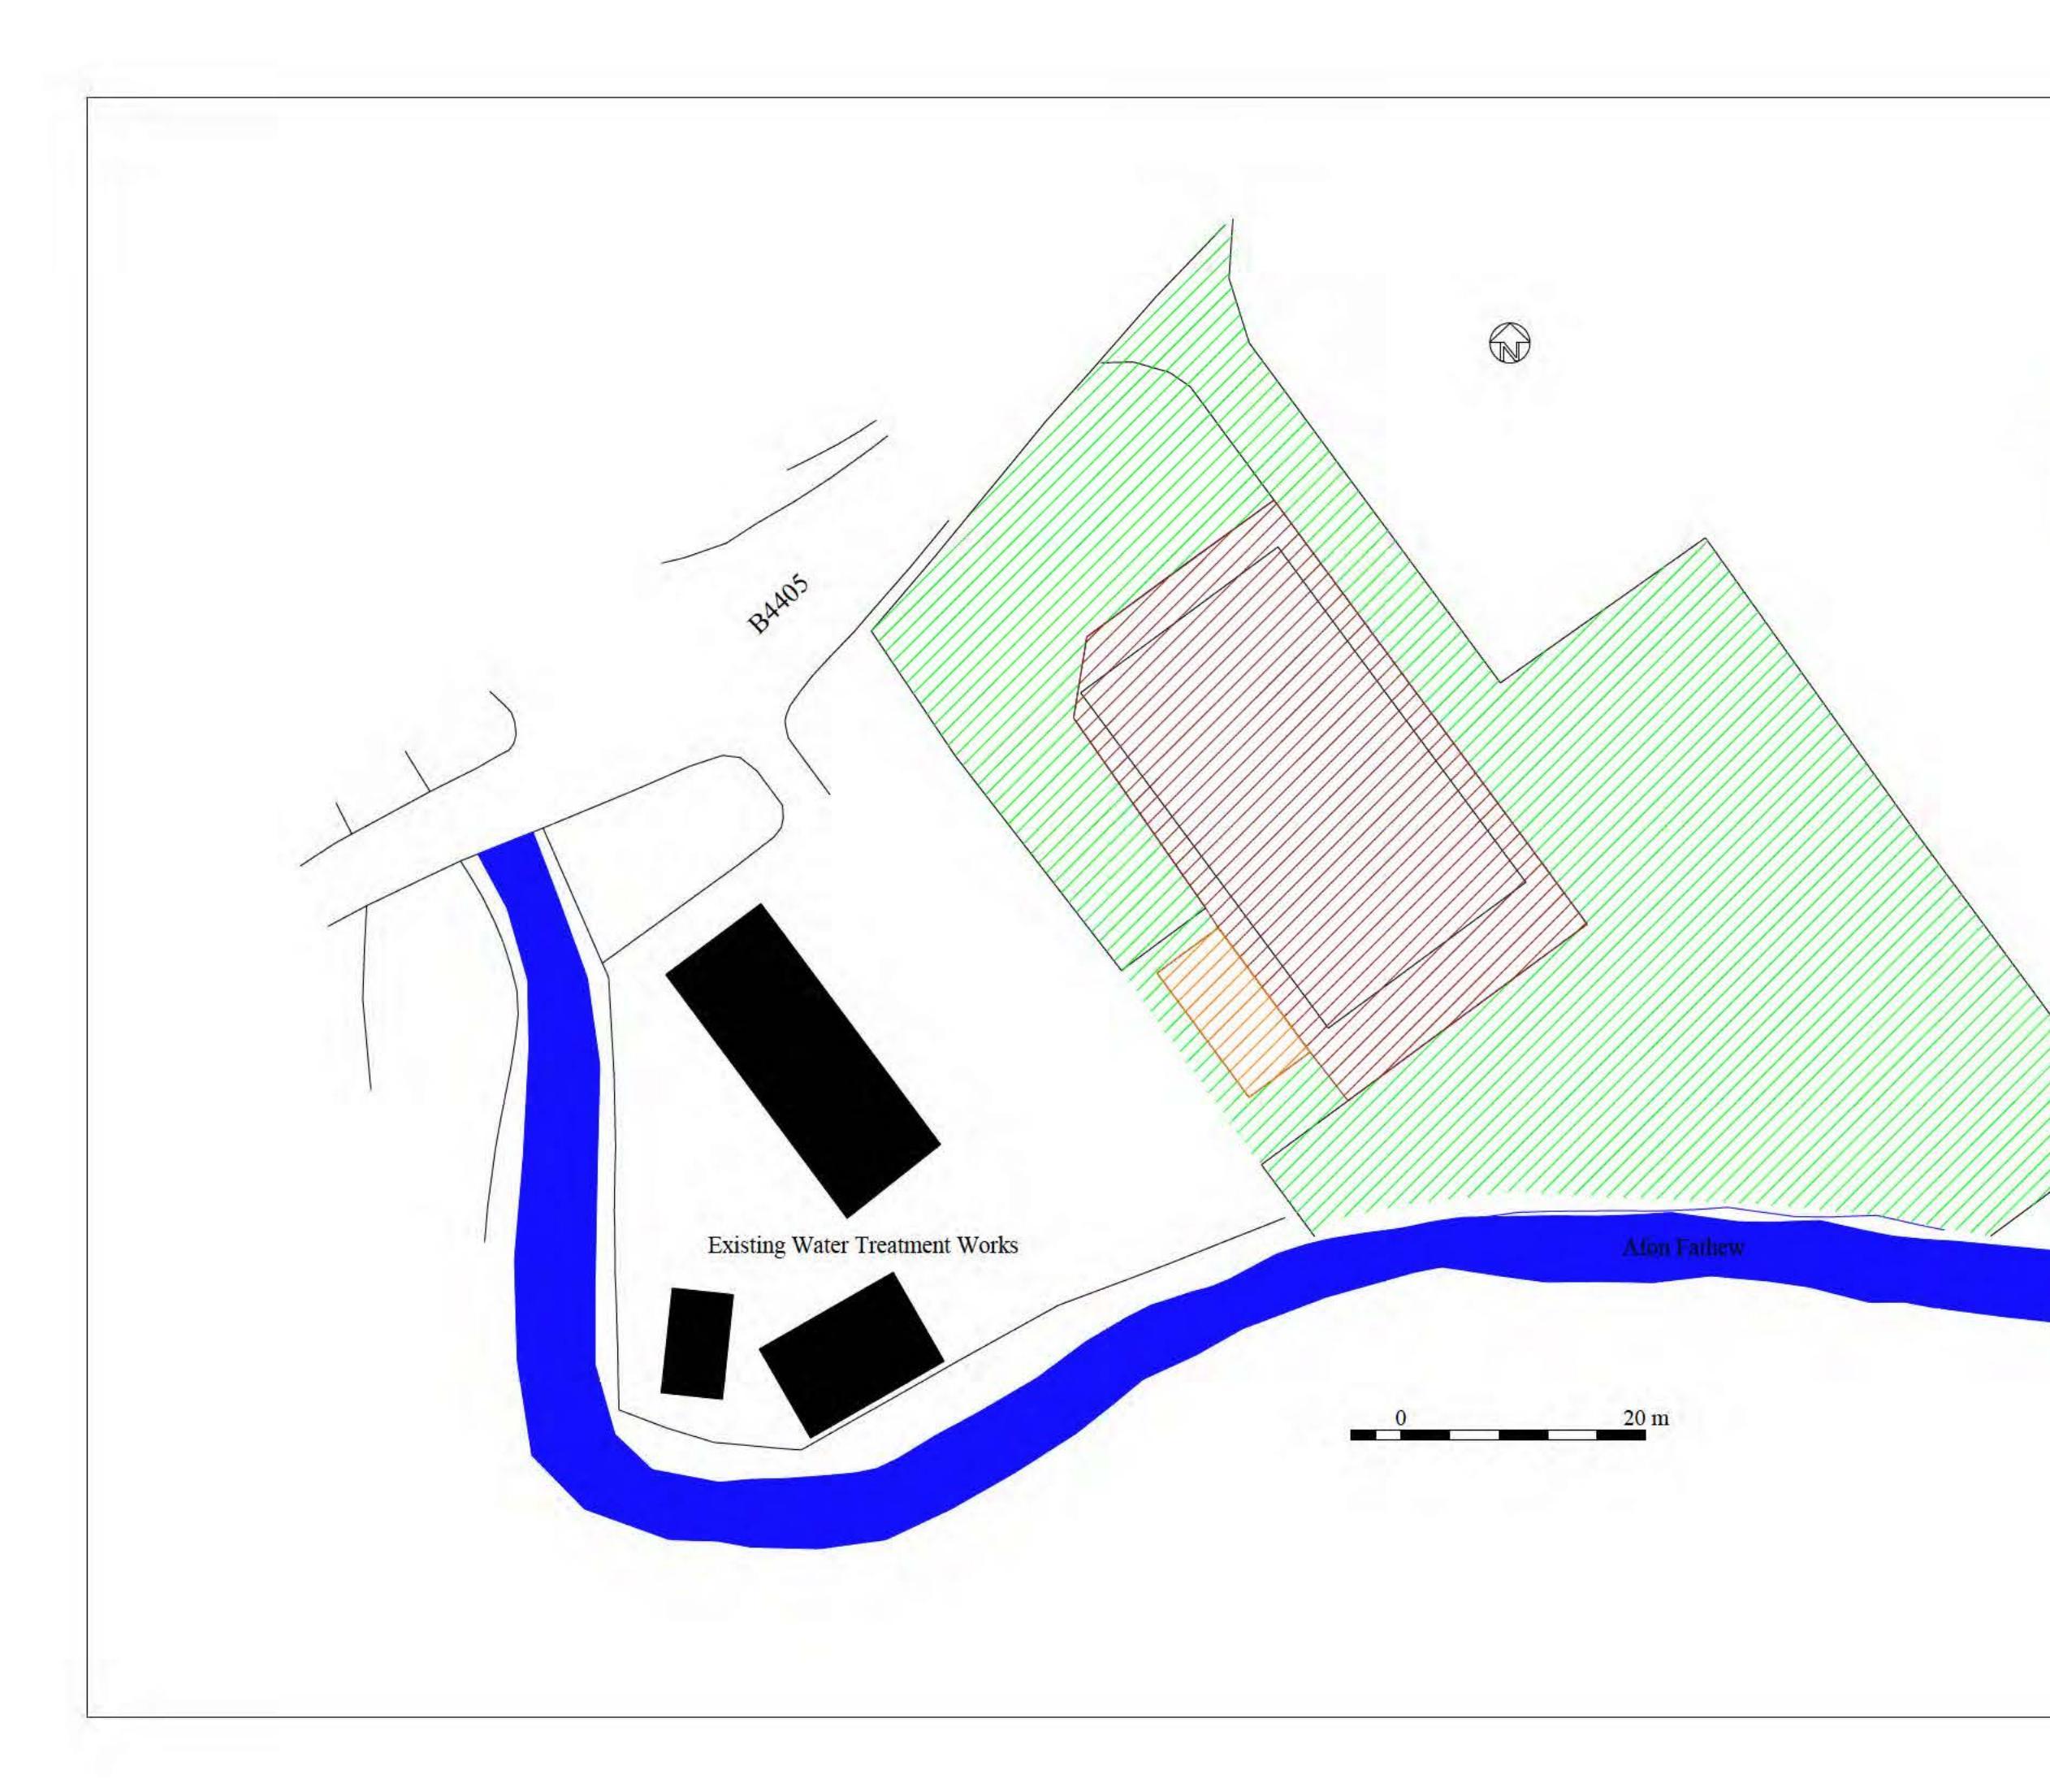
> Figure 2: Summary of the Level of Disturbance Scale 1:500

Area of removal of topsoil Area of removal of alluvium Deep pit

A test pit was dug within an area defined for the location of a deep pit (Figures 2 and 4). This was 1.8 m x 4 m in size and was dug to a depth of approximately 5 m below the base of the topsoil. The area of the deep pit was later piled and the contents removed, however the use of piles made the archaeological monitoring of this deep pit impossible.

The level of the sub-soil was further reduced within the area of the building. Approximately 450-550 mm of alluvium was removed revealing the underlying river gravels in places (Figure 2).

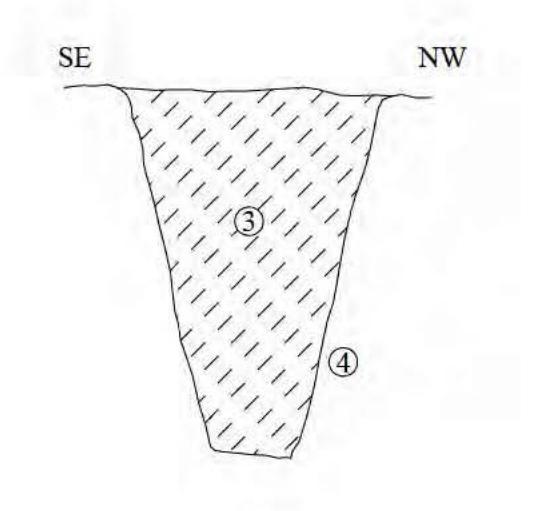
Figure 5: Section Through the Feature Scale 1:10

The alluvium also sealed the single archaeological feature (Context 3) recorded from the site (Figure 4). This was a feature 350 mm in diameter and up to 460 mm deep (Figure 5, Plate 3). The form of the feature suggested that it was the result of a timber being driven into the underlying deposits, i.e. a pile rather than a post hole. It was filled by a clean pale grey clay (Context 4) which may be the result of natural silting below a body of still water. The date of this feature is not known. No finds were associated with this feature; however it was sealed by at least 450 mm of alluvium suggesting that it may be of some antiquity.

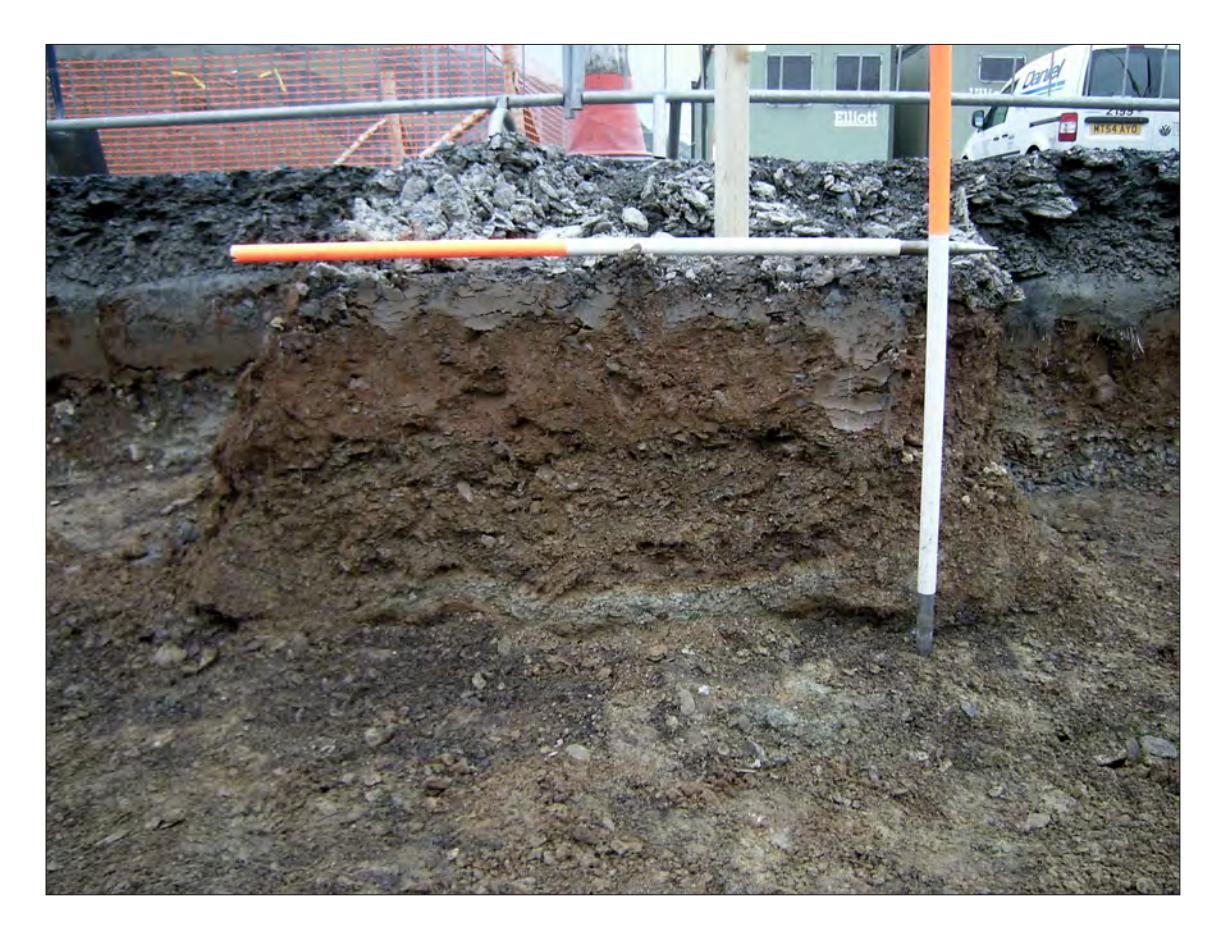
Plate 2: General section through the alluvium

The removal of the topsoil (Context 1) revealed a layer of alluvium (Context 2) covering the whole of the development site. This proved to be between 450 and 550 mm thick, sealing the underlying fluvial gravels (Context 5). The alluvium contained very few stones and was presumably the result of the flooding of the river valley in times of flood (Plate 2). No artefacts were recovered from the alluvium.
