Evaluation Commissioned by Gwynedd County Council

> Ysgol Arbennig Archaeological Evaluation

January 2015 EAS Client Report 2015/01

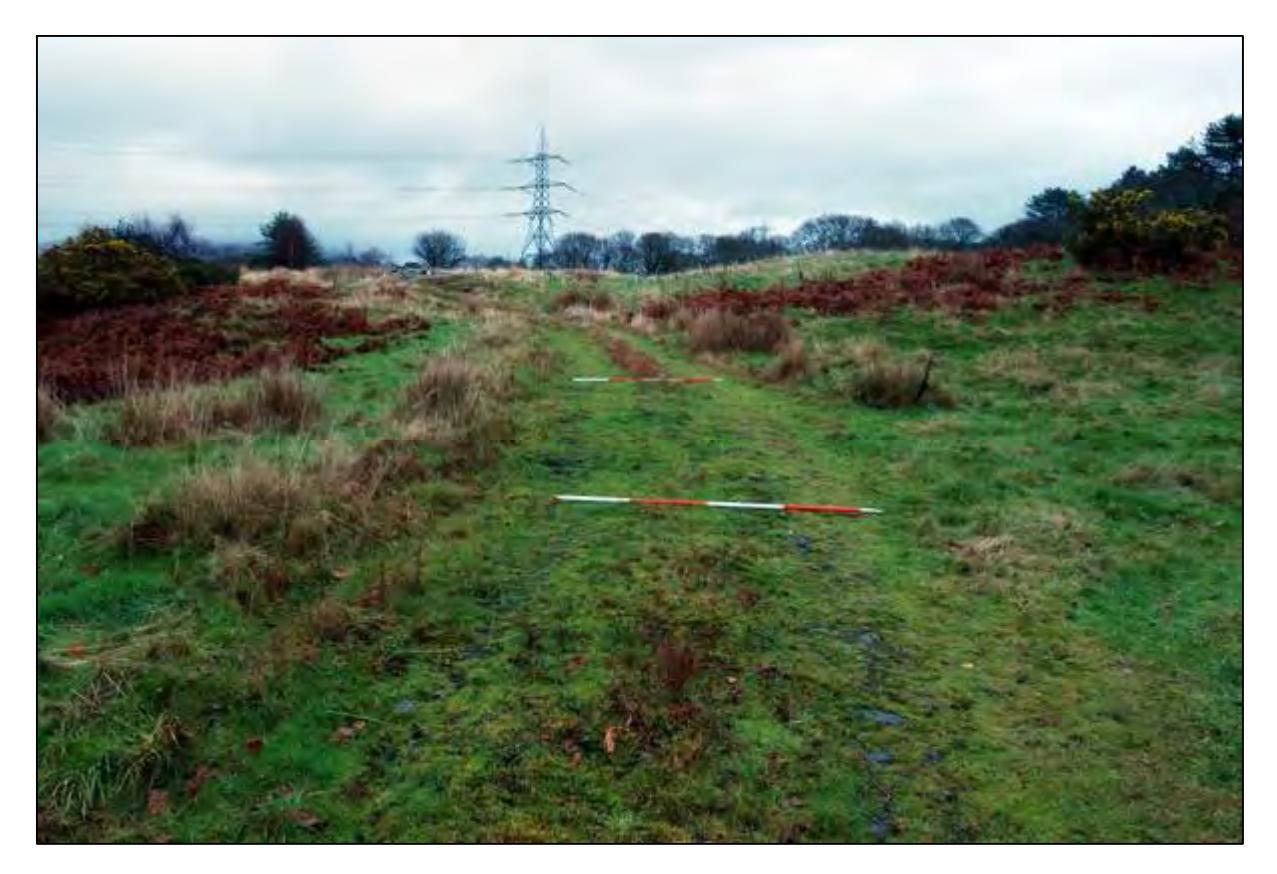
Plate 1: Track (Feature 1) looking NE

The track into the western side of the development area (Feature 1, Wilson Parry and Evans 2014, 16). This enters the development area through a rusting metal gate, heading in a roughly north eastern direction (Plate 1). It runs close to the northern side of the stone spread (Feature 6) before petering out. There is some evidence that there was a short spur which lead directly to Feature 6. The track has a hard surface, partly though use and partly with dumps of stone. Generally, the track is level with the surrounding landscape, however, near to Feature 6 the southern side of the track has been terraced into the hillslope leaving a step, approximately 0.20 m high (Plate 2). The track is approximately 3.00 m wide. The course of this track suggest that it is related to the spread of building debris (Feature 6) which is a dominant feature of this part of the site. Wilson Parry and Evans (2014, 15) suggest it may relate to the track seen on the First Edition Ordnance Survey map, however, if this is the same track leading to the building on the 1917 Ordnance Survey map (Figures 3 and 4) then this track dates to after 1917.

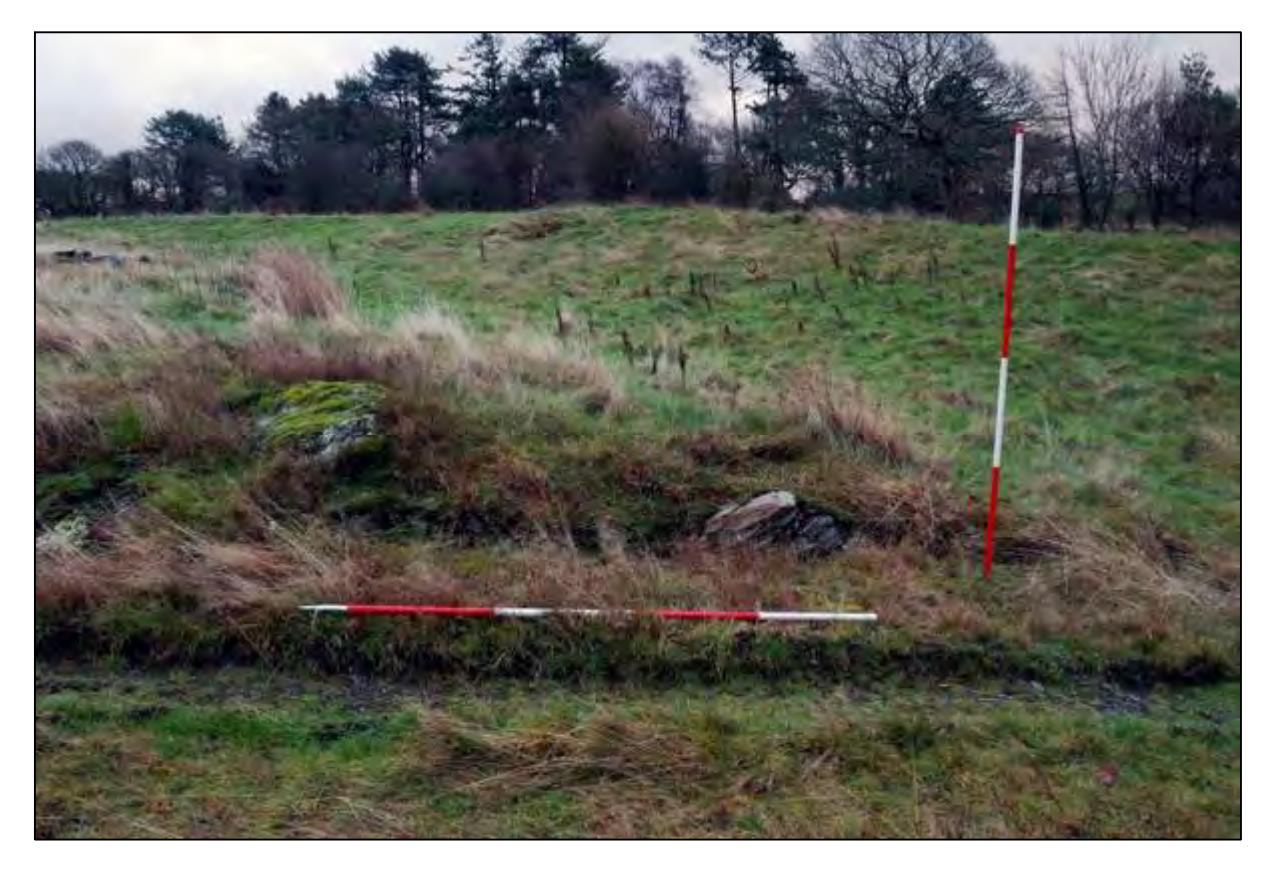
Plate 2: Edge of track (Feature 1) near to Feature 6

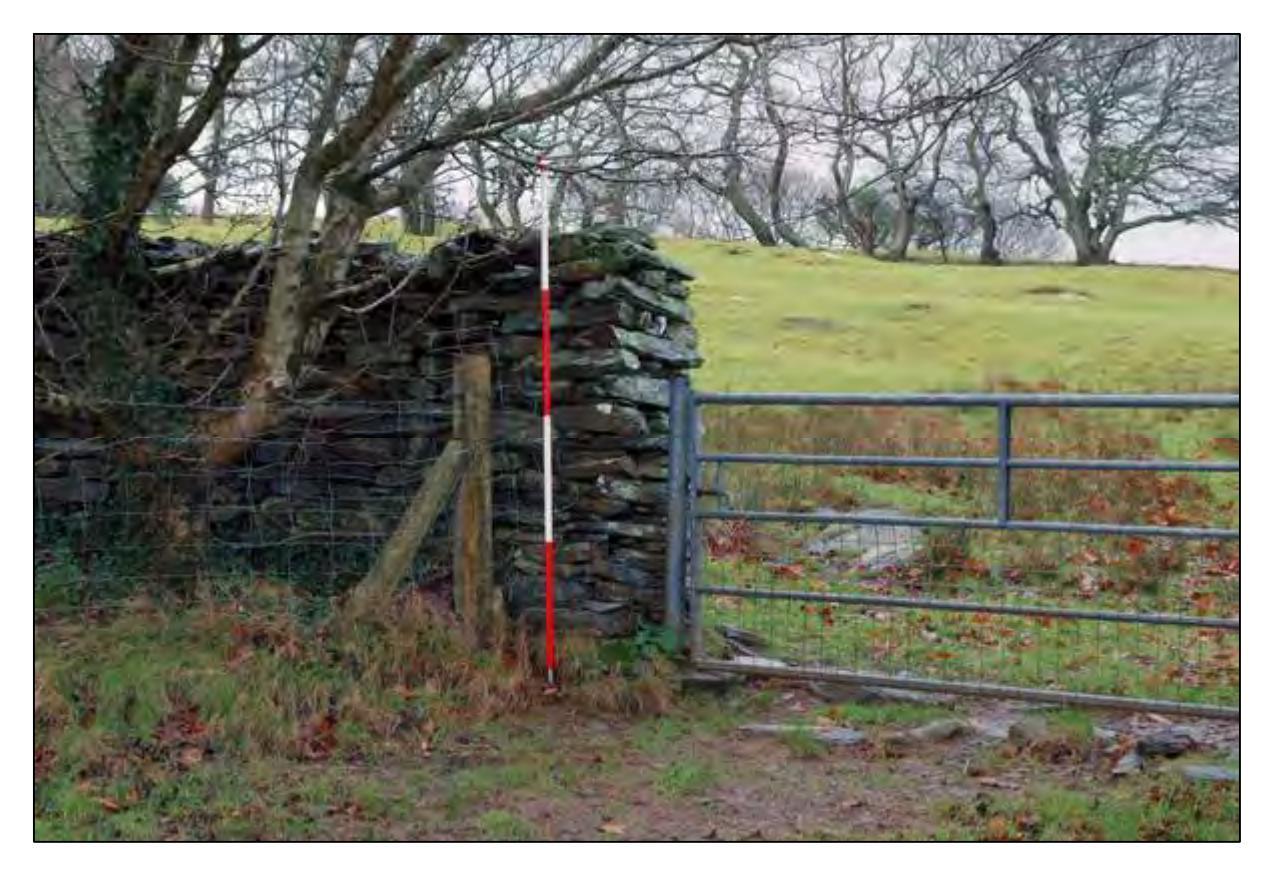
Plate 3: Eastern side of the gateway (Feature 3) and character of the stone wall (Feature 4)

In the north western corner of the development area there is a modern gateway (Feature 3, Wilson Parry and Evans 2014, 16) through the dry stone wall (Feature 4, *ibid* 16) which defines the northern and eastern boundary of the fields within the development area. The gateway (Plates 3 and 4) has a modern galvanised gate of a standard size with galvanised posts suggesting that even if there had been an opening here before it has been re-defined to allow the passing of modern farm machinery. The wall is up to 1.75 m high and 0.70 m wide and is constructed of blocks of slatev rock which are assumed to have been quarried from a series of informal quarries within the development area. The approach to the gate is at the bottom of a marked slope which defines the western edge of one of the development areas (Plate 5). The correlation

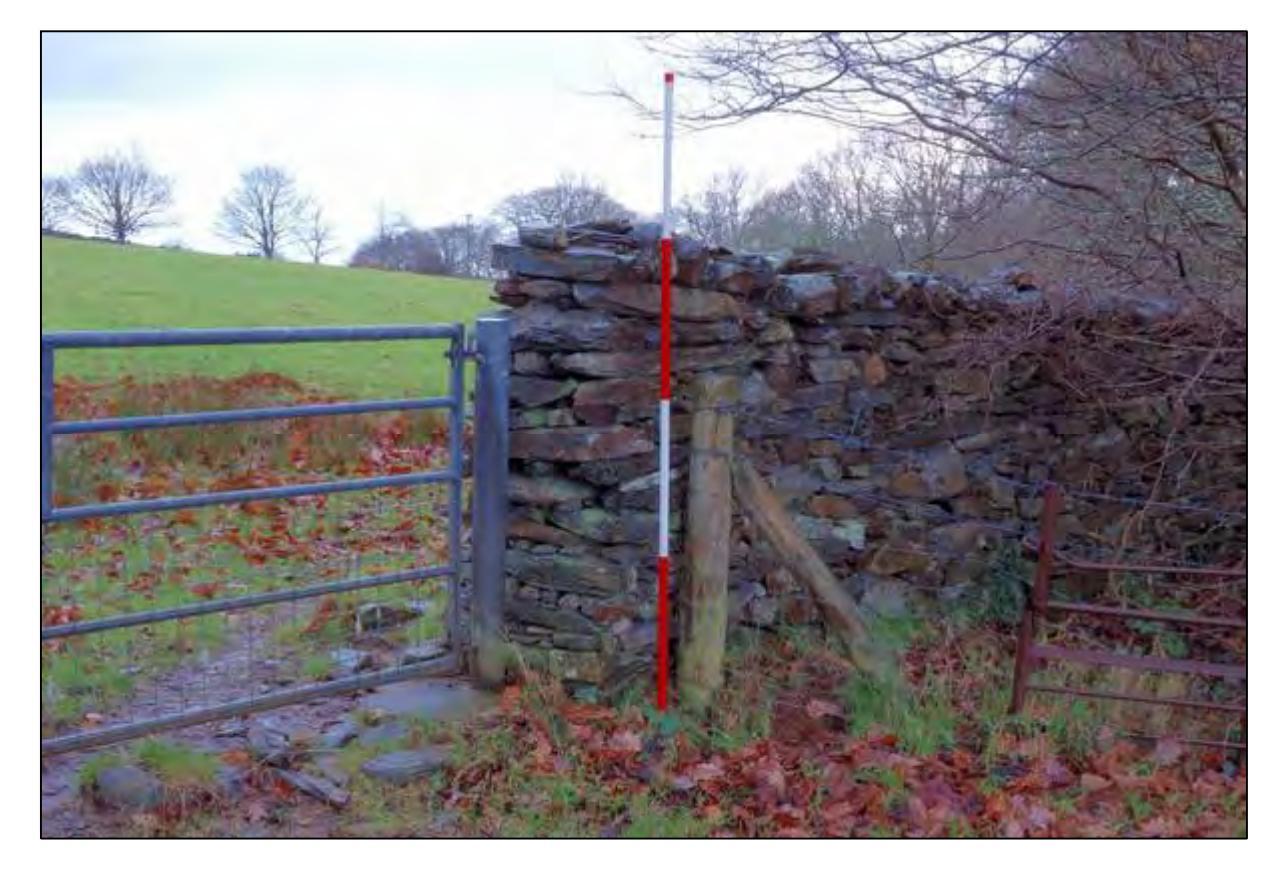
Plate 4: Western side of the gateway (Feature 3) and character of the stone wall (Feature 4)

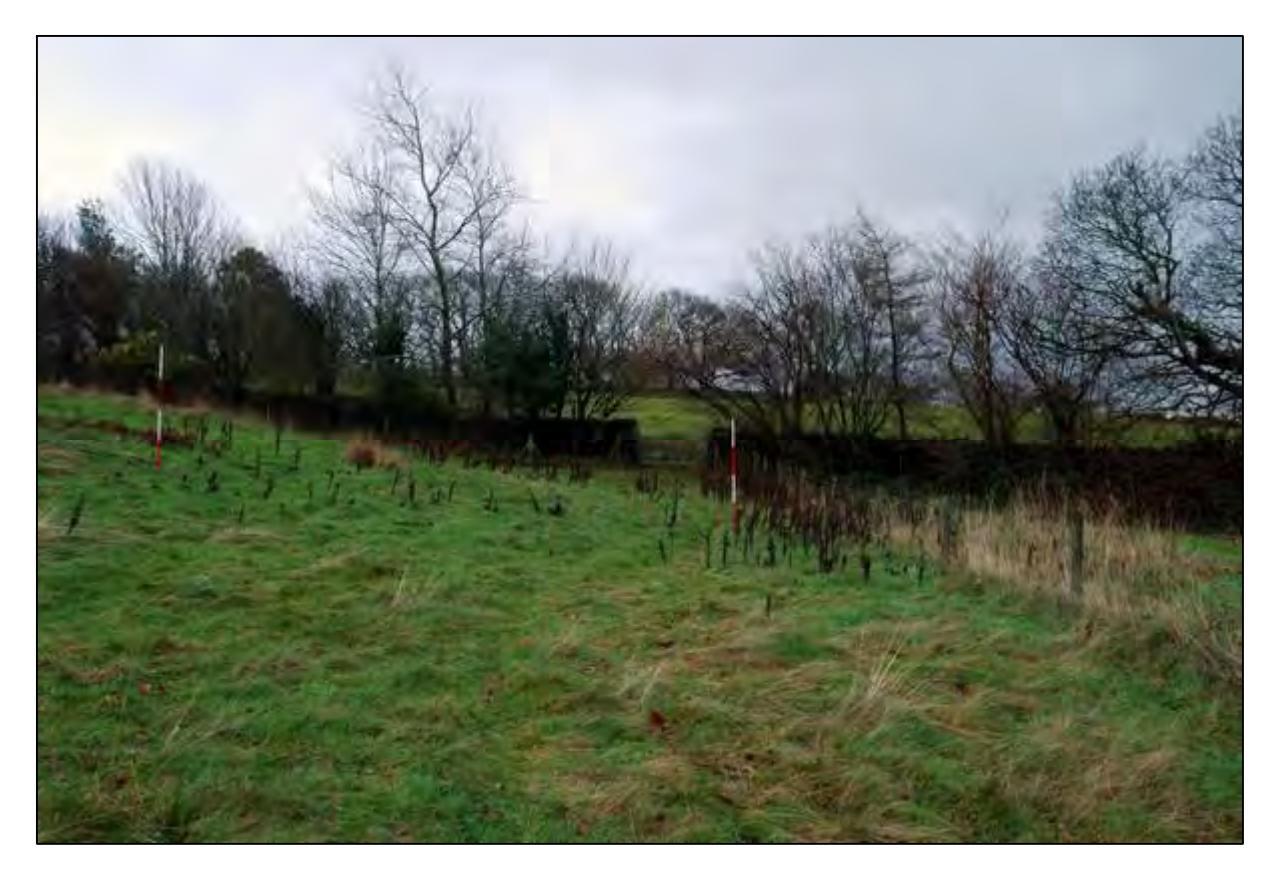
Plate 5: Location of the gateway (Feature 3)

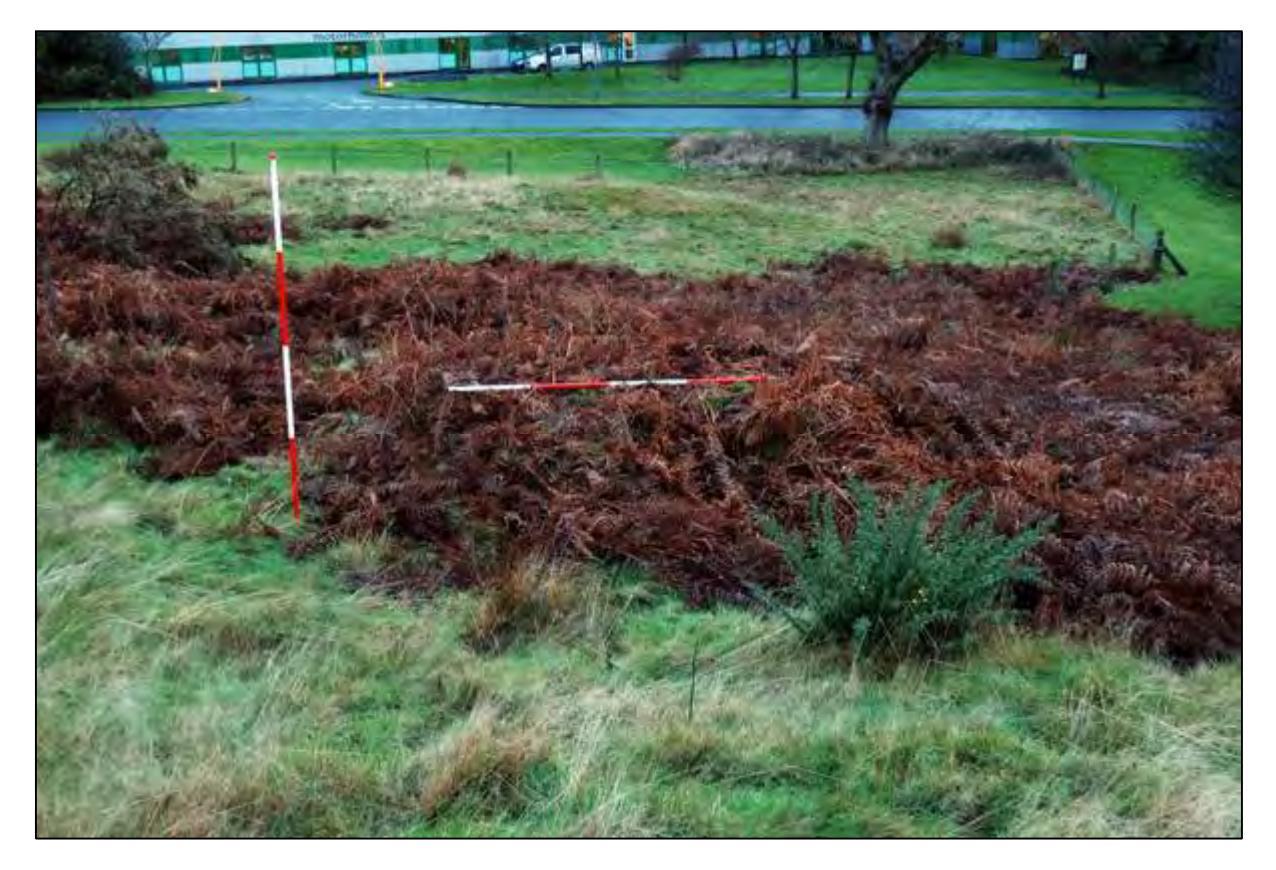
Plate 6: Mound (Feature 9) before excavation

At SH 60188 38388 there is a small, oval mound, 3.62 m long, 2.47 m wide and up to 0.84 m high (Plate 6) which was recorded as Feature 9 by the Gwynedd Archaeological Trust (*ibid* 19) Few further features could be determined prior to excavation, however Trench 3 (see below) was designed to determine the character of this mound. The mound occupies a slightly sloping site with the general slope being to the north and west.

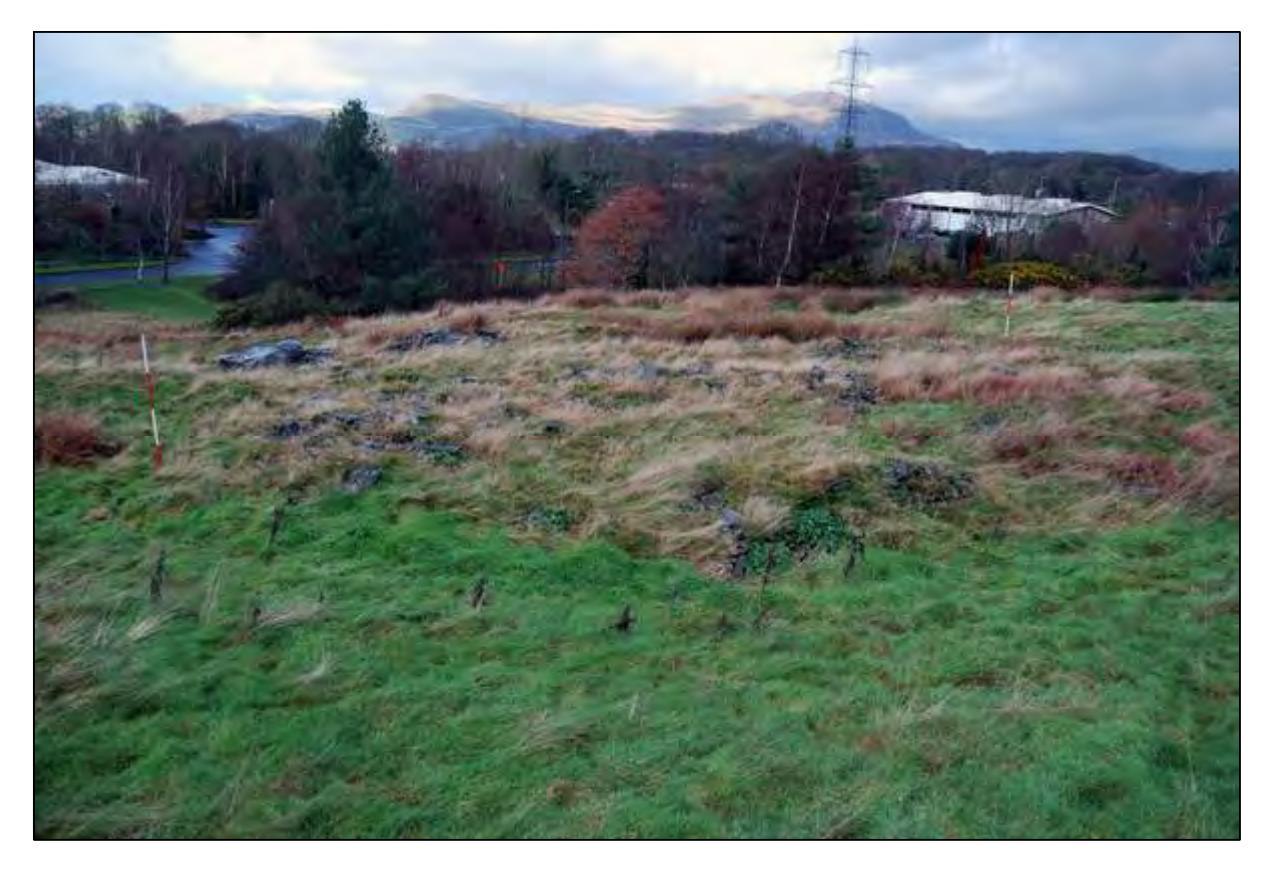
Plate 7: Spread of building debris (Feature 6), looking NW

Adjacent to the eastern end of the track (Feature 1) is a large spread of building debris (Feature 6, *ibid* 17) covering an area of 17.77 x 16.02 m (Plate 7). It is formed of stone blocks which are typically 0.40 x 0.25 x 0.15 m in size, however there are also a few very large, squared boulders up to 1.10 x 1.10 x 0.50 m in size (Plate 8). Whilst the majority of the stones were of a shaley lithology, typical of the immediate area, the large blocks were of a fine grained granite. This is typical of materials guarried at the Minffordd Quarry approximately 1 km to the North West. The spread of building debris also included concrete blocks, fragments of wooden telegraph poles and concrete paving blocks. The debris was deposited in a series of linear dumps which lead to the apparent edges shown in purple on Figure 2. These were originally thought to be possible wall lines, however on further investigation they proved to be a product of the method of deposition.

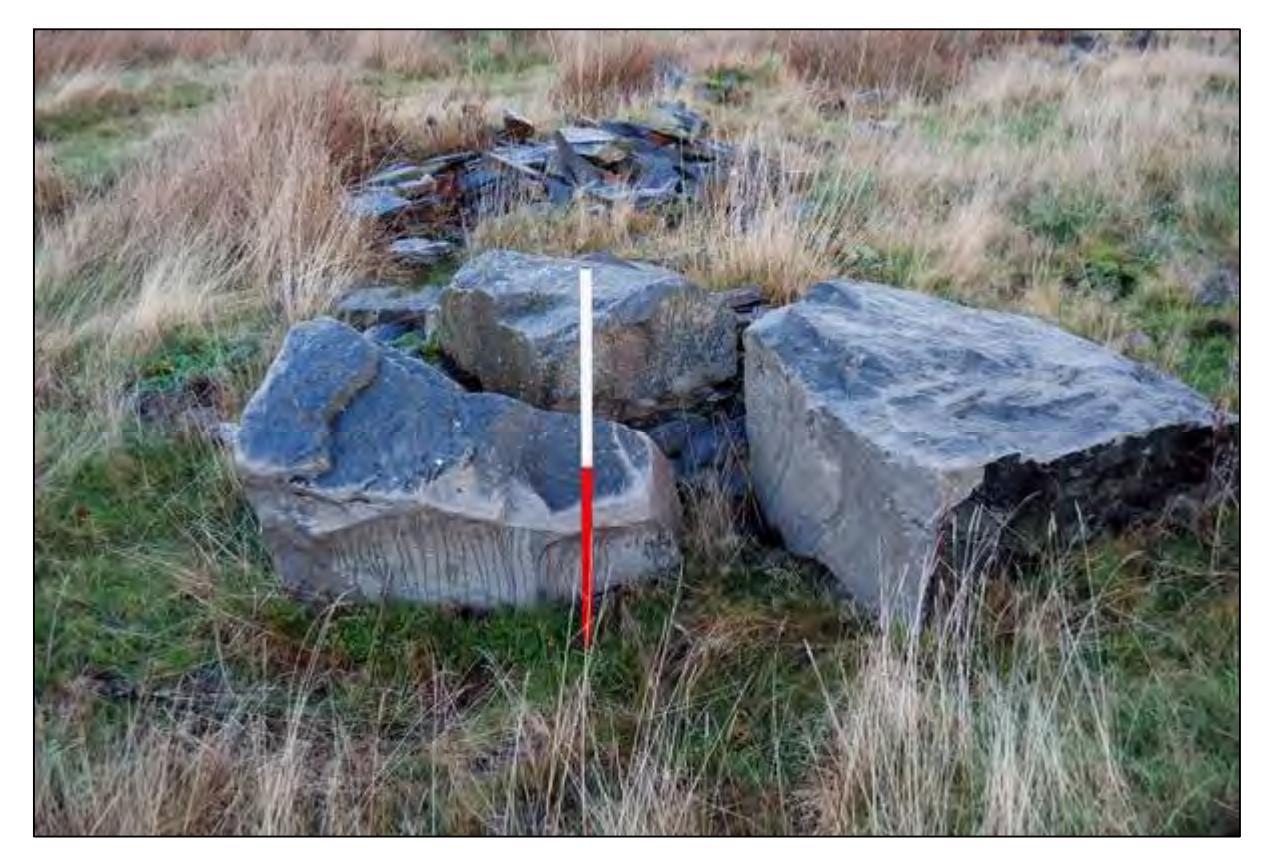
Plate 8: Largest blocks within the spread of building debris

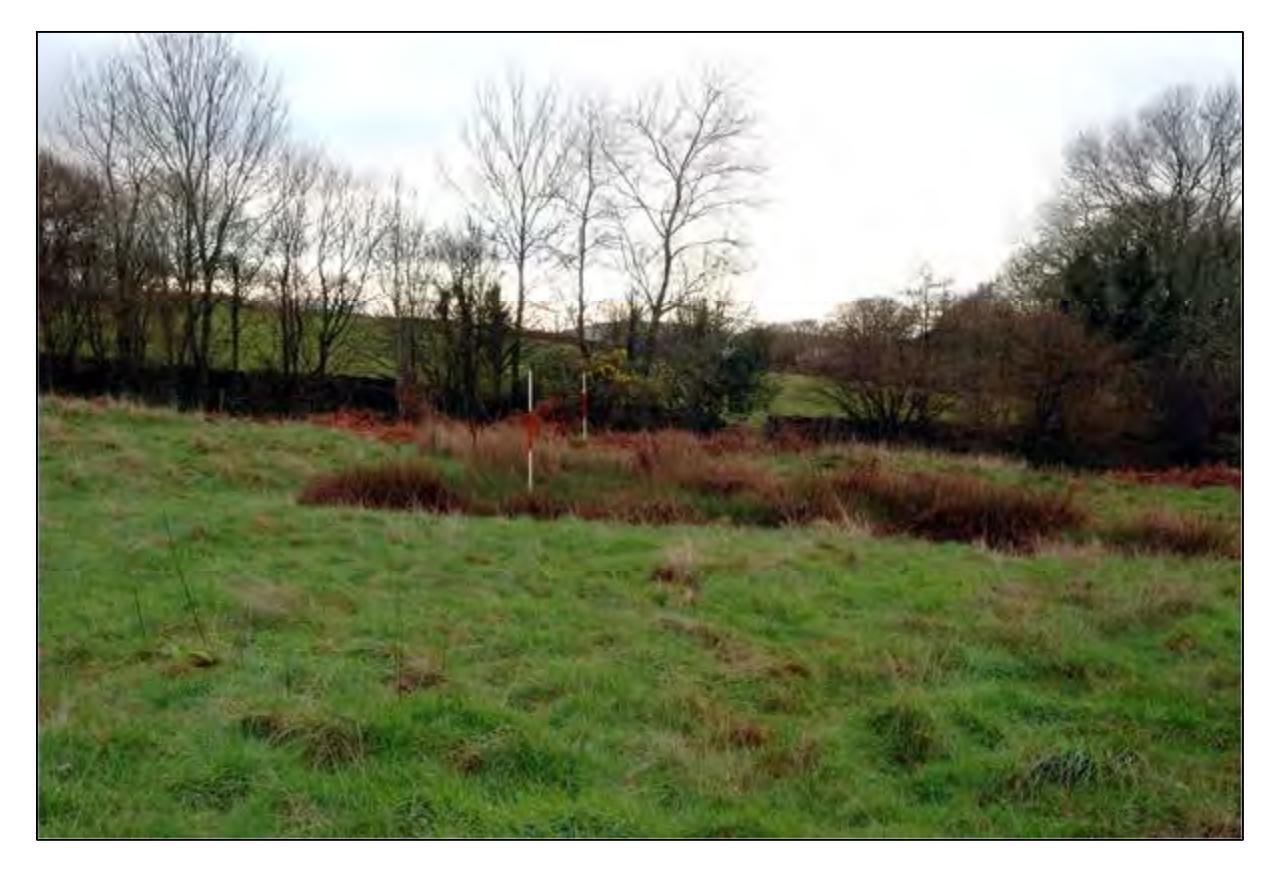
Plate 9: Large hollow slightly to the north of the building (Feature 5) shown on the 1917 Ordnance Survey Map

Feature 5 (*ibid* 17) was based on a building shown on the First Edition Ordnance Survey map. No obvious signs of a building were recorded, however the area includes a distinct break of slope, which corresponds to an old field boundary shown on the 1917 Ordnance Survey map (Figure 4), and a hollow in the surface above the break of slope. This hollow is roughly rectangular in shape with an extension leading to the south and east. The main area is 16.20 m x 15.15 m in size and up to 0.40 m deep (Plate 9), whilst the extension is approximately 6.0 m wide and 9.7 m long. Neither of these hollows reflects the footprint of the building shown on the 1917 Ordnance Survey map (Figure 4) which crosses the junction between the two hollows.

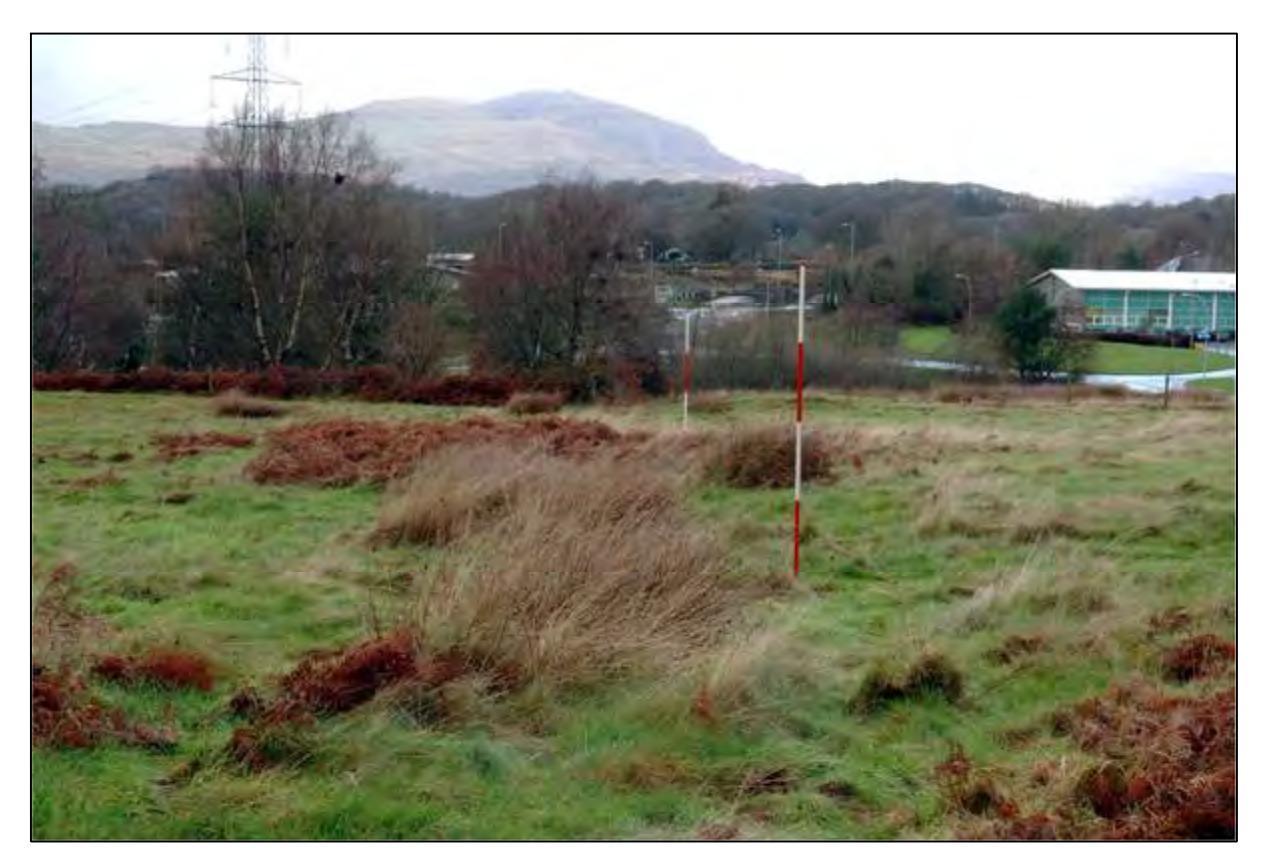
Plate 10: Linear feature (Feature 11)

A linear hollow (Feature 11, *ibid* 18) runs across the development area and was interpreted as the remains of a field boundary by the Gwynedd Archaeological Trust. The hollow is 4.35 m wide and approximately 0.12 m deep (Plate 10) possibly suggesting that it may have been a track running alongside the field boundary shown on the 1917 Ordnance Survey Map (Figure 4).

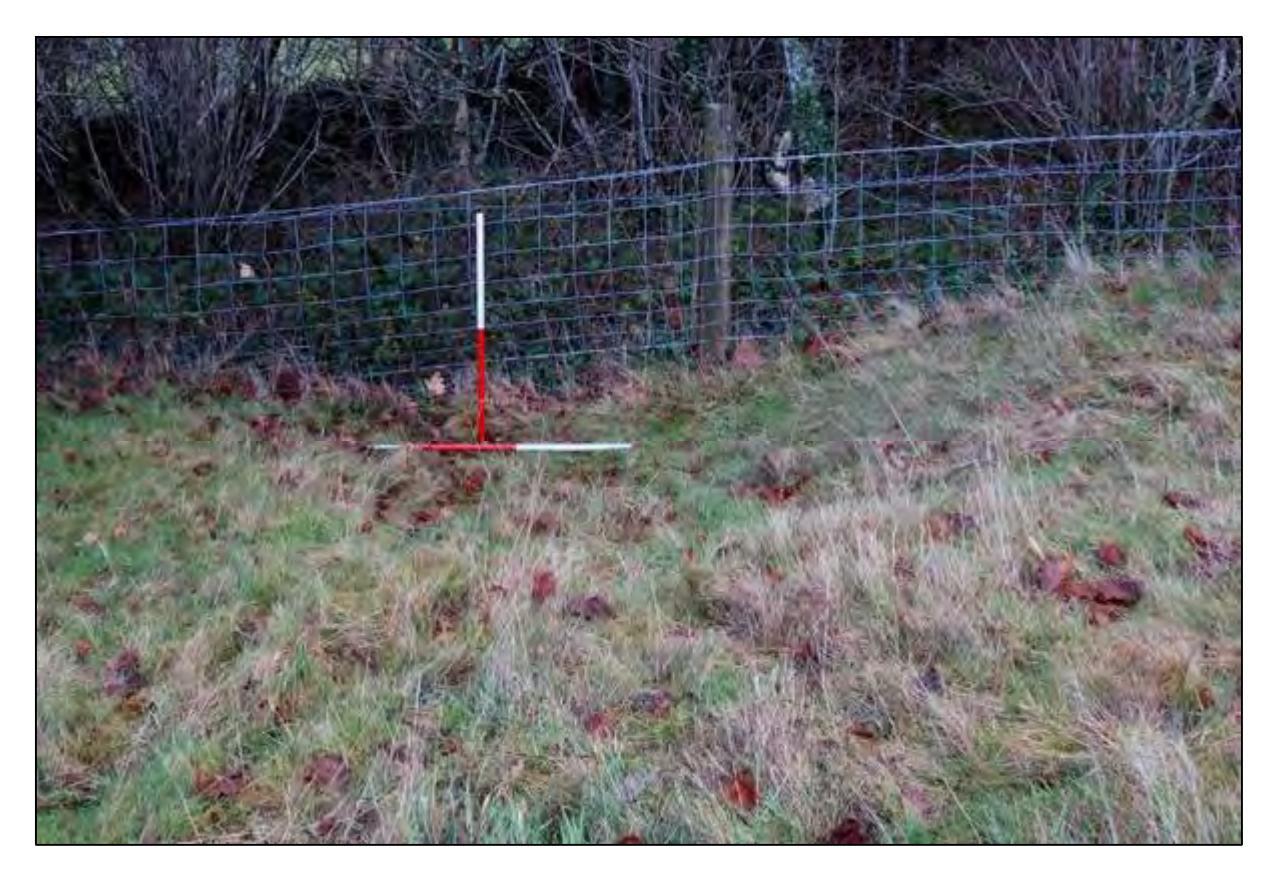
Plate 11: Southern hollow (Feature 8)

In the north eastern corner of the development area the Gwynedd Archaeological Trust located two, small, hollows (Feature 8, *ibid* 17-18) which they interpreted as quarry pits. The southern hollow (Plate 11) is at least 4.00m in diameter, although it extends beyond the limits of the development, and was 0.35 m deep. The northern hollow (Plate 12) also extends beyond the development area. It was at least 6 m in diameter and was 0.45 m deep. These undoubtedly relate to small scale quarrying in this corner of the field, however they probably also relate to the much larger area of probable quarrying (Plate 13) only 40 m to the south. This covers an area of at least 37.0 x 24.2 m and reaches a depth of 0.60 m at its southern end, although the depth tends to reduce to approximately 0.30m at the northern end of the feature. The somewhat irregular shape of the feature probably suggests this a series of intercutting informal quarries.

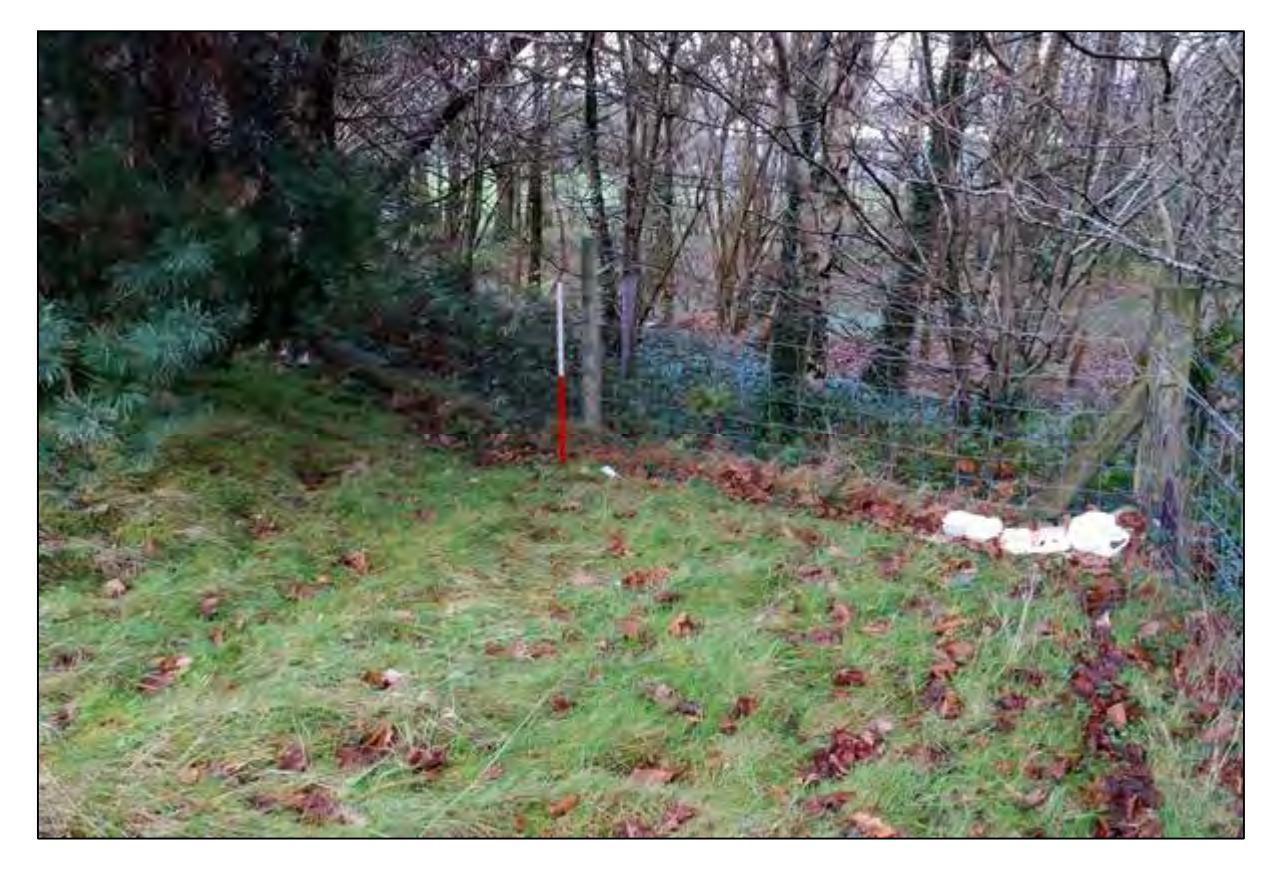
Plate 12: Northern hollow (Feature 8)

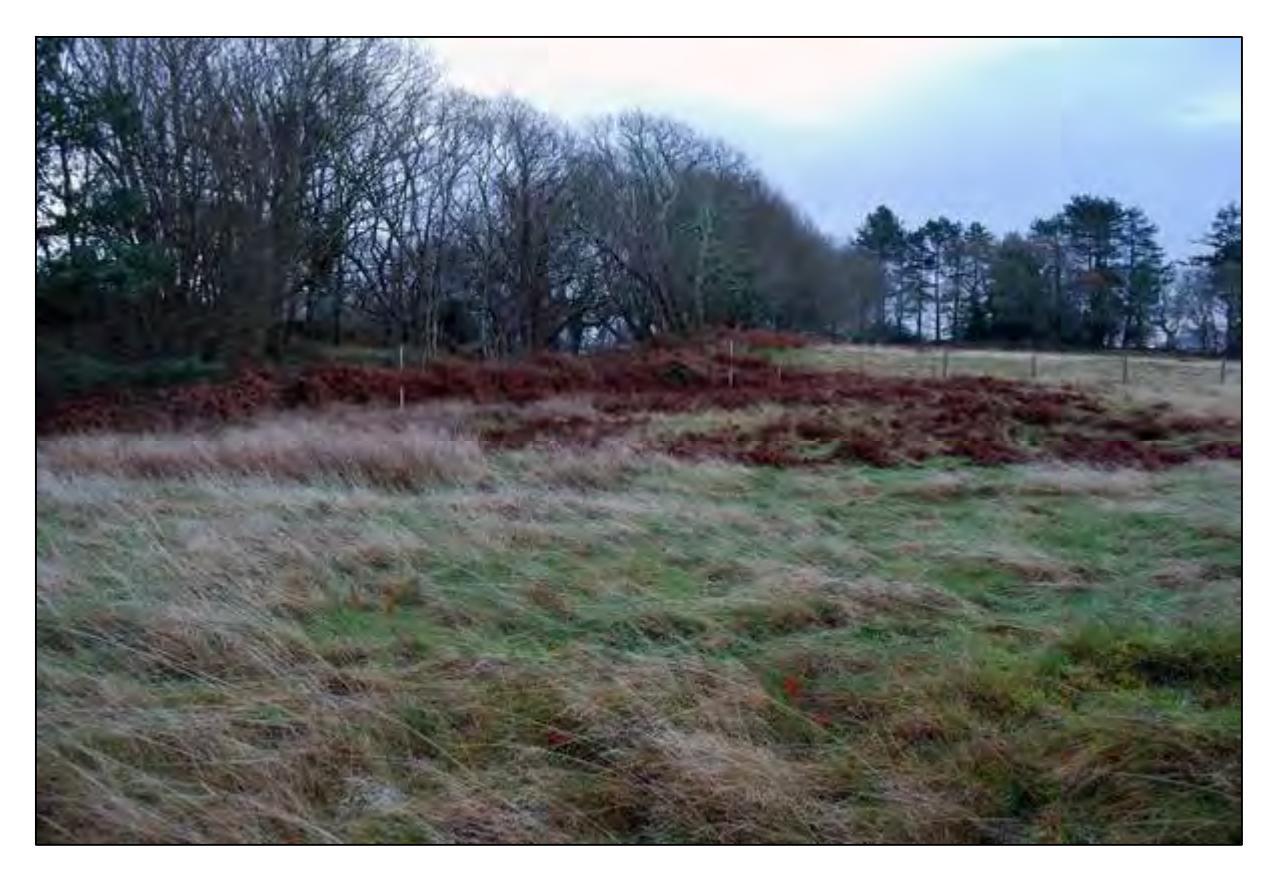
Plate 13: Large area of informal quarrying

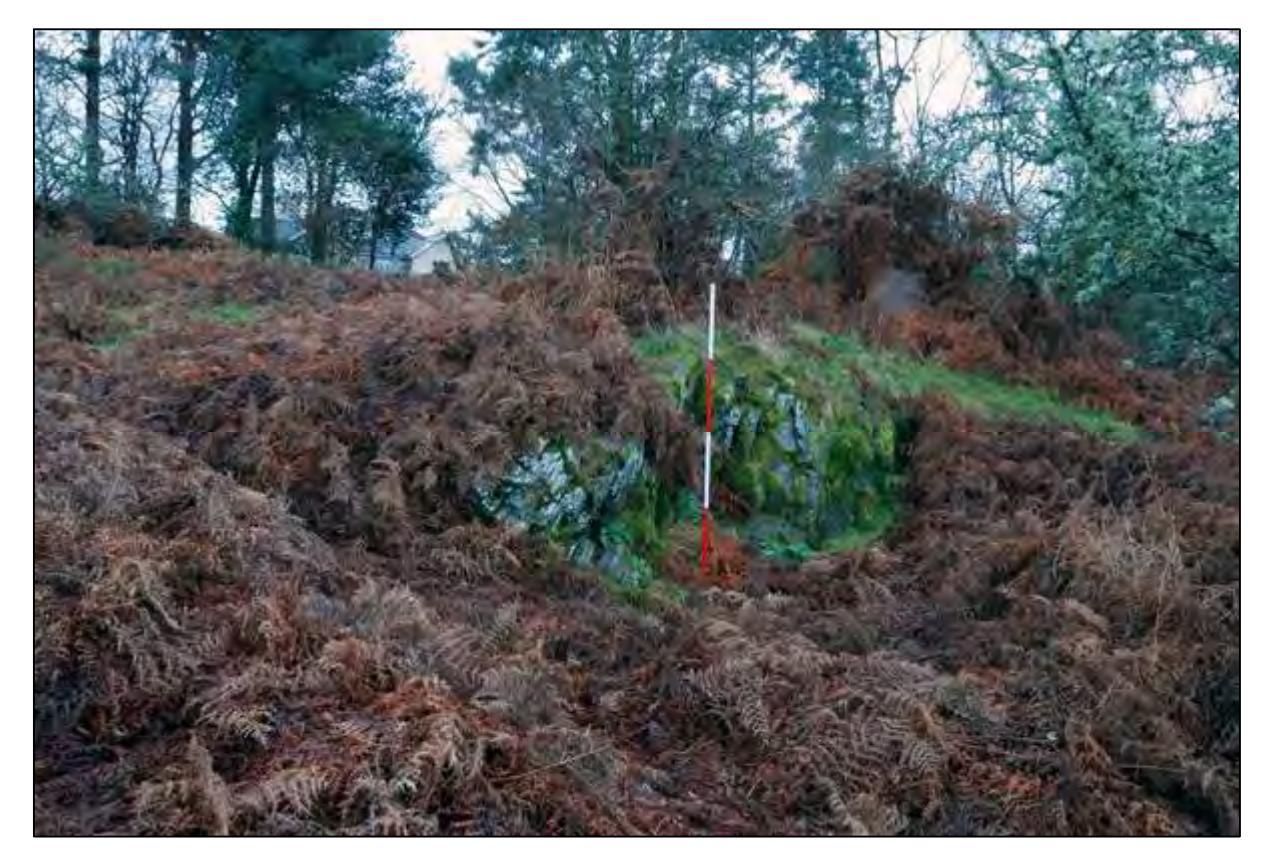
Plate 14: Quarry

Other signs of small scale quarrying were also noted. At SH 60283 38299 there is a small quarry with an active face approximately 5 m long and up to 1.5 m high (Plate 14). This feature also has two, crescentic dumps to the north (Plate 15) which are approximately 5 m long and up to 0.65 m high, probably representing both the clearing of the site prior to quarrying and the disposal of some of the waste product. It is possible that the probable track (Feature 11) relates to this quarry and was used to transport the products away. To the east of this obvious quarry a marked step of rock exposures was noted at SH 60244 38295 (Plate 16). This was approximately 0.30 m high and it appears to relate to a south facing break of slope leading to the west for a further 13.50 m. These features tend to suggest a level of informal quarrying in this southern sector of the development area.

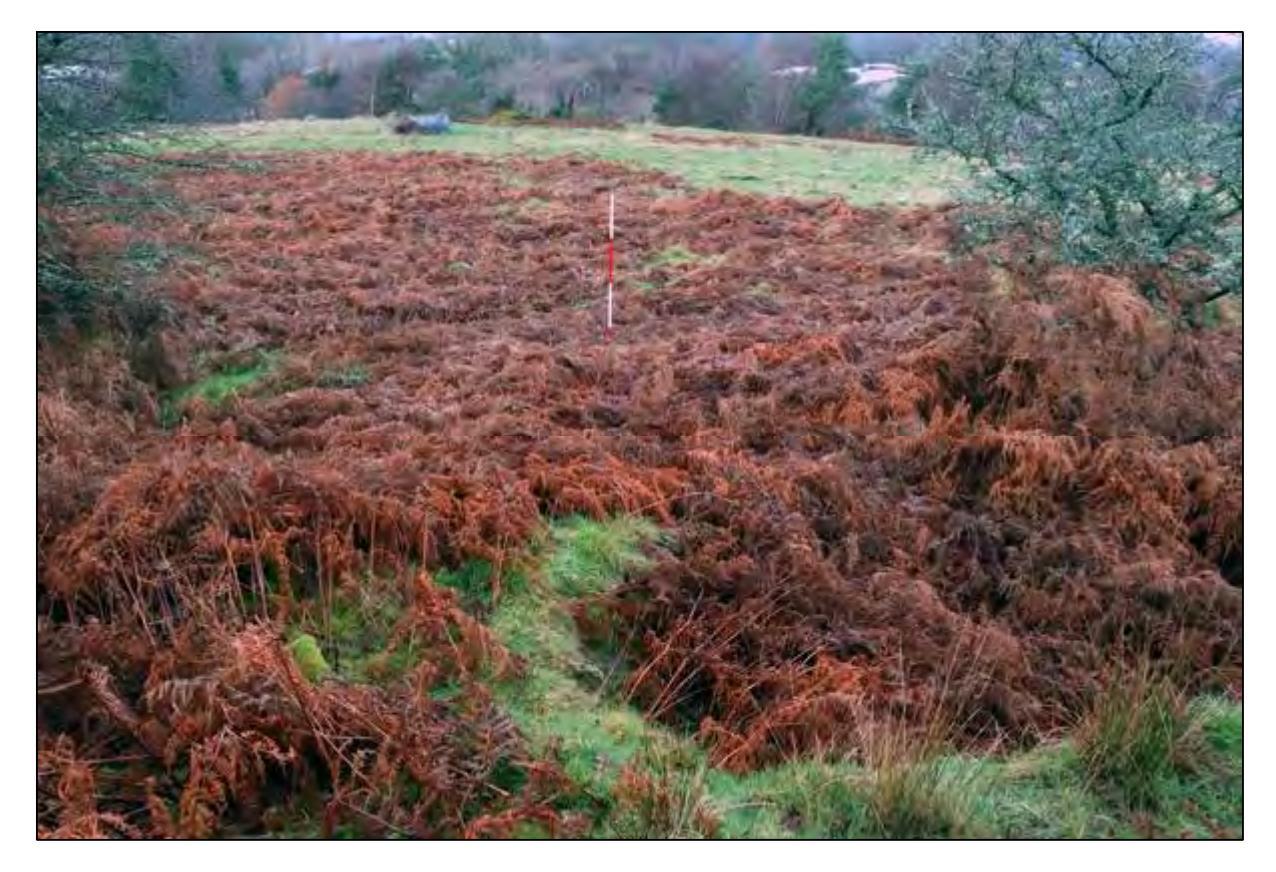
Plate 15: One of the waste dumps to the north of the quarry

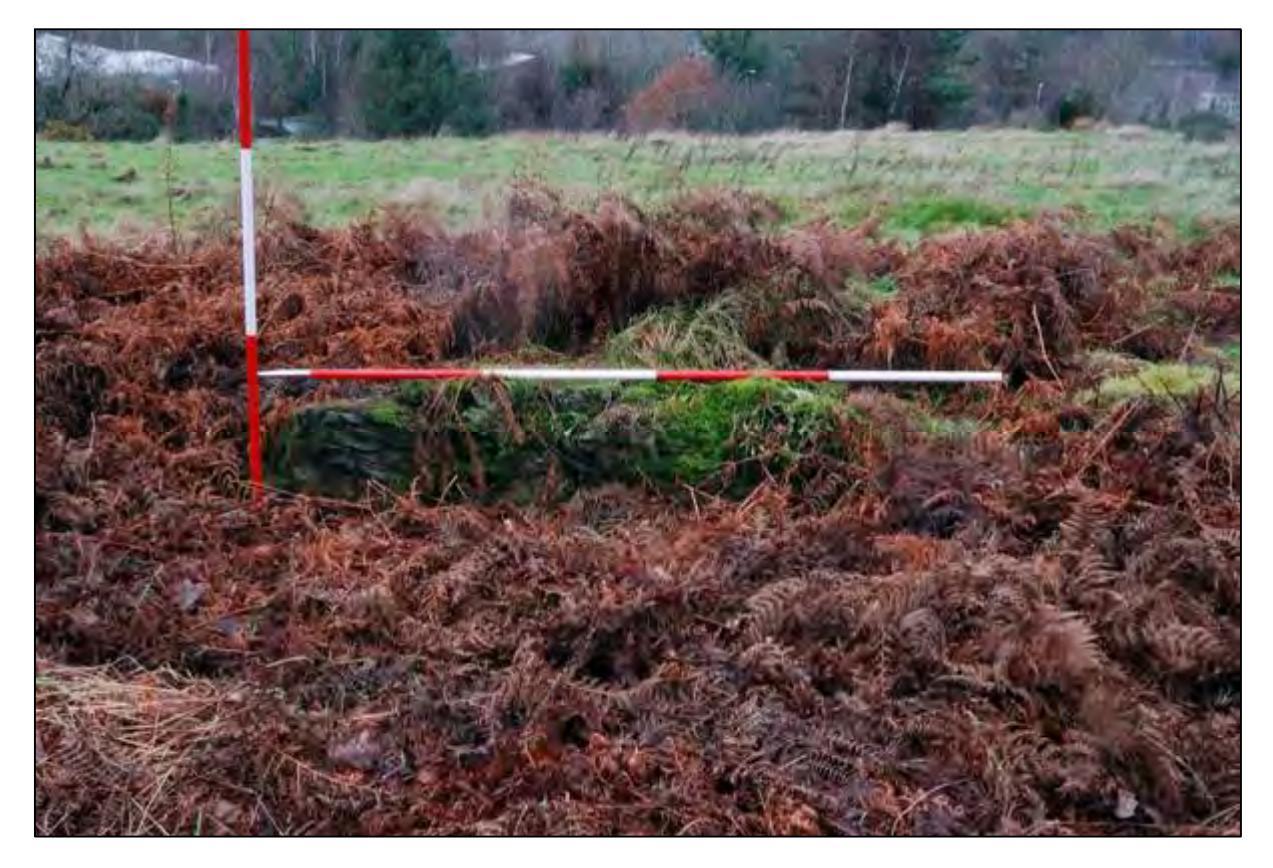
Plate 16: Rock step

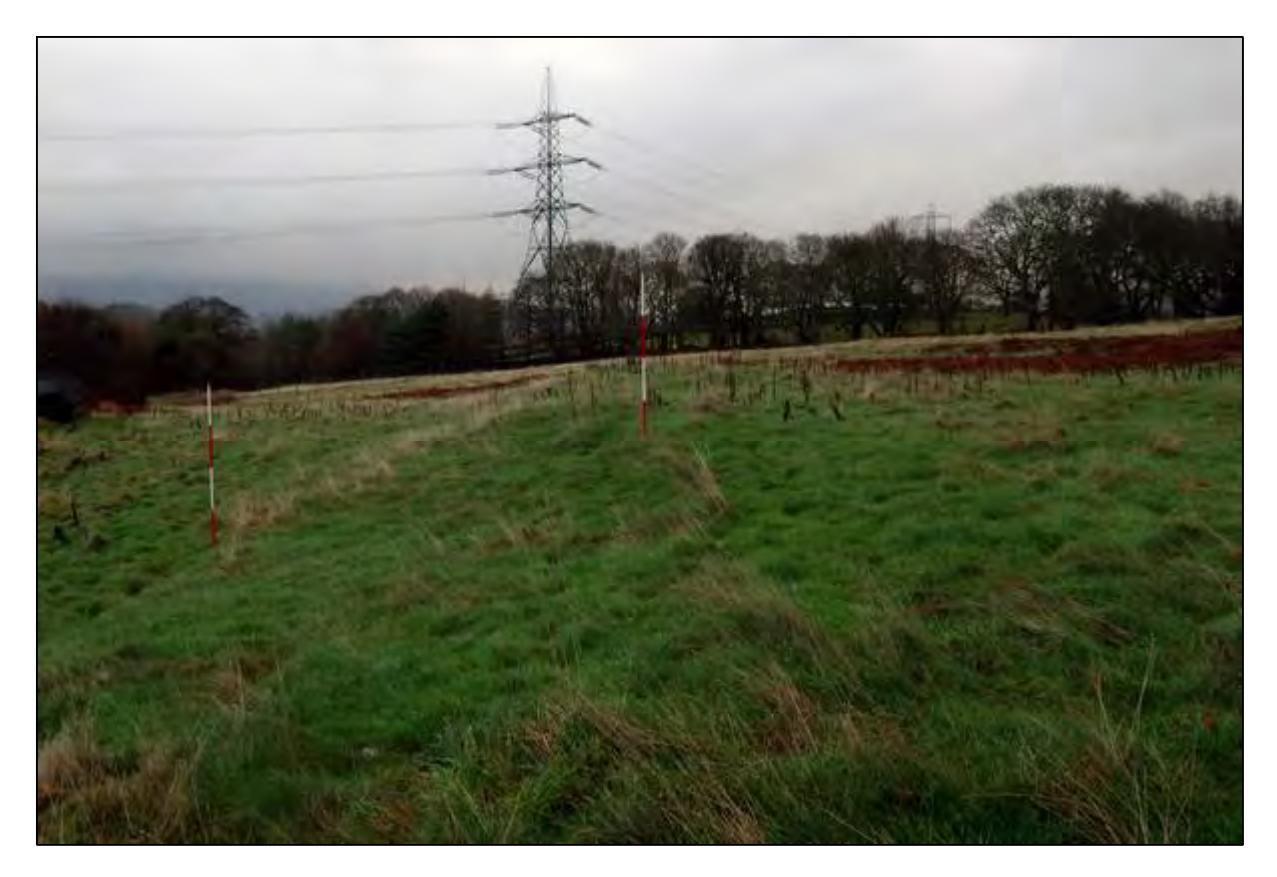
Plate 17: Break of slope between the middle and lower terraces

The dominant feature of the western half of the development area, however, are a series of large terraces running approximately ENE – WSW across the site. The upper terrace is the most slight, being only about 0.20 m high with a relatedly flat area to its south. The middle terrace is by far the most dominant feature being approximately 20.0 m wide and 0.80 m high along its northern edge (Plate 17). This edge runs from near to Feature 11 for approximately 94.0 m before it turns to the south along the line of the old field boundary shown on the 1917 Ordnance Survey map (Figure 4).

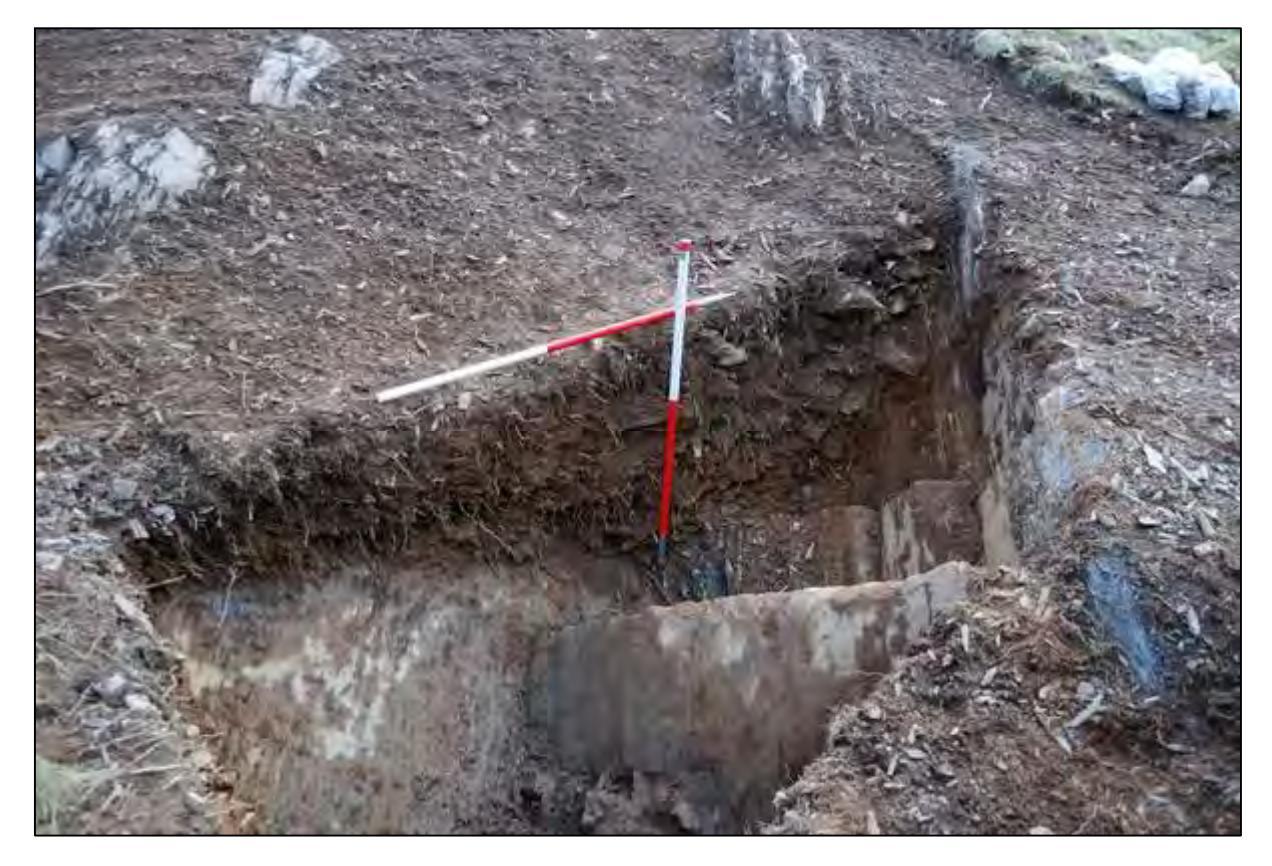
Plate 18: Tr 1, Section across the quarry (Context 16)

Although the original hollow appeared to be a roughly circular feature, approximately 0.35 m deep, the underlying feature clearly has both an irregular plan (Figure 6) and profile (Figure 7, Plate 18) which is defined by the underlying rock formations. It would appear that the quarry was designed to extract blocks of more slatey materials. Along the north-western side of the quarry these blocks would appear to
