Evaluation Commissioned by Gwynedd County Council

> Ysgol Arbennig Archaeological Evaluation

January 2015 EAS Client Report 2015/01

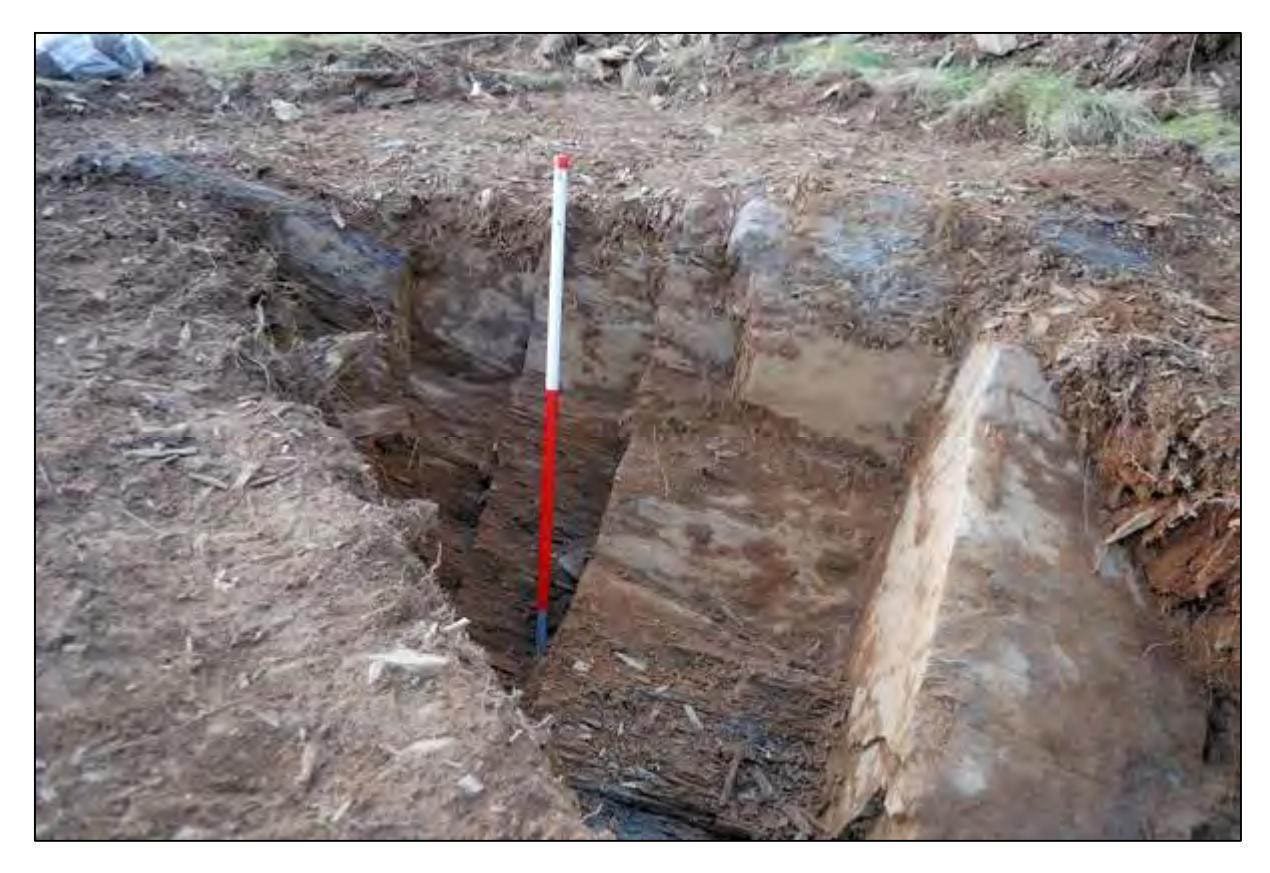
Plate 19: Detail of the extraction technique used in the quarry (Context 16)

have been approximately 300 mm wide (Plate 19).

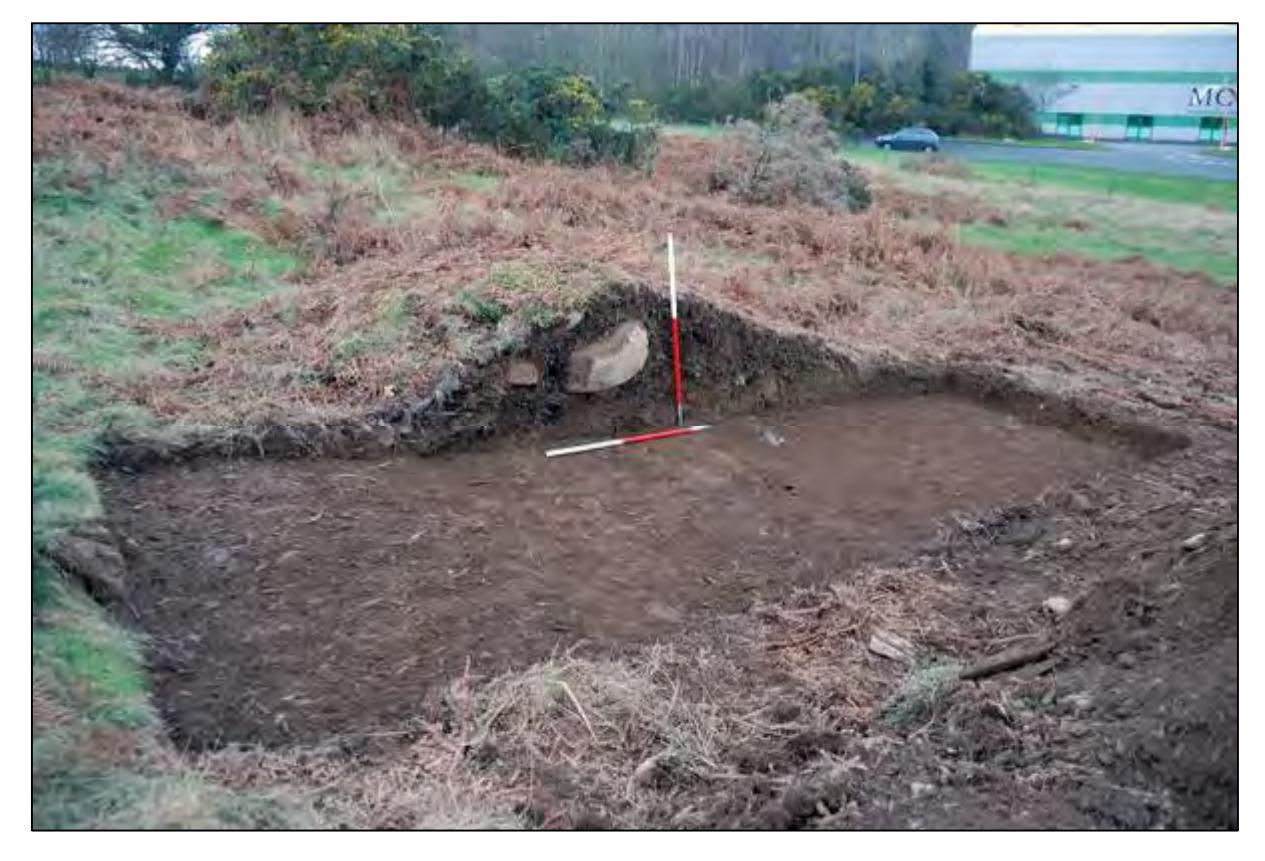
Plate 20: Tr 2, section through the mound

The majority of the mound (Figure 8) consisted of a soily layer (Context 5) with the occasional large rounded boulder up to 0.55×0.35 m in size (Plate 20). This sits on the topsoil layer (Context 4) which can be traced beyond the extent of the mound. The only exception is a lens of yellow clay (Context 6) on the western side of the mound which appears to be a deliberate dump of material.

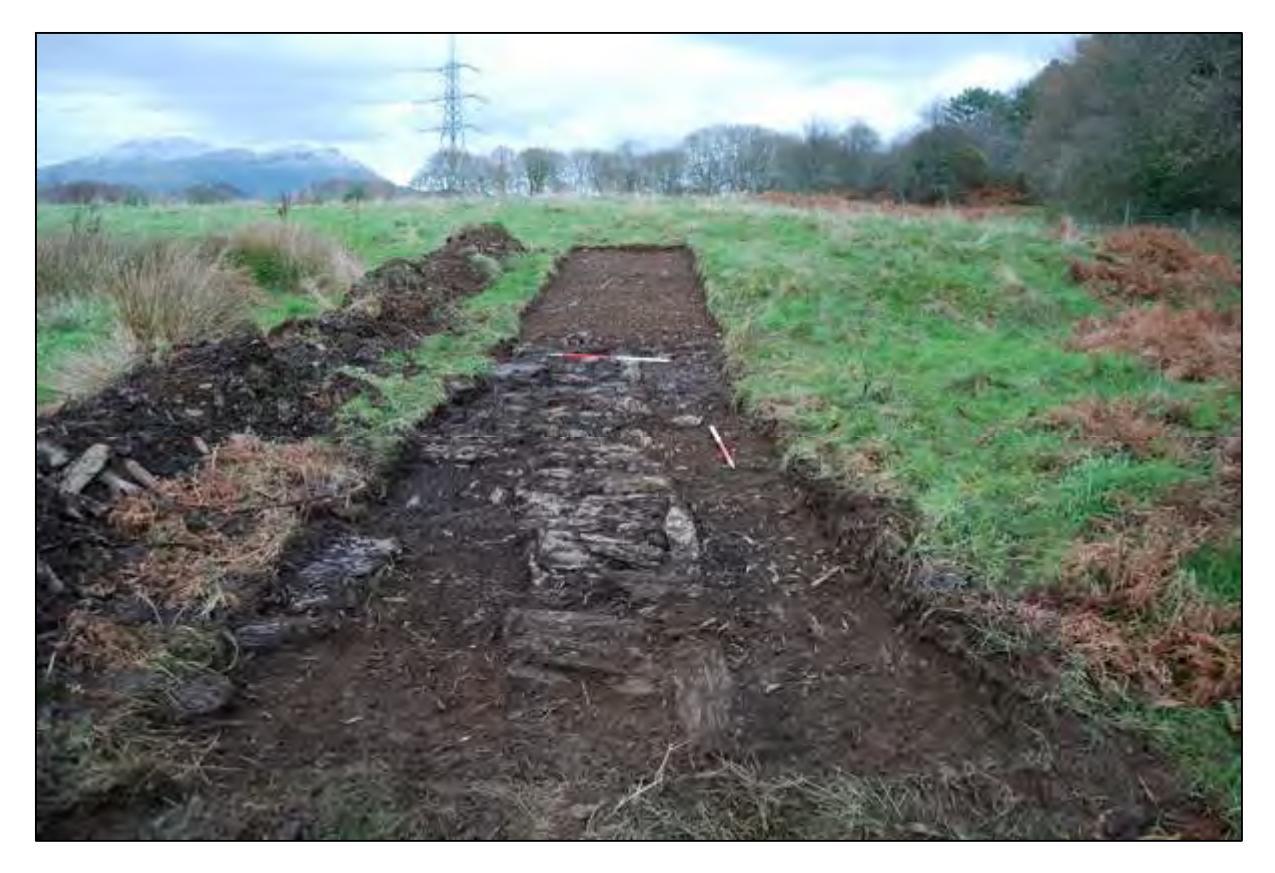
Plate 21: Tr 3, looking east

The trench revealed the southern wall (Context 2) of the building (Context 9) (Figure 9, Plate 21) running along the line of the trench. Approximately7.00 m of wall was exposed within the trench which was 0.70 m wide. Only one course of stones survive over most of the length of the wall, however this reveals the structure used in the lower part of the foundations (Plate 22). Blocks of stone were place at right angles to the line of the wall to form a firm base for the rest of the structure. It is possible that two areas of stone (Contexts 7 and 8) extend to the north of the trench. Whilst these may be fragments of the floor of the building it is also likely that they represent dividing walls within the building. The gable wall at the eastern end of the building is not clearly defined, however there appears to have been some revetting along the eastern end of the building (Context 10) to retain the natural slope so that the building was slightly terraced in to the hillslope.

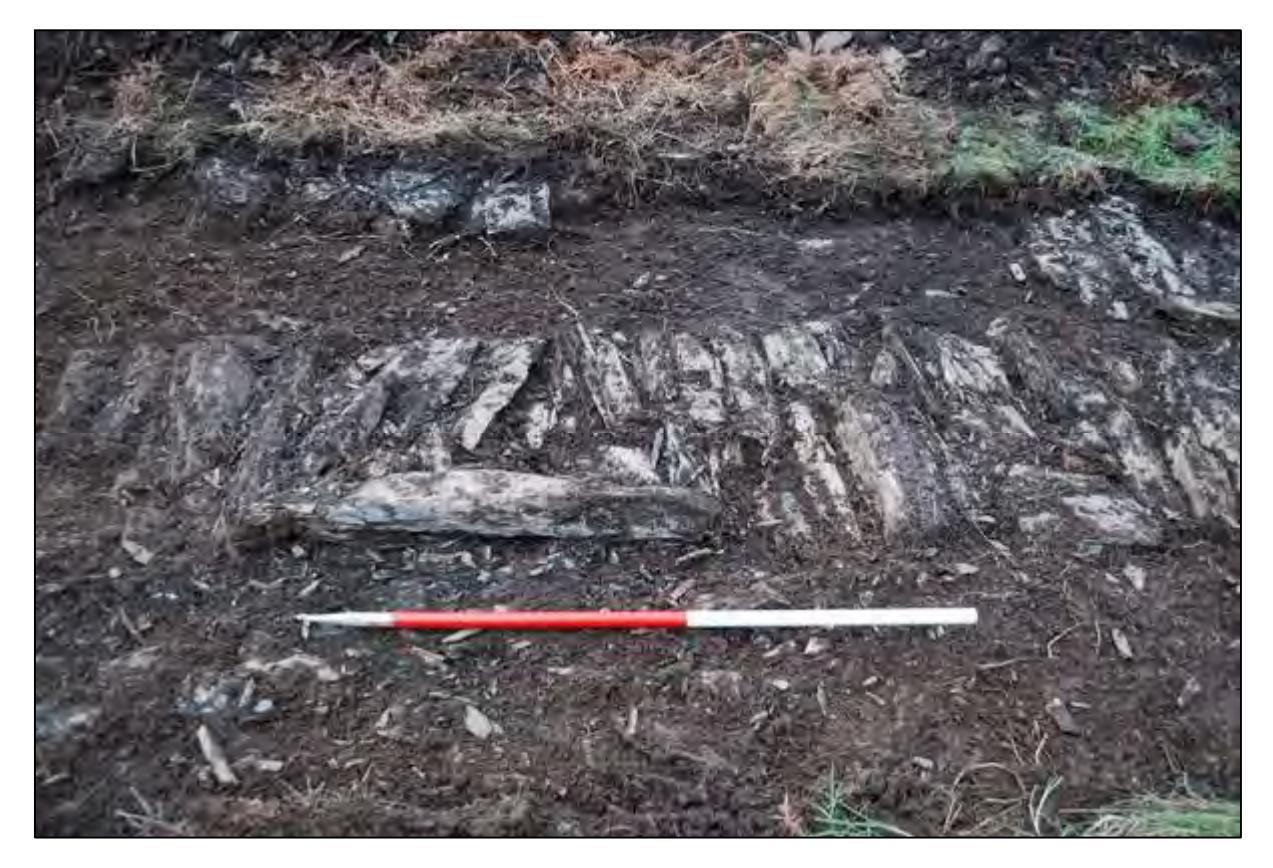
Plate 22: Tr 3, detail of the wall (Context 2) structure

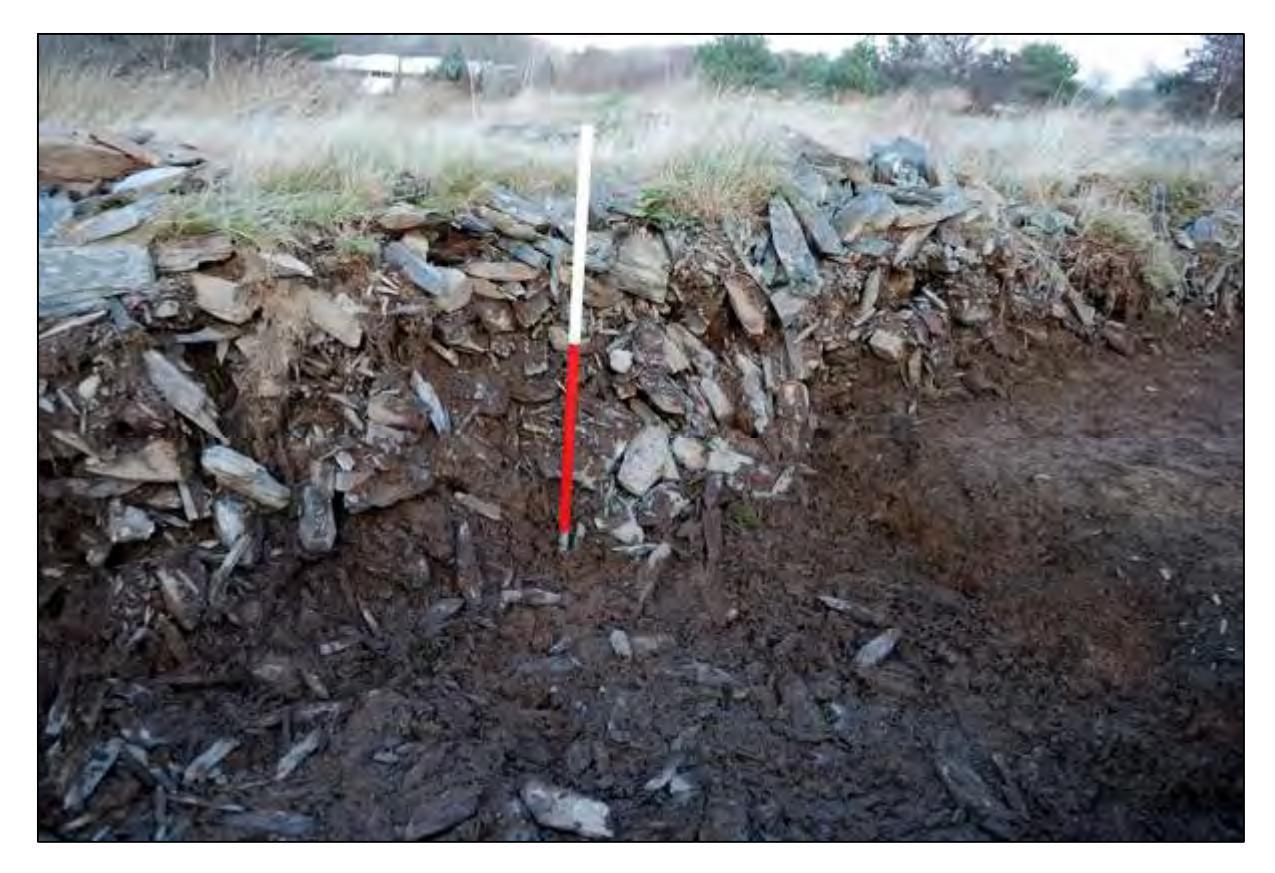
Plate 23: Tr 4, Building debris (Context 11) and cut feature (Context 13)

Trench 4 investigated the spread of building debris (Feature 6). A trench, 20.10 x 2.00 m size, was excavated across the spread with a mechanical excavator revealing the modern date of this feature. The spread of building materials (Context 11) sealed the topsoil layer (Context 12) which extends beyond the extent of Context 11). It also sealed a cut feature (Context 13) (Plate 23) within the middle section of the trench. This feature was at least 4.0 m wide and at its eastern end more than 0.35 m deep. It also cuts Context 12 suggesting it may be relatively recent in date. The modern nature of Context 11 was demonstrated by the recovery of a corrugated iron sheet and plastic sheep netting from a depth of 0.8 m below the current ground level.

The spread of building material is clearly modern in date. It fills and extends beyond a cut feature which is possibly a farm quarry. One possibility is that Context 11 was deposited during the construction of the Snowdonia Business Park and includes the remains of the building in Tr 3(Context 9).

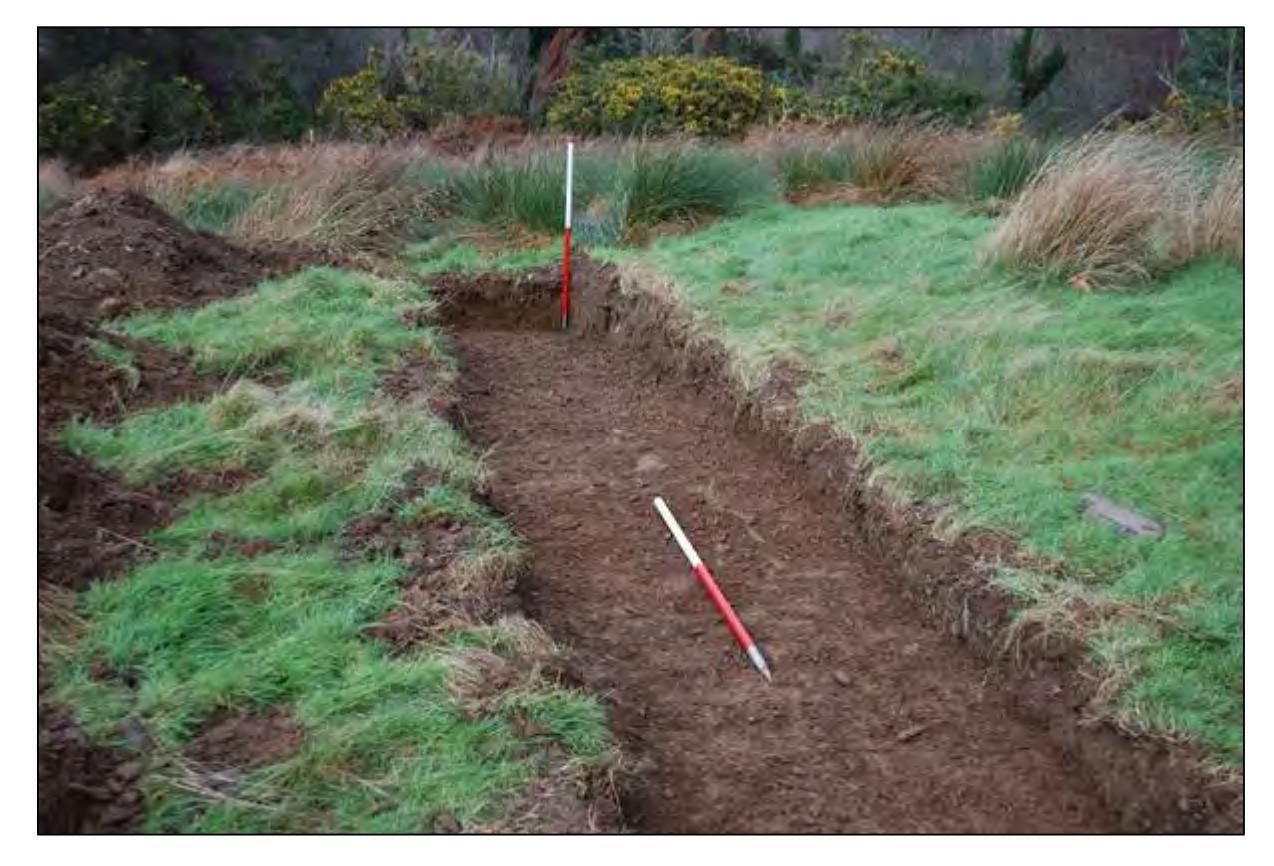
Plate 24: Tr 5, north western end of the trench

The profile of this trench (Figure 12) shows a relatively constant topsoil (Context 14) thickness of 0.2 m along most of the trench. However at the north western end of the trench this increases to 0.40 m where the topsoil was accumulating over the brow of the break of slope (Plate 24). No similar accumulation was noted at the south eastern end of the trench.

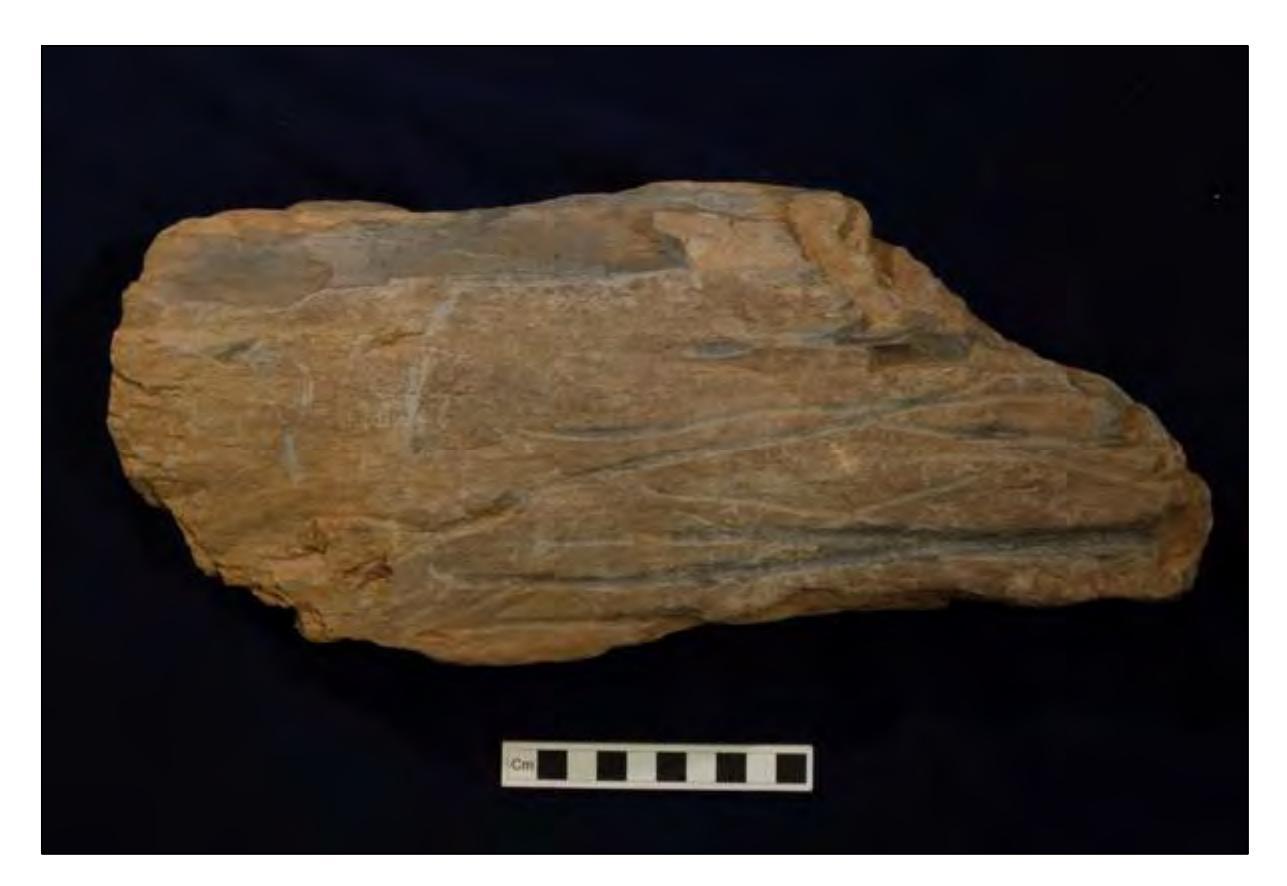
Plate 25: Stone block from Tr 5 with possible plough marks

A block of the local stone was recovered from the topsoil within Trench 5. It is $350 \times 150 \times 51$ mm in size and has a series of shallow grooves on its upper surface (Plate 25) which would suggest that the field has been ploughed at some date.
