Anafon Hydro-Electric Scheme Archaeological Survey

Anafon Hydro-Electric Scheme, Archaeological Watching Brief

**Ynni Anafon Energy Cyf**

Engineering Archaeological Services Ltd EAS Client Report 2015/16

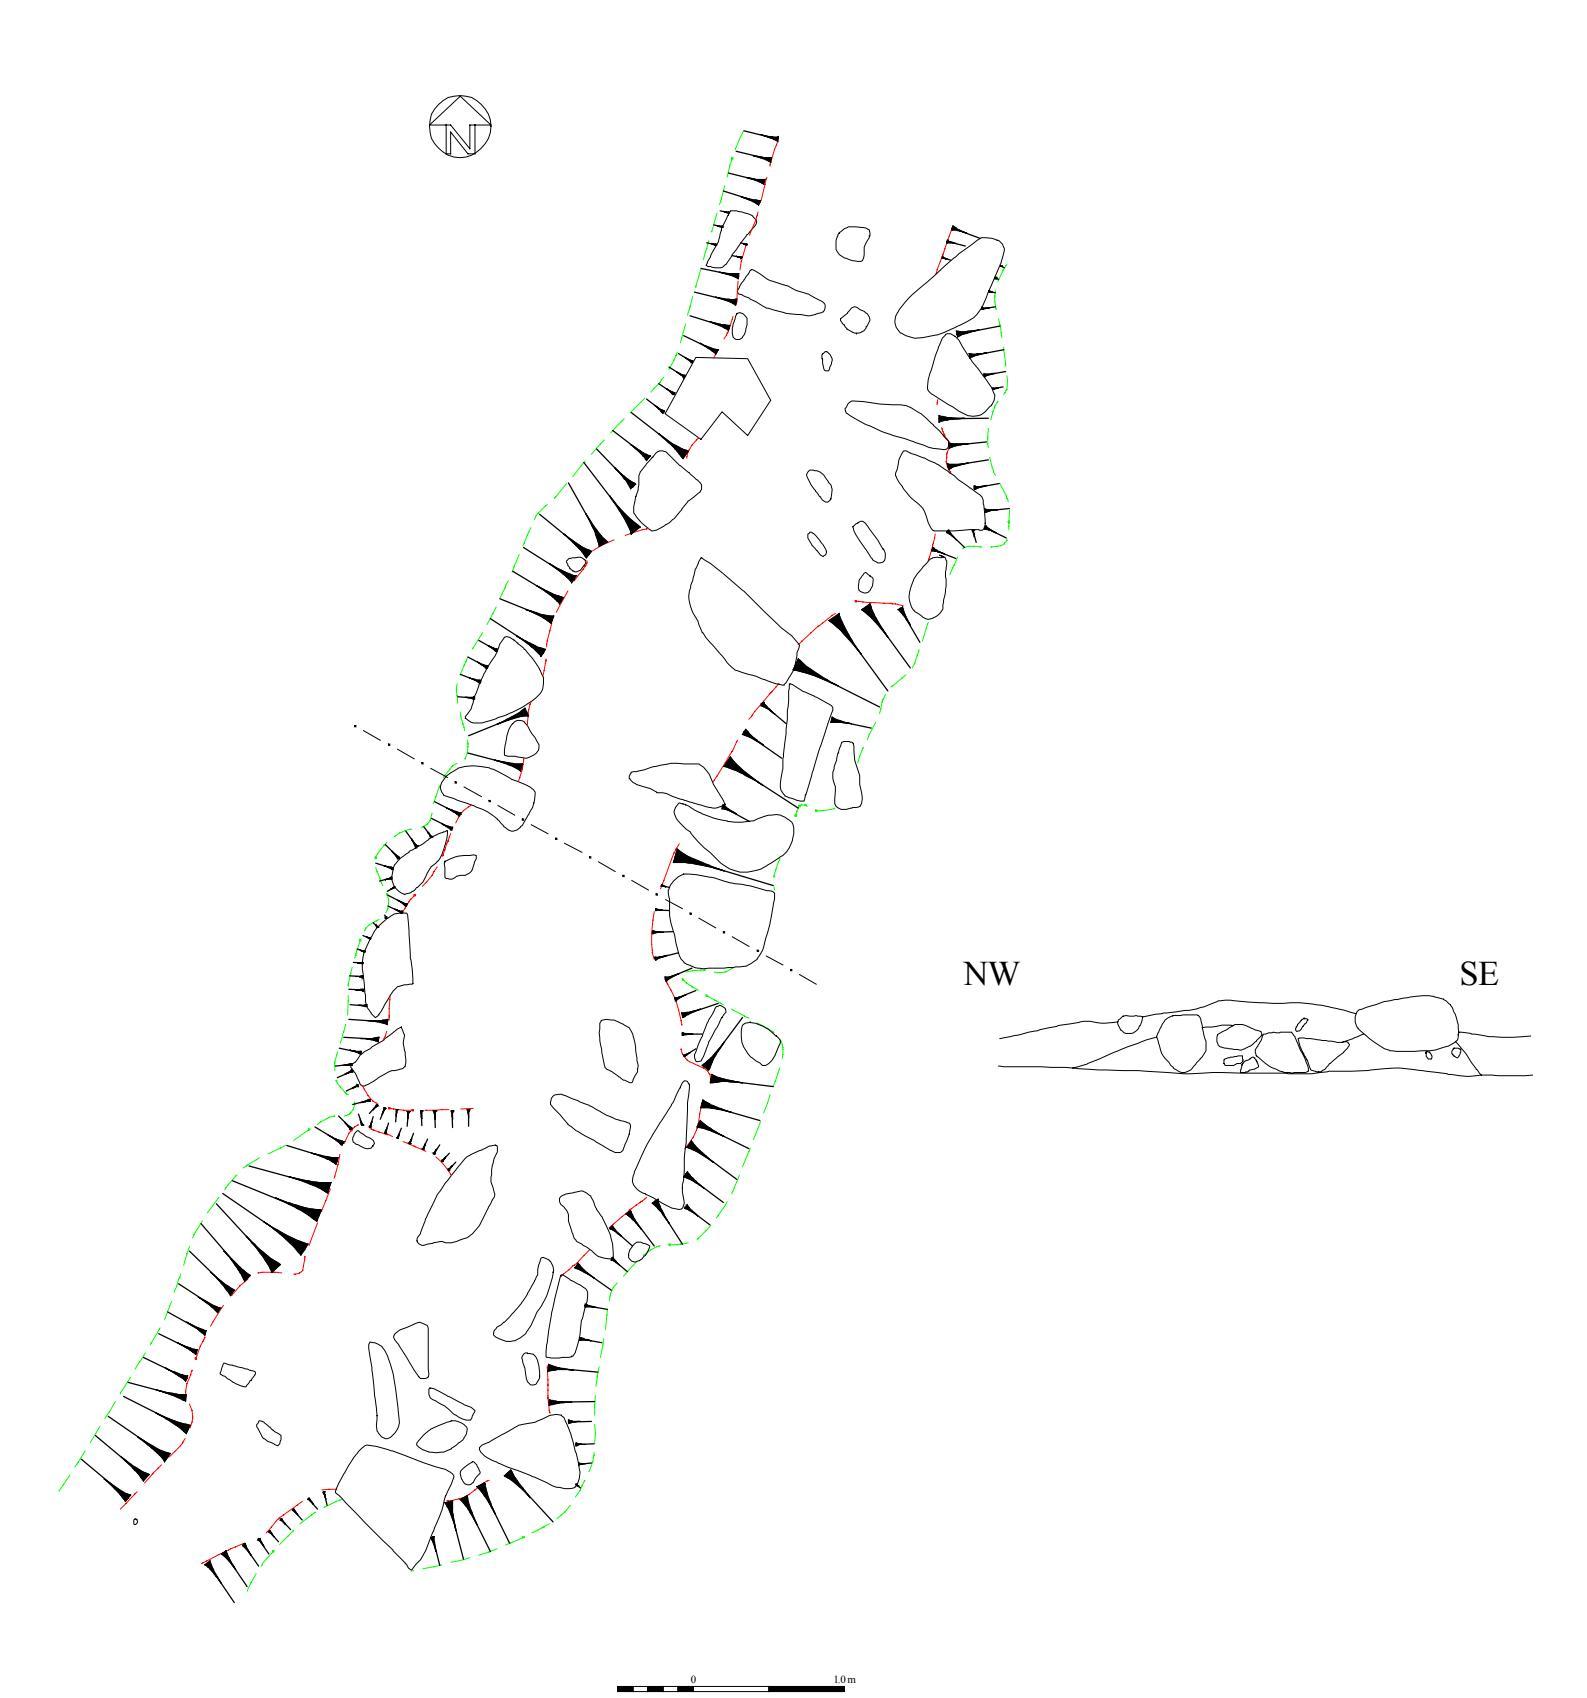
Figure 3: Bank 1, Plan and Section Scale 1:50

The pipe route crossed the line of the bank forming the enclosure PRN 3889. This is a low earth and stone bank, up to 2.90 m wide and 0.30 m high which appears to have stone boulders marking each of the edges (Plate 17, Figure 3) and a mixed stone boulder and earth core (Plate 18). Particular care was taken when crossing this feature, the topsoil on the easement was stripped to either side of the bank and only the pipe trench excavated though the feature. Unfortunately no dating evidence was recovered from this feature. It is part, however of an extensive enclosure defining an area of 475 m long and up to 140 m wide on the northern bank of the river. The bank itself can be traced to the break of slope to the river channel at SH 68770 71100 and via a large loop to the point where it is cut by the modern track through the valley at SH 68328 71267. There is a break in the bank between SH 68664 71251 and SH 68632 71264 as the result of later disturbance. This was due to the construction of a rectilinear building which was later converted into a sheepfold. The form of this structure would suggest a late medieval or post-medieval date for its construction suggesting the bank predated this period. There is also no clear relationship to the known medieval features within the valley, which given with the form of the bank may suggest a possible prehistoric date for the enclosure.

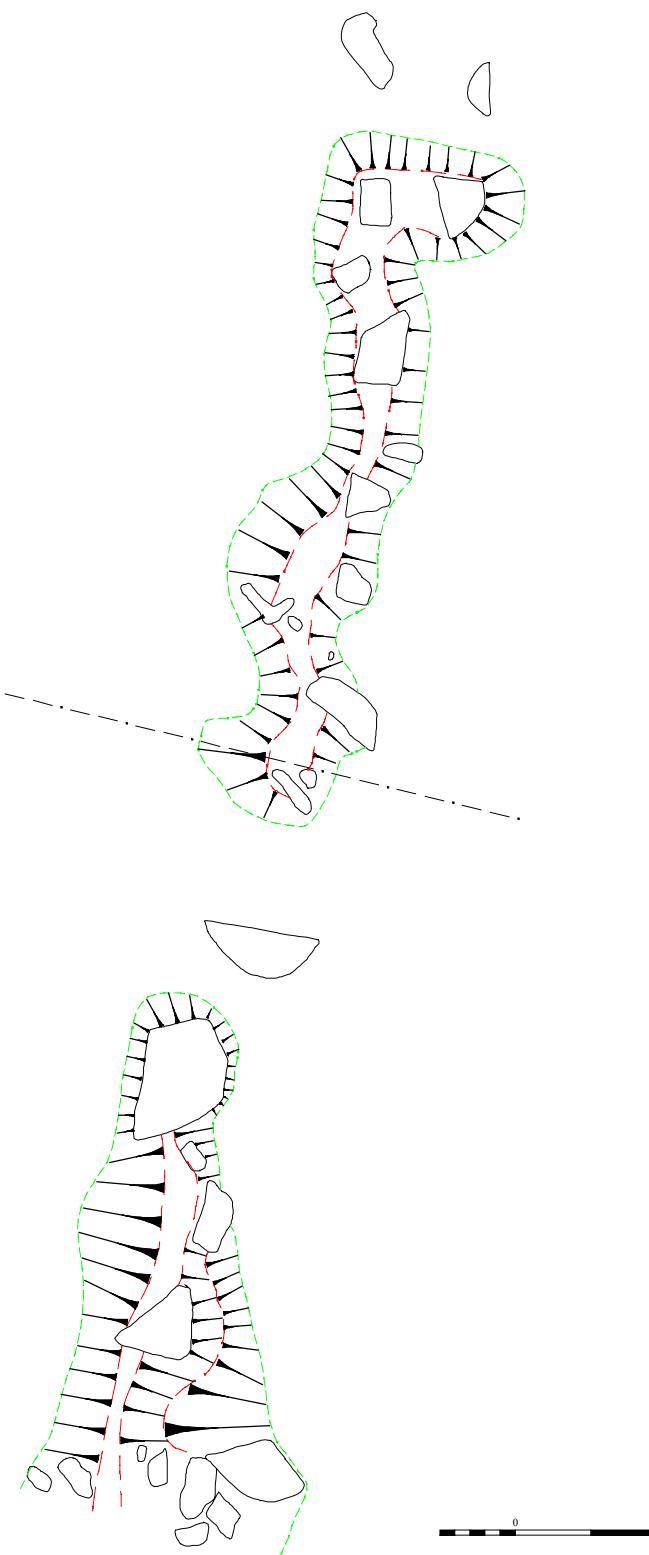
Figure 4: Bank 2, Plan and Section Scale 1:50

The second boundary crosses by the pipeline was less well defined, it runs between the break of the slope for the river channel at SH 68491 71218 to the point where it merges with a stone spread at SH 68494 71237. The bank is only between 0.6 and 1.0 m wide and up to 0.10 m high (Plates 21 and 22, Figure 4), but is a clear feature within the landscape. It is constructed of earth and large stones is unlike the other bank as this feature does not have the structured form with stones lining both sides of the bank, but has the stones and earth forming a single context. This bank does, however, mark a difference in the appearance of the subsoil. The stripping of the topsoil revealed that there are few, if any, boulders and larger stones in the area between the bank and the break of slope for the river to the west (Plate 23). This is unlike the eastern side of the bank which has the occasional boulder. Whilst this may be a function of the local glacial geology the proximity of prehistoric round houses (PRN 818, 342) and a medieval hafod (PRN 817) may suggest that this area could be a deliberately cleared area, possibly either a prehistoric field or a garden associated with the hafod.

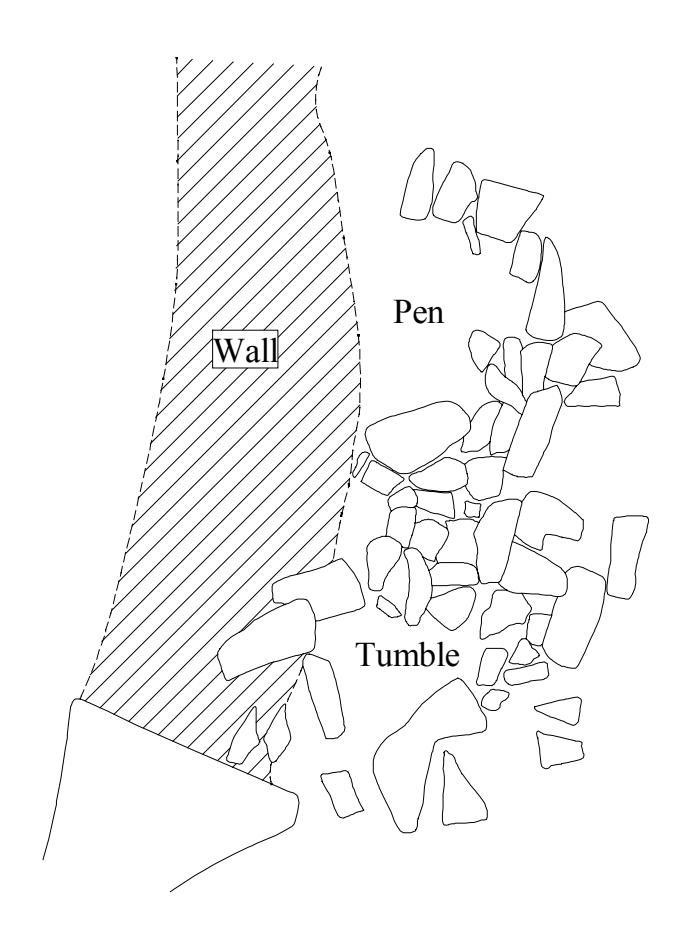
Figure 5: Plan of the Hefting Pen Scale 1:50

Little archaeology was recorded between the river crossing and the boundary between the land owned by the National Trust and the forestry. This is largely because of the local topography with a relatively steep side slope making this area unsuitable for archaeological features. At the western end of this section, however there is the remains of a tumbled stone wall running parallel to a small stream running, approximately north – south, near to the current property boundary. Attached to this boundary there was the remains of a small pen, at SH 67851 70945, (Plate 26, Figure 5) marked by a single layer of stone blocks defining an area 1.28 x 1.0 m in size. The stones defining this area were different from the general scatter from the collapse of the wall being clearly placed rather than tumbled. It is assumed that this was a small animal pen, probably a hefting pen.

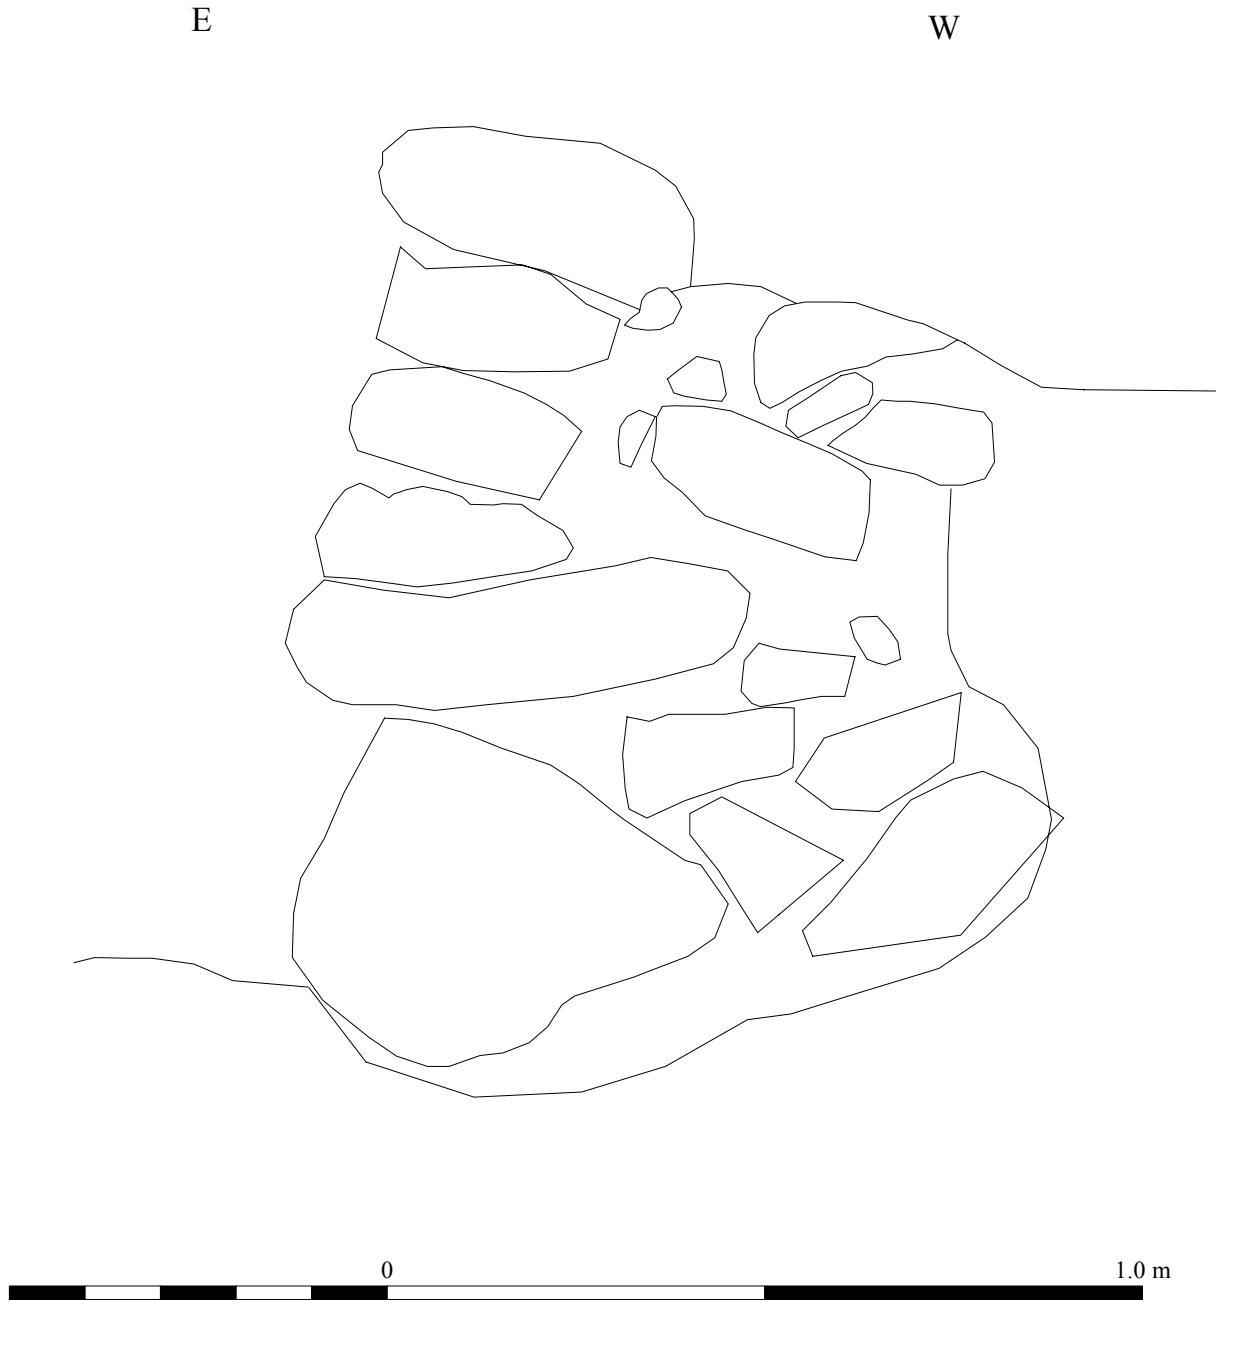
Figure 6: Section of the Wall Scale 1:10

The wall stood to a maximum height of 1.1 m and was 0.8 m thick (Plates 27 and 28, Figure 6). It revets the side of the stream with a difference of about 1 m between the two sides of the wall. It is assumed that this was originally the boundary between the two properties with the current boundary now marked by a wire fence approximately 3 m to the west.

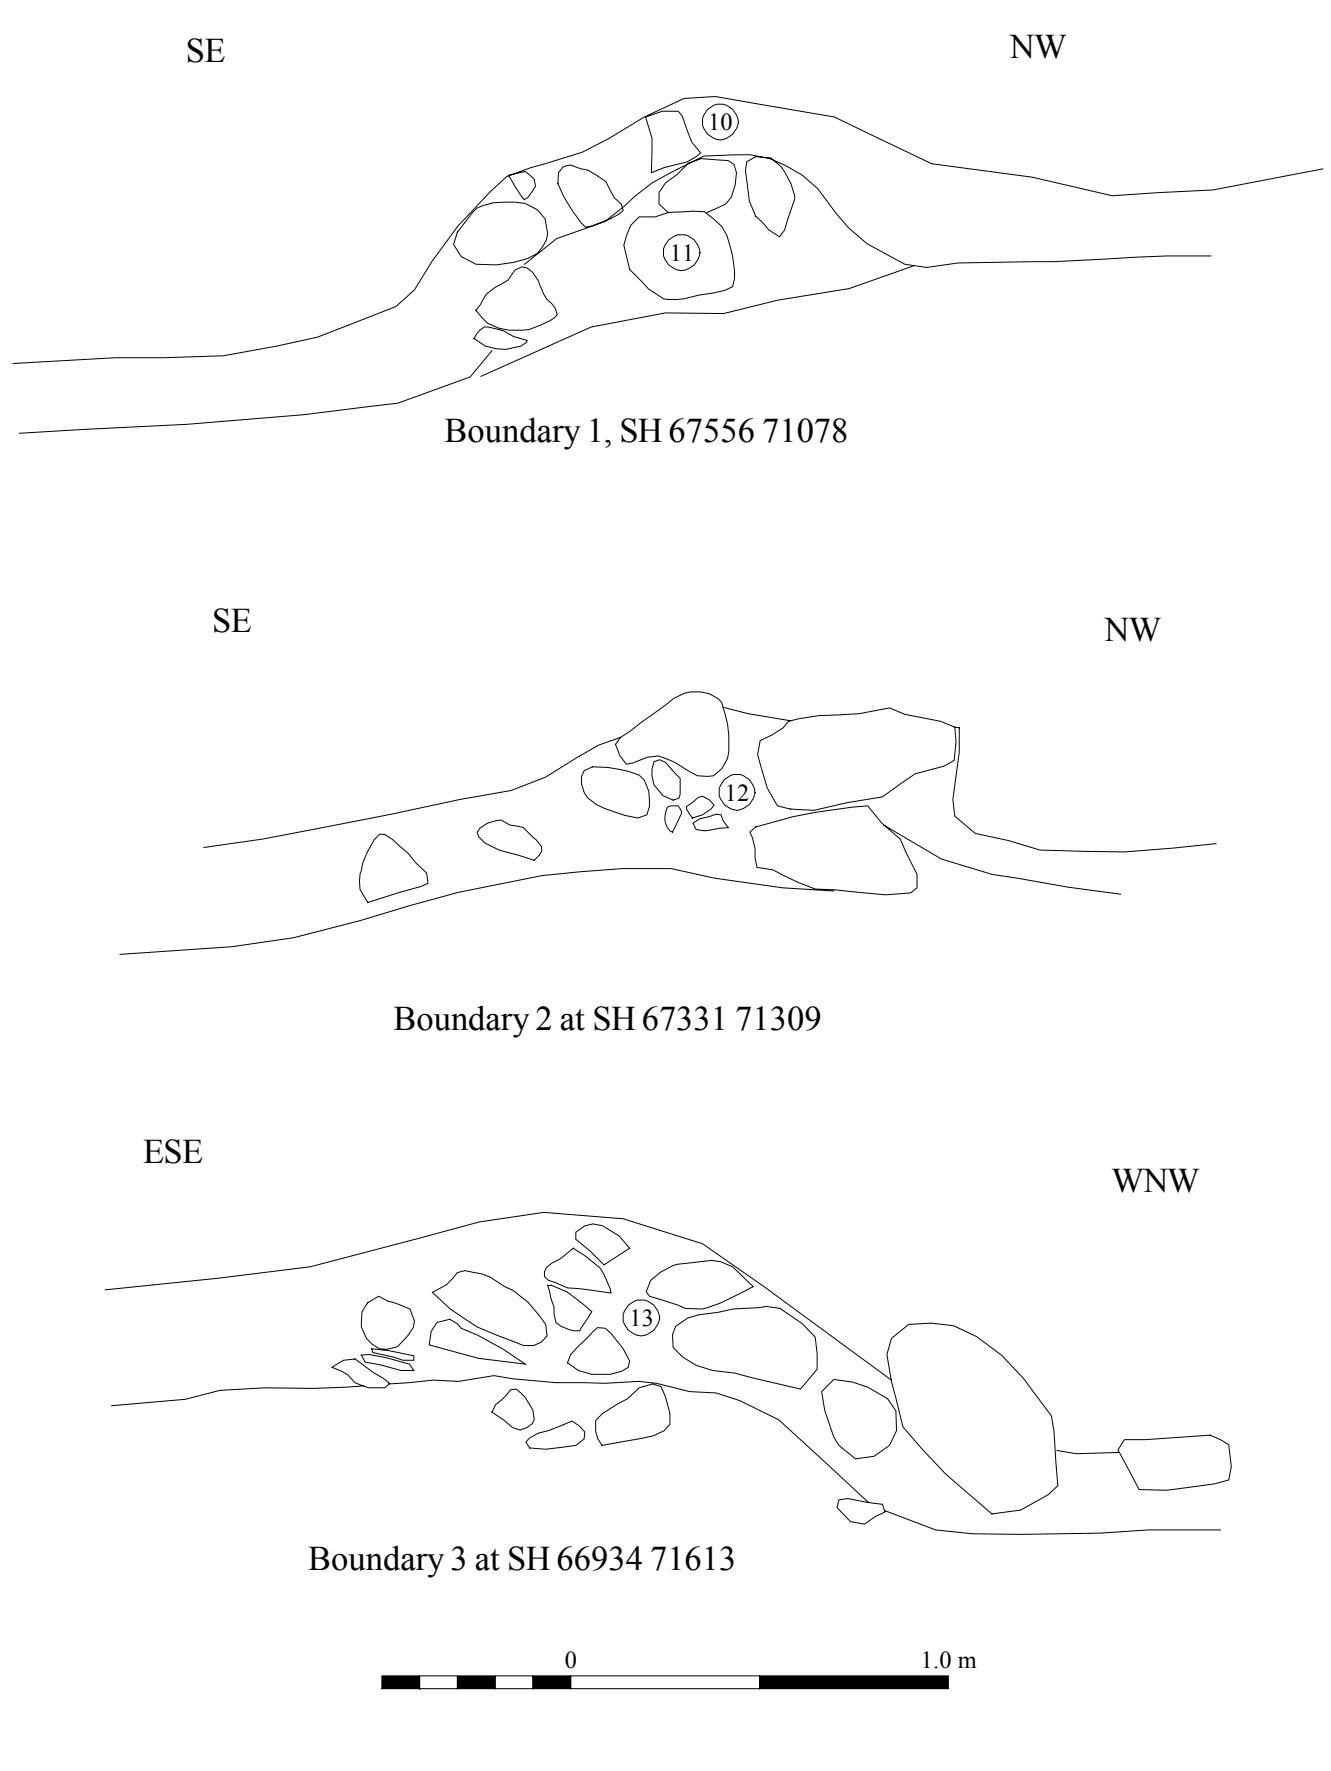
Figure 7: Sections through the Boundaries in the Forestry Scale 1:20

At SH 67556 71078 an earthen bank, or highly tumbled wall, was recorded (Figure 7, Plate 30). This is only 0.6 m high and 1.4 m wide and was partly terraced into the hillside with the eastern side of the boundary being approximately 0.5 m lower than the western side.

Another boundary was recorded at SH 66934 71613 (Figure 7, Plate 32). This is up to 0.6 m high and is 2.0 m wide and it is partly terraced into the hillside such that the western side of the boundary is 0.5 m below that on the eastern side. The form of this feature would suggest it was most likely an earth and stone bank boundary.

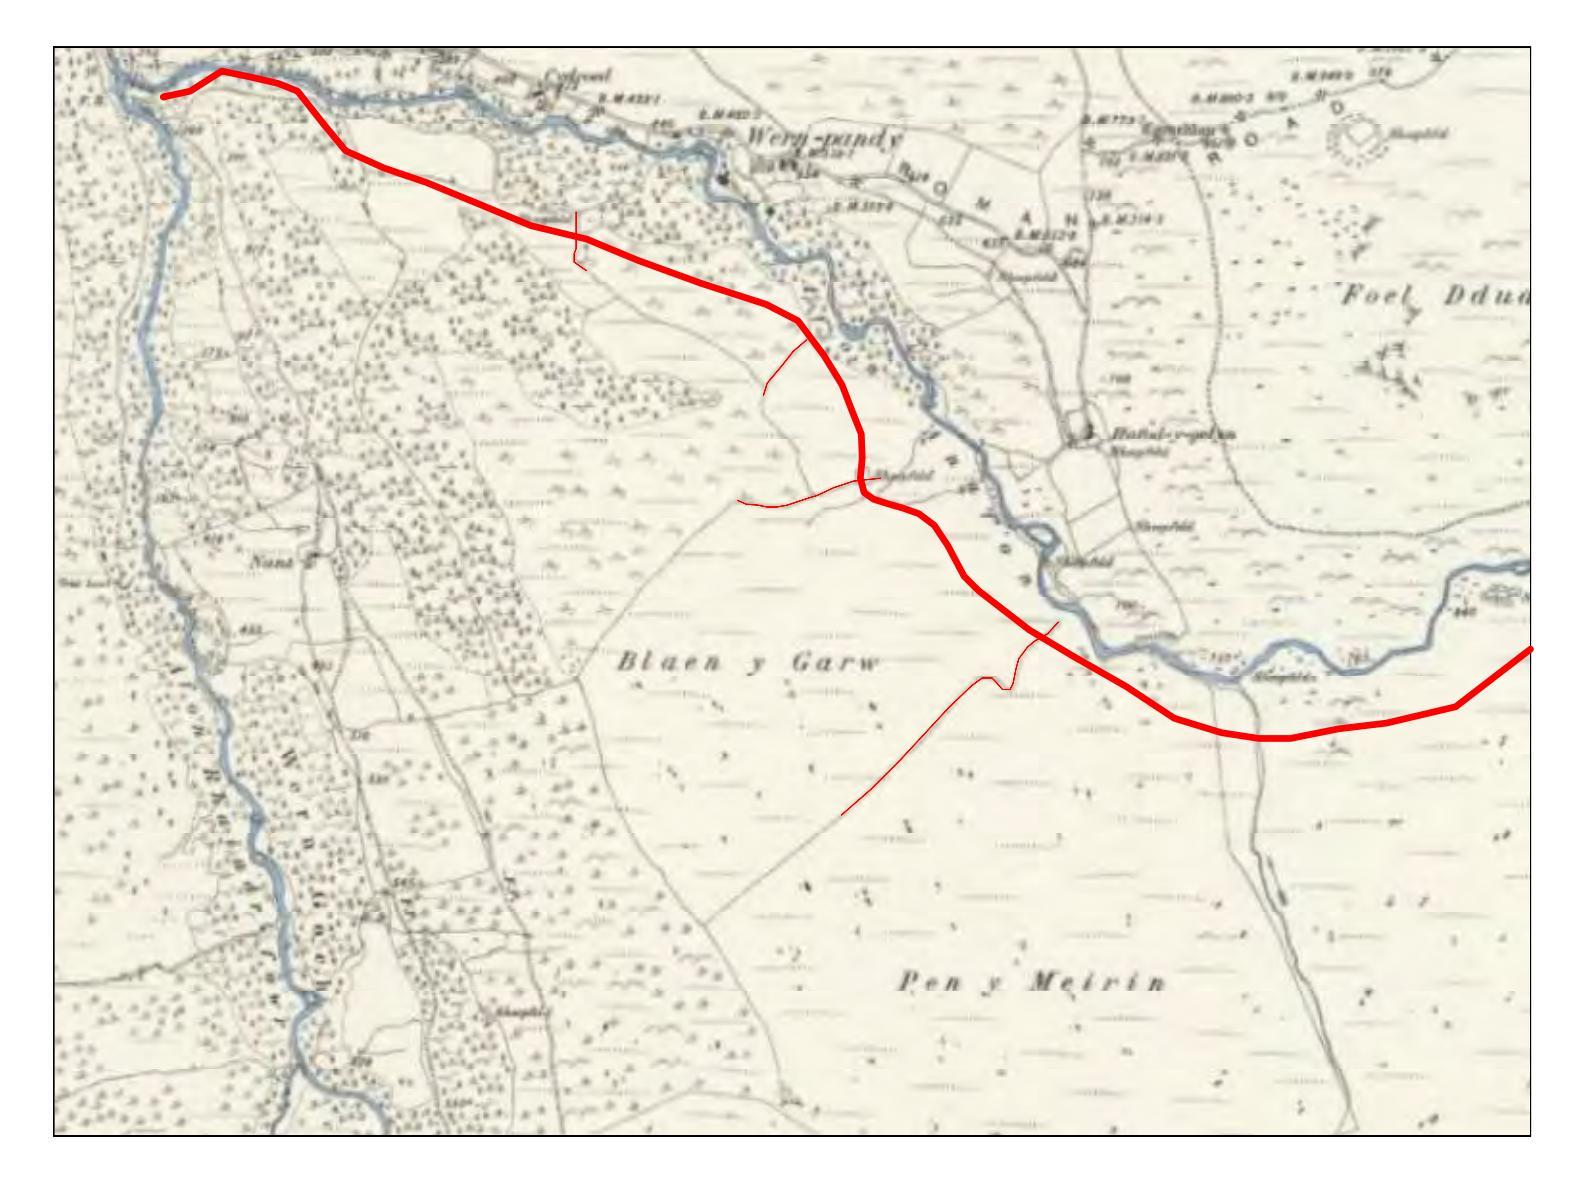
Figure 8: Location of the Boundaries Recorded based on an Extract from the Ordnance Survey 1888 Caernarvonshire VII.SE map Re-scaled to 1:10,00

The three boundaries recorded in the construction phase and a fourth seen in the initial walkover phase of the project can be related to a series of boundaries seen on the First Edition Ordnance Survey map of the area (Figure 8). These reflect the agricultural division of the land before the establishment of the forestry. They can be proved to be older than the late nineteenth as they appear on the First Edition Ordnance Survey map published in 1888.

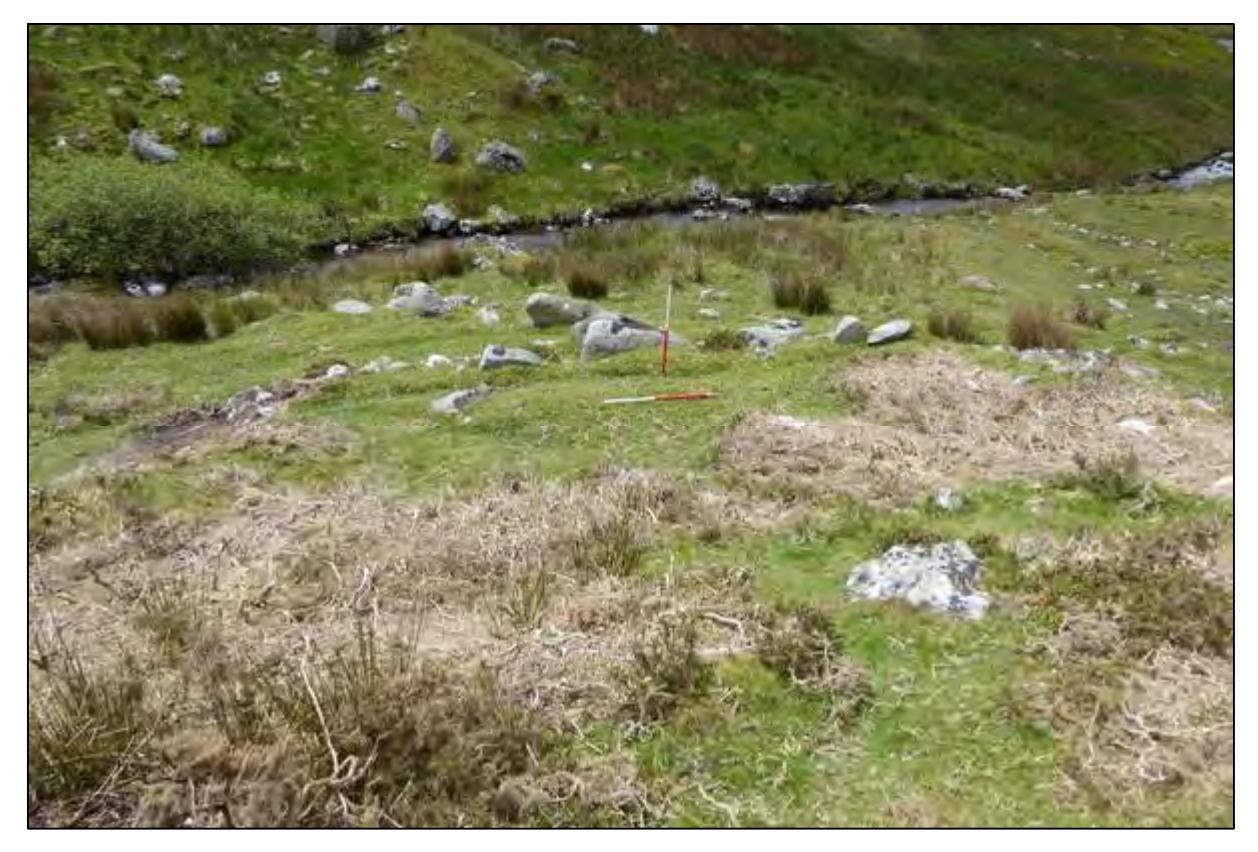
Off the line of the pipe and cut into the terrace side of the river is a rectangular house platform at SH 68836 71089 (Plate 2). This feature is approximately 9.0 x 5.5 m in size and has the remains of a low stone wall, approximately 0.8 m wide along its western, southern and eastern sides. The platform is cut parallel to the slope. This is possibly the hut platform recorded as PRN 825 on the Gwynedd Historic Environment Record, although the grid reference is slightly different. The relationship between this house platform and the medieval remains on the opposite side of the Afon Anafon (PRN 823, 832 and 833) is uncertain, however the proximity between these features (they are within 50 m of each other) is suggestive.

Plate 2: Rectangular house platform at SH 68836 71089

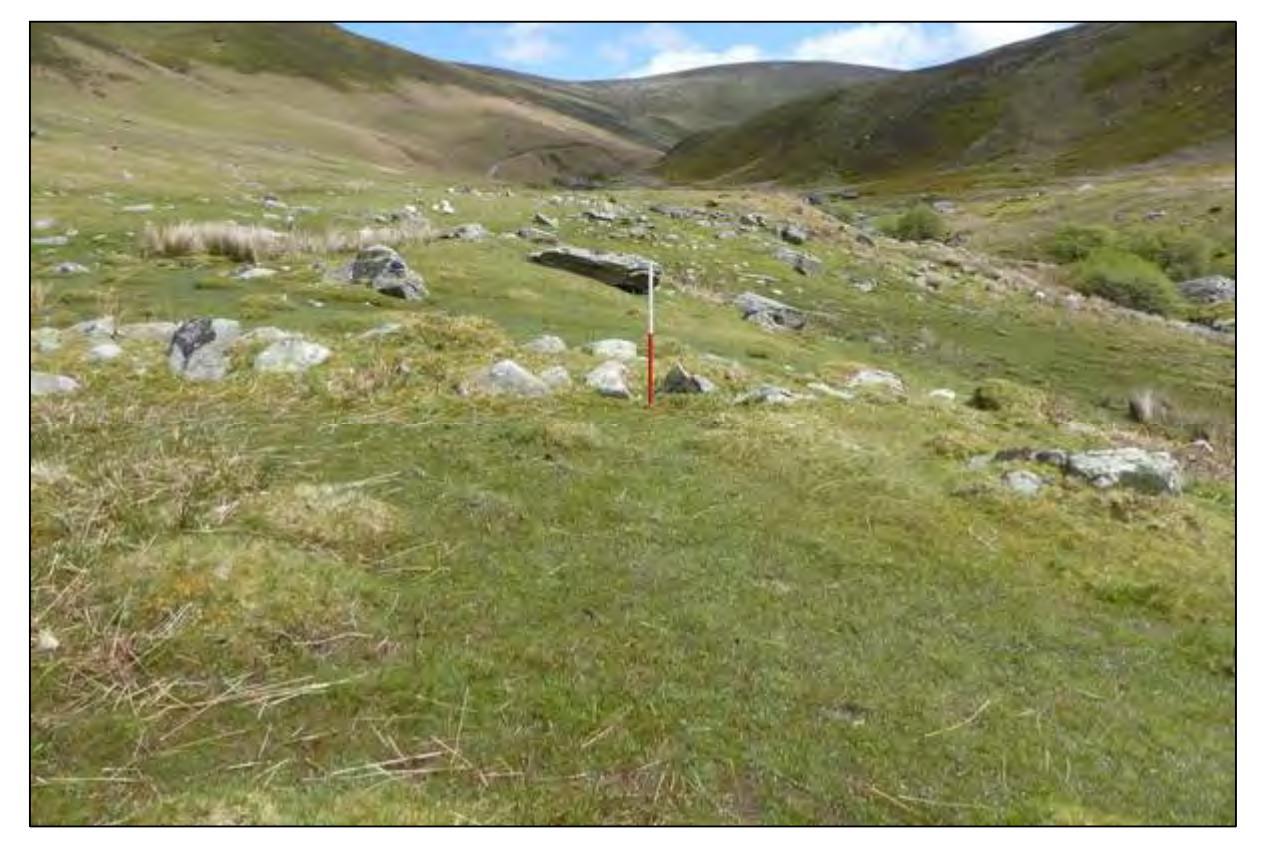
wide. The date of this enclosure is uncertain, however its line is disturbed by the construction of a rectangular building which was later converted into a sheepfold at SH 68667 71258 (PRN 349). This feature has previously been recorded as PRN 3889.

Plate 3: Bank (PRN 3889) looking east.

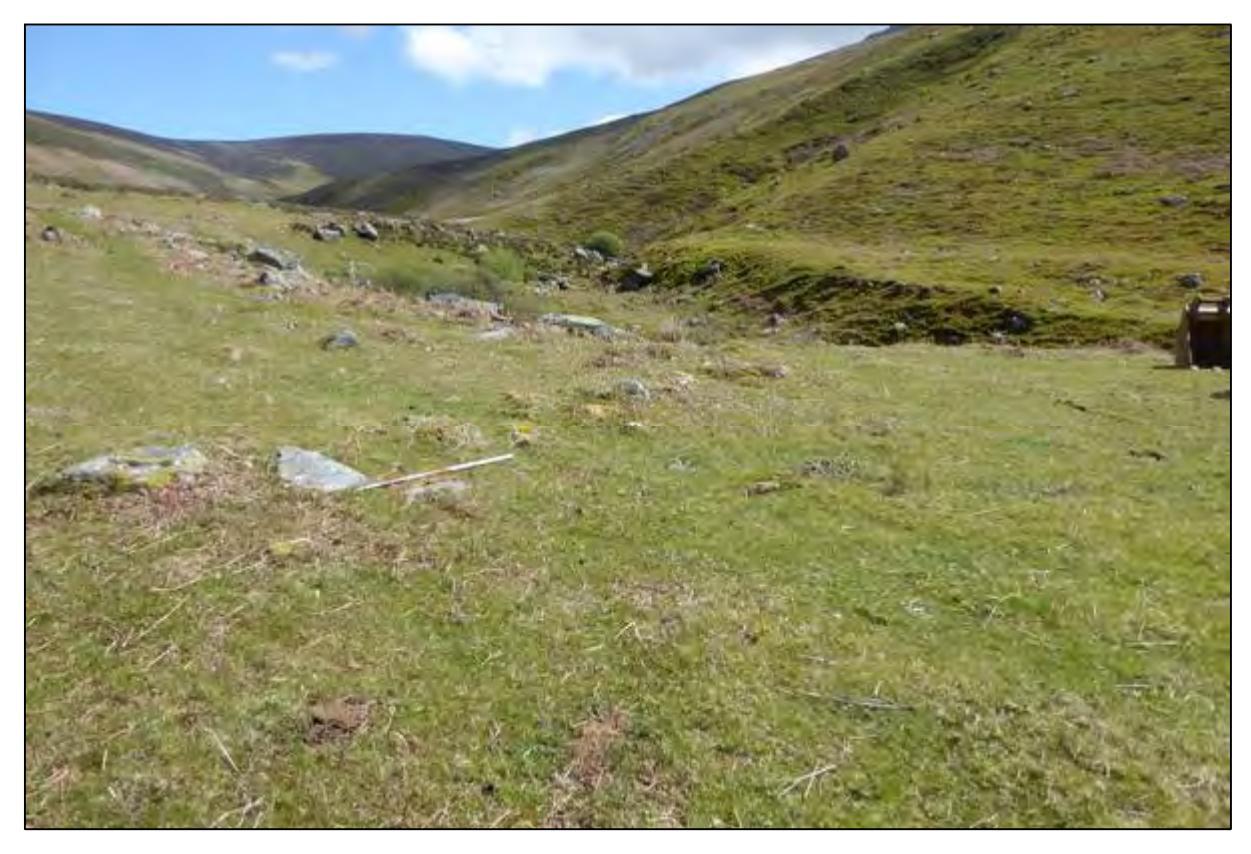
The second bank has not been previously recorded. It runs for a short distance from SH 68494 71237 and SH 68492 71225 and is approximately 1 m wide, but only 0.1 m high (Plate 5). It runs from a spread of stone (PRN 818, Plate 6) which appears to be the disturbed remains of a circular building to the break of slope above the river. The relationship between this feature and PRN 818, however is uncertain.

Plate 5: Bank between SH 68494 71237 and SH 68492 71225

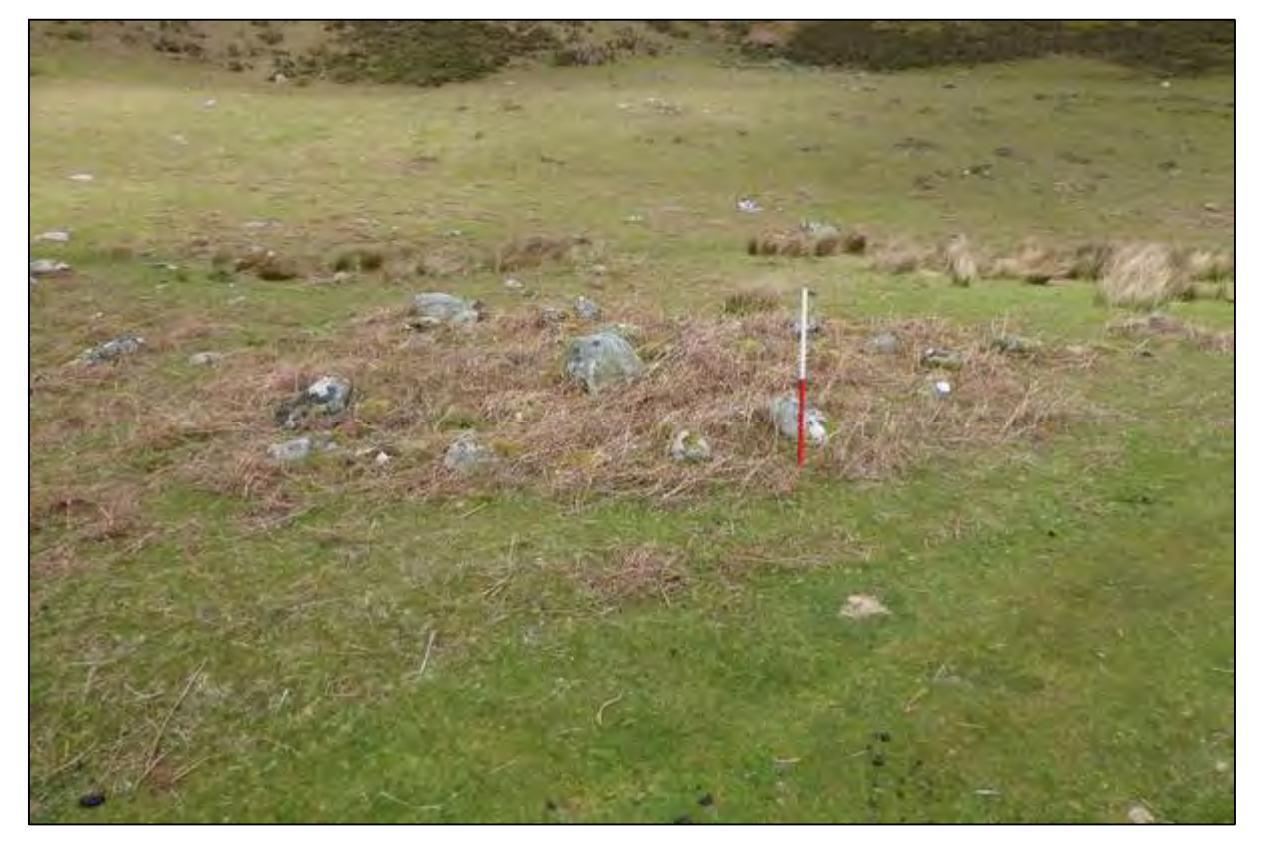
A second, slightly better defined circular feature is located at SH 68455 71241 which has been previously recorded as PRN 817 as "Circular structure said to have been erected by a group of young men coming back to Aber from Australia in early 19 century" (<u>http://cofiadurcahcymru.org.uk/arch/query/page.php?watprn=GAT817</u>), however its current form is closer to a prehistoric round house (Plate 7). Adjacent to this feature, at SH 68463 71235, however is a previously unrecorded sunken stone box (Plate 8), probably a cist. This feature is approximately 1.5 m long and 0.5 m wide and is lined with stone blocks on at least three sides. Both of these features were protected with a temporary fence from accidental damage.

Plate 7: Possible round house PRN 817

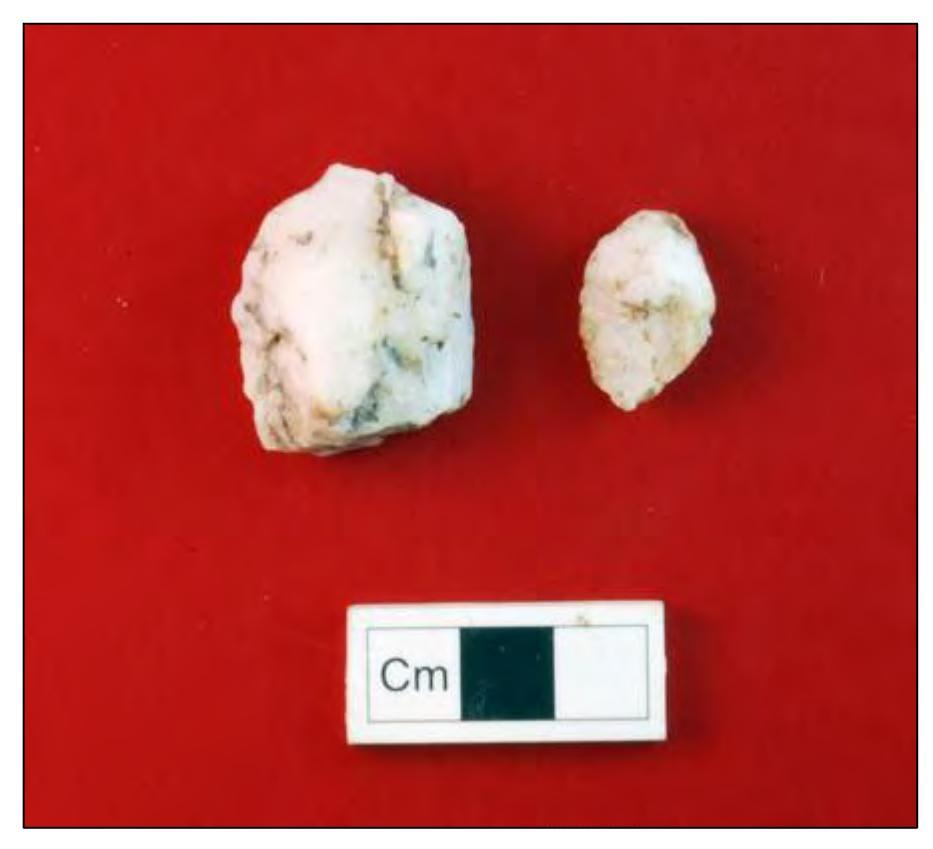
The stripping of the topsoil from the inlet construction compound revealed no archaeological features, however, two artefacts made on the local vein quartz were recovered at SH68847 71138 (Plate 15, see below). Neither of these were particularly well made, but one appears to have retouch along one end suggesting it has been used as a scraper. Whilst they are essentially undatable the size and use of such a poor raw material may suggest a Late Mesolithic association.

The quartz artefacts (Plate 15) are relatively crude, however this is a function of the poor raw material which has been used. The larger of the artefacts is a thick, tertiary flake  $30.8 \times 26.5 \times 13.7$  mm in size. Although it has numerous natural faults there is a flat platform and at least three flake scars on the dorsal surface demonstrating the human origins of this flake. The smaller artefact is based on a natural flake,  $21.7 \times 14.6 \times 9.0$  mm in size. The distal end, however has a series of abrupt, scalar removals along the distal end forming a scraping edge.

Plate 15: Artefacts of vein quartz

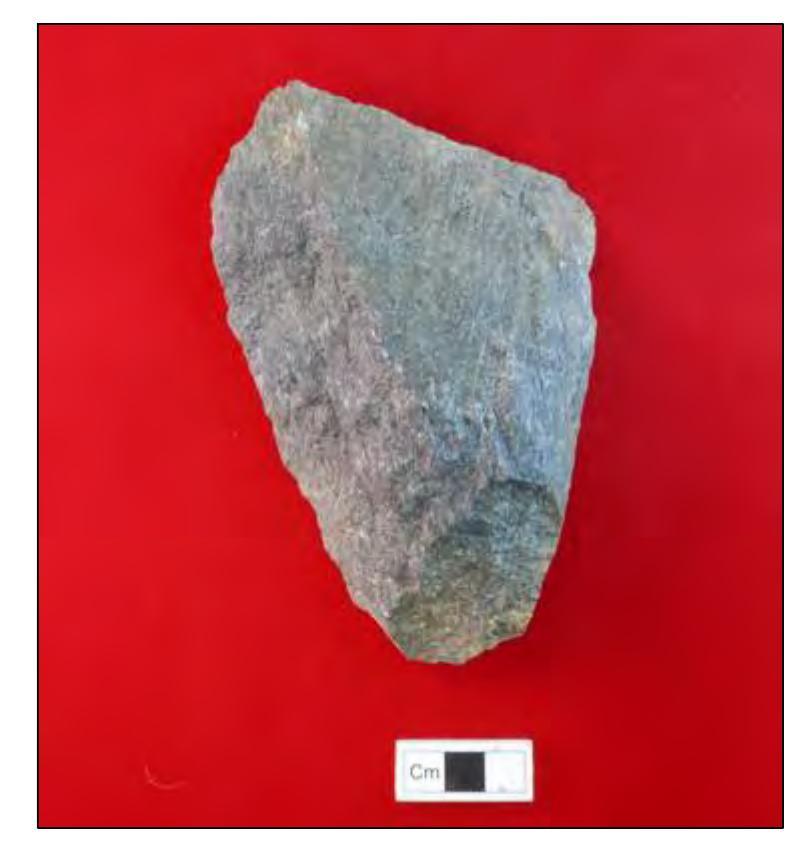
Within the spoil from the digging of the trench at SH 68819 71097 a large flake of stone was found (Plate 16). This was on a distinctive lithology unlike that of the boulders in the immediate vicinity and it demonstrates a clear knapping strategy. There is a prepared platform and at least two deliberate flake scars on its dorsal surface demonstrating that it is not an accidental artefact. Whilst, again, this artefact is essentially undatable the size and style of knapping may suggest possible Neolithic or Early Bronze Age affinities.

The stone flake from SH 68819 71097 (Plate 16) is 144.6 x 94.0 x 26.6 mm in size and is of a similar raw material of to that within a series of scatter of knapped materials recorded from Llwytmor overlooking the valley of the Afon Anafon (Brooks 2014) some 800 m to the south. The lithology is distinct and unlike any of the boulders or outcrops in the immediate vicinity of the pipeline and it is, therefore, likely that the source was a glacial erratic. The flake has a trimmed platform and at least two flake scars on its dorsal surface demonstrating a level of control over the knapping process even though a hard hammer technology is suggested.

Plate 16: Stone flake

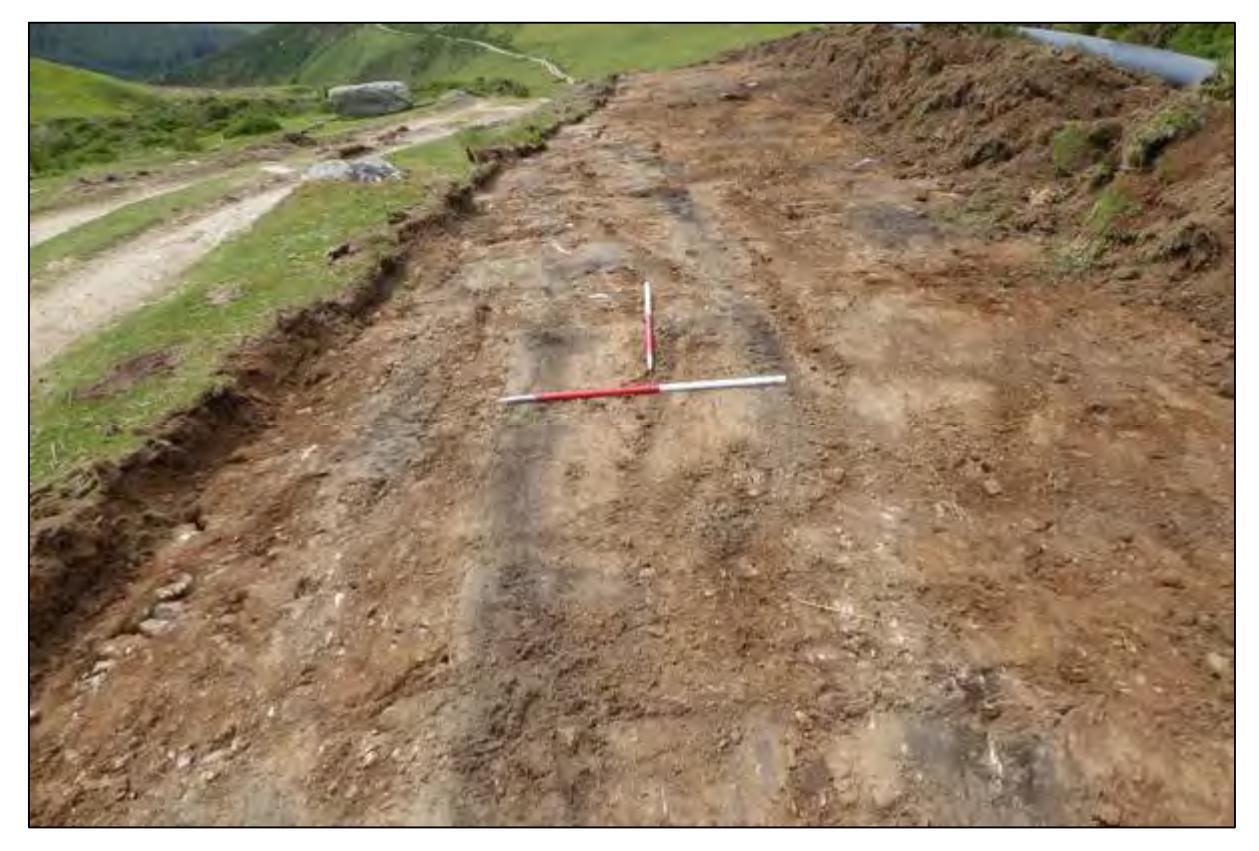
The stripping of the topsoil to the north of the track running along the valley at SH 68667 71194 revealed two, parallel features 0.80 m apart, which diverge from the track and run for a distance of 26 m (Plate 19) Each of the linear features were between 0.2 and 0.3 m wide, but were less than 10 mm deep. Their form would suggest they are the result of a modern vehicle leaving the track during wet conditions and leaving slight ruts compressed into the sub-soil. Indeed these features correspond with the gauge of the vehicle currently being used by the tenant farmer.

Plate 19: Vehicle tracks

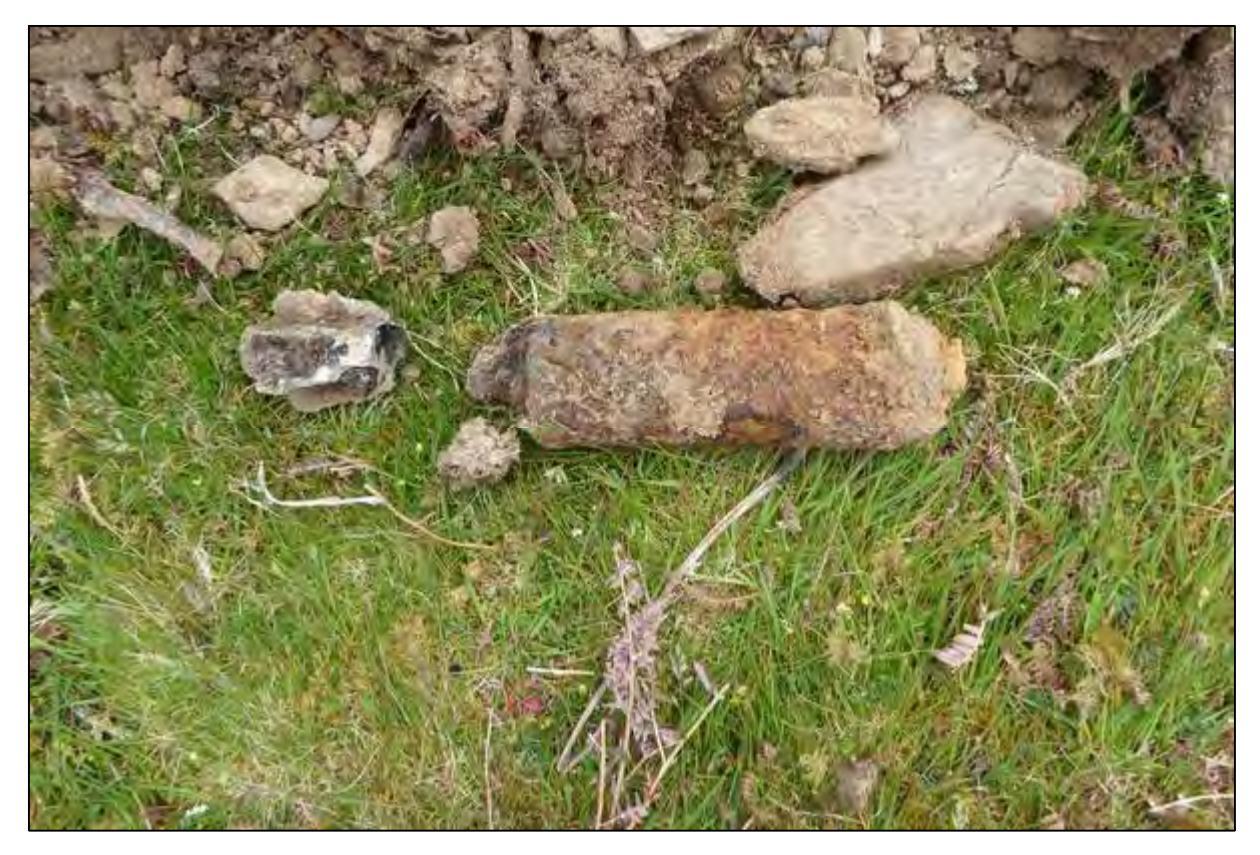
A live 2" mortar round (Plate 20) was found during topsoiling at SH 68615 71221. This was destroyed by the bomb squad.

Plate 20: Mortar round from SH 68615 71221

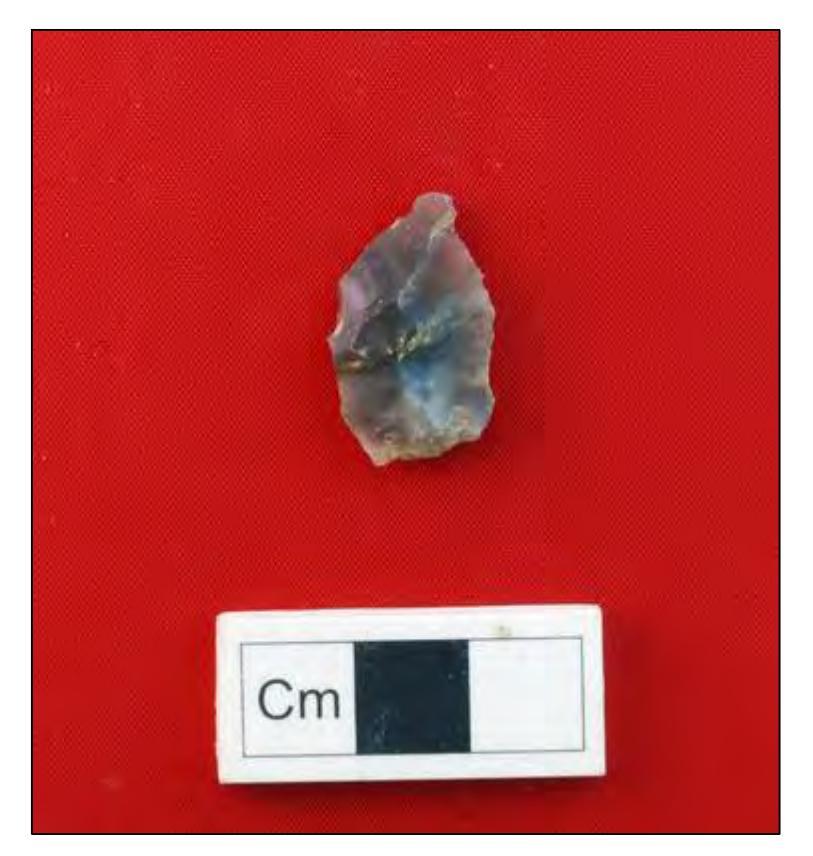
A single flint artefact was recovered at SH 68419 71208 on the eastern bank of the Afon Anafon. This is a light weight awl made on a re-used flake reflecting the difficulties of obtaining raw materials in North Wales.

A single flint artefacts (Plate 24) was found, this a light weight awl produced on a tertiary, thinning flake. The raw material is a translucent dusky yellowish brown (10 YR 2/2 Goddard *et al* 1948) flint, probably of glacial origins. The flake on which this artefact is based is 29.9 x 15.0 x 3.9 mm in size, with a facetted platform and a series of flake scars on the dorsal surface suggesting that a thinning flake from a core tool was re-used for this tool. The distal end has a series of abrupt, scalar removals forming a straight edge at an oblique angle and forming a point in the distal, right corner of the flake.

Plate 24: Flint artefact
