Anafon Hydro-Electric Scheme Archaeological Survey

Anafon Hydro-Electric Scheme, Archaeological Watching Brief

**Ynni Anafon Energy Cyf**

Engineering Archaeological Services Ltd EAS Client Report 2015/16

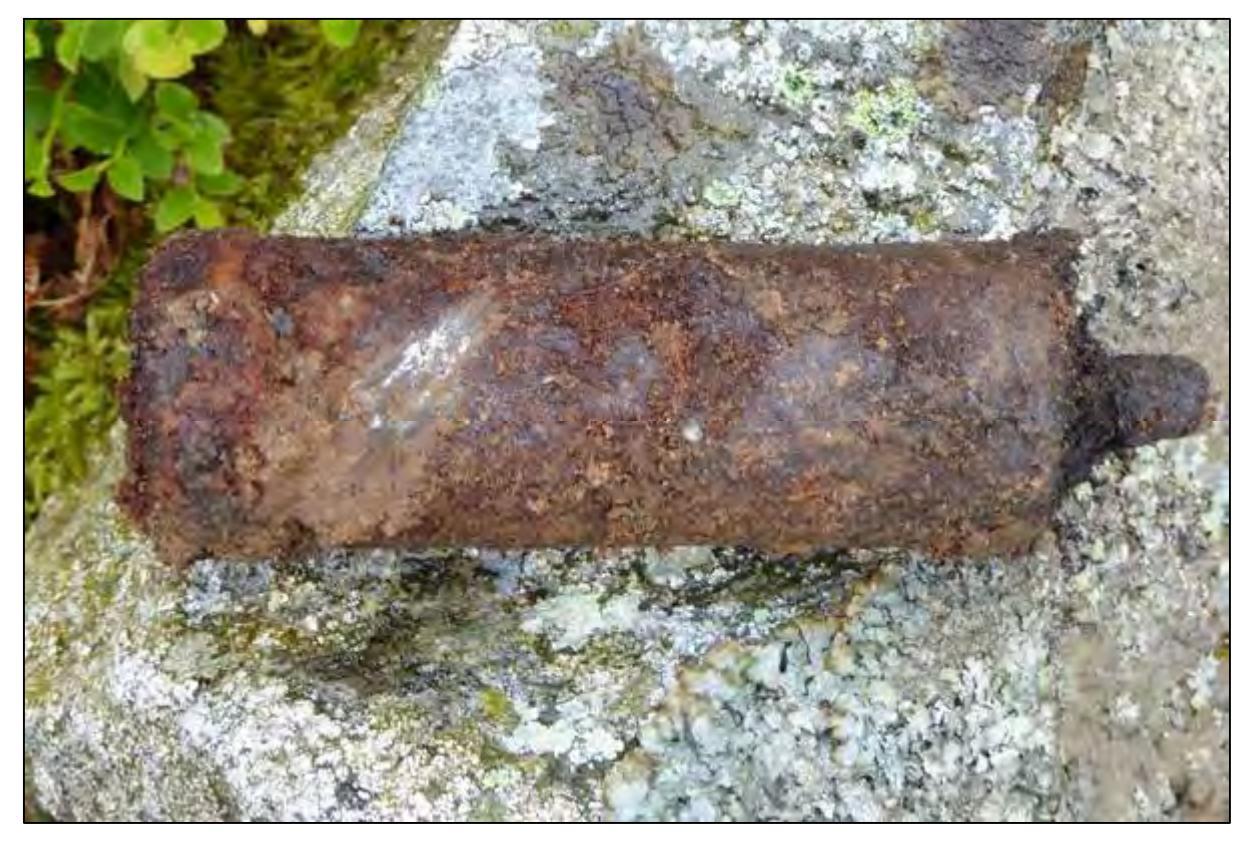
A second live mortar round (Plate 25) was found on the western bank of the Afon Anafon at SH 68384 71201. This was also destroyed by the bomb squad.

Plate 25: Mortar round from SH 68391 71200

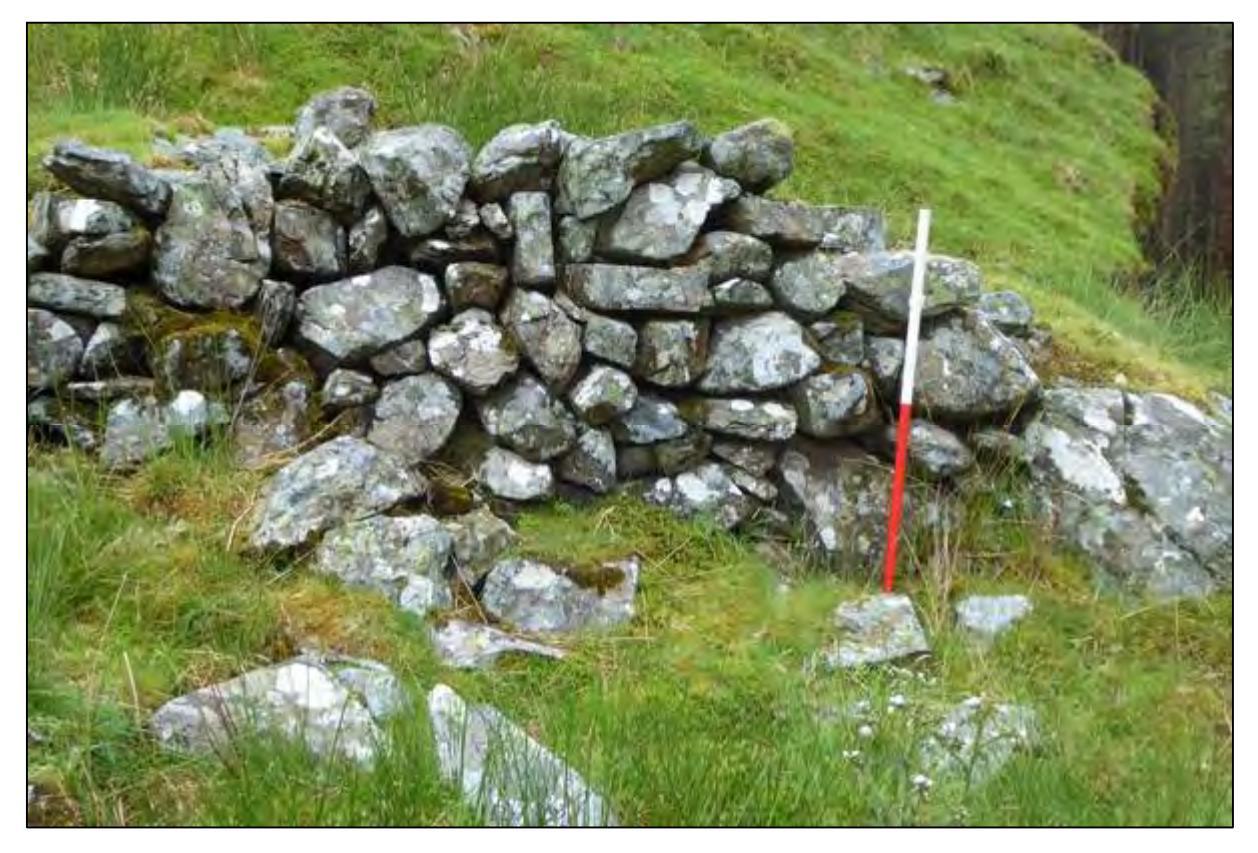
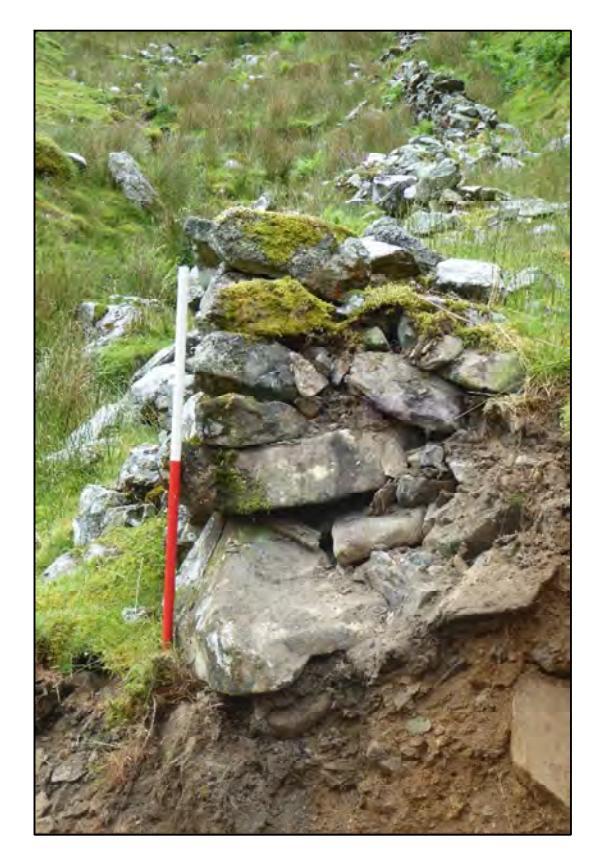
The wall stood to a maximum height of 1.1 m and was 0.8 m thick (Plates 27 and 28, Figure 6). It revets the side of the stream with a difference of about 1 m between the two sides of the wall. It is assumed that this was originally the boundary between the two properties with the current boundary now marked by a wire fence approximately 3 m to the west.

Plate 27: Wall

Plate 28: Section though the wall

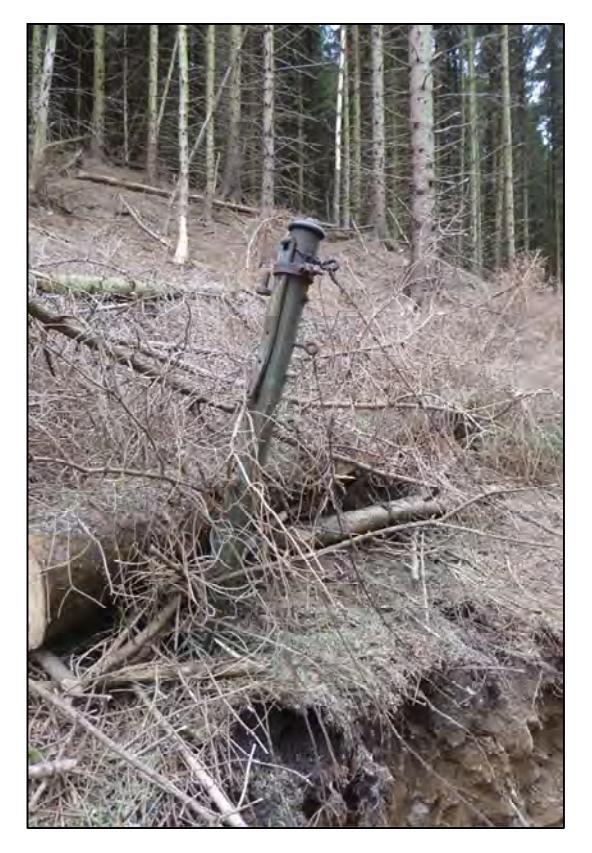
Approximately 50 m into the forestry the remains of a disused fence line was recorded at SH 67793 70955 (Plate 29). This fence consisted of four strands of wire supported by flat metal posts. The straining posts, however are of a distinctive form being circular cross sectioned, metal posts with an ogee cap. Wires are held by metal eye and the post immediately on the south of the pipeline has pintels attached to its southern side marking the position of a gate. Clearly a modern feature this fence line makes little topographic sense, however it corresponds with the legal boundary to the land owned by the National Trust

Plate 29: Fence

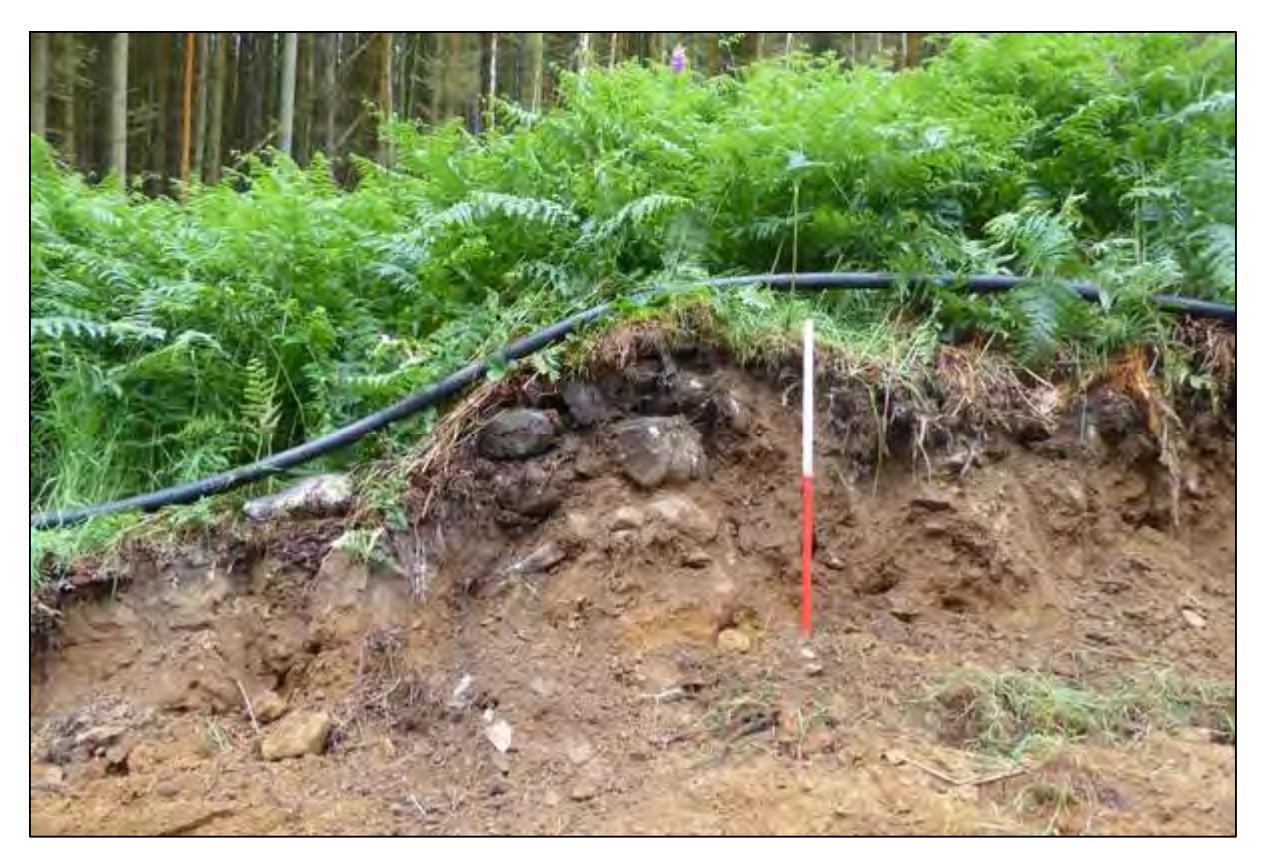
At SH 67556 71078 an earthen bank, or highly tumbled wall, was recorded (Figure 7, Plate 30). This is only 0.6 m high and 1.4 m wide and was partly terraced into the hillside with the eastern side of the boundary being approximately 0.5 m lower than the western side.

Plate 30: Boundary 1 in the forestry

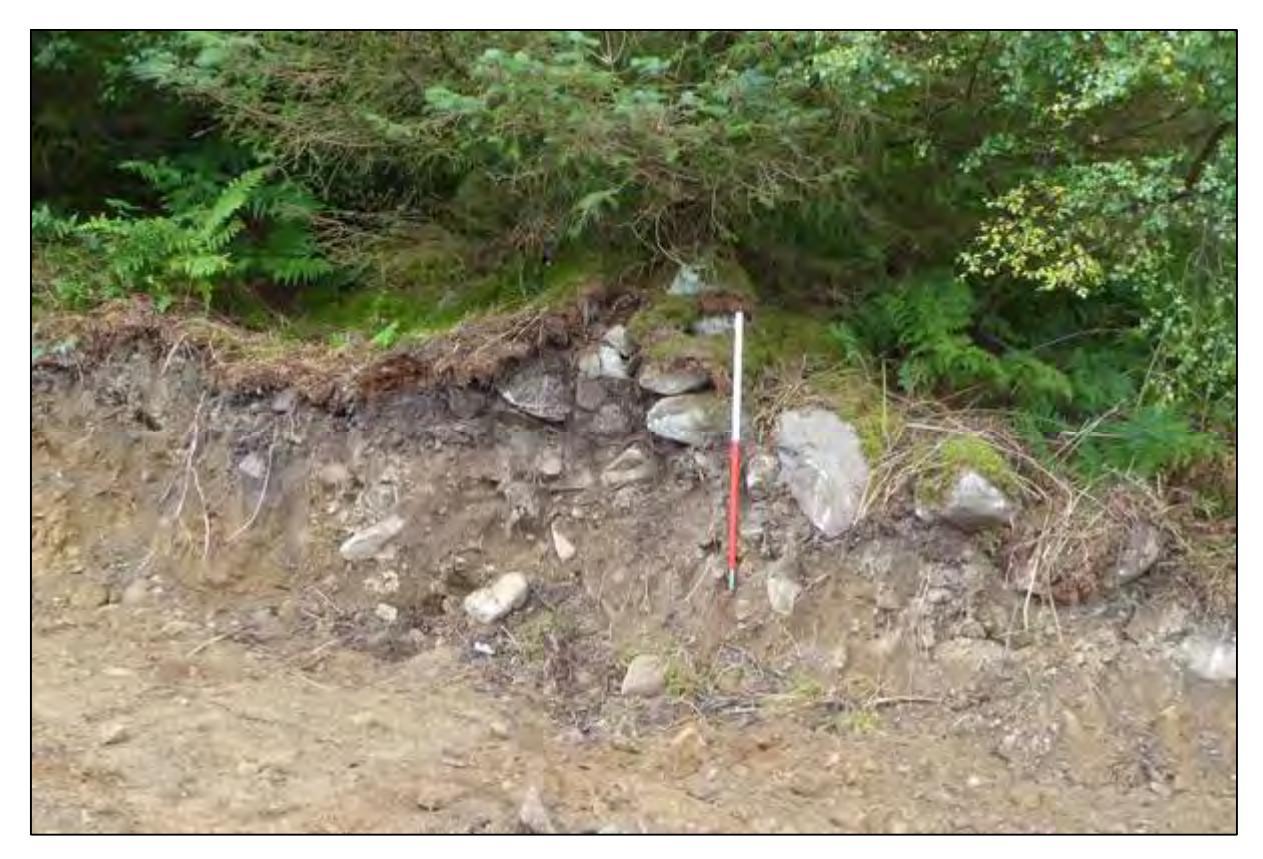
Another boundary was recorded at SH 66934 71613 (Figure 7, Plate 32). This is up to 0.6 m high and is 2.0 m wide and it is partly terraced into the hillside such that the western side of the boundary is 0.5 m below that on the eastern side. The form of this feature would suggest it was most likely an earth and stone bank boundary.

Plate 32: Boundary 3

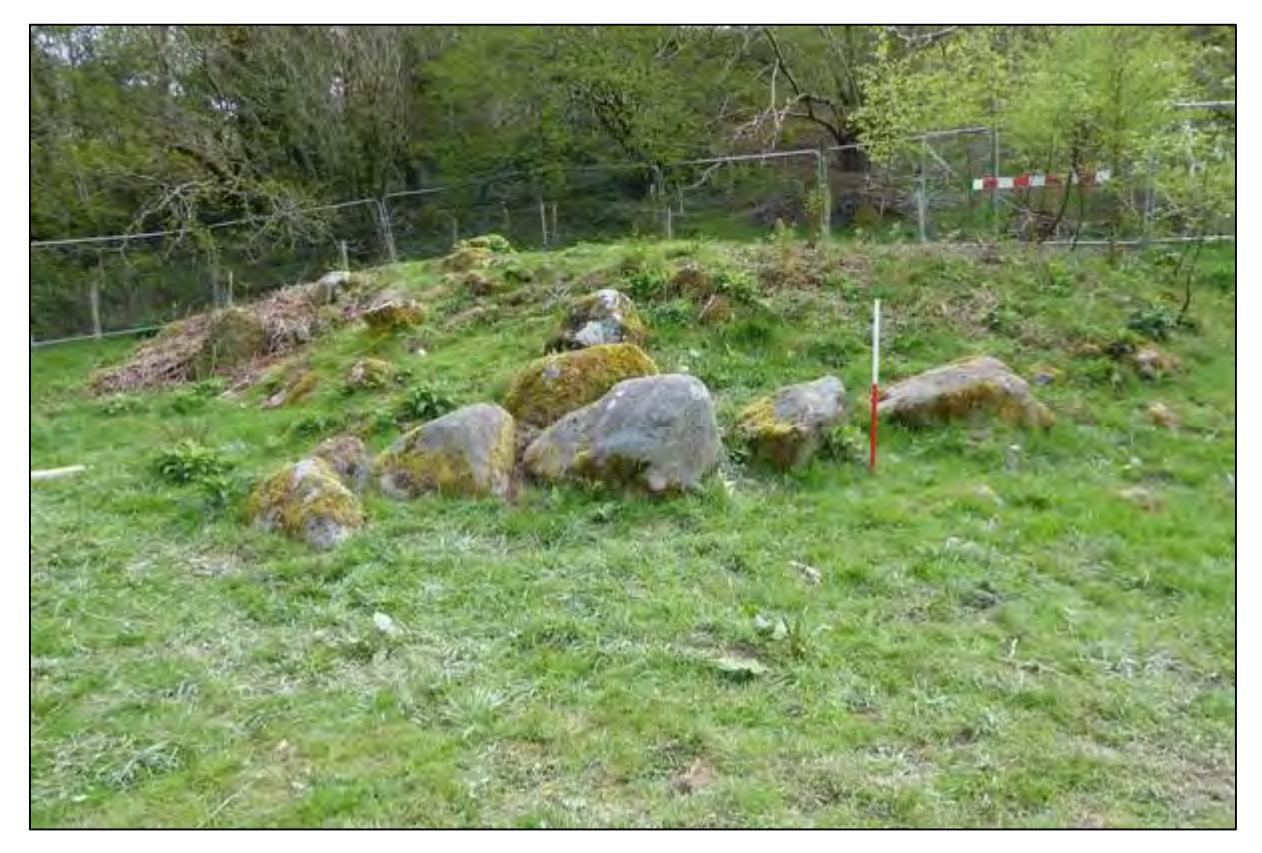
The area of the turbine house was subject to a continuous watching brief. Prior to construction the site was partly occupied by a large mound which appeared to possibly be a platform (Plate 33). The south western side of this mound was marked by a line of large boulders which lead diagonally towards the modern track which passes to the south and west of the turbine site (Plate 34). The mound was cut back as part of the digging of the foundations for both the turbine house and generator hall (Plate 35) demonstrating that this was largely a natural composing a mound of glacial gravels and boulders. There was some minor dumping of material on the mound, however the recovery of two "Northern Dairy" milk bottles from within the dumping suggest this was a modern activity.

Plate 33: The mound before construction started

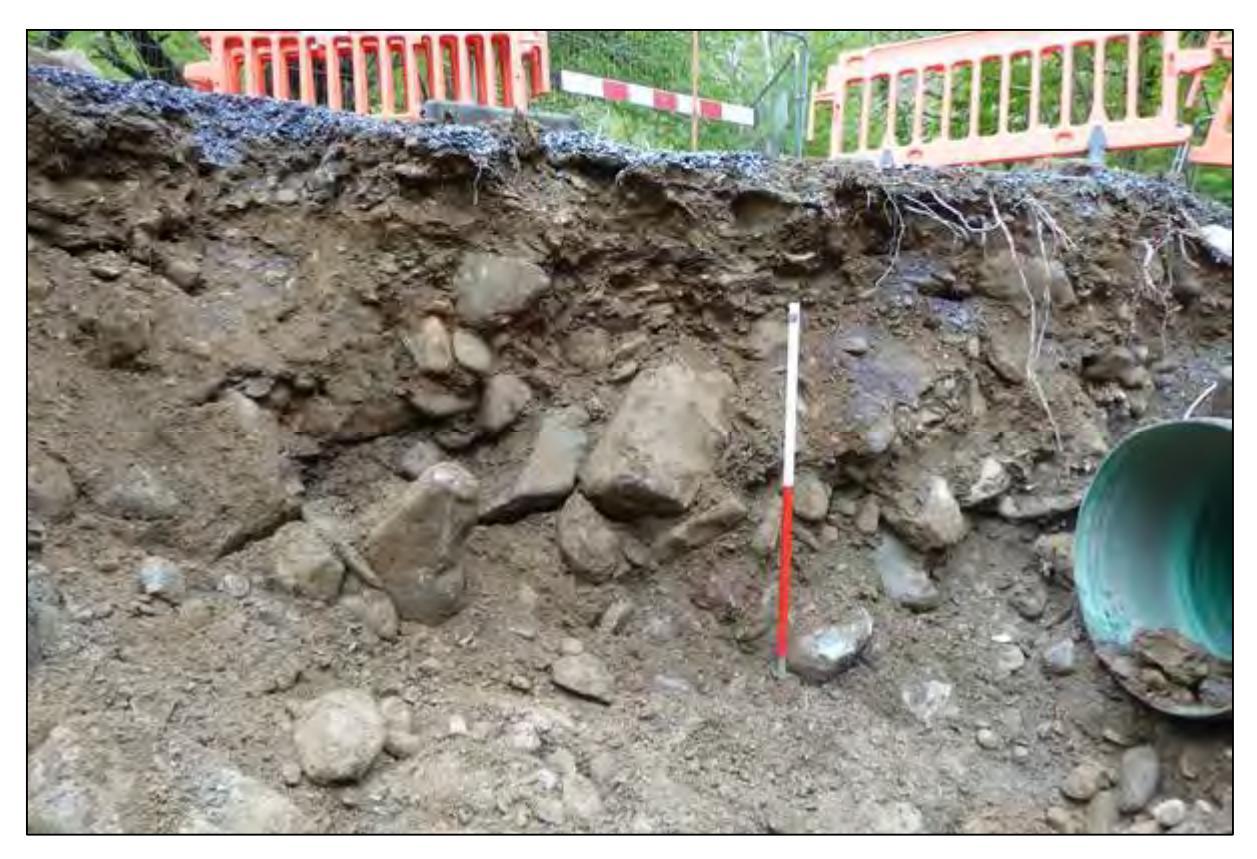
The foundations of the turbine and generator houses were dug through a similar gravel to that which made up the mound (Plate 36), however at a depth of about 1.20 m below the ground level a band of grey clay crossed the base of the foundations of the turbine house (Plate 37). This would appear to be a palaeo channel within the gravels of the valley, unfortunately the dating of this feature is unknown. The context of this layer, however, would suggest it is likely to be glacial or early post glacial given the depth to which it is buried below a gravel containing large boulders.

Plate 36: Natural boulders in side of turbine trench
