•	BRITISH WA	M+SW	<u></u>			1//			
A	BW Region				PRN	166			
	Waterway	M+BC			OS Sheet				
	BW Struc No	BR NO BI			NGR				
	Side	TOW OFF	CEN) отн	Photo Neg No	0 12 / 10 + 11			
	BW Owned	Y	(UK)	N	MMS/PMS				
в	County	GWENT			Alt Address	LLANOVER BRIDGE			
	LA District Parish Address	Monumora BR No. 8	HADT T	Torfaen	- BÁD MOVSE	·····			
	Date Listed		(j~v3~		SAM No	-			
	Grade	· · · · · · · · · · · · · · · · · · ·	*	11	Protected Are	a (NP) AONB CA SSSI			
	Serial No				Structures in Item				
)	Design Integ	A B	С	D	Context	VIL URB ISO GRO			
	Setting	A B	С	D	Condition	A (B) - (C) D			
	Group Value	Y	(N)	····	Present Use	ROAD BRIDGE			
	Listable	- Y	(\mathbb{N})		·				
Ε	Building Type PUBLIC RUAD BRIDGE								
	Date	1) 1812		2)		3) CIQ + CZO RENEWAL/			
	_ Designer(s)	WILLIAM	n cri	JSLEY		REBUILDING			
	Materials	BR (ST)_	EBR					
		TI	SL	СТІ	CER	AS OTH			
	S Features/ Tech Merit								
	Date Inspected	18	10 ¹	95	· · · ·	· · · · · · · · · · · ·

F Site Notes/List or Scheduling Description

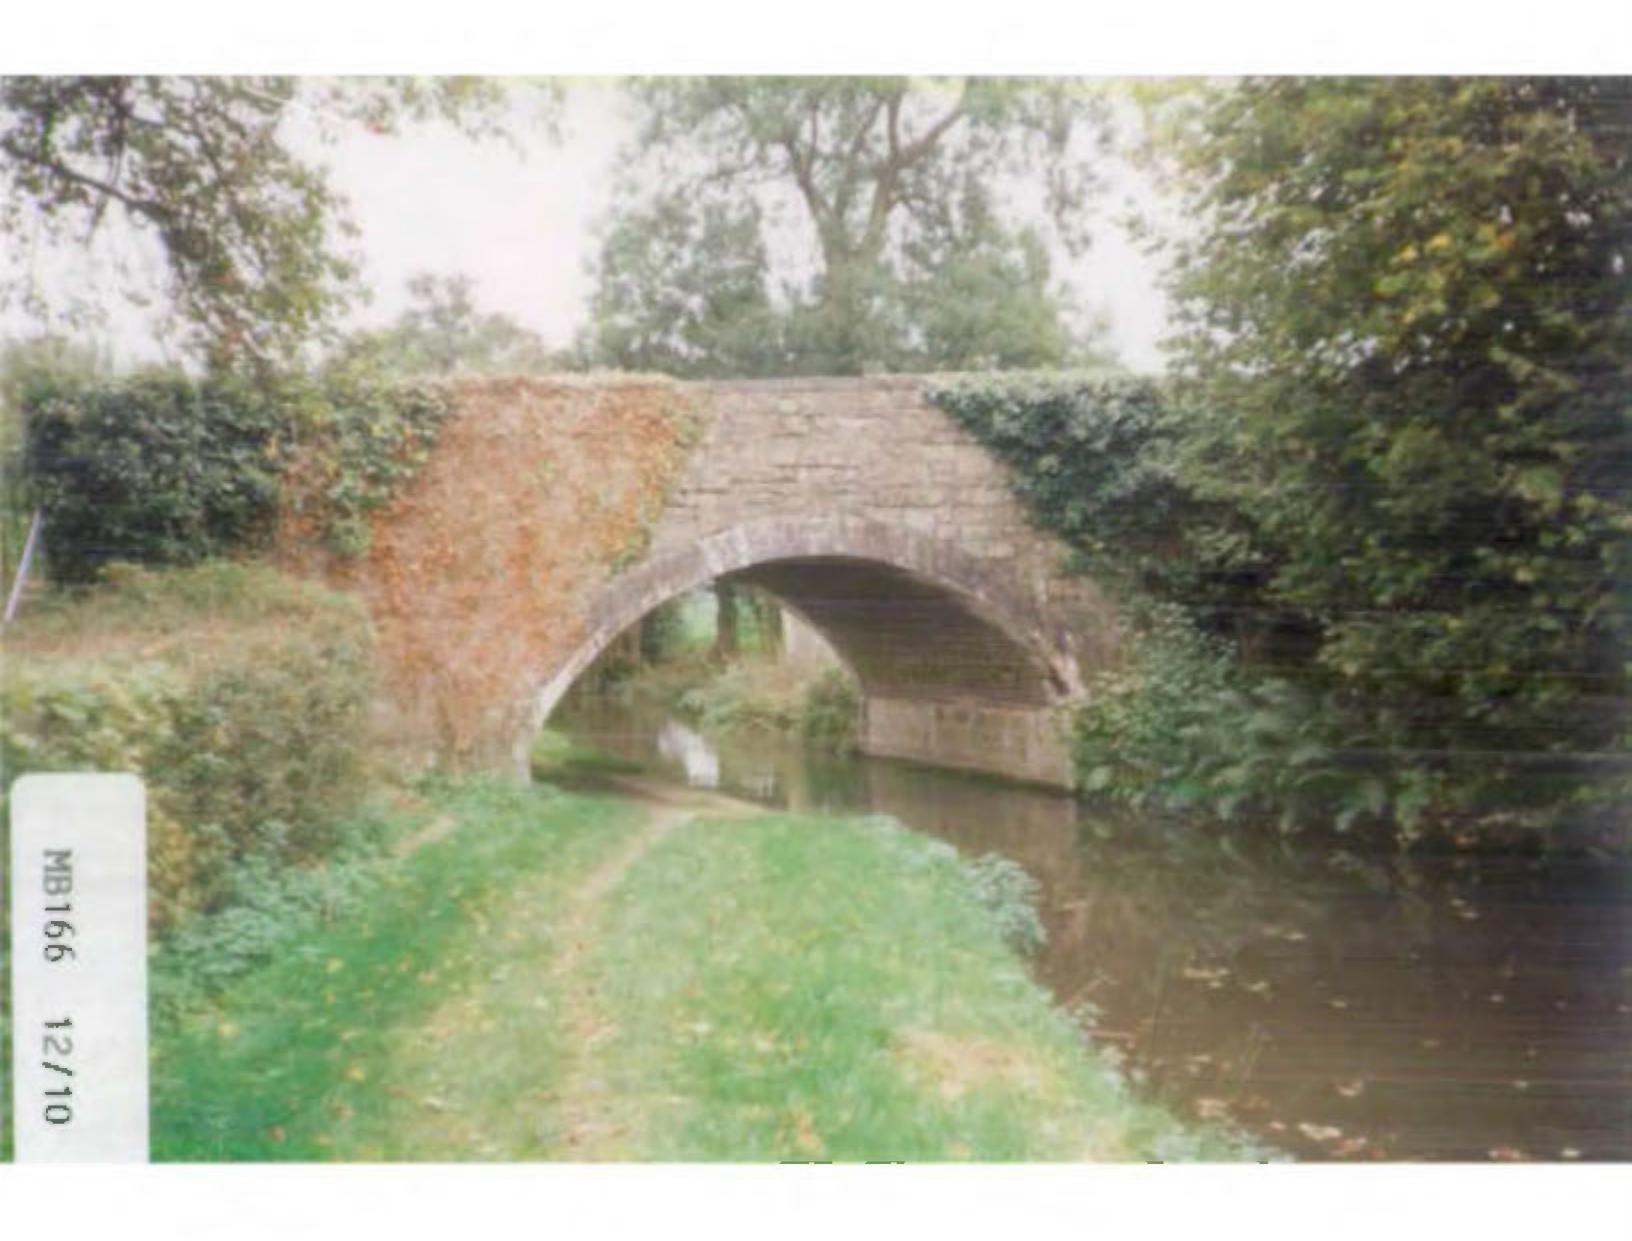
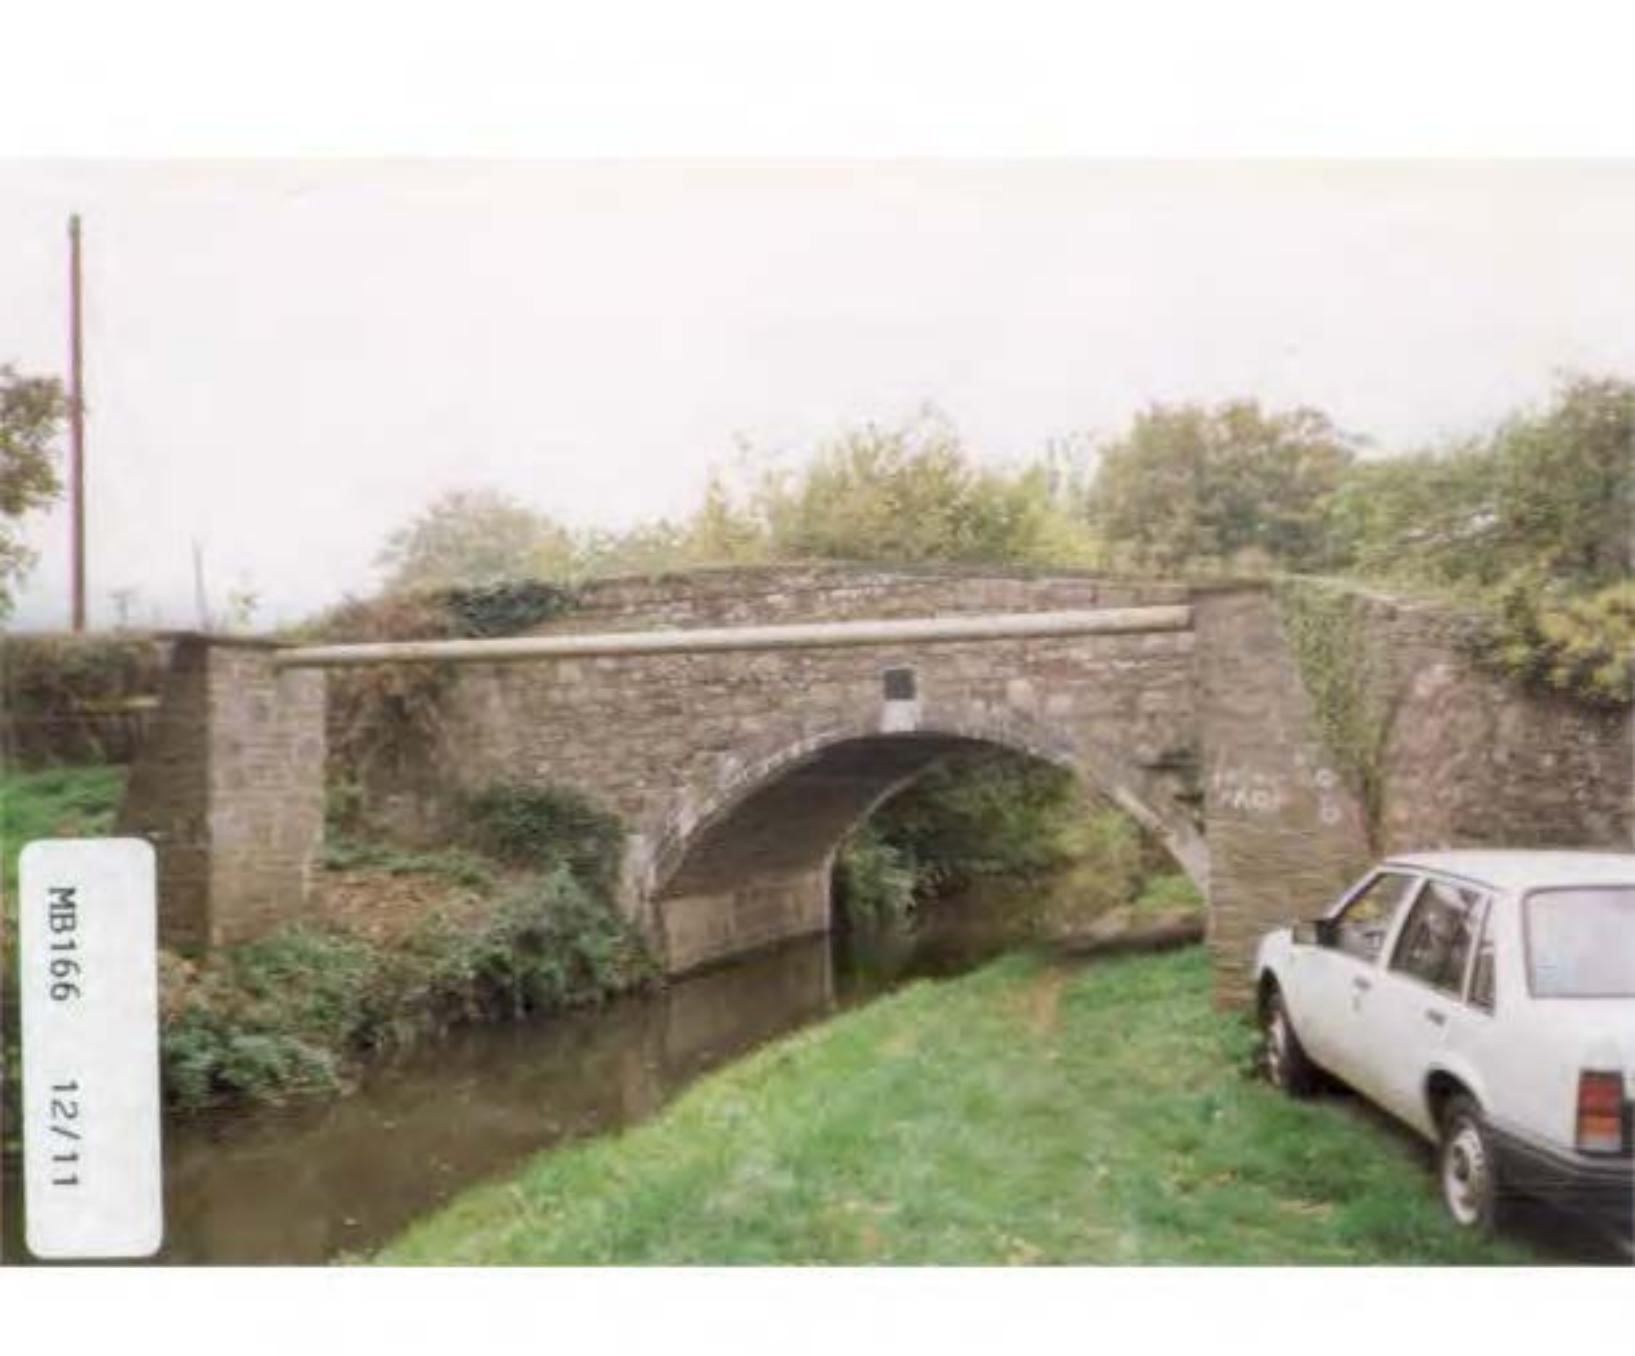
Public road bridge. c1812 with C19 and C20 renewal. William Crossley engineer. Coursed rubble sandstone. Segmental arch has been rebuilt with engineering brick voussoirs and soffit, and reconstituted stone beneath springing line. Slightly hump-backed parapet with engineering brick copings. Plastic pipe carried on MC20 rubble stone abutments just south of the bridge.
