MEDIEVAL AND POST-MEDIEVAL CROSSES

A THREAT-RELATED ASSESSMENT 2010-11

Prepared by Dyfed Archaeological Trust
For Cadw

RHIF YR ADRODDIAD / REPORT NO. 2011/1
RHIF Y PROSIECT / PROJECT RECORD NO. 100384

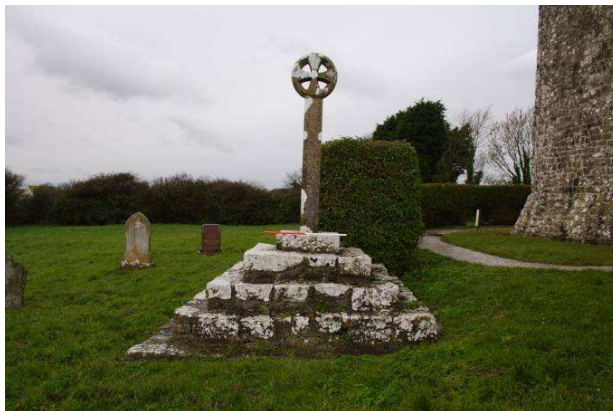
R Ramsey 2010.

A RCAHM visit to this site in 1922 recorded '..a restored cross, the shaft and head in one piece; it stands upon a base of three steps'. The Ordnance Survey, after a visit in 1965, considered the steps to be 'original' and the cross shaft and head to be modern. The monument lies some 6m to the south of the southern porch of the church and comprises a roughly square (3.4m sq. bottom step) platform of four steps to a height of c.1.2m upon which lies a 0.76m sq. by 0.2m high socket stone containing a 1.68m high chamfered (octagonal) shaft topped by a separate 0.6m diameter wheel cross to a height of 0.64m. The cross and shaft are unweathered and modern. The platform steps are well mortar pointed (recently repointed?) and may represent an original base for an earlier, perhaps medieval, churchyard cross.

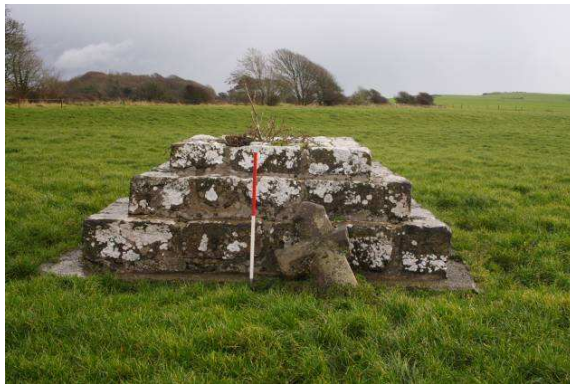
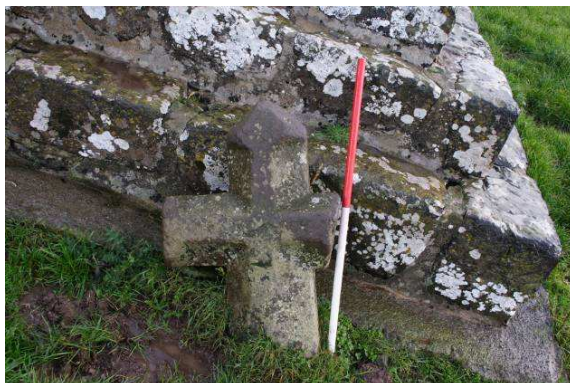
R Ramsey 2011

A 3m sq by 1.05m high 3-stepped mortared limestone cross-base situated in the field some 76m to the south-east of Park House (PRN 6982). The base lies on a modern concrete foundation set in the ground. At the time of a recent site visit a fragment of the, possibly original, stone cross-head (of hard reddish sandstone) was lying against the bottom step of the base; the cross arms are chamfered and appear octagonal in section; one end is complete, the other truncated. The cross-head is chamfered to a point at the top but is truncated at its lower, shaft, end; the cross measures 0.86m from top to bottom and the cross arms are 0.6m long in total, with the whole fragment measuring c.0.21m thick. No cross shaft was present on the site or in the near vicinity. The base was restored, in its original location, in the mid-1970s under the auspices of Baron Bernard von Friesen immediately prior to the sale of the Stackpole Estate by the late Lord Cawdor (pers comm. the owner of Park House, daughter of the Baron). The RCAHM in 1925 recorded the presence of the three-stepped base and described loose stones lying around it as part of the cross pillar, no mention is made of the cross head being present at that time. The monument is considered to be the in situ village cross of the deserted medieval village of Stackpole.

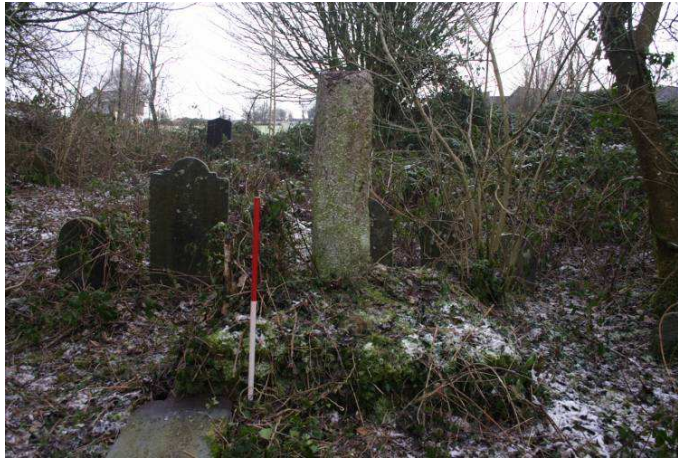
R Ramsey 2011

The probable shaft of a churchyard cross, minus its head, situated in the churchyard to the south of the ruins of Cilrhedyn church. The monument comprises a 1.35m high upright monolith measuring 0.4m E-W by 0.3m N-S, approximately rectangular in plan, and situated centrally upon a 0.38m high mortared roughly hewn shale base measuring 1.8m E-W by 1.7m N-S. A recess sculpted into the east side at the top of the stone, to a depth of 0.17m and height of 0.31m, was recorded by the RCAHM in 1925 as having formerly accommodated a sundial, which had gone by that time. The stone reputedly bore Ogam inscriptions but the Ordnance Survey observed none during their visits to the site in 1966 and 1977. It is possible that chisel marks present on the stone, still discernible today (especially on its SW edge), were mistakenly interpreted as Ogam. A visit to the site in December 2010 found the churchyard heavily overgrown and neglected.

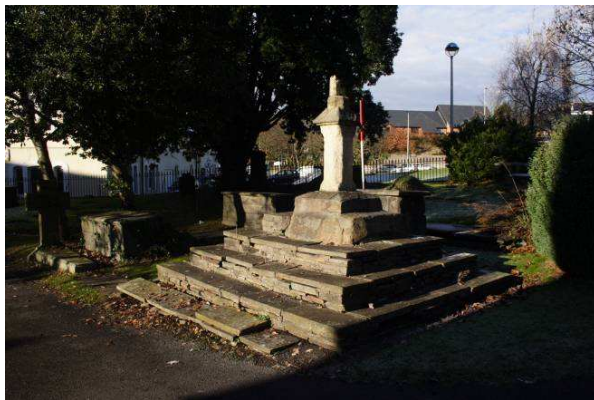
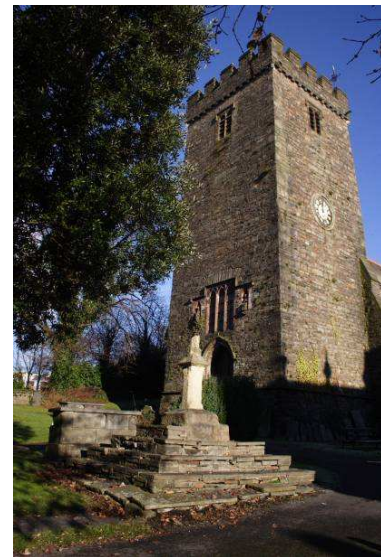
R Ramsey 2011

The RCAHM in 1917 described the churchyard cross, situated to the southwest of St. Ellwy's church west entrance, as a modern replacement of an earlier one, but added nothing more. In 1967 the Ordnance Survey described the monument as consisting 'of a medieval cross-base upon a calvary of five steps, surmounted by a modern cross-shaft'. The five-step rectangular platform (calvary) of neatly hewn mortared sandstone flags measures 4m E-W by 3.6m N-S at its base to a height of c.1m; the fifth step is restricted to being only 0.23m high by c.0.9m wide by 0.4m deep and is built up against the west side of a sculpted, nearly 1m square, sandstone monolith that acts as the cross plinth or socket stone. The plinth is itself partially stepped in appearance with a sculpted ledge or recess at a height of 0.3m around its east and northern sides to a level depth of 0.26m and 0.1m respectively; the height of the plinth stone is c.0.57m with the top equally chamfered on all sides to form a smaller square platform that accommodates the cross shaft. All that remains of the 19th century cross are three shaft elements of broached and chamfered yellow limestone or bathstone to a height of about 1.5m. The plinth stone is unusual and may represent an original medieval element. The stepped platform, which may also have medieval origins, was badly in need of consolidation at the time of the site visit in December 2010.

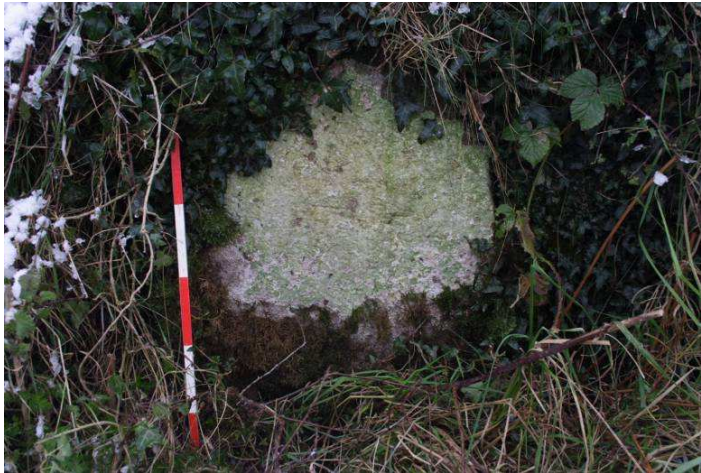
R Ramsey 2011

A cross-carved stone set in what appears to be a hedgebank, but is in fact a length of vegetation-covered stone boundary wall, on the south side of the road immediately to the east of a house named Dolwerdd. The stone is at least 0.65m high (where exposed above ground) and no greater than 0.99m wide; its depth is unknown because of its incorporation into the stone boundary. The exposed flat face of the stone has a 0.27m high simple Latin cross incised centre-left, which is obscured by an accumulation of lichen and moss growth. Nancy Edwards (2007) considers the cross-type as atypical of early medieval examples, concluding only that its date is uncertain. Historically, the stone was first described by Laws and Owen in the Pembrokeshire Archaeological Survey between 1897 and 1906 but it became 'lost' until rediscovered in 1983. The amount of vegetation surrounding the stone and its close proximity to the road make it potentially vulnerable to loss or damage.

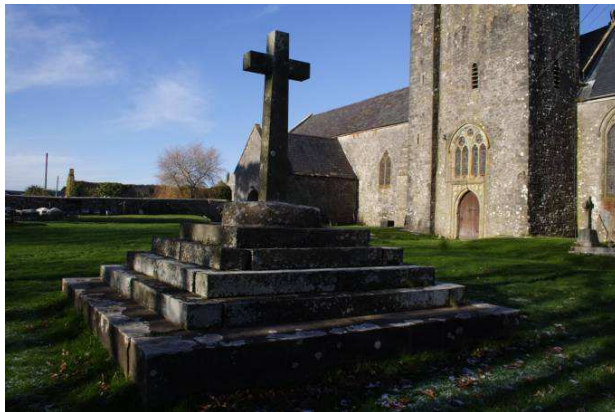
R Ramsey 2011.

It is recorded in *Archaeologia Cambrensis* (1882) that the churchyard cross was pulled down circa 1847 and some of the pieces placed within the church tower. The present cross (said to be in the same location as the original) is modern and set in a circular socket stone, measuring 1.2m diameter by 0.26m high, that resembles an old millstone. The socket stone may be the original stone from the former medieval churchyard cross. The cross is situated on a modern square five-stepped platform that bears a commemorative inscription 'To the Glory of God and the Memory of the Unnumbered Dead' over three steps on its eastern side; commemorating disarticulated human skeletons recovered from between the nave and chancel during restoration and building work in the church in the late 19th century. The monument is located in the churchyard to the south of St. Nicholas' Priory church.

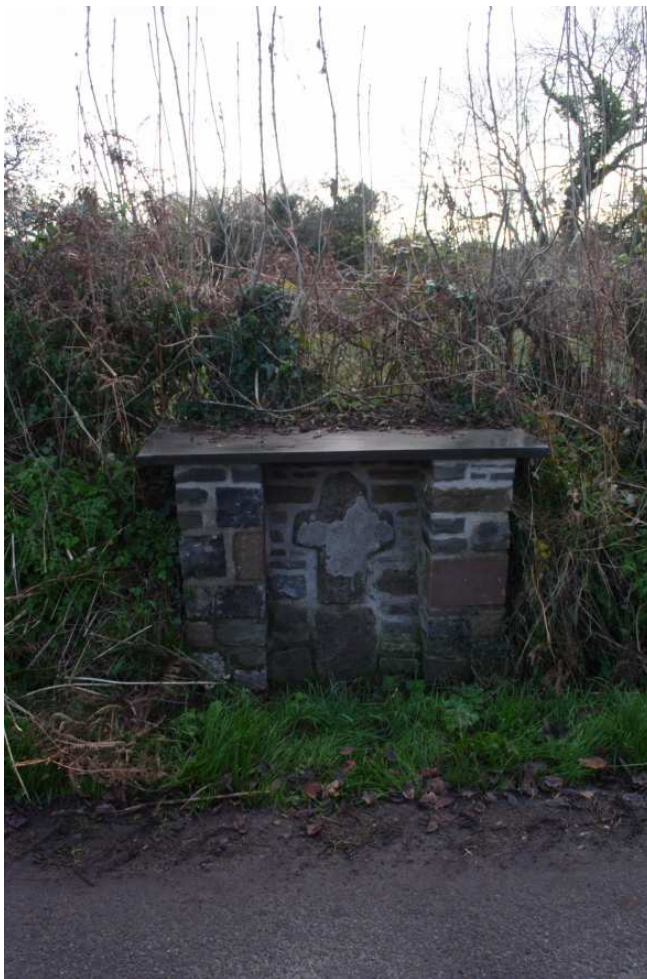
R Ramsey 2011.

A plain Latin cross-head built into the wall of a specially built masonry alcove set in the hedgebank on the south side of the road about 1km from the village of Jeffreyston. The cross is 0.52m high by 0.37m wide (cross-arms) and is of roughly hewn stone. The cross was originally discovered during the demolition of a nearby 'clom'-built cottage and placed in its current location by a former parish rector. Most authorities consider it to be medieval and it has also been conjectured that it is the original head of the Jeffreyston churchyard cross (PRN 3477) viz: Nancy Edwards (2007), in her discussion of the stone, states that the cross-head is the top of the later medieval cross, still standing in the churchyard, and has now been replaced with a modern head.

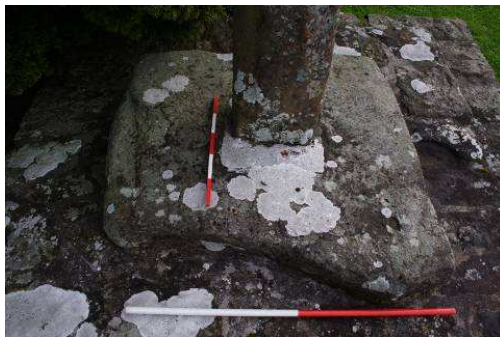
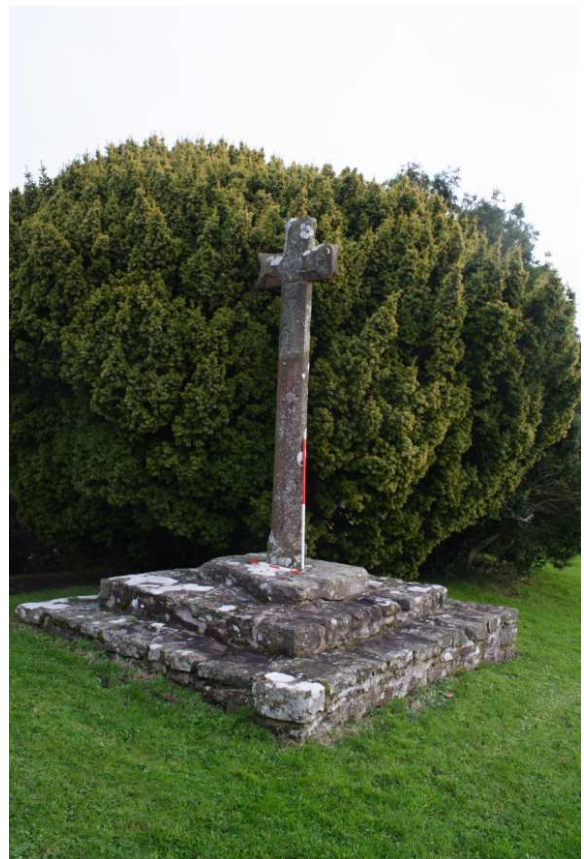
R Ramsey 2011.

A 2.4m high octagonal shafted cross with an equal armed cross-head measuring c.0.7m wide situated in the churchyard close to the southeast corner of the church tower. The cross is set in a crude roughly hewn rectangular socket stone that rests centrally on a two-stepped masonry platform. The shaft appears to be broach-stopped at its base and is tapering; there are two elements to the shaft, the smaller upper one has the remains of an iron pin in it indicating past repair and there are two newer looking rivets at the top of the lower element (all are on the west side). It is possible that the upper element of the shaft had been lying elsewhere and was added at a later date once re-discovered (*cf* photo in Rees, S 1992 and later DAT photos). The cross-arms are octagonal with widening ends. The RCAHM, in 1925, considered that the head was modern with the rest being original. It is described generally as a 14th century preaching cross by Sian Rees (1992); J Rigg of the OS (1965) considered that the cross-head and shaft were 'coeval and may be a modern restoration', whilst implying that the restored two-stepped base and socket stone may be original. Some authorities think it possible that the roadside cross (see PRN 3476) situated some 0.6km to the southwest of the church is the original cross-head to this monument.

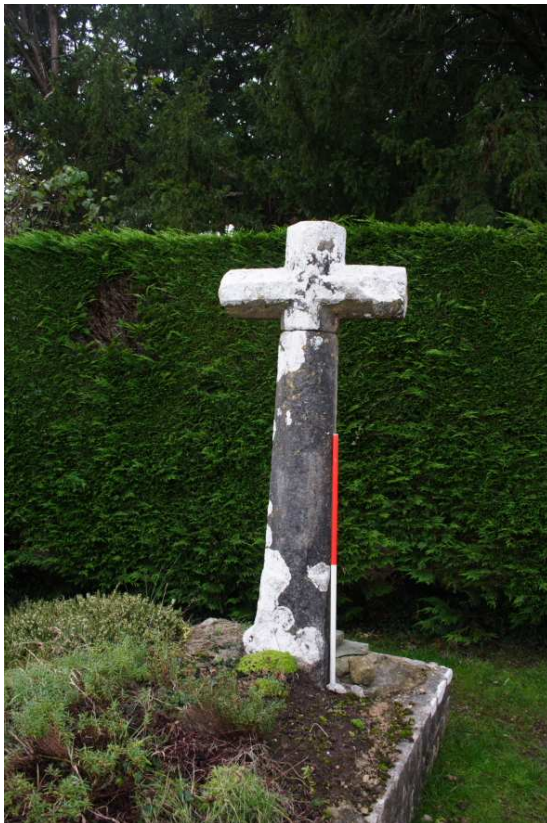
R Ramsey 2011

A 1.75m high stone cross situated on a restored single-step rectangular masonry base some 2m to the south-west of the south-west corner of Upton chapel. The cross comprises a 1.32m high tapering octagonal shaft, broached at its base up to circa 0.5m, surmounted by a 0.43m high by 0.75m wide octagonal cross-head. A small, concrete-filled hole in the top of the cross-head indicates the probable former presence of a finial. No socket stone is visible as the rectangular base has been turned into a raised bed and is planted with shrubs and flowers. A late 18th to early 19th century painting of Upton Castle by Warwick Smith shows the cross, complete with a spherical finial, situated on a two-step stone base and in the same location as it is today. The general condition of the cross is good with only slight damage to the top of the shaft and the northern arm of the cross-head. The monument is listed as part of a group listing, Listed Building Grade II, along with Upton Castle and the chapel.

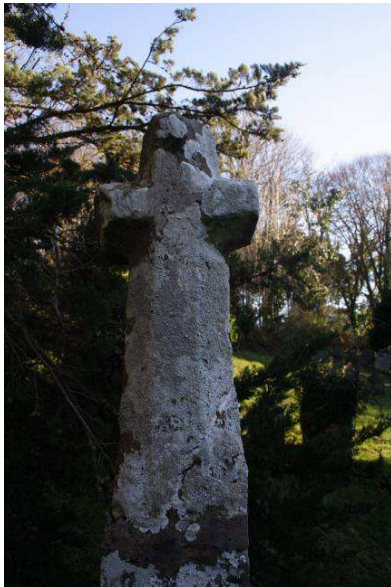
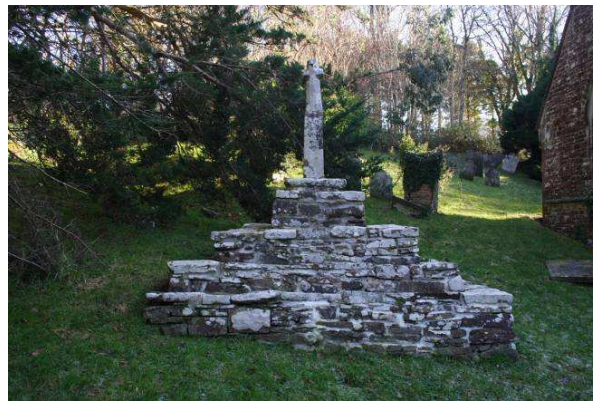
R Ramsey 2011.

A medieval churchyard cross located, unusually, on the north side of St. Issel's church some 5m from the north porch. The monument comprises a restored four-stepped masonry base (circa 3.1m square by 1.38m high) upon which is set a 1.41m high cross set in a socket stone. The cross comprises a 0.71m high by 0.22m square plain lower shaft of sandstone (probably modern) with a combined shaft and cross-head measuring 0.6m high by 0.25m above. The upper element has broach stops at its base with the remaining parts, including the cross-arms, being octagonal in section; it is possible that the cross-arms have been truncated, hence their stubby appearance. It is considered that the upper, cross, element is medieval. The socket stone measures 0.62m by 0.55m by c0.10m high and may be an original feature; two metal pegs have been driven or drilled into the surface of the stone to the north and south of the cross. The monument has Grade II Listed Building status.

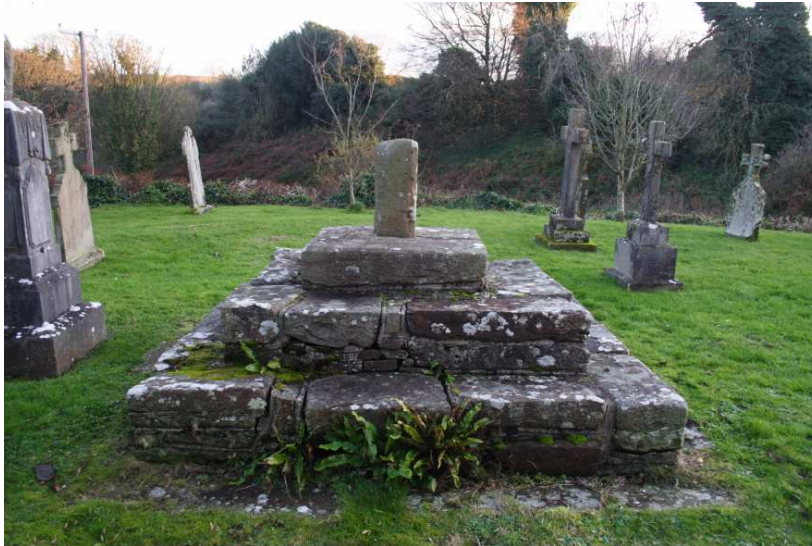
R Ramsey 2011.

The remains of a churchyard cross comprising a restored four-stepped rubble masonry base with a 0.6m high by 0.3m by 0.12m upright fragment of cross shaft centrally set on top of it. The shaft fragment is much weathered but there is a hint that it was chamfered and it may have at sometime appeared octagonal in section. The RCAHM, after a visit to the site in 1915, described it thus 'a fragment of the stem of a tall cross stands upon its original base'. The base may be original but it is much restored. There is a commemorative stone tablet on the second step of the base on its west side with the inscription 'PREACHING CROSS CIRCA 900'. The monument has Grade II Listed Building status and is located in the churchyard to the south of St. Elidyr's church.

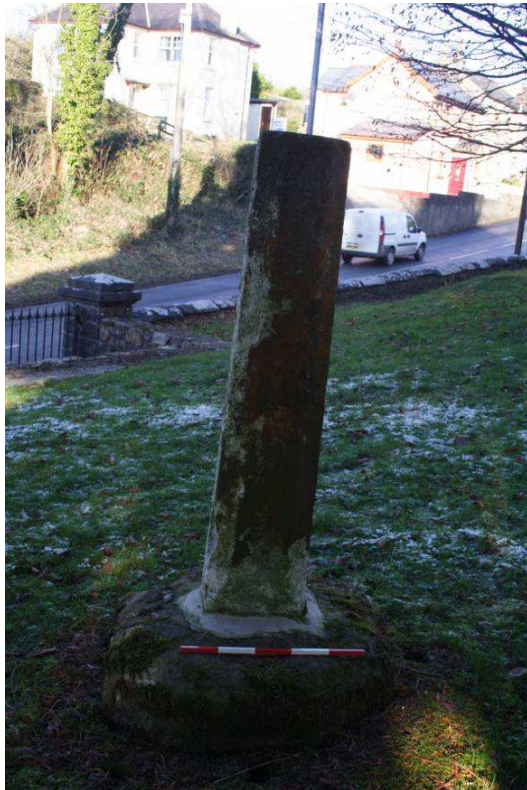
R Ramsey 2011.

A 1.35m high tapering octagonal sandstone cross-shaft, with broached stops near its base, and set in an octagonal socket stone, is located in the churchyard to the southwest of St. John's church. The octagonal socket stone is chamfered and measures 0.8m across by 0.25m high; the cross-shaft appears to have recently been re-set into the socket with concrete. The cross was moved to the churchyard from its original siting at SN1131 1168, shown on the 1907 edition of the 25" Ordnance Survey map. The cross is mentioned by Richard Fenton in his Historical Tour Through Pembrokeshire (1811).

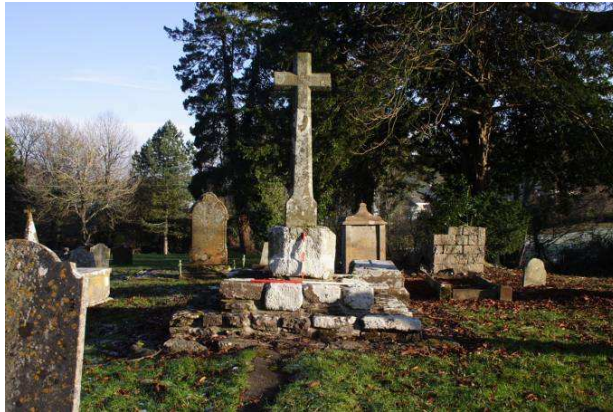
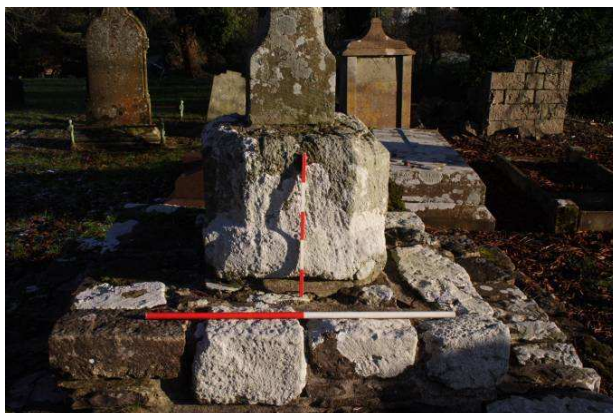
R Ramsey 2010.

A 0.54m high two to three-stepped restored masonry cross base and original socket stone surmounted by a modern cross is situated in the churchyard to the south of St. Peters church. The base measures 2.9m by 2.57m and the broached rectangular socket stone is 0.56m high by 0.64m by 0.86m, both elements are considered to be medieval. The modern cross comprises a 1.26m high tapering broach-stopped octagonal shaft and a 0.6m by 0.6m equal-armed octagonal Latin cross-head. The RCAHM, after a visit to the site in 1918, recorded the presence in the churchyard of what they considered to be part of the cross-head of the original cross; and in 1965 the Ordnance Survey confirmed the presence of the fragment at NGR SN1553 1444. However, by 1975 (OS) the original cross-head was missing although the then vicar thought that it was still present somewhere in the churchyard. During a visit to the churchyard in December 2010 the cross-head was not found, but recent vegetation clearance undertaken had revealed stockpiles of worked stone/architectural fragments at the northern and eastern boundaries of the churchyard; the missing cross-head may be hidden amongst the collected stone.
