MEDIEVAL AND EARLY POST-MEDIEVAL MILLS

A THREAT-RELATED ASSESSMENT 2013-14

PEMBROKESHIRE & additional CARMARTHENSHIRE SCHEDULING RECOMMENDATIONS

RHIF YR ADRODDIAD / REPORT NO.2014/7
RHIF Y PROSIECT / PROJECT RECORD NO. 102665
DAT 105

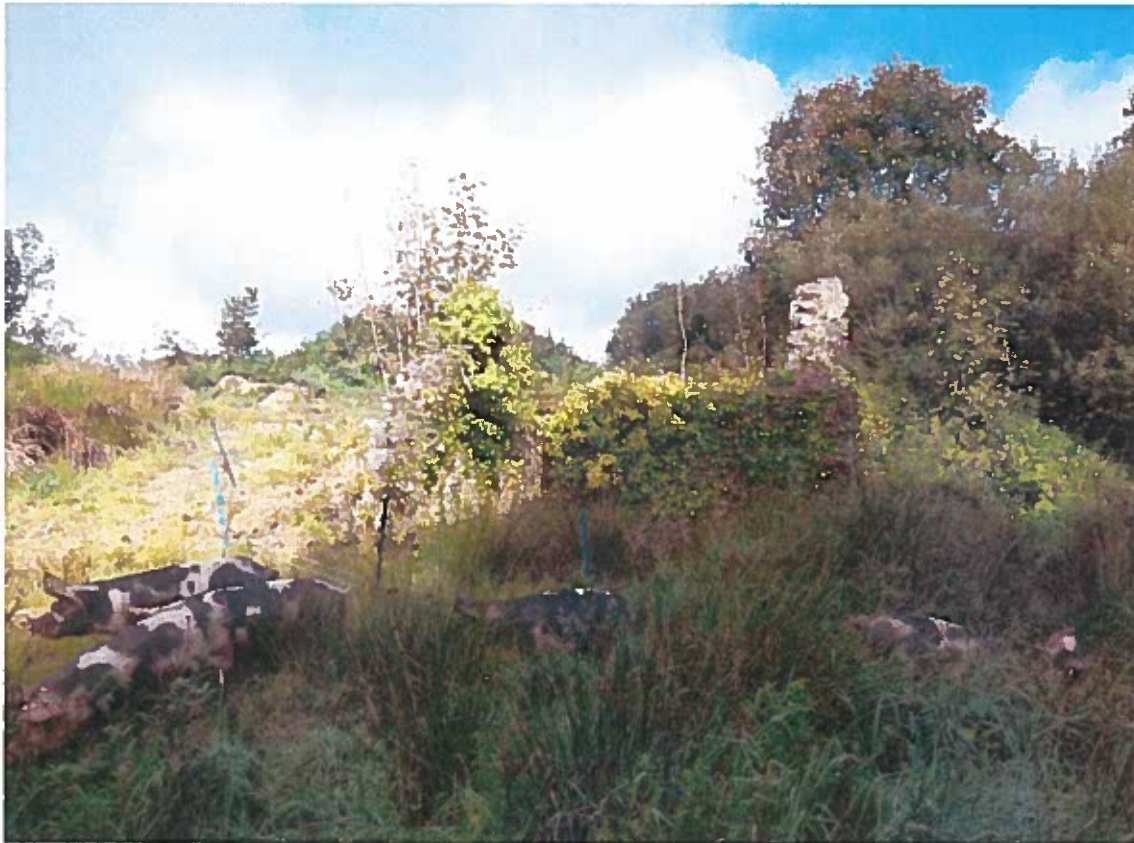
The ruins of Old Mill (PRN 17957), a gorse mill at Upper Eweston Farm, Pembrokeshire

The building is near intact and the current owner told me that he recently applied to put a tin roof on it, in order to preserve the masonry, but ran into problems with PCNP regulations.

We recommend that the site is comprehensively surveyed - the water management features are apparently preserved, if silted and overgrown - and its future management reviewed. The owner would like to restore/preserve the site. A gorse mill is a rare site type in west Wales and this one, of apparent similar dimension and appearance to that (from Denbighshire) now rebuilt at St Fagans, is certainly worth protecting.
