Historic Environment Feature Management Report:

Mount Pleasant Iron Age Defended Enclosure

UID: 302 000

PRN 12269 Name MOUNT PLEASANT

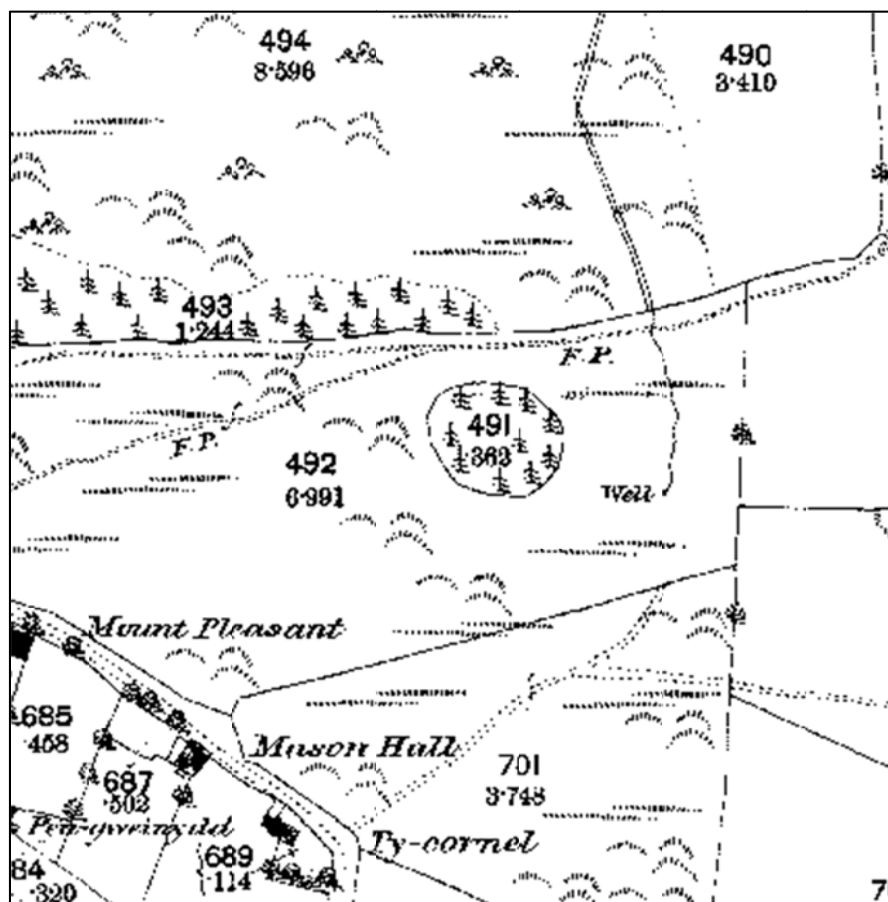
Detail from the Ordnance Survey 1st edition map (1889) © and database right Crown copyright and Landmark Information Group Ltd (All rights reserved 08/05/2012)

An Iron Age defended enclosure. It can be identified on the Ordnance Survey 1st and 2nd edition maps (1889) as an enclosed circular feature covered with conifer trees standing discretely in an area of unimproved grassland. Its isolated position and coniferous tree cover suggests that the woodland was deliberately planted to create a picturesque feature, as part of a wider designed landscape. The shape of a circular earthwork bank with an entrance on the NE side is shown on the most recent Ordnance Survey mapping (Mastermap 2011) mapping. Recent aerial photographs (Ordnance Survey Next Perspectives 2009) show the site is still covered with trees with a thick canopy.
