Historic Environment Feature Management Report: Kings Mill, Farmstead

Customer Reference Number: A0028568

UID: 303,302

PRN 12488 Name KING'S MILL

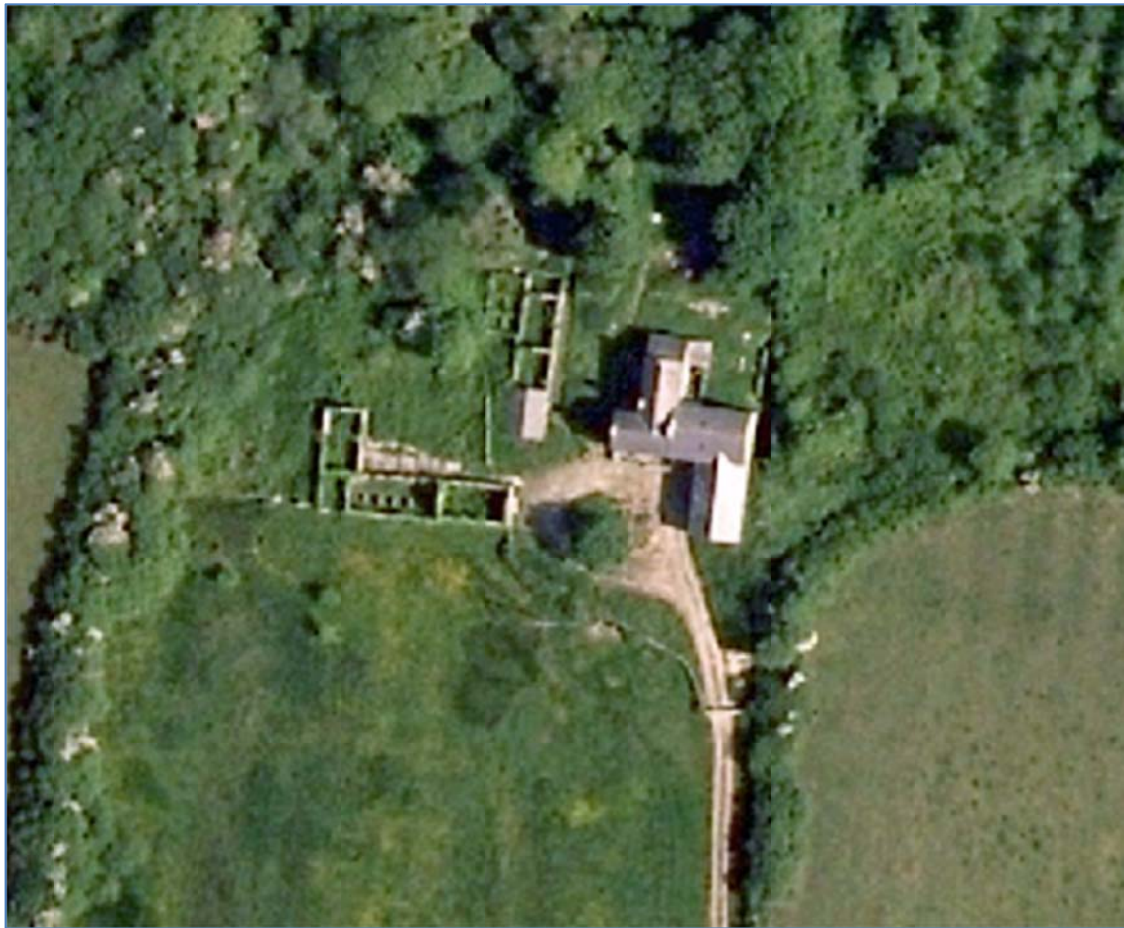
Kings Mill is a former medieval water driven corn mill. The extant ruins at the site, being the subject of this report, comprise an L shaped range of buildings and a further rectangular building to its NE. The standing ruins are of a 19th century farmstead established at the site which may have incorporated former ancillary buildings for the mill such as storage or workshops. Below ground archaeological remains of both the farmstead and earlier features associate with the mill may survive. The whole complex is medieval in origin with earliest known reference being a mention in a land grant in 1591. The main mill buildings (PRN 7848) the farmhouse now called Corn Mill House PRN 59432) are both Listed and occupied buildings lying in the east of the complex. The 19th century layout is clearly shown on the 2nd edition Ordnance Survey Map (1907). Recent aerial photographs (Next Perspectives 2009) show the buildings as roofless but standing to full height.

- Cut back vegetation by hand in order to prevent further damage and to enhance the visibility of the structure.
- Do not pull-up by the roots as this is potentially destabilising to masonry bonds.

It may be desirable to carry out a programme of masonry consolidation and re-pointing in order to make the structure safe. Contact Dyfed Archaeological Trust for further advice.
