# Historic Environment Feature Management Report:

## **Nant Coli farmstead**

UID: 311033

**PRN 36056 Name** NANT COLI

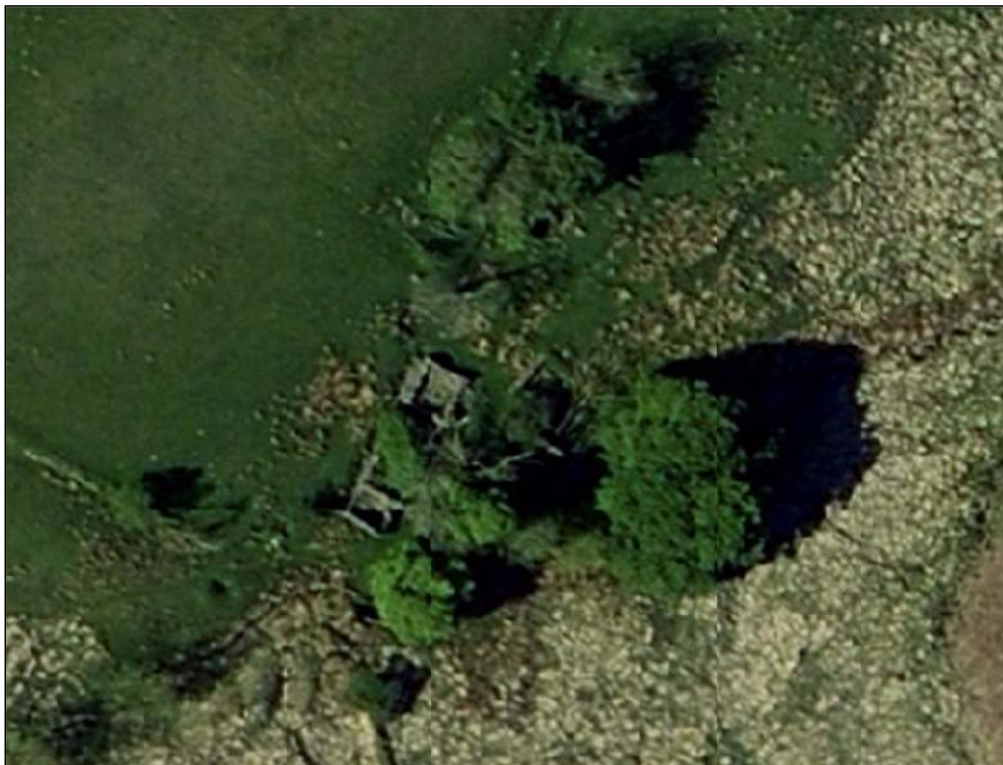
'© Next Perspectives. Welsh Assembly Government 2009'

Recent aerial photographs (Ordnance Survey Nest Perspectives, 2009) indicate the farmstead as being ruinous and lying within a grazing area under scrub and tree growth. The main management issue for this site is the control of damaging vegetation which has the potential to damage buried archaeological remains through the disruptive activity of root development, and built structural remains by the prising apart of masonry bonds.

- Remove mature trees which are at risk of wind throw and could threaten the site through uprooting (root plate damage) or falling limbs.
- Remove any young trees or vegetation growing out of the wall tops but cutting by hand. Do not pull-up by the roots as this is potentially destabilising to masonry bonds. Spot treat to prevent re-growth.
- Cut any scrub back by hand in order to retain the visibility of the cottages.
- If present maintain a canopy of mature trees over the settlement. This will reduce light entering the ground, inhibiting scrubby vegetation growth.
