Tir Gofal Farm Visit Report

Blaenwaun Ganol

W/11/438

ACA Project Record No 39041

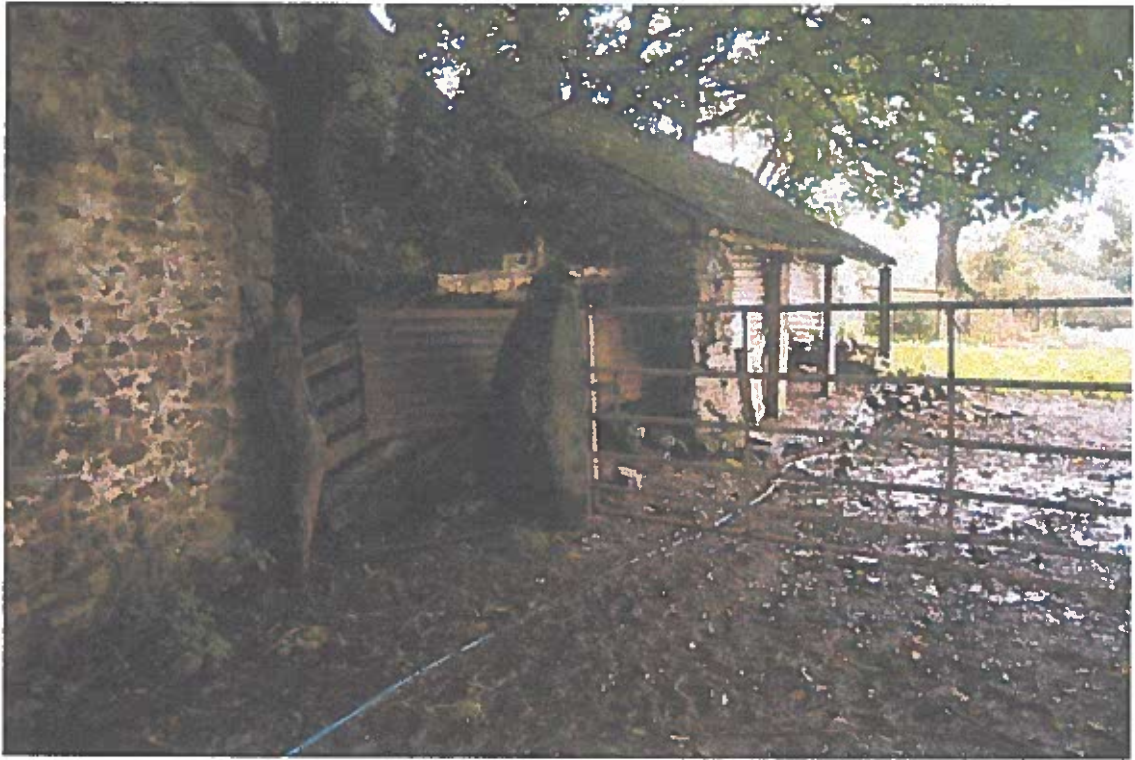
This stone stands approximately 1.6m high and is 0.7m wide and 0.3m thick. It is now used as a gate post. In 1979 it was recorded prostrate and was noted as a possible Bronze Age standing stone. There is nothing in the size or shape of the stone to suggest that it ever was anything other than a gate post - there are other similar sized stones in use as gate posts on the farm.

Gate post 9458.

There are no management recommendations.

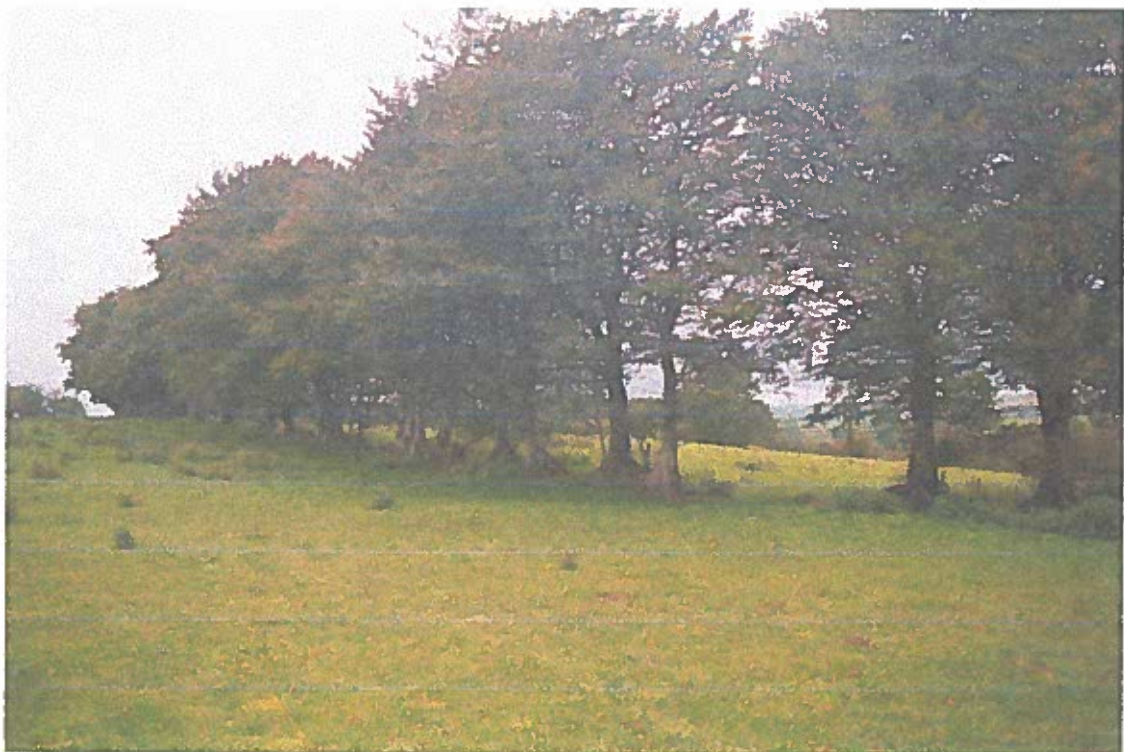
The farm holding of Blaenwaun Ganol now includes the land and buildings of Blaenwaun Uchaf. Blaenwaun Ganol farmstead, PRN 39050) dates to the second half of the 19th century, but the site is clearly more ancient. The original Blaenwaun Uchaf farmstead (39043) lay 300m to the north of Blaenwaun Ganol farmstead and is equally ancient, but was removed to its present location (39055) in c. 1876. The land of the holding is totally enclosed, but nevertheless three distinct though overlapping zones of enclosure can be detected. To the east of Blaenwaun Ganol and old Blaenwaun Uchaf the land falls away gently onto poor quality rushy and boggy ground. The tithe map and early OS maps show that in the 19th century this was partially enclosed. Indeed, the enclosure pattern of this area is still weak and defined by low stony earth banks topped with straggling hedges and/or ditches. In some instances the hedges on the banks have completely gone and the area has reverted back to moorland. In a zone roughly from Blaenwaun Ganol and old Blaenwaun Uchaf farmsteads to the west up to the Llanwenog/Llanwenog parish boundary on gently sloping east-facing land the field system is old-established and consists of small irregular enclosures surrounded by earth banks topped with hedges. The land-use here is improved pasture and the boundaries are in fair to good condition with very little dereliction of hedges. Some hedges contain distinctive hedgerow trees particularly those that line the lane that runs east from Blaenwaun Uchaf farmstead. The third zone lies in Llanwenog parish on the highest point of the farm to the south of Blaenwaun Ganol. The enclosure pattern here though dating to at least 1840 has the appearance of being more recent than that to the east. Apart from roadside boundaries which are in good condition the low earth banks are now devoid of stock-proof hedges though two of them have lines of mature beech trees on them.

General view of farm, 39042, showing beech trees on old hedgebank - zone three of the enclosure pattern.

It is important that the field boundaries of what is probably the most ancient enclosed land - in the zone to the west of Blaenwaun Ganol farmstead - are maintained in their current condition; this will require management and a little repair work where gaps have begun to open in some hedges. Elsewhere the less ancient enclosure pattern has begun to break down; no maintenance or management of boundaries is required where this has occurred.

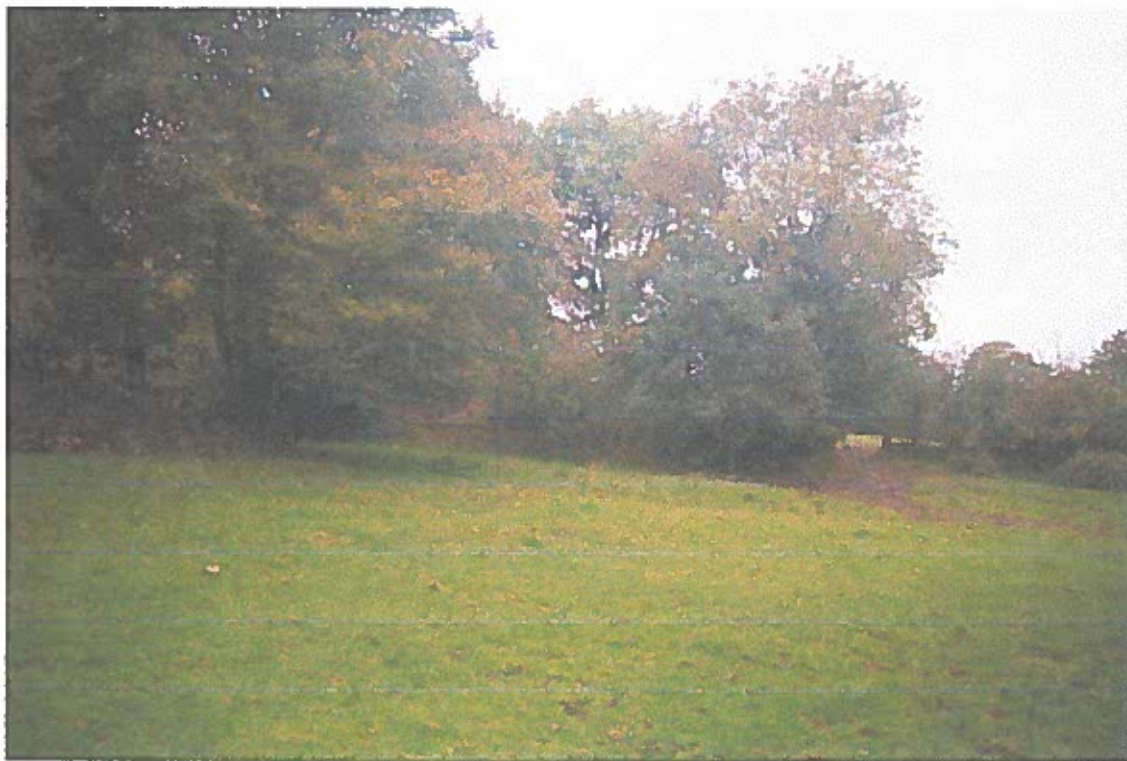
This is the original site of Blaenwaun Uchaf farm prior to its relocation in about 1876. According to the owners of Blaenwaun Ganol the present Uchaf was built in 1876. This corresponds with the documentary evidence - the old farm is marked on the tithe map of 1844 but was deserted and the buildings gone by the OS survey of 1887. It is represented by a 'yard' defined by hedgebanks with a enclosure surrounded by hedgebanks to the west. The buildings consisted of two parallel ranges facing each other across the yard. These are now represented by low earthworks. It is uncertain which was the house and which the outbuildings. To the east of the buildings lies a pond (39044), to the southwest a gin (39045) and to the west a corn-drying kiln (39046).

This gin which lies in the old 'yard' of the deserted farm of Blaenwaun Uchaf is not marked on any maps. It lies on a slight slope which runs down from west to east and it is marked by a circular terrace/platform partly cut into and partly built out on the slope. The circle is approximate 8m diameter and stands to 0.5m high on the downslope side. A slight central boss presumably accommodated a central post/axle. The gin is now grass-covered, but the present owners of Blaenwaun Ganol remember a cobbled surface to the gin. The purpose of the gin is unknown.

39043, the original site of Blaenwaun Uchaf farmstead. The gin is the low earthwork in the centre of the photograph.

It is unusual to discover a deserted farm in such good condition with most of its elements readily identifiable. Care should be taken not to disturb the remains of this site. It is particularly important that no earth-moving machinery is used on the site.

This gin survives in relatively good condition, with little surface damage. It does, however, lie close to a field gate and care needs to be exercised to ensure that it is not subjected to damage from machinery or stock.

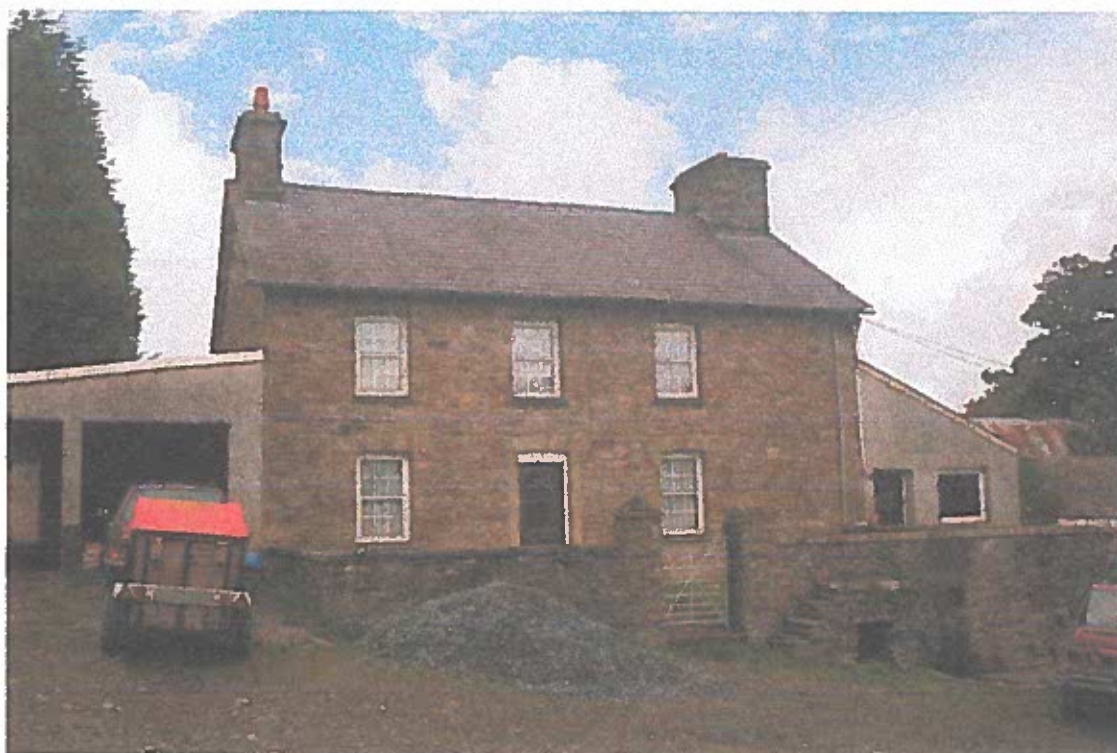
Blaenwaun Ganol is an old established farmstead - it was certainly in existence by the early 19th-century. The location of the farm buildings are recorded on the 1844 tithe map but according to the present owners the farmhouse was rebuilt in c. 1860. It would seem that the outbuildings were constructed contemporaneously with or soon after this as a window sill on the old stable is dated: D J BUILT 1878. The stone-built outbuildings comprise a cowshed with attached pig sty, a cart house with stables? and the dated stables with a mill at the east end. The mill has been allocated number 39051. A 20th century brick-built cow shed has been attached to the stables and there is an assemblage of modern farm buildings at the farmstead. The stone-built farm buildings are in fair to good condition. The farmhouse has been modernised

Blaenwaun Ganol farmhouse, 39050.

Maintain as existing.

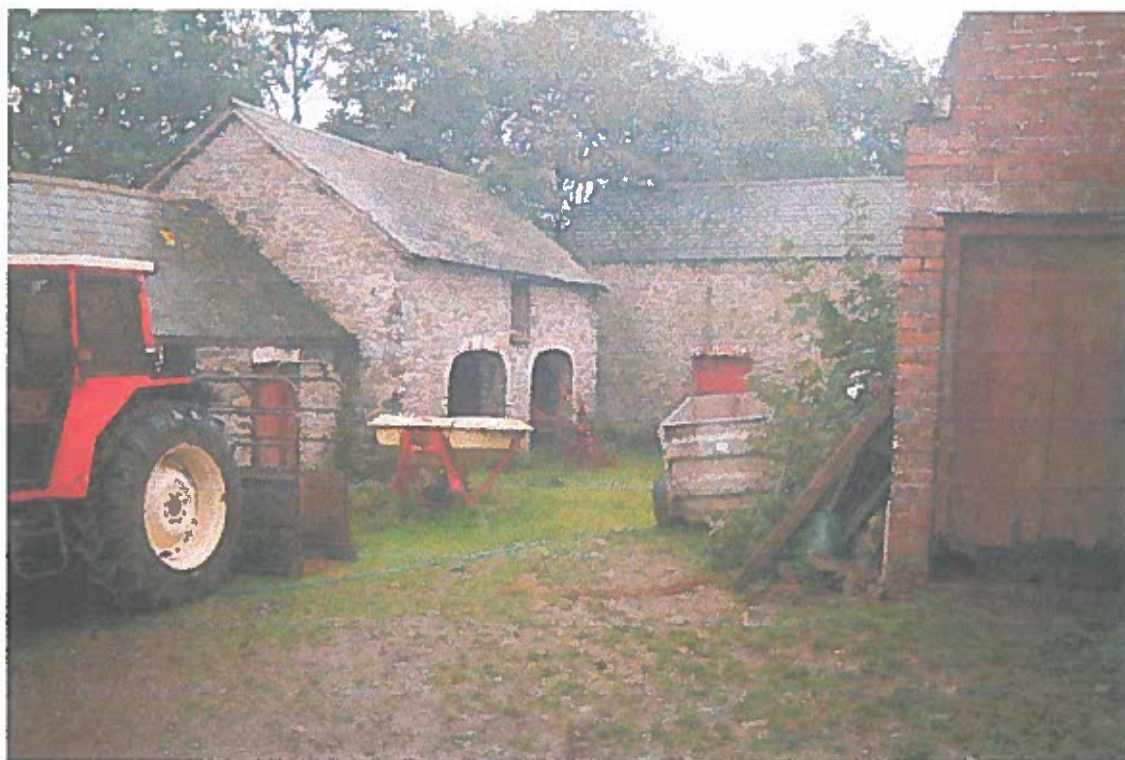
This mill is integral to a stable block dated on a window sill: D J BUILT 1878. The mill now has no internal fittings. A metal overshot wheel is situated immediately to the east of the building. This was supplied by a concrete race (broken) from a mill pond that lay to the southwest (SN50934887). The pond is now filled in and covered with a modern concrete farm buildings. What seems to be a date stone with the number '56' carved on it has fallen into the wheel pit.

Blaenwaun Ganol farmstead, 39050, showing the carthouse and the mill, 39051.

Maintain as existing.

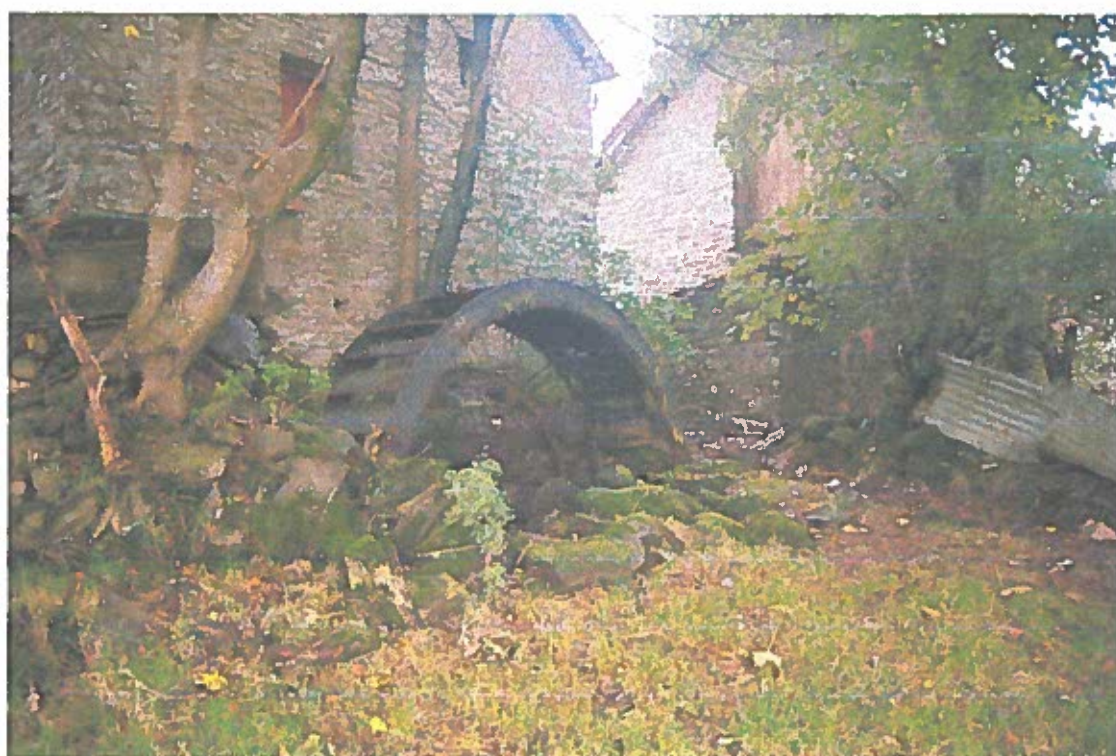
Blaenwaun Ganol farmstead mill, 39051

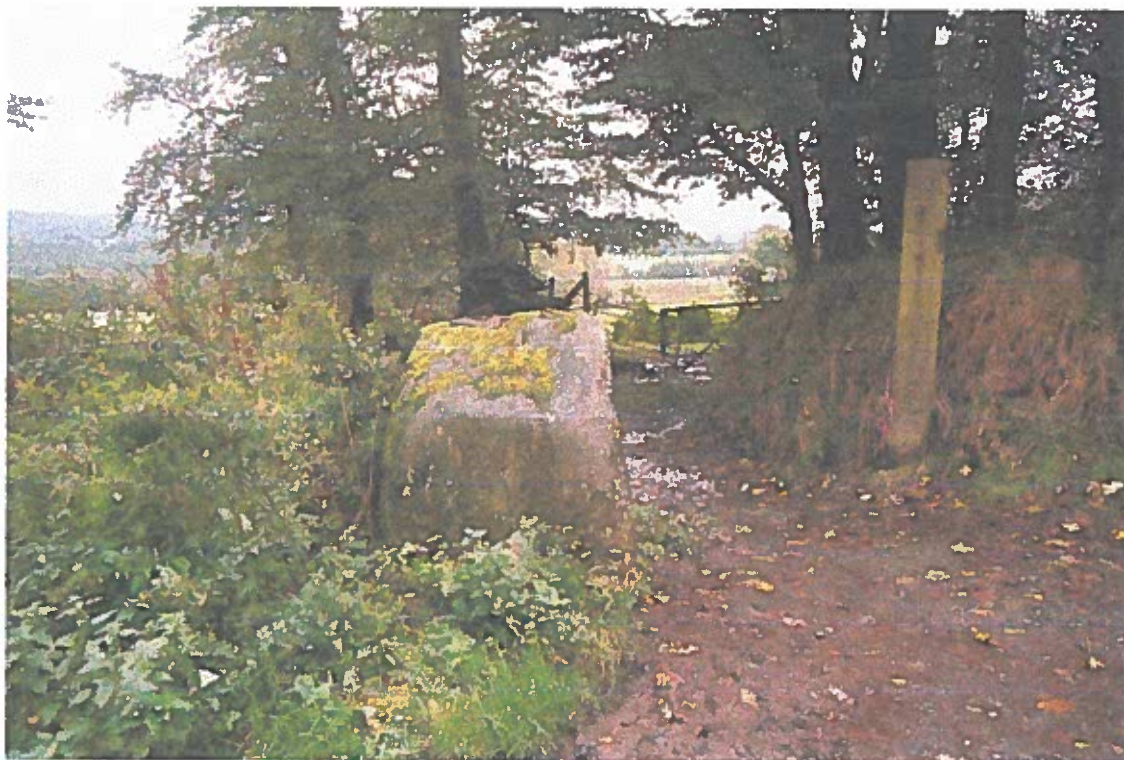
A rounded boulder c. 1.2m high, 1.2m wide and 1.2m thick has been used as a gate post. It is inscribed '1882' in neatly carved numbers.

Gate post, 39049.

Maintain as existing.

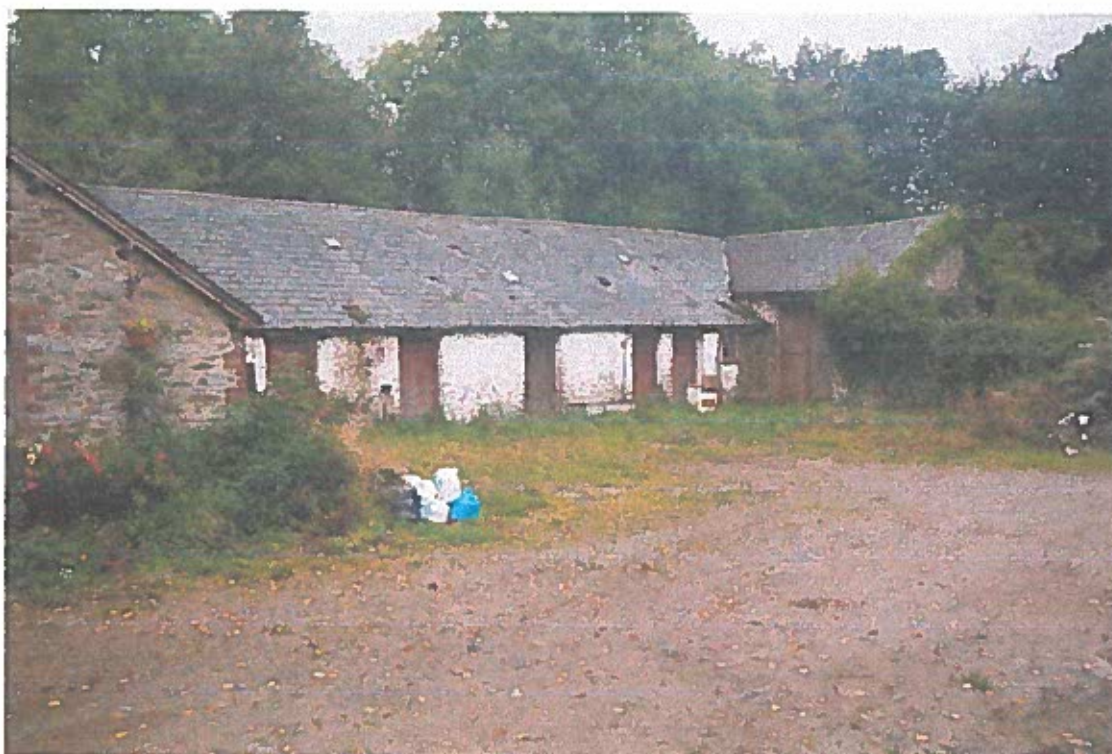
According to the current owners of Blaenwaun Ganol Farm, Blaenwaun Ucha farmstead was moved from its old site 300m to the east of Blaenwaun Ganol (PRN 39043) to its present location in 1876. The farmhouse and outbuildings probably date to 1876. The tithe map and 1891 OS map support this. The farmhouse is two-storeyed with a catslide roof to rear, 3-bayed rendered and recently modernised. A range of outbuildings lies to the north of the house. These are stone built with some red-brick detailing under a slate roof. Essentially it consists of one east-west aligned range with a barn at right angles at the east end. The main range is single-storey with a half loft over. At a later date, but judging from the OS map, pre 1891 a stable wing was added to the west end this was later extended by the addition of a cart house. The whole range contains many original fittings including cow stalls, windows and doors. However it has been disused for some time; slates are missing and there is general neglect.

Blaenwaun Uchaf, 39055, outbuildings.

This farmstead contains an interesting collection of farm buildings. These have not been modernised. It would be desirable to restore them, if a new role for them could be identified.
