Tir Gofal Farm Visit Report

Craig y Borian

W/13/751

ACA Project Record 39320

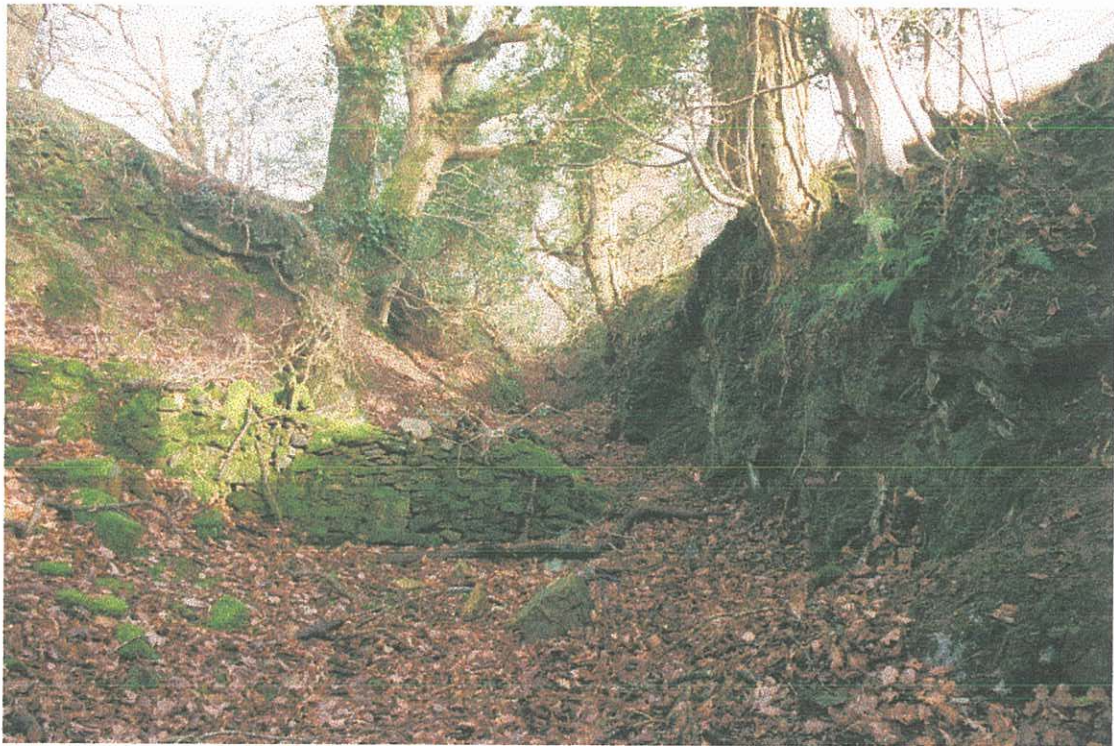
A deep, narrow cutting that extends for some 130m NNE from the site of Pwll-y-Grippin farmstead, PRN25108. In places the cutting is up to 4m deep and c.9m wide. For much of its length the sides are vertical rock faces. The shape of this feature is unusual for a quarry and it is more likely that it was used for some type of mineral extraction (Latham and Jones 1990, 22). A low dry-stone wall extends nearly all the way across the bottom of the feature at roughly the midpoint. There are no obvious signs that the wall was part of a larger structure, but the area is covered in vegetation, leaf litter and dumping so that it is not possible to be certain that there are no other associated structures or features. If the wall was not part of a larger structure it may be that it was constructed to form a simple fold in the bottom of the feature.

Plate 1: PRN 25109 - a low stone wall constructed across the bottom of possible ore workings

It is intended to fence off this feature as part of the Tir Gofal scheme which will protect it from trample damaged by animals. Further dumping should be avoided. Some clearance may be desirable in the area of the wall to try to assess its character.

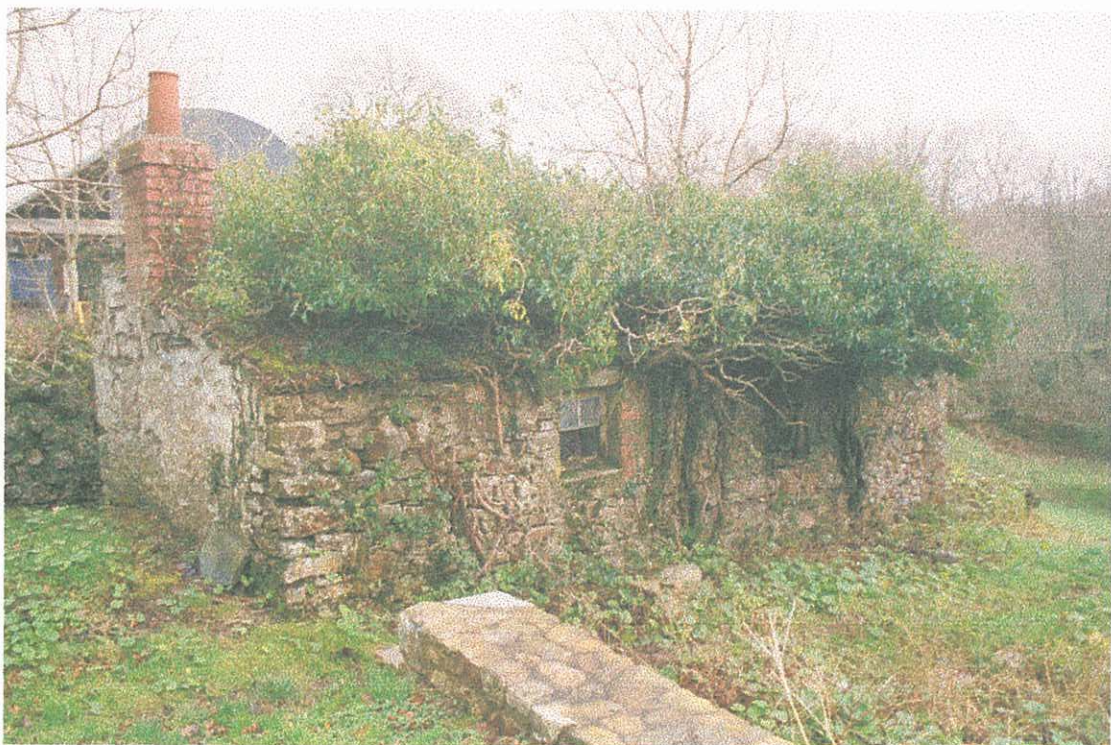
Small, single-storey stone-built structure with a slate roof. The building is aligned NW-SE. It has a sloping roof and a square brick chimney on the NW end wall. There is a toilet in the SE end, entered from the outside. The wooden toilet seat survives. The interior of the building is divided into two equal rooms, although the SE room has the toilet extending into the SW corner. There is a fireplace in the NW wall of the NW room. Both rooms are entered through doors in the NE wall, and both have windows in the SW wall. This building was probably a small cottage for one of the farm workers. This building was shown on the OS 1st edition 1:10560 map published in 1891, and it seemed to be in a small enclosure, possibly a garden plot.

Plate 2: PRN 39322 - worker's cottage in corner of terraced orchard.

This building is in fairly good condition, but it is beginning to suffer from damp and other problems of neglect. It is currently used as a chicken shed and at the very least it should be maintained in its present condition. Ideally the building should be consolidated and the major defects made good.
