AN ARCHAEOLOGICAL EXCAVATION AT TWO LOCATIONS ON  
**THE GENTLEMAN'S WALK**  
HAFOD, CEREDIGION  
DECEMBER 2000

Report No. 2001/35

REPORT NO. 2001/35  
PROJECT RECORD NO. 42750

AN ARCHAEOLOGICAL EXCAVATION AT TWO LOCATIONS ON THE  
GENTLEMAN'S WALK, HAFOD, CEREDIGION, DECEMBER 2000

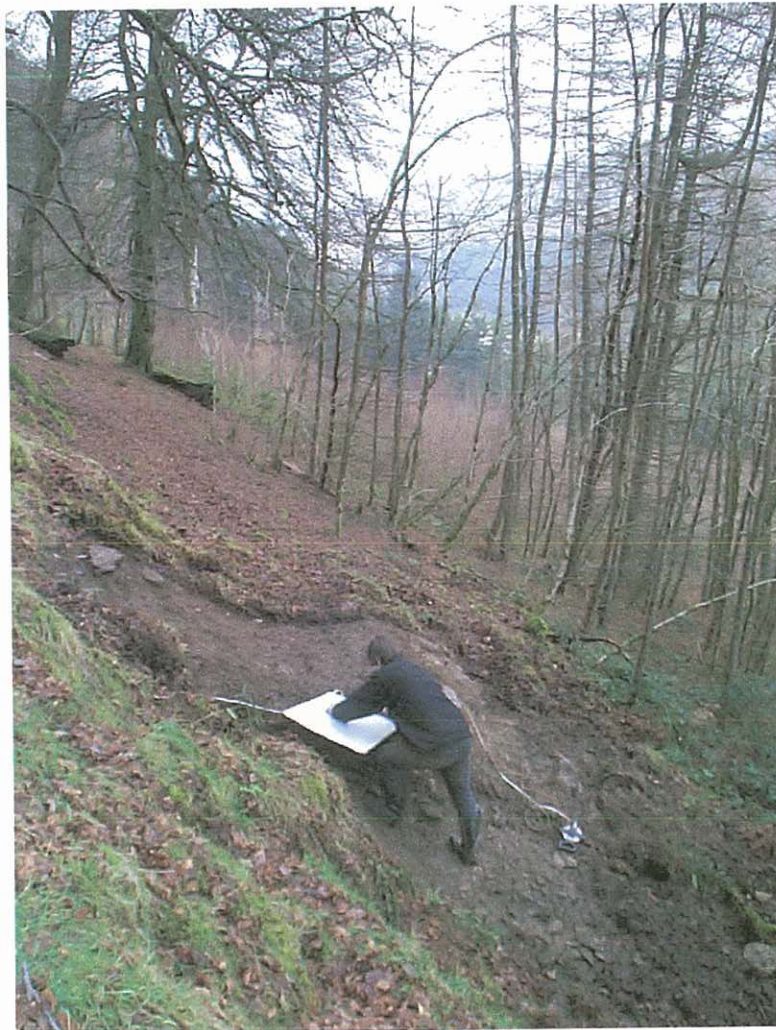
Cover Photograph: Trench 2 during excavation.

The hill-slope in this location is very steep, and therefore a relatively short trench across the path of 3.6m was sufficient to reveal all the constructional elements of the walk. The trench width along the path was *c.* 3m (Fig. 4, Photo 1 and report cover photograph). Along this straight section of the walk on the very steep slope small outcrops of bedrock are apparent at many locations, including at the site of the excavation trench. Removal of leaf mould and the vegetation mat revealed a thin topsoil deposit, 0.1m thick on average (1). On the steepest part of the slope, below the walk, the topsoil was extremely thin, as little as 10mm in places. Topsoil consisted of a dark brown to black, humic, silty clay loam with occasional small stones. Removal of the topsoil revealed constructional elements of the walk. Geological deposits comprised a friable, pale grey-brown silty clay loam with *c.* 40% small- to large-sized angular stones and occasional angular boulders up to 0.4m long (3). Bedrock emerged at the surface down-slope of the walk at the western end of the trench. As with the walk in Trench 1, a walk shelf had been constructed simply by cutting into the steep slope. Rock outcrops and other irregularities precludes the possibility of projecting the original slope profile onto the excavated section (Fig. 4), but it would appear from an examination of the deposits that the sharp outer lip of the walk did not consist of soil deposited from the cutting of the walk shelf into the slope, but was a natural break of slope, including a rock outcrop. However, this outer lip of the walk had been enhanced by the positioning of boulders along its length. Some of these boulders have slipped down the slope. They are too few to ever have formed an outer revetment to the walk shelf, and even calling them a kerb suggests an element of construction that they probably never possessed. It is most likely that they were derived from the geological deposits during cutting of the walk shelf and were placed on outer lip of the terrace to provide definition to the walk. A *c.* 1m wide, 20mm thick, band of compact, slightly gleyed, mid grey-brown clay loam with *c.* 60% small- to medium-sized angular stones (2) defined the surface of the walk. This material, though little different from the underlying geology, from which it was undoubtedly derived, had the appearance of a laid surface, although it is entirely possible that its creation was the result of several decades of trampling, causing a hard crust to form on the exposed geological deposits. As with the surface in Trench 1, the gleying is probably the result of water lying on the compacted surface. It is clear from the excavation plan that the walk curved around the site of the fallen tree. It was not possible to determine whether this was part of the original layout of the walk, or whether it developed through the passage of feet as the tree grew on the outer lip of the walk.

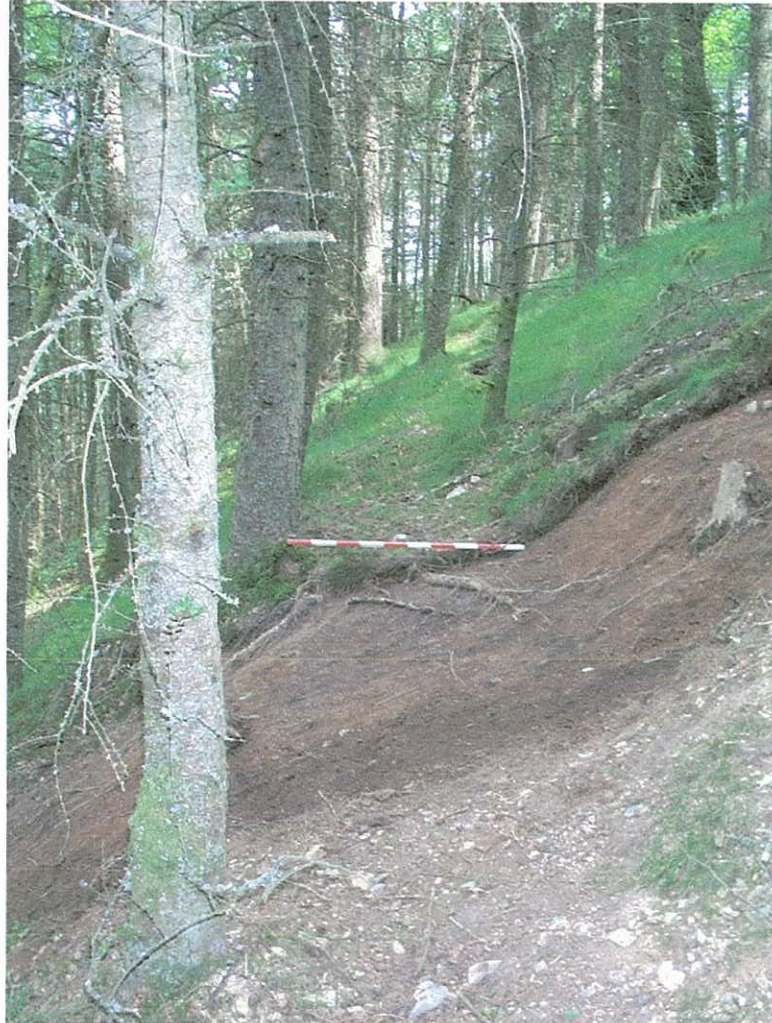
*Photograph 1. Trench 1 viewed from the south showing the path shelf cut into the steep hill-side.*

A single trench, 5.5m long across the path and wide along the path was excavated (Fig. 3, Photo 1). On the southern side of the trench a 0.6m wide section was excavated down to c. 0.4m below the ground surface in order to examine details of the walk's construction. This narrow trench was back-filled on completion of the excavation; the remainder of the excavation was left open to permit examination as part of the restoration process.

Following the removal of sphagnum moss a layer of leaf mould and topsoil lay across the full width and length of the trench (1). On excavation this proved to be about 0.1m to 0.12m thick and consisted of very dark brown to black silty clay loam with a very high humic content. On removal of this layer, subsoil and the walk's surface was revealed. Subsoil (3) comprised a loose and friable yellowish-brown silty clay loam with frequent small angular stones. At a depth of c. 0.20m - 0.25m the subsoil merged into undisturbed fluvio-glacial deposit (4) comprising a slightly more compact, but nevertheless friable, orangy-brown silty clay loam containing approximately 30% - 40% small- and medium-sized angular stones. Layer 3 had been cut into on the up-slope side to form a terrace for the walk. The profile of the terrace compared with the projected pre-walk ground profile suggests that material from the cut was deposited on the outer lip of the walk, although there was no detectable difference between the material on the lip of the path and the subsoil (3). The surface of the path was marked by a thin, 10mm - 20mm, 1.10m wide, compacted layer (2) of a gleyed, light greyish-brown silty clay loam containing frequent small stones. This lay directly on the subsoil (3). It was not possible to demonstrate whether this layer was directly derived from the subsoil and had been formed by the passage of feet compacting the loose silty clay loam, or whether it had been deliberately laid down. The gleying of this deposit may have been the result of standing water and a muddy layer forming over this compact layer during use.

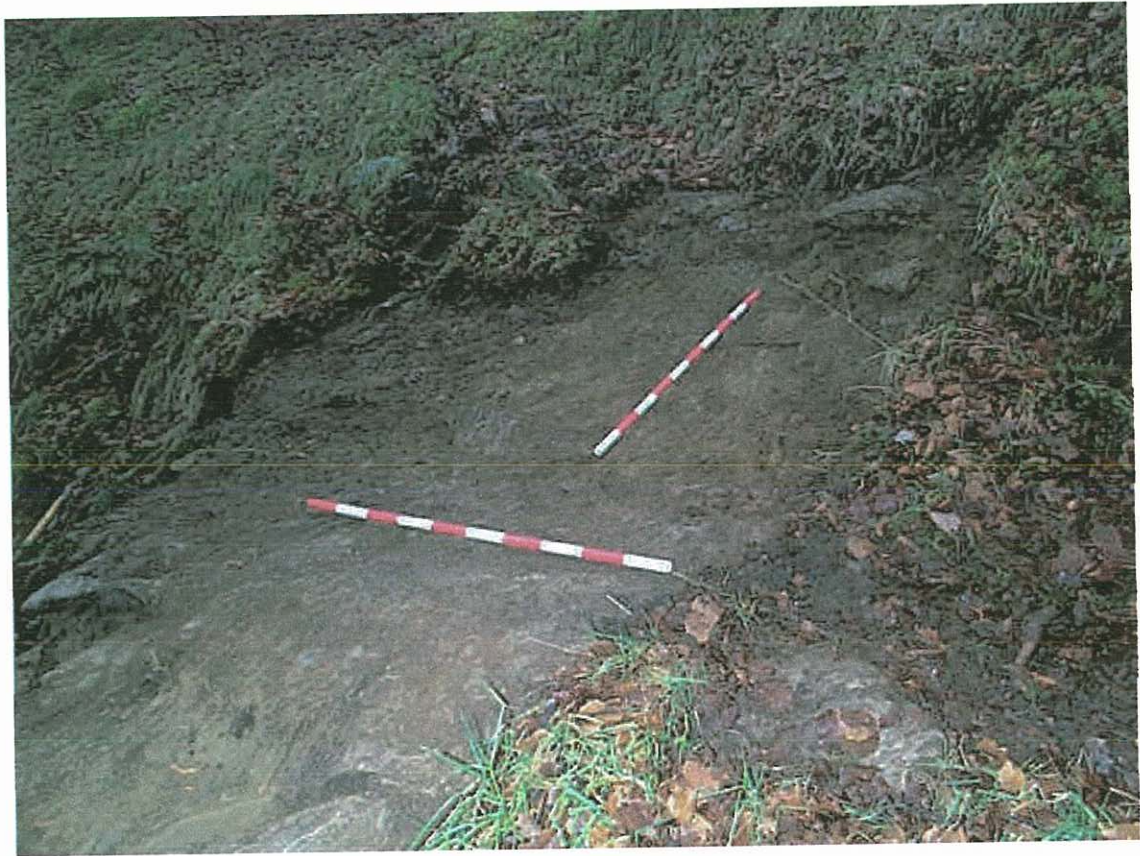
*Photograph 2. Trench 2 viewed from the northwest showing the path shelf cut into the steep hill-side and the stones/bedrock on the outer lip of the walk.*
