Pantau E/10/3201

Tir Gofal Farm Visit Historic Environment Report

REPORT NO. 2002/83
PROJECT RECORD NO. 44098

Pantau
Tir Gofal Farm Visit Historic Environment Report

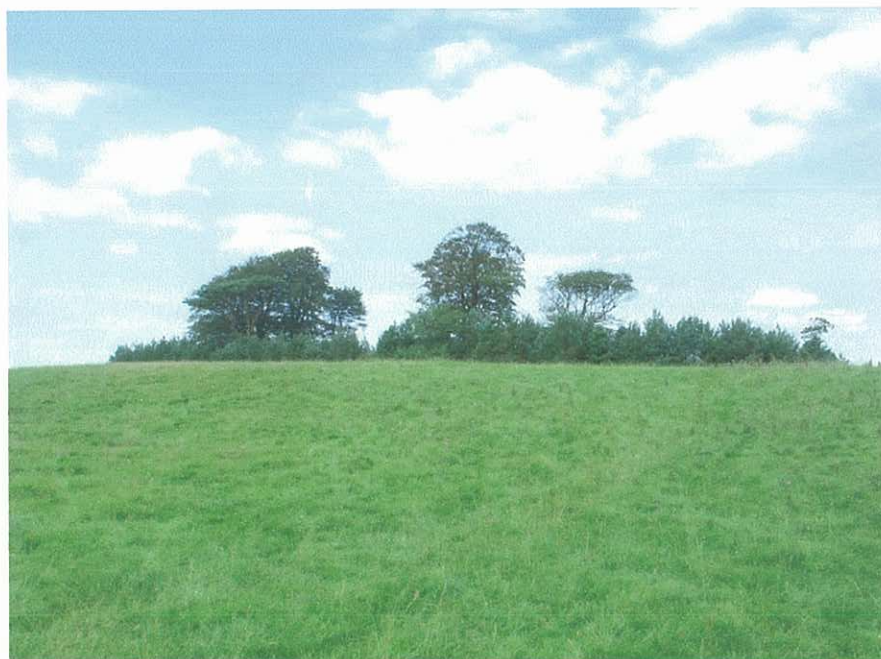
The grove is obviously much diminished from the more extensive area of woodland indicated on the 1749 map (John Butcher) and appears to have been managed to achieve a classic parkland spinney of deciduous and conifer trees by the late 19th century. The deciduous trees represented within the enclosure include beech and hornbeam. The oval enclosure, which probably dates from this period, is defined by an earth bank 1 metre high and 2 metres wide.

Prn 14007 – 'The Grove' is an enclosure of deciduous and conifer trees which occupies a prominent position on the highest point of the holding.

This area is now becoming rather choked with immature coniferous trees and would benefit from some degree of thinning. If any works are to be carried out in this area, care should be taken not to damage the enclosure bank which lies some distance within the now enlarged area of planting.

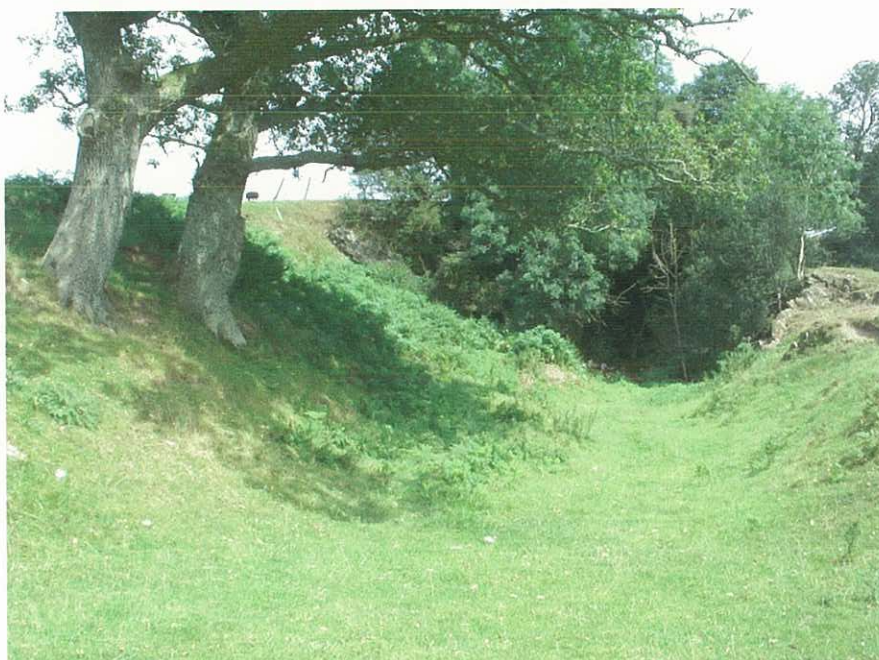
The quarry survives today as a linear cut on a northeast axis into the hillside. At the northeastern end the quarry face and the strike of the rock are still visible, although it is becoming quite overgrown with mature trees. There has also been some dumping of garden waste.

Prn 18807 – this quarry was first recorded on the Ordnance Survey map of 1891.

The quarry should be maintained as a visible historic feature and cleared of debris.

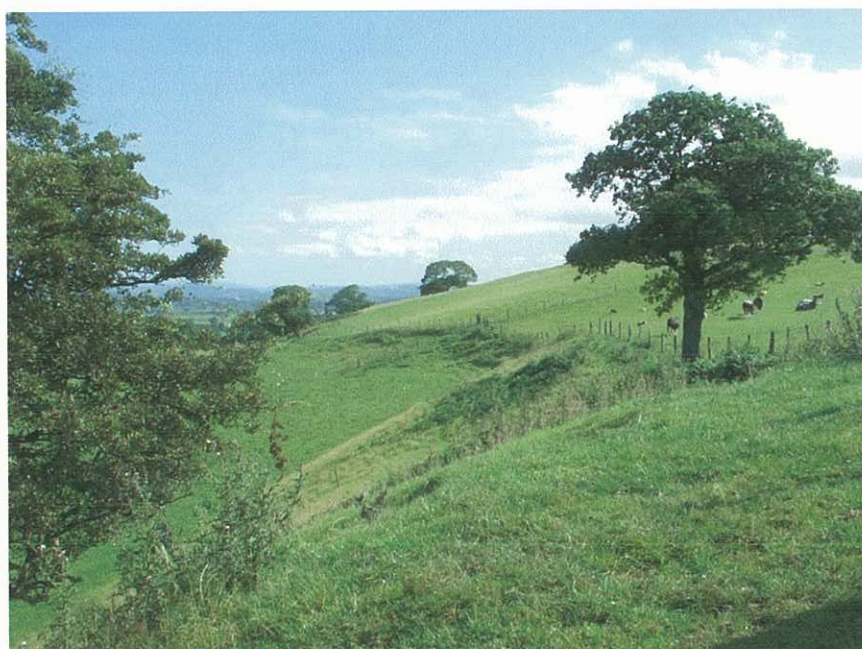
The characteristic parkland landscape at Pantau appears to have been established in the last half of the 19th century. The parkland was probably created by removing existing field boundaries, whilst selectively retaining existing trees and allowing them to grow into mature parkland specimens, so distinctive of this type of land use. Hence the 1st edition Ordnance Survey map of 1891 indicates the position of parkland trees which appear to correspond to the alignments of the preceding field pattern.

Prn 45020 – the parkland at Pantau appears to be partially created from relic field boundaries.

It has been suggested that a programme of tree planting is carried out through the scheme and it is recommended therefore, that the 1st edition Ordnance Survey map should provide a guideline on which to base any future planting schemes and that new planting should broadly correspond with the alignments and groupings indicated on this document. The existing species composition should also be replicated in any new planting.

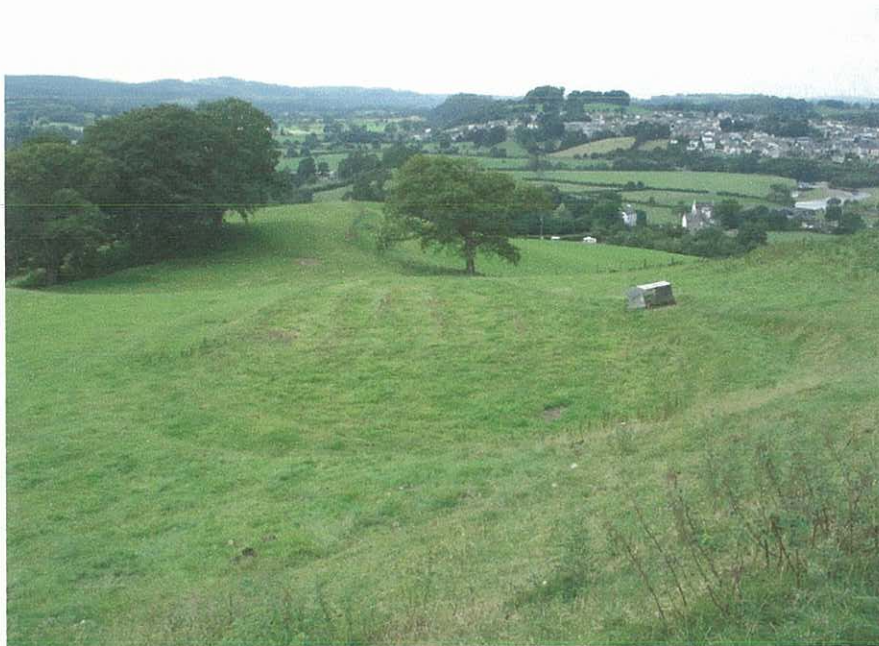
The golf course, established in 1909, is a major feature which has also left an imprint on the landscape of Pantau. The parkland has been influenced by various areas of levelling to create greens or tees.

Although the landscaping is largely in a stable condition at present a sheep feeder is causing some erosion at grid ref: SN 64572257.

Prn 45021 - the landscape at Pantau is peppered with landscaping for the golf course which was established in 1909.

Areas of landscaping should be avoided for feeding livestock and should not be subject to any ground intrusive activities.

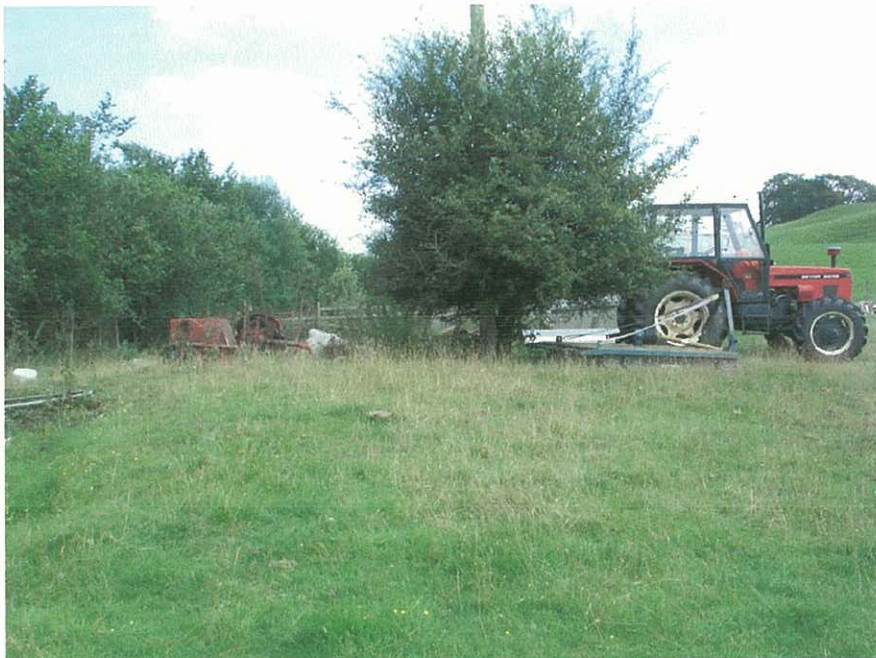
A clubhouse associated with the golf course was situated in the western corner of the land holding, close to the current entrance. There are no upstanding remains of the golf clubhouse, although some foundations can be seen in places at turf level. The services and footprint of the building undoubtedly survive just below the ground surface.

Prn 45023 – the golf clubhouse used to occupy this site, the foundations can still be traced at ground level.

It has been suggested that a new agricultural building is sited in this position. In order to preserve the historic remains which are located here the surviving archaeology must be given due consideration in advance. It is suggested that there are two options; either the building is not sited on the foundations of the old clubhouse and is positioned elsewhere within the enclosure at the west corner of the field. Alternatively it may be possible to overlay the foundations of the clubhouse with a membrane and hardcore to preserve the old foundations *in situ*. This would undoubtedly reduce the archaeological impact. However, an archaeological watching brief would still be necessary during site clearance and the laying of services.

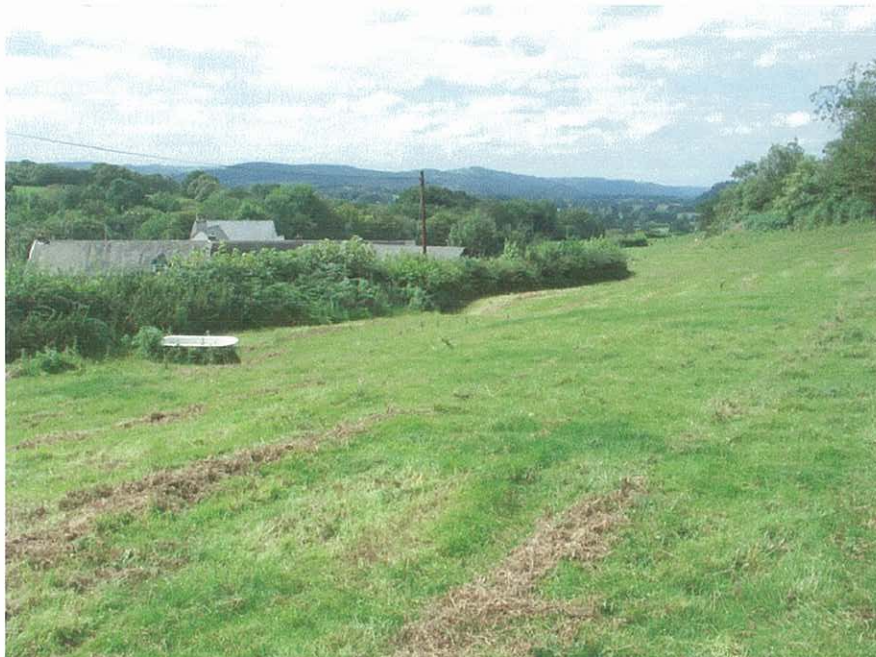
A triangular enclosure is recorded on the tithe map of Llandeilo-fawr in 1838, which appears to be associated with the cottage which was situated on the south side of the road. The eastern boundary is all that is recorded on the 1st and 2nd edition Ordnance Survey maps and this appears to survive as a very slight earthwork bank. There is currently a water trough sited against this relic boundary.

Prn 45026 – the slight earthwork bank is the remains of an enclosure associated with a cottage on the other side of the road.

Although the water trough does not appear to be causing significant damage, ideally it should be relocated away from this area.
