Blaenau Farm E/10/2905

Tir Gofal Farm Visit Historic Environment Report

Report No. 2002/101

REPORT NO. 2002/101
PROJECT RECORD NO. 44100

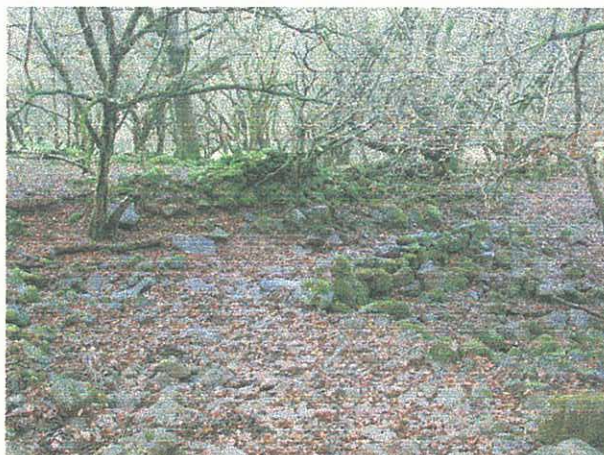
Stone surfaced road crossing over the Afon Sawdde to the west of Blaenau Farm, and leading past the sheepfold PRN 47101 onto the mountain to the south towards Llyn y Fan Fach. It is labelled as 'BR' (Bridle Road) on the Ordnance Survey mapping.

Plate 1 – Stone surfaced bridle road (PRN 47102),
with some evidence of dry stone side walls present.

Maintain as a historic landscape feature.

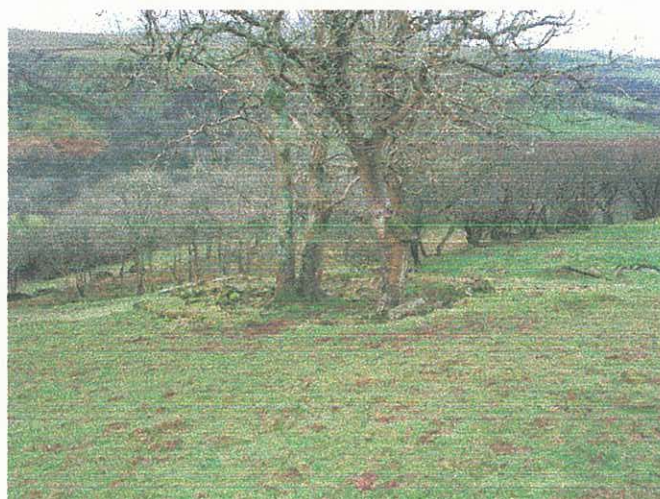
Cottage site on the north side of trackway PRN 47112. Now a low stone and earth bank enclosure with mature trees in its centre. It is shown on the 1838 Tithe Map and Apportionment for Llanddeusant Parish but marked as an open enclosure. It was therefore unoccupied prior to the middle of the 19th Century.

Plate 2 – Cottage site (PRN 47105)

Maintain as existing. No ground breaking works should be undertaken within 15 metres of this site in order to protect any buried archaeological remains.

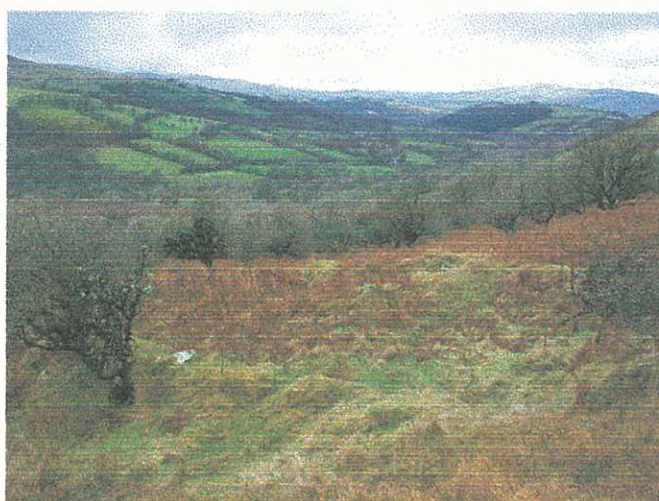
Cottage site high up past the end of the trackway from Gelli-onen (PRN 47112) and the two other cottage sites attached to the trackway (PRNs 47105 and 47106). It is shown on both the first (1891) and second (1907) edition Ordnance Survey maps but marked as an open enclosure. It is therefore likely to be an unoccupied dwelling prior to the end of the 19th Century.

Plate 3 – Cottage site (PRN 47107)

Maintain as existing. No ground breaking works should be undertaken within 15 metres of this site in order to protect any buried archaeological remains.

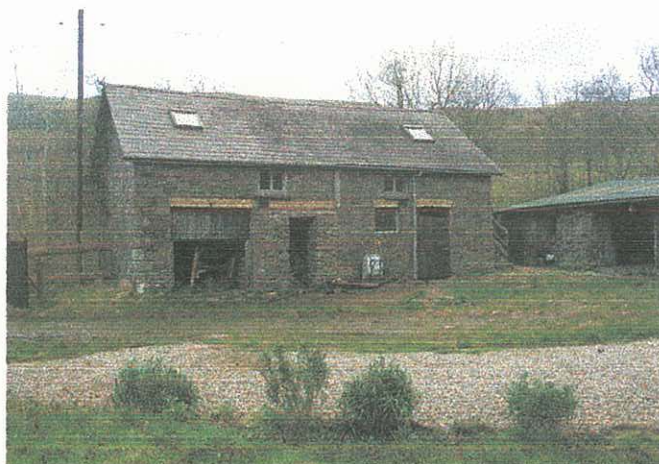
Two storey east – west gabled barn with stabling and cart sheds below, and accommodation above accessed by an external staircase at the east end. The farmer believes that this building relates to the construction, between 1914 and 1918, of the reservoir at the head of the valley, Llyn y Fan Fach. It may have been built for accommodation of the men and animals who worked on laying a mains water pipe from the lake to provide a water supply for the Llanelli district.

However, the first and second edition Ordnance Survey maps appear to show a building where this barn stands and they predate the construction of the dam wall. It is possible that the present building is a rebuilding of an existing structure during the period when the dam wall was constructed. Alternatively the building predates the dam wall and may or may not have been used during the construction of the reservoir.

Plate 4 – Stables and cart shed building (PRN 47109)

This building is in good condition and should be kept in good order. Any repairs or maintenance works should use traditional materials and methods in order to preserve its historic character.

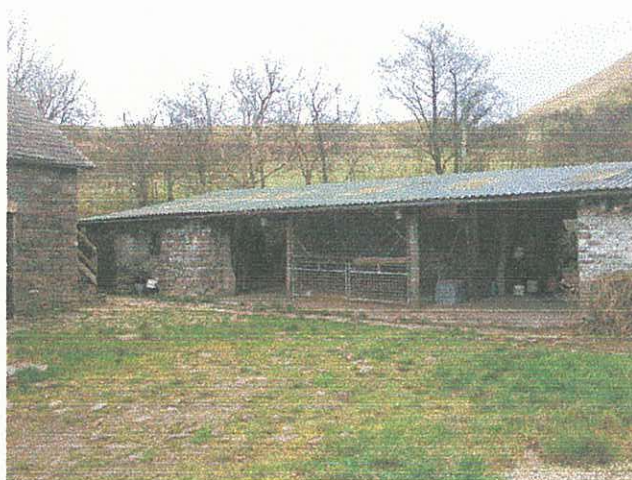
Long low one storey range attached to the north end of Blaenau farmhouse (PRN 47111) and forming an 'L' shaped range with stables and cart shed building (PRN 47109). It is now in use as a kennels.

Plate 5 – Shed (PRN 47110)

This building is in good condition and should be kept in good order. Any repairs or maintenance works should use traditional materials and methods in order to preserve its historic character.

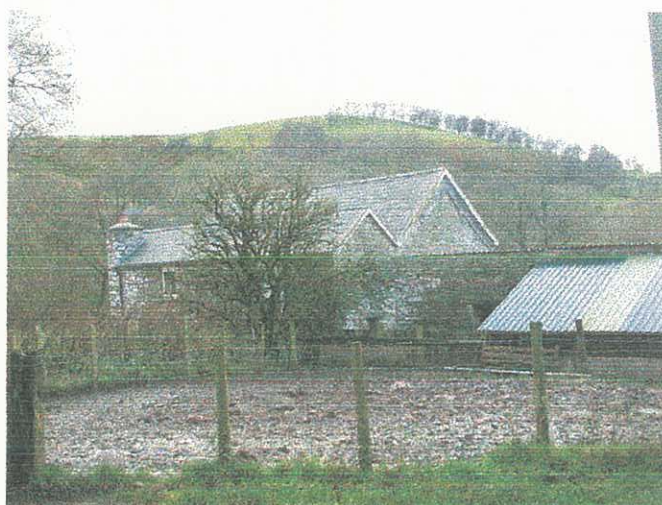
West facing farmhouse with uneven 'M'-shaped roof and large chimney stack at the south east corner. According to the farmer at Blaenau, it was extended in or around 1870 which may relate to the demolition of 'Tyr r Bwch' cottage (PRN 47106) and the use of the building materials from there in the extension works on the farmhouse.

Plate 6 – Rear of Blaenau farmhouse (PRN 47111)

This building is presently used as a dwelling and is not included in the Tir Gofal agreement.

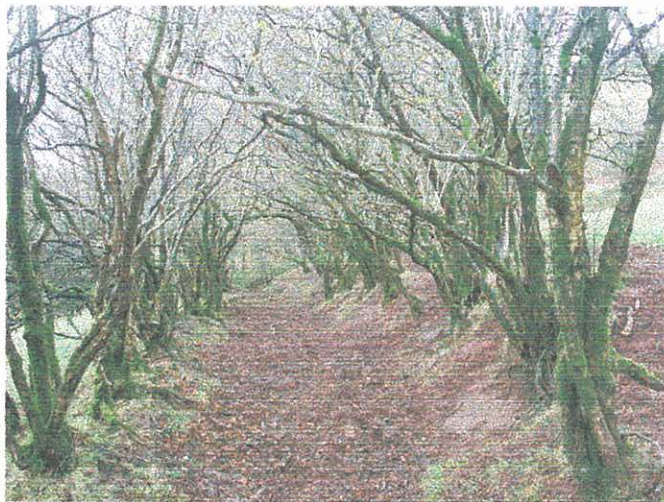
Wide trackway bordered by outgrown hedgerows on either side, leading from Gelli-onen farm (SN79252431) to the west past cottage sites PRN 47105 and 47106 and terminating when it reaches Nant y Creigiau with the cottage site PRN 47107 above.

Plate 7 – Looking west along trackway (PRN 47112)

Maintain as a historic landscape feature.
