LLANLLWCH MILL LEAT AND POND

SURVEY FOR MR. W. JENKINS,

DYFED ARCHAEOLOGICAL TRUST LTD.

SUMMARY OF SURVEY

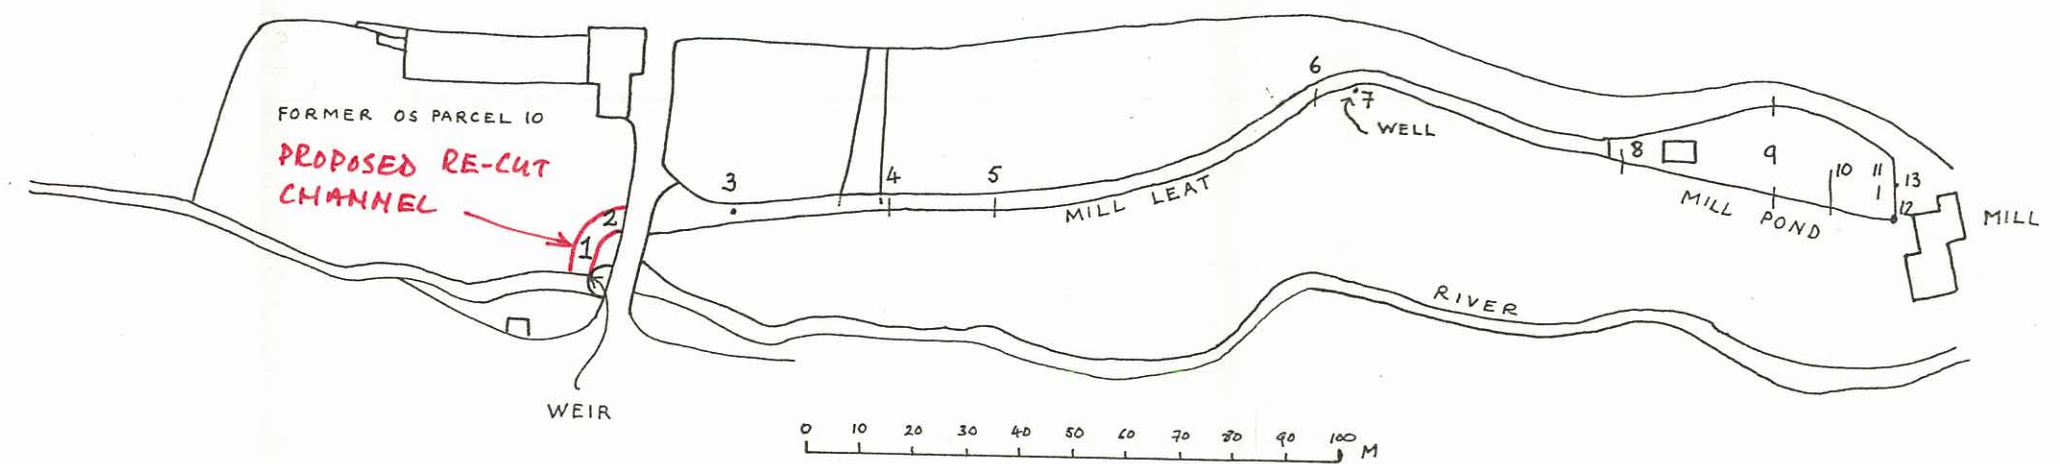
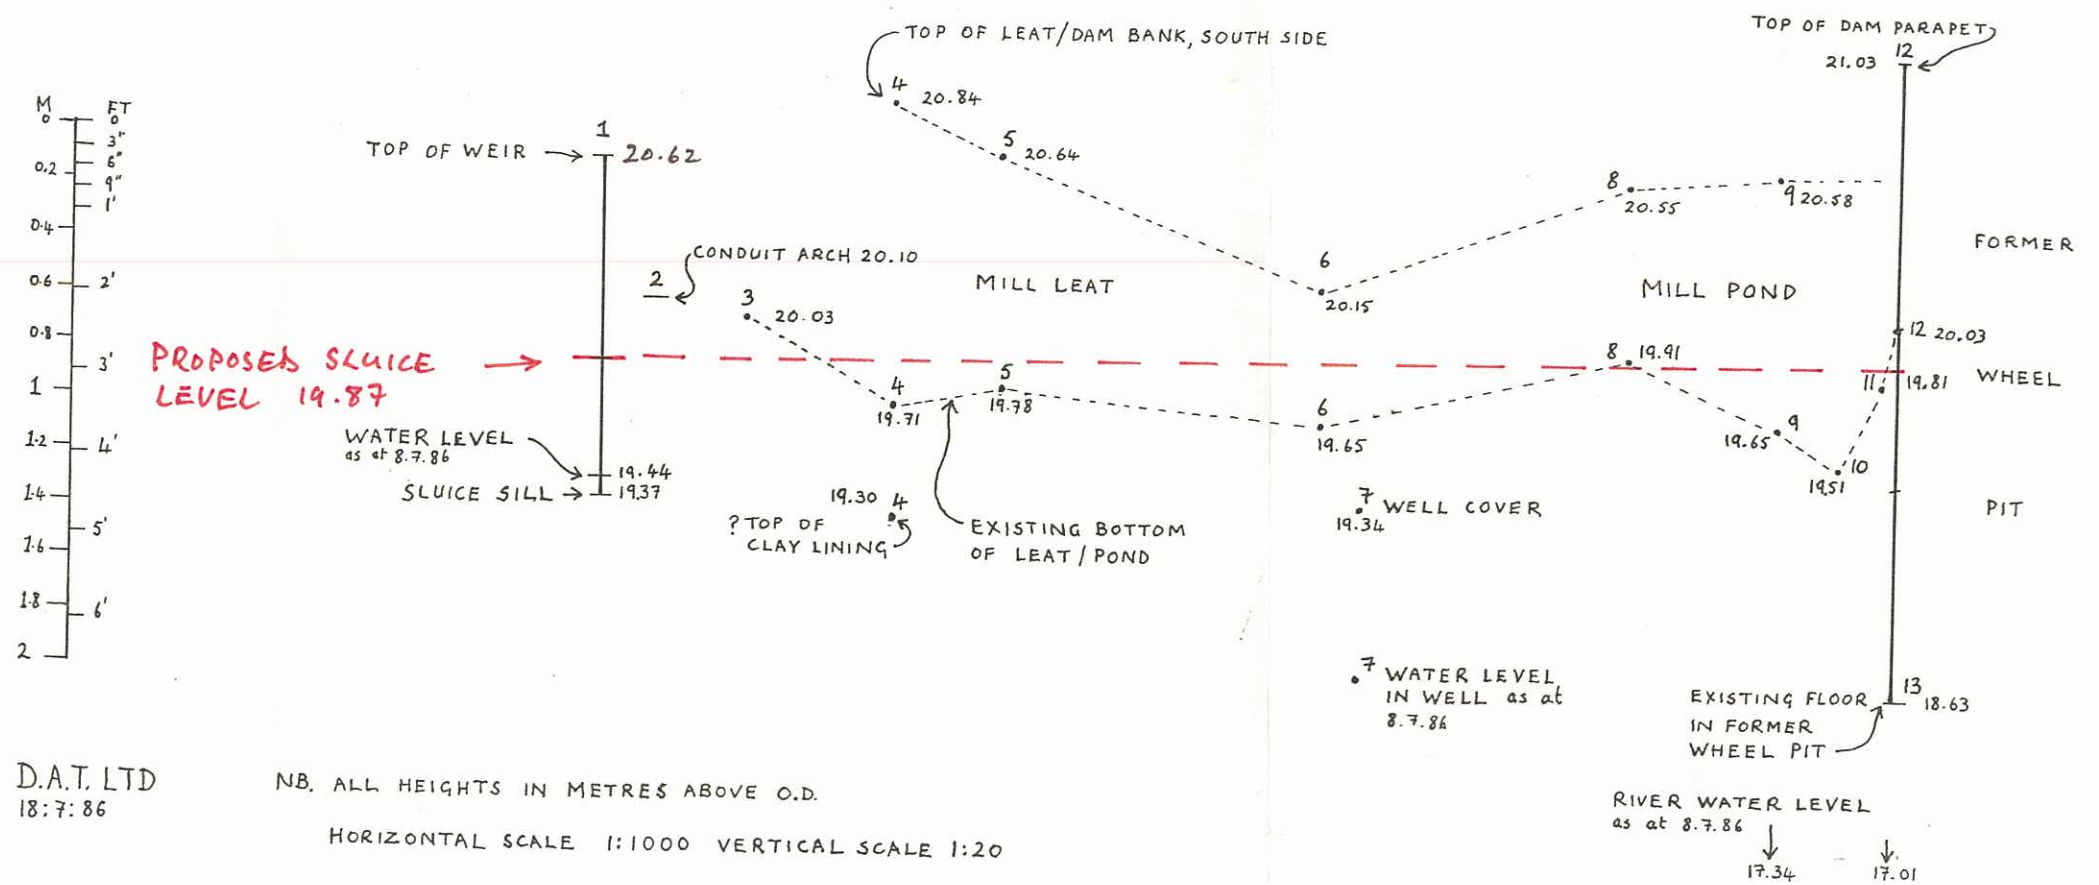
LLANLLWCH MILL

A complete longitudinal profile along the leat bottom and top of the leat bank was not undertaken, but it is considered that the spot levels taken at the intervals shown on the accompanying diagrams were sufficient to establish water level requirements. Irregularities in the level of the bottom of the leat and in the mill pond are due to a limited amount of dumping in a few areas (eg point 3, and point 7). A certain amount of soil has accumulated as a result of natural weathering since the leat was withdrawn from working use, but this material could easily be removed. A small excavation at Point 4 suggested that the original clay lining of the leat lies some 40cms/1'4" below the existing bottom of the leat. Further excavation would be necessary to establish this matter conclusively.

To secure this situation, we imagine that it would be necessary to obtain rights to re-cut and maintain a channel from the north side of the weir to the conduit feeding the leat (as marked in red on the enclosed plan), and reconstruct and maintain the weir with sluice gates at a height of 50cms/1'8" (at 19.87m above OD) above the existing sill.
