Berthlwyd W/12/2842

Tir Gofal Farm Visit Historic Environment Report Call Out

Report No. 2003/40

Berthlwyd
Tir Gofal Farm Visit Historic Environment Report

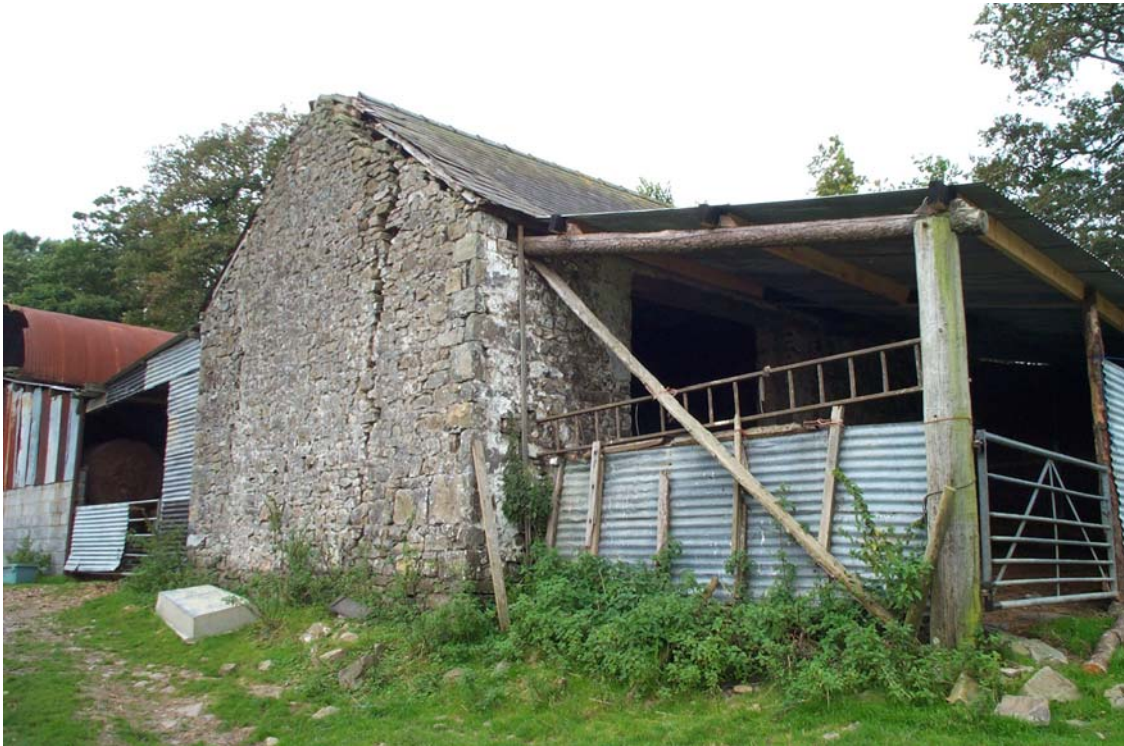
The east gable end of Berthlwyd barn

The barn is currently suffering from two massive structural cracks in the east gable wall, on either side of the apex. The cracks extend from the wall tops to very nearly plinth level. Therefore the centre section of the east gable end has lost its bonding with the stone quoins to either side and appears to have moved out of plumb.

The roof is also in a poor condition at this gable end with the wall tops exposed to the elements. No doubt the weathering of the wall tops, with water percolating through the walls and washing out the bonding matrix, has had some part in causing the structural instability in the gable wall. It also appears that the plinth has become unstable and some of the stone is loose, due to weathering of the bonding mortar.

The owner, Mr. Adams, hopes to repair and restore this barn within the Tir Gofal scheme. This proposal is to be welcomed. Due to the severity of the cracks, Mr Adams has proposed that the central section of the gable wall is taken down and that a concrete raft is inserted at ground level, underpinning the gable end. The gable end will then be rebuilt in traditional materials to tie in with the existing masonry to either side.

It is almost always preferable that traditional building materials are used throughout the restoration process of a building. In this case, the use of concrete underpinning should only be used if it ensures the long-term structural stability of the building. The rebuilding of the gable wall and the stone plinth should use stone with lime mortar bonding to match that existing, in order to retain the historic character of the building as far as possible.
