ST. MICHAEL'S CHURCH, MYDDFAI

ARCHAEOLOGICAL WATCHING BRIEF

Report No. 2002/77

Report Prepared for:
ROGER CLIVE POWELL ARCHITECTS

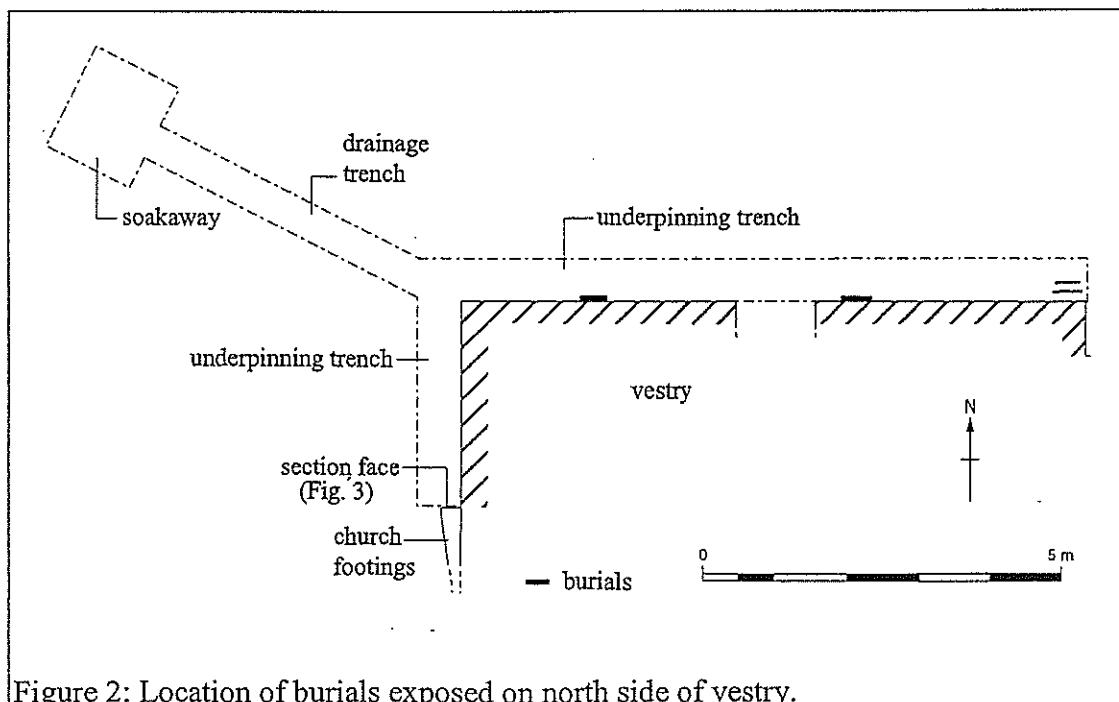
New drains were required around the church building to aid the ground water run-off. The insertion of the drains was carried out at the same time as a programme of underpinning around the north and west walls of the vestry. The drainage trenches were fairly shallow, c.0.3-0.5m deep, and ran along the outer face of the walls.

The shallow nature of most of the trenches ensured that few deposits of archaeological interest were exposed. Three human burials were partially exposed but left undisturbed along the north wall of the vestry (Fig. 2). They all pre-date the construction of the vestry in the 19th century.

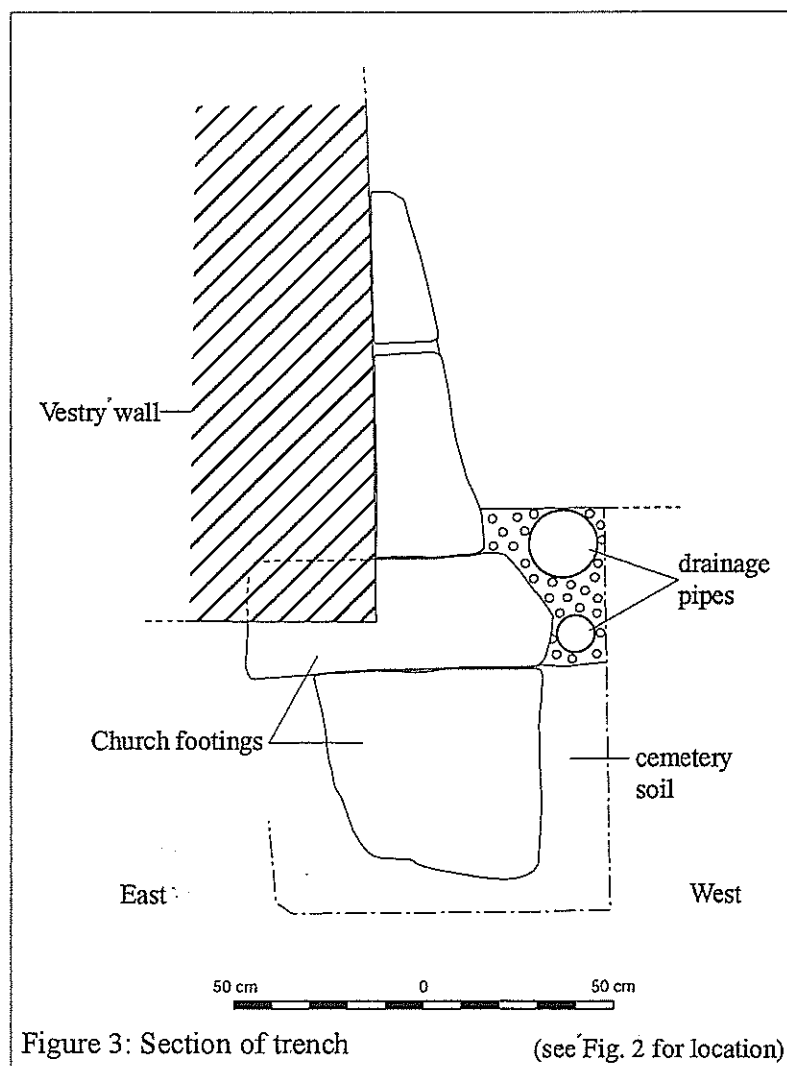
Part of the large stone foundations for the medieval church were also recorded in section (Fig. 3).
