TIR GOFAL MANAGEMENT PLAN: HERITAGE MANAGEMENT INFORMATION (HE2)

**Prepared for:
Llwyn-y-brain**

**Tir Gofal Reference No
W/12/3942**

**ACA Report No. 2005/21
Project Record No. 48464**

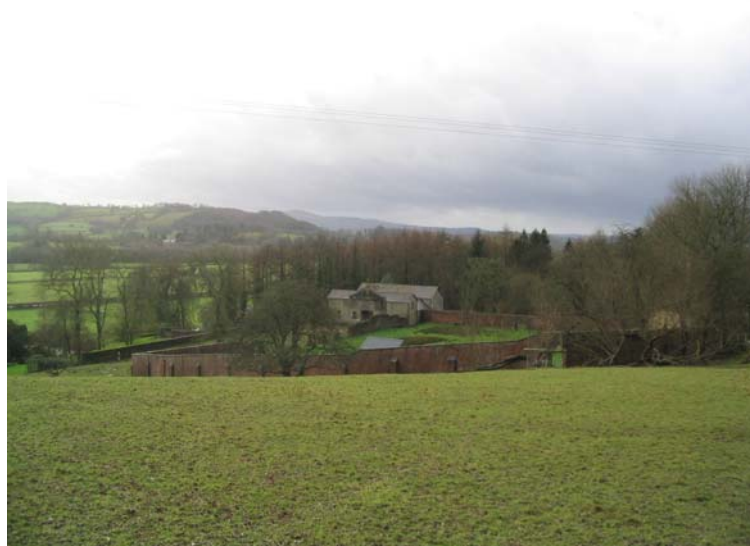
Name (& PRN)	Period/Site type	NGR	Status SAM/listing	Management required
1	LLWYN-Y-BRAIN (53406)	Post Medieval walled garden	SN73683295	B	Specific
<p>A fine walled garden to the north of Llwyn-y-brain mansion (PRN20926). The garden is roughly rectangular, aligned northeast - southwest and covers about one and a half acres. The high walls are built of brick and capped with slate slabs with narrow buttresses set at regular intervals. There was once a building against the south wall, the stone rear wall of which survives and is now incorporated in the garden perimeter. The rest of the south wall consists of an ornamental entrance and section of wall comprising a series of inverted brick arches supporting ceramic round finials.</p> <p>The garden appears on an estate plan of Llwyn-y-brain of 1856. It is shown as an irregular rectangle of around one acre and remained as such until at least 1887 (Ordnance Survey First Edition map) but had been extended to about one and a half acres by 1906 (Ordnance Survey Second Edition map) when the garden appears in its present form for the first time. Several glass houses are shown but none of these survive.</p> <p>The perimeter walls are intact and stable but masked by ivy in places. An orchard has been recently established inside the garden.</p>

**LLWYN-Y-BRAIN WALLED GARDEN
(53412)**

The aim is to slow down decay of the garden walls and enhance visibility.

- Cut back ivy growth on the walls leaving the roots in situ. This will reduce weight on the walls from excessive vegetation growth.
- Young trees growing on/ within the walls to be cut off at the roots and spot treated to prevent re-growth. This will prevent displacement of brickwork by uprooting or collapse.
- Vegetation removal to be followed up with a programme of consolidation and re-pointing using a traditional lime mortar mix. As a general rule repointing is not necessary until mortar has weathered back to a depth equivalent of the joint width or is very loose. Seek specialist advice on an appropriate mix.
- Mature trees growing near to the walls to be monitored. Unstable specimens to be cut off at the roots before being allowed to fall naturally. This will prevent damage by trees/ branches collapsing on to the walls.
