TIR GOFAL HISTORIC ENVIRONMENT: CALL OUT VISIT

Prepared for: Llanfair-fawr W/11/4634

Report No. 2005/11 Project No. 49534

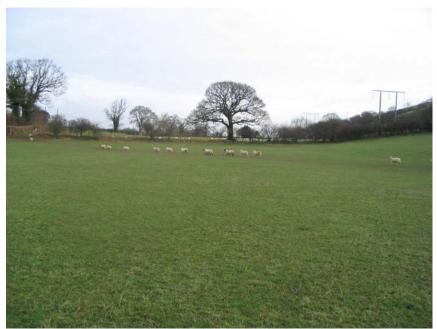
The line of the Roman road. No obvious earthwork traces survive.

No obvious earthwork traces of the road were identified during the farm visit. These fields have a history of cultivation with cereals, fodder crops (sweed, fodder beat) and ley pasture grown in rotation.

Earthwork remains of the road have been planed flat and buried remains have undoubtedly been disturbed and damaged. It is likely that undisturbed archaeological deposits lie beneath the maximum depth of cultivation however.

It is proposed that cultivation will continue within these fields under arable options offered within the Tir Gofal scheme. Oats, swedes and ley pasture will be grown in rotation.

Establishment methods for these crops will be similar to those used previously and the depth of cultivation will not increase. The swede is intended as a fodder crop and will not be harvested. Sub-soiling will not be undertaken.

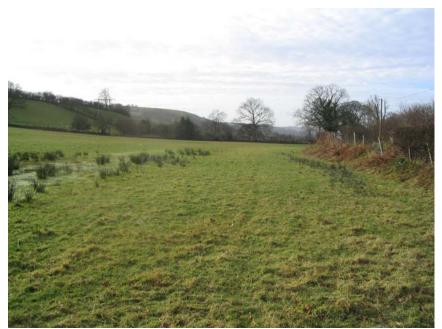
The road (PRN 51950) appears as a 500m long cropmark in four fields in the north of the farm. Proceeding south the route is less distinct. A projected southsouthwest line, linking with a southwest aligned cropmark at Pentre continues south towards Carmarthen. There is a popular belief that a second route diverges to the southeast to following the line of an unclassified road, before crossing the Nant Clywedog and eventually joining the Sarn Helen. Locals remember the road showing as a parchmark during haymaking in the dry summer of 1976.

Vegetation changes may mark the course of the road in the north of the holding.
