AN ARCHAEOLOGICAL EVALUATION AT Y BEUDY, MATHRY PEMBROKESHIRE

APRIL 2005

RHIF YR ADRODDIAD / REPORT NO. 2005/47
RHIF Y PROSIECT / PROJECT RECORD NO.54066

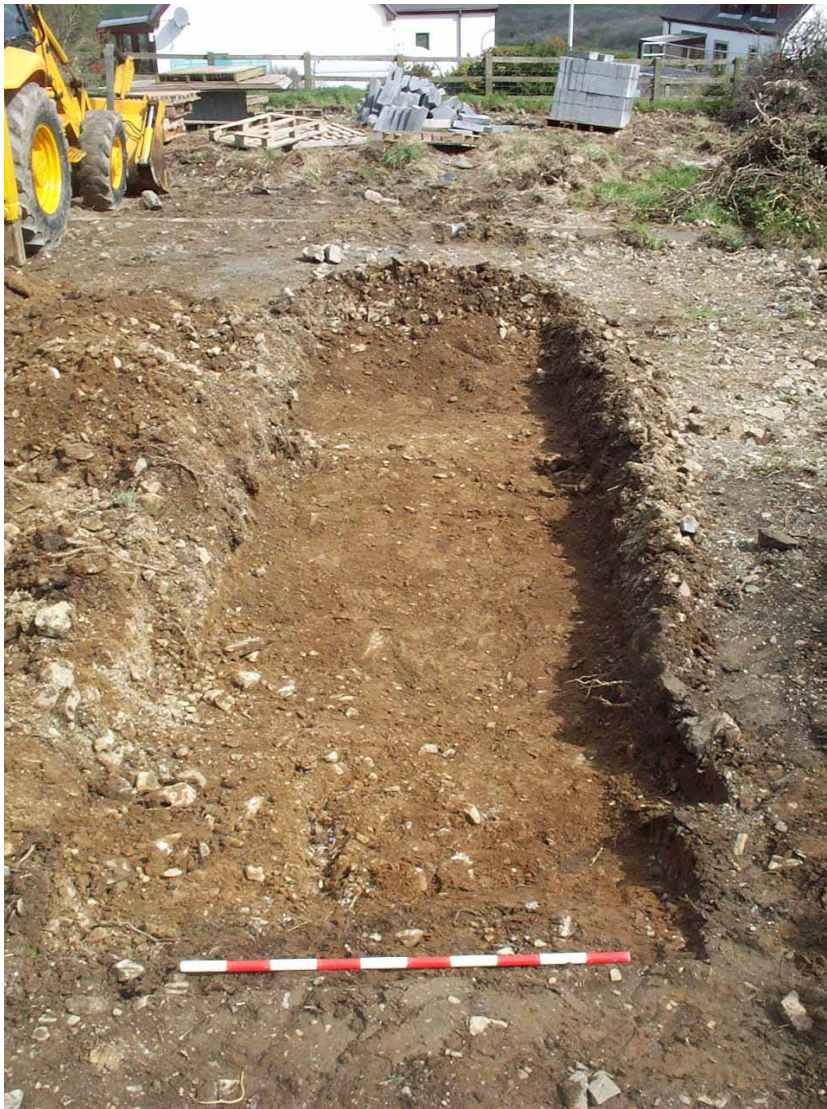
Photo 1: Trench 1, looking north

The ground surface had been previously compacted. Topsoil was removed down to the interface with the natural geology of the area. In this location natural consisted of mid brown silt with shattered shale inclusions known locally as 'rab'. The topsoil was essentially the same material with a greyer silt with a higher organic content.

Yellow-grey silts lying just above the natural geology were excavated but were found to be remnants of topsoil that remained where the underlying geology sloped down slightly towards the north.
